MEMORANDUM | August 17, 2023

I-20 / I-26 / I-126 Corridor Improvement (Carolina Crossroads)
Asset IDs 7272, 7586, and 7937 - Laboratory Studies of Concrete Cores

WJE PROJECT NO. 2023.1990

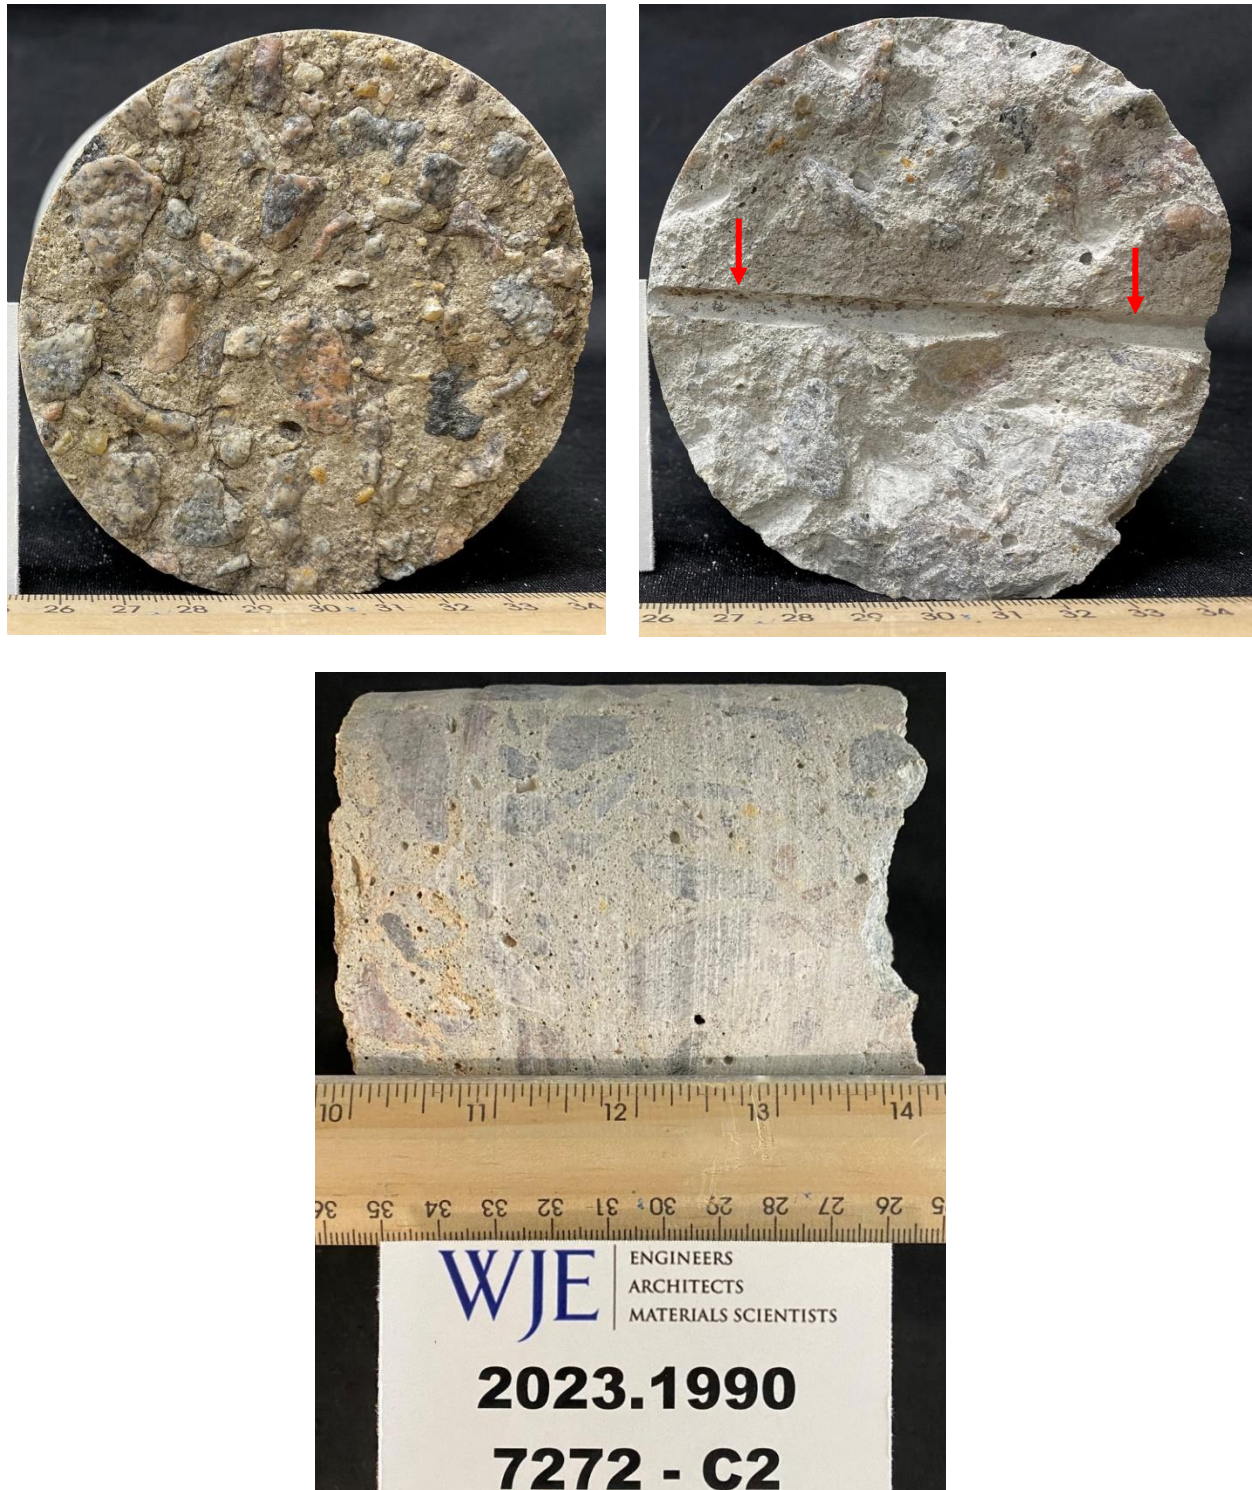
Figure 1. 7272-C2. As-received, with the top surface in the top left image, bottom surface in the top right, and a longitudinal view of the core with the top surface to the left in the bottom image. Red arrows indicate impressions of steel wire on the bottom of the core. Note orangish, discolored paste along the top surface region, likely due to carbonation and weathering.

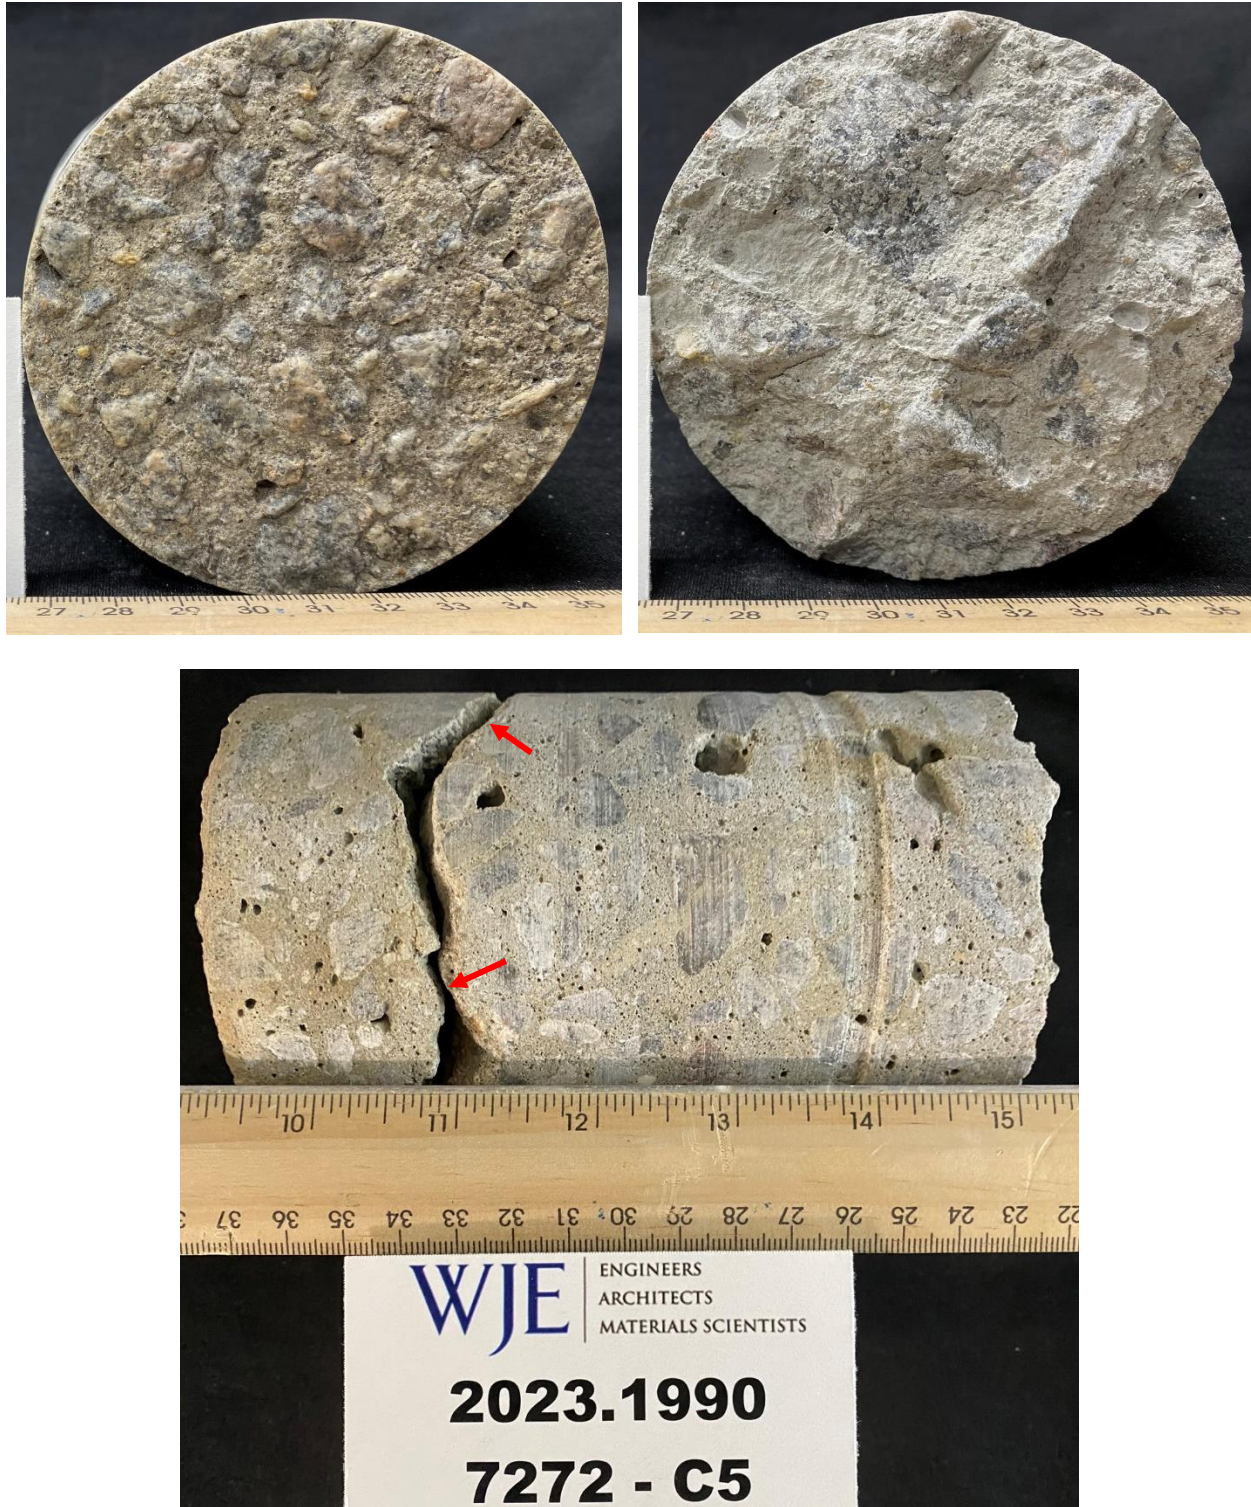
Figure 2. 7272-C5. As-received, with the top surface in the top left image, bottom surface in the top right, and a longitudinal view of the core with the top surface to the left in the bottom image. Red arrows indicate a surface-parallel to surface-oblique fracture.

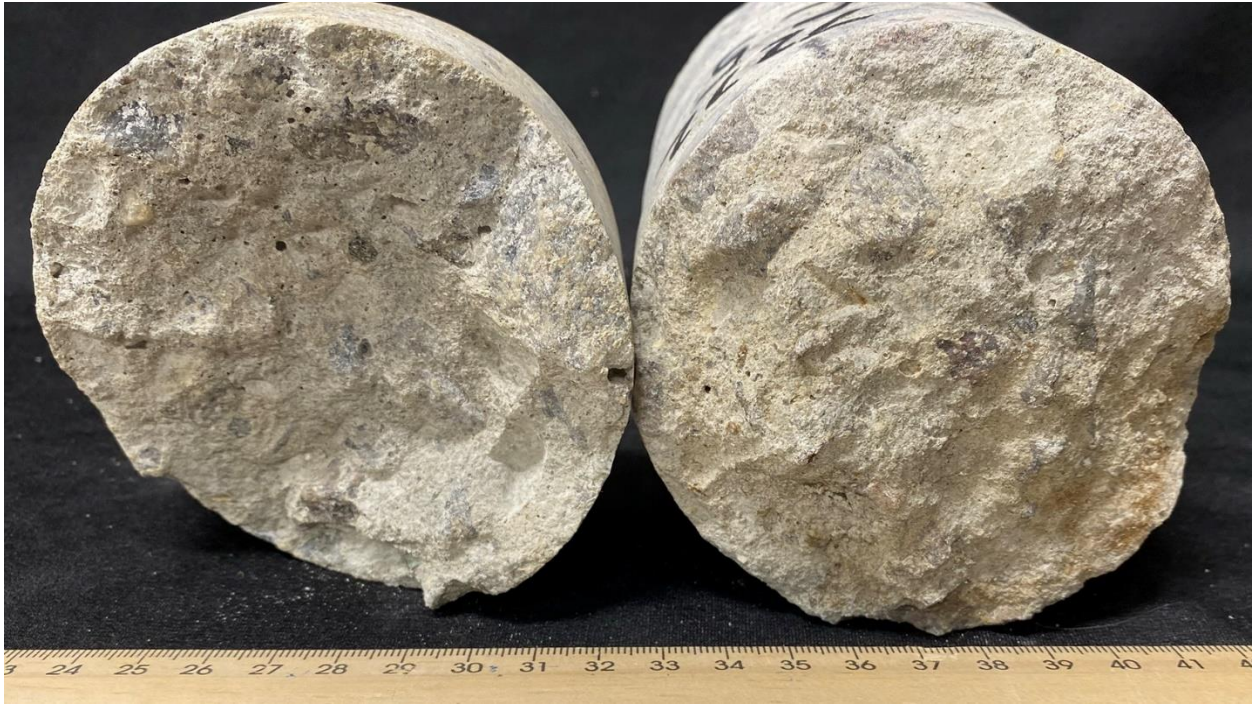
Figure 3. 7272-C5. Opposing fracture faces within the core. There are no impressions of rebar along the fracture. The fracture propagates around and through coarse aggregate.

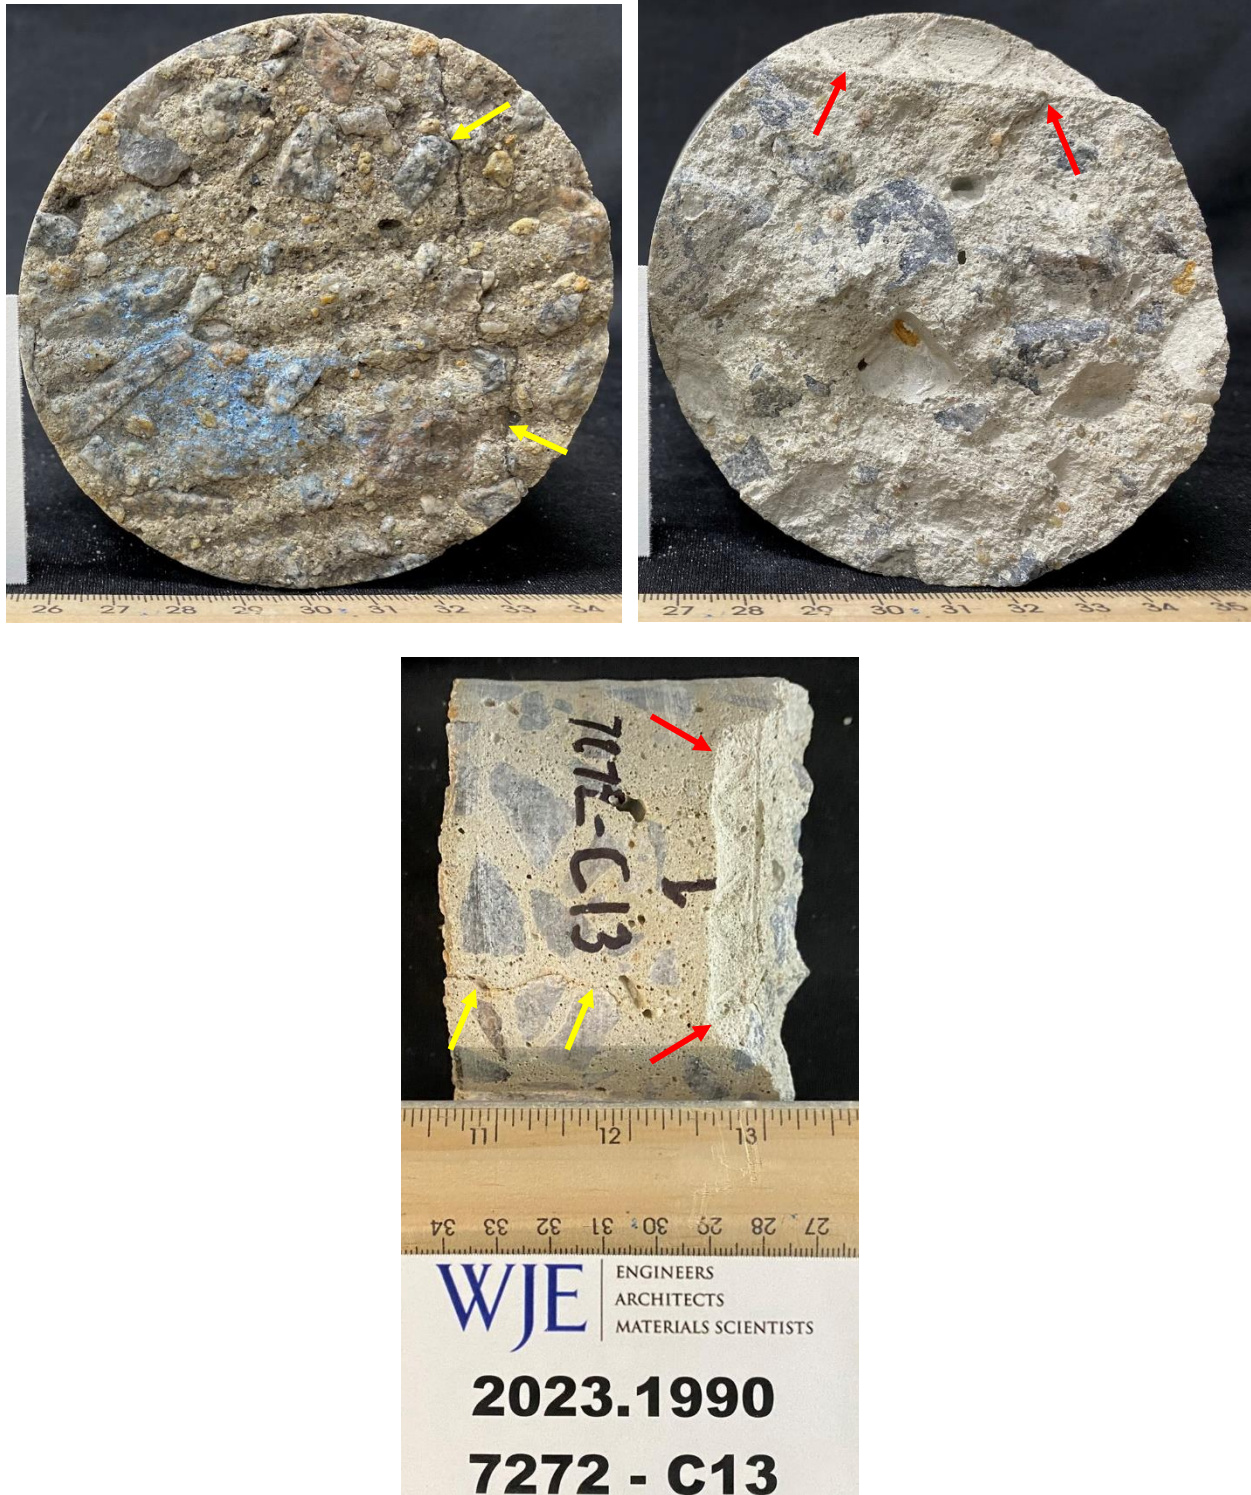
Figure 4. 7272-C13. As-received, with the top surface in the top left image, bottom surface in the top right, and a longitudinal view of the core with the top surface to the left in the bottom image. Red arrows indicate impressions of a rebar on the bottom of the core. Yellow arrows indicate a crack propagating from the top surface

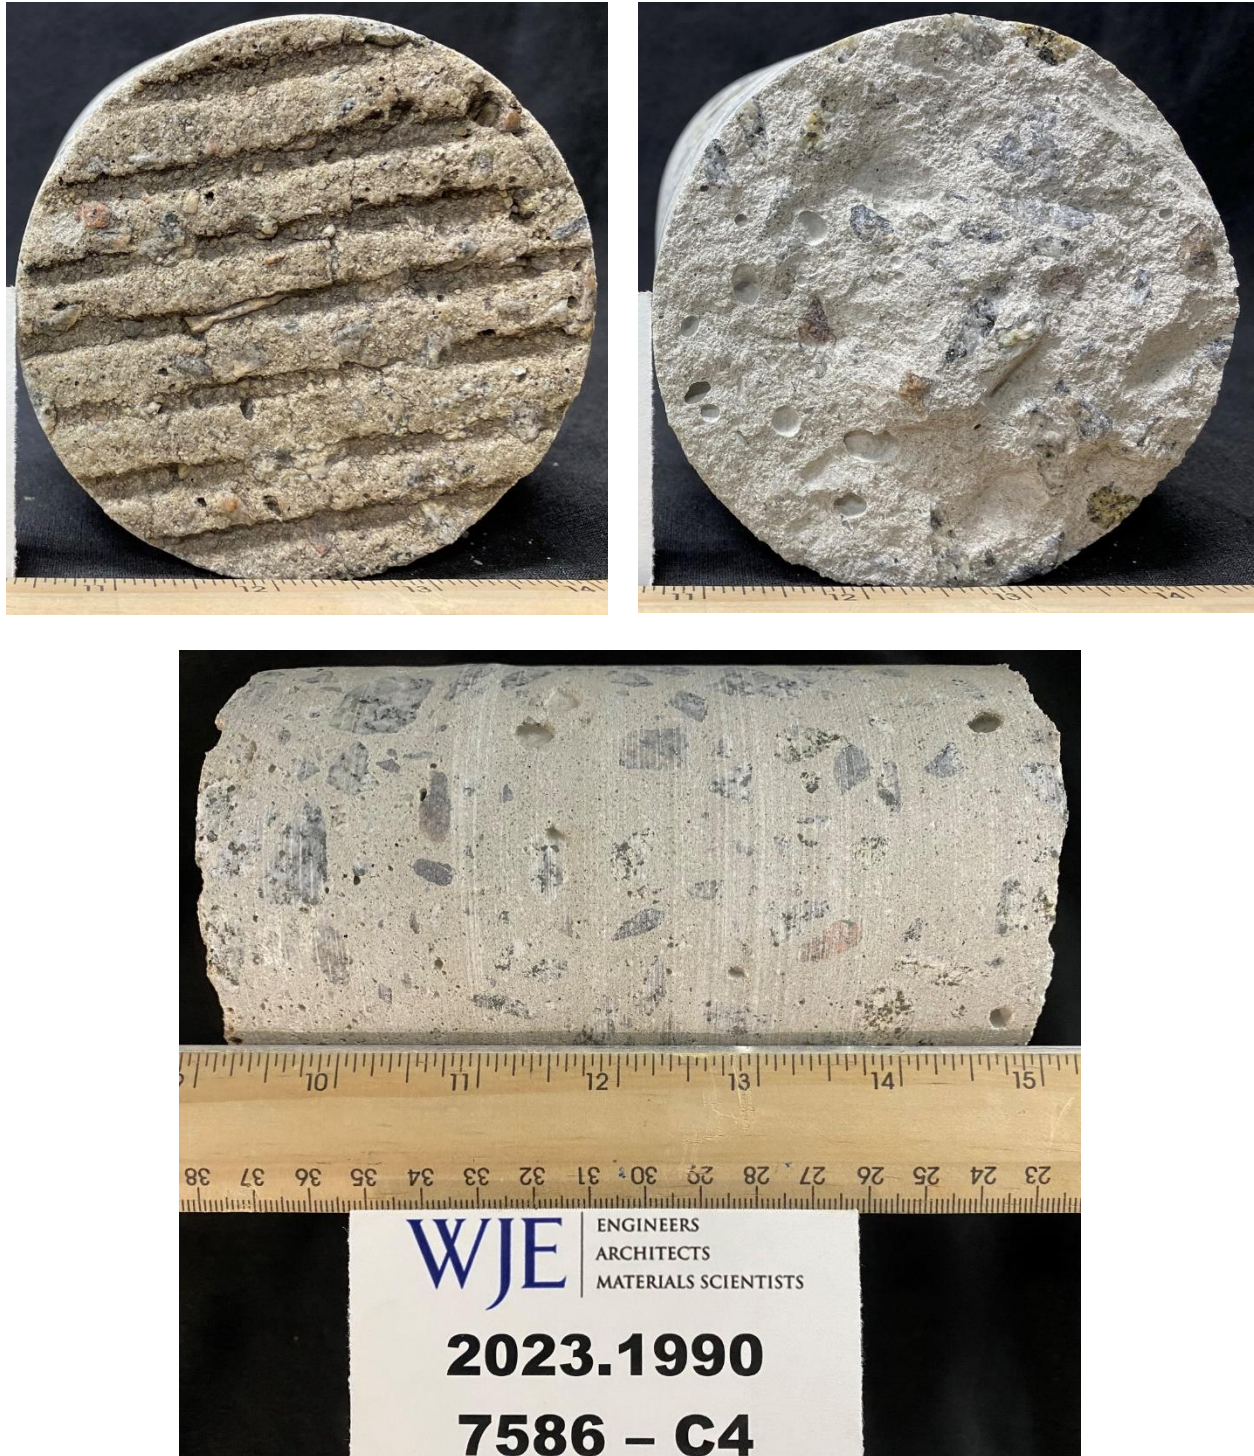
Figure 5. 7586-C4. As-received, with the top surface in the top left image, bottom surface in the top right, and a longitudinal view of the core with the top surface to the left in the bottom image. Note the well-preserved tines on the top surface.

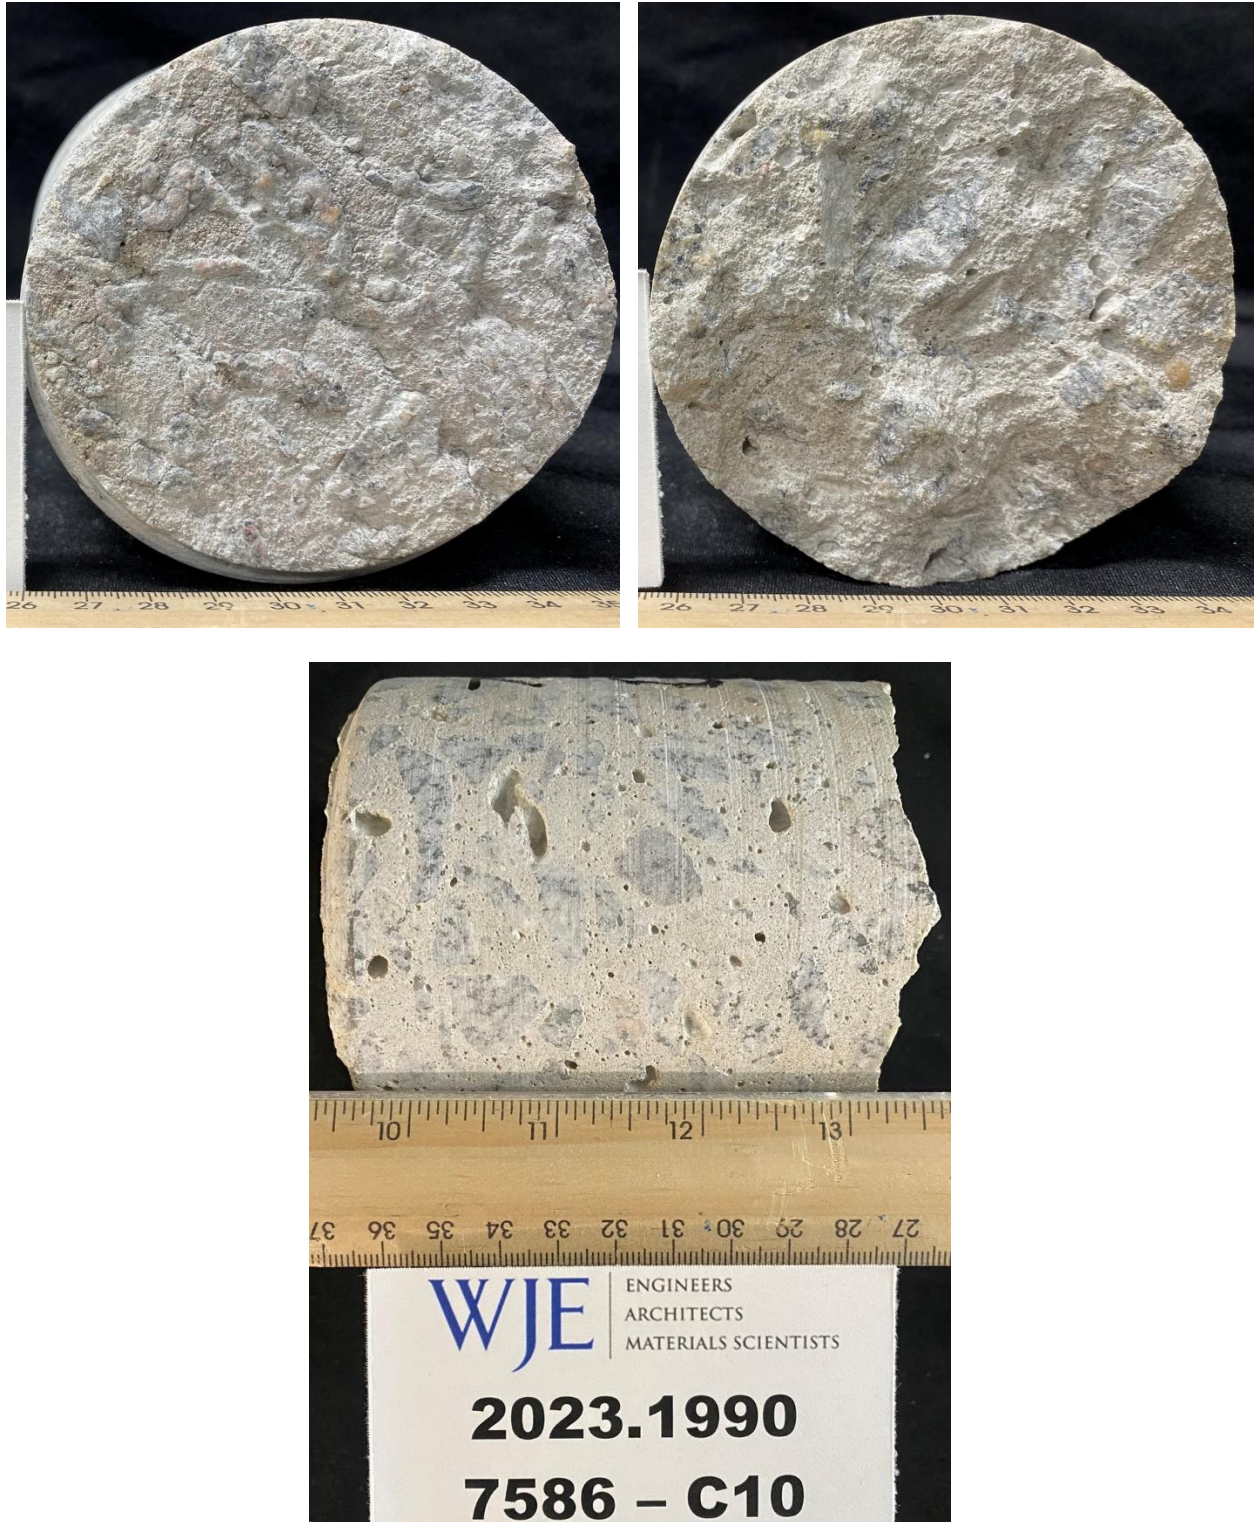
Figure 6. 7586-C10. As-received, with the top surface in the top left image, bottom surface in the top right, and a longitudinal view of the core with the top surface to the left in the bottom image. Note the severely eroded top surface.

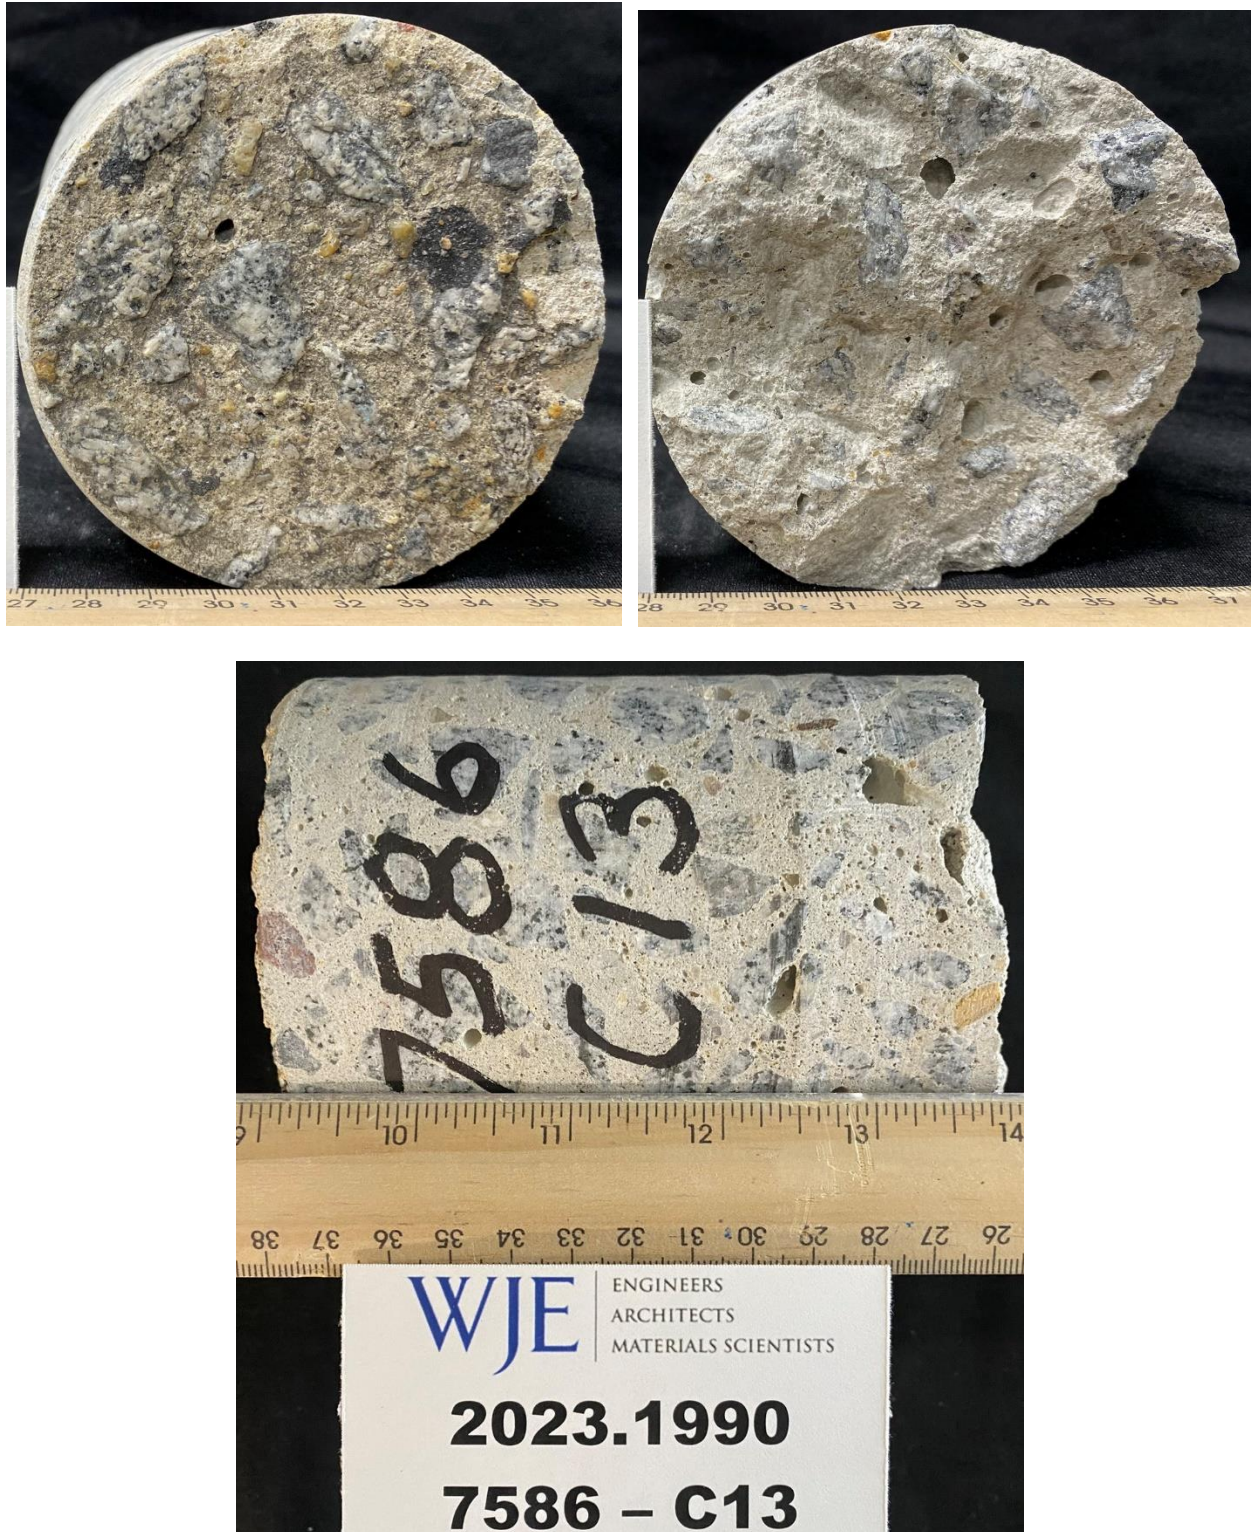
Figure 7. 7586-C13. As-received, with the top surface in the top left image, bottom surface in the top right, and a longitudinal view of the core with the top surface to the left in the bottom image. Note the eroded top surface.

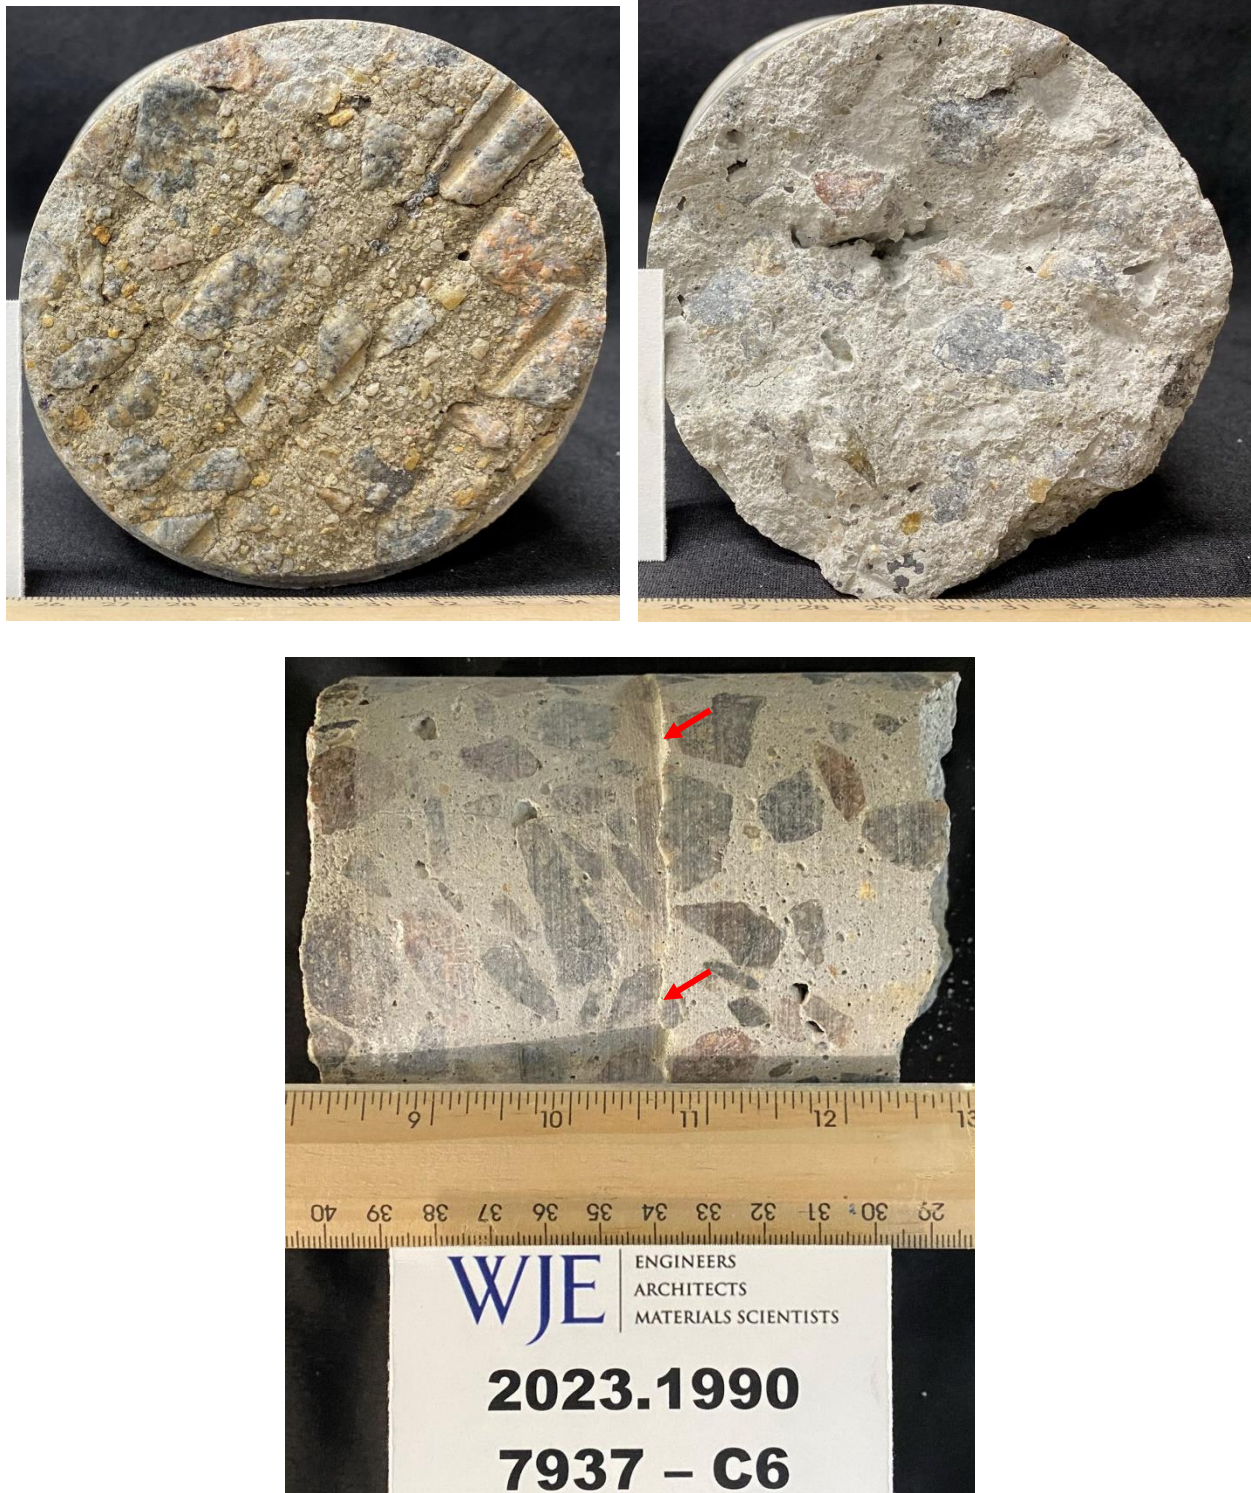
Figure 8. 7937-C6. As-received, with the top surface in the top left image, bottom surface in the top right, and a longitudinal view of the core with the top surface to the left in the bottom image. The core barrel appears to have slipped during coring, causing a strange shape along the core edges (red arrows) that is not a feature of the concrete.

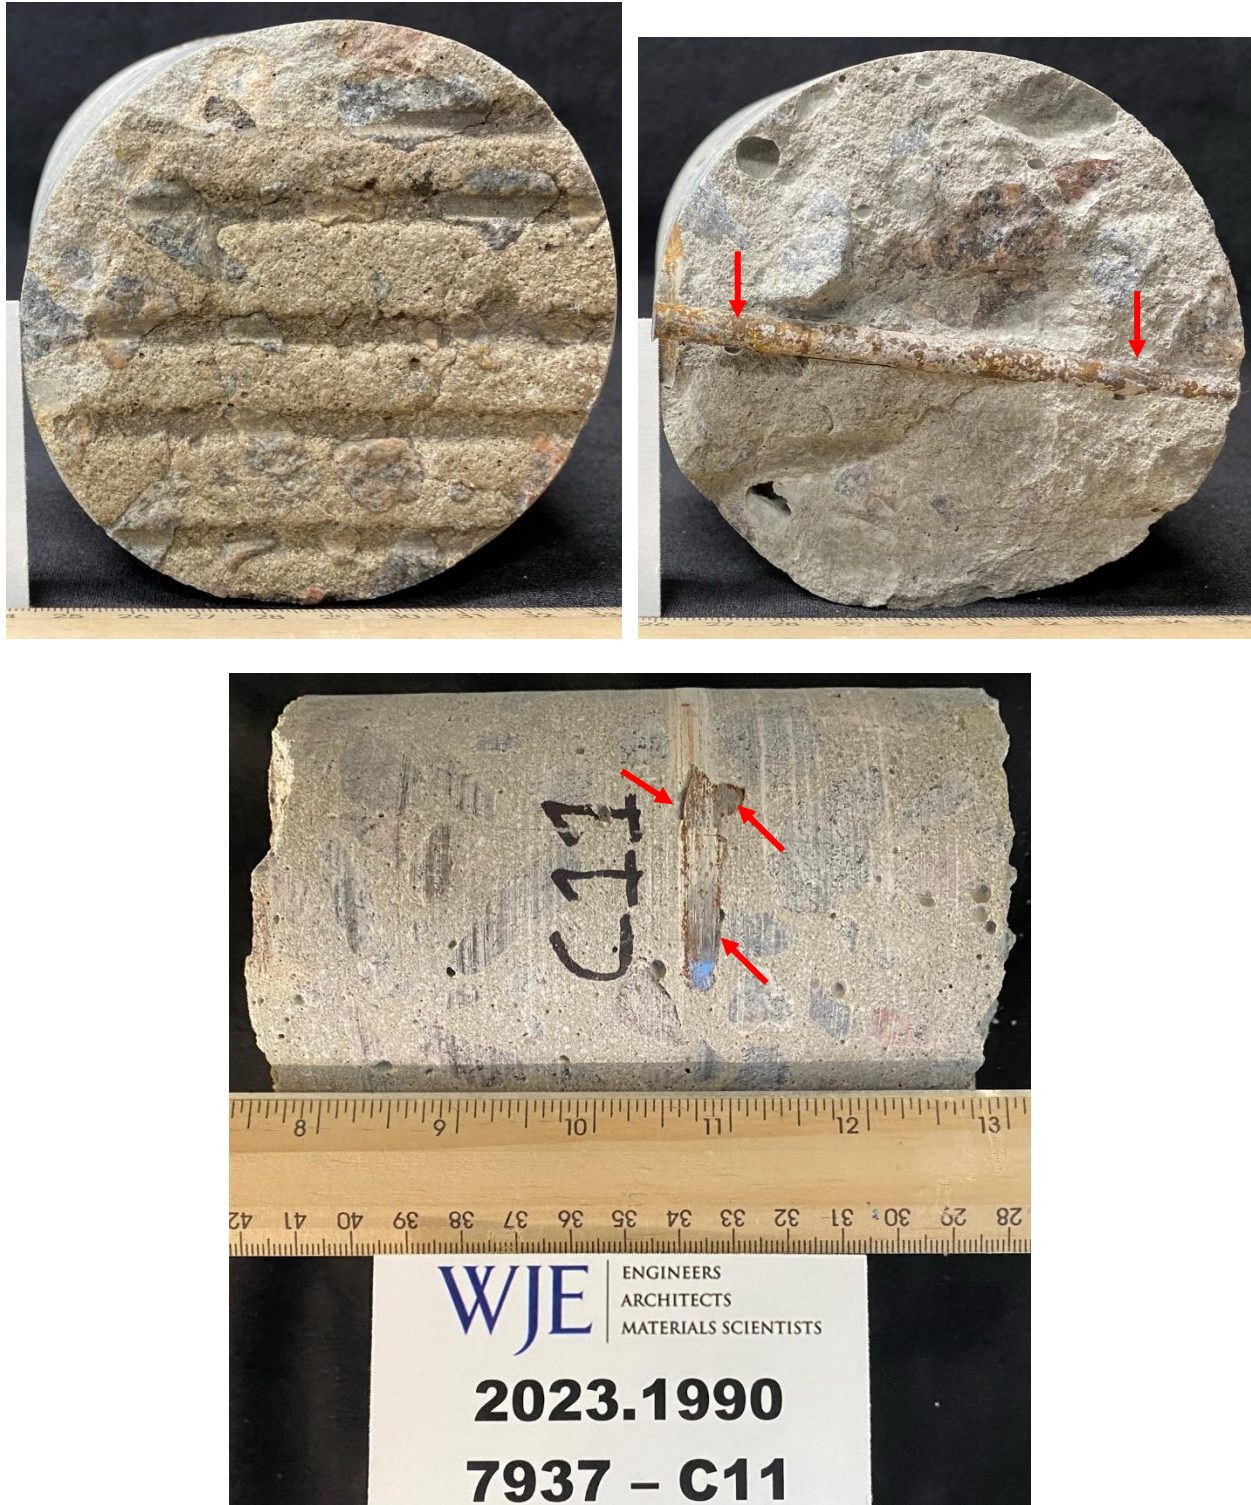
Figure 9. 7937-C11. As-received, with the top surface in the top left image, bottom surface in the top right, and a longitudinal view of the core with the top surface to the left in the bottom image. Red arrows indicate steel wires on the side and bottom of the core.

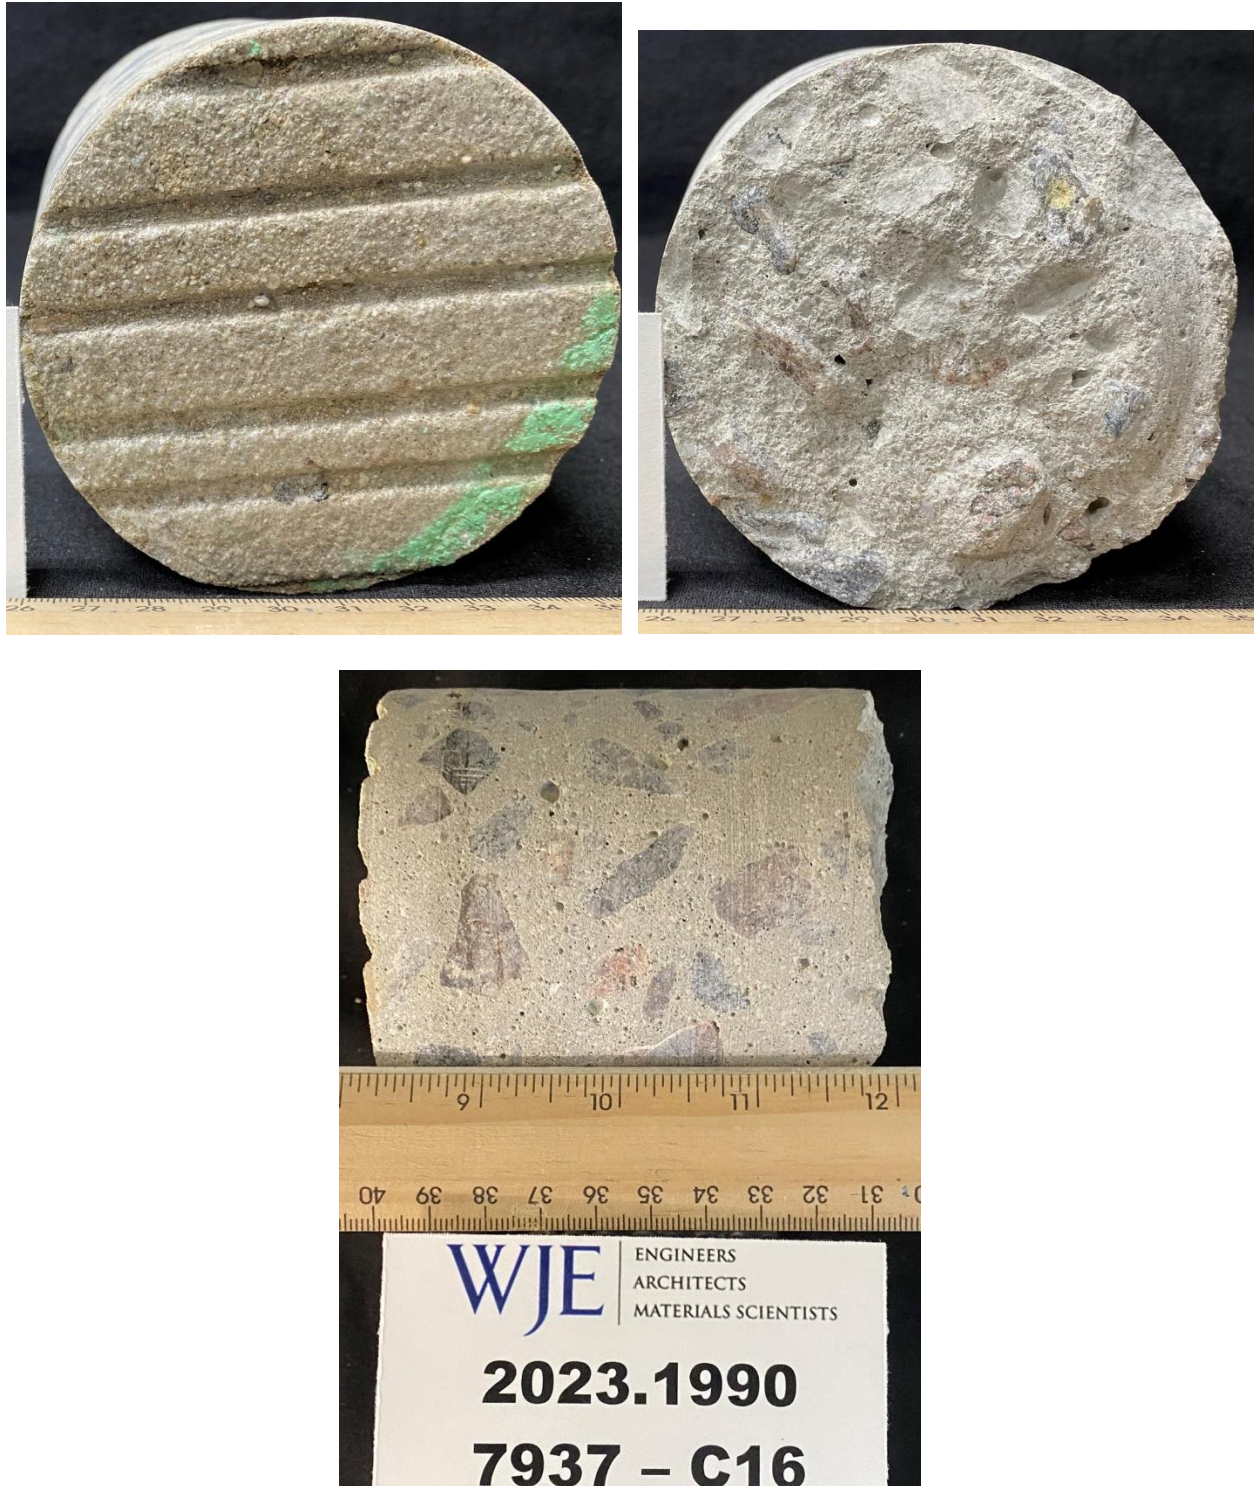
Figure 10. 7937-C16. As-received, with the top surface in the top left image, bottom surface in the top right, and a longitudinal view of the core with the top surface to the left in the bottom image. Note the very well-preserved tines and slightly glossy or shiny appearance on the top surface.

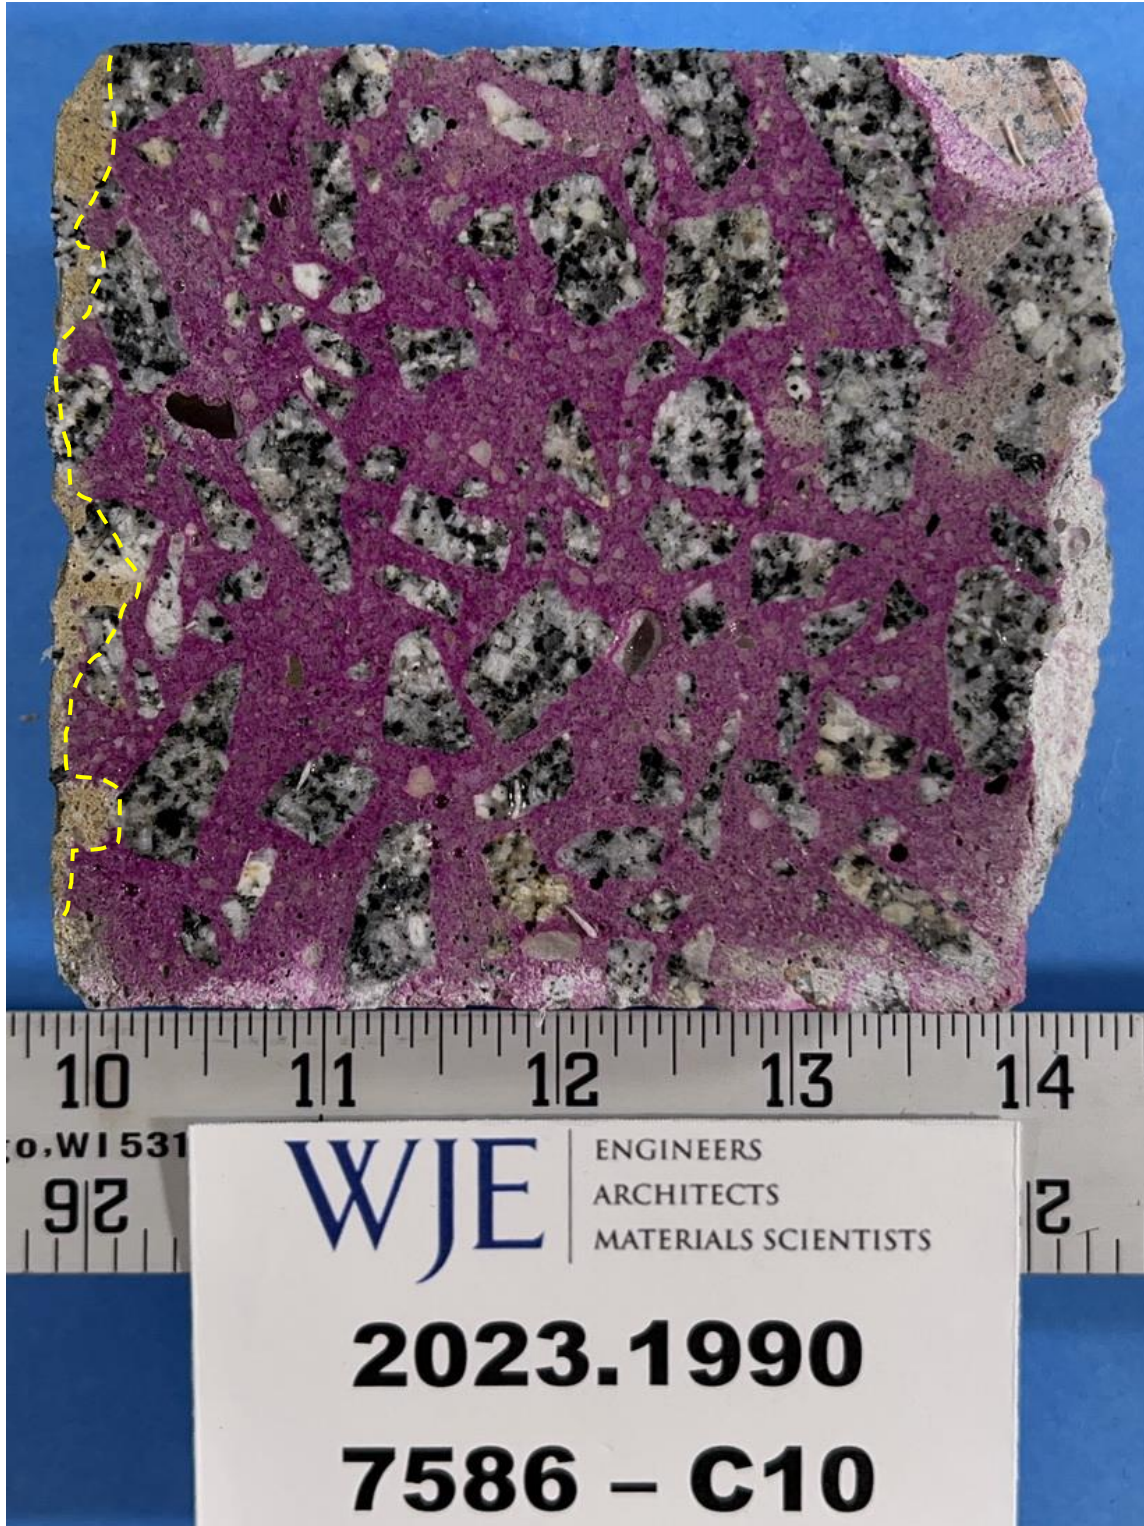
Figure 11. Core 7586-C10. Cut face shortly after being sprayed with phenolphthalein solution. Top surface to the left of the image. Note a thin layer (average of 1/16 inch, but locally up to 1/2 inch) of carbonated paste along the top surface, to the left of the yellow dashed line.

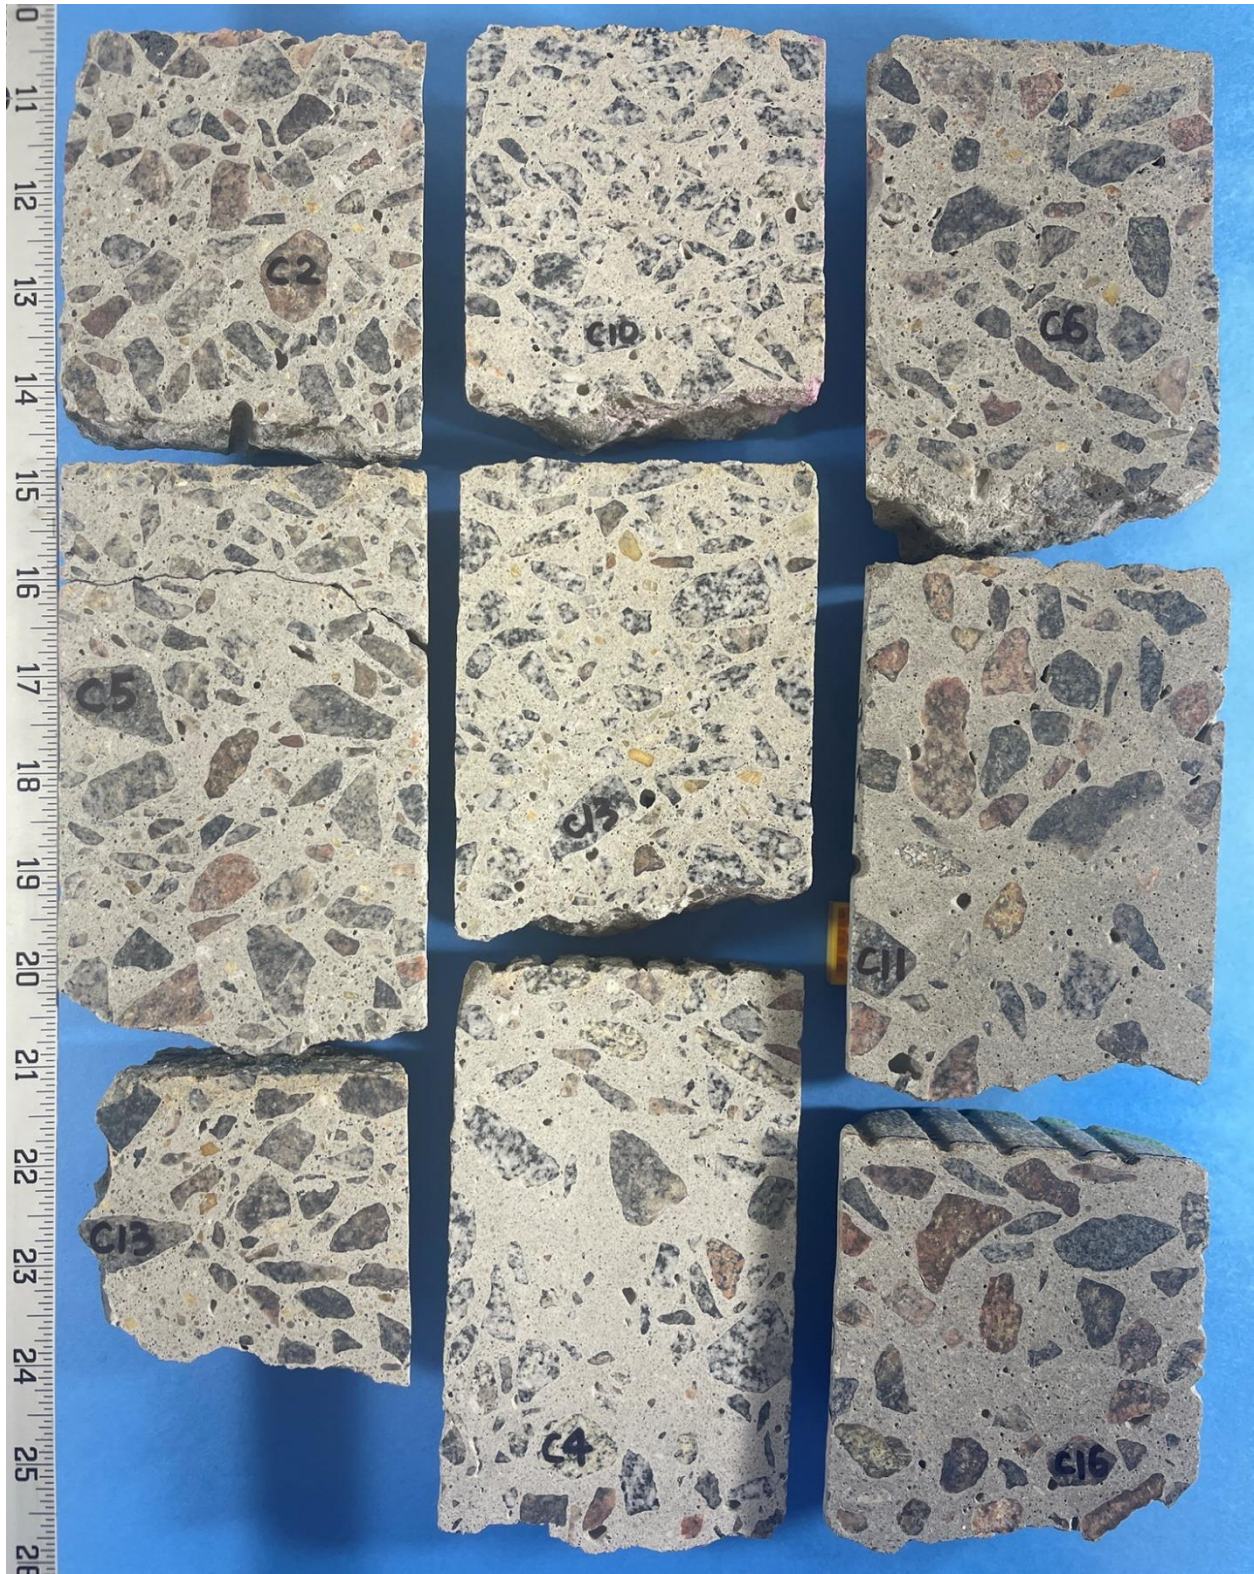
Concretes from the same asset exhibit overall similar appearance and contain similar composition of aggregate and cement (Figure 12). Variations in paste color, estimated w/c, air contents, and aggregate gradations were observed between the assets.

Figure 12. Lapped cross sections of the 9 cores from the three bridges. Left: Cores 2, 5 and 13 of Asset 7272; Middle: Cores 10, 13 and 4 of Asset 7586; Right: Cores 6, 11 and 16 of Asset 7937.
