MEMORANDUM | August 17, 2023

I-20 / I-26 / I-126 Corridor Improvement (Carolina Crossroads)
Asset IDs 7272, 7586, and 7937 - Laboratory Studies of Concrete Cores

WJE PROJECT NO. 2023.1990

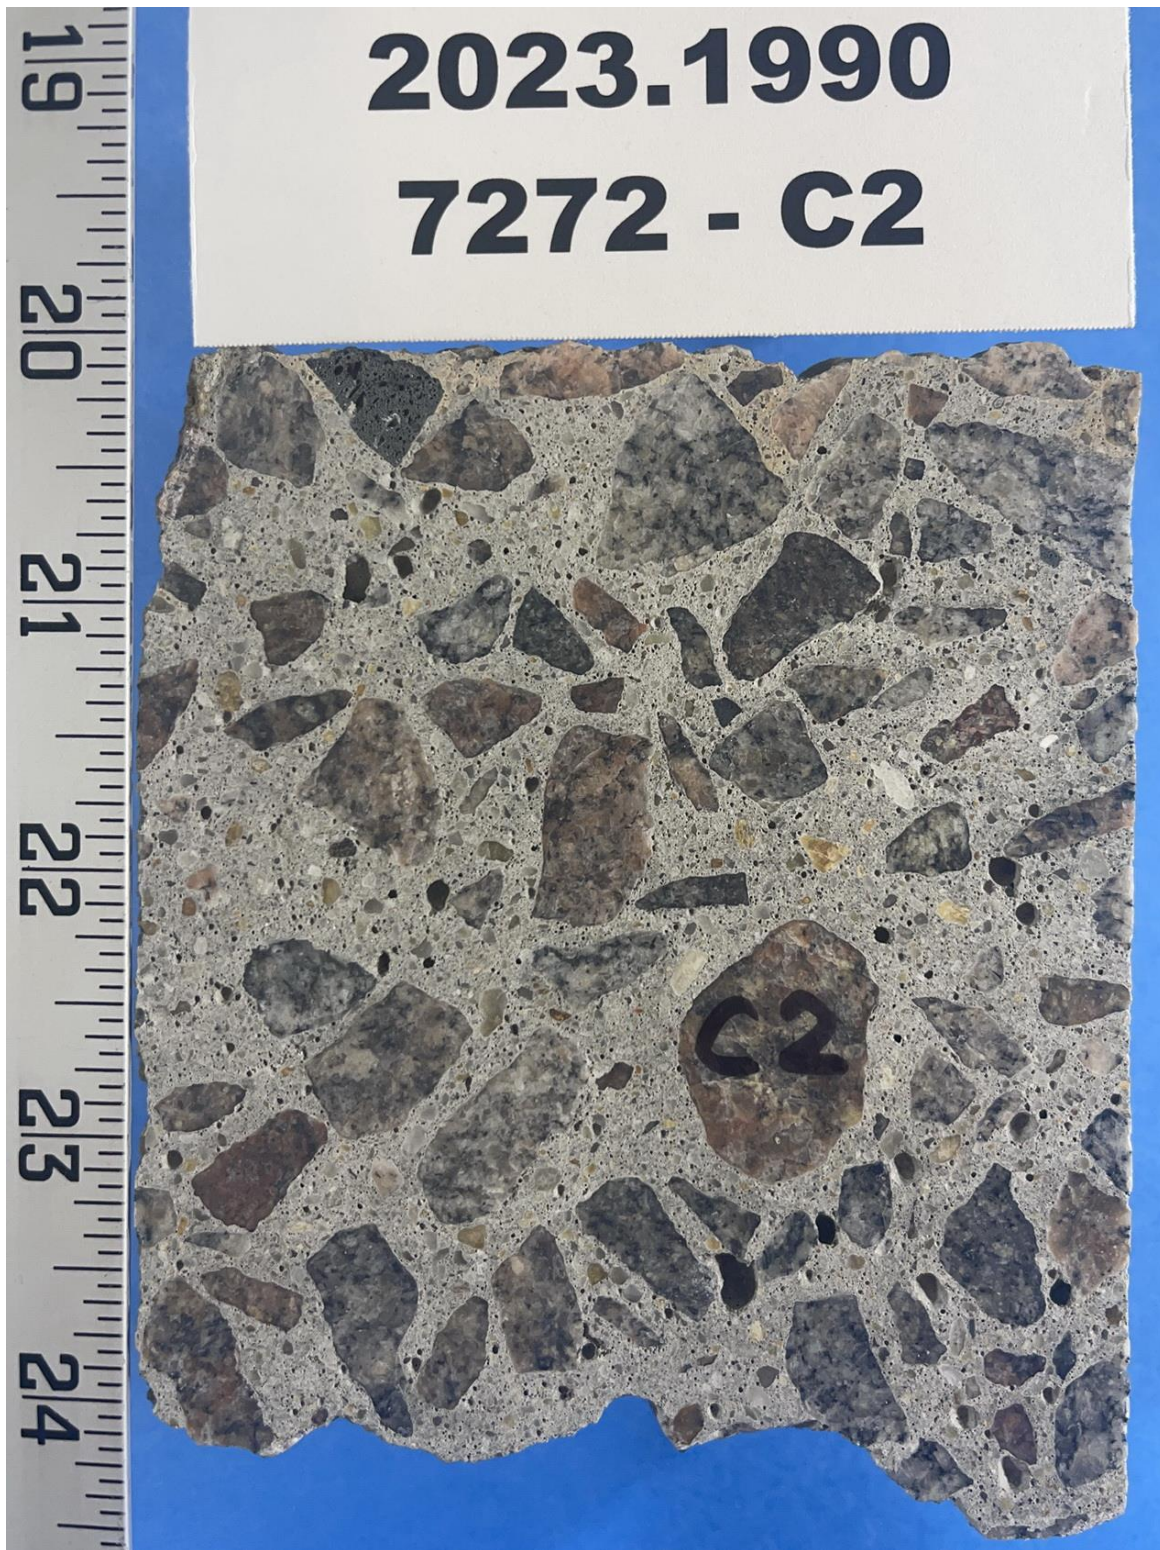
Figure 13. 7272-C2. Lapped longitudinal section, with the top surface towards the top of the image. Note the uneven top surface and loss of tines.

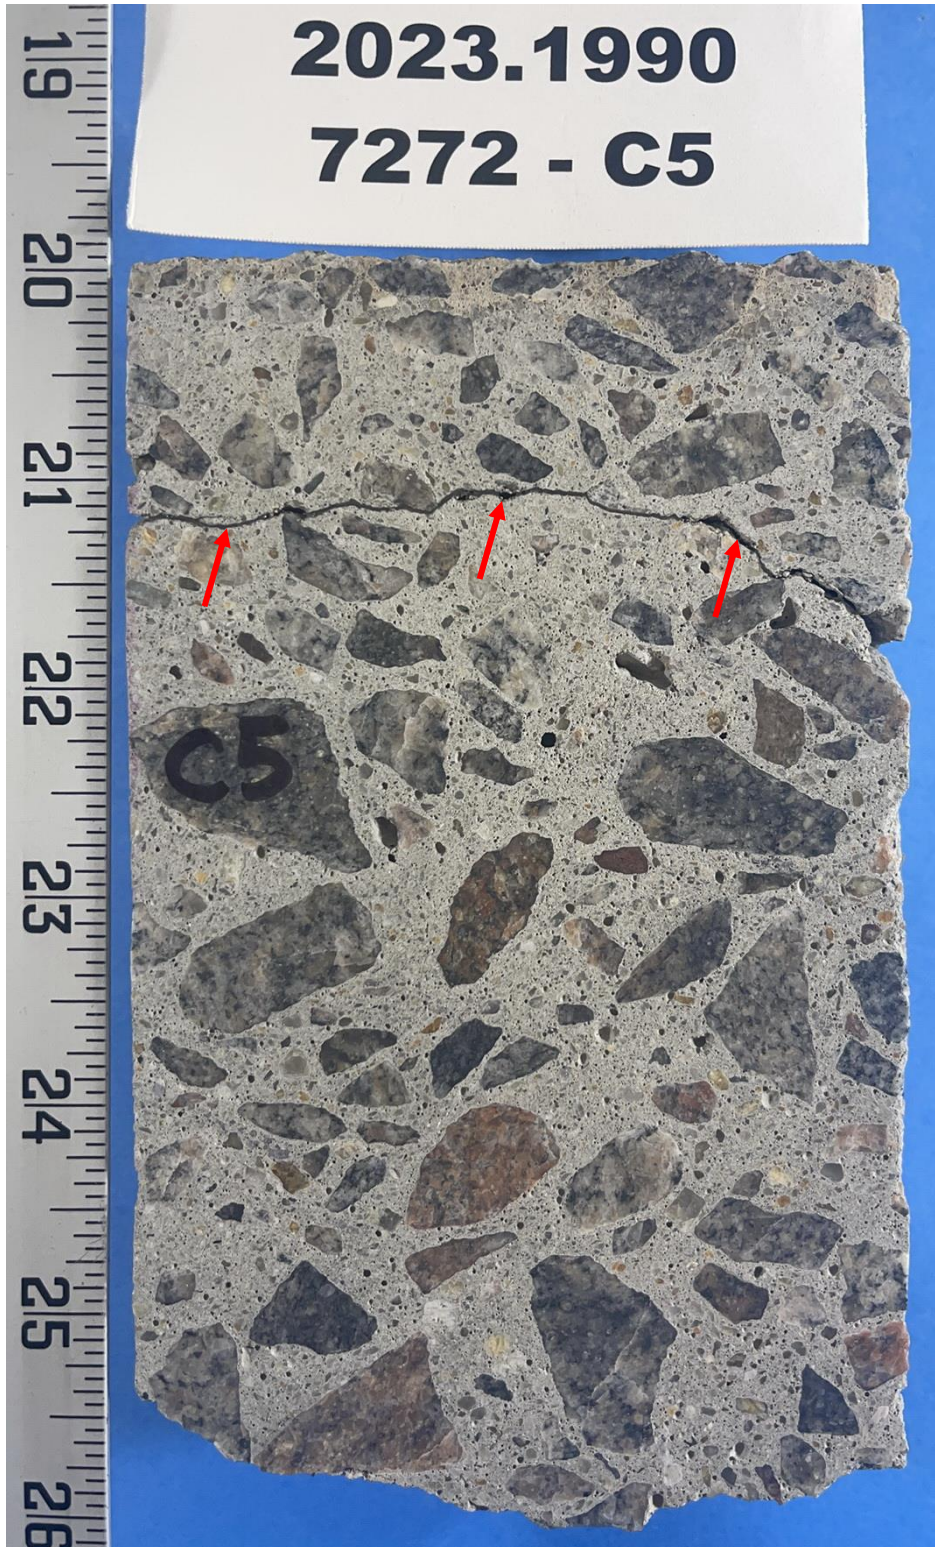
Figure 15. 7272-C5. Lapped longitudinal section, with the top surface towards the top of the image. Note the uneven top surface and loss of tines. Red arrows indicate a fracture below the surface.

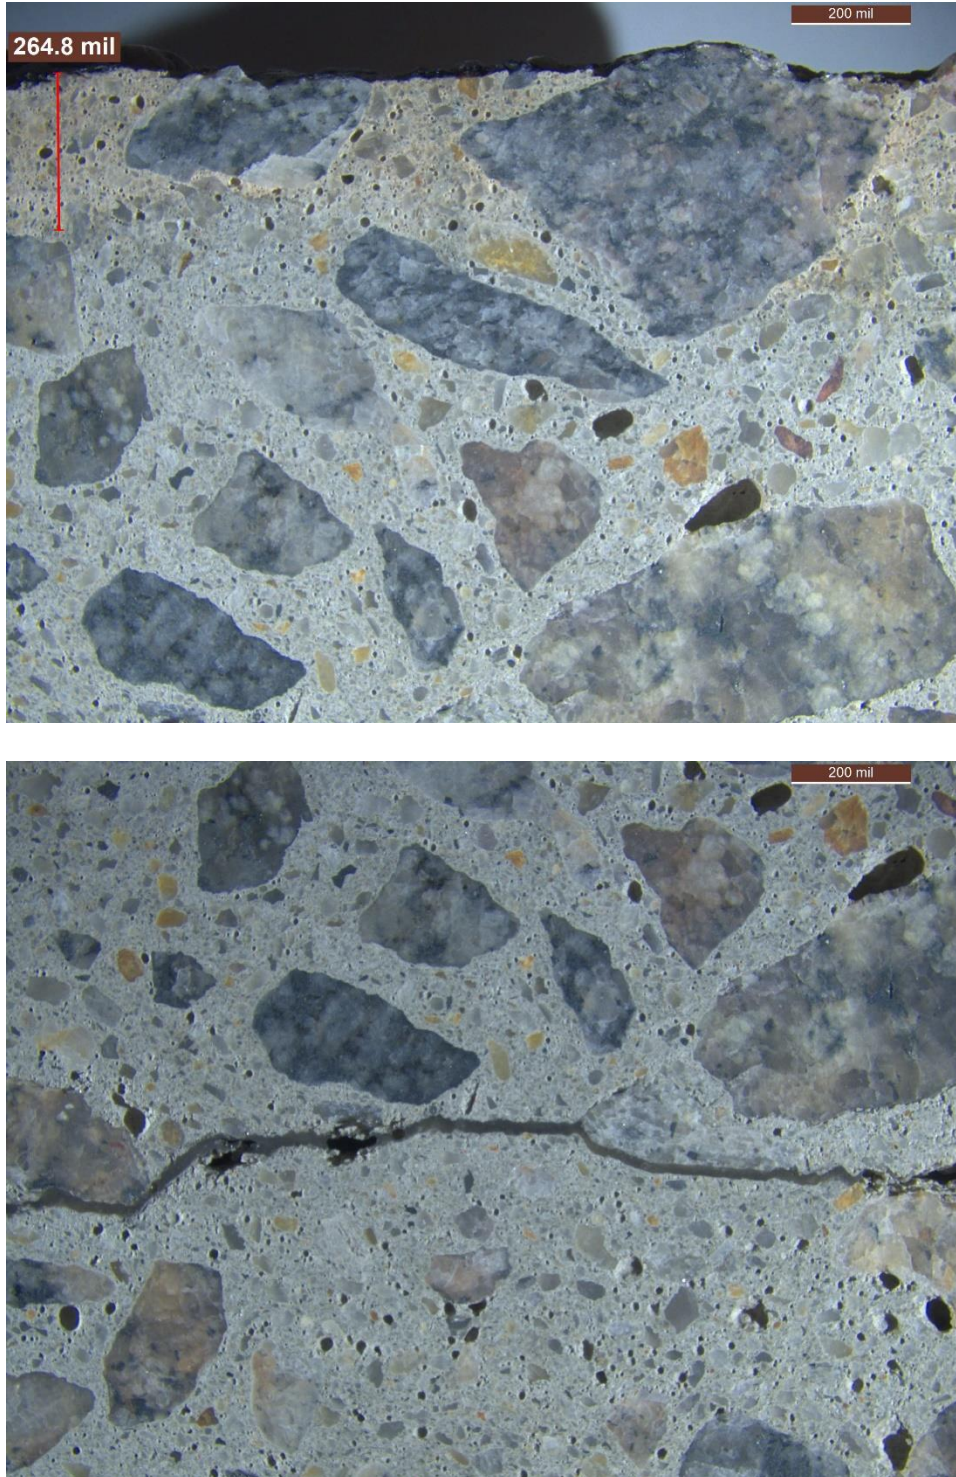
Figure 16. 7272-C5. Closeup views of the top region (top photo) and approximately 1 inch deep near the fracture (bottom photo) of the core show paste, air voids, and aggregate of the concrete. Carbonation-related discoloration is measured roughly 1/4 inch thick (264.8 mils).

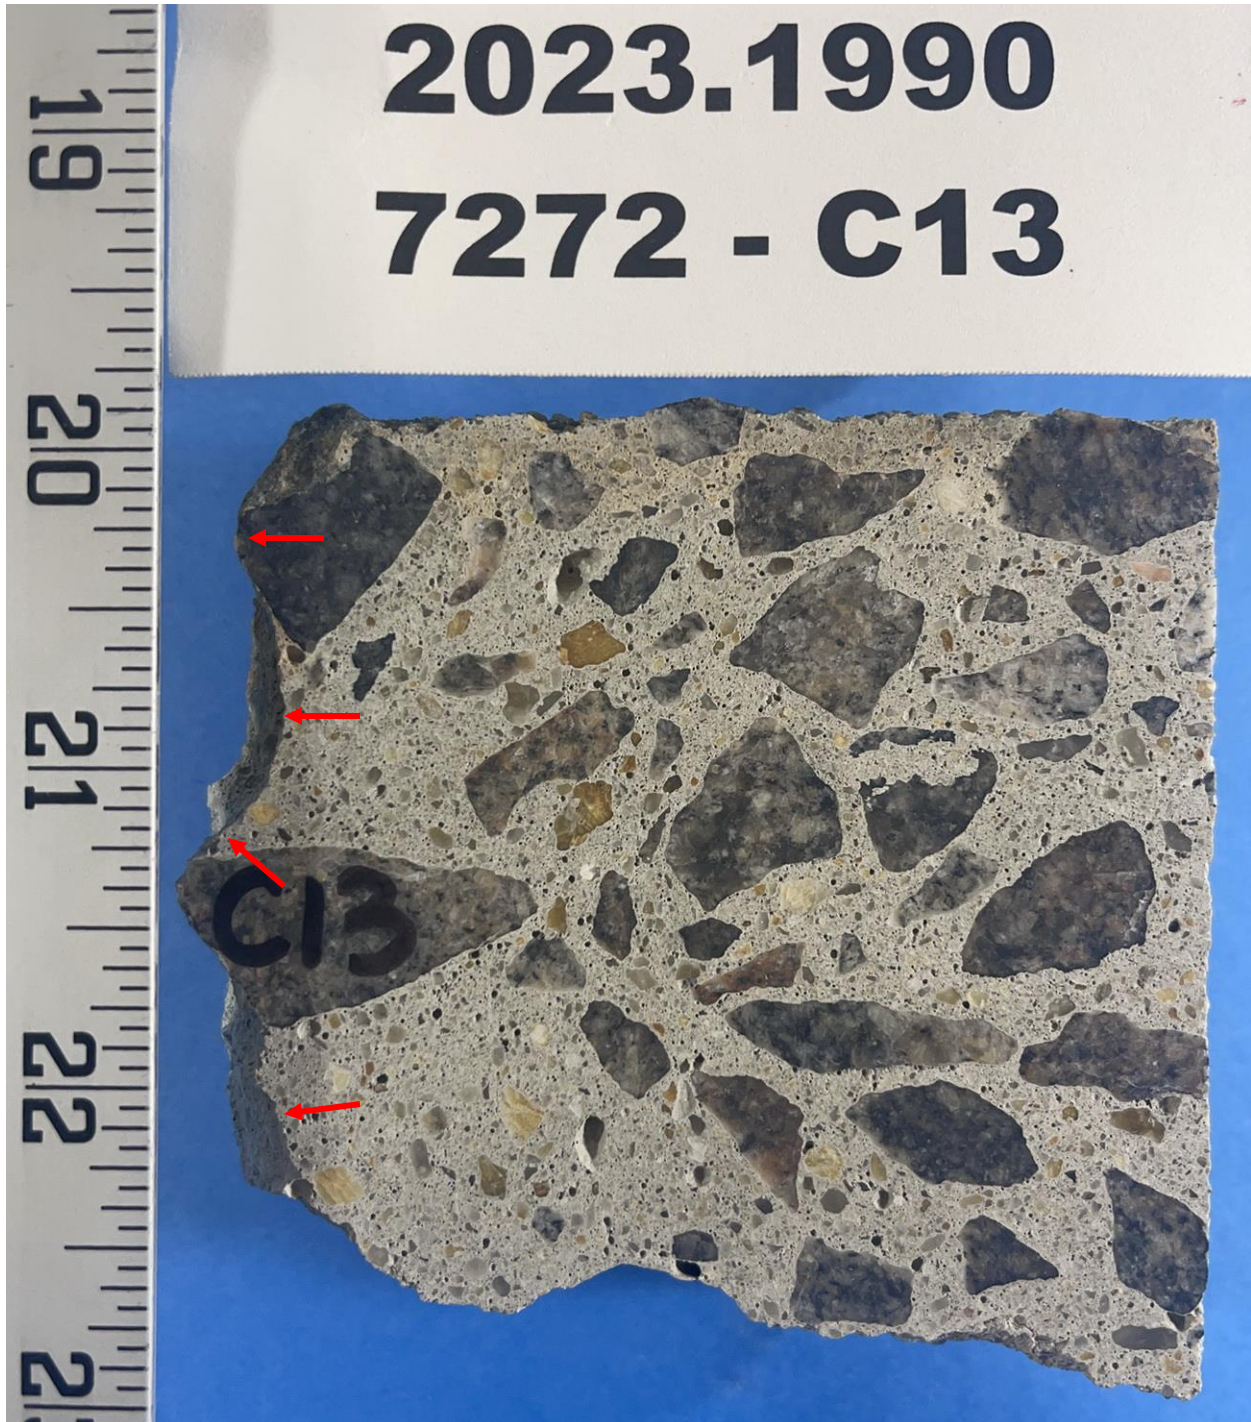
Carbonation depth was slightly deeper in near-surface areas with coarse aggregate particles or along vertical cracking. Core 7272-C13 contained a crack along the top surface that propagated approximately 2 inches below the surface. Carbonation was deeper along the crack and carbonated paste extended up to 1/8 inch from the sides of the crack. Overall, the depth of carbonation was considered minor for concrete placed in the 1970s and 1980s.

Figure 17. 7272-C13. Lapped longitudinal section, with the top surface towards the top of the image. Note the uneven top surface and loss of fines. The core originally contained a vertical crack that opened during sample preparation, represented by the fractured left surface of the core (red arrows).

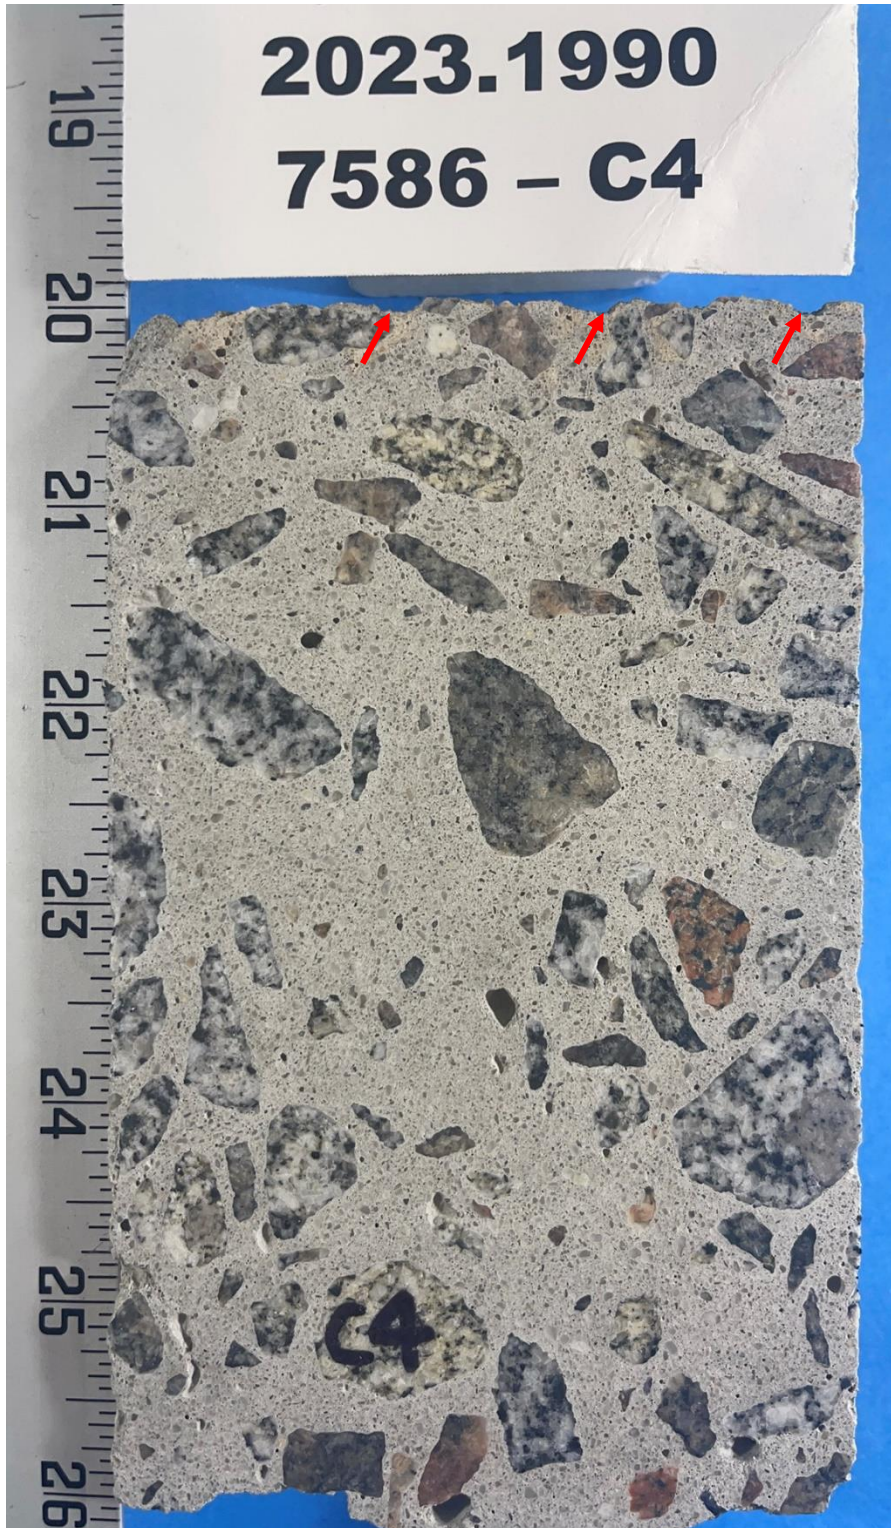
Figure 19. 7586-C4. Lapped longitudinal section, with the top surface towards the top of the image. Note the uneven top surface and somewhat preserved tines, indicated with red arrows. The aggregate in cores from Asset 7586 is different than that from 7272.

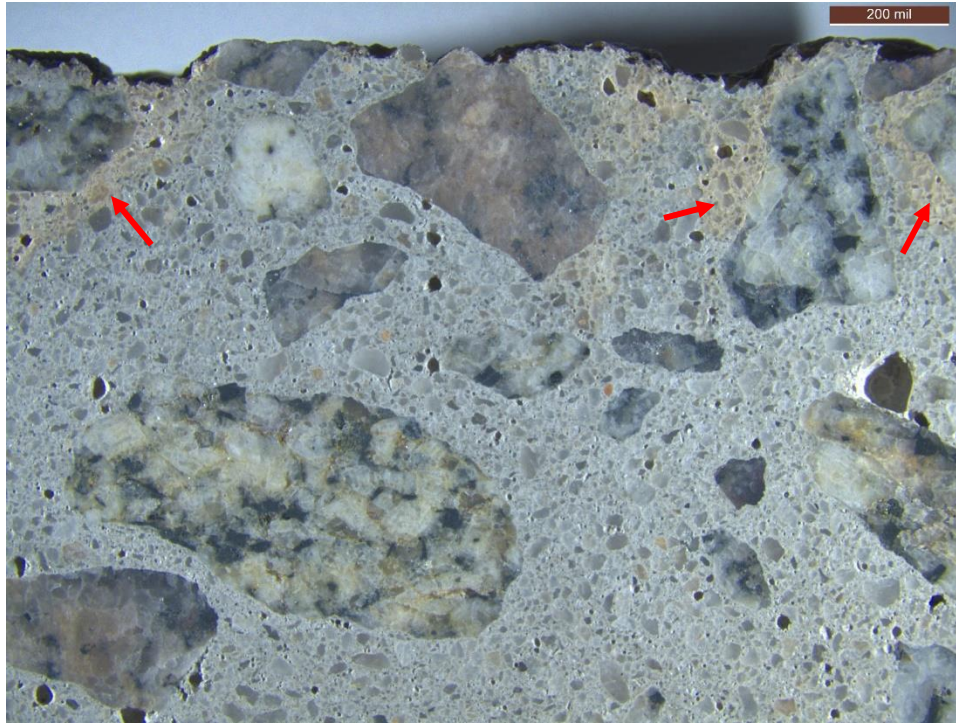
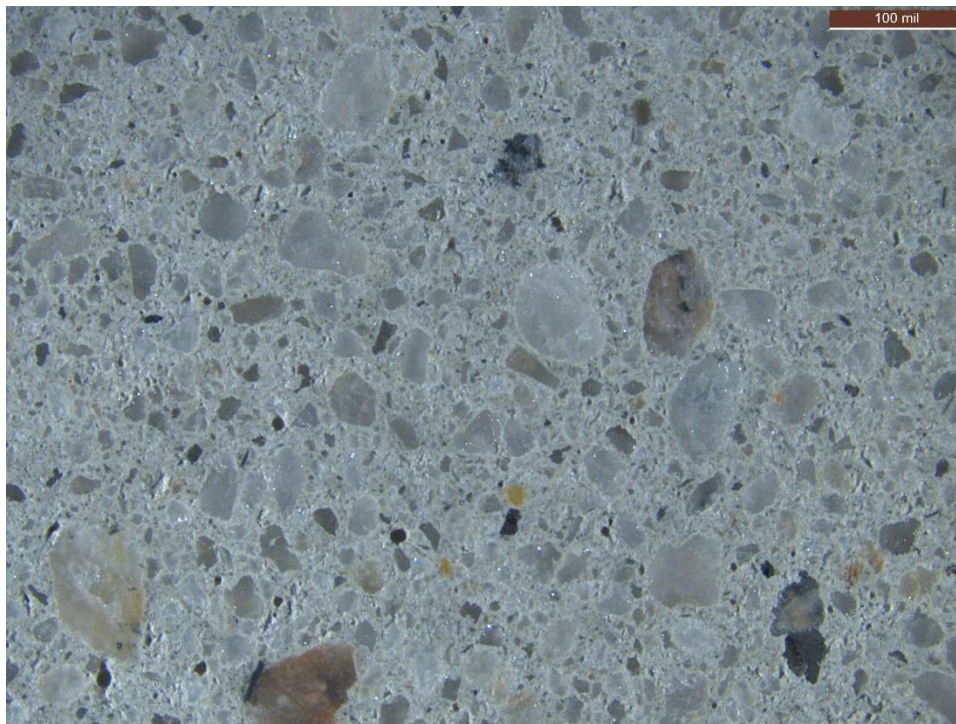
Figure 20. 7586-C4. Closeup views of the top region (top photo) and bottom region (bottom photo) of the core show paste, air voids, and aggregate of the concrete. Arrows indicate localized discoloration likely due to carbonation.

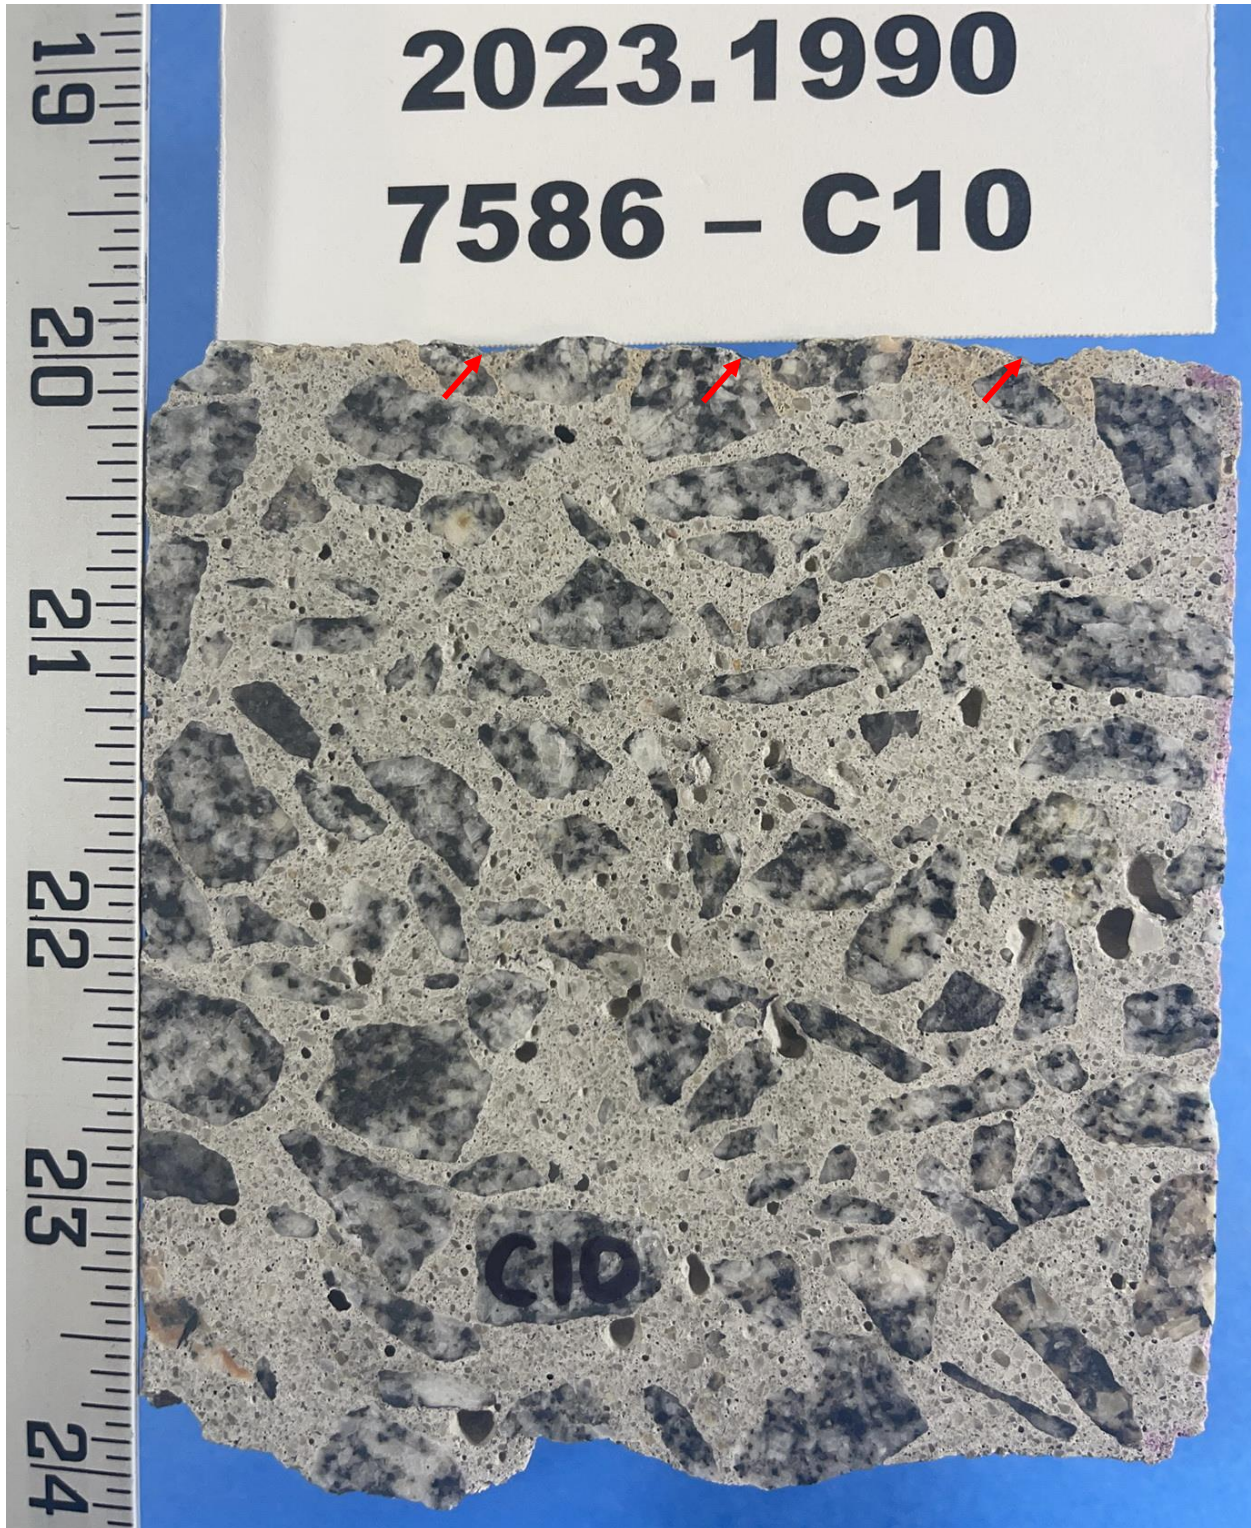
Figure 21. 7586-C10. Lapped longitudinal section, with the top surface towards the top of the image. Note the uneven top surface and somewhat preserved tines, indicated with red arrows. The aggregate in cores from Asset 7586 is different than that from 7272.

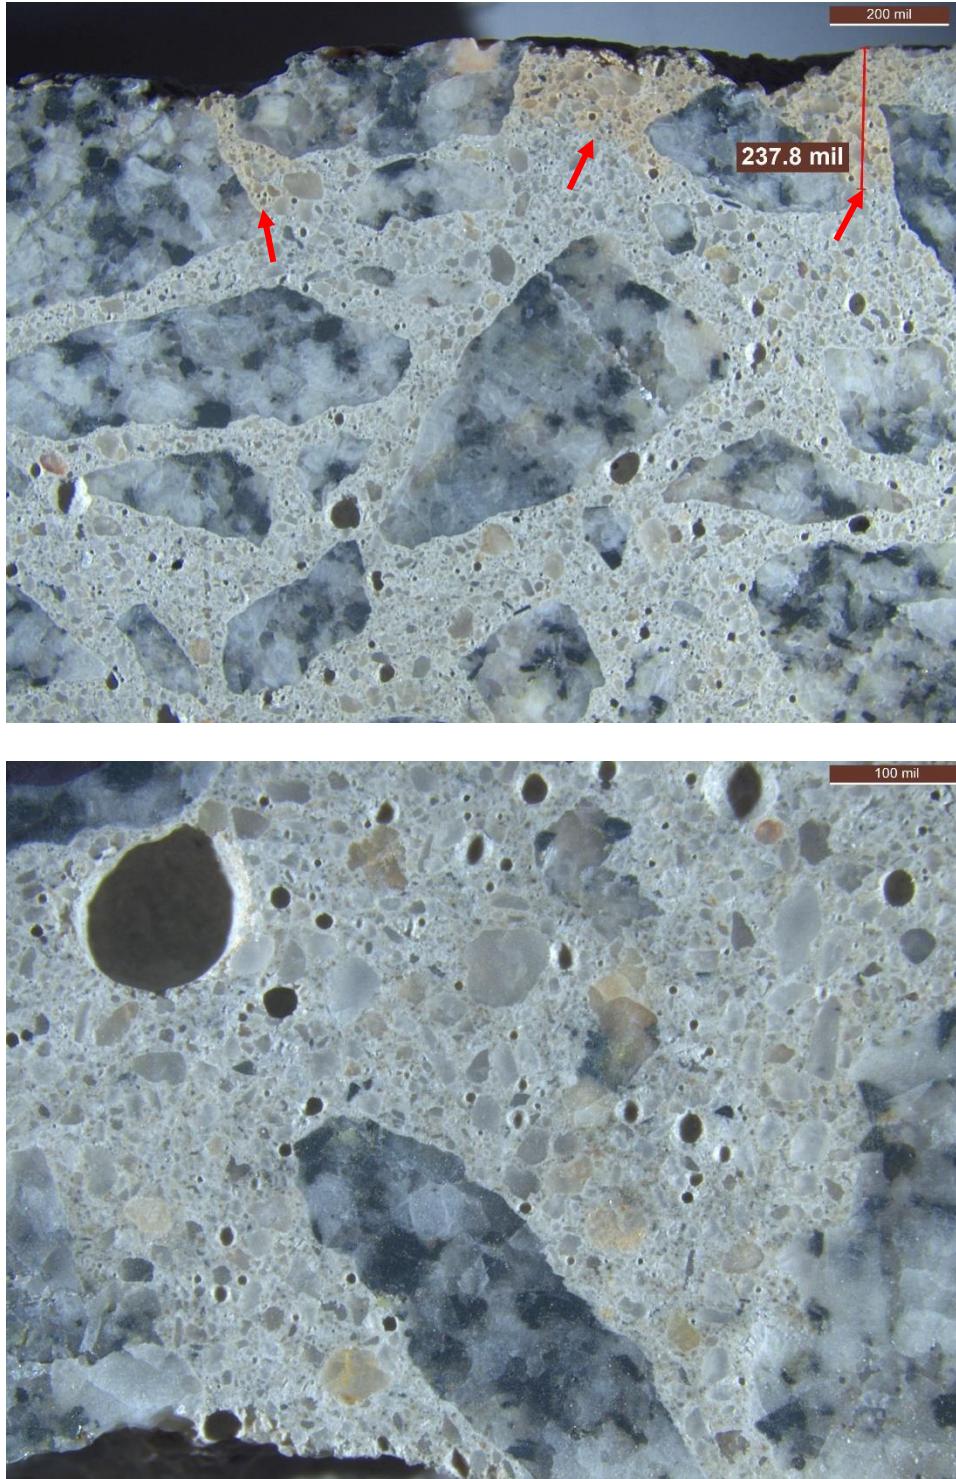
Figure 22. 7586-C10. Closeup views of the top region (top photo) and bottom region (bottom photo) of the core show paste, air voids, and aggregate of the concrete. Arrows indicate localized discoloration likely due to carbonation that measures roughly 1/4 inch.

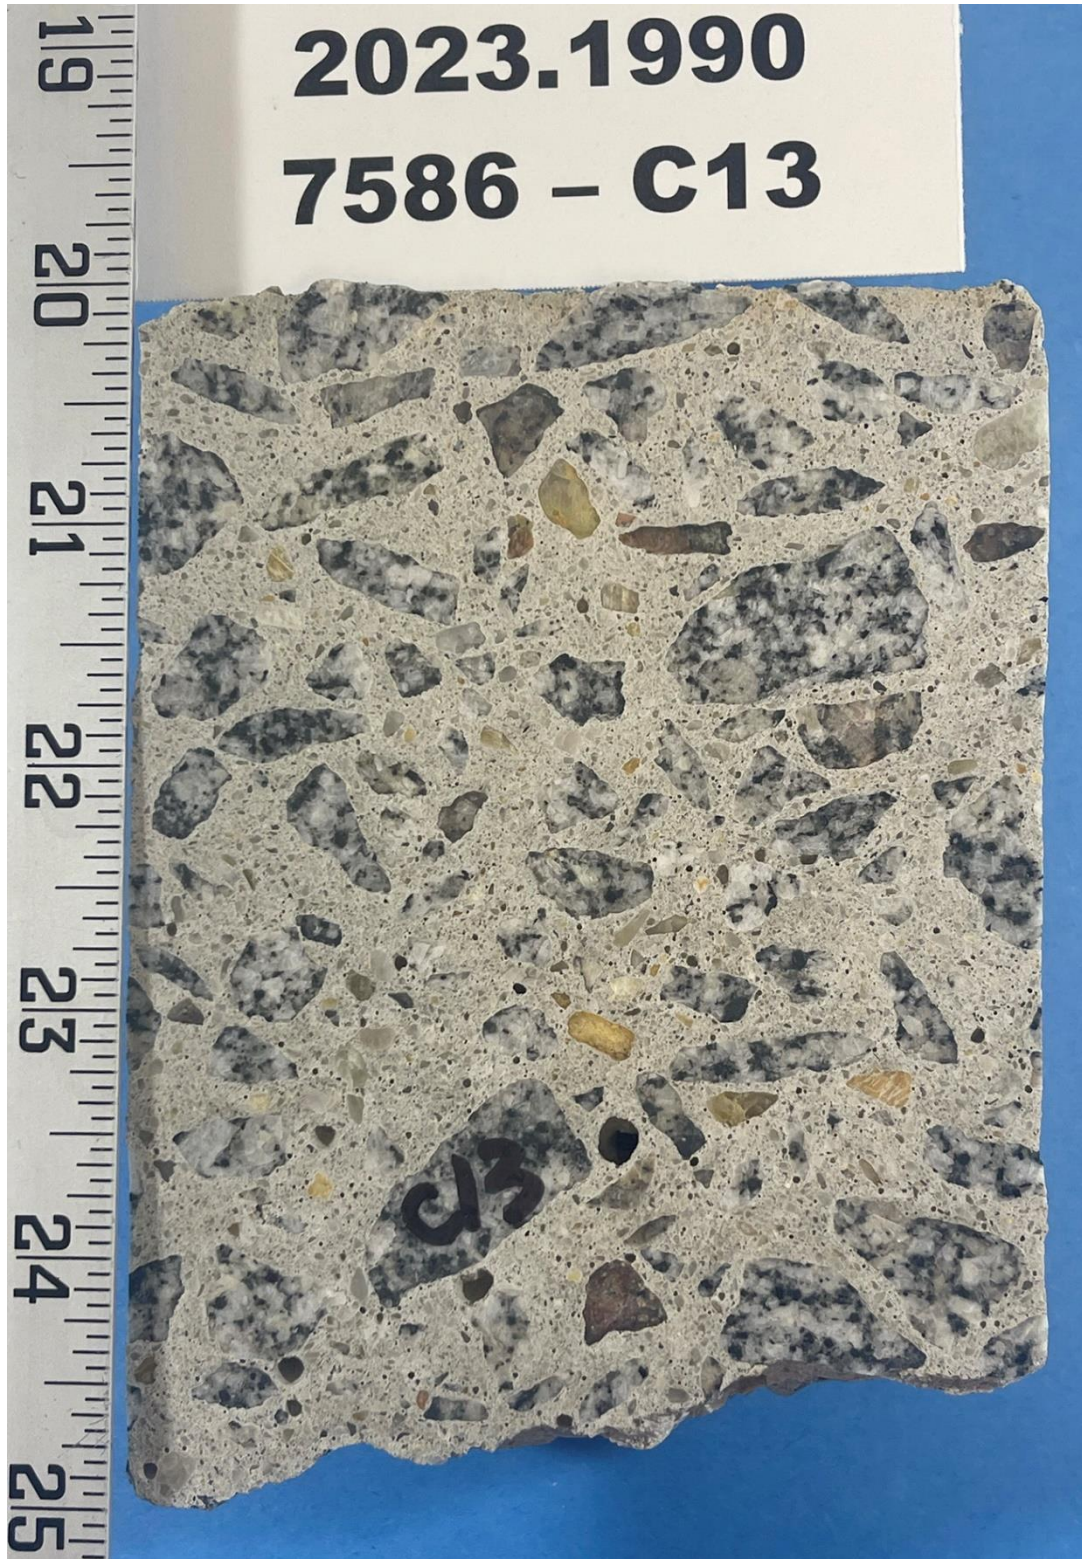
Figure 23. 7586-C13. Lapped longitudinal section, with the top surface towards the top of the image. Note the uneven top surface and loss of fines. The aggregate in cores from Asset 7586 is different than that from 7272.

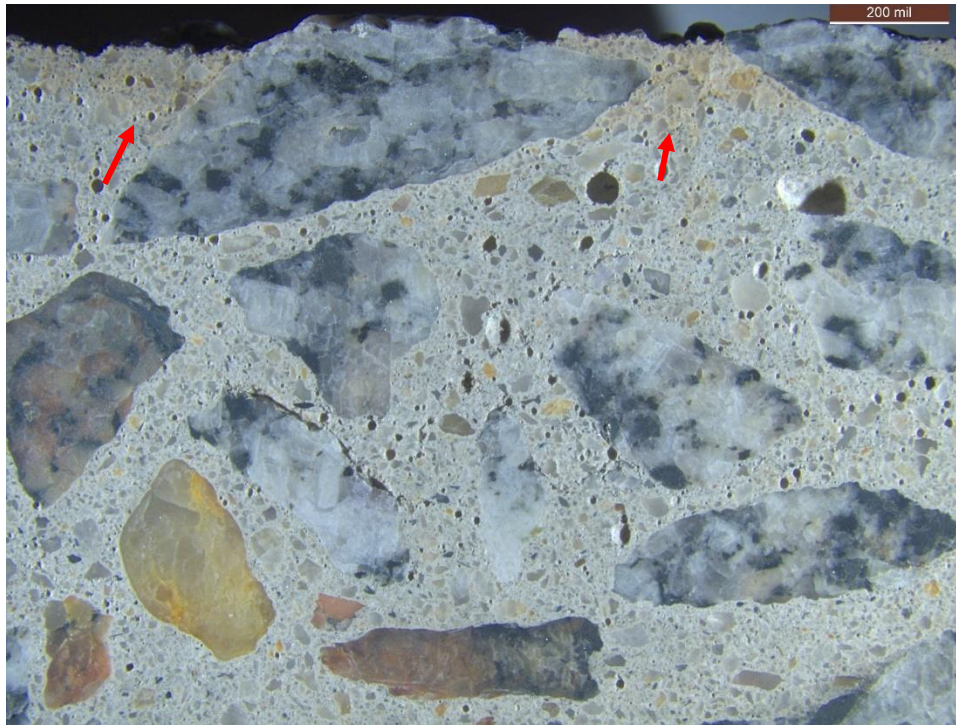
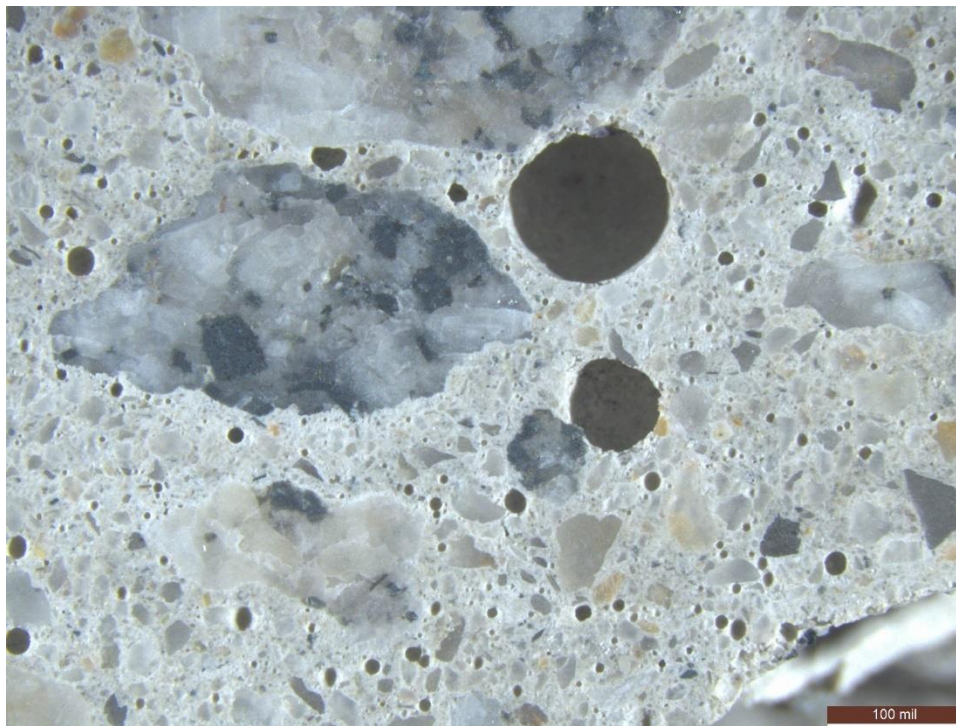
Figure 24. 7586-C13. Closeup views of the top region (top photo) and bottom region (bottom photo) of the core show paste, air voids, and aggregate of the concrete. Arrows indicate discoloration likely due to carbonation.

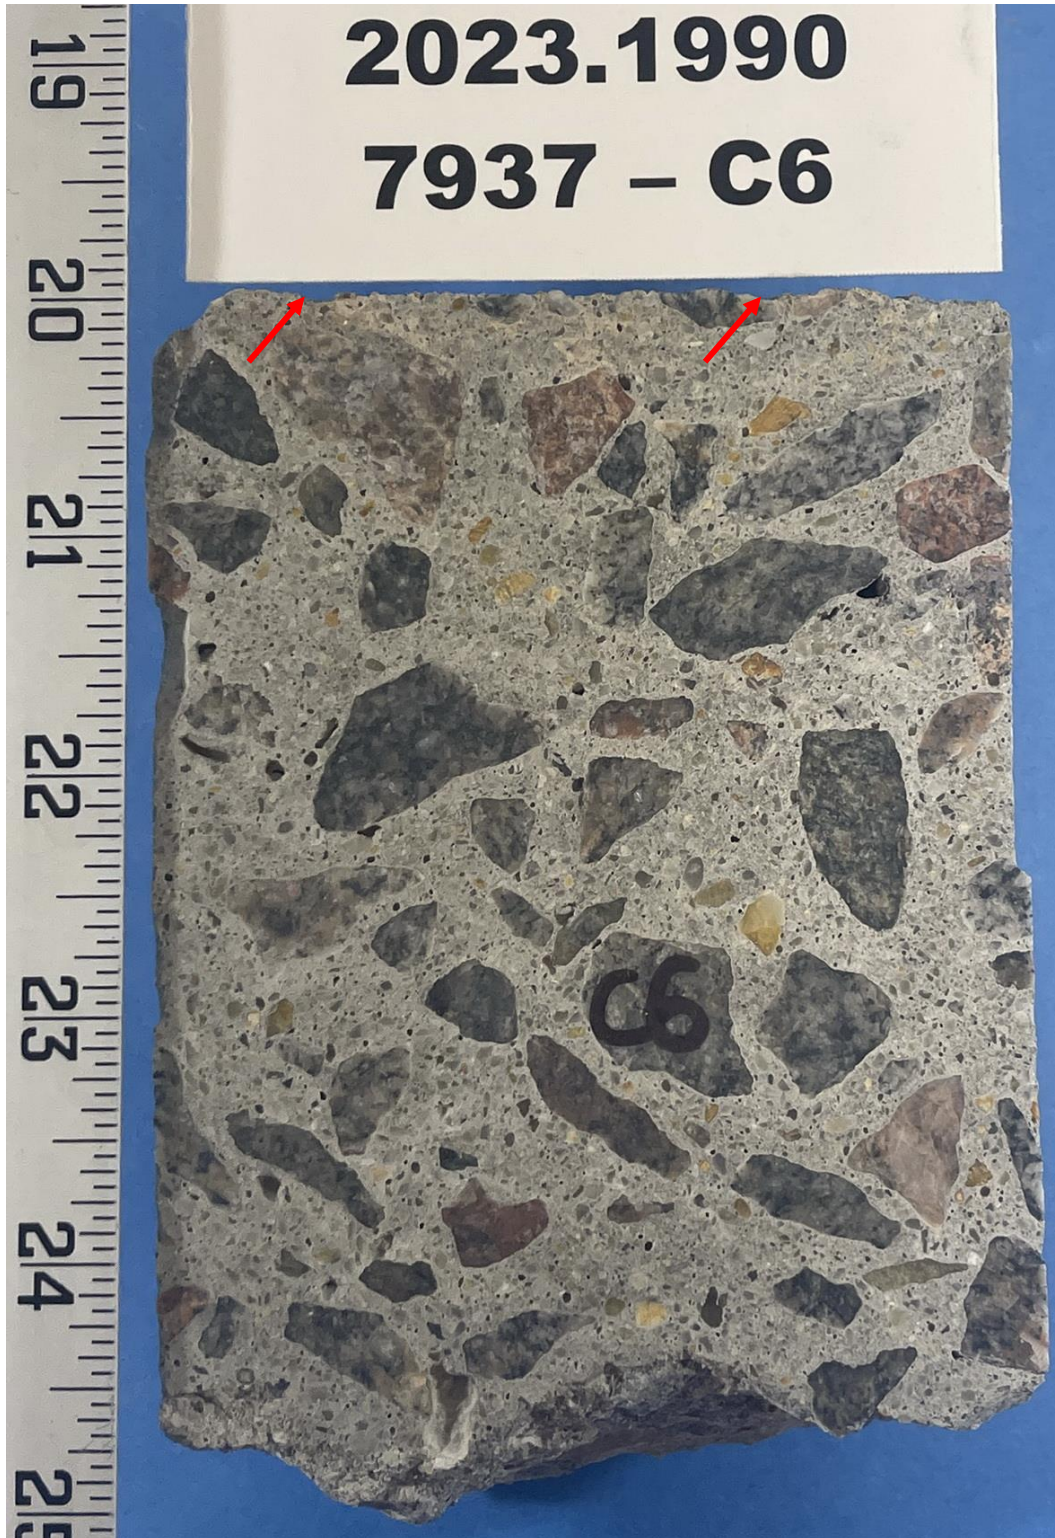
Figure 25. 7937-C6. Lapped longitudinal section, with the top surface towards the top of the image. Note the uneven top surface and somewhat preserved tines, indicated with red arrows. The aggregate in cores from Asset 7937 is similar to that from 7272.

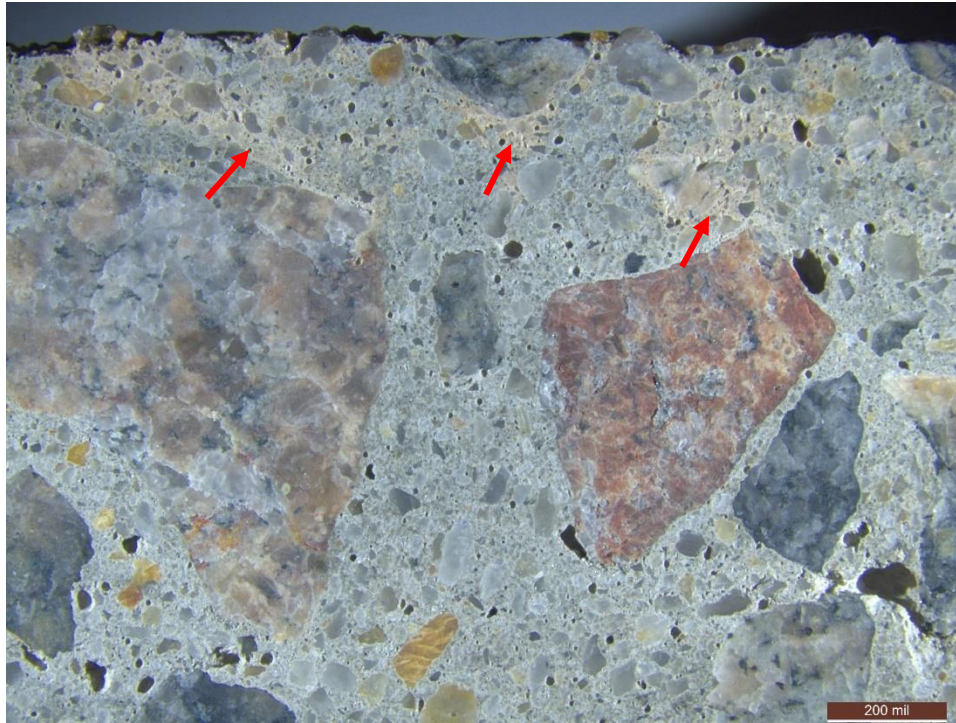
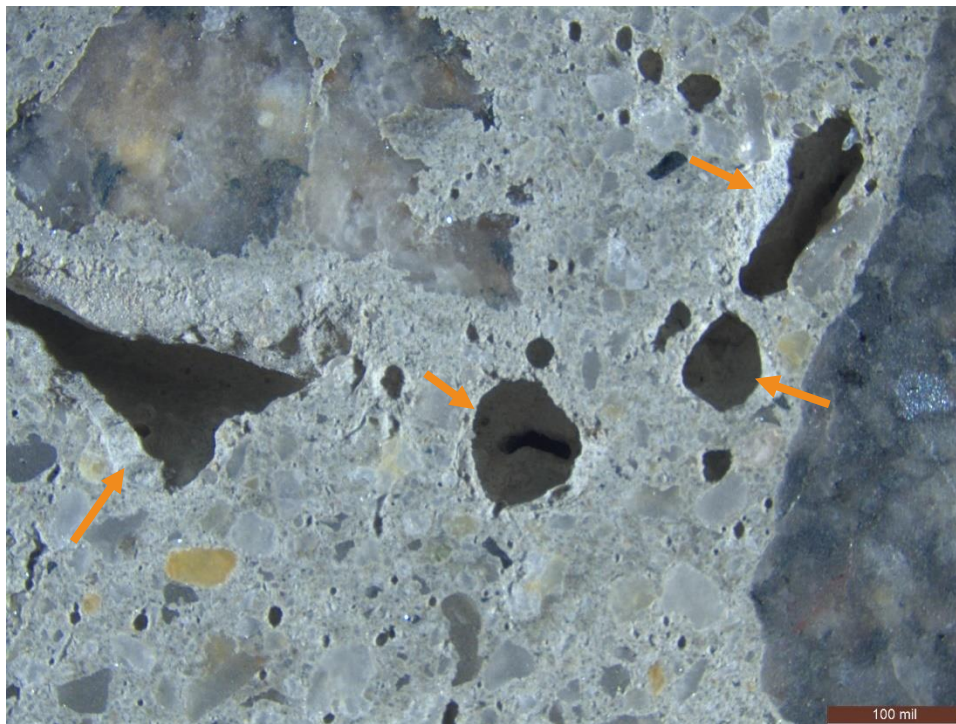
Figure 26. 7937-C6. Closeup views of the top region (top photo) and a region roughly 2 inch deep (bottom photo) of the core show paste, air voids, and aggregate of the concrete. Red arrows indicate localized discoloration likely due to carbonation. A few entrapped air voids were observed in the bottom photo (orange arrows).

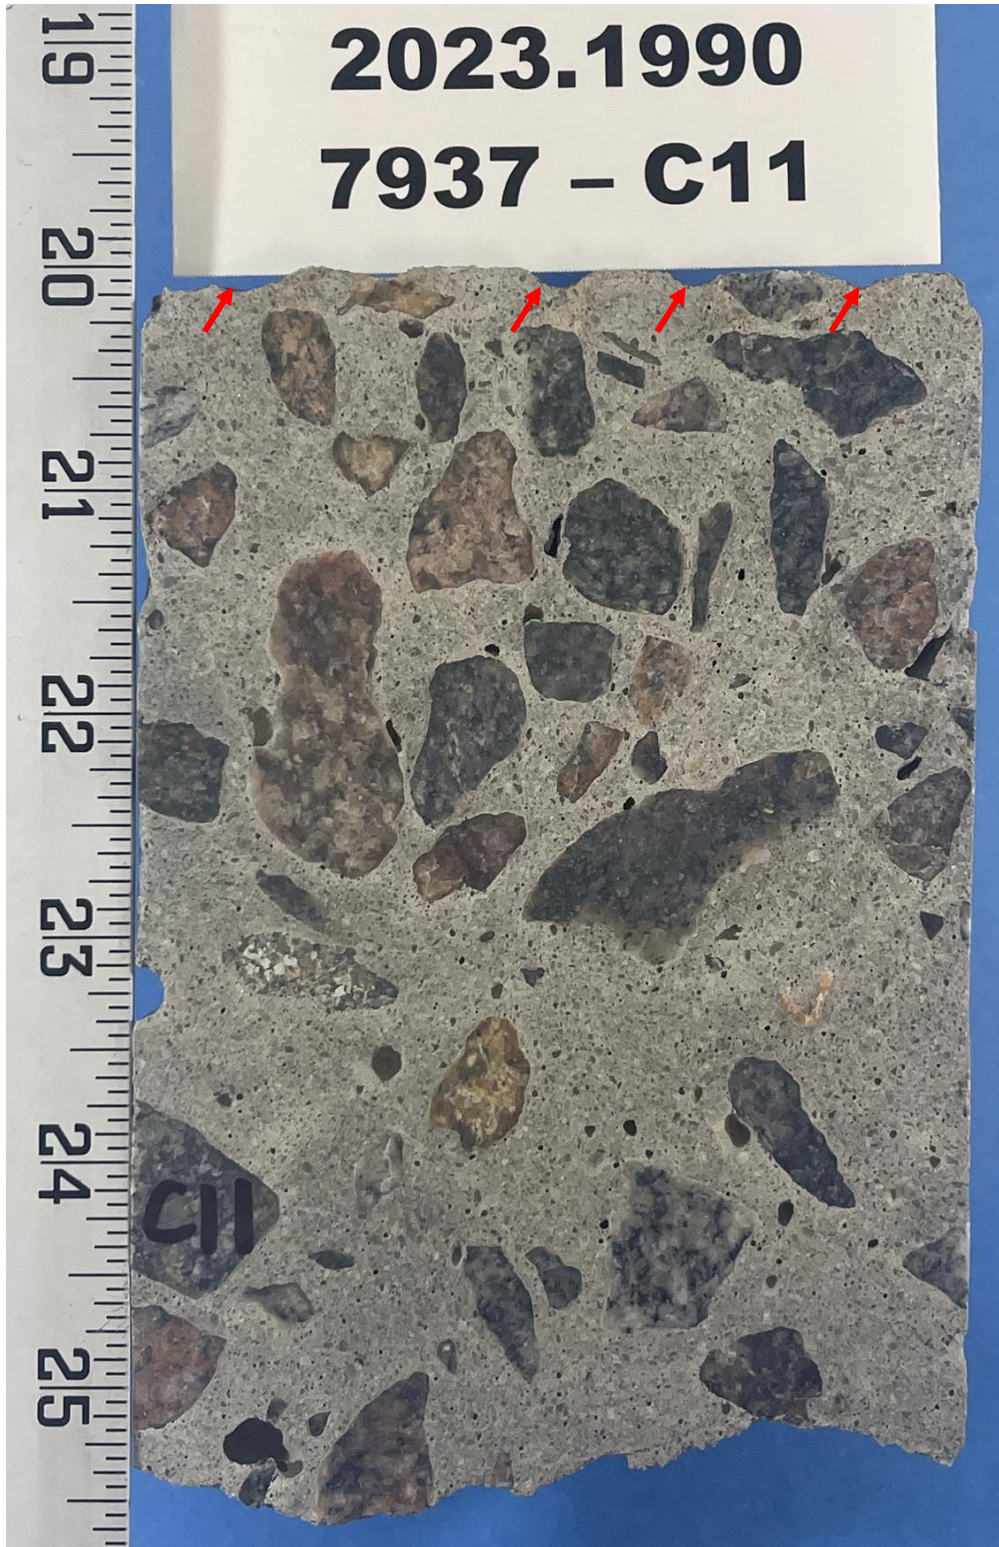
Figure 27. 7937-C11. Lapped longitudinal section, with the top surface towards the top of the image. Note the relatively well-preserved tines, indicated with red arrows. The aggregate in cores from Asset 7937 is similar to that from 7272.

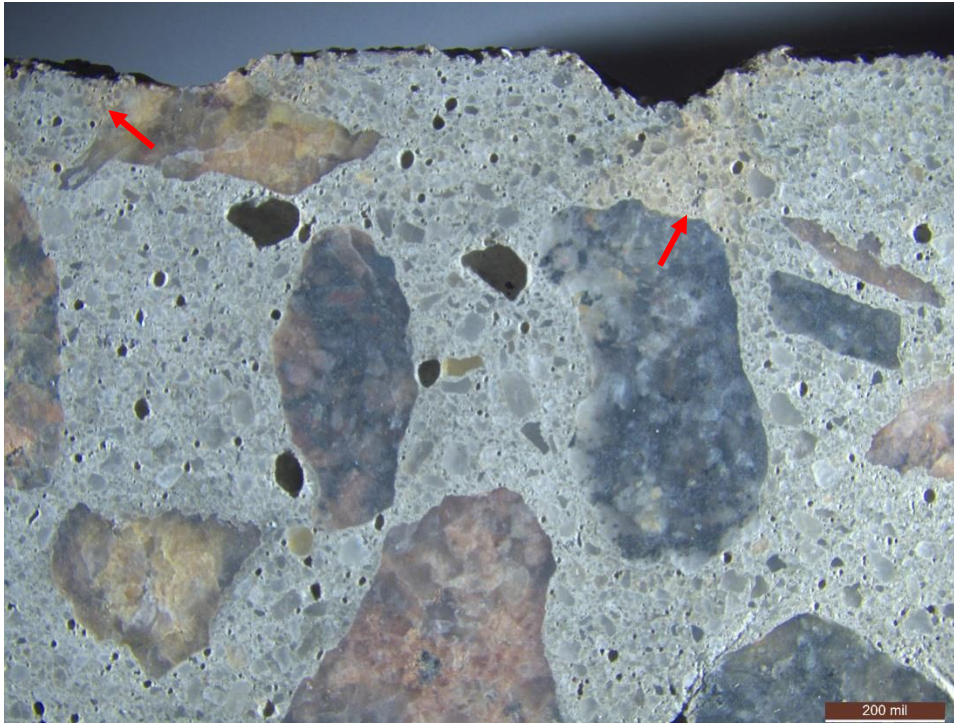
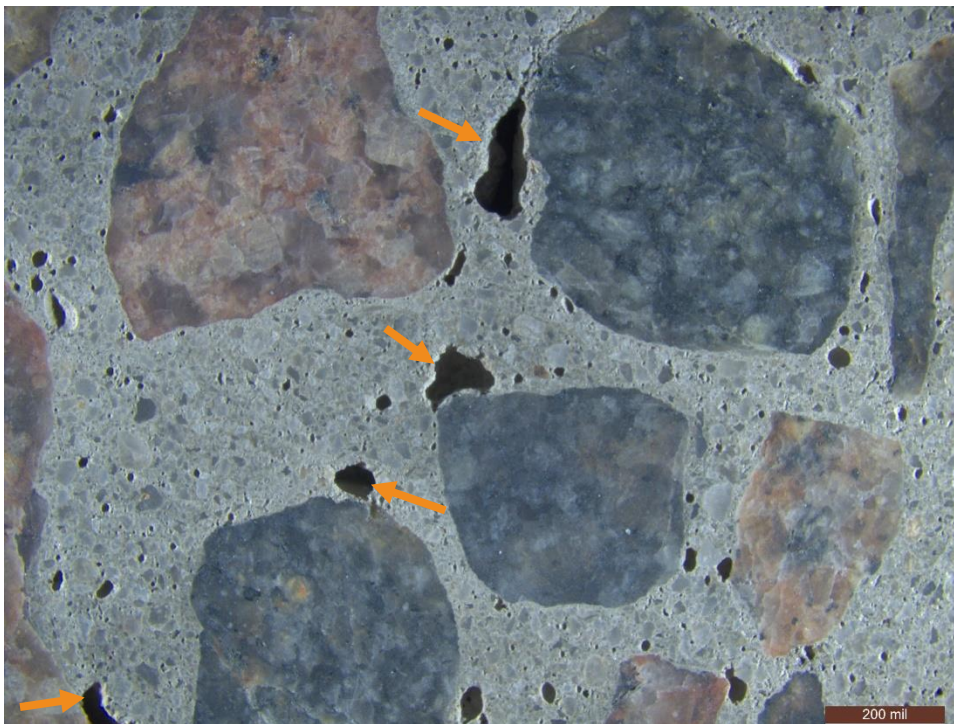
Figure 28. 7937-C11. Closeup views of the top region (top photo) and a region roughly 1.5 inch deep (bottom photo) of the core show paste, air voids, and aggregate of the concrete. Red arrows indicate localized discoloration likely due to carbonation. A few entrapped air voids were observed in the bottom photo (orange arrows).
