MEMORANDUM | August 17, 2023

I-20 / I-26 / I-126 Corridor Improvement (Carolina Crossroads)
Asset IDs 7272, 7586, and 7937 - Laboratory Studies of Concrete Cores

WJE PROJECT NO. 2023.1990

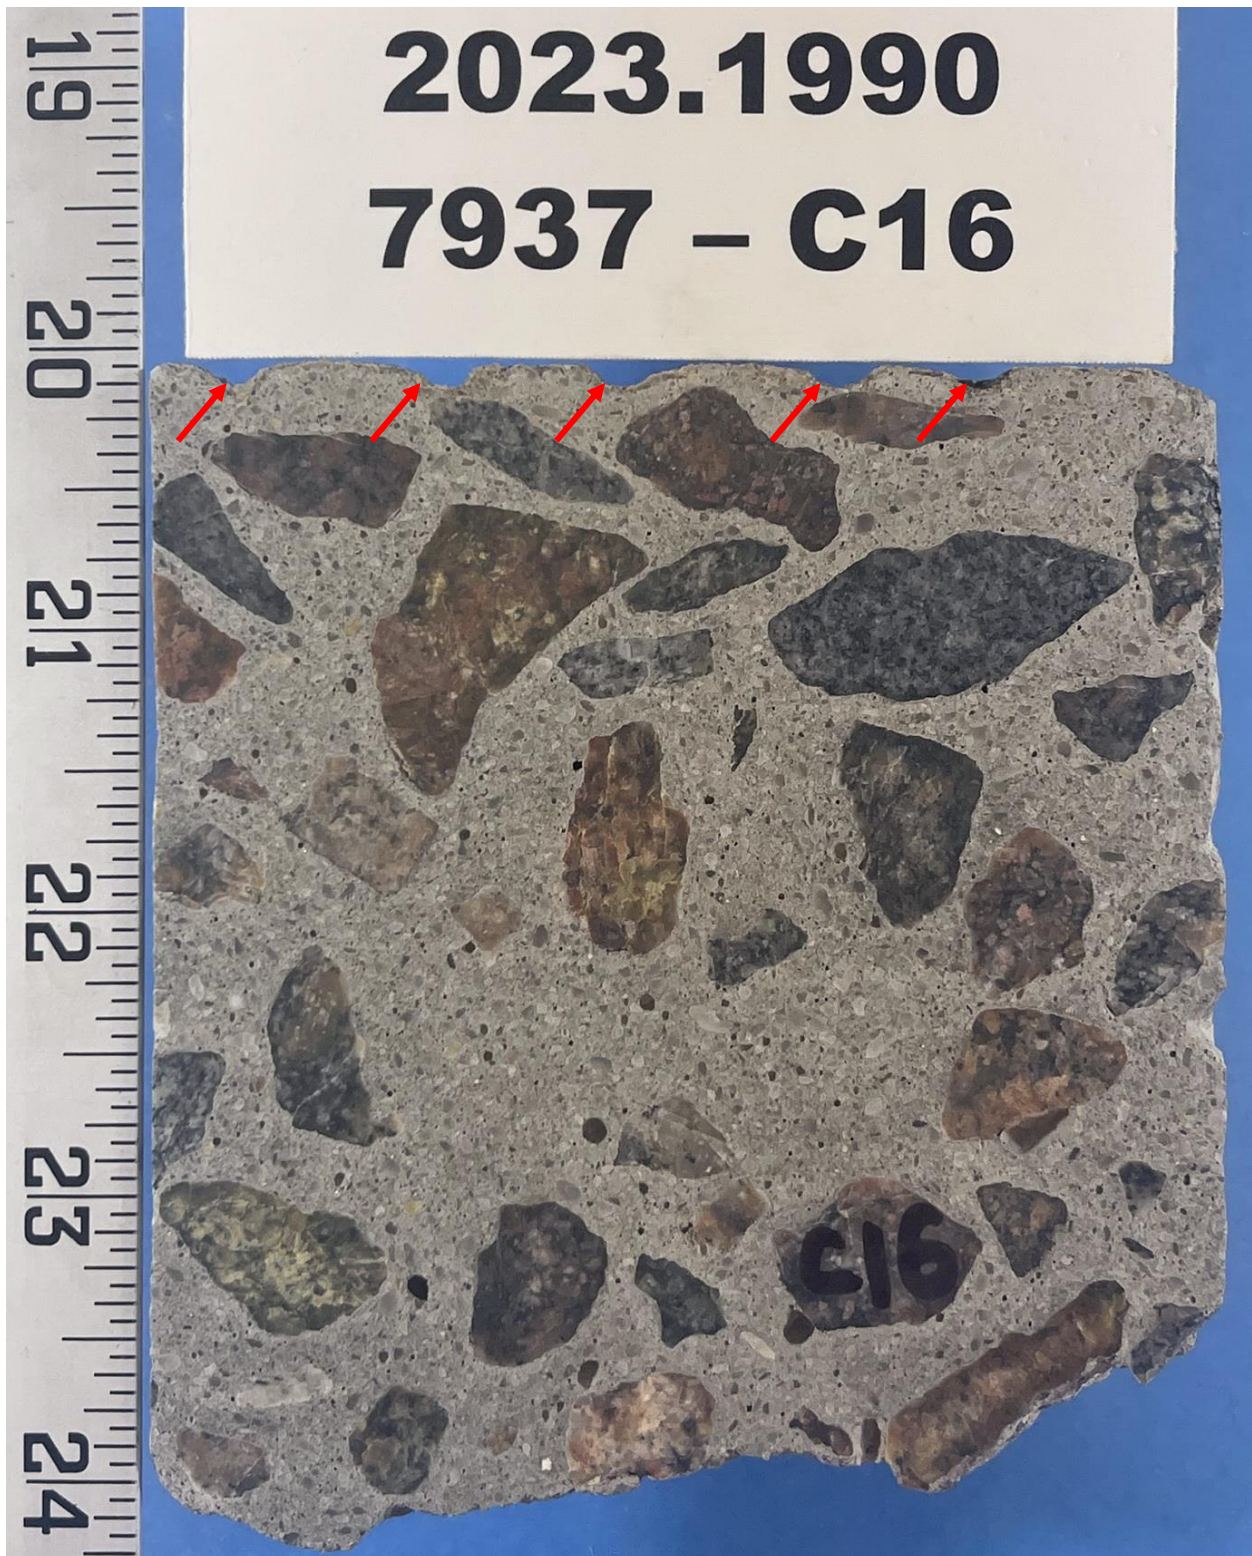
Figure 29. 7937-C16. Lapped longitudinal section, with the top surface towards the top of the image. Note the relatively well-preserved tines, indicated with red arrows. The aggregate in cores from Asset 7937 is similar to that from 7272.

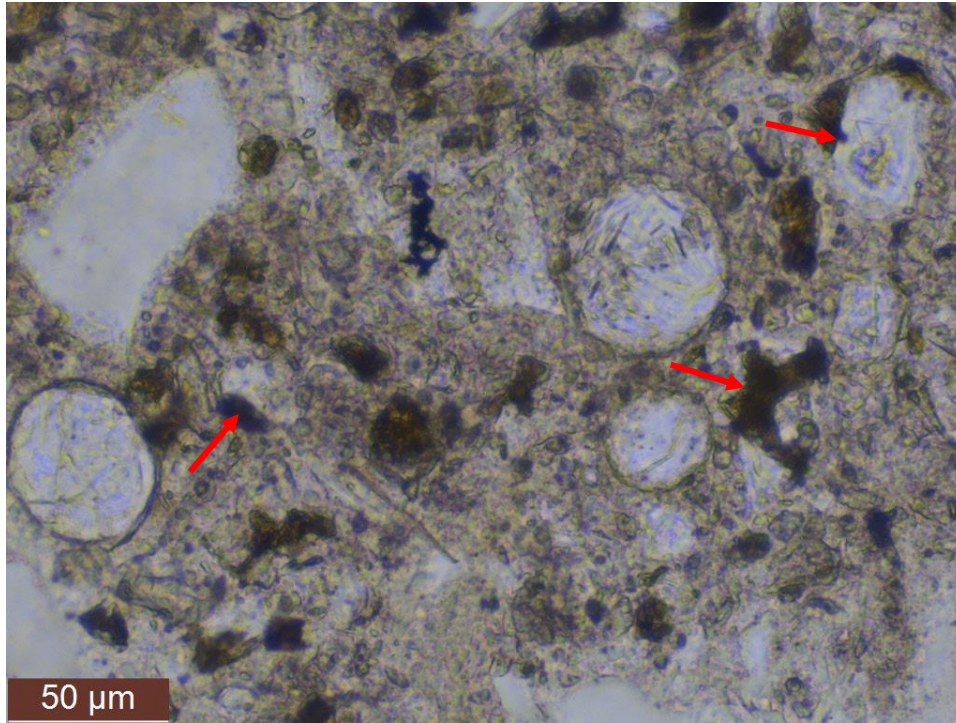
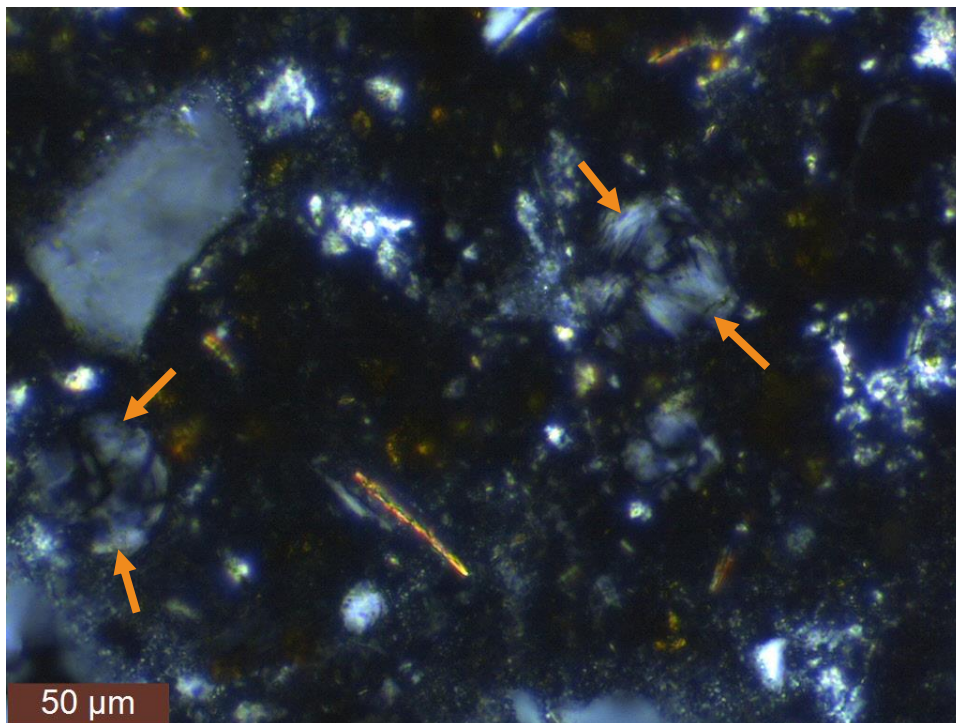
Figure 31. 7272 C-13. Thin section images. Red arrows indicate portland cement particles; orange arrows indicate ettringite line air voids. Top image: plane-polarized light. Bottom: cross-polarized light.

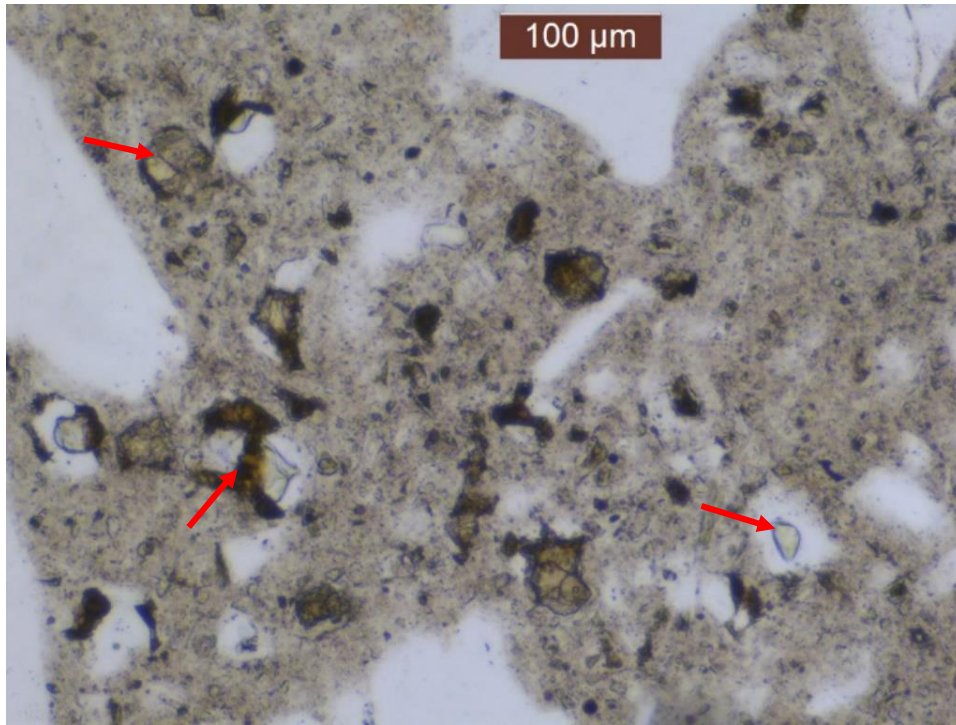
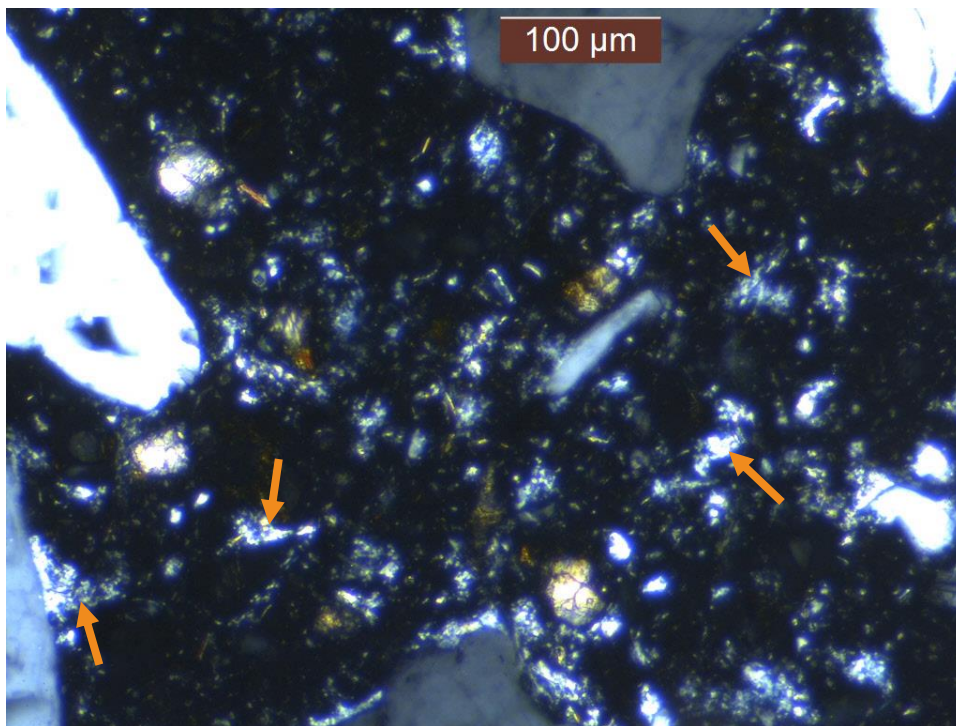
Figure 32. 7586 C-10. Thin section images. Red arrows indicate portland cement particles; orange arrows indicate calcium hydroxide crystals. Top image: plane-polarized light. Bottom: cross-polarized light.

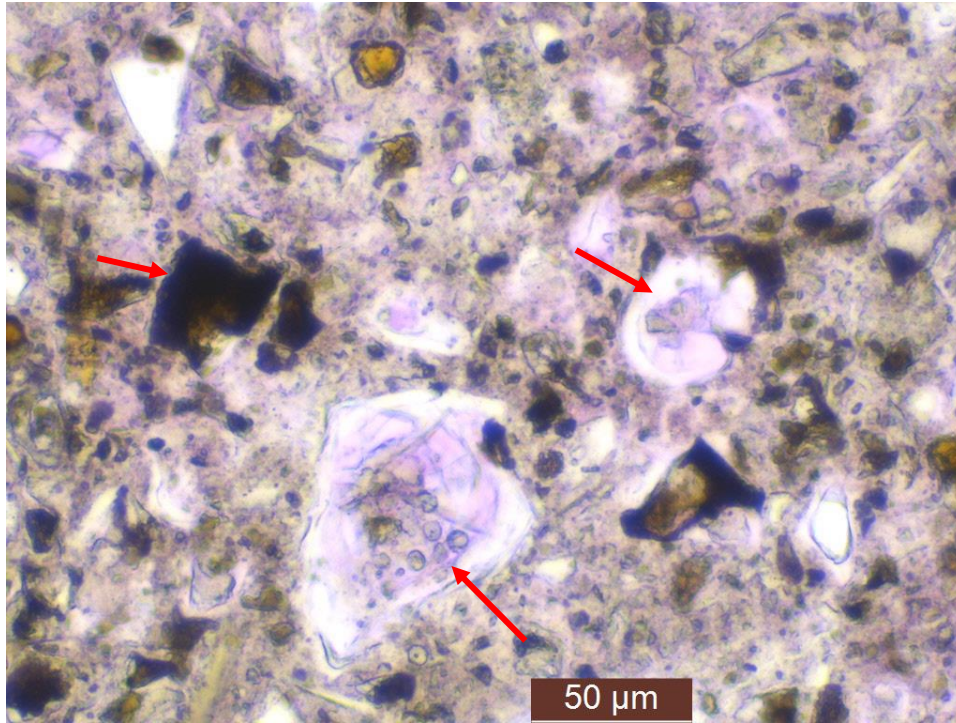
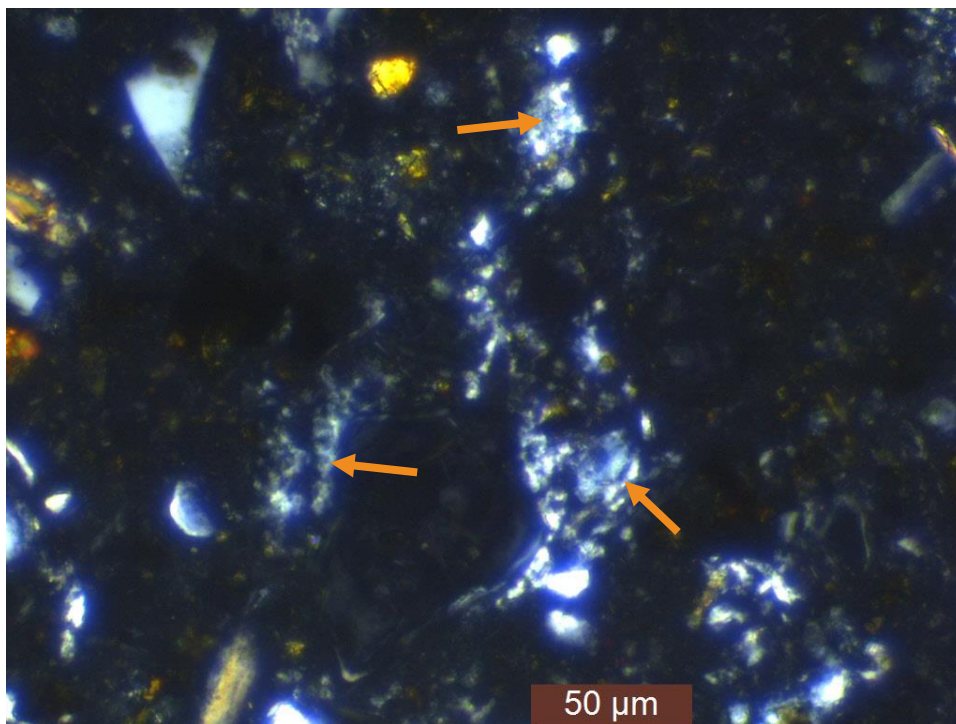
Figure 33. 7937 C-16. Thin section images. Red arrows indicate portland cement particles; orange arrows indicate calcium hydroxide crystals. Top image: plane-polarized light. Bottom: cross-polarized light.
