SCDOT BRIDGE INSPECTION FORM

(008) BRIDGE ID: 4070289200100	(005) ROUTE: RICHLAND S-2892
(420) ASSET NO: 4411	(006) CROSSING: I-20
(419) RAMP NO:	(009) LOCATION: 5 MI NW OF COLUMBIA
(026) FUNCTIONAL CLASS: 18	(016) LAT: 34d 2m 15.95s (017) LON: 81d 6m 26.44s

Bridge ID: 40-7-02892-0-01-00

31 Mar 2021

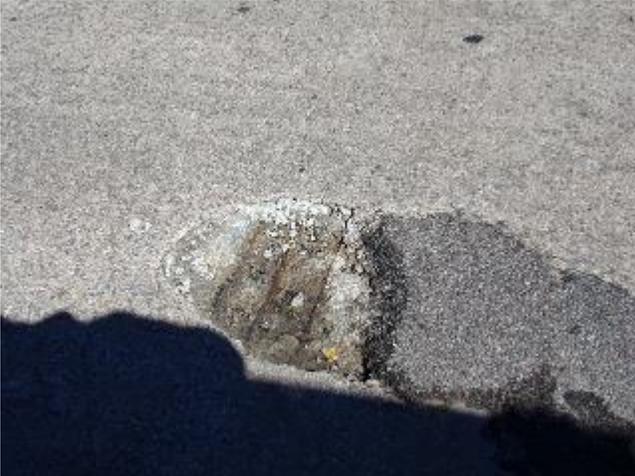
36" x 30" x 1 1/2" deep spall with exposed rebar in Eastbound lane near midspan (Photo 1)

1	Span 4 deck: 36" x 30" x 1 1/2" deep spall with exposed rebar in Eastbound lane near midspan	2	End Bent 7 Abutment: 5' hairline diagonal crack at North end

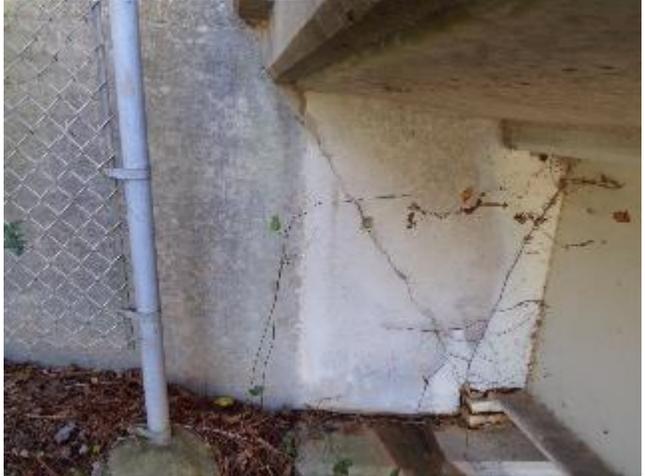
End Bent 7 Abutment: 5' hairline diagonal crack at North end (Photo 2)
8" x 6" x 1" deep spall in Bay 1 adjacent to Beam 2 (Photo 3)
20" up to 1/16" horizontal crack in Bay 2
5" x 3" x 1" deep spall in Bay 3 adjacent to Beam 3
(2) up to 17" hairline horizontal cracks in Bay 3 (Bay 4 similar)

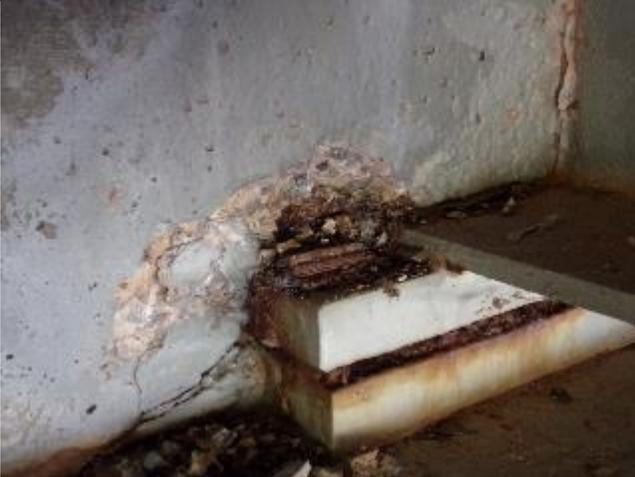
3	End Bent 7 Abutment: 8" x 6" x 1" deep spall in Bay 1 adjacent to Beam 2	4	Bent 6 Cap: (2) up to 26' x 3" x 1/2" deep spalls with exposed rebar on bottom of cap

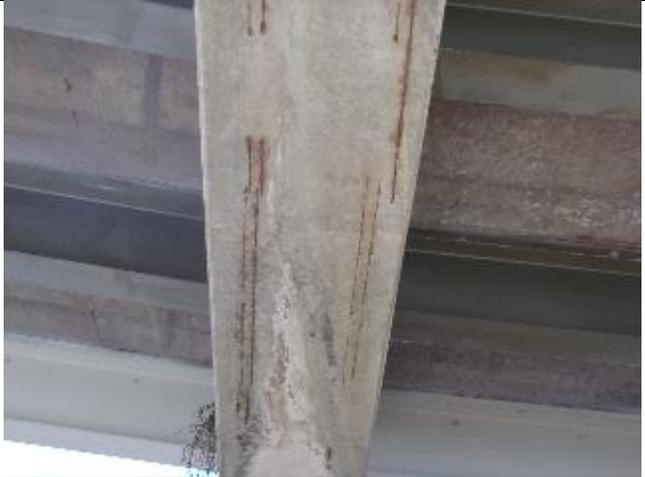
Bent 6 Cap: (2) up to 26' x 3" x 1/2" deep spalls with exposed rebar on bottom of cap (Photo 4)
(5) 6" hairline vertical cracks on Span 5 face at South end
19" x 19" area of delamination with up to 1/16" longitudinal and transverse cracks on bottom of cap at South end
7' x 3' area of delamination with up to 1/8" vertical and horizontal cracks on Span 6 face under Bay 4 (Photo 11)

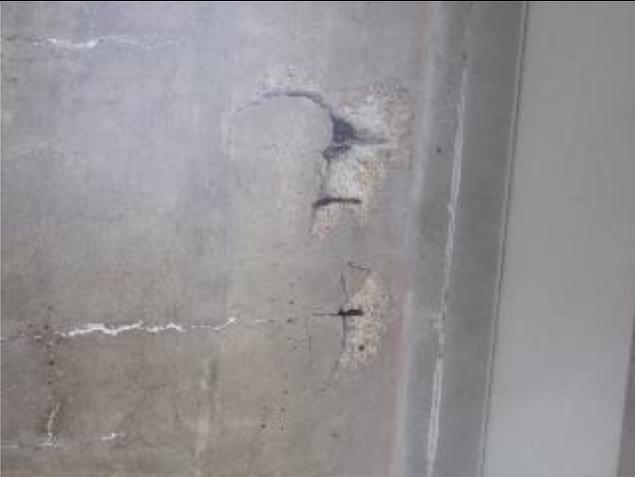
(2) up to 30" x 24" x 1 1/2" deep spalls with exposed rebar on bottom of deck in Bay 3, 8' from Bent 6 (Photo 5)

5	Span 5 deck: (2) up to 30" x 24" x 1 1/2" deep spalls with exposed rebar on bottom of deck in Bay 3, 8' from Bent 6	6	Bent 5 Cap: (2) up to 5' x 2' x 1 1/2" deep spalls with exposed rebar and areas of delamination on bottom of cap between Columns 1 and 2

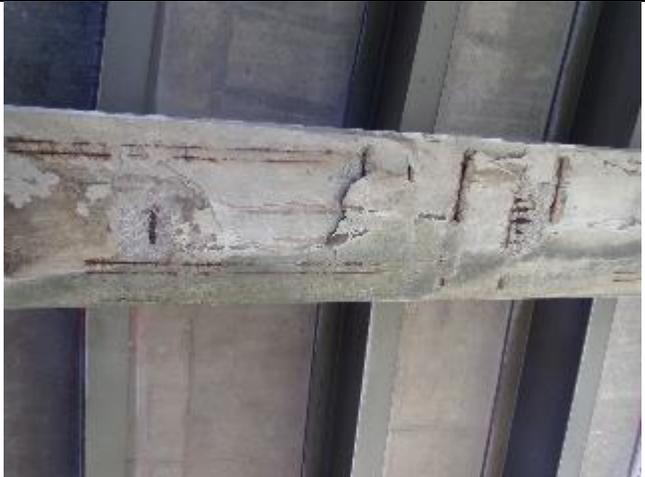
Bent 5 Cap: (4) up to 5' x 3" x 1/2" deep spalls with exposed rebar on bottom of cap between Columns 1 and 2
(2) up to 5' x 2' x 1 1/2" deep spalls with exposed rebar and areas of delamination on bottom of cap between Columns 1 and 2 (Photo 6)
14" x 8" area of delamination on bottom of cap between Columns 1 and 2
2' hairline vertical crack on Span 4 face above Column 1
(2) up to 23" x 6" x 1" deep spalls with exposed rebar between Column 2 and end of cap
6" hairline vertical crack on Span 5 face under Bay 4
2' hairline vertical crack on Span 5 face under Beam 5
1' hairline vertical crack on Span 5 face at South end
2' hairline horizontal crack on South face

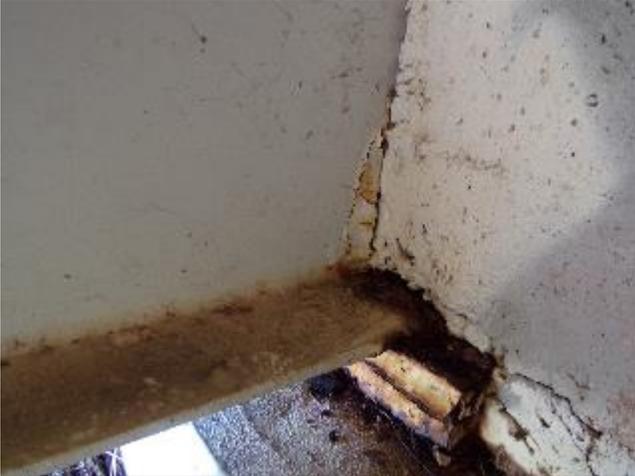
Span 1 Beam 5: 1' peeling paint with rust on both flanges and web at End Bent 1 (Photo 7)
Span 3 Beam 5: 10' surface rust on both flange
Span 4 Beam 5: Full length surface rust on both flanges
Span 6 Beam 5: 8' peeling paint with rust on both flanges

7	Span 1 Beam 5: 1' peeling paint with rust on both flanges and web at End Bent 1	8	Span 6 right bridge rail: 8" x 8" x 1" deep spall on end post

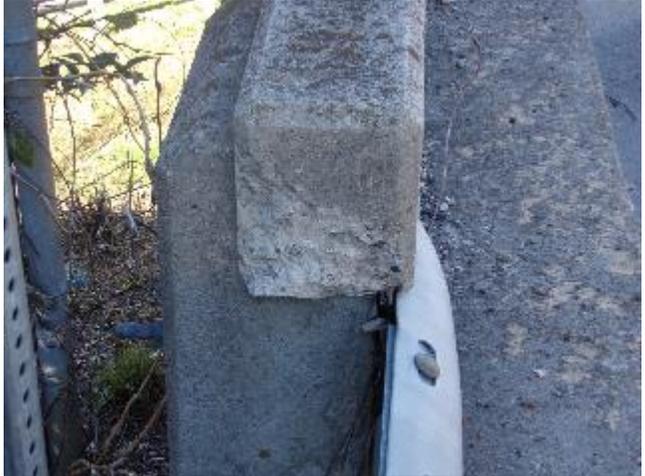
Span 6 right: 8" x 8" x 1" deep spall on end post (Photo 8)
(17) hairline vertical and transverse cracks

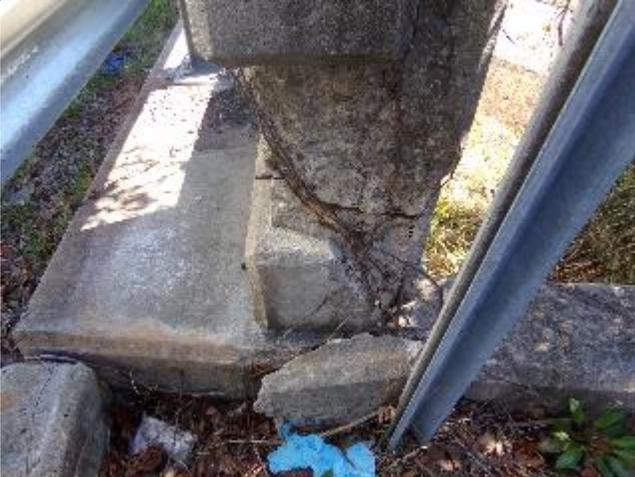
Span 1 right: (15) hairline vertical and transverse cracks
18" x 10" x 2" deep spall with exposed rebar on end post (Photo 9)

9	Span 1 right bridge rail: 18" x 10" x 2" deep spall with exposed rebar on end post	10	Bent 2 Cap: 10' x 1' x 2" deep spall with expsd rebar and area of delamination on Span 1 face under Beam 4

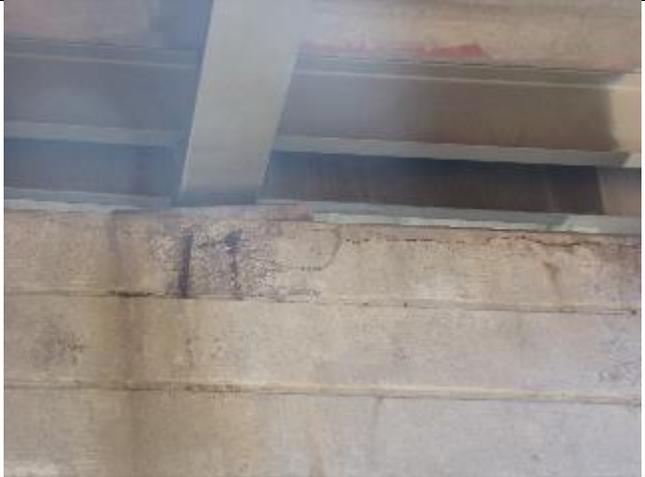
Bent 2 Cap: 10" x 2" area of honeycombing on Span 2 face under Beam 4
(2) up to 2' x 3' area of up to 1/16" vertical and horizontal cracks on Span 1 Face under Beam 4
18" x 5" area of delamination on Span 1 face under Bay 2
10' x 1' x 2" deep spall with exposed rebar and area of delamination on Span 1 face under Beam 4 (Photo 10)
1' up to 1/8" vertical crack on Span 2 face under Beam 5
(8) up to 3" x 28" x 1/2" deep spalls with exposed rebar on bottom of cap

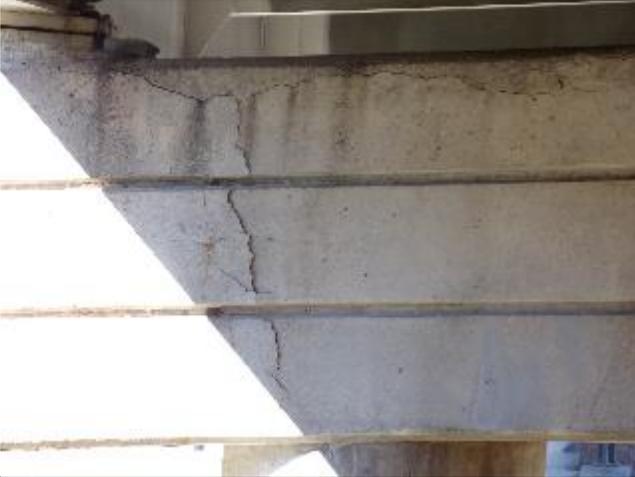
11	Bent 6 Cap: 7' x 3' area of delamination with up to 1/8" vertical and horizontal cracks on Span 6 face under Bay 4	12	End Bent 7 Cap: 20" x 6" x 1" deep spall with exposed rebar under Beam 3

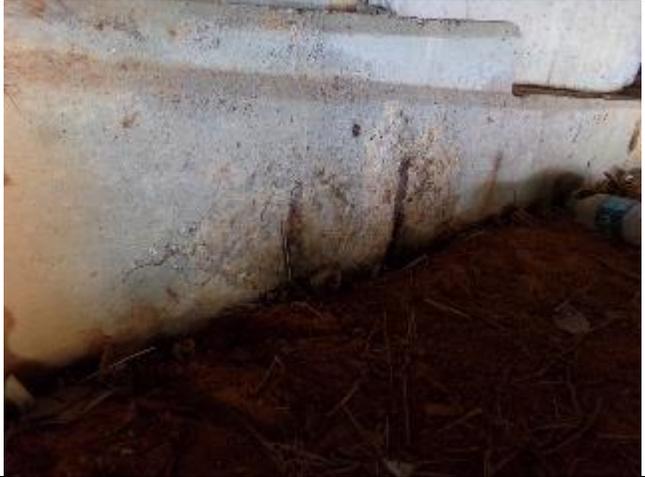
End Bent 7 Cap: 1' hairline horizontal crack under Bay 1
6" x 1" x 1" deep spall in Bay 2
20" x 6" x 1" deep spall with exposed rebar under Beam 3 (Photo 12)

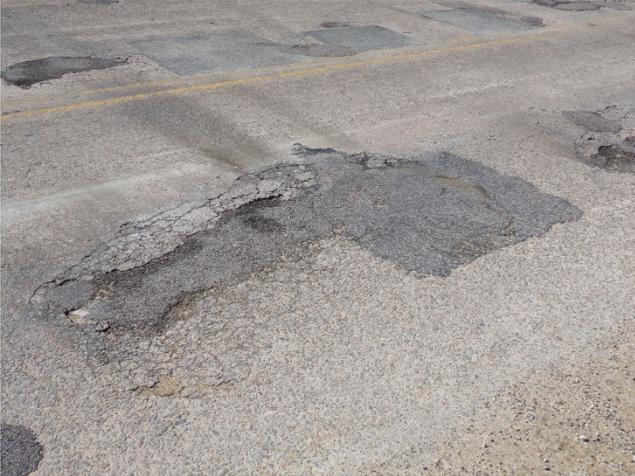
(15) up to 11' x 4' areas of unsound patches (Photo 13)

13	Span 2 Deck: (15) up to 11' x 4' areas of unsound patches	14	Span 2 Deck: 3555 square feet hairline map cracking

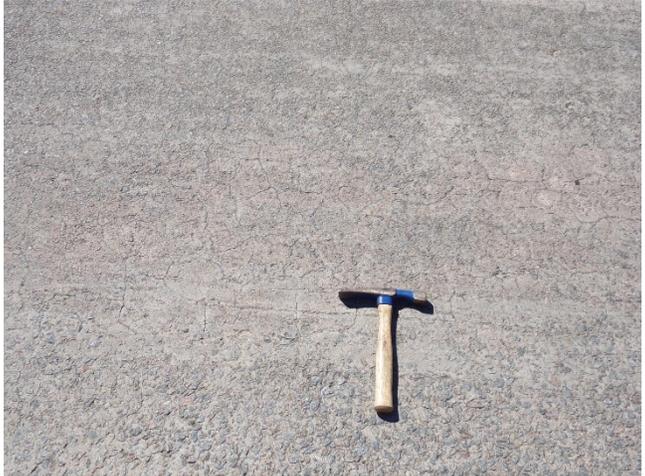
3555 square feet hairline map cracking (Photo 14)

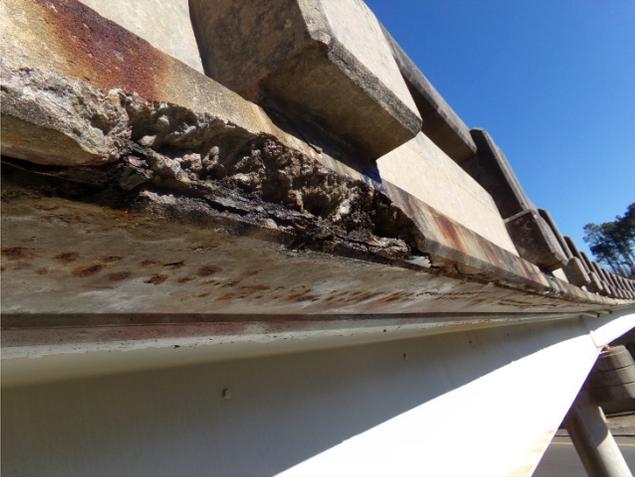
32' x 3" x 2" deep spall and area of delamination in South overhang (Photo 15)

15	Span 1 Deck: 32' x 3" x 2" deep spall with exposed rebar and area of delamination in South overhang
