SCDOT BRIDGE INSPECTION FORM

(008) BRIDGE ID: 3210002600400			(005) ROUTE: LEXINGTON I-26		
(420) ASSET NO: 3022			(006) CROSSING: SALUDA RIVER		
(419) RAMP NO:			(009) LOCATION: 4 MI W OF COLA

Bridge Element Group Textual Data

Bridge ID: 32-1-00026-0-04-00

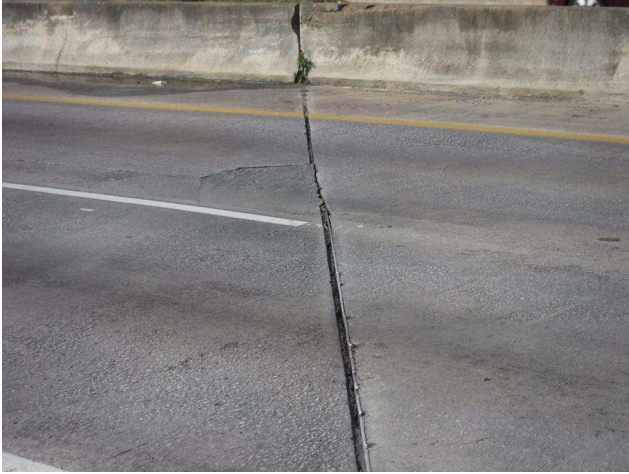
Expansion joints have loss of adhesion throughout bridge [See sketch sheets].

Throughout joints on bridge Loss of Adhesion [up to 1/2" wide x 50' Long]

7	Typical loss of adhesion in pourable joints	8	Typical loss of adhesion in compression joints

C	805	repair/replace joints due to seal adhesion/missing [approx 1100LF]	<input type="checkbox"/>	8	<input type="checkbox"/>
-			<input type="checkbox"/>		<input type="checkbox"/>

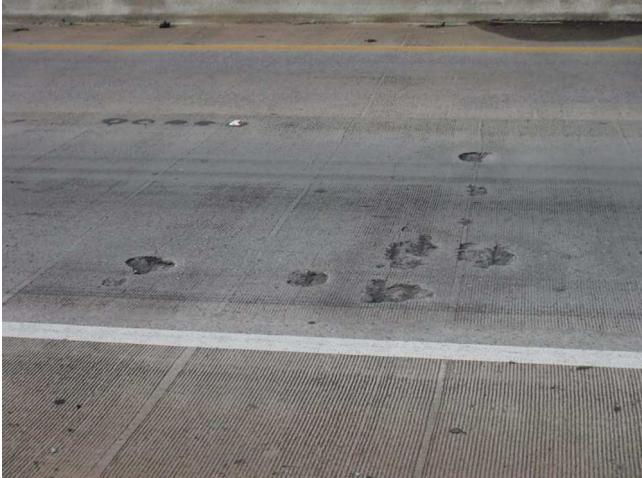
Following locations have failed patches and spalls, some with exposed rebar.

9	Typical spall in top of deck	10	Typical failed patch in top of deck

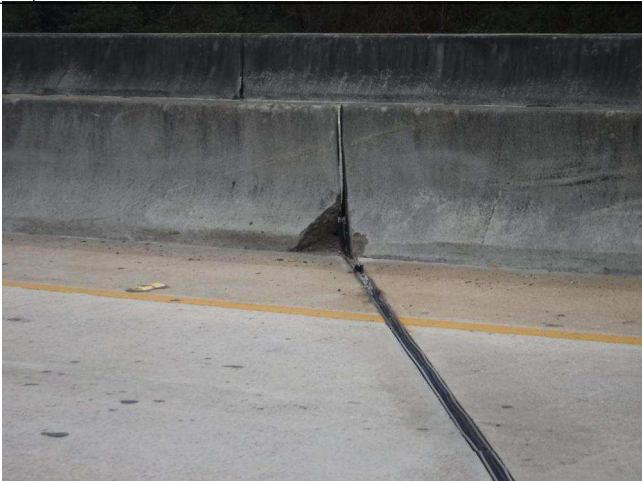
WBL of I-26, East end, at construction joint, spall up to 12"L x 12"T x 5" deep with exposed rebar with no section loss. Throughout parapets, Hairline cracks most with efflorescence staining. Throughout parapets at expansion joints [8] spalls up to 10"L x 10"T x 4" deep.

11	Typical spalling in RC parapets	12	Spall in Parapet at East end

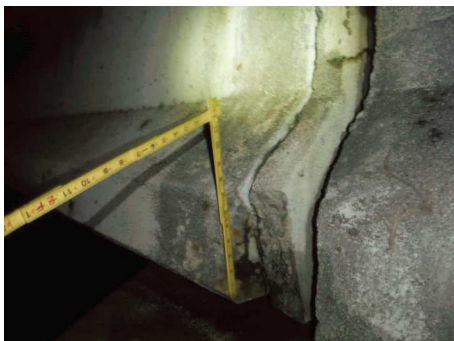
Hairline cracks and spalls with exposed strands throughout beams (see sketch sheet). Hairline cracks and spalls up to 3" x 3" x 1/2" with exposed rebar in diaphragms.

Photo #: 1 Caption: Patch Spalls in Beams [approx 14LF]

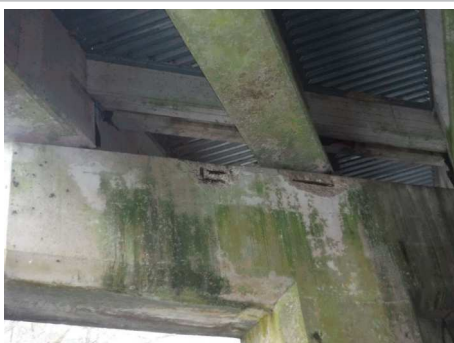
Hairline to 0.04" cracks several with efflorescence and spalls, several with rust and exposed rebar in caps, (see sketch sheet). Throughout Pier walls diagonal hairline cracks with efflorescence staining. Throughout pier walls abrasion up to 1/8" with no loose aggregate. Dirt and debris on caps. Throughout Columns abrasion up to 1/8" with no loose aggregate.

Photo #: 3 Caption: Clean and paint all exposed rebar in caps, columns and deck. [approx 41LF]

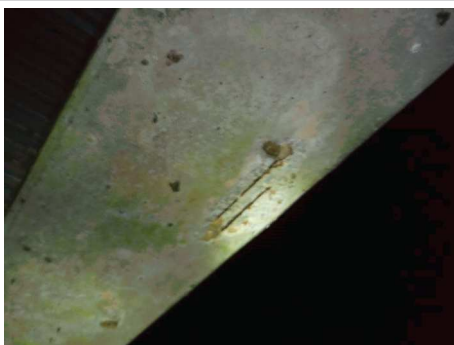
Beam 5-1 at middle of span, spall [14"L x 6"W x 1" deep] with [2] prestressed strands exposed [No section loss]

Beam 5-19 at bent 6 has a spall [5"L x 28"T x 4" deep] with [1] prestressed strand exposed

Photo #: 5 Caption: clean and paint exposed prestressing strands in beams [approx 16LF]

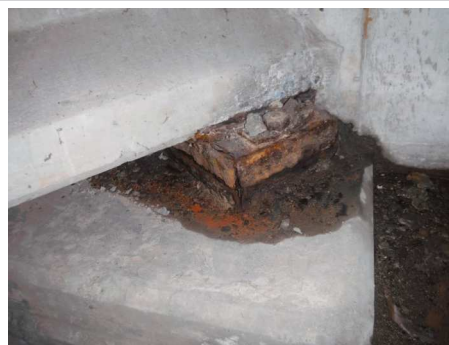
Steel bearings at beams 1-10 at abutments, corrosion with pack rust up to 1/4" and pitting up to 1/16"

Paint has failed on bearings and allowed corrosion with pack rust and pitting.

Photo #: 6 Caption: Clean and paint bearings [10 bearings]

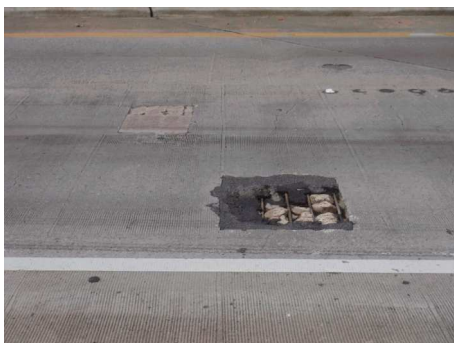
Throughout deck, cracking up to .04"W, abrasion, and spalls/failed patches with exposed rebar. [See sketch sheet]

Photo #: 7 Caption: Patch spalls in top of deck [approx 75SF]
