SCDOT BRIDGE INSPECTION FORM

(008) BRIDGE ID: 3270003600200	(005) ROUTE: LEXINGTON S-36
(420) ASSET NO: 7586	(006) CROSSING: I-26
(419) RAMP NO:	(009) LOCATION: 6 MI NW OF COLUMBIA
(026) FUNCTIONAL CLASS: 14	(016) LAT: 34d 2m 40.63s (017) LON: 81d 7m 4.76s

Bridge ID: 32-7-00036-0-02-00

16 Feb 2023

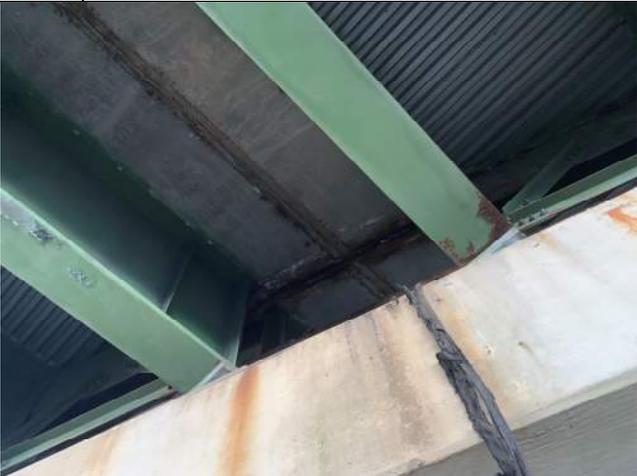
Random, minor surface rust at the ends of steel girders and to steel 'K' cross frames on all spans (Photo 7). (96 LF = CS2)

7	Random, minor surface rust at the ends of steel girders and to steel 'K' cross frames on all spans.	8	Beam 2-8, 4'-0" of surface rust along the bottom flange.
9

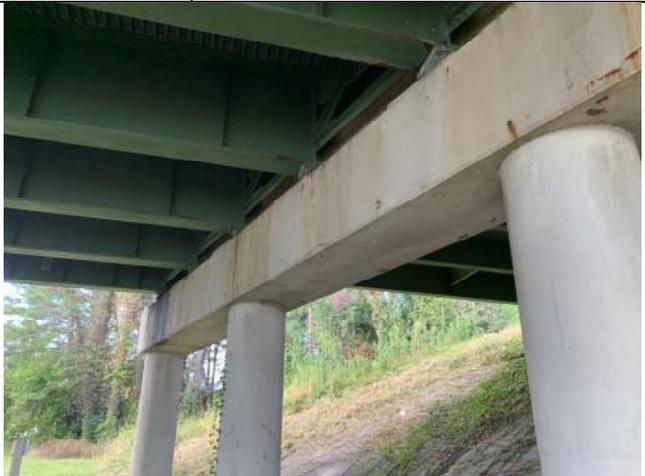
Beam 2-8, 4'-0" of surface rust along the bottom flange (Photo 8). (4 LF = CS2)

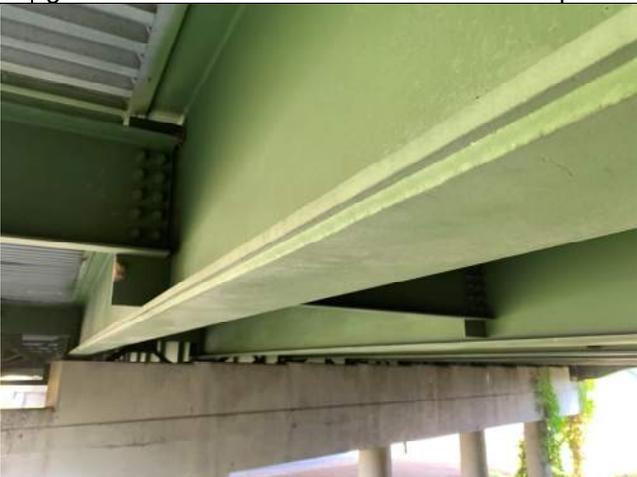
Welded bottom flange cover plate on Beam 1-2, Beam 1-11, Beam 4-2 and Beam 4-11 (Photo 9).

9	Welded bottom flange cover plate on Beam 1-2, Beam 1-11, Beam 4-2 and Beam 4-11.	10	Seal joint material at all joints is cracked, torn or missing.
11

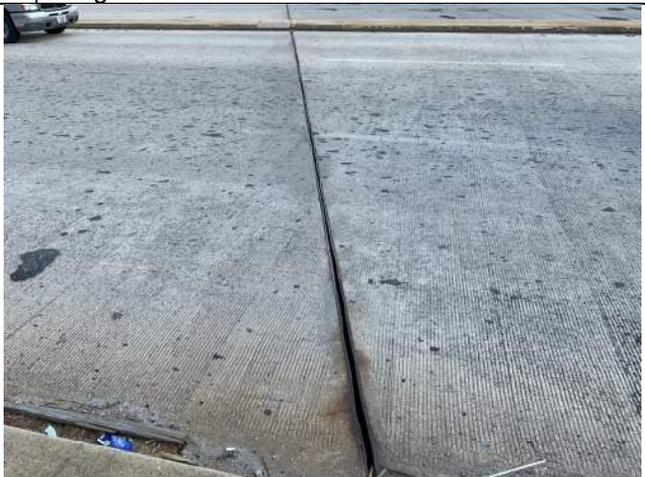
Seal joint material at all joints is cracked, torn or missing (Photo 10) (232 LF = CS4)

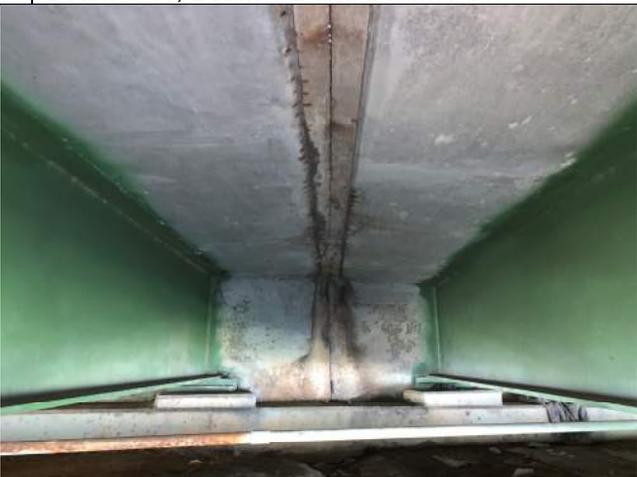
The eastbound and westbound structures were built with a longitudinal joint through the deck along the centerline of the bridge. The longitudinal deck joint is cracked, torn or missing (Photo 11).

11	The longitudinal joint through the deck along the centerline of the bridge is cracked, torn or missing.	12	Reinforced Concrete Deck: Approximately 17.5% of the top of the deck is patched in Span 3.

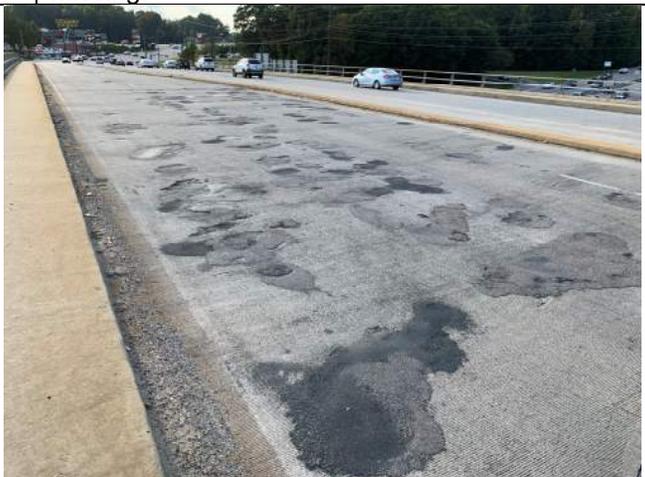
Reinforced concrete deck exhibits widespread deterioration with concentration on Span 2 in the NBL and heavy concentration on Span 3 in the NBL. Some patches are sound. Approximately 7.5% of the top of the deck is patched in Span 2. Approximately 17.5% of the top of the deck is patched in Span 3 (Photo 12). Some patches have failed and spalls exhibit exposed transverse reinforcement with active corrosion (40 SF = CS3). Failed or poor patches in approximately 10% of the total deck area (Photo 13). Nominal section loss on the reinforcement. The largest spall is 3 feet in diameter with six exposed transfer bars between Lane 1 and Lane 2 on Span 2 in the SBL (Photo 14). (4805 SF = CS2 and 3203 SF = CS3)

SCDOT performed a deck drag in January 2017 and indicated 15% of the deck was spalled or delaminated. Inspectors note that bridge may be included in future I-26 project. Consider future deck drag in 2027 (10 years following the previous drag).

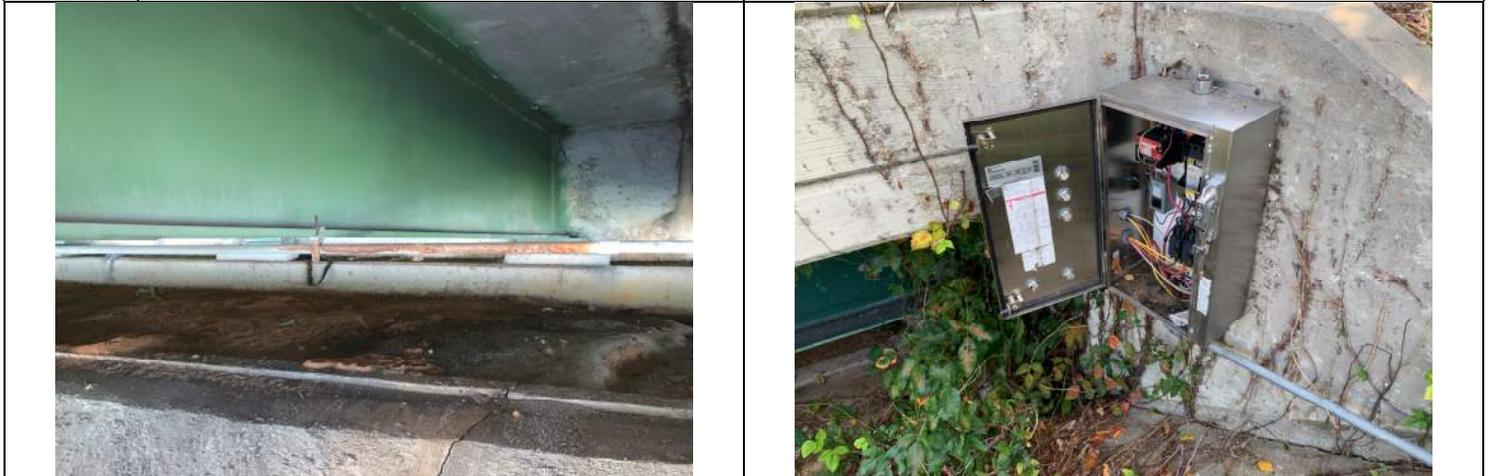
Random surface rusting on 3/4" diameter metal conduit and "C" clamps, typical across bridge (Photo 19).

Box at northwest wingwall is open with internal components exposed (Photo 20).

19 Random surface rusting on 3/4" diameter metal conduit and "C" clamps, typical across bridge.	20 Metal electrical box attached to northwest wingwall at Bent 1, left side. Box at northwest wingwall is open with internal components exposed.
---	--
