SCDOT BRIDGE INSPECTION FORM

(008) BRIDGE ID: 3270027300200	(005) ROUTE: LEXINGTON S-273
(420) ASSET NO: 7272	(006) CROSSING: I-20
(419) RAMP NO:	(009) LOCATION: 5 MI NW OF WEST COLUMBIA
(026) FUNCTIONAL CLASS: 14	(016) LAT: 34d 1m 53.76s (017) LON: 81d 7m 16.98s

Inspection Leader: BRIAN EGGERTON, HDR	Reviewed By: MURDZIA, DAN
Date:	Date: 2/16/2023

Bridge ID: 32-7-00273-0-02-00

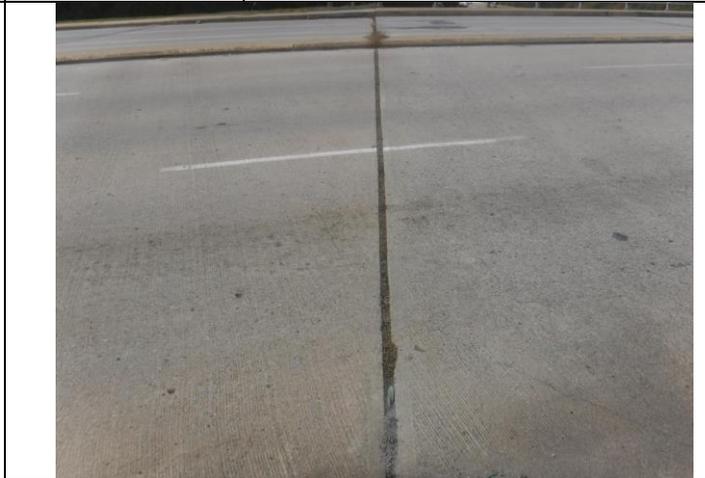
Expansion material cracked, pulling loose, and missing throughout.

End Bent 1 and 5, FQ Impaction (CS3) Dirt and Debris accumulation with vegetation growth throughout.
End Bent 1, Up to to 72" x 6" edge spalls and 18" x 5" area of delamination along End Bent 1 header.

8 | END BENT 1 JOINT, END BENT 5 JOINT SIMILAR

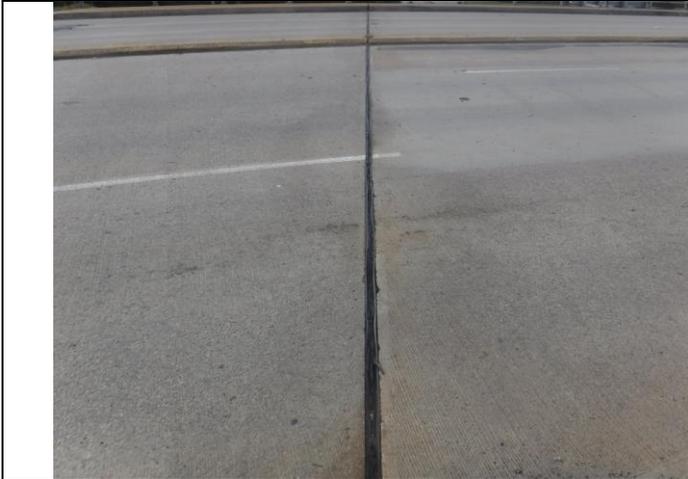
FQ Seal Damage (CS4) cracked torn and missing joint material thought joints.

11 | BENT 2 JOINT, BENTS 3 AND 4 SIMILAR

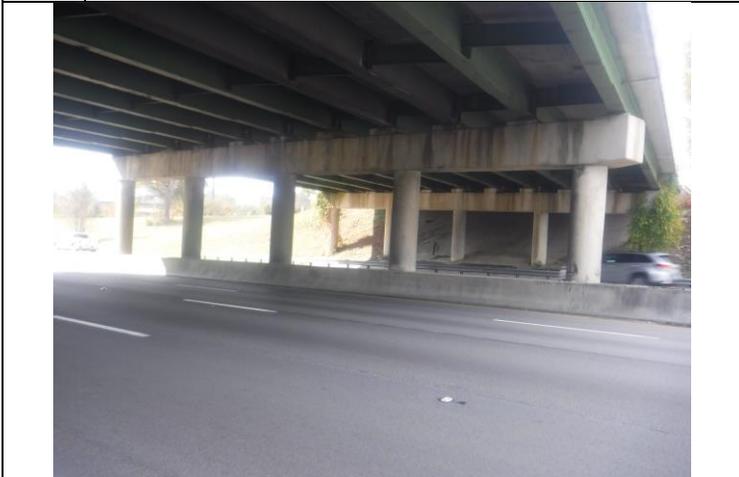
15 BENT 3, BENTS 2 AND 4 SIMILAR

(3) 2' vertical hairline cracks above column 2, South face.
1' vertical hairline crack with efflorescence and rust under beam 2, South face.
3' vertical hairline crack between columns 2 and 3 in South face.

(2) 2' x 0.02" horizontal crack with efflorescence and rust under beam 3 in South face.
36" x 24" x 1" deep spall and hairline map cracking in bottom of cap between columns 2 and 3.
2' x 0.02" horizontal crack with efflorescence/rust between columns 2 and 3, North face.

(3) 3' diagonal hairline cracks with efflorescence under beams 3 in both faces.
2' horizontal hairline crack with efflorescence under beam 4, North side.

(2) 3' diagonal hairline cracks with efflorescence between beams 4 and 5, North face.
2' vertical hairline cracks with efflorescence between beams 4 and 5 in both faces.

(2) 3' transverse hairline cracks in bottom of cap between columns 4 and 5.
3' vertical hairline crack under beam 9, South face.
6" x 6" x 1" deep spall in bottom of cap at left end.
Hairline map cracking at left end of cap on South face.
Hairline cracks with efflorescence at construction joints.
Hairline map cracking bottom at left end of cap.
14" diameter spall with exposed rebar with moderate corrosion underside at left end.

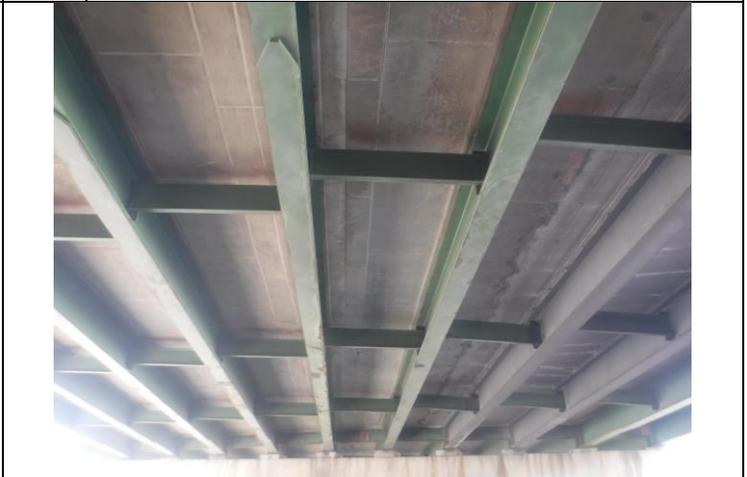
16 SPAN 2 UNDERDECK, OTHER SPANS SIMILAR

Transverse cracks and Hairline map cracking with and without efflorescence throughout.
Moderate spall with rust between beams 10 and 11 at deck drain on bottom of deck.
Minor spalls on bottom of deck at joints, (concrete on caps)

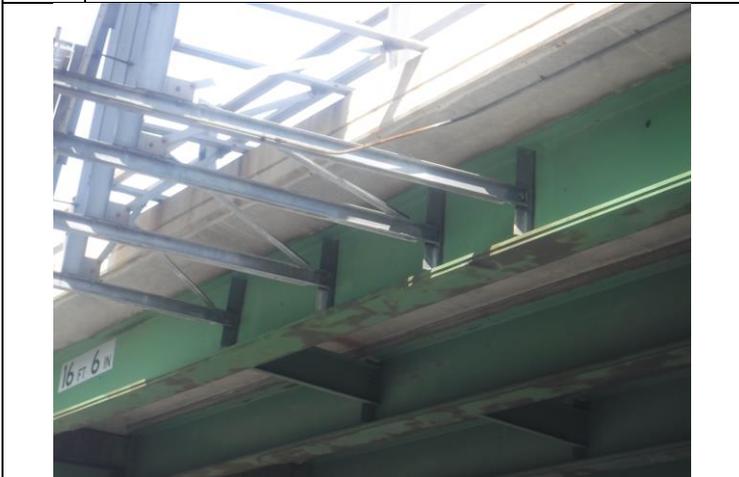
Surface corrosion forming on flanges and web at beams ends, with Heavy rust on exterior cover plates.
Minor surface corrosion on diaphragms at joints. Corrosion forming where sign supports connections are welded.
Diaphragms at beams 8-11, span 2 are welded.

17 SIGN ATTACHED TO BEAM 1 IN SPAN 2

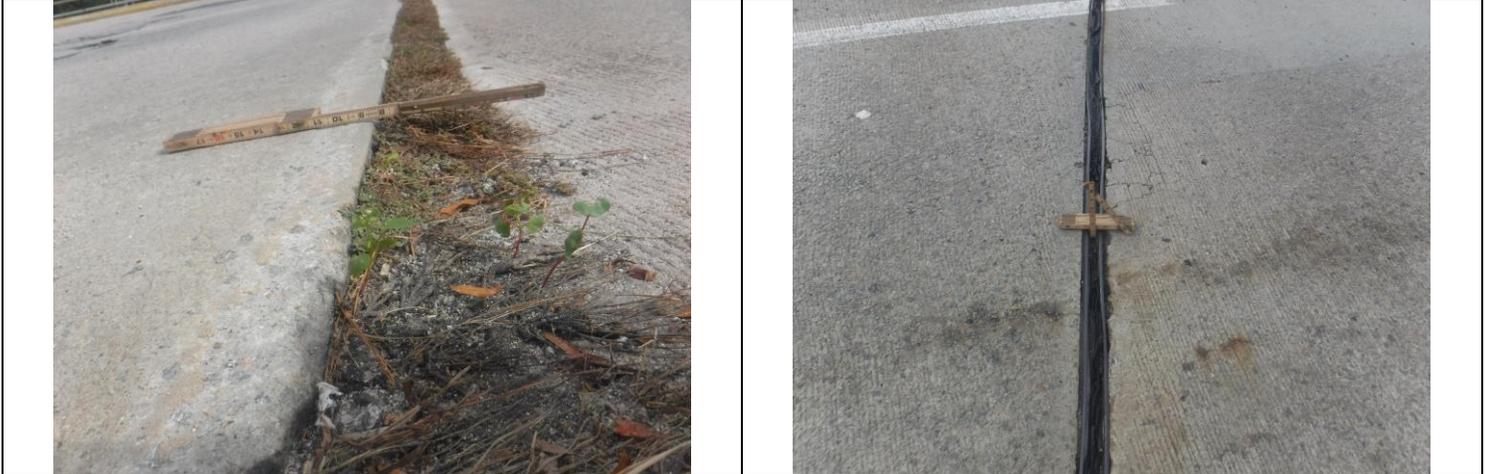
Settlement of both approach slabs has caused up to 5" of joint separation at both End Bents.

19	SETTLEMENT AT SOUTH APPROUCH	20	TORN, DETACHED AND MISSING JOINT MATERIAL, BENT 2
----	------------------------------	----	---

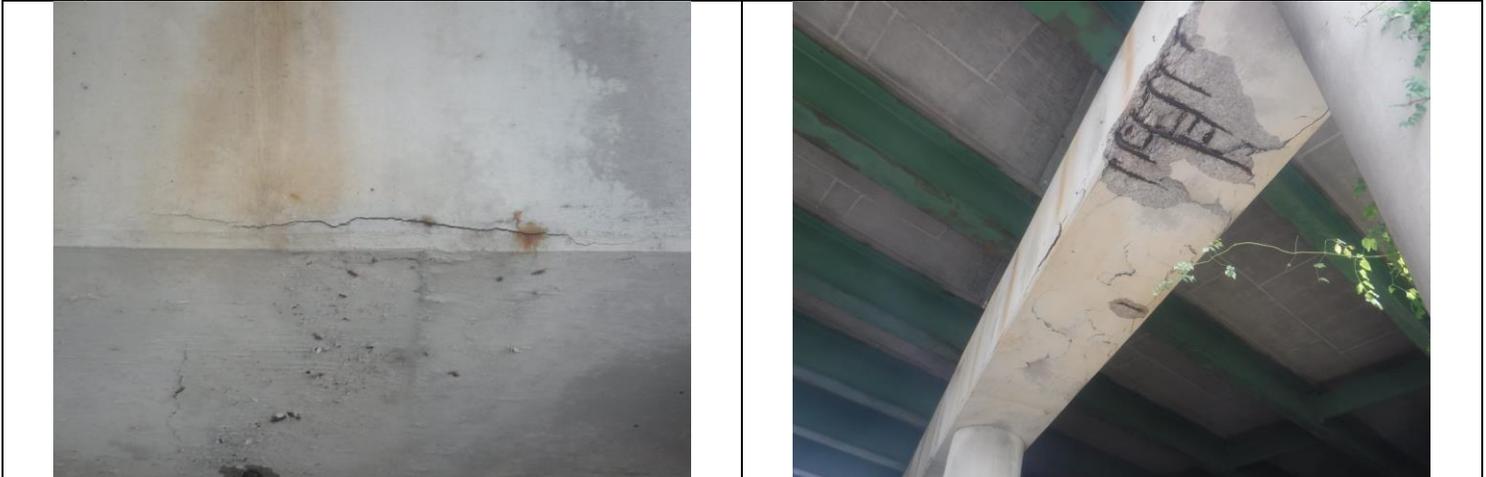
36" x 48" spall with exposed rebar on bottom of cap between columns 1 and 2,
36" x 1/16" horizontal crack in North face.
2' x 0.02" Horizontal crack w/rust between columns 2 and 3 in the North face.
Hairline map cracking between columns 2 and 3, in North face.
2' long x 0.02" horizontal crack w/rust on bottom between columns 2 and 3.
4" x 4" x 1/2" deep spall on bottom between columns 2 and 3.
6" vertical hairline crack under beam 3, South face.
36" dia. area of delamination with 2' L x 1/8" horizontal crack between columns 4 and 5 in the North face.
8" x 8" spall between beams 9 and 10 in the North face.
Hairline cracks with efflorescence at construction joints.

21	1/8" HORIZONTAL CRACK IN FACE OF BENT 2 CAP	22	BENT 2 SPALL WITH EXPOSED REBAR ON BOTTOM OF CAP BETWEEN COLUMNS 1 AND 2
----	---	----	--

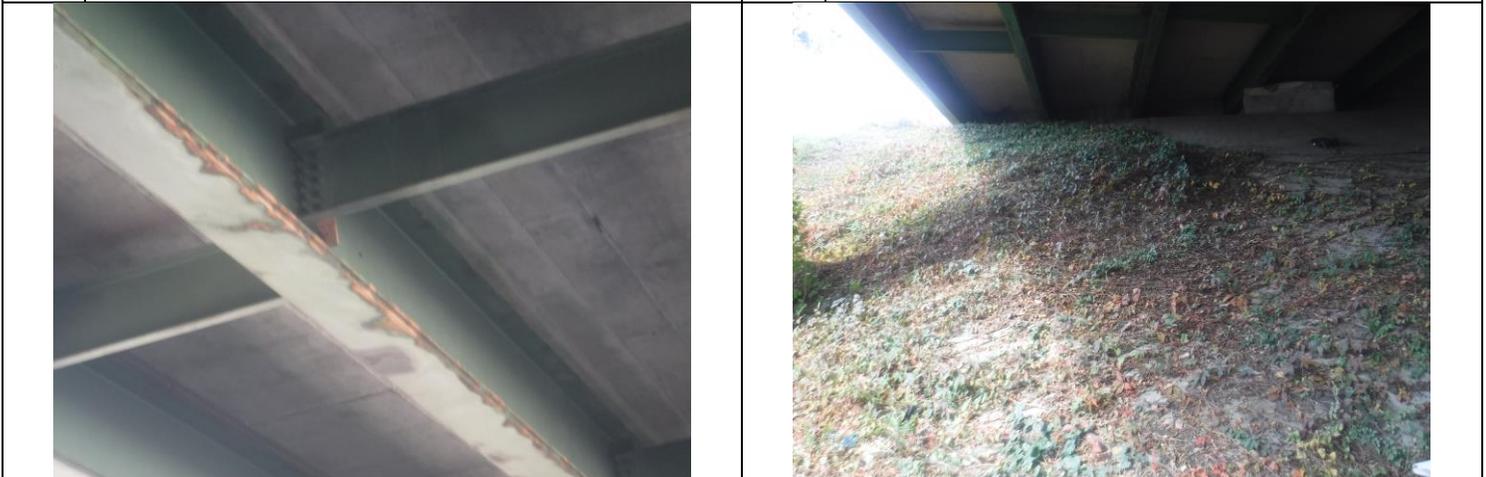
Hairline cracks in concrete slope protection.

23	TYPICAL SURFACE CORRSION ON EDGES OF FLANGES	24	VEGETATION OVERGROWTH THROUGHOUT CONCRETE SLOPE PROTECTION
----	--	----	--
