SCDOT BRIDGE INSPECTION FORM

(008) BRIDGE ID: 4010002600200	(005) ROUTE: RICHLAND I-26
(420) ASSET NO: 4407	(006) CROSSING: I-20
(419) RAMP NO:	(009) LOCATION: 5 MI NW OF COLUMBIA
(026) FUNCTIONAL CLASS: 11	(016) LAT: 34d 2m 13s (017) LON: 81d 6m 38s

Inspection Leader: MICHAEL MEYER, WSP	Reviewed By: RAGHU SURAPANENI, WSP
Date:	Date: 3/2/2022

02 Mar 2022

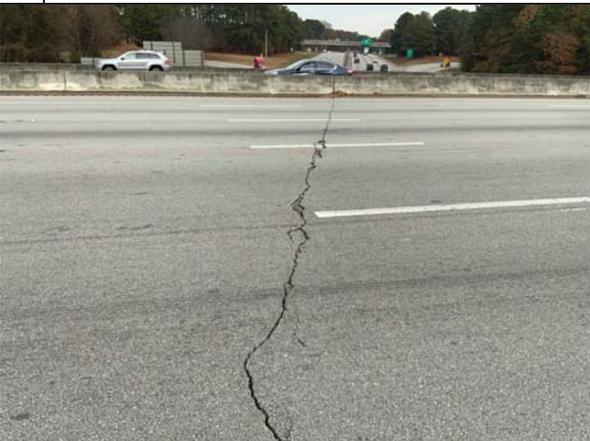
AWS (I-26 EBL) over Bent 3, transverse crack (full width x up to 3/4in) with scattered pot holes (up to 2ft x 6in) (Photo 1)

#1	AWS (I-26 EBL) over Bent 3, transverse crack (full width x up to 3/4in) with scattered pot holes (up to 2ft x 6in)	#2	End Bent 5 backwall in bays between original beams, scattered delaminations and spalls (up to 18in x 3ft x up to 1in)

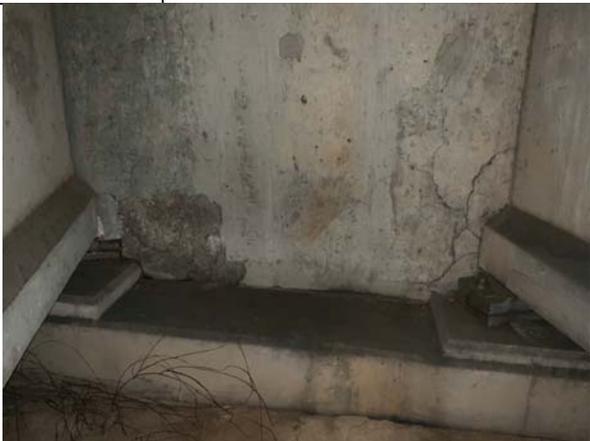
End Bent 5 backwall in bays between original beams, scattered delaminations and spalls (up to 18in x 3ft x up to 1in) (Photo 2)

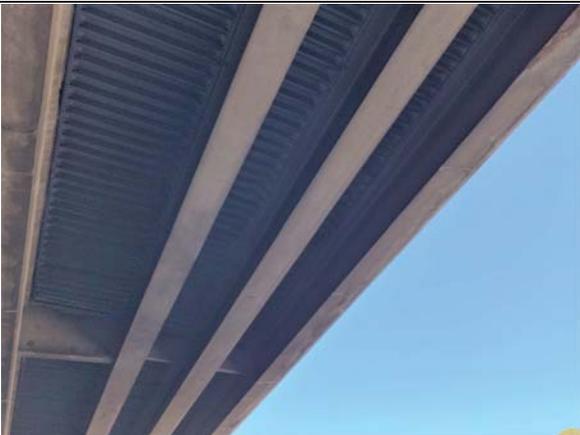
Span 2, Beams 23 & 24 have minor scrape marks from a high load. (photo 3)

#3	Span 2, Beams 23 & 24 have minor scrape marks from a high load.	#4	Span 2, Beam 21 has been hit by high load and has a moderate spall with (3) strands exposed

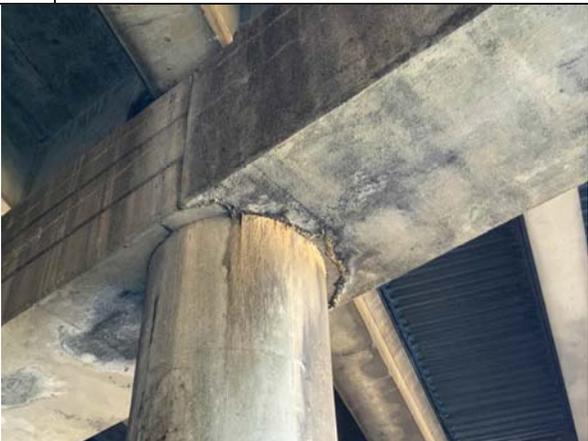
#7	Bent 2 Cap, Efflorescence bleeding through construction joints, typical scattered throughout all interior bents.	#8	Span 2, Bent 2, Beam 15, north face of bottom flange at bearing area, diagonal crack (6" x 1/16")

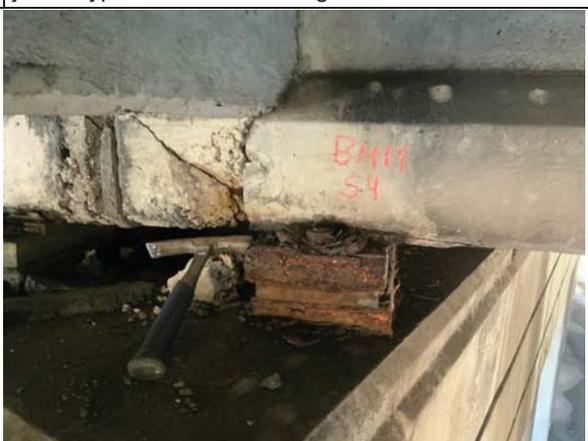
Span 4, Bent 4, Beam 15, right side at bearing area, diagonal crack (6" x 1/16").
 Span 4, Bent 4, Beam 16, right side at bearing area, diagonal crack (6" x 1/16").
 Span 4, Bent 4, Beam 17, both sides at bearing area, diagonal crack (6" x 1/16").
 Span 4, Bent 4, Beam 18, left side at bearing area, vertical crack (6" x 1/16").
 Span 4, Bent 4, Beam 19, right side, spall (6" x 3" x 1") with exposed strand and adjacent delam (6" x 6") (photo #9)
 Span 4, Bent 4, Beam 20, right side at bearing area, diagonal crack (6" x 1/16").

#9	Span 4, Bent 4, Beam 19, right side, spall (6" x 3" x 1") with exposed strand and adjacent delam (6" x 6")	#10	Span 1, Bent 2, left side of Beam 17, severed bolt and nut

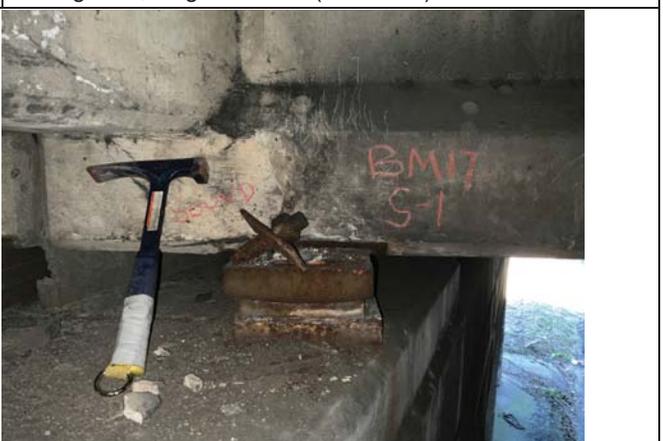
Beam	Bent	Span	
24	5	4	Left side
23	5	4	Left side
7	2	1	Left side
17	2	1	Left side (photo #10)
23	2	1	Left side (photo #11)
2	1	1	Right side
1	1	1	Right side

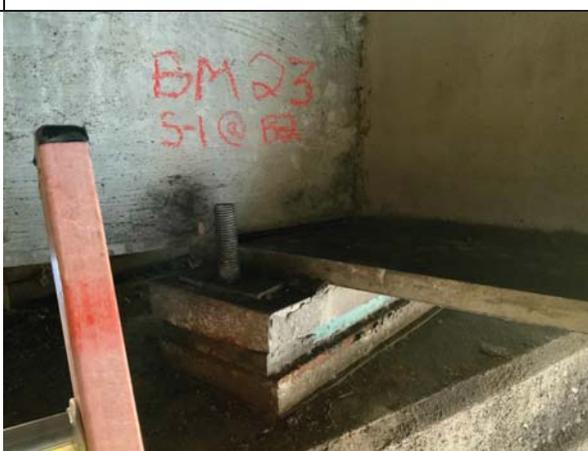
#11	Span 1, Bent 2, left side of Beam 23, missing nut	#12	Bent 4 Column 7, bottom of south face, minor spall with exposed rebar (4" x 6") and adjacent patch (2' x 2').

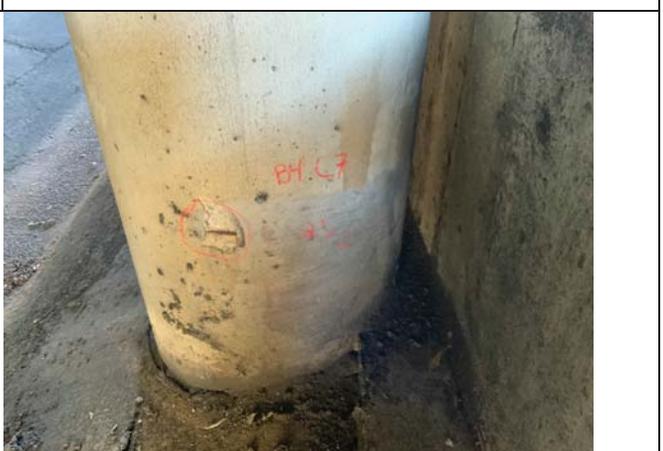
Bent 4 Column 7, bottom of south face, minor spall with exposed rebar (4"x 6") and adjacent patch (2' x 2'). (photo #12)

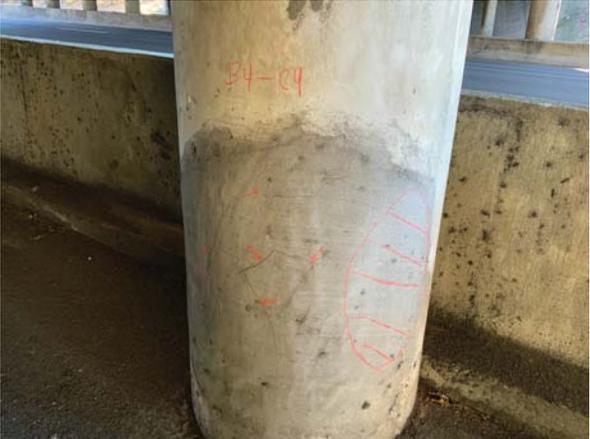
Bent 4 Column 4, bottom of west face, unsound patch (4' x 4') with map cracking (1/16") (photo #13)

#13	Bent 4 Column 4, bottom of west face, unsound patch (4ft x 4ft) with map cracking (1/16in)	#14	Bent 4 Cap, west face under beam 15, spall (4in x 1ft x 2in)

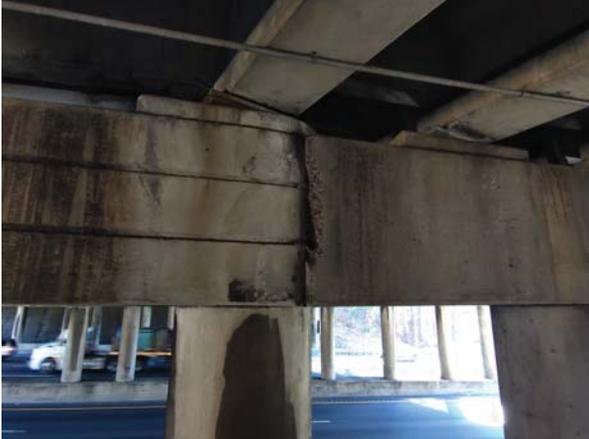
- under beam 15, west side, spall (4" x 1' x 2"). (photo #14)
- under beam 7, west side, 2' vert. h/l crack.
- under beam 5, west side, 1' vert. h/l crack.
- under beam 13, east side, horizontal crack (1' x 1/16").
- Eff. bleeding through construction joints.

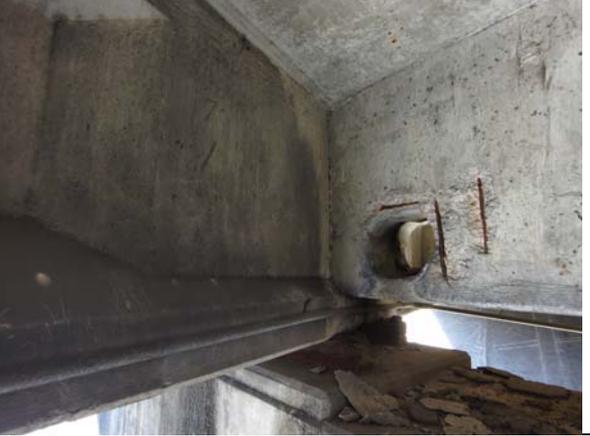
#15	Diaphragms over Bent 4 on Span 3 and 4 sides, spall around void (up to 16in x up to 12in x 1/2in) with exposed rebar	#16	
#17		#18
