# SCDOT BRIDGE INSPECTION FORM

(008) BRIDGE ID: 4010002640300	(005) ROUTE: RICHLAND I-26
(420) ASSET NO: 8030	(006) CROSSING: I-126
(419) RAMP NO:	(009) LOCATION: 3MI NW OF COLUMBIA
(026) FUNCTIONAL CLASS: 11	(016) LAT: 34d 1m 41s (017) LON: 81d 6m 6s

**Bridge ID: 40-1-00026-4-03-00**

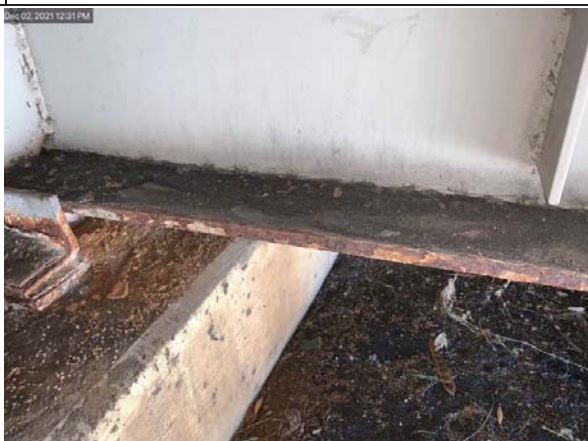
Minor corrosion starting to form on bearings, anchor bolts, and anchor bolt nuts (span 1 beam 4 near bearing shown) (Photo 5)

#5	Minor corrosion starting to form on bearings, anchor bolts, and anchor bolt nuts (span 1 beam 4 near bearing shown)	#6	Minor corrosion starting to form on beam ends (span 1 beam 4 at end bent 1 shown)

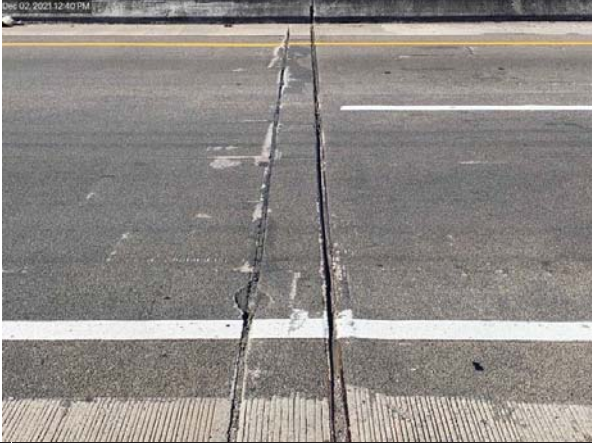
Expansion material pulling loose and/or missing (Photo 7).

#7	End bent 1 joint, expansion material pulling loose and/or missing	#8	Hairline transverse and map cracking, minor abrasion, moderate spalling with rust, and delamination that has been patched on deck, overlaid coating is starting to peel

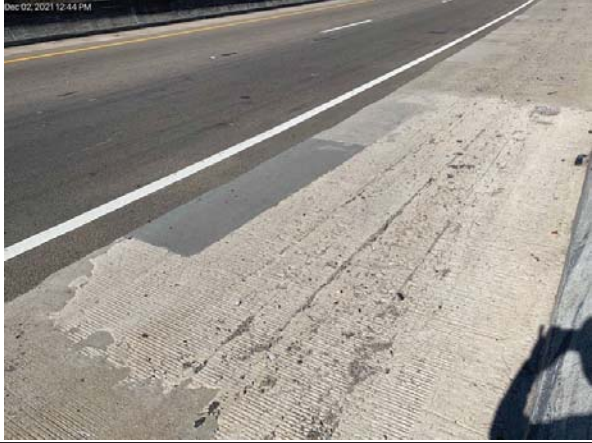
Hairline transverse and map cracking, minor abrasion, moderate spalling with rust, and delamination that has been patched on deck, overlaid coating is starting to peel (Photos 8 and 9).

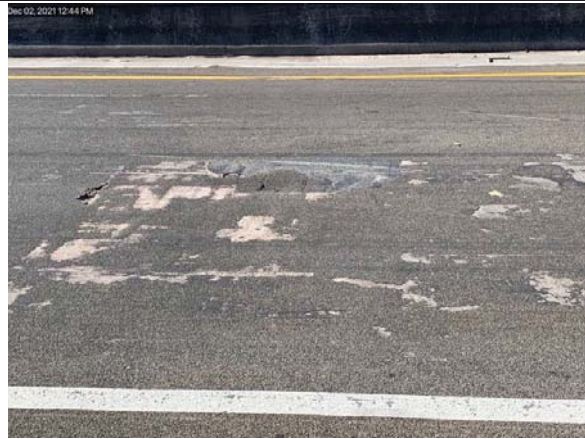
#9	Hairline transverse and map cracking, minor abrasion, moderate spalling with rust, and delamination that has been patched on deck, overlaid coating is starting to peel	#10	Span 4 deck left lane near midspan, spall (2ft diameter x 2in deep) with exposed rebar
