SCDOT BRIDGE INSPECTION FORM

(008) BRIDGE ID: 3210002600400	(005) ROUTE: LEXINGTON I-26
(420) ASSET NO: 3022	(006) CROSSING: SALUDA RIVER
(419) RAMP NO:	(009) LOCATION: 4 MI W OF COLA
(026) FUNCTIONAL CLASS: 11	(016) LAT: 34d 1m 25.46s (017) LON: 81d 6m 13.04s

1.0 INTRODUCTION

I-26 over Saluda River

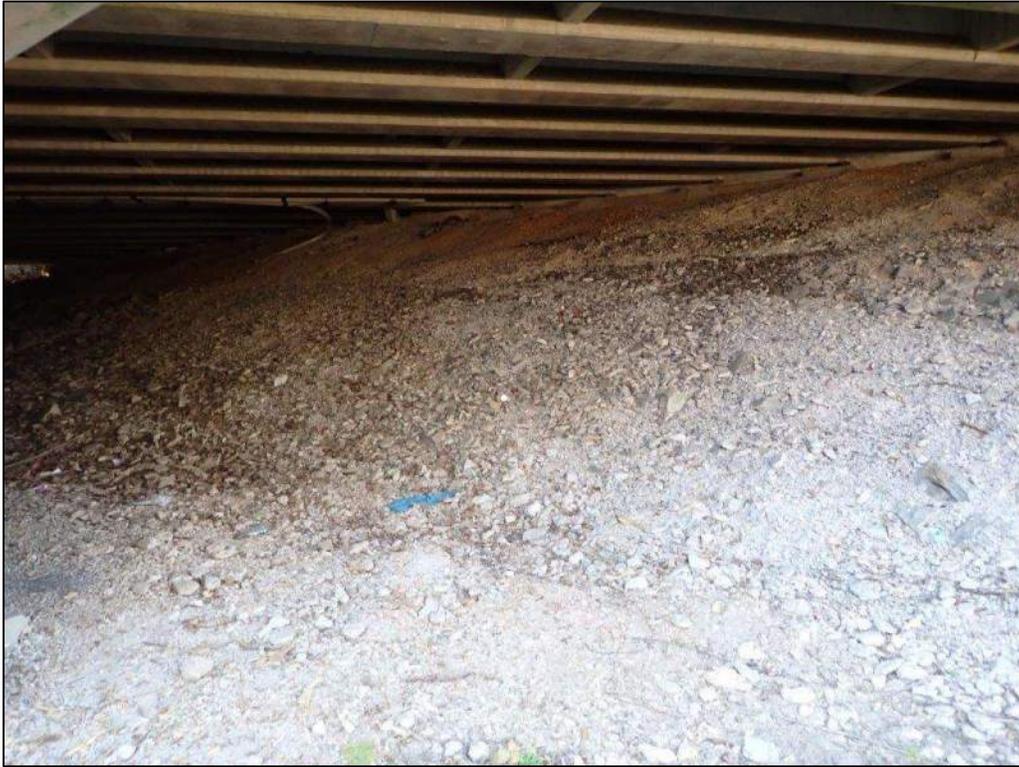
- The north embankment is covered in riprap with minor erosion trenches, up to 1 ft. deep (Photos 5 and 6).
- The south embankment is in stable condition with riprap slope protection (Photo 7).
- The stream flow angle of attach is 10-degrees but does not affect the structure.
- Throughout channel along inspected bents, timber debris, up to 2 ft. diameter logs, extending from channel bottom up 5 ft., approximately 10 CY.
- The channel bottom primarily consists of silt and organic material.

Photo 5: North Embankment

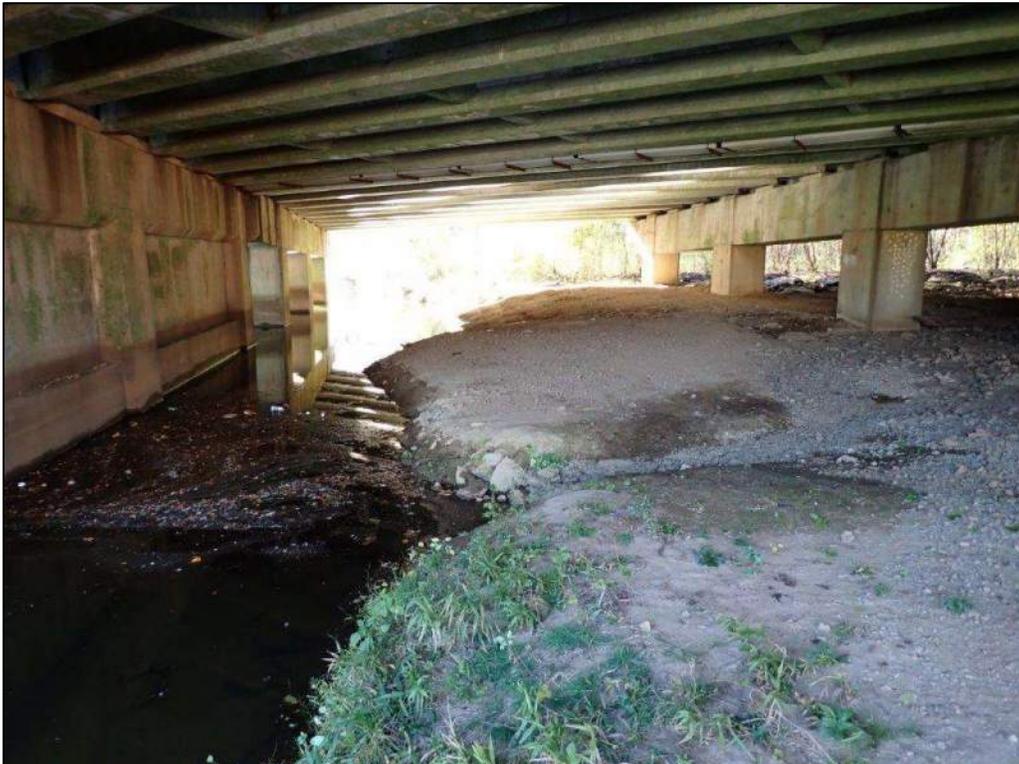
Photo 6: North Channel Bank

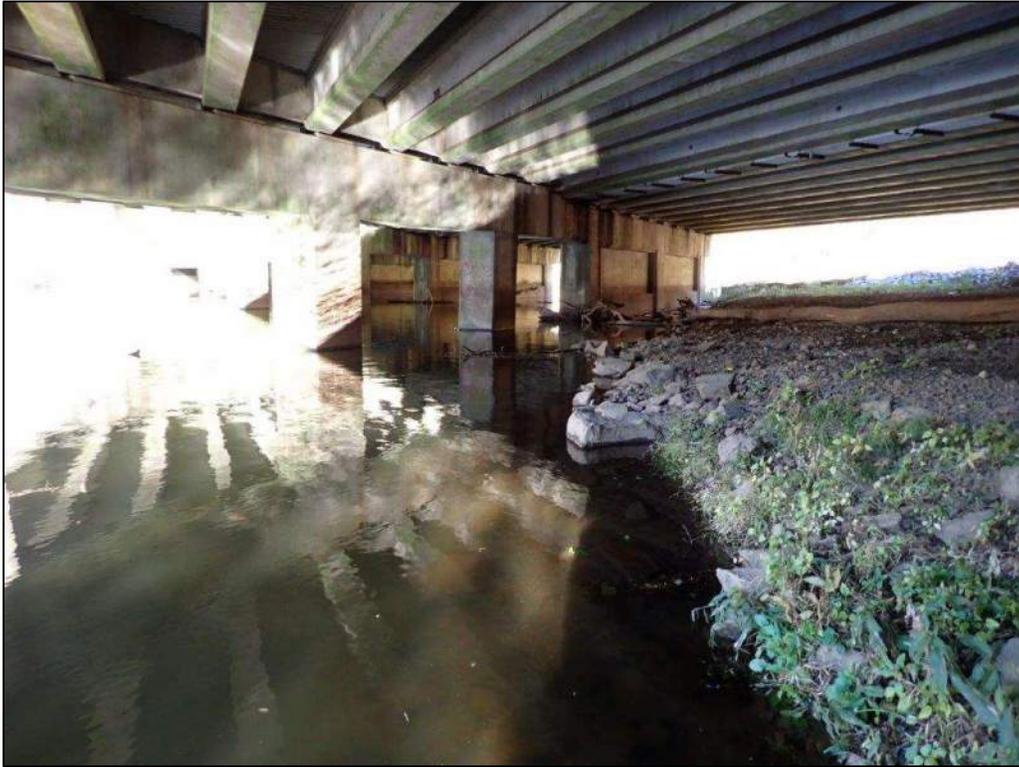
Photo 7: South Channel Bank

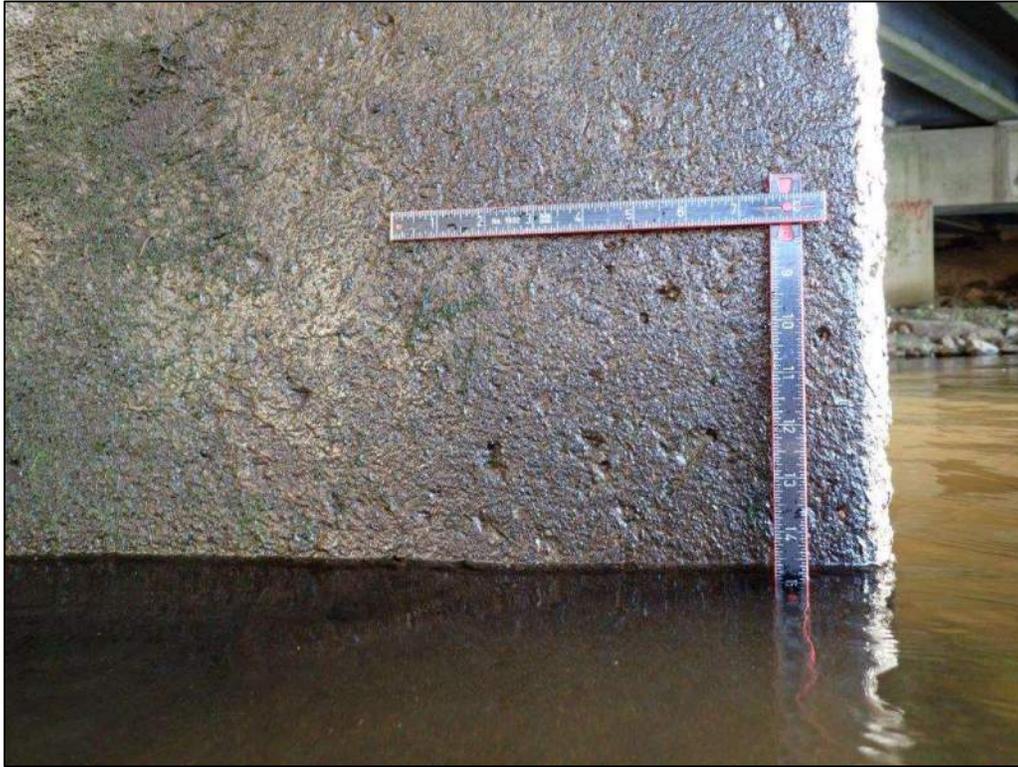
- All inspected bents, from high watermark to channel bottom, abrasion, up to 1/8 in. deep, with exposed secure aggregate (Photos 9 and 10). [CS2]

Photo 9: Bent 9, Column 5, Typical Concrete Condition at Waterline

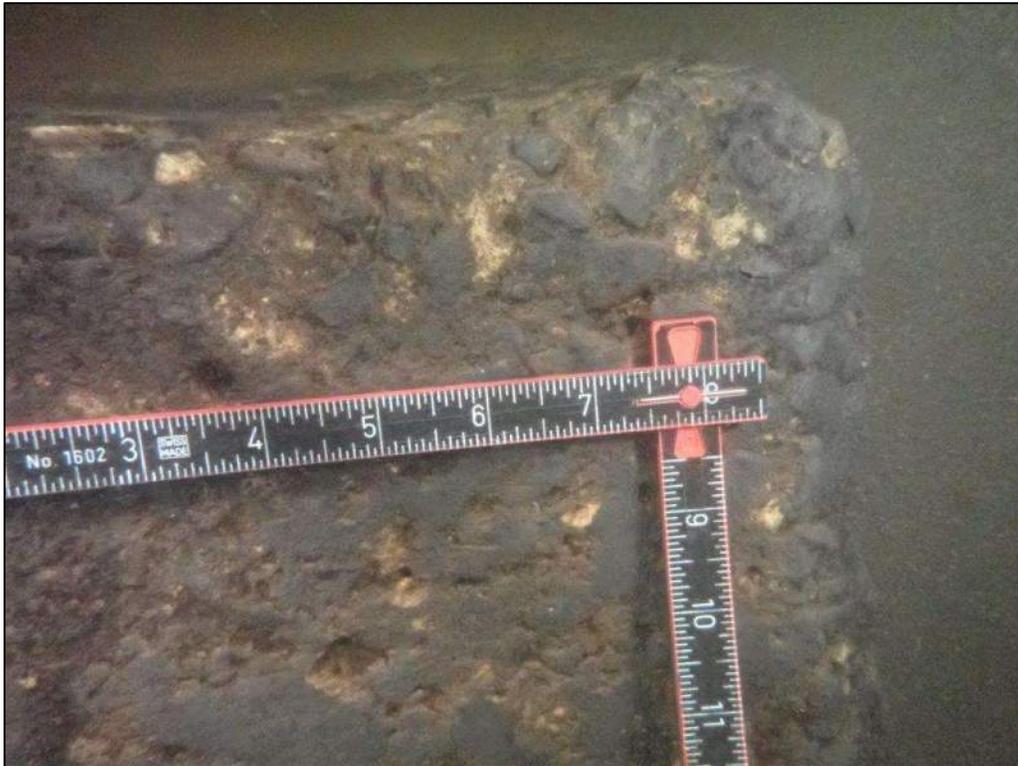
Photo 10: Bent 8, Footing 2, Typical Concrete Condition Below Waterline

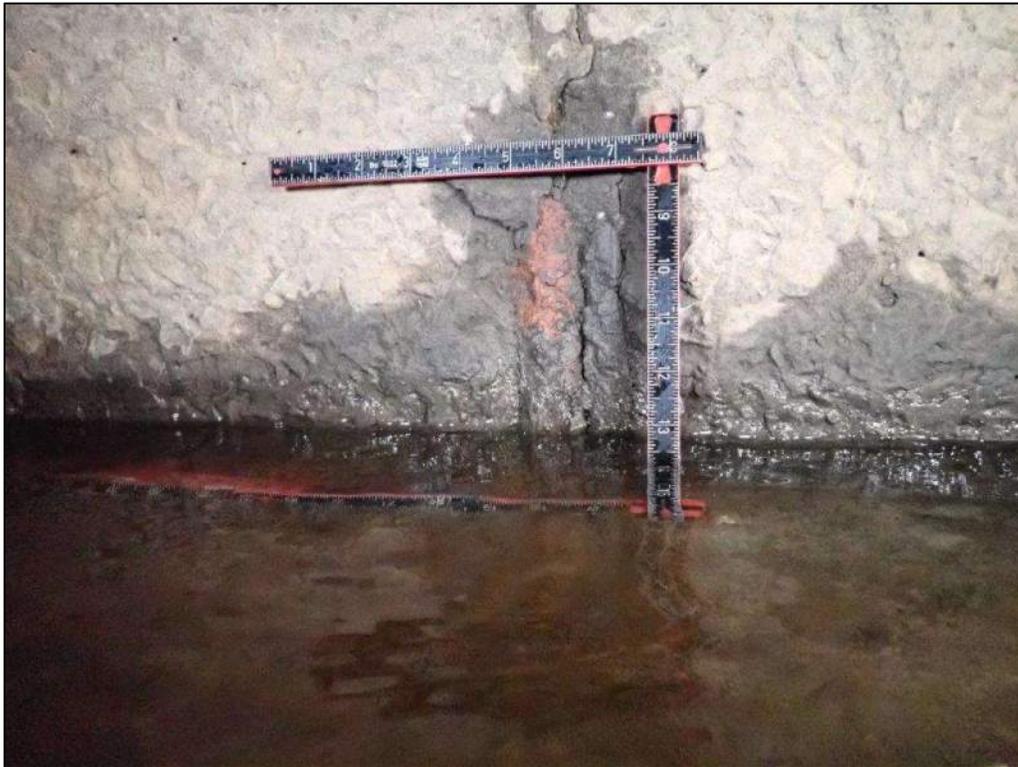
- Column 2, south face, at column/footing interface, [3] spalls due to insufficient cover, up to 9 in. high x 3 in. wide x 1/2 in. deep, with exposed rebar, up to 20% loss (Photo 11). [CS3]
- Column 4, south face, 6 in. above footing, spall/delamination, 2 ft. high x 3.5 ft. wide x up to 2 in. deep (Photo 12). [CS3]
- Footing 5, southeast corner, 3 ft. below top of footing, spall, 6 in. wide x 10 in. high x 2 in. deep. [CS3]

Photo 11: Bent 8, Column 2, Spall with Exposed Rebar

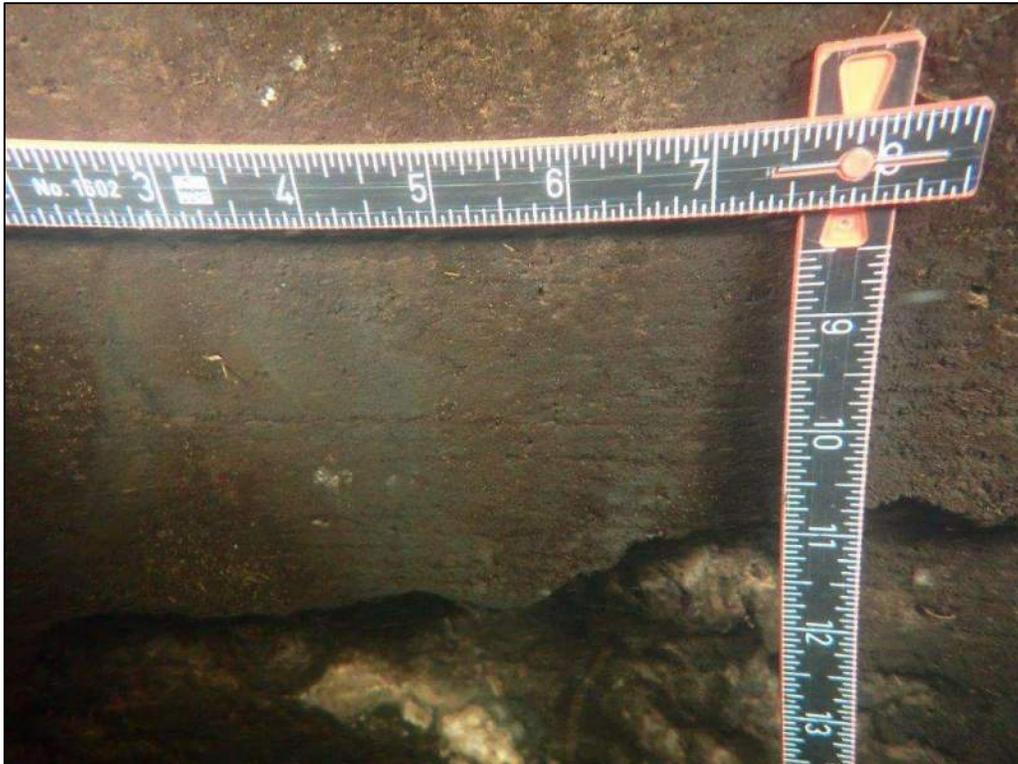
Photo 12: Bent 8, Column 4, Delamination/Spall

- 6 Bent 8, Column 4, south face, 6 in. above footing, spall/delamination, 2 ft. high x 3.5 ft. wide x up to 2 in. deep.
- 7 Bent 8, Footing 5, southeast corner, 3 ft. below top of footing, spall, 6 in. wide x 10 in. high x 2 in. deep.

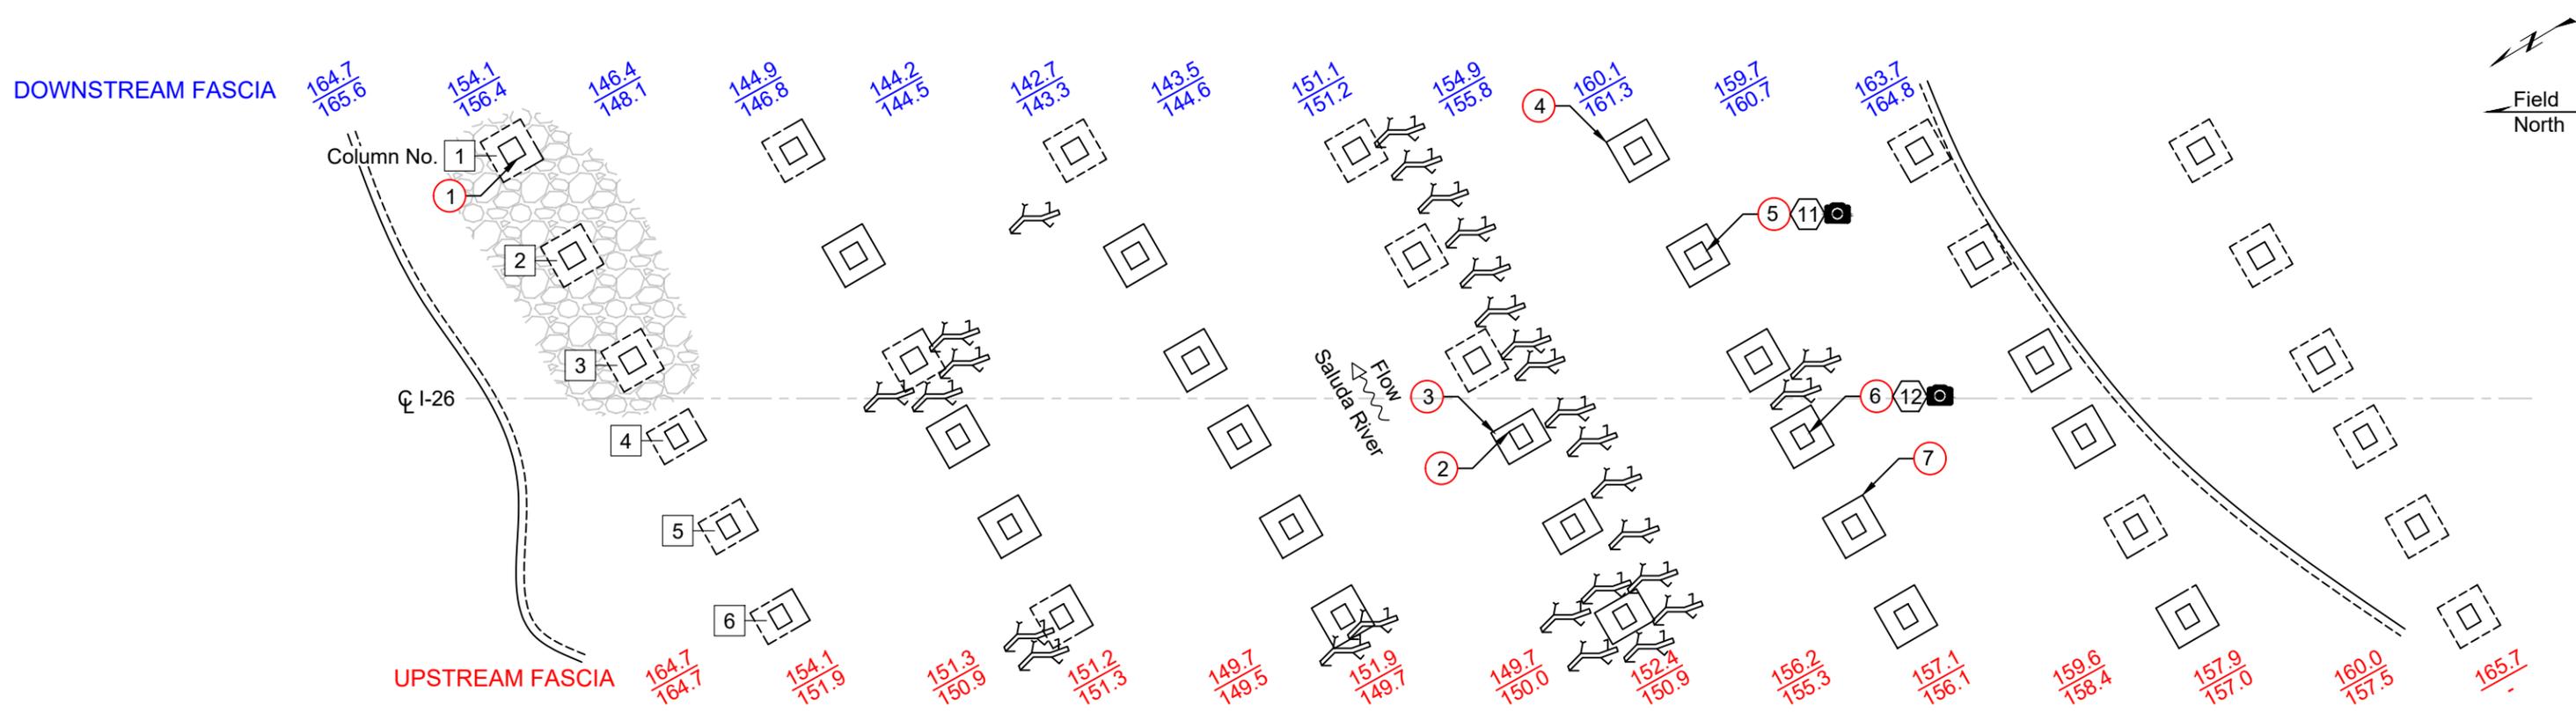
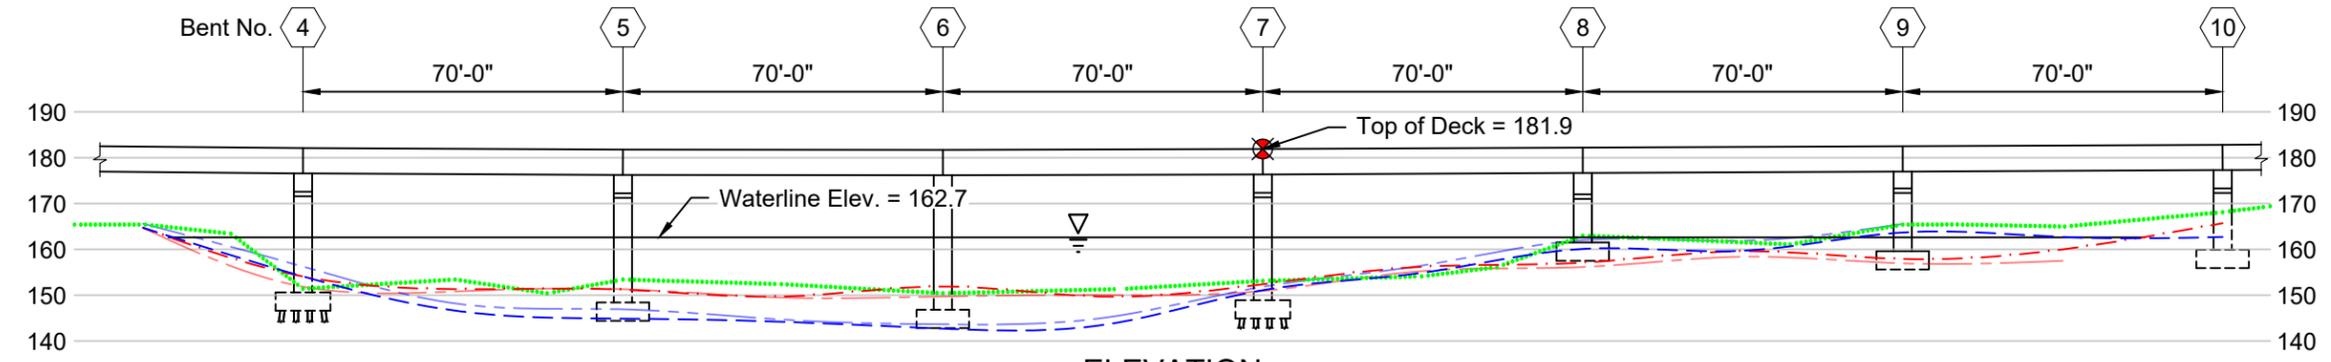
DATE November 2022	 40 Concourse Way Greer, SC 29650 PH.: 864.595.8030	 SOUTH CAROLINA DEPARTMENT OF TRANSPORTATION Asset ID: 03022	I-26 over Saluda River	FIG NO. 1
-----------------------	--	---	------------------------	--------------

Due to a combination of local and general scour since construction, vertical footing exposure is present at all inspected bents. There has been up to 3 ft. of channel degradation throughout the channel since the 2017 underwater inspection. Undermining was recorded at the following locations:

- Bent 8, Footing 4, northwest corner, 6 in. high x 1.8 ft. penetration.
- Bent 8, Footing 6, southeast corner, 6 in. high x 1.3 ft. penetration.

- At the time of inspection, the waterline was located approximately 19.2 ft. below the top of the deck at the downstream side of Bent 7. This translates to a waterline elevation of 162.7 according to the available as-built plans.
- Soundings across the channel were taken parallel to the bridge at the bents and are actual channel bottom elevations in feet determined on November 21, 2022.
- This figure was developed from field notes, sketches, and South Carolina Department of Transportation as-built plans dated January 1986.
