SCDOT BRIDGE INSPECTION FORM

(008) BRIDGE ID: 4010002600400	(005) ROUTE: RICHLAND I-26
(420) ASSET NO: 2823	(006) CROSSING: RR CSXT
(419) RAMP NO:	(009) LOCATION: 4 MI NW OF COLUMBIA
(026) FUNCTIONAL CLASS: 11	(016) LAT: 34d 1m 34.83s (017) LON: 81d 6m 8.28s

Bridge ID: 40-1-00026-0-04-00

02 Mar 2022

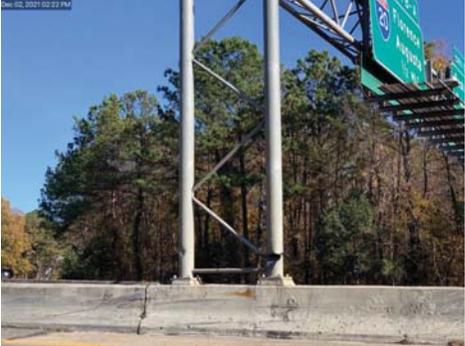
Photo #: <u>1</u> Caption: Overhead sign at west end of bridge, impact damage area with tear on metal (base of both poles next to EBL's of I-26 shown)	Photo #: <u>2</u> Caption:		
Photo #: <u>3</u> Caption:	Photo #: <u>4</u> Caption:		
Photo #: <u>5</u> Caption:	Photo #: <u>6</u> Caption:		
Photo #: <u>7</u> Caption:	Photo #: <u>8</u> Caption:

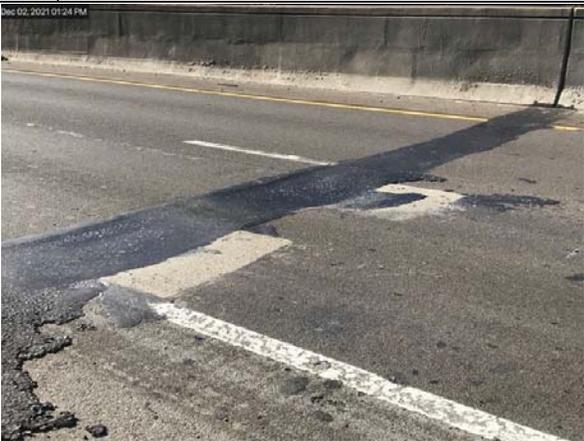
Span 1 center lanes at bent 2, (2) patched areas (15sf) that are depressed (up to 1in) on westbound right lane (Photo 1)

#1	Span 1 center lanes at bent 2, (2) patched areas (15sf) that are depressed (up to 1in) on westbound right lane	#2	End bent 4 abutment on north end at top corners, (2) spalls (up to 18in x 1ft x full thickness)

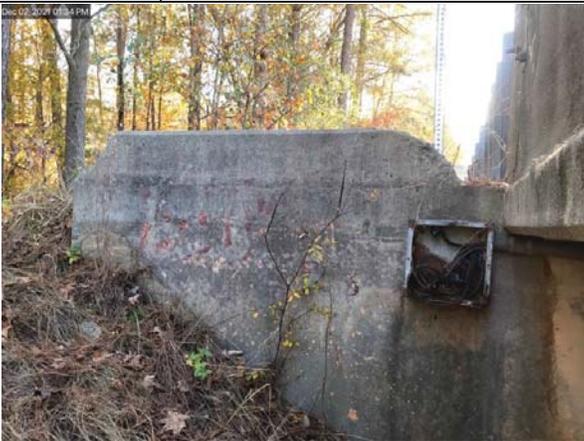
End bent 4 abutment on north end at top corners, (2) spalls (up to 18in x 1ft x full thickness) (Photo 2)

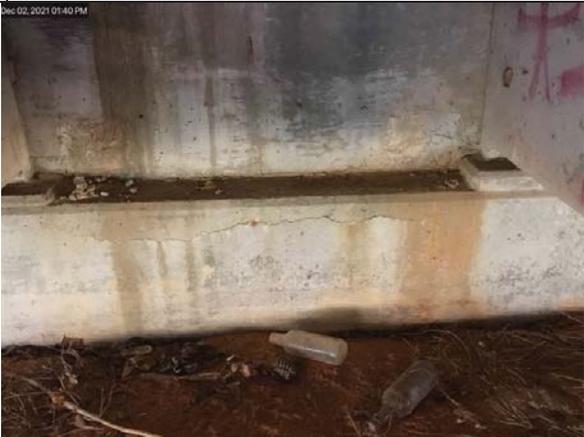
between beams 2 and 3, 3ft long. 0.04in crack .
between beams 3 and 4, 3ft long. 0.04in crack w/eff.
under beam 9, 1ft long. h/l crack.
between beams 9 and 10, 2ft long. h/l crack.

#3	Hairline to 1/16in cracks in caps (end bent 4 cap between beams 2 and 3 shown)	#4	Continuous saddles have been installed at bents 2 and 3, both sides, beams 1-10

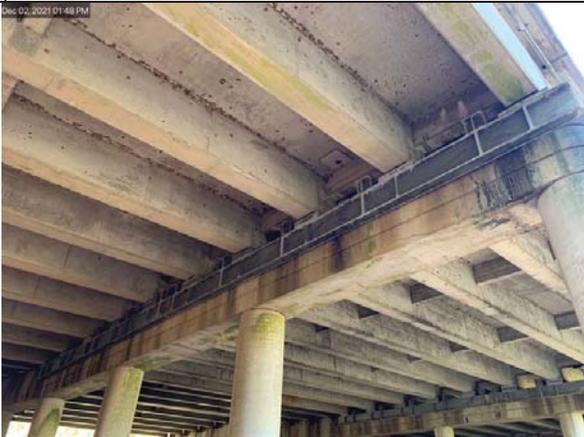
Continuous saddles have been installed at bents 2 and 3, both sides, beams 1-10 (Photo 4)

Saddle connections at bent 2, beams 4-6 are not pulled up tight. Paint starting to peel from beams.

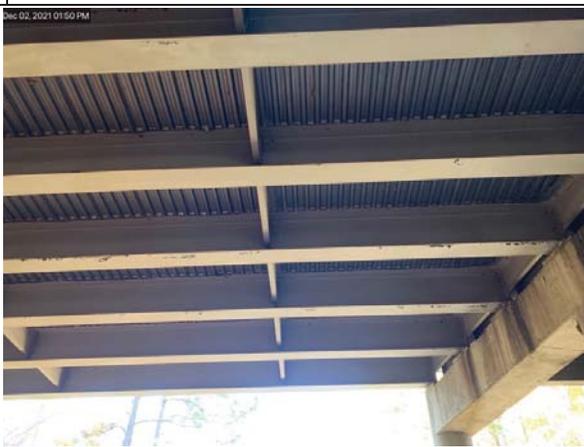
Paint system is starting to fail on beams (top coat only) (Photo 5)

#5	Paint system is starting to fail on beams top coat only	#6	Interior bent 3 cap at south end, (2) spalls (up to in 6in x 1ft x 1/2in deep) with exposed rebar

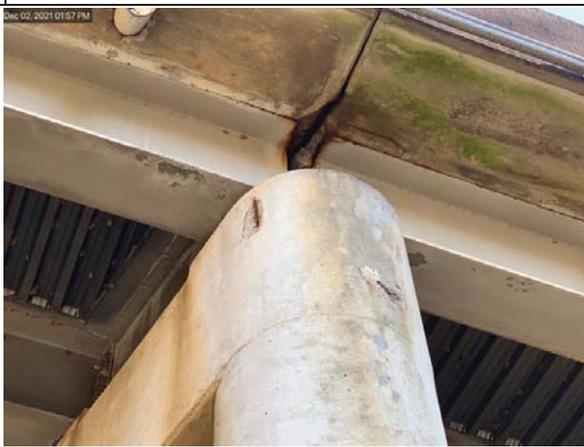
above column 1, East side, 3ft vert. h/l crack.
above column 1, East side, 3ft diag. h/l crack.
bottom between columns 1 and 2, (3) 2ft trans. h/l cracks
bottom between columns 1 and 2, (2) 1ft trans. 0.04in crack w/rust.
between columns 1 and 2, west side, 4ft long. 0.04in crack w/rust .
under beam 3, west side, 1ft long. 0.04in crack.
above column 4, west side, 3ft diag. h/l crack.
above column 7, east side, minor spall 3in x 4in x 1/2in.
end of cap, west side, minor spall w/rust 1ft x 6in x 1/2in.

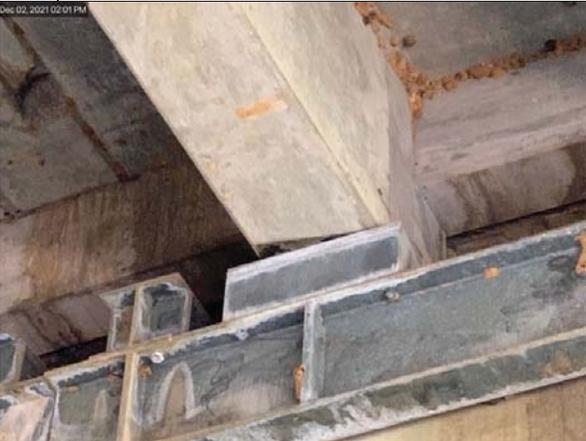
Several elastomeric pads are starting to bulge out past saddles at bents 2 and 3 (span 2 beam 5 at bent 2 shown) (Photo 7)

<p>#7 Several elastomeric pads are starting to bulge out past saddles at bents 2 and 3 (span 2 beam 5 at bent 2 shown)</p>

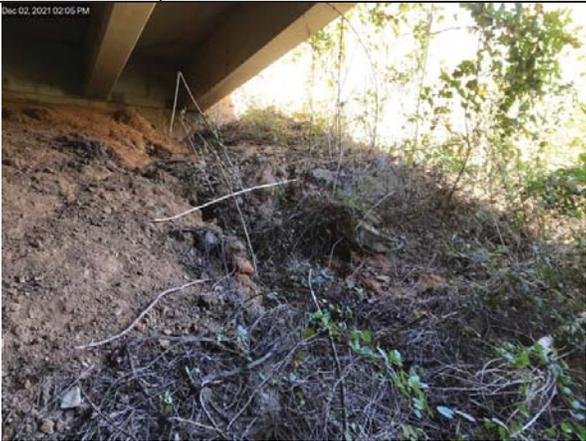
End bent 1 slope at north end, erosion channel (full length x 5ft x 30in) (Photo 8)

<p>#8 End bent 1 slope at north end, erosion channel (full length x 5ft x 30in)</p>

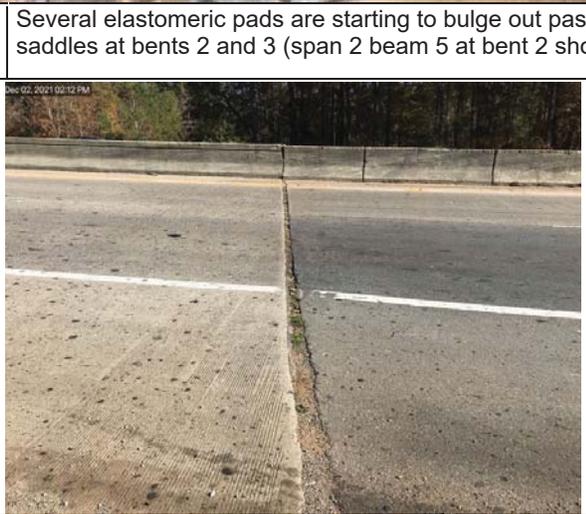
Expansion material torn, pulled loose, and missing, EBL's of I-26 and filled with dirt/debris/vegetation (end bent 4 joint shown) (Photo 9)

<p>#9 Expansion material torn, pulled loose, and missing, EBL's of I-26 and filled with dirt/debris/vegetaion (end bent 4 joint shown)</p>

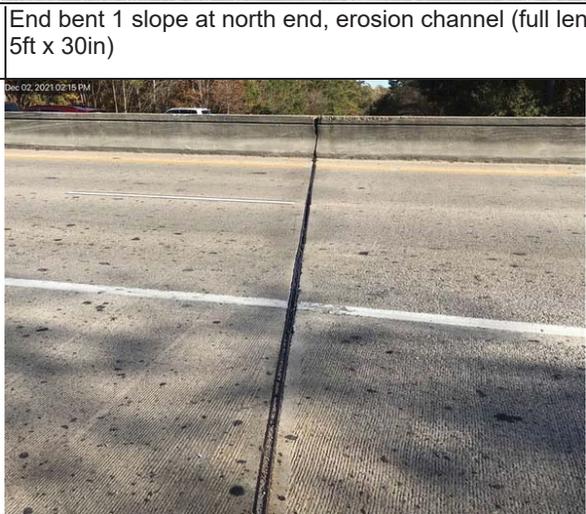
Expansion material torn, pulled loose, and missing, EBL's of I-26 (interior bent 3 joint shown) (Photo 10)

<p>#10 Expansion material torn, pulled loose, and missing, EBL's of I-26 (interior bent 3 joint shown)</p>

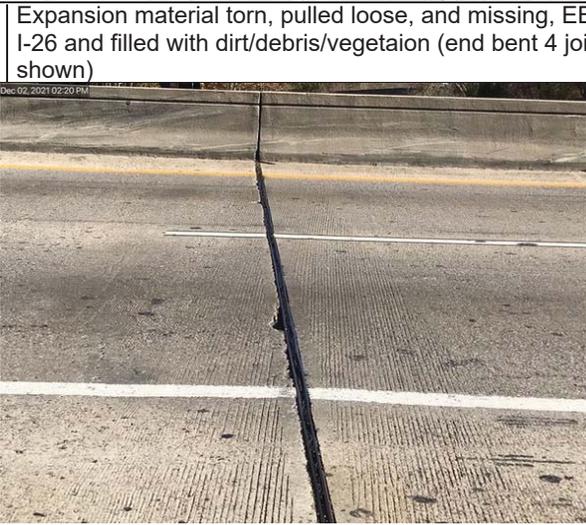
Span 1 deck right lane of EBL's of I-26, spalling (up to 1.5in deep) next to bent 2 joint (Photo 10)

<p>#11 Span 1 deck right lane of EBL's of I-26, spalling (up to 1.5in deep) next to bent 2 joint</p>

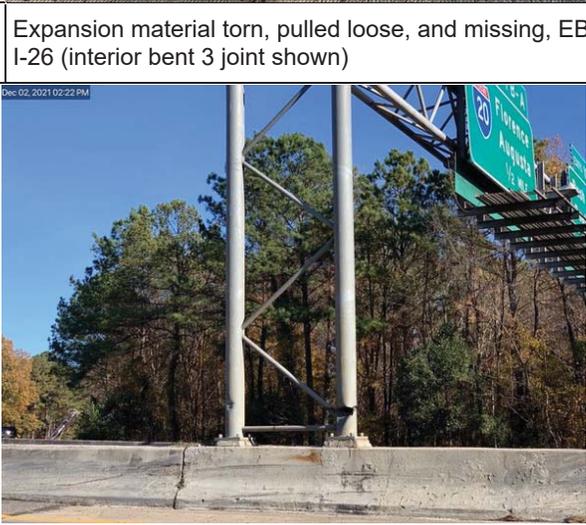
Overhead sign at west end of bridge, impact damage area with tear on metal (base of both poles next to EBL's of I-26 shown) (Photo 12)

<p>#12 Overhead sign at west end of bridge, impact damage area with tear on metal (base of both poles next to EBL's of I-26 shown)</p>
