SCDOT BRIDGE INSPECTION FORM

(008) BRIDGE ID: 4010012620071	(005) ROUTE: RICHLAND I-126
(420) ASSET NO: 7934	(006) CROSSING: SALUDA RIV&I-26&I-126&RR
(419) RAMP NO: 7769	(009) LOCATION: 4 MI NW OF COLUMBIA
(026) FUNCTIONAL CLASS: 11	(016) LAT: 34d 1m 31.30s (017) LON: 81d 5m 54.80s

1.0 INTRODUCTION

Ramp Off I-126 WB over Saluda River

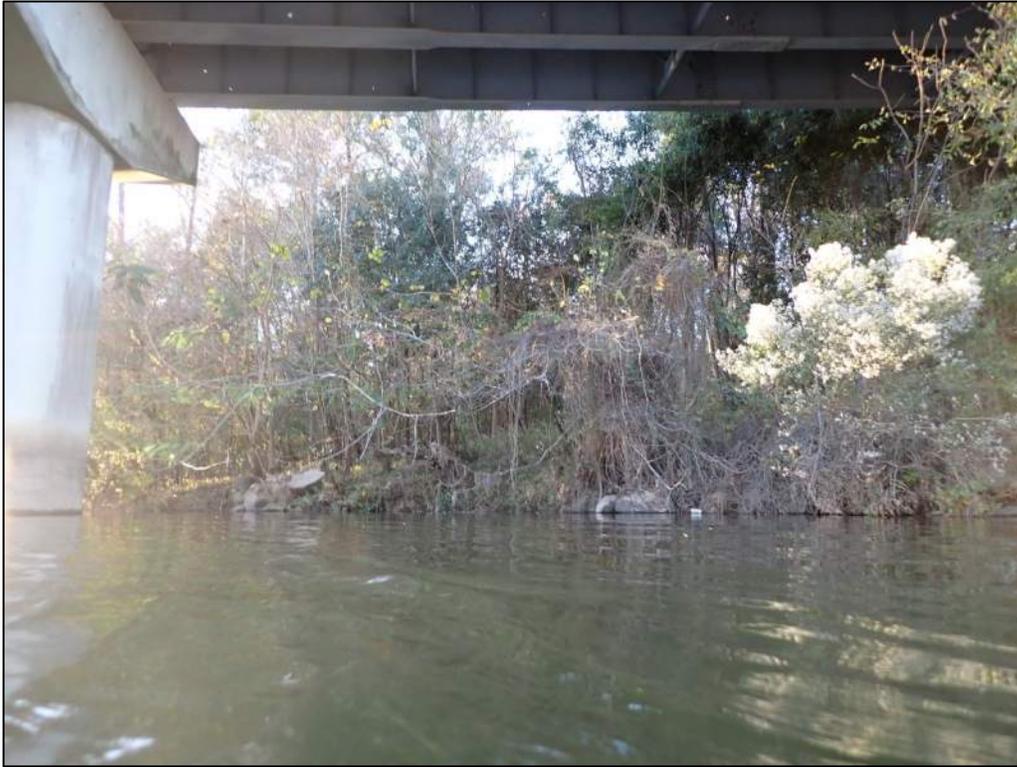
Photo 5: North Channel Bank

- The north and south embankments are stable and well vegetated; however, under the bridge both banks are cut, up to 3 ft. high (Photos 5 and 6).
- The stream flow is well aligned with the bents in the waterway.
- The channel bottom primarily consists of sand and silt.
- Bent 18, upstream nose, timber debris, up to 1 ft. diameter [5 CY].

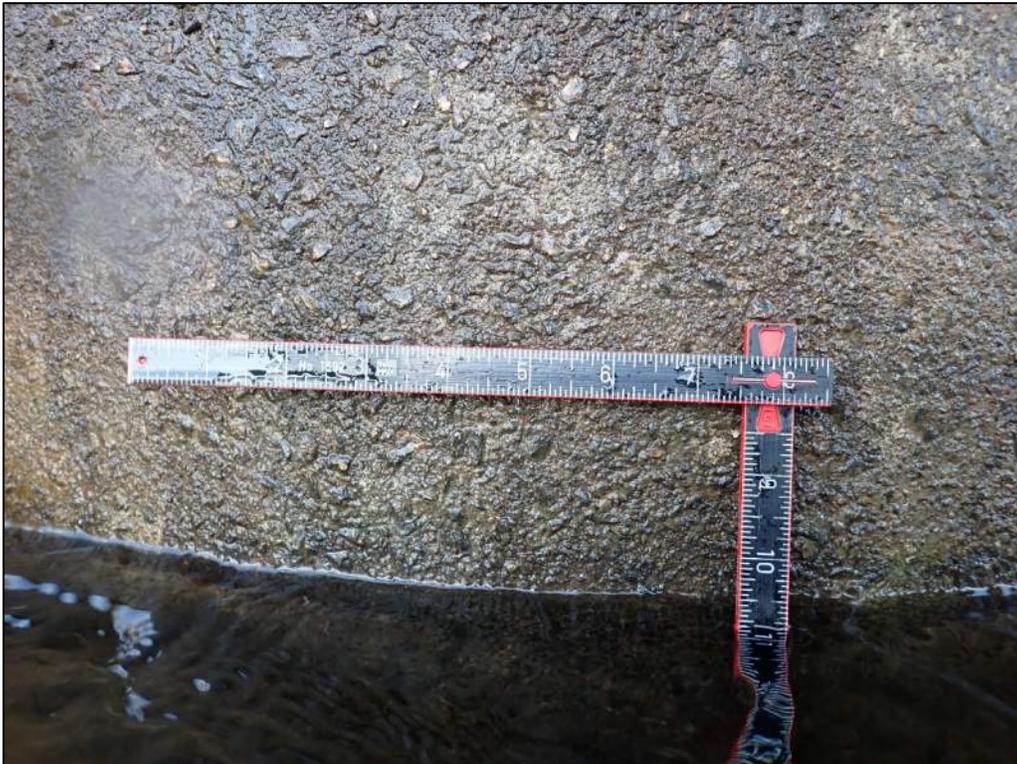
Photo 8: Bent 17, Upstream Nose, Typical Concrete Condition at Waterline

- All inspected bents, from high watermark to channel bottom, abrasion, up to 1/4 in. deep, with exposed secure aggregate (Photos 8 and 9). [CS2]

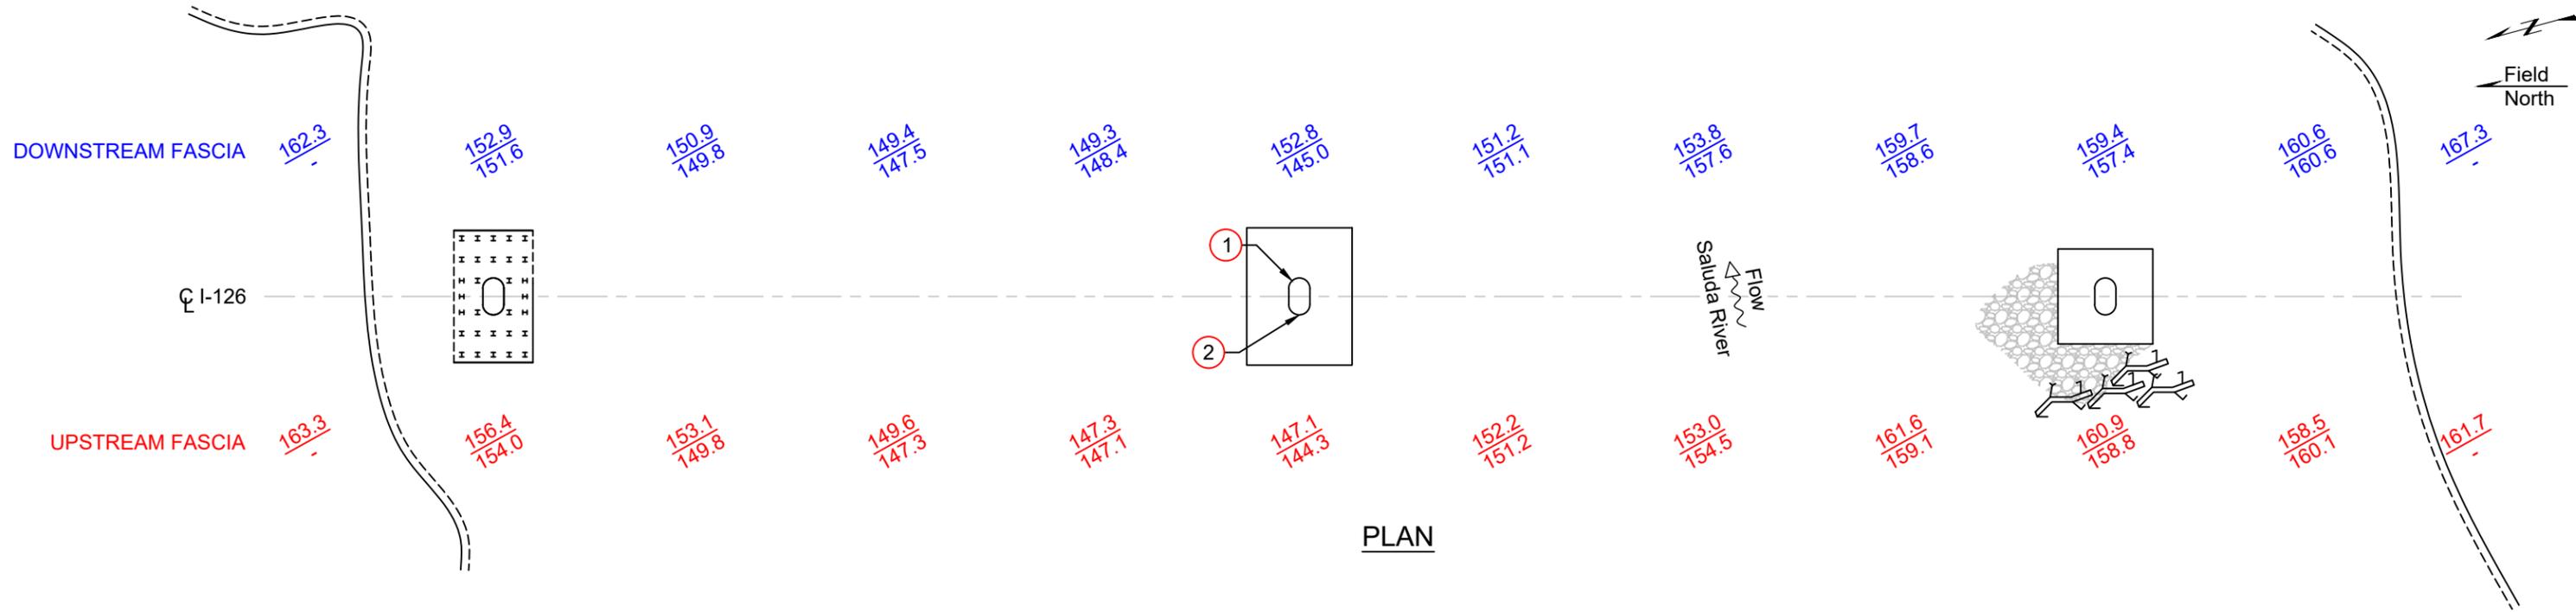
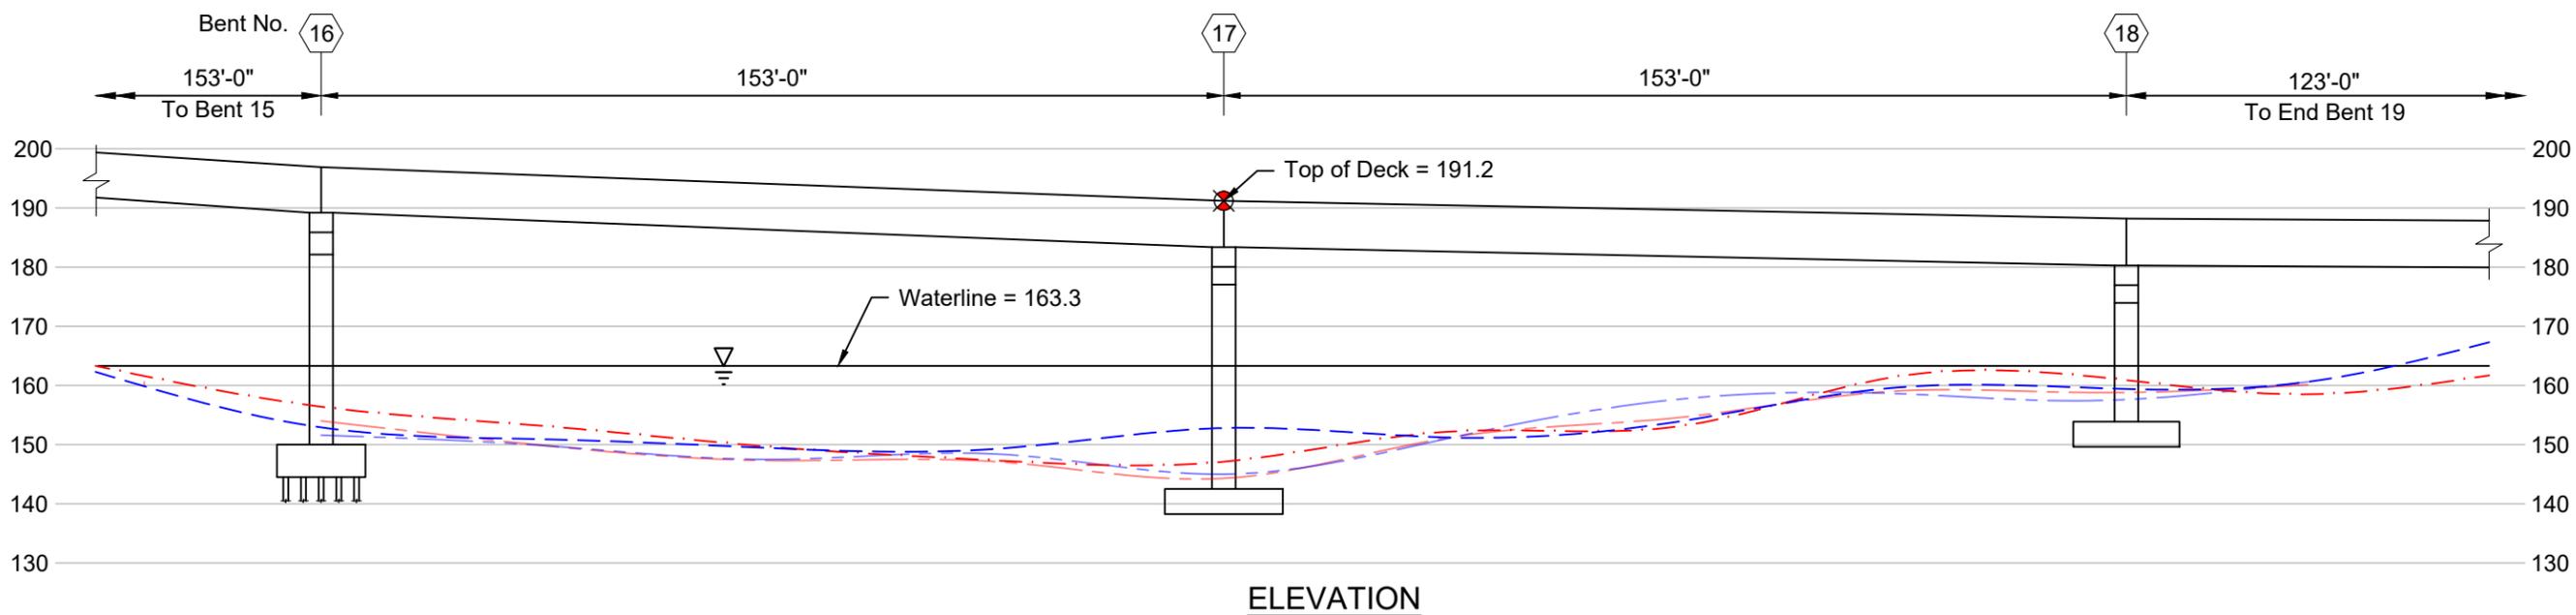
<p>GRAPHIC SCALE</p> <p>0 30' 60'</p>	DATE	<p>40 Concourse Way Greer, SC 29650 PH: 864.595.8030</p>	<p>SOUTH CAROLINA DEPARTMENT OF TRANSPORTATION</p> <p>Asset ID: 07934</p>	<p>Ramp Off I-126 over Saluda River</p>	<p>FIG NO. 1</p>
	November 2022

Due to a combination of local and general scour since construction, the footings are exposed at all bents located in the waterway. Refer to Table 5 for a listing of the sounding measurements and to Figure 1 for an illustration of the channel bottom profiles. Refer to Table 6 for a complete listing of observed footing exposures.

- GN** All inspected bents, from high watermark to channel bottom, abrasion, up to 1/4 in. deep, with exposed and secure aggregate.
- 1** Bent 17, Column, northeast corner, at column/footing interface, spall, 1.3 ft. wide x 2 ft. high x 4 in. deep.
- 2** Bent 17, Column, east face, 1 ft. above footing, [2] spalls, up to 12 in. diameter x 5 in. deep.

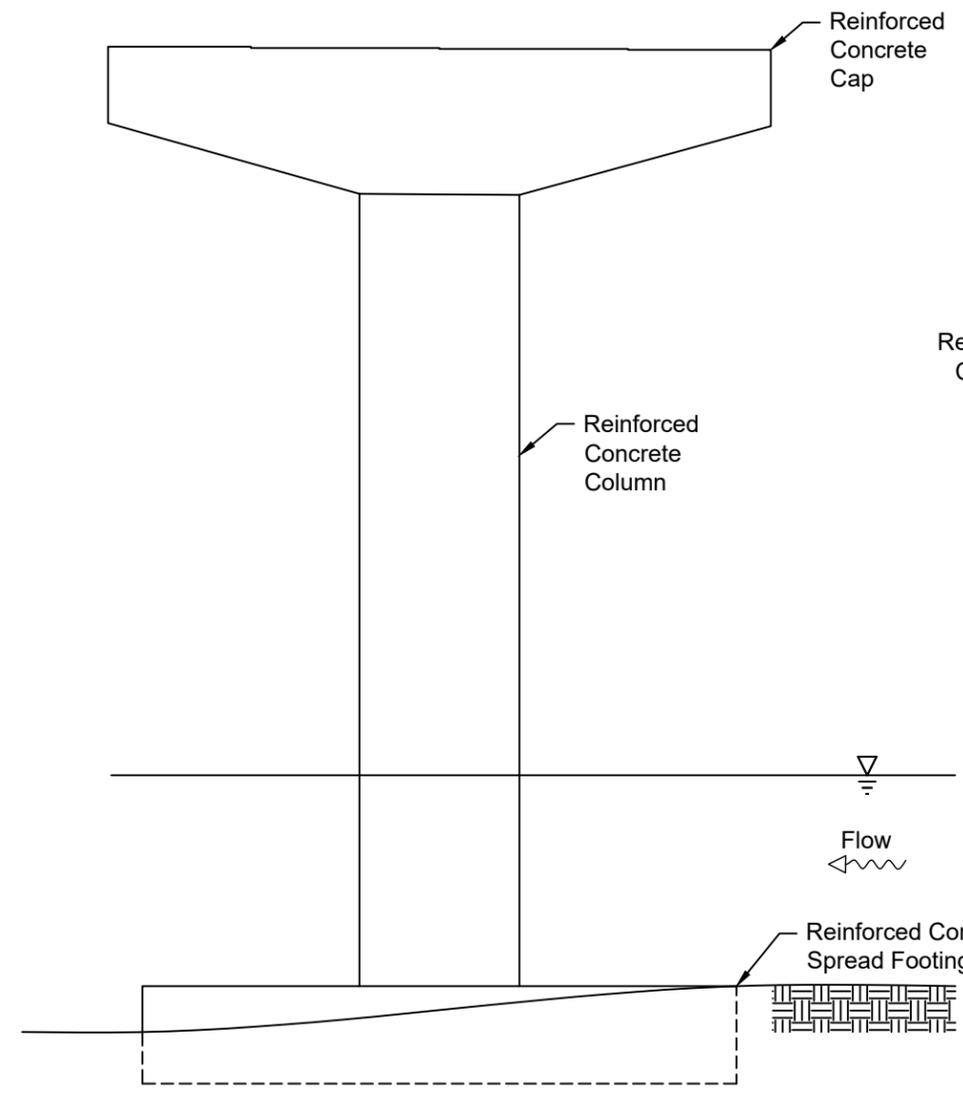
North Elevation
Bent 17

- Column, northeast corner, at column/footing interface, spall, 1.3 ft. wide x 2 ft. high x 4 in. deep. [CS3]
- Column, east face, 1 ft. above footing, two [2] spalls, up to 12 in. diameter x 5 in. deep. [CS3]
