SCDOT BRIDGE INSPECTION FORM

| (008) BRIDGE ID: 4010012620071 | (005) ROUTE: RICHLAND I-126 |
| (420) ASSET NO: 7934 | (006) CROSSING: SALUDA RIV&I-26&I-126&RR |

Bridge ID: 40-1-00126-2-00-71

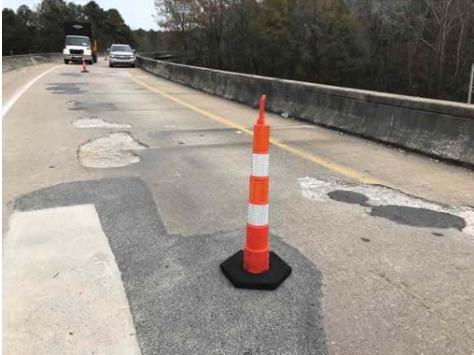
Span 12 middle of ramp lane near midspan, (3) spalls (up to 4ft x 9ft x 2in) with exposed rebar (Photo 25)

Photo #: 1 Caption: Span 12 middle of ramp lane near midspan, (3) spalls (up to 4ft x 9ft x 2in) with exposed rebar

| Part II – Repair Recommendations | | | | | |
|---|---|--|---|---|---|
| C | 801 | Span 12 middle of ramp lane near midspan, (3) spalls (up to 4ft x 9ft x 2in) with exposed rebar | <input type="checkbox"/> | 1 | <input type="checkbox"/> |

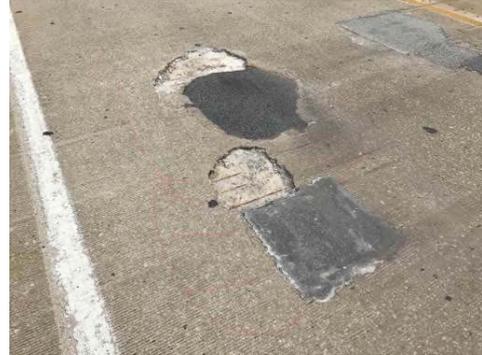
Span 9 deck ramp lane next to white line at approximately 25ft from bent 9, spall/delamination (5.5ft x 12ft x 2in) with exposed rebar (Photo 26)

Photo #: 2 Caption: Span 9 deck ramp lane next to white line at approximately 25ft from bent 9, spall/delamination (5.5ft x 12ft x 2in) with exposed rebar

| Part II – Repair Recommendations | | | | | |
|---|---|--|---|---|---|
| C | 801 | Span 9 deck ramp lane next to white line at approximately 25ft from bent 9, spall/delamination (5.5ft x 12ft x 2in) with exposed rebar | <input type="checkbox"/> | 2 | <input type="checkbox"/> |

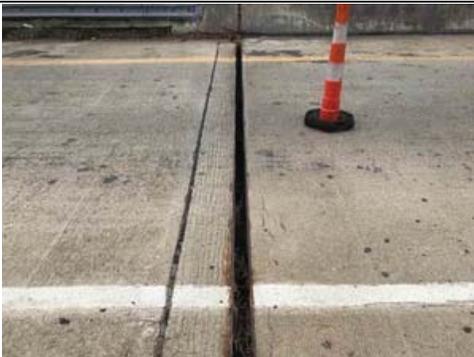
End bent 1 joint, joint material missing (full length) (Photo 27)

Photo #: 3 Caption: End bent 1 joint, joint material missing (full length)

| Part II – Repair Recommendations | | | | | |
|---|---|--|---|---|---|
| C | 805 | End bent 1 joint, joint material missing (full length) | <input type="checkbox"/> | 3 | <input type="checkbox"/> |

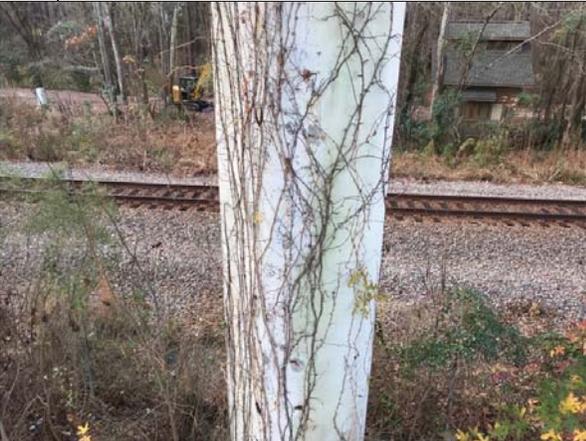
Bent 5 column northeast side, (7) spalls (9in diameter x 1/2in) with exposed rebar (Photo 7)

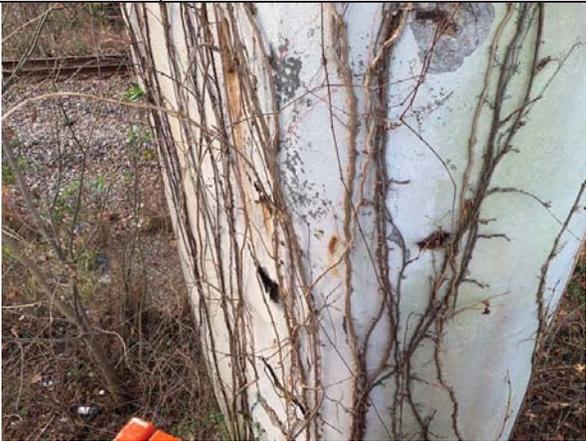
Bent 5 column northeast face below cap, delamination (30in x full height) with spalls and exposed rebar near base (up to 1ft diameter x 1in) (Photo 8 and 9)

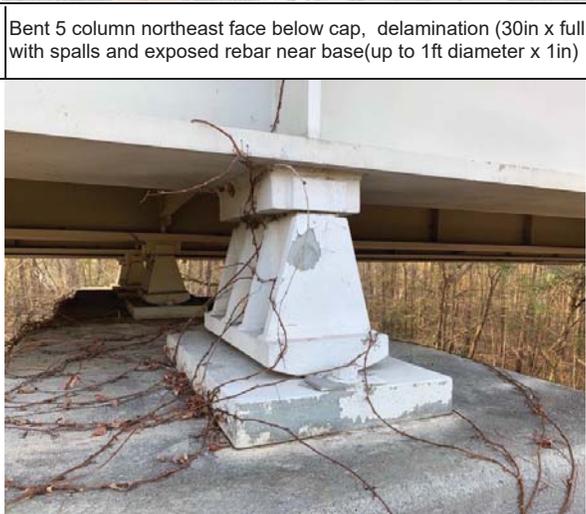
Typical paint peeling on bearings (Photo 10)

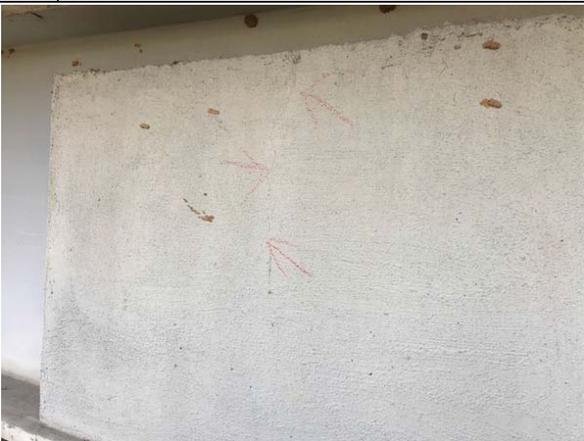
Bent 13 cap north face, vertical crack (2ft x hairline) (Photo 13)

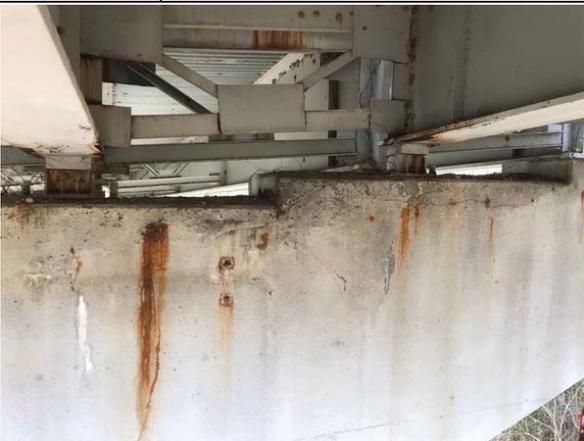
Bent 14 cap east face under beams 2 through 4, horizontal crack (12ft x 1/16in) with rust and efflorescence, adjacent delamination (6.5ft x 30in) (Photo 14)

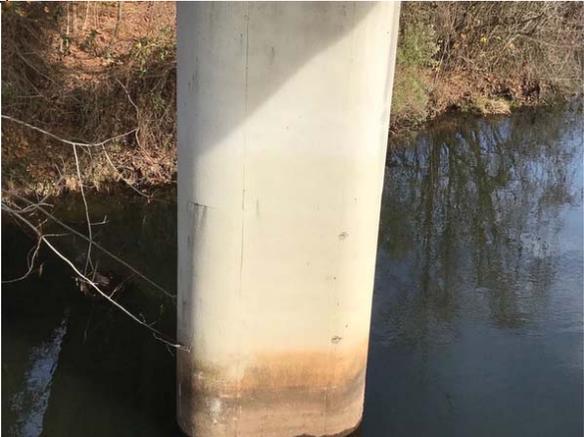
Bent 16 column 1 west face at 5ft and 10ft from waterline, (2) spalls (4in diameter x 1/2in) with exposed rebar (Photo 15)

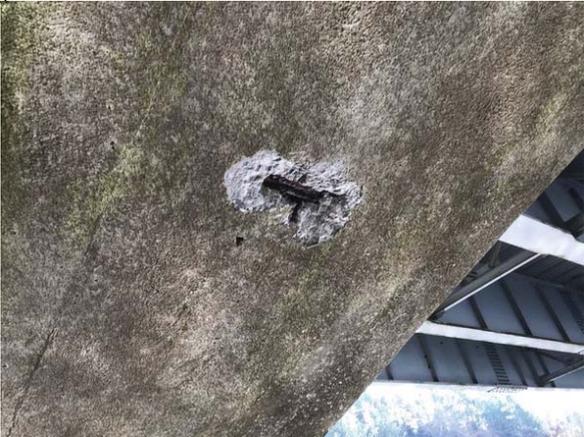
Bent 17 cap underside between beams 3 and 4, spall with exposed rebar (9in x 16in x 1.5in) (Photo 16)

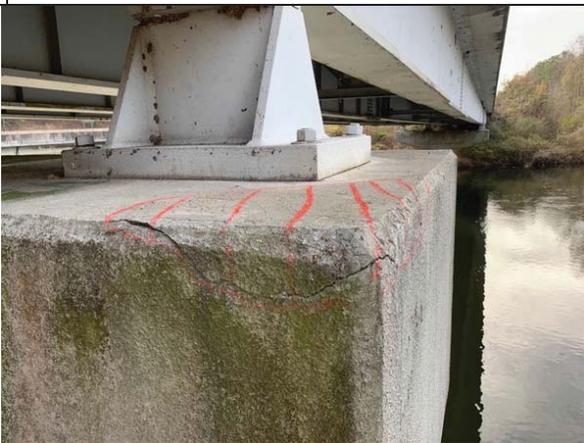
Bent 17 cap top northeast corner, delamination (28in x 20in) (Photo 17)

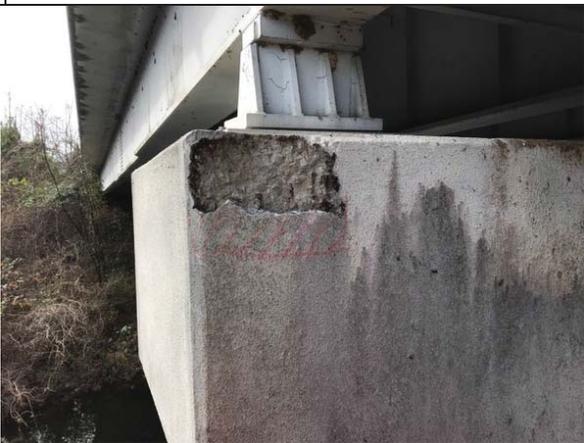
Bent 18 cap top southeast corner, delamination /spall with exposed rebar (16in x 13in x 1.5in) (Photo 18)

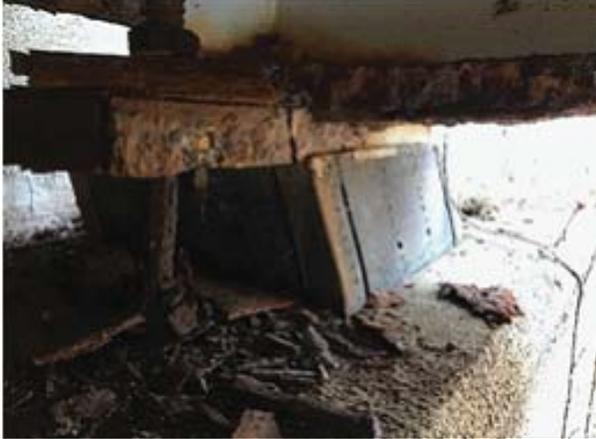
Elastomeric bearing pad is leaning out of plumb and protruding out of alignment (1/4in) at end bent 19 beam 4 (Photo 19)

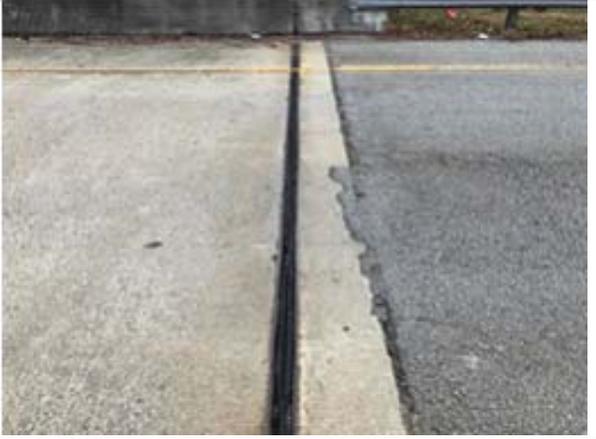
End bent 19 joint, joint material torn and damaged (full length) (Photo 20)

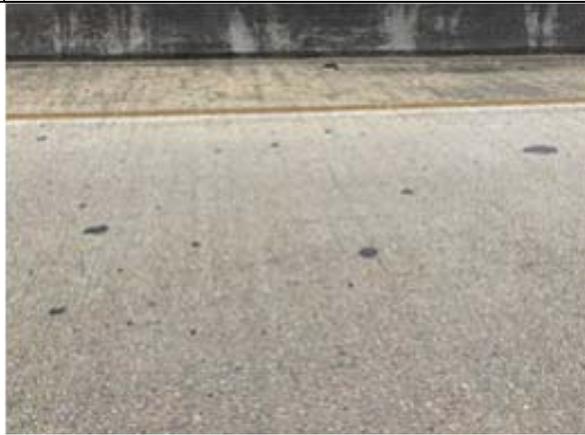
Typical transverse cracking (1/16in) and scattered hairline map cracking on top of deck (Photo 21)

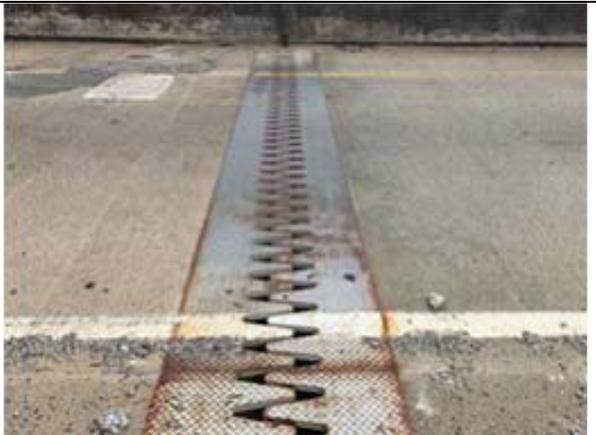
Typical minor corrosion on finger joints (Photo 22)

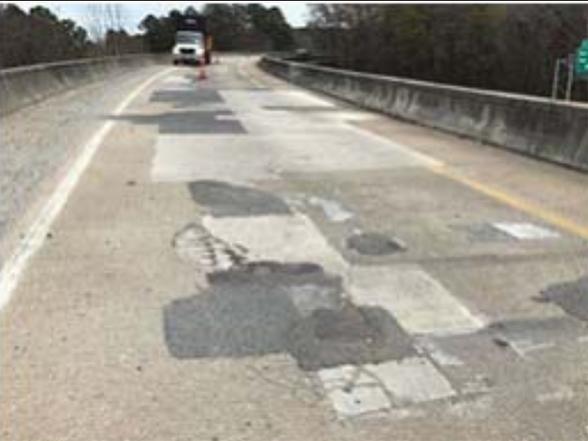
Typical spall/delamination on deck (up to 2in deep) with exposed rebar majority have been patched (Photo 23)

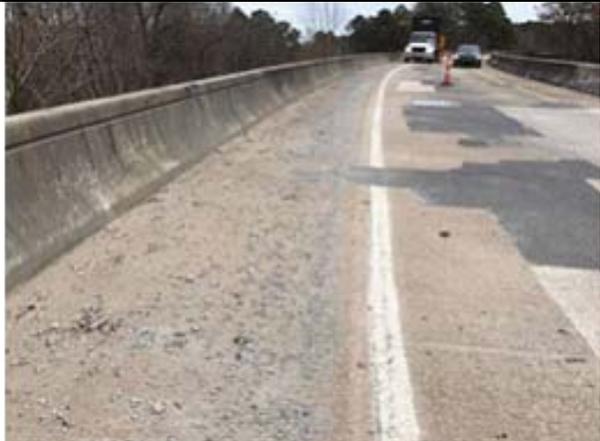
Typical debris accumulation with loose rocks on shoulders (Photo 24)
