SCDOT BRIDGE INSPECTION FORM

(008) BRIDGE ID: 3210002000400	(005) ROUTE: LEXINGTON I-20
(420) ASSET NO: 4604	(006) CROSSING: SALUDA RIVER
(419) RAMP NO:	(009) LOCATION: 5MI NW OF COLUMBIA
(026) FUNCTIONAL CLASS: 11	(016) LAT: 34d 1m 32.16s (017) LON: 81d 7m 41.80s

SCDOT Asset ID 04604 carries I-20 over Saluda River in Lexington County. On November 22, 2022, Consor Engineers, LLC performed a routine underwater investigation at the bridge to evaluate the condition of all substructure units (SSUs) located in the water. This report includes a general description of the structure and the method of investigation, as well as a detailed description of the conditions noted. In addition, this report contains an element level condition assessment of the bridge components evaluated and presents recommendations for structural repairs.

I-20 over Saluda River

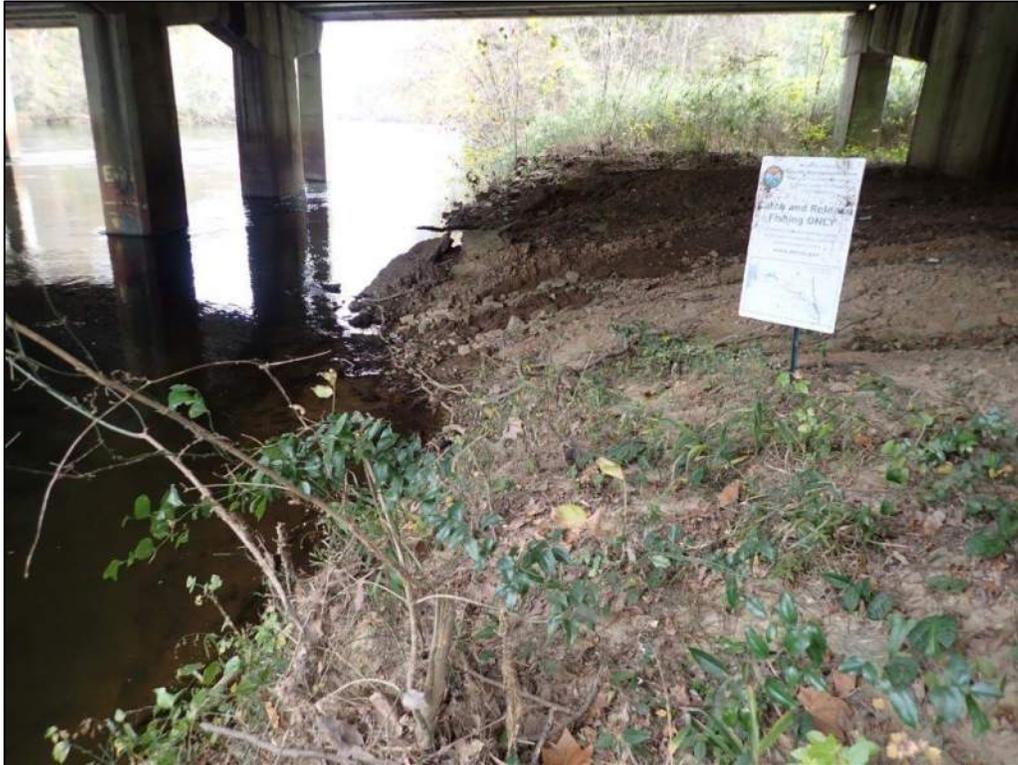
Photo 5: West Channel Bank

- The west embankment has scattered riprap under Span 1 with erosion channels extending from Bent 2 to the channel bank, up to 2 ft. deep (Photo 5).
- The east embankment is unprotected and has erosion channels from Bent 8 to Bent 7, up to 2 ft. deep (Photo 6).
- The stream flow is well aligned with the bents in the waterway.
- Timber debris throughout channel along bents, up to 2 ft. diameter.
- The channel bottom primarily consists of silt and rock.

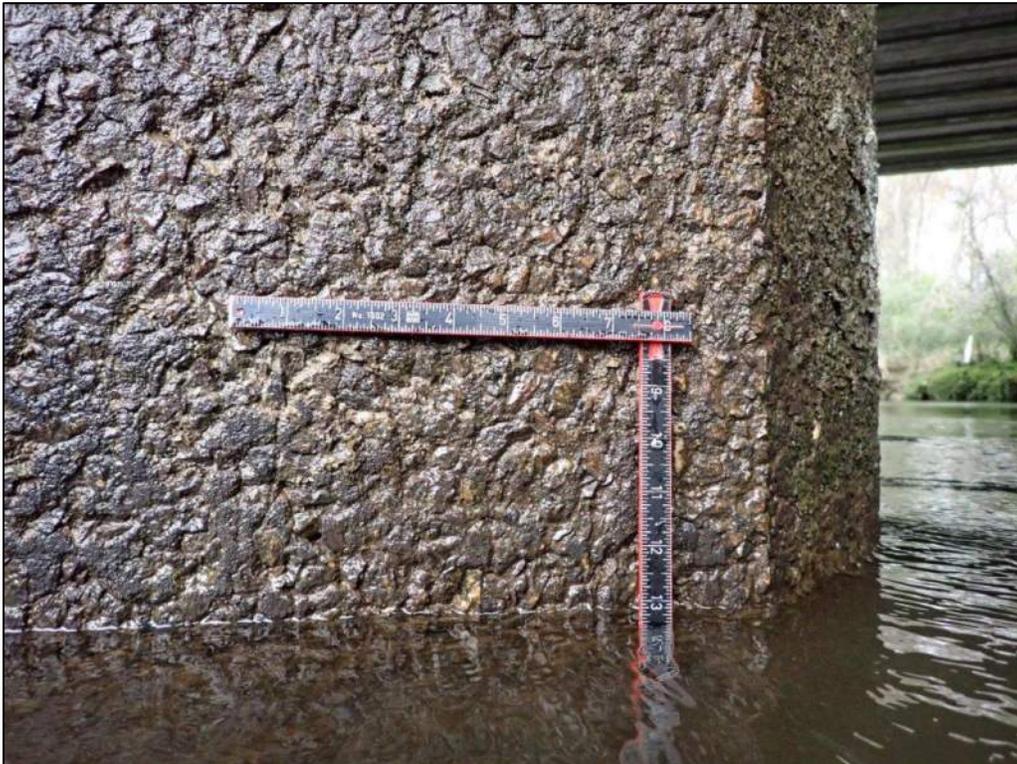
- All inspected bents, from high watermark to channel bottom, abrasion, up to 1/8 in. deep, with exposed but secure coarse aggregate (Photos 8 and 9). [CS2]

Photo 8: Typical Concrete Condition at Waterline, Bent 6, Column 3 Shown

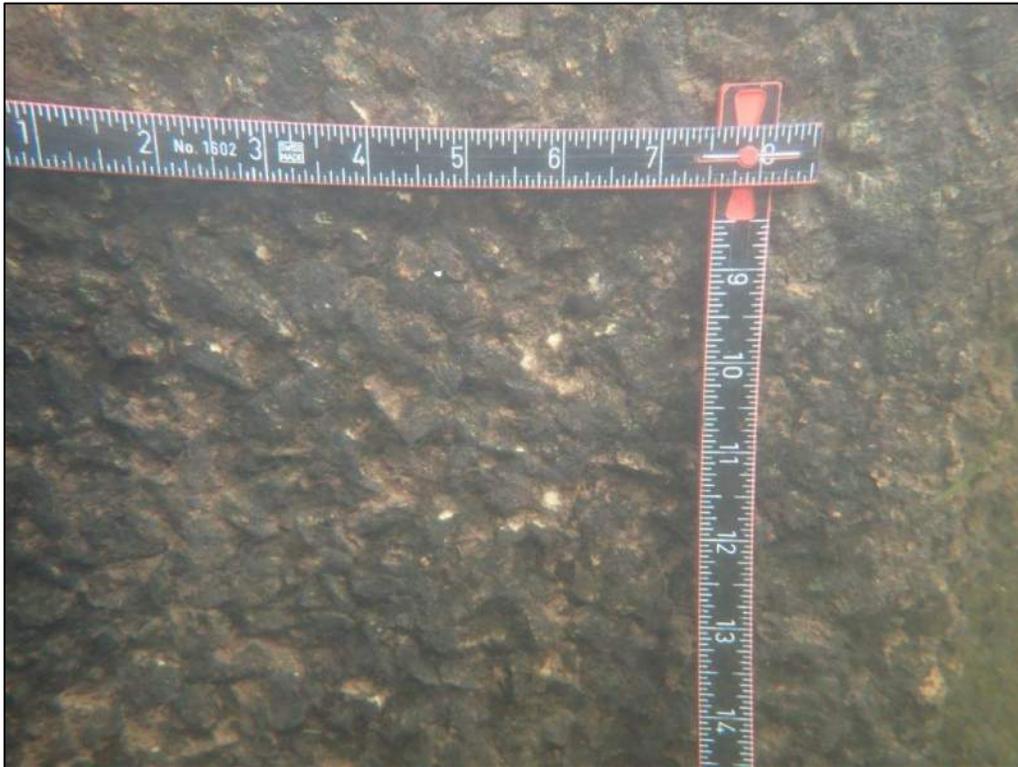
Photo 9: Typical Concrete Condition Below Waterline, Bent 6, Column 3 Shown

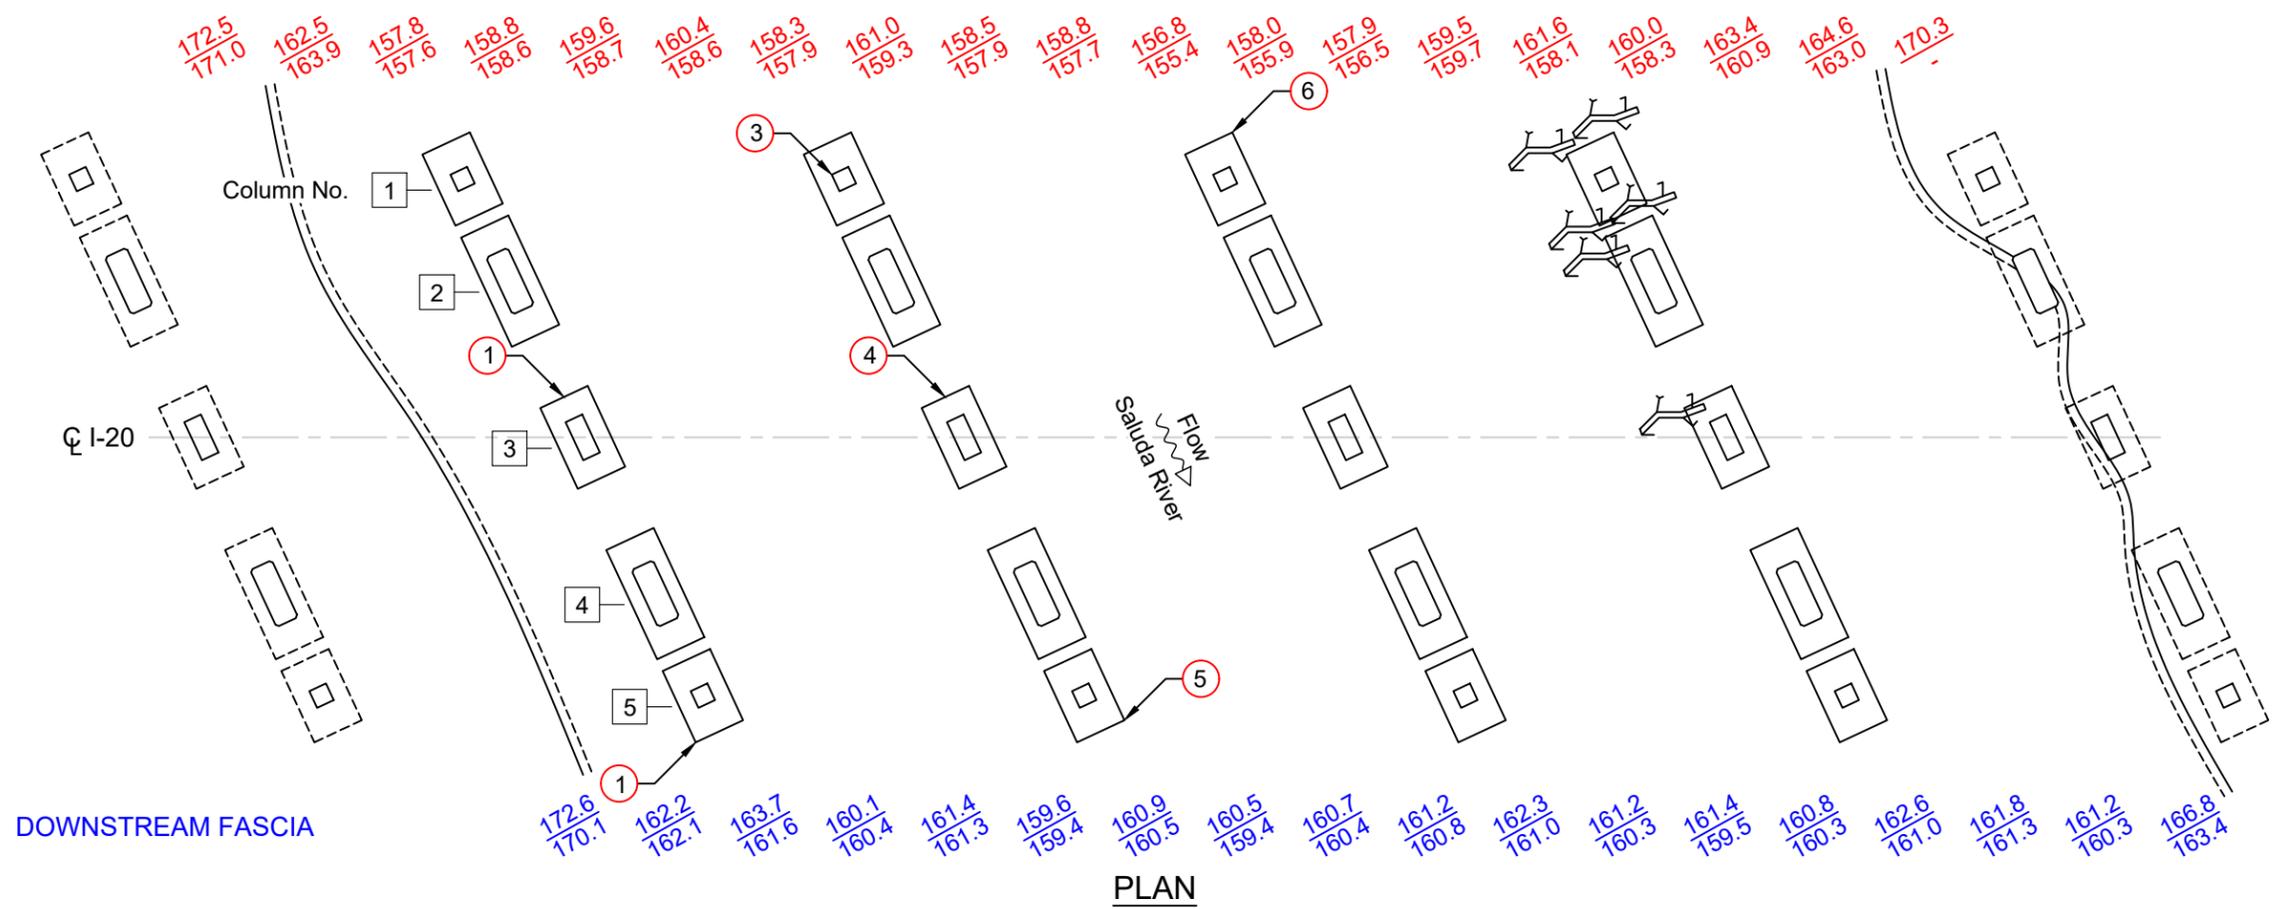
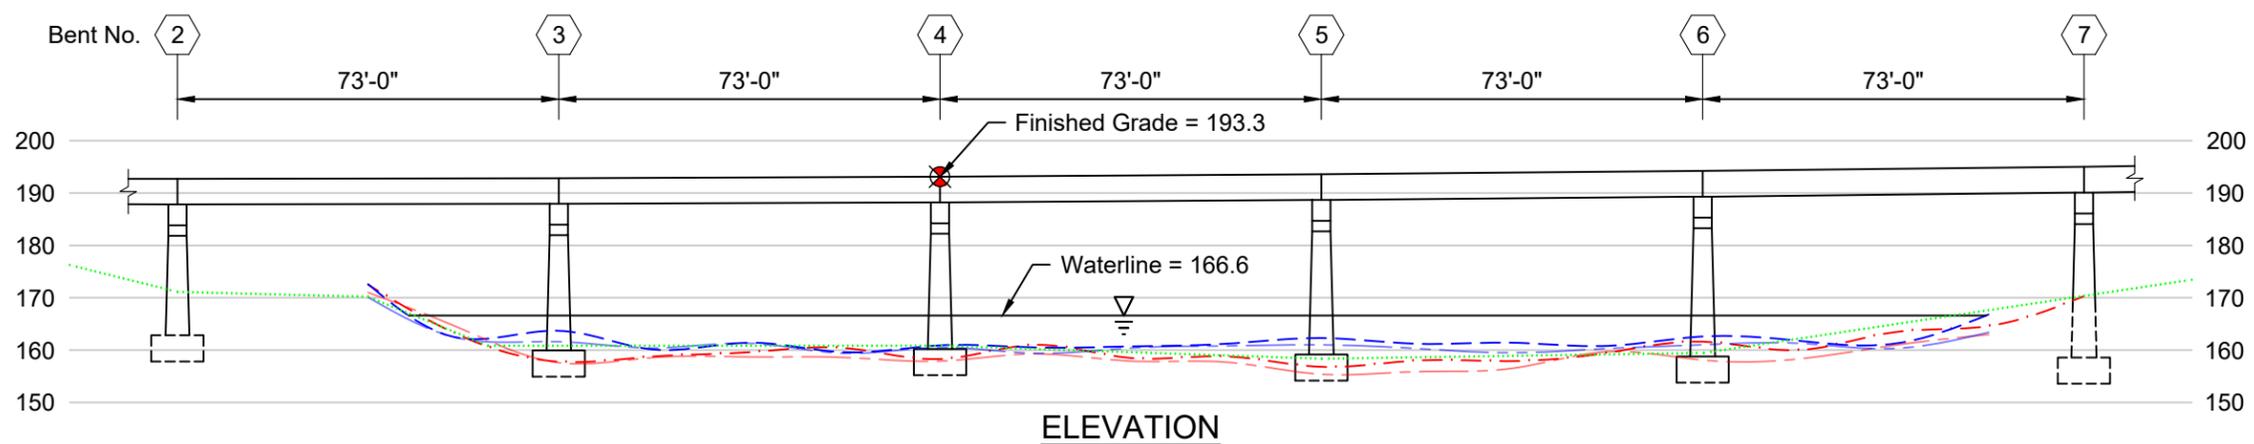
FIG NO. 1

There has been limited general and local scour at the bridge site since construction, resulting in up to 6 in. high undermining; however, the extent of vertical footing exposures and undermining have remained relatively unchanged since the 2017 underwater inspection. Refer to Table 5 for a listing of the sounding measurements and to Figure 1 for an illustration of the channel bottom profiles. Refer to Table 6 for a complete listing of observed footing and seal exposures.

- At the time of inspection, the waterline was located approximately 29.5 ft. below the top of the deck at the downstream side of Bent 4. This translates to a waterline elevation of 166.6 according to the available as-built plans.
- Soundings across the channel were taken parallel to the bridge at the bents and are actual channel bottom elevations in feet determined on November 22, 2022.
- This figure was developed from field notes, sketches, and South Carolina Department of Transportation as-built plans dated October 1965 and May 1987.

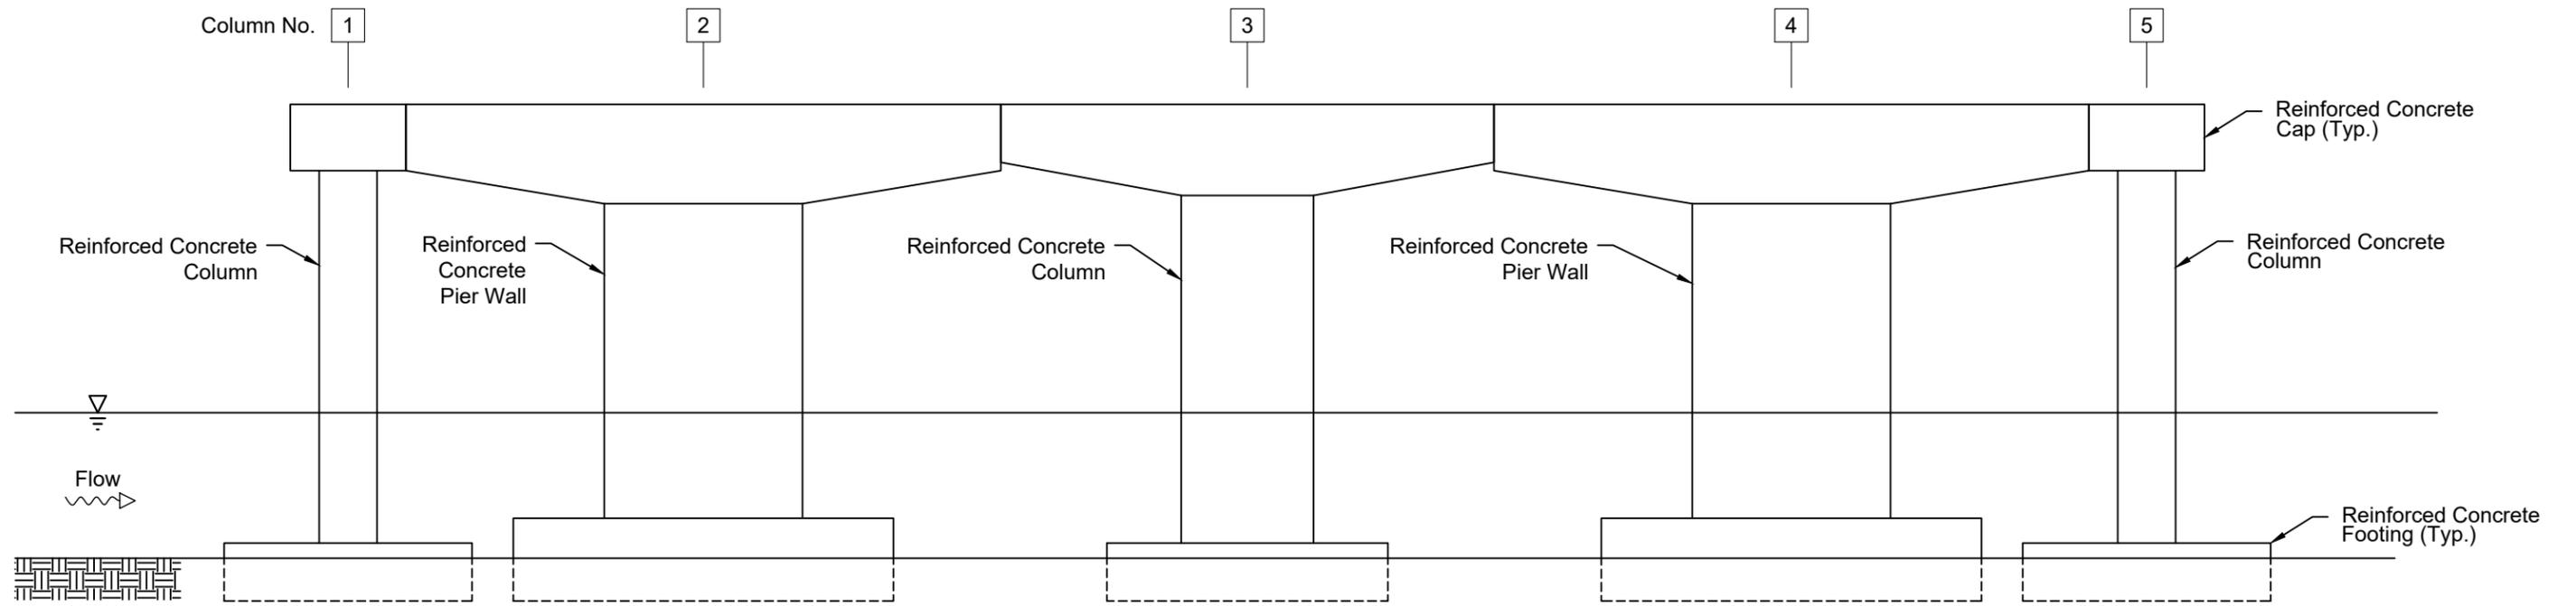
West Elevation
(Bents 3 through 6)

- GN All inspected bents, from high watermark to channel bottom, abrasion, up to 1/8 in. deep, with exposed but secure coarse aggregate.
- 1 Bent 3, Footing 3, along north face, undermining, up to 4 in. high x 4 in. penetration.
- 2 Bent 3, Footing 5, southwest corner, at top of footing, spall, 5 in. high x 8 in. long on west face x 6 in. long on south face x 1.5 in. deep.
- 3 Bent 4, Column 1, northwest corner, at column/footing interface, void, 3 in. high x 5 in. wide x 2 in. deep.
- 4 Bent 4, Footing 3, along north face, undermining, up to 4 in. high x 5 in. penetration.
- 5 Bent 4, Footing 5, southeast corner at top of footing, spall, 1.2 ft. long x 5 in. high x 1 in. deep.
- 6 Bent 5, Footing 1, northeast corner, undermining, 6 in. high x up to 6 in. penetration.
