SCDOT BRIDGE INSPECTION FORM

(008) BRIDGE ID: 3210002000400	(005) ROUTE: LEXINGTON I-20
(420) ASSET NO: 4604	(006) CROSSING: SALUDA RIVER
(419) RAMP NO:	(009) LOCATION: 5MI NW OF COLUMBIA
(026) FUNCTIONAL CLASS: 11	(016) LAT: 34d 1m 32.16s (017) LON: 81d 7m 41.80s

Inspection Leader: ERIC BEACH, COLLINS ENG	Reviewed By: KEVIN VELLO, COLLINS ENG
Date:	Date: 2/16/2022

Bridge Inspected on 11/21/2021. Cloudy, 52 degrees.

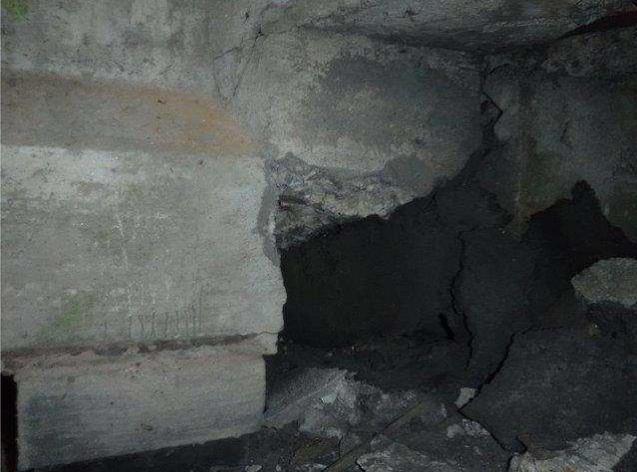
- Beam 6, Bent 7, Span 8 has a:
 - Spall up to full width x 11"L x 8" deep
 - Diaphragm spall w/exp. rebar
- Beam 4, Bent 8, Span 8 has a minor spall in filler behind bearing.

1	Element (109) in CS3, Spall at Beam 6, Span 8	2	Element (109) in CS3, Spall at Beam 13, Span 6

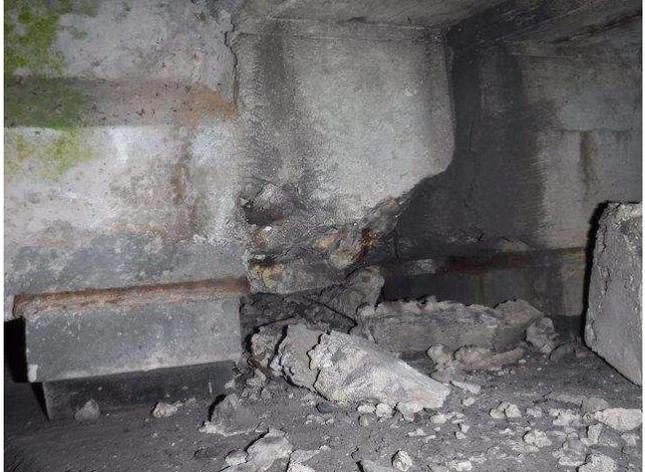
- Beam 13, Bent 7, Span 6 has a spall up to 12"L x 11"W x 4" deep w/exp. rebar at the beam end past bearing
- Beams 2-4, 6, 13-15, & 17, Bent 7, Span 7 have cracks in filler behind bearing.

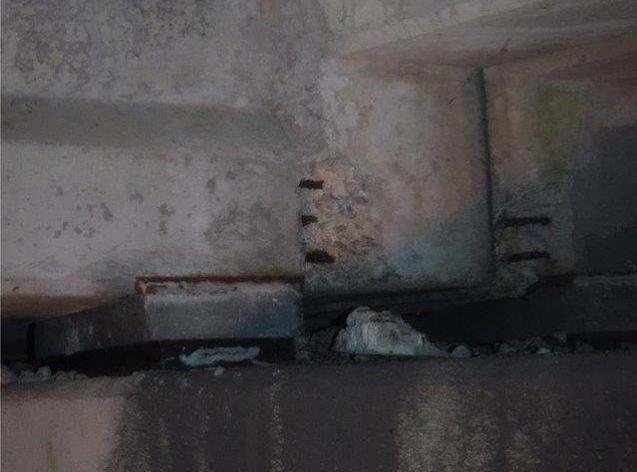
- Beam 18, Bent 7, Span 7 has a spall up to 12" x 12" x 12" w/exp. rebar at the beam end past bearing
- Beam 13, Bent 8, Span 7 has a spall up to 5"L x 8" tall x 2" deep w/ (3) exp. prestressed strands at the beam end past bearing

3	Element (109) in CS3, Spall with exposed prestressed strands at Beam 13, Span 7	4	Element (301) in CS3, Seal adhesion failure at Bent 2 Joint

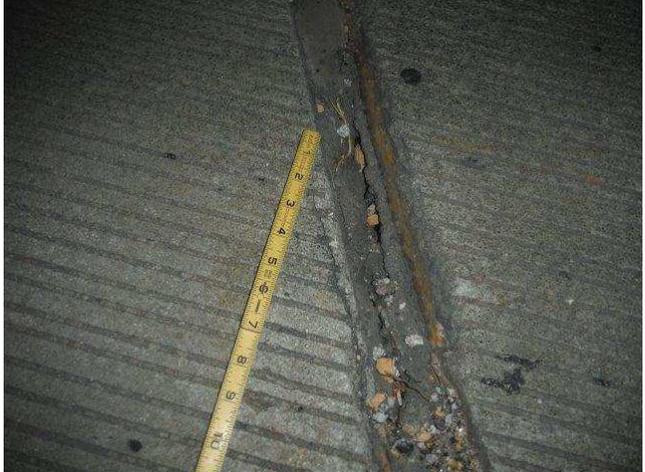
Bent 2 Joint:
 -Seal adhesion failure up to 5' long x 1/2" wide w/debris impaction in 5 areas

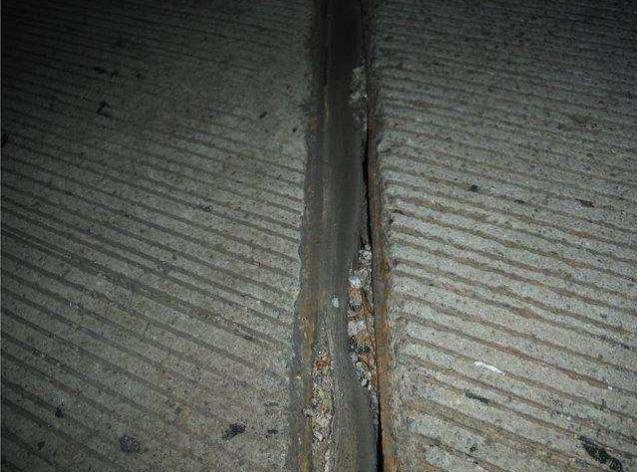
Bent 4 Joint:
 -Seal adhesion failure up to 4' long x 1/2" wide in 10 areas

5	Element (301) in CS3, Seal adhesion failure at Bent 4 Joint	6	Choose an item or enter a caption.

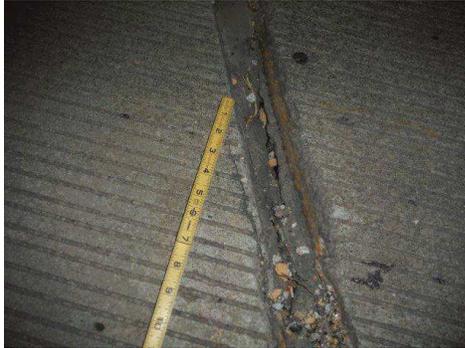
Expansion material is cracked, torn, pulled loose, and missing.

Photo #: 1 Caption: **Expansion joint damage**

Part II – Repair Recommendations					
Flag Type (A, B or C)	HMMS Deficiency Code	Deficiency Description (include approximate quantity & location for maintenance to be aware of the deficiency)	Pile Repair Report Needed? (A5.27)	Photo Number (if used)	DBIS: Already in HMMS?
C	805	Replace expansion joint material (Approx 150 LF)	<input type="checkbox"/>	1	<input type="checkbox"/>
C	807	Patch spalls in concrete caps (Approx 15 LF)	<input type="checkbox"/>	2	<input type="checkbox"/>
C	803	Patch spalls in concrete beams (Approx 25 LF)	<input type="checkbox"/>	3	<input type="checkbox"/>
C	803	Patch spalls in concrete diaphragms	<input type="checkbox"/>	4	<input type="checkbox"/>

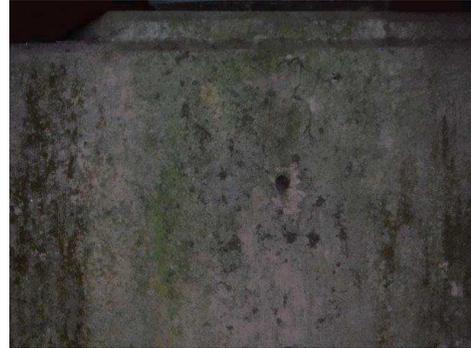
- Cap Bent 2 has:
- (3) minor spalls w/rust under Beam 13, East side.
 - Minor spall w/corros. under Beam 14, East side.
- Cap Bent 3 has a:
- Minor spall w/corros. under Beam 3, East side, 3"x3".
 - Minor spalls at pop-outs, both sides.
- Cap Bent 4 has minor spalls at pop-outs, both sides.
- Cap Bent 5 has minor spalls at pop-outs, both sides.
- Cap Bent 6 has:
- Minor spall w/corros. under Beam 3, West side, 2'x3".
 - Minor spall w/corros. under Beam 6, West side, 2'x6".
 - Minor spalls at pop-outs, both sides.

Photo #: 2 Caption: **Spalls in concrete cap**

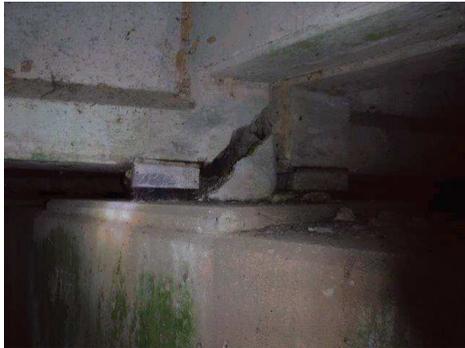
Photo #: 3 Caption: **Spalls in concrete beams**

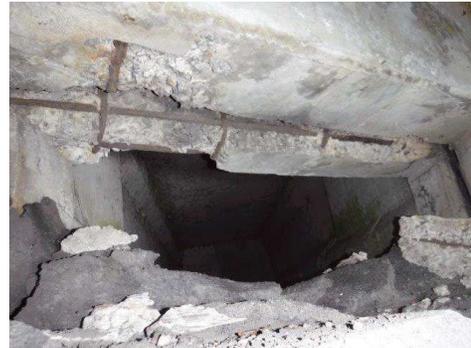
Photo #: 4 Caption: **Spalls in concrete diaphragms**
