Cypress Avenue Over Murrells Inlet Creek (S-26-154) Bridge Rehabilitation

Substructure Evaluation

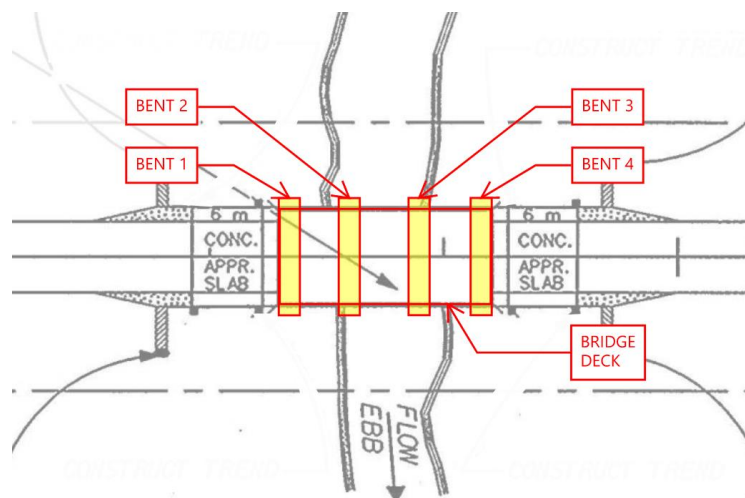
Figure 1. Overview of Cypress Ave bridge with labeled bent caps.

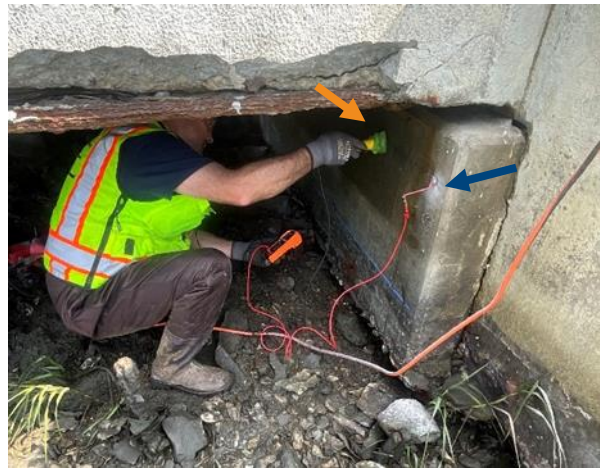
Figure 3. HCP testing of bent cap 4, showing reference electrode (orange arrow) and connection to reinforcing steel (blue arrow.)

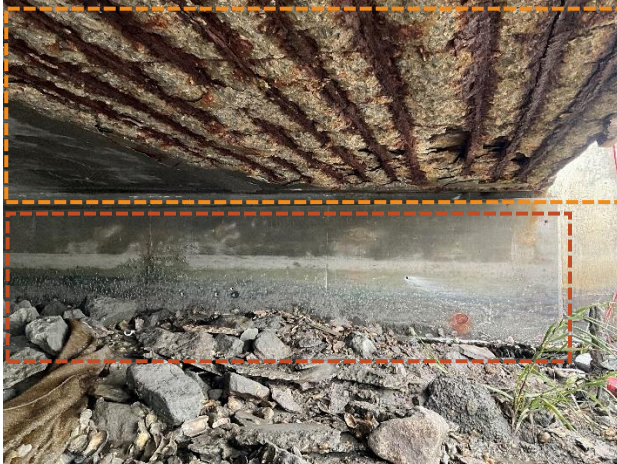
Figure 4. Representative deterioration of existing bridge deck in orange box and good condition of bent cap 4 with piles below grade in red box.

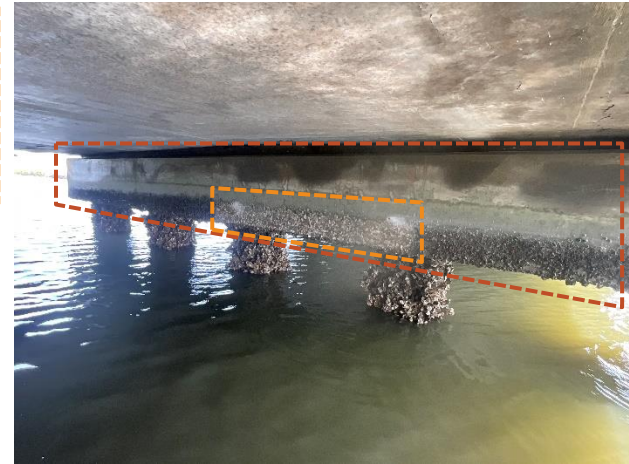
Figure 5. Good condition of concrete substructure at bent cap 3 in red. The representative region cleaned for inspection, HCP, and LPR testing is shown in orange.

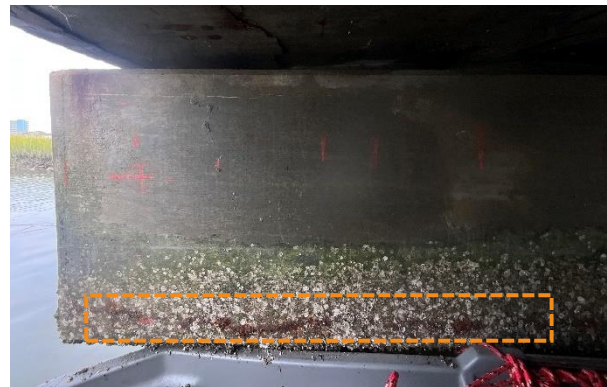
Figure 6. Visible corrosion byproduct and cracking on bottom longitudinal reinforcing layer on bent cap 3.

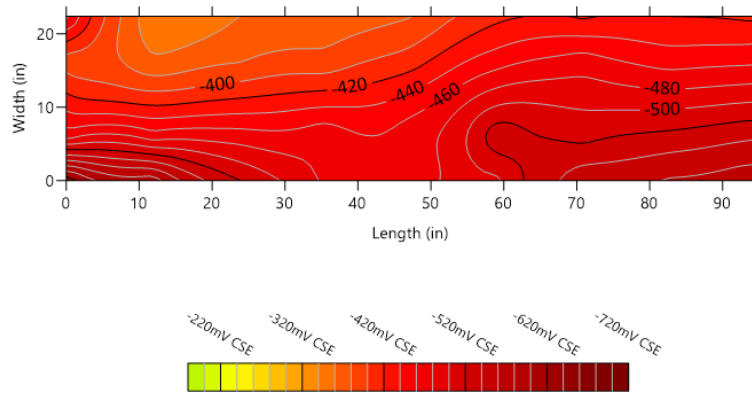
Figure 7. Representative electrical potential contour map from HCP test on bent cap 1.

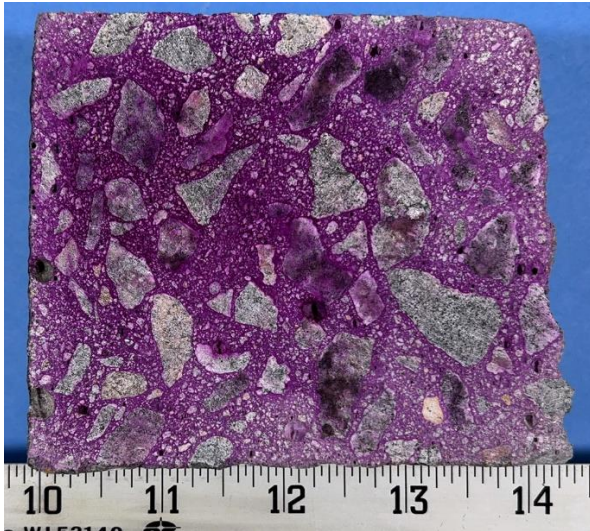
Figure 9. Core 3 carbonation test – no carbonation visible

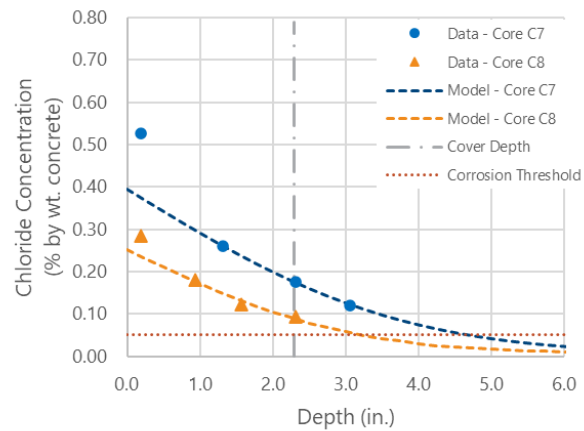
Figure 14. Chloride concentration vs. depth – bent cap 4

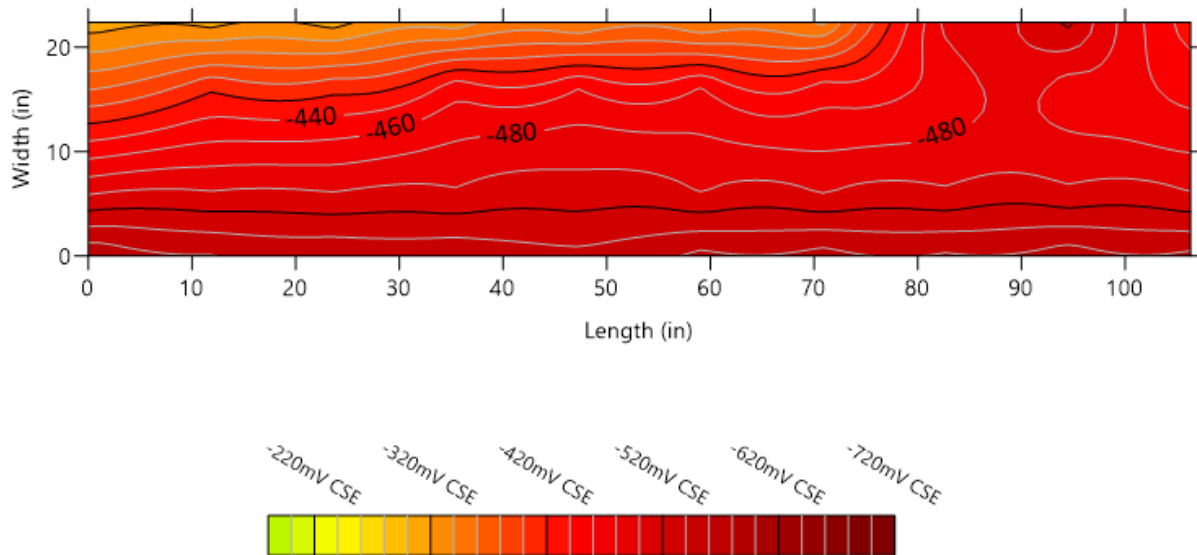
Per ASTM C876-15 Appendix X.1:

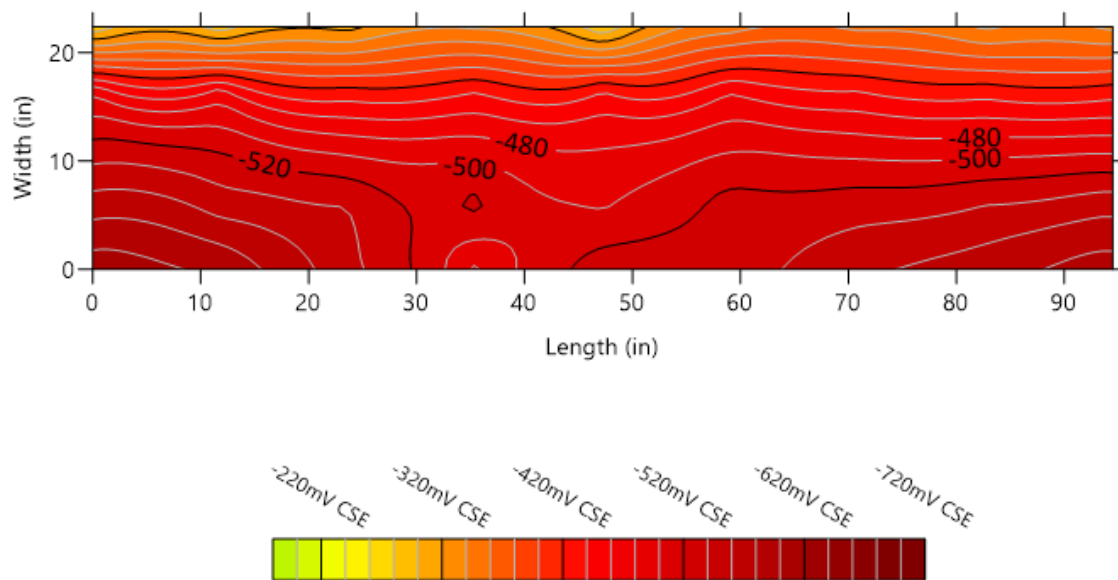
Per ASTM C876-15 Appendix X.1:

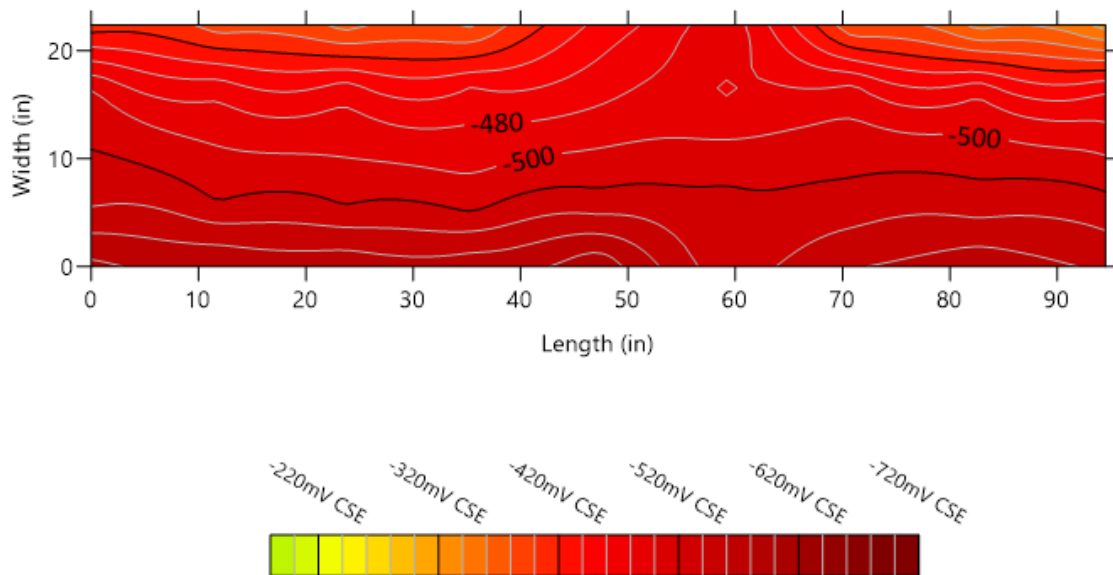
Per ASTM C876-15 Appendix X.1:

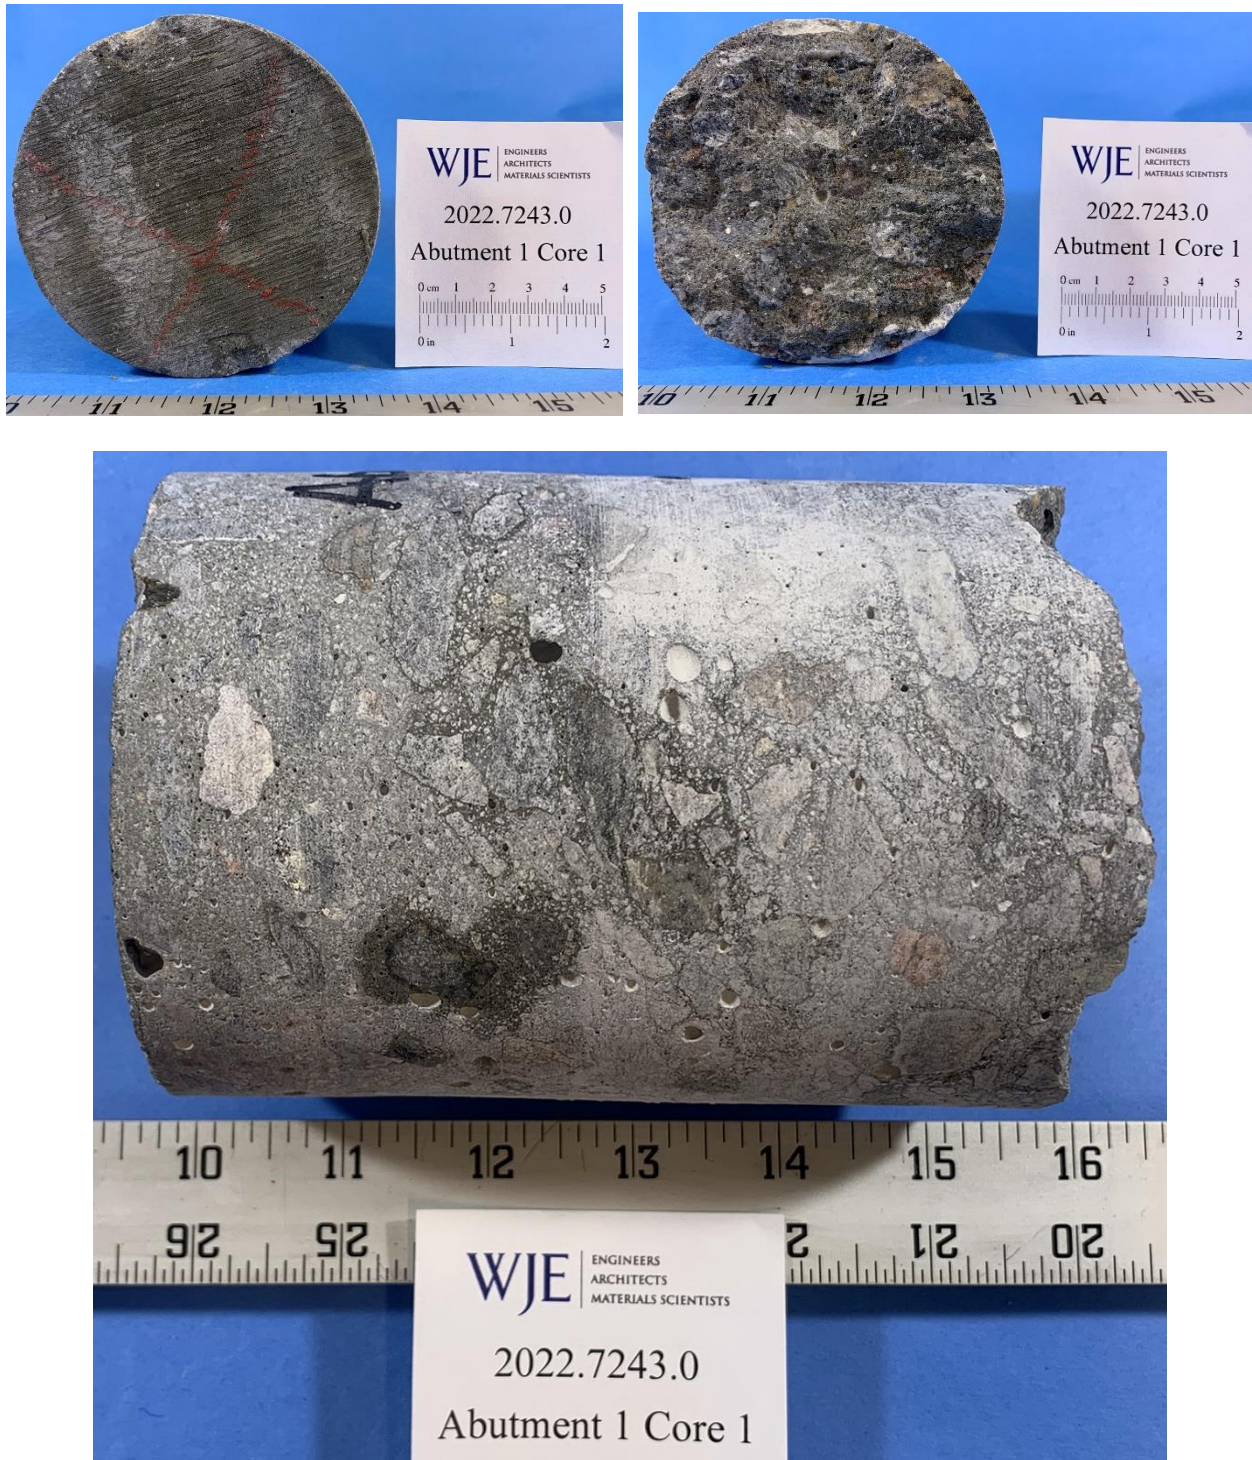
Figure D1. Core 1. Images of the sample as-received, with the exterior surface in the exterior left image, bottom surface in the exterior right image, and longitudinal view of the core with the exterior surface facing left in the bottom image.

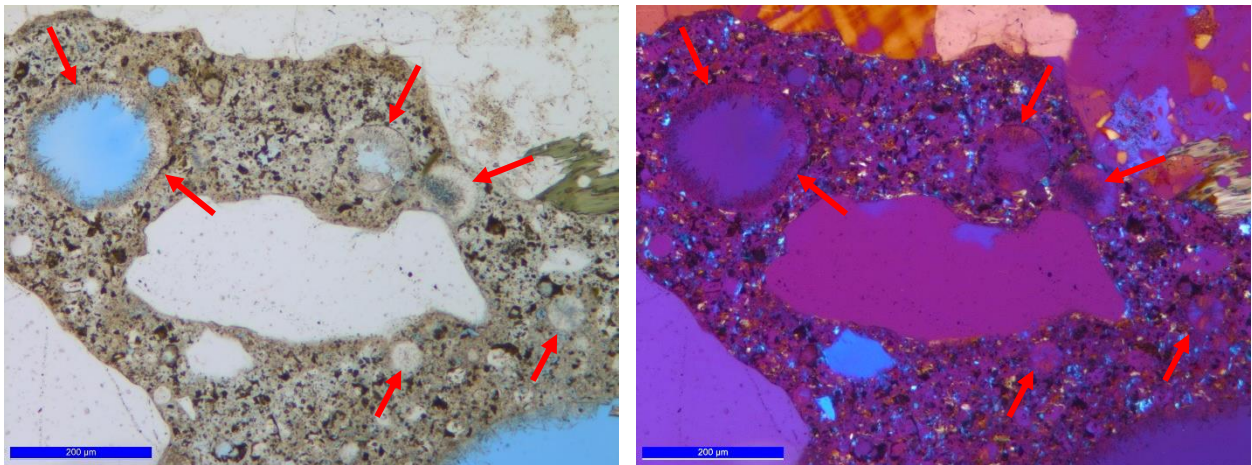
Figure D15. Core 7. Secondary deposits of ettringite were observed lining entrained air voids (red arrows). Left image taken in plane-polarized light, right image taken in cross-polarized light with a gypsum plate.

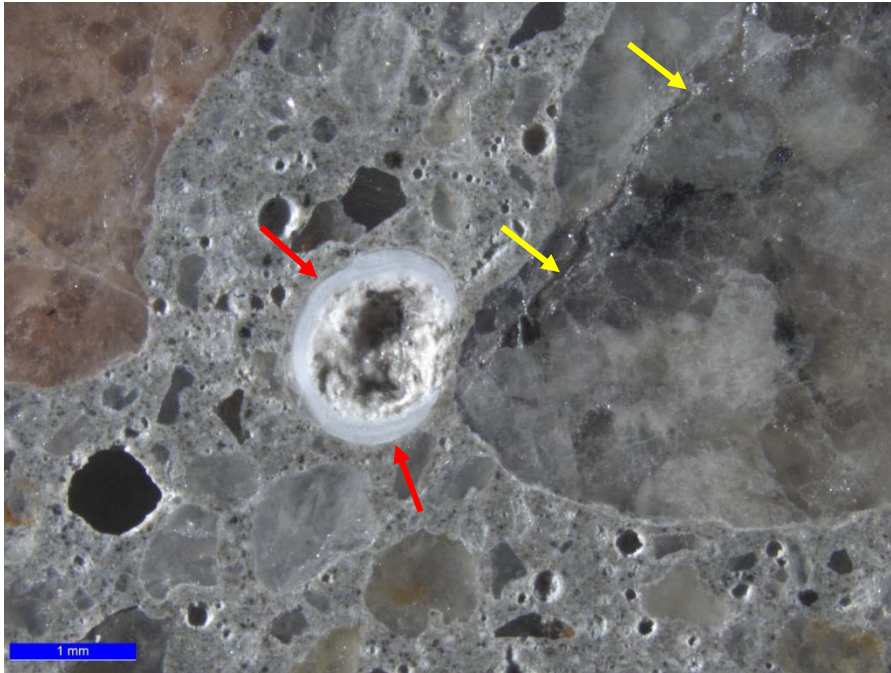
Figure D16. Core 1. ASR gel within an air void (red arrows). The gel likely emanated from the volcanic particle to the right, which contains an internal crack that suggests reactivity (yellow arrows).

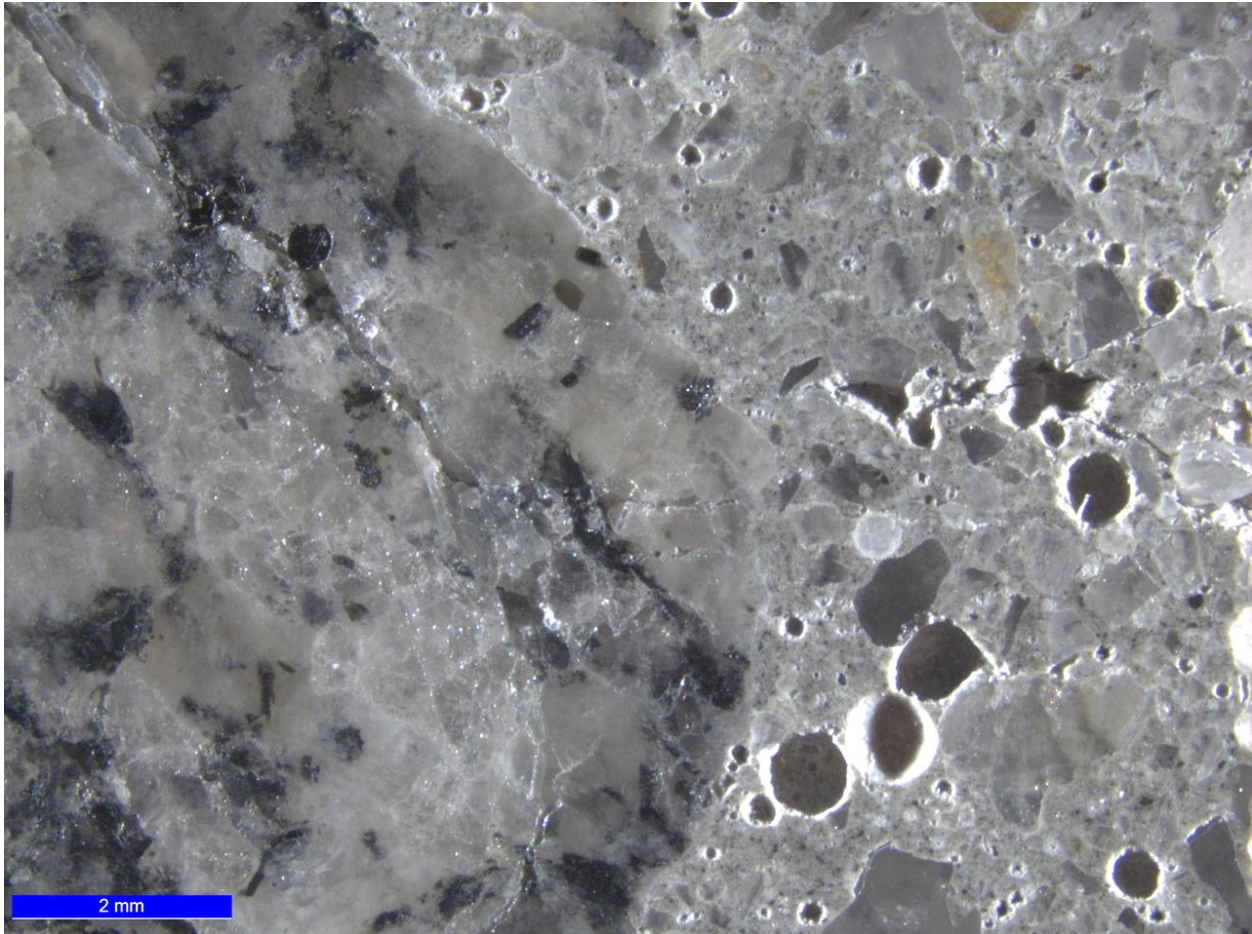
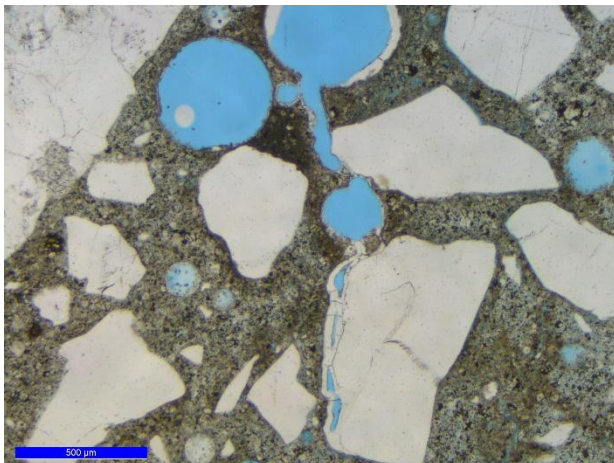
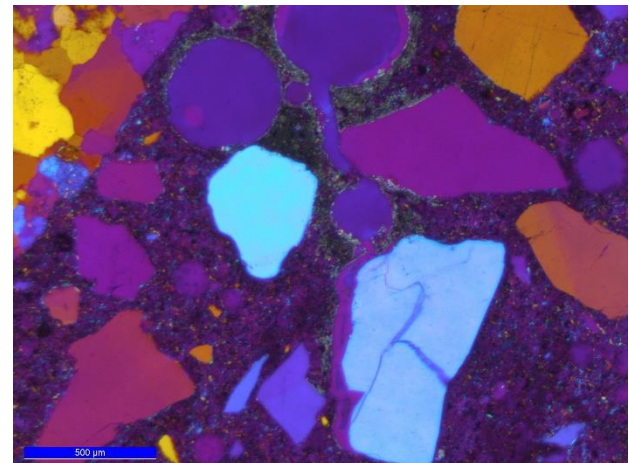
Figure D17. Core 5. Images of ASR gel in air voids and cracks (red arrows) and microcracking (yellow arrows) through and around aggregate particles. The exterior image was taken approximately 3-1/2 inches below the exterior surface, while the photomicrographs were taken 5/8 inch below the surface. Bottom left image taken in plane-polarized light, bottom right image taken in cross-polarized light with a gypsum plate.
