# Geotechnical Data Report

**I-20 Wateree River Bridge Repairs  
Kershaw County, SC**

Terracon Project No. 7321P043A (Rev. 1)

**Geotechnical Data Report**  
**I-20 Wateree River Bridge Repairs**  
**Kershaw County, SC**  
**PIN: P029450, P029776, P029777**  
**Terracon Project No. 7321P043A (Rev. 1)**  
**May 11, 2022**

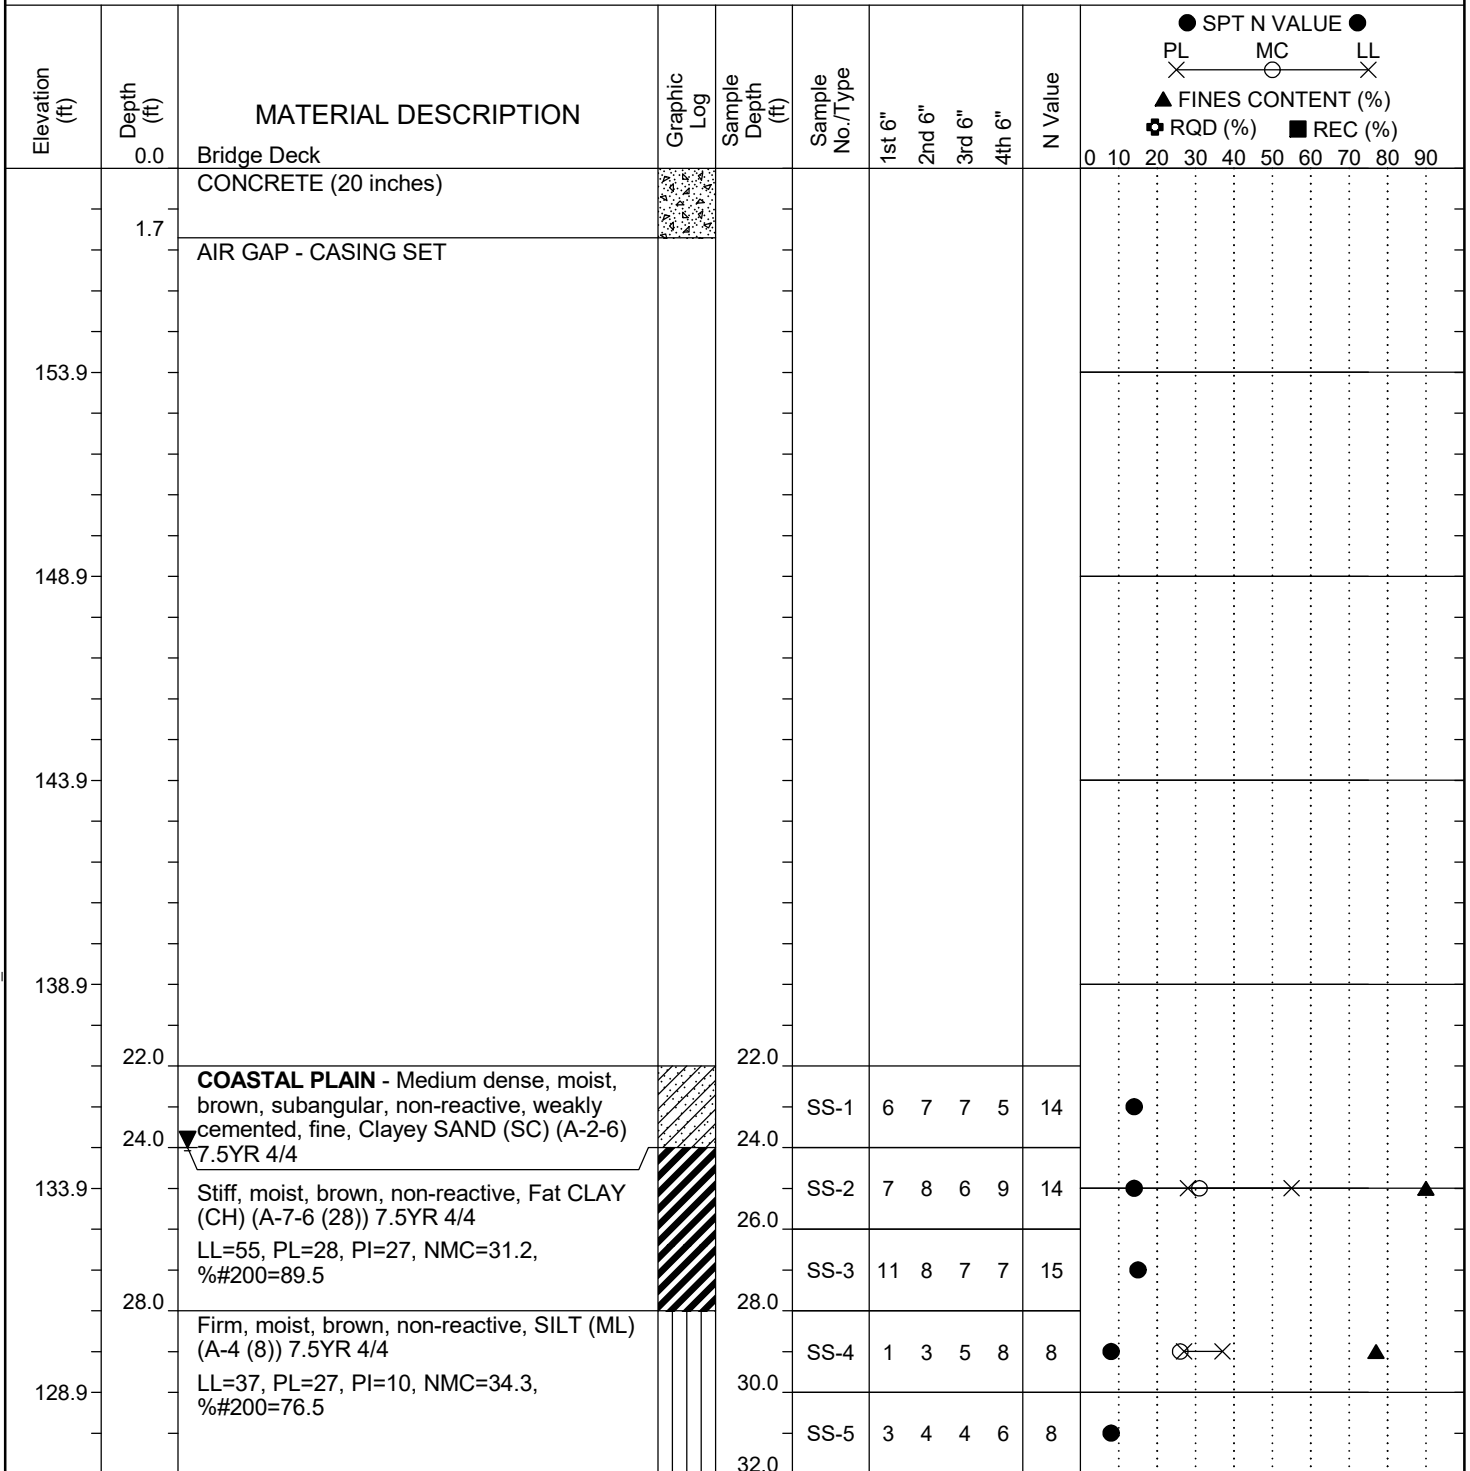
<b>Project ID:</b> P029450, P029776, P029777	<b>County:</b> Kershaw	<b>Boring No.:</b> B-1
<b>Site Description:</b> I-20 Wateree River Bridge Repairs	<b>Route:</b> I-20	
<b>Eng./Geo.:</b> LM	<b>Boring Location:</b> 1879+26.88	<b>Offset:</b> 56.41 L <b>Alignment:</b> Existing
<b>Elev.:</b> 158.9 ft	<b>Latitude:</b> 34.2186098	<b>Longitude:</b> -80.6065739 <b>Date Started:</b> 6/14/2021
<b>Total Depth:</b> 60 ft	<b>Soil Depth:</b> 60 ft	<b>Core Depth:</b> 0 ft <b>Date Completed:</b> 6/22/2021
<b>Bore Hole Diameter (in):</b> 3	<b>Sampler Configuration</b>	<b>Liner Required:</b> Y (N) <b>Liner Used:</b> Y (N)
<b>Drill Machine:</b> CME-55/727	<b>Drill Method:</b> RW	<b>Hammer Type:</b> Automatic <b>Energy Ratio:</b> 88.8%
<b>Core Size:</b> N.A.	<b>Driller:</b> ST	<b>Groundwater:</b> TOB N.M. <b>24HR:</b> 24 ft

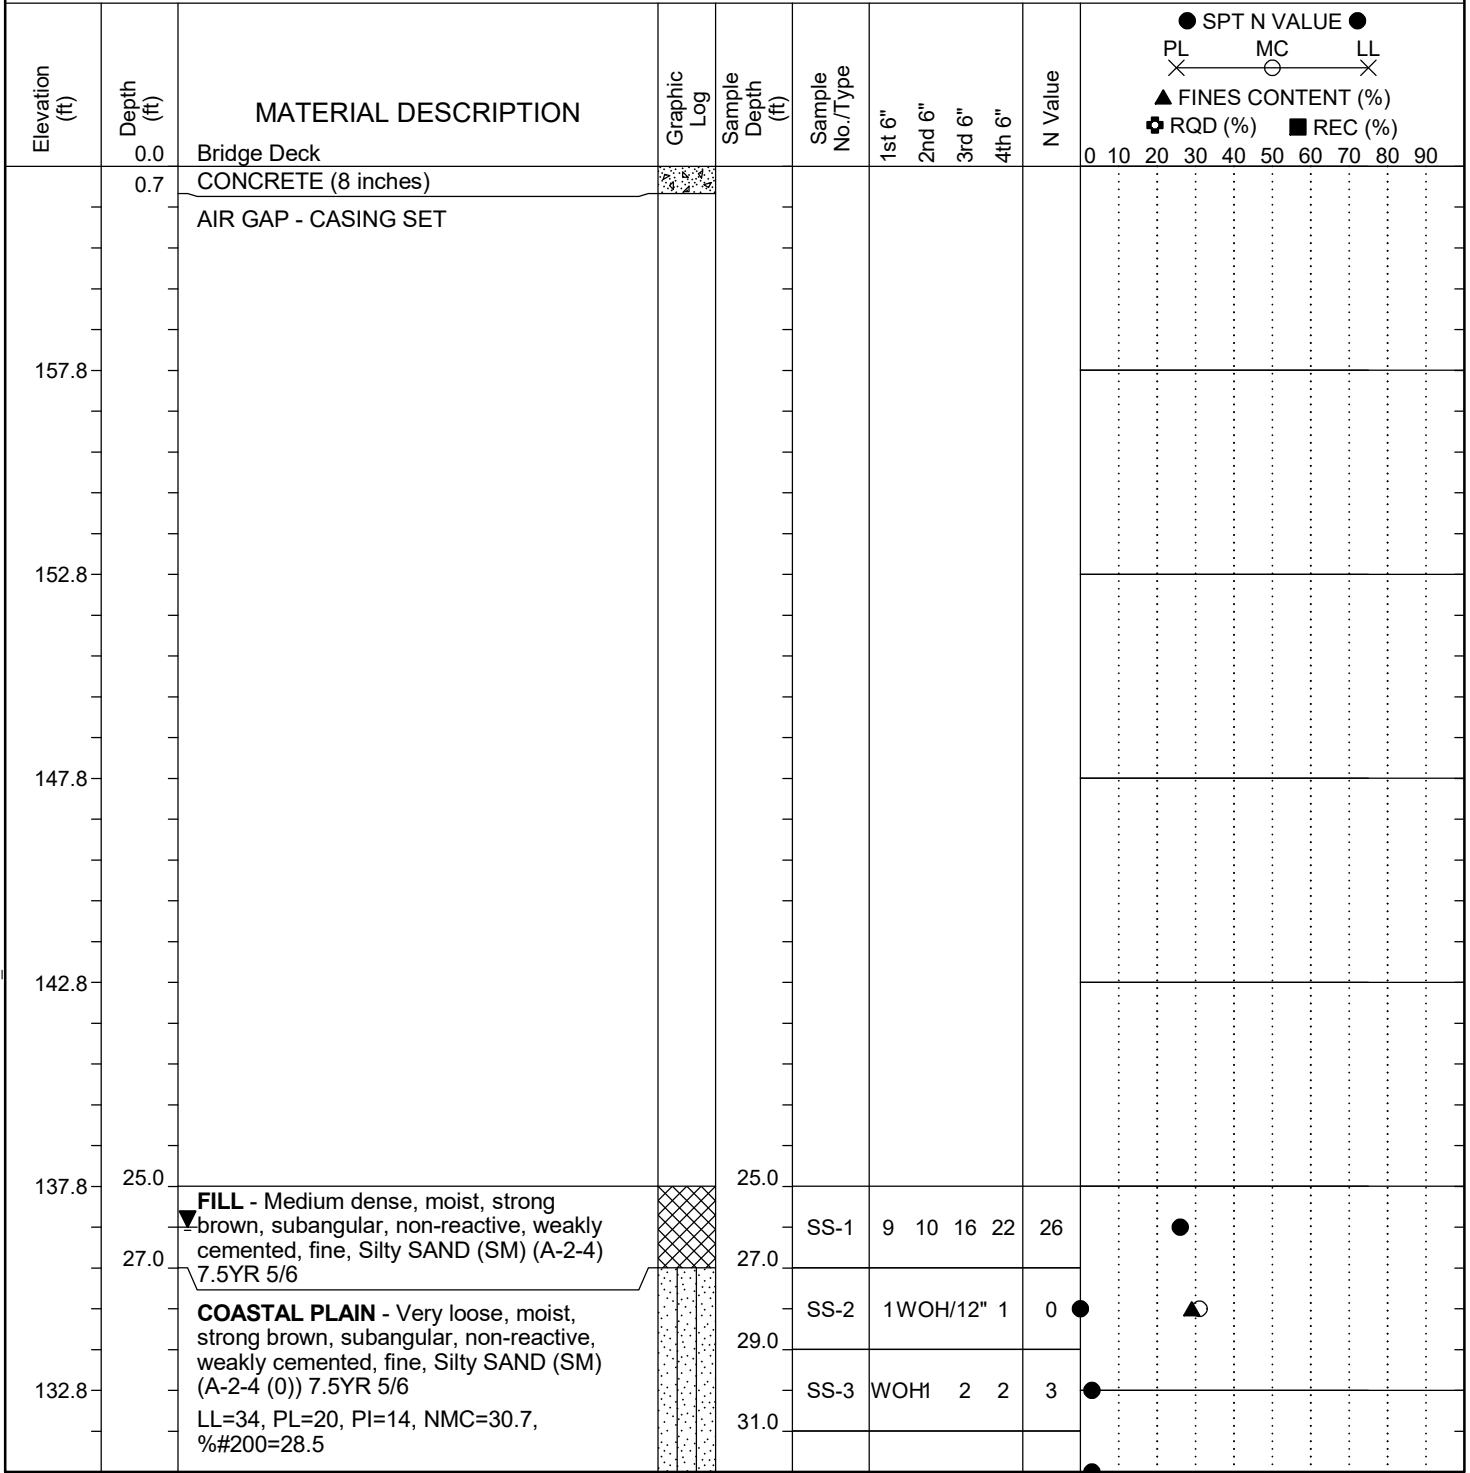
<b>Project ID:</b>	P029450, P029776, P029777			<b>County:</b>	Kershaw	<b>Boring No.:</b>	B-5
<b>Site Description:</b>	I-20 Wateree River Bridge Repairs					<b>Route:</b>	I-20
<b>Eng./Geo.:</b>	LM	<b>Boring Location:</b>	1810+35.00	<b>Offset:</b>	56.06 L	<b>Alignment:</b>	Existing
<b>Elev.:</b>	162.8 ft	<b>Latitude:</b>	34.2177853	<b>Longitude:</b>	-80.6290932	<b>Date Started:</b>	5/5/2021
<b>Total Depth:</b>	48.5 ft	<b>Soil Depth:</b>	48.5 ft	<b>Core Depth:</b>	0 ft	<b>Date Completed:</b>	5/6/2021
<b>Bore Hole Diameter (in):</b>	3	<b>Sampler Configuration</b>		<b>Liner Required:</b>	Y (N)	<b>Liner Used:</b>	Y (N)
<b>Drill Machine:</b>	Simco 2800	<b>Drill Method:</b>	RW	<b>Hammer Type:</b>	Automatic	<b>Energy Ratio:</b>	84.4%
<b>Core Size:</b>	N.A.	<b>Driller:</b>	ST	<b>Groundwater:</b>	TOB N.M.	<b>24HR</b>	26 ft

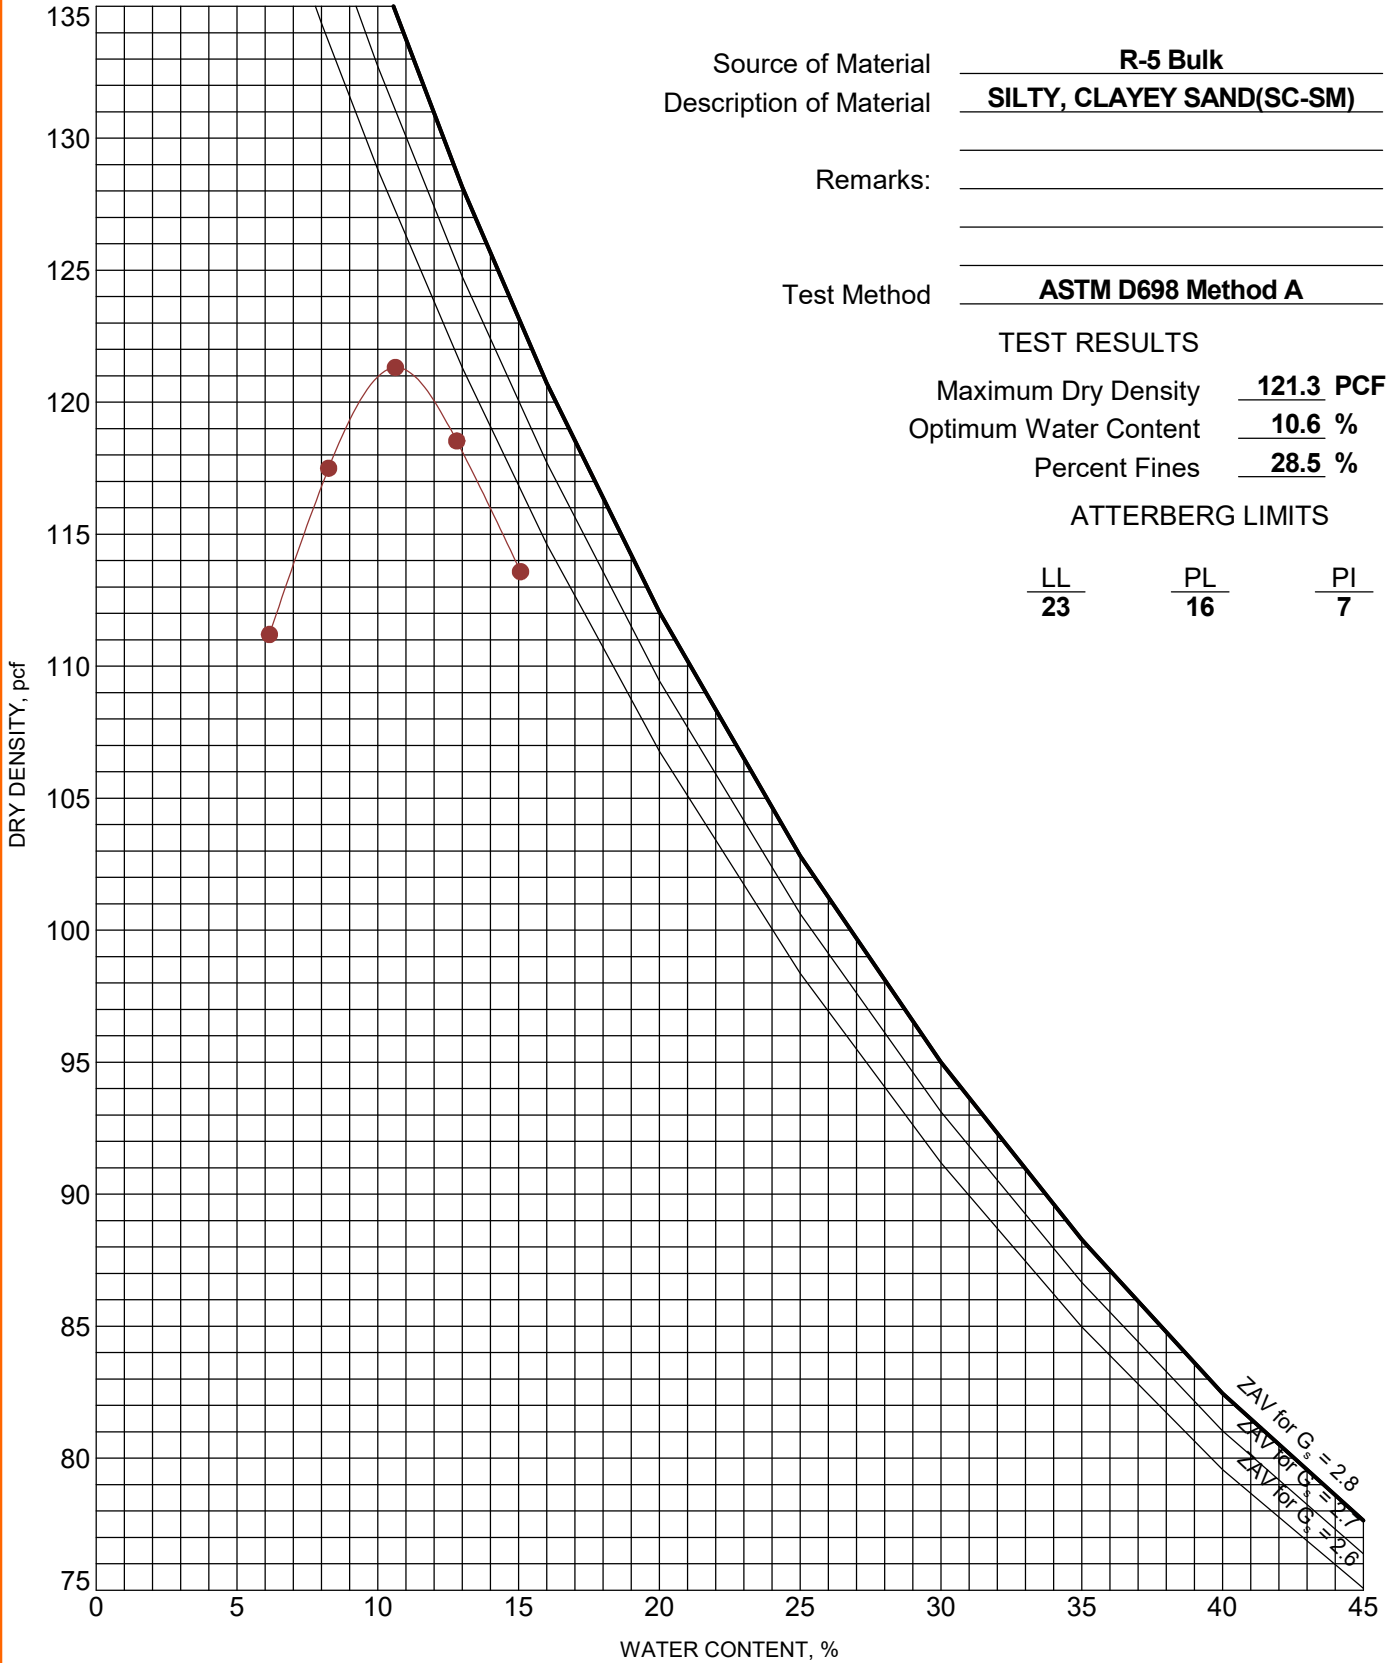
Source of Material R-5 Bulk  
 Description of Material SILTY, CLAYEY SAND(SC-SM)  
 Remarks: \_\_\_\_\_  
 Test Method ASTM D698 Method A

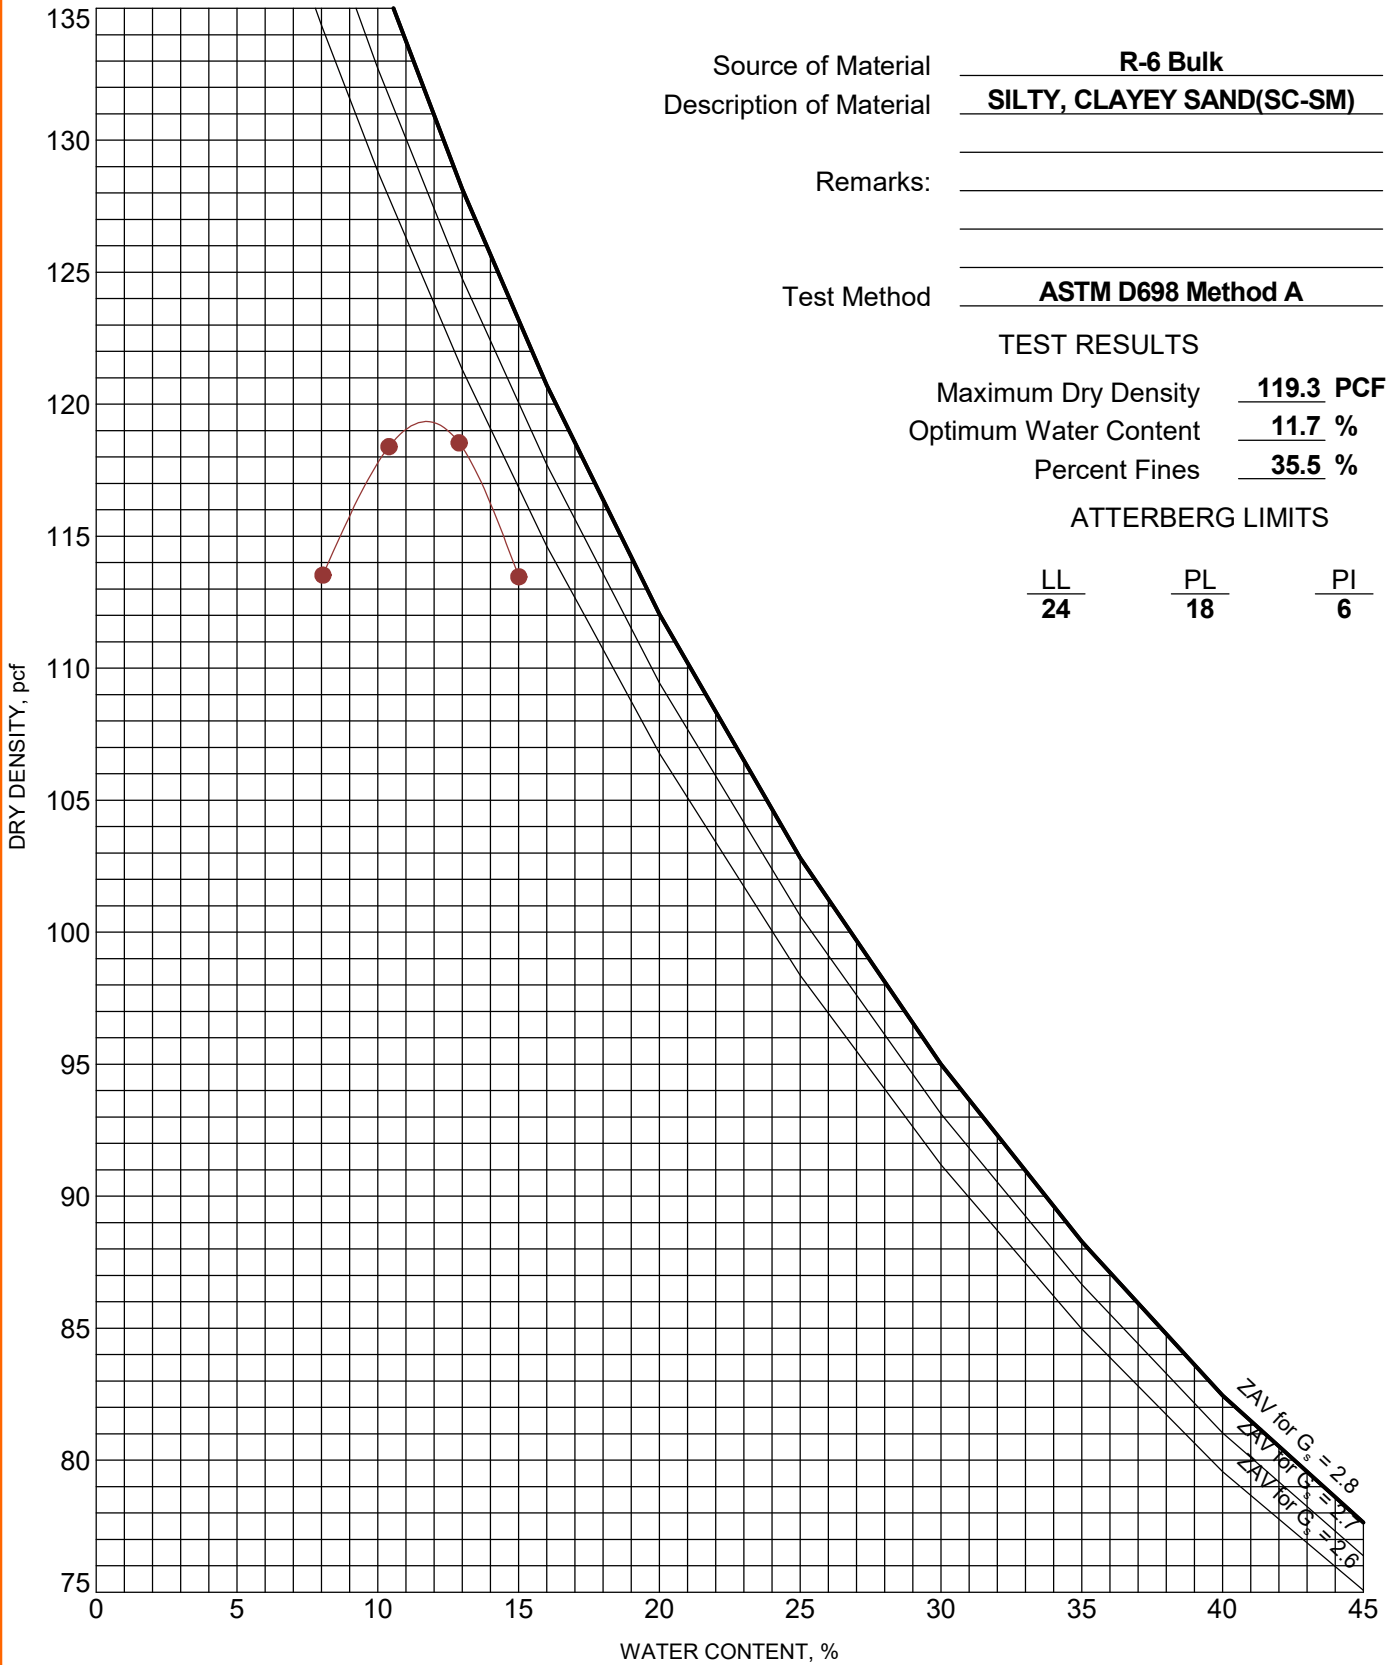
Source of Material R-6 Bulk  
 Description of Material SILTY, CLAYEY SAND(SC-SM)  
 Remarks: \_\_\_\_\_  
 Test Method ASTM D698 Method A
