# **SC 4 over South Fork Edisto River Bridge Replacement**

**Aiken County, South Carolina**

**Preliminary Jurisdictional Determination Package**

**February 12, 2021**

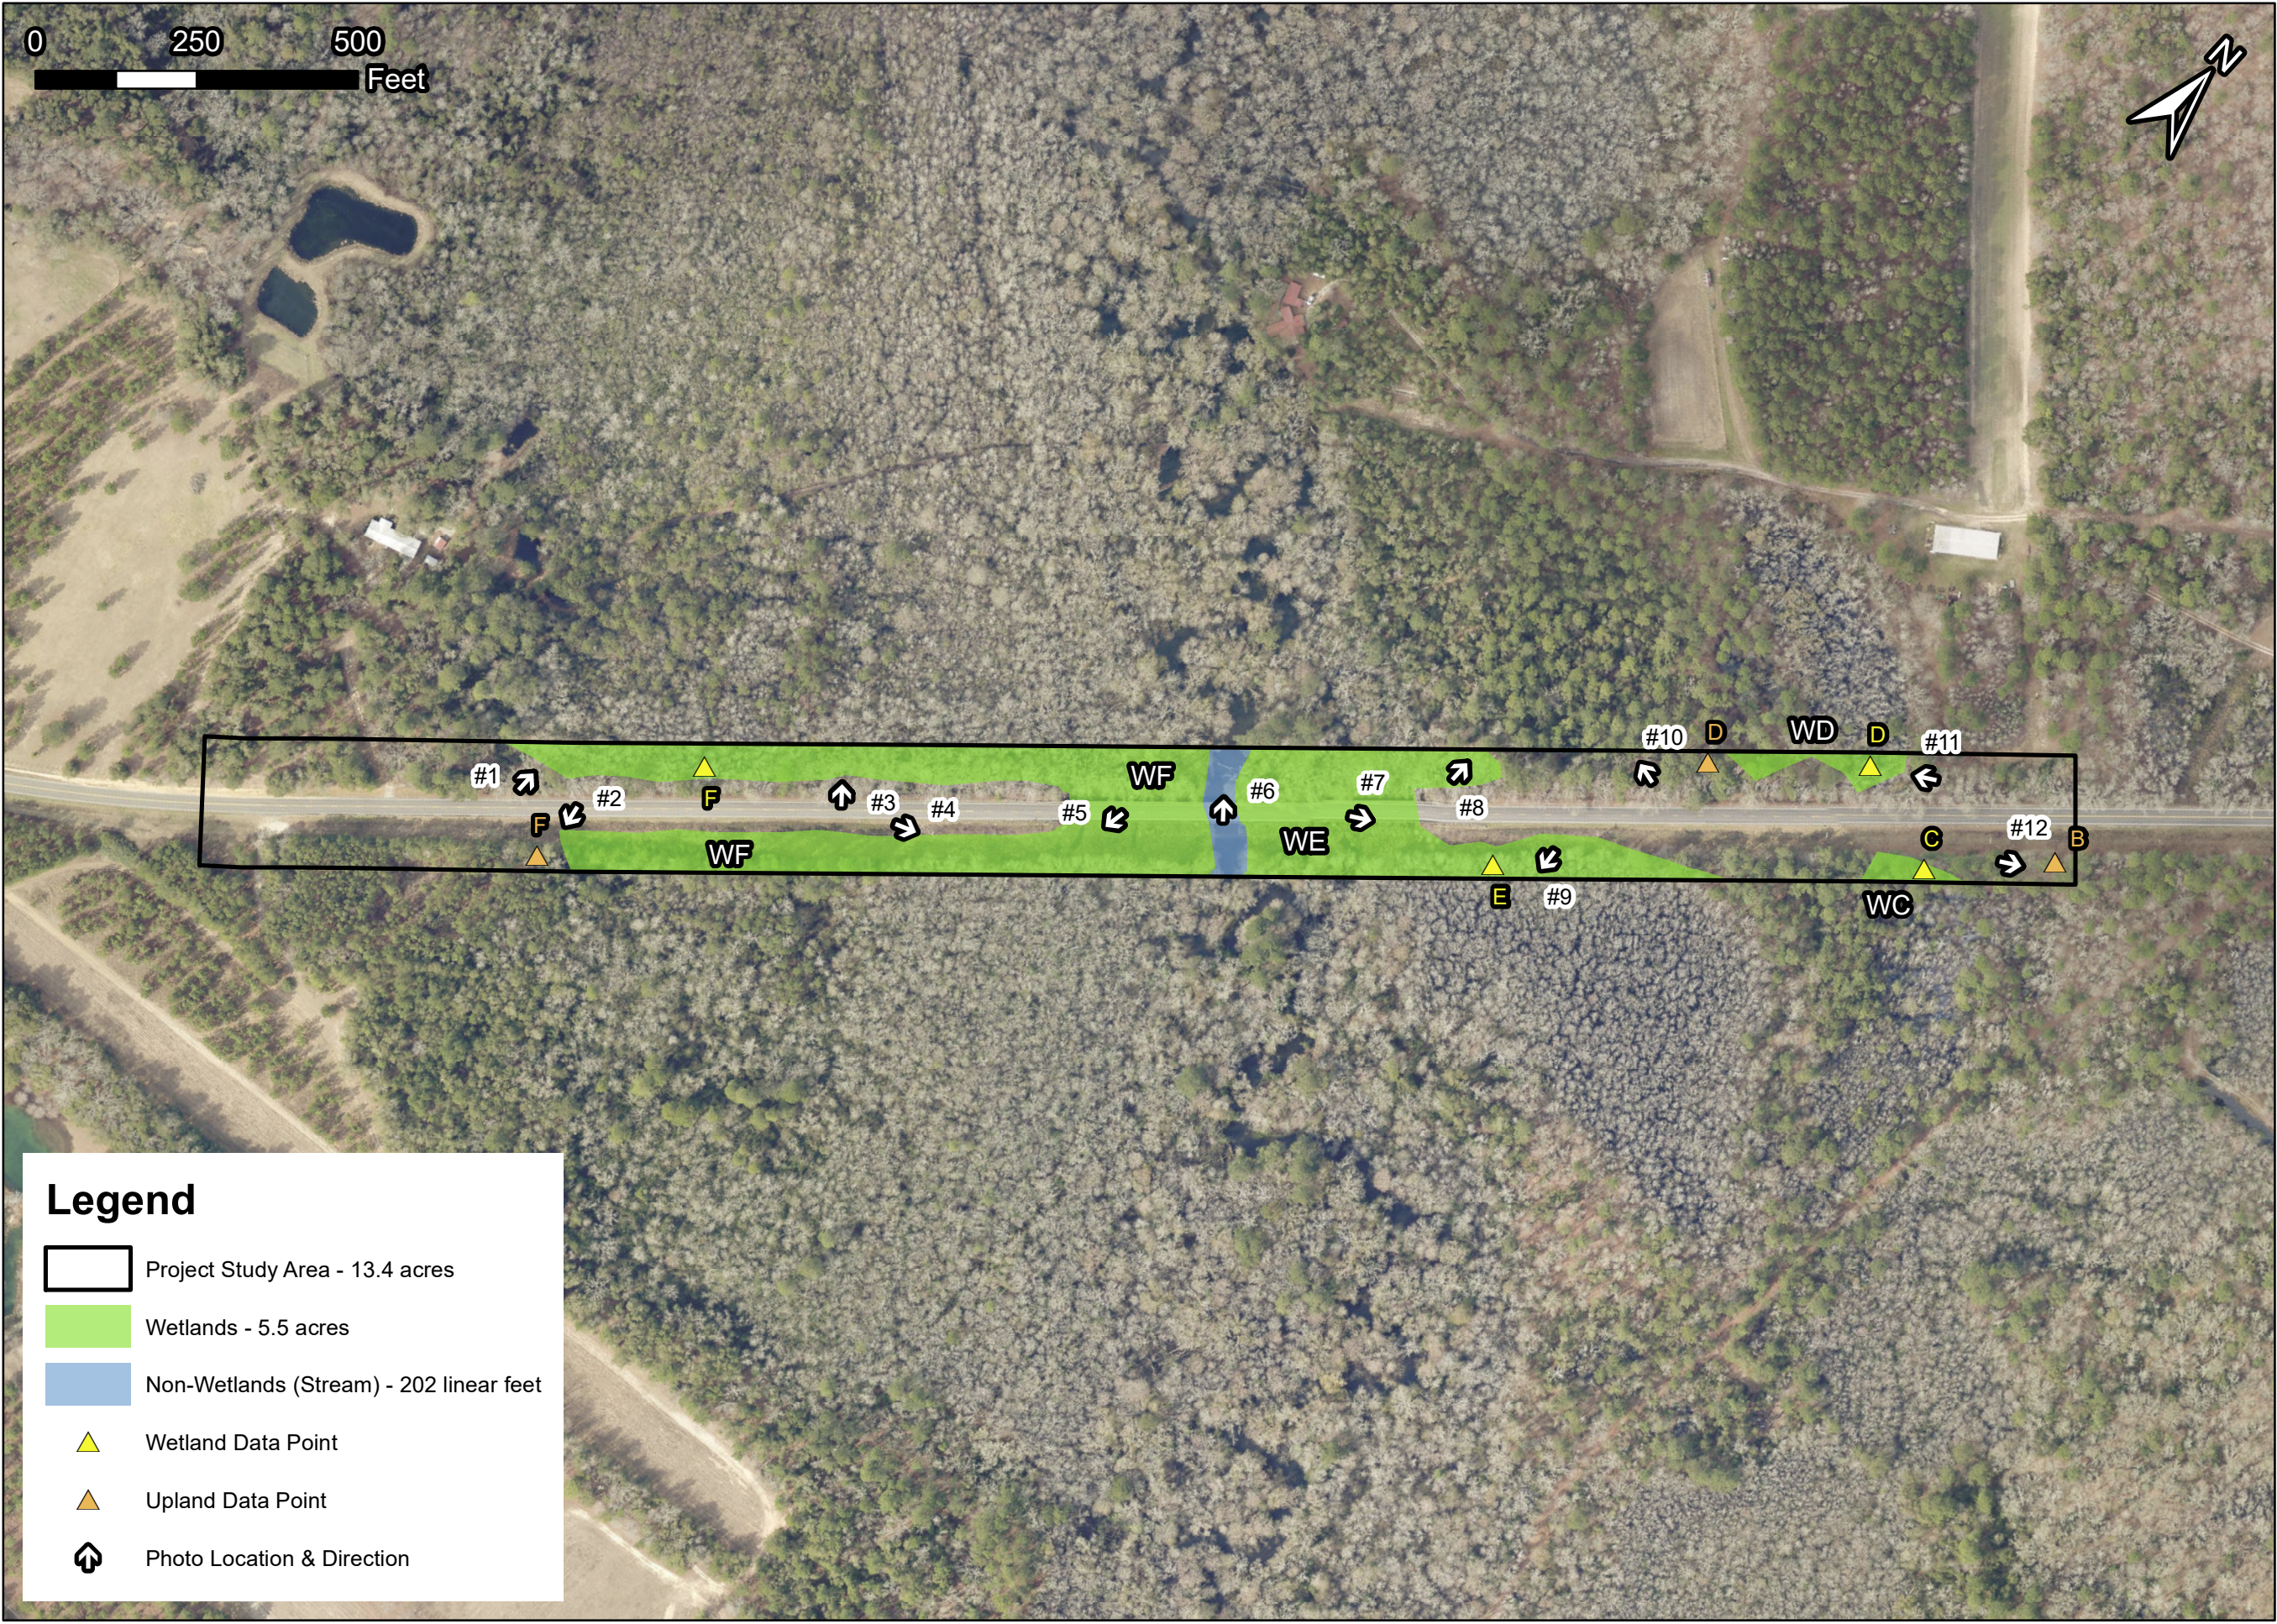
## Delineated Features

- Project Study Area - 13.4 acres
- Wetlands - 5.5 acres
- Non-Wetlands (Stream) - 202 linear feet
- Wetland Data Point
- Upland Data Point
- Photo Location & Direction

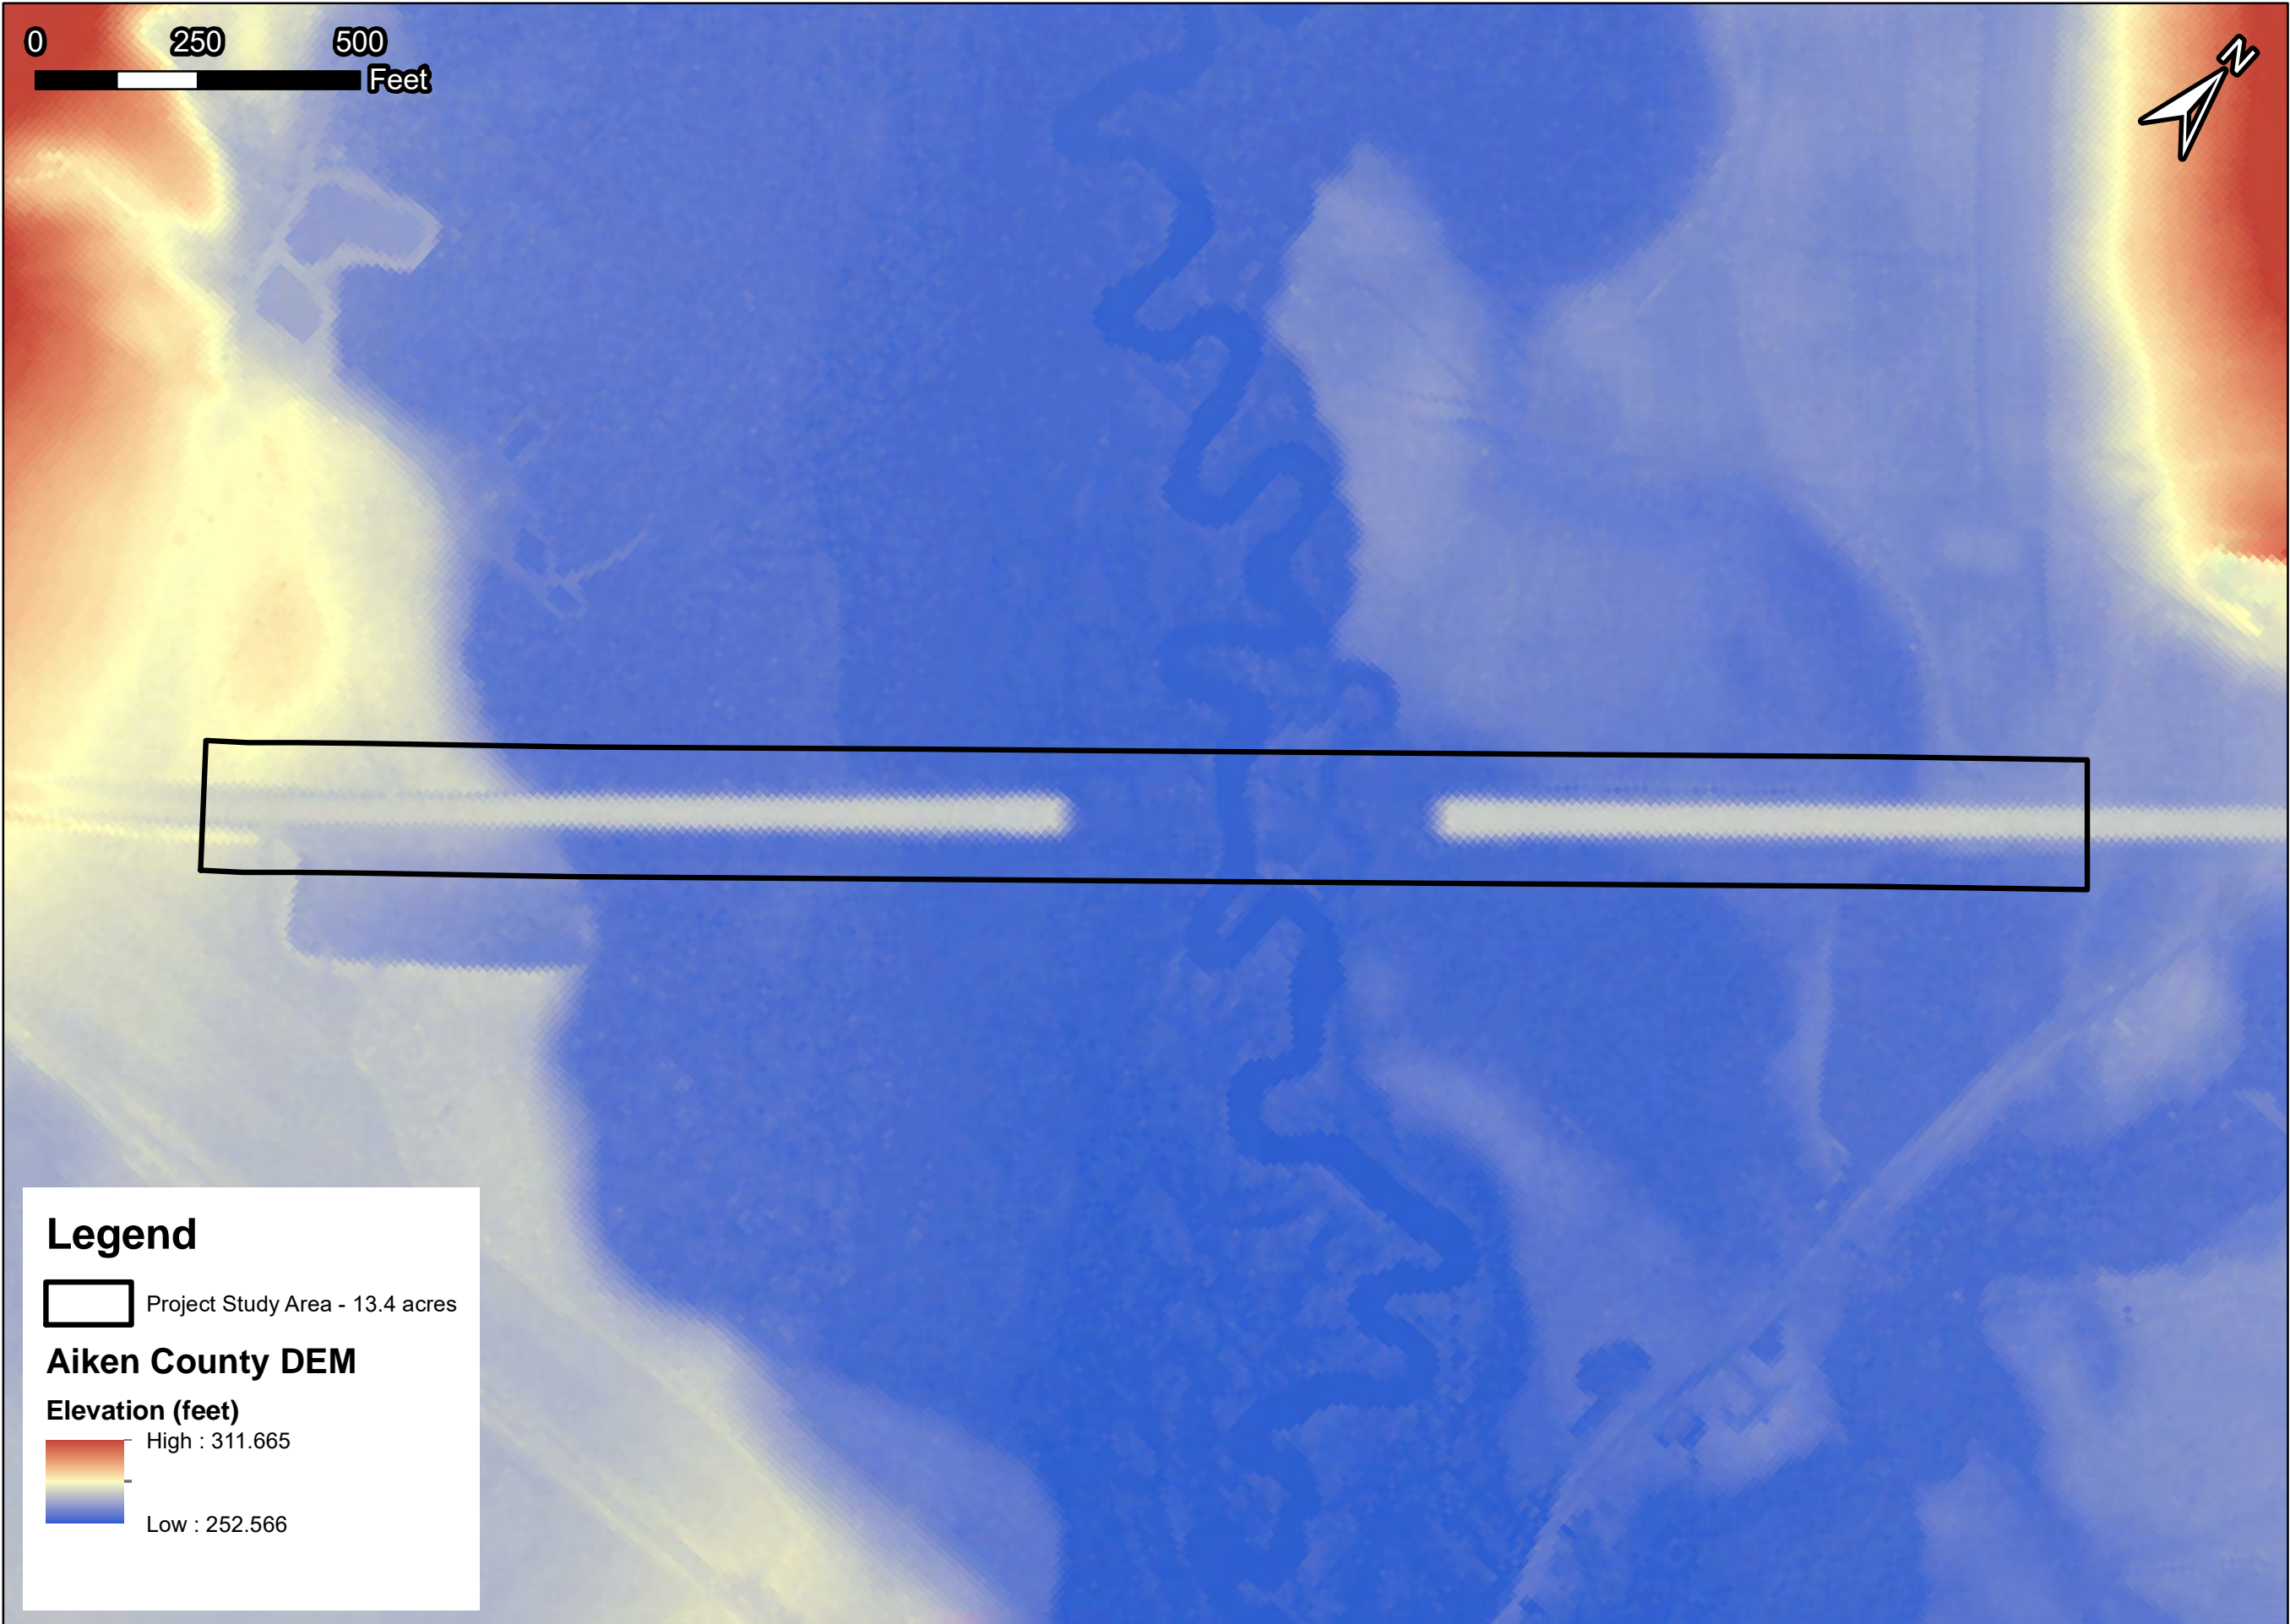
### Aiken County DEM

Elevation (feet)

High : 311.665

Low : 252.566

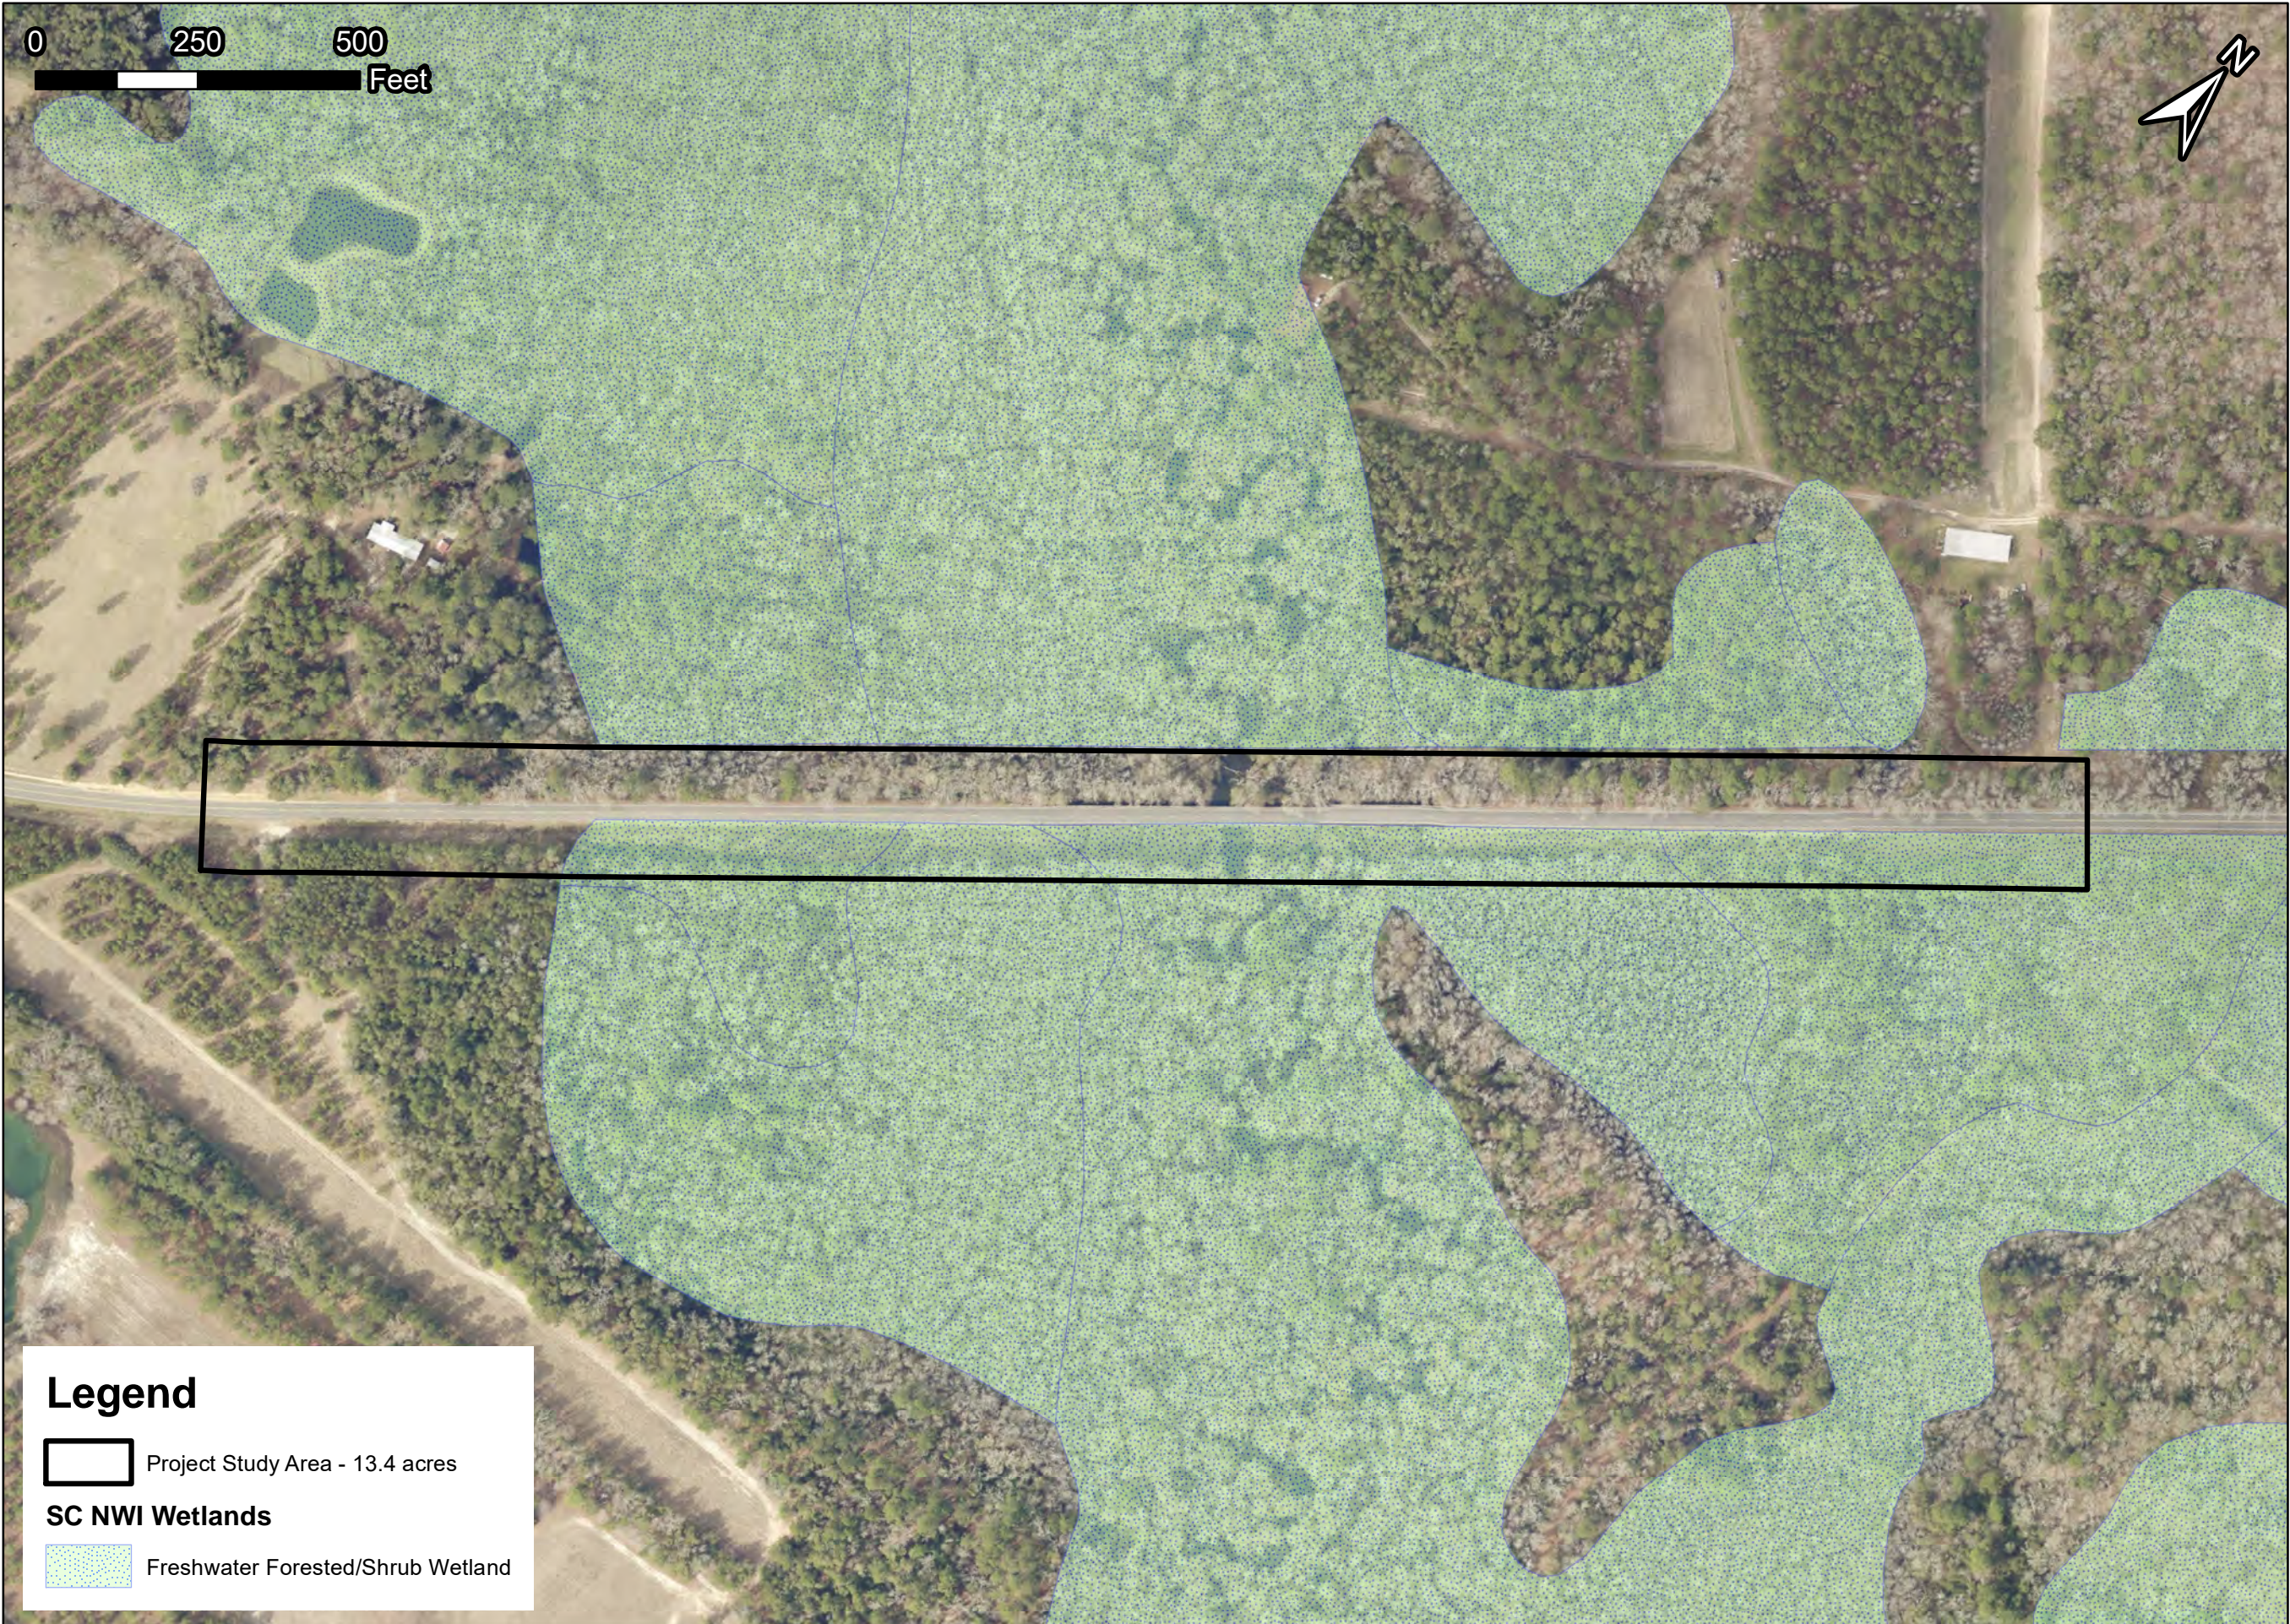
## National Wetlands Inventory Data

Project Study Area - 13.4 acres
- SC NWI Wetlands**
-

Freshwater Forested/Shrub Wetland

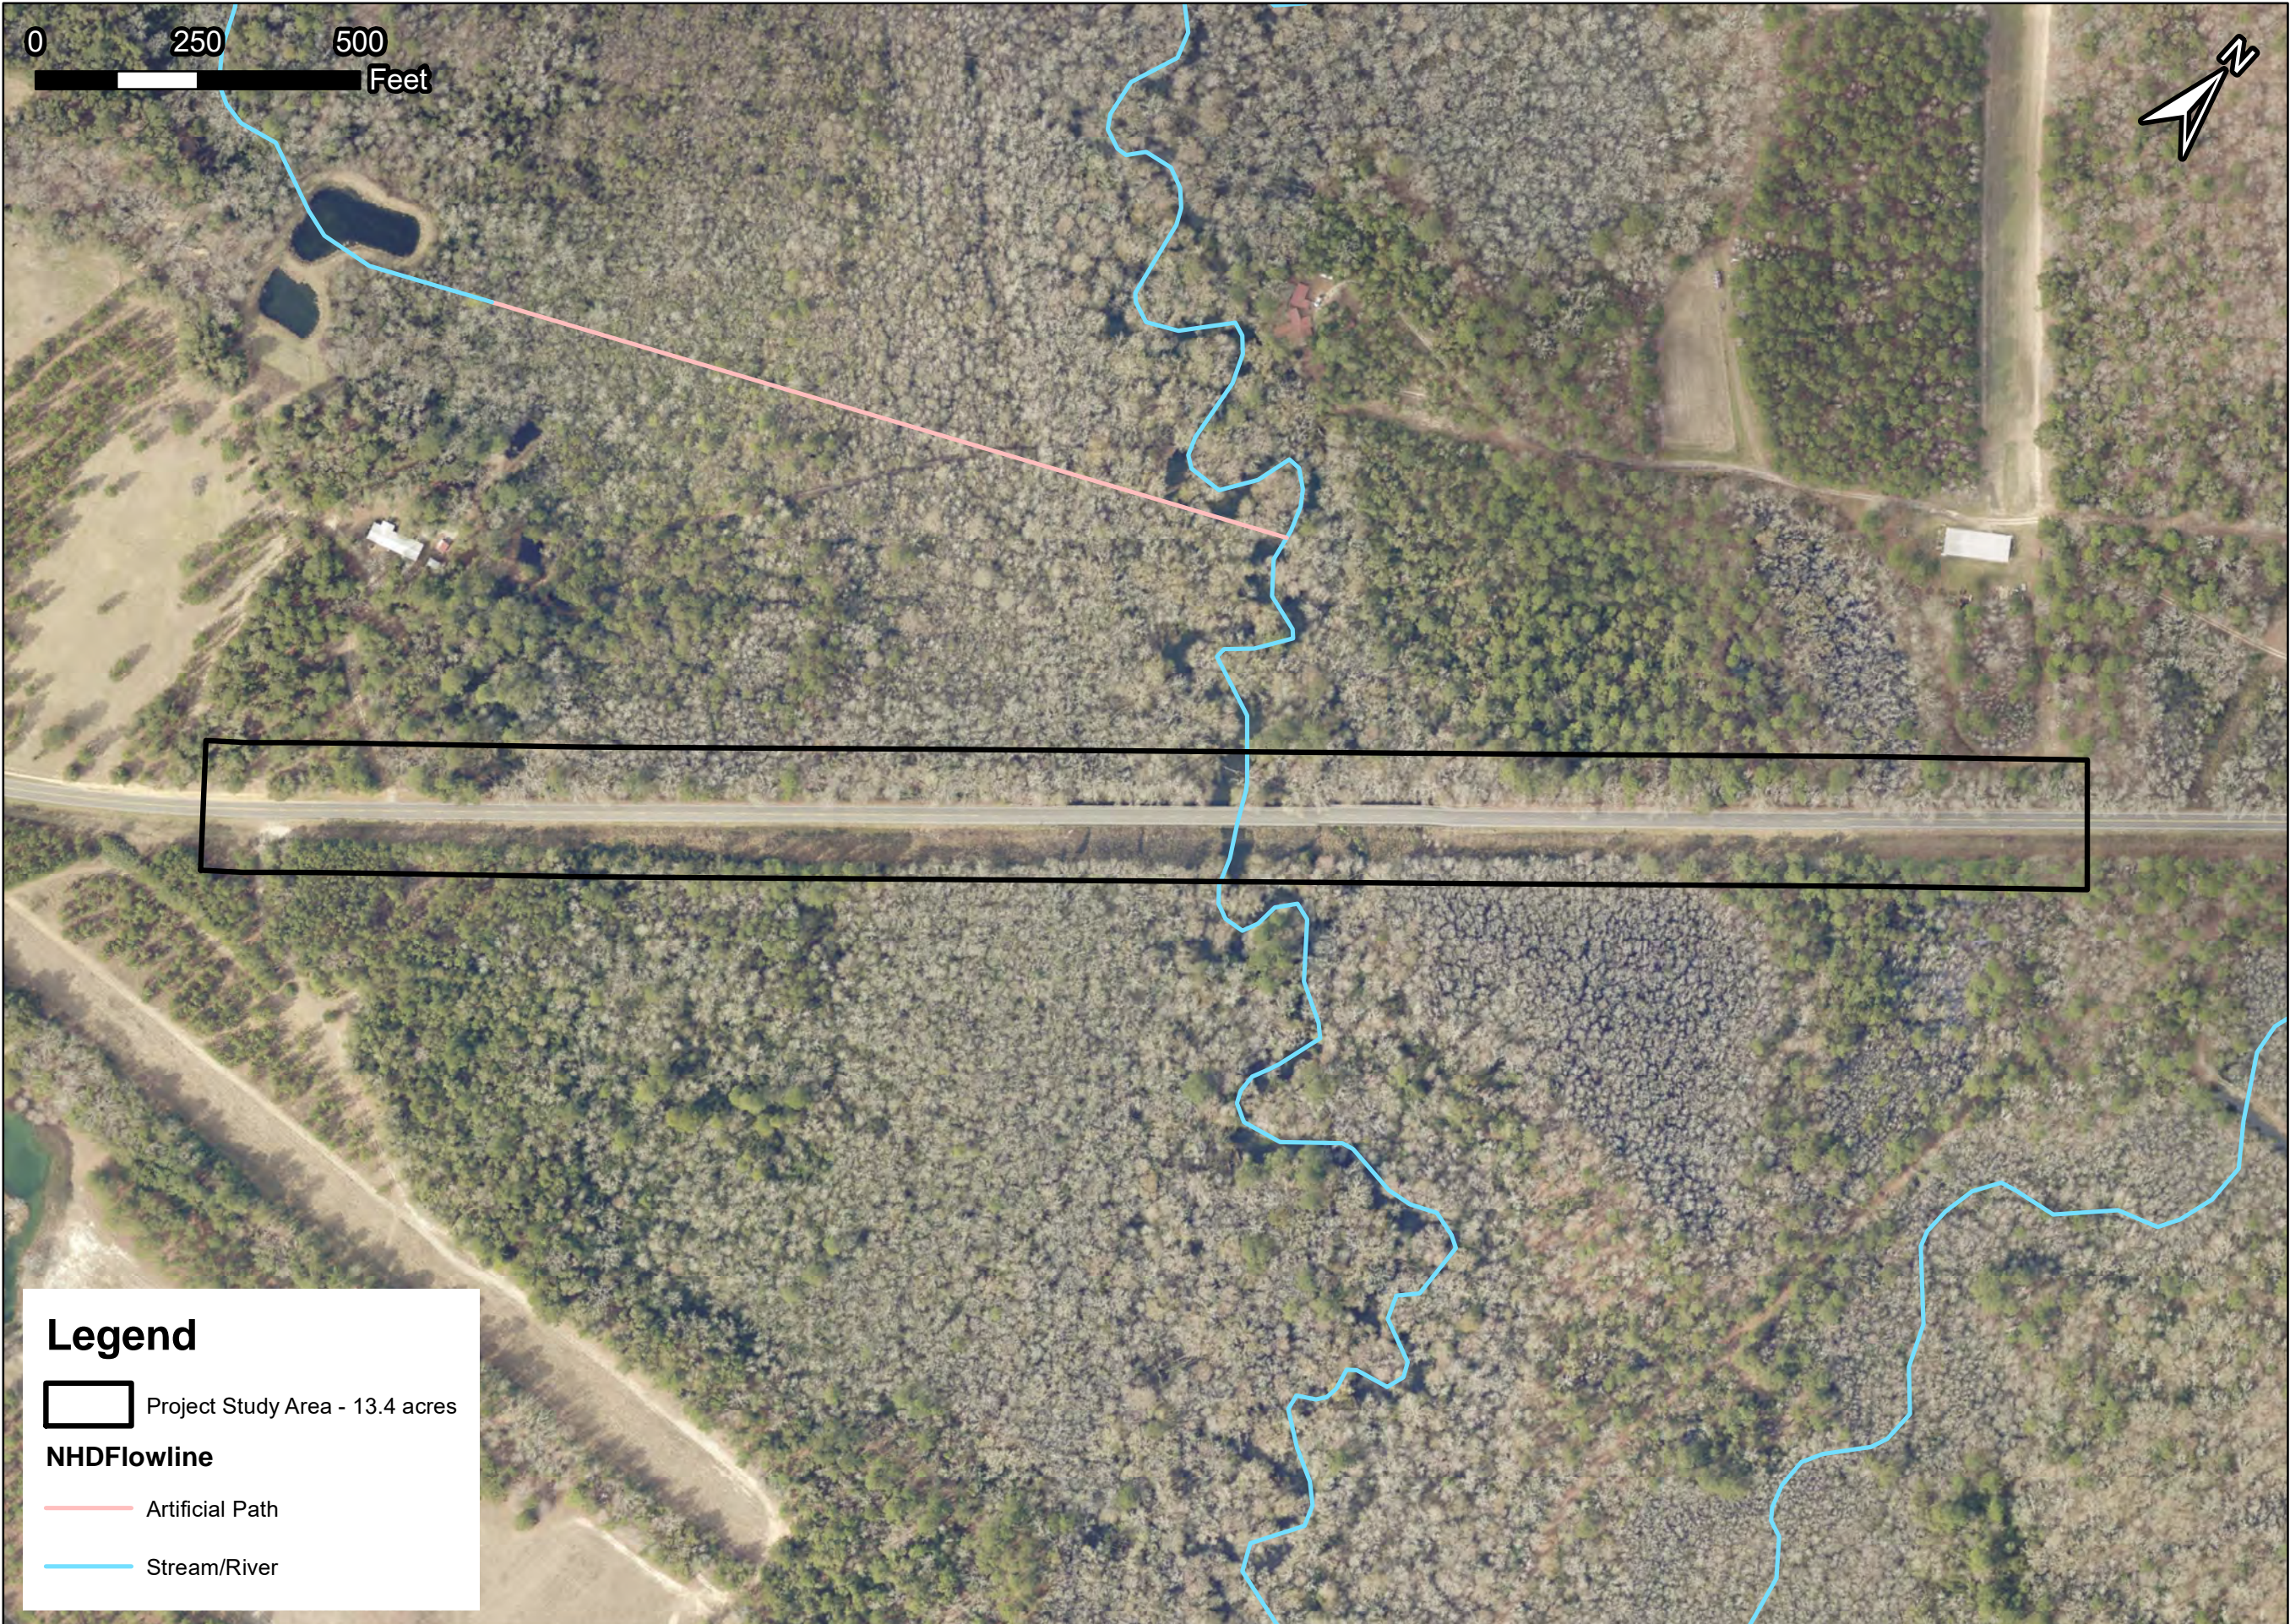
## National Hydro- graphy Data

Project Study Area - 13.4 acres
- NHDFlowline**
-

Artificial Path
-

Stream/River

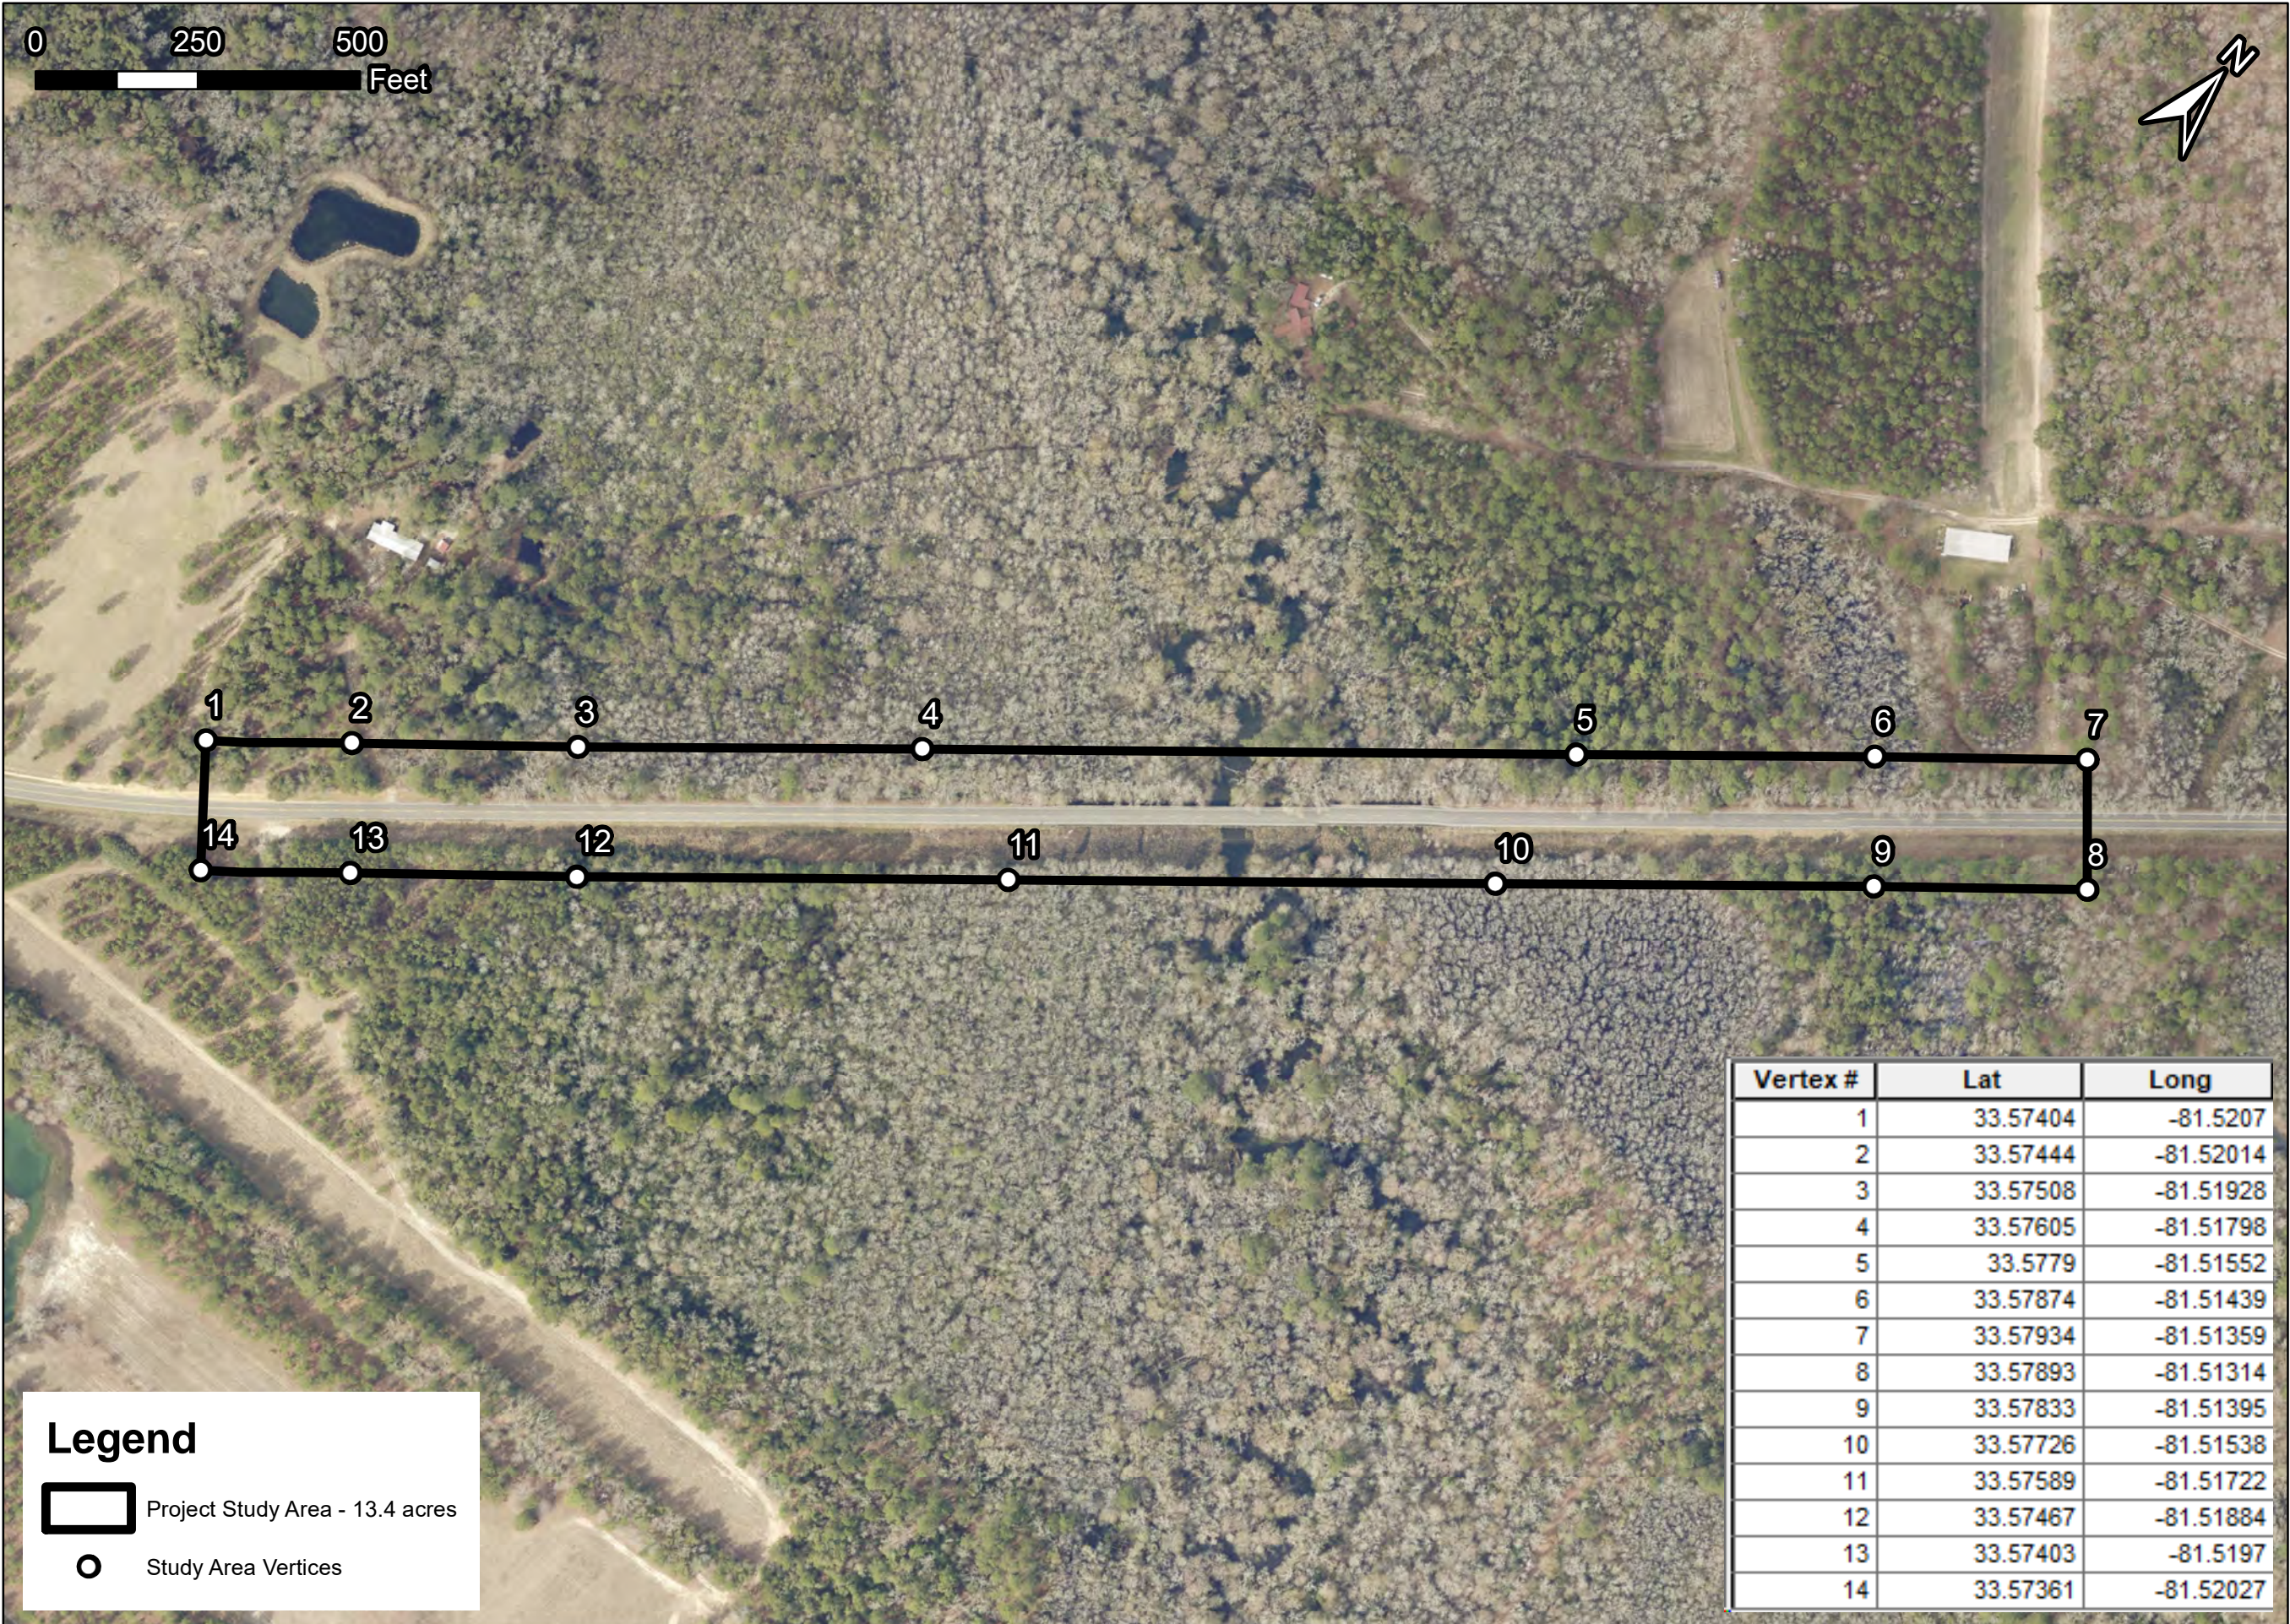
## Study Area Vertices

Vertex #	Lat	Long
1	33.57404	-81.5207
2	33.57444	-81.52014
3	33.57508	-81.51928
4	33.57605	-81.51798
5	33.5779	-81.51552
6	33.57874	-81.51439
7	33.57934	-81.51359
8	33.57893	-81.51314
9	33.57833	-81.51395
10	33.57726	-81.51538
11	33.57589	-81.51722
12	33.57467	-81.51884
13	33.57403	-81.5197
14	33.57361	-81.52027
