US-29 (E. Cherokee St.) Bridge over I-85 (Exit 106)  
Cherokee County, South Carolina

Asbestos and Lead-Based Paint  
Survey Report

ARM Project #16-314-15

March 8, 2017

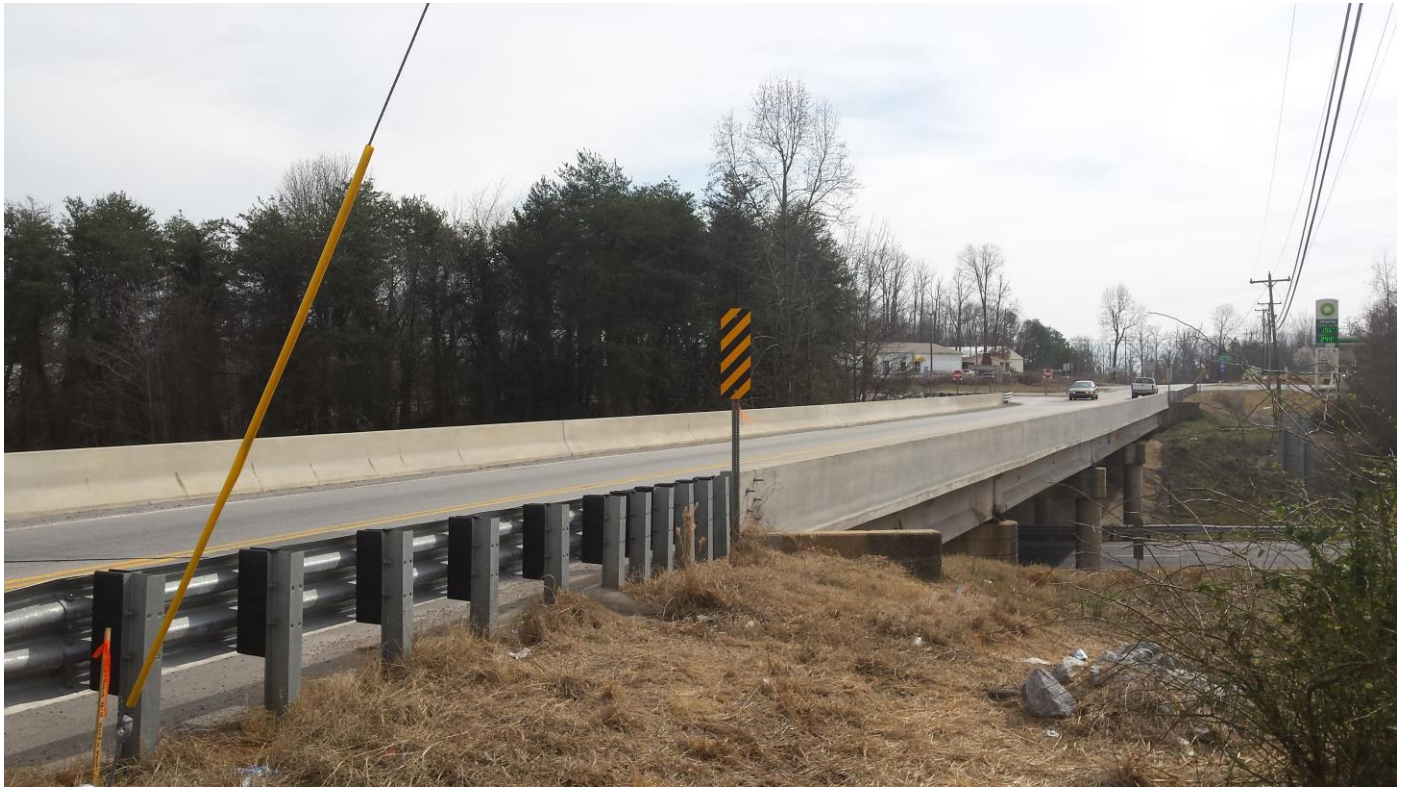
**Photograph 1** – View of the top of the bridge structure at US- 29 (E. Cherokee St.) in Cherokee County, SC.

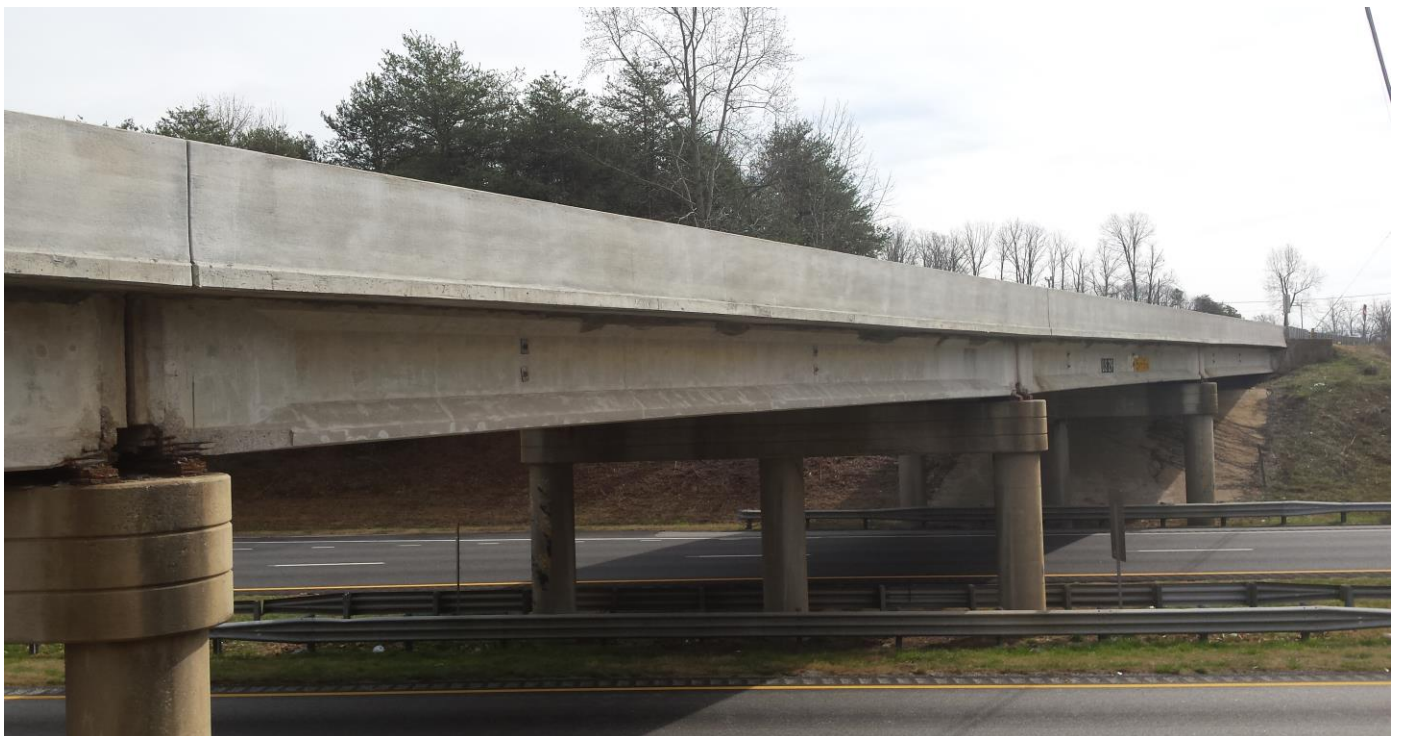
**Photograph 2** –View of the side of the US- 29 (E. Cherokee St.) bridge at Exit 106 in Cherokee County, SC.

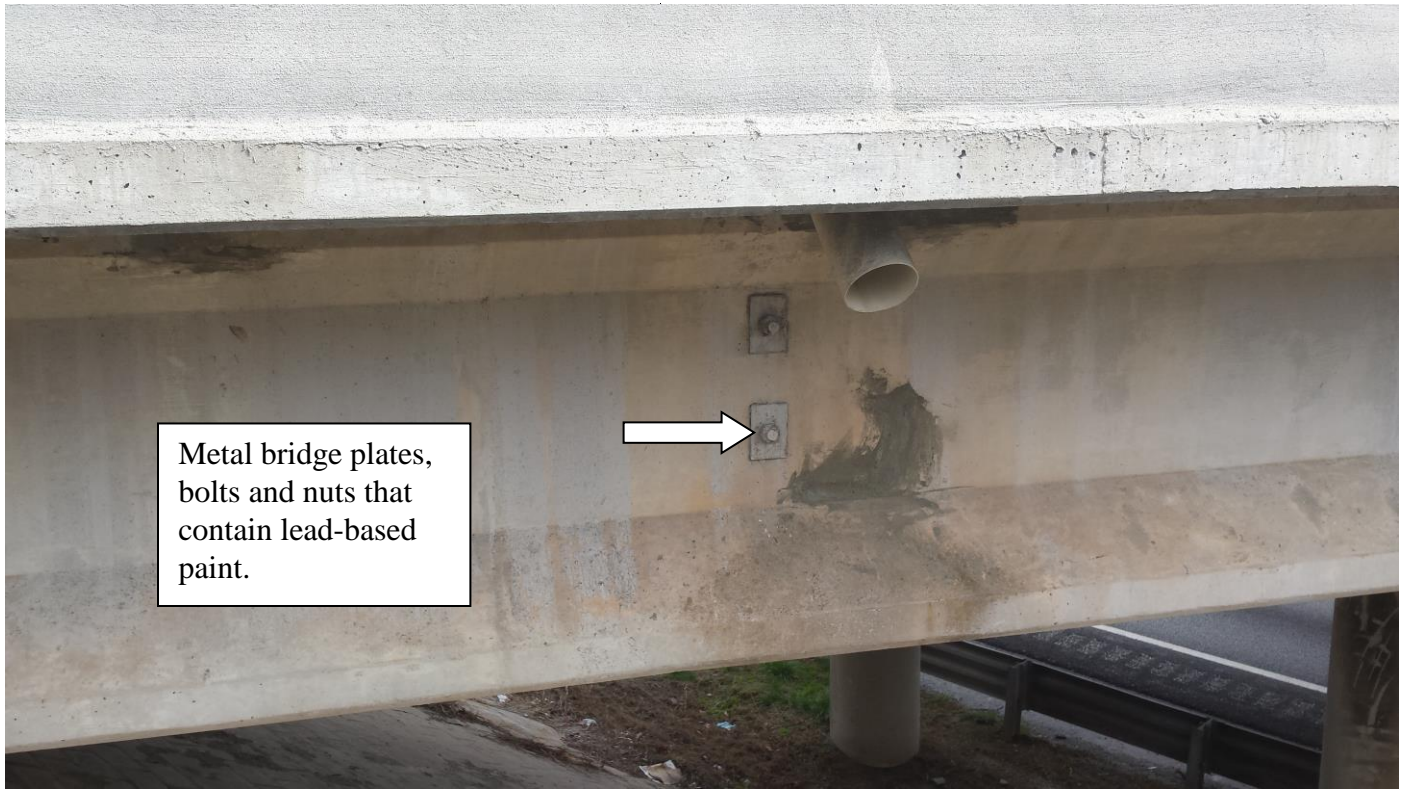
The bridge structure is primarily composed of unpainted concrete. The only materials sampled for lead based paint were the metal bridge shoes, metal bridge bolts and plates, and the concrete bridge piers. **The results of the XRF analyses indicate that the metal bridge shoes, metal bridge bolts and plates, and the concrete bridge piers were found to contain lead-based paint** as summarized in Table 3 on the following page.

**Photograph 3** – View of the metal bridge plates, bolts and nuts that contain lead-based paint.

A lead-based paint survey was performed for the US-29 (E. Cherokee St.) Bridge over I-85 at Exit 106 in Cherokee County, South Carolina. **The results of the XRF analyses indicate that the metal bridge shoes, metal bridge bolts and plates, and the concrete bridge piers were found to be coated with lead-based paint.** If these bridge components are disturbed during renovation or demolition, contractors and workers should be informed as to the presence of lead-based paint and appropriate work practices and personal protective equipment should be used to prevent exposure to lead dust/fumes or spreading lead contamination from the work site. The building components containing lead based paint should be disposed of in accordance with federal and state regulations. All waste debris coated with lead-based paint equal to or greater than 0.7mg/cm<sup>2</sup> must be disposed of in an approved Class II (C&D) or Class III (MSWLF) landfill or approved metal recycler. The OSHA lead standard for construction work (29CFR 1926.62) would apply to all demolition or renovation activities that disturb any of the materials containing lead.

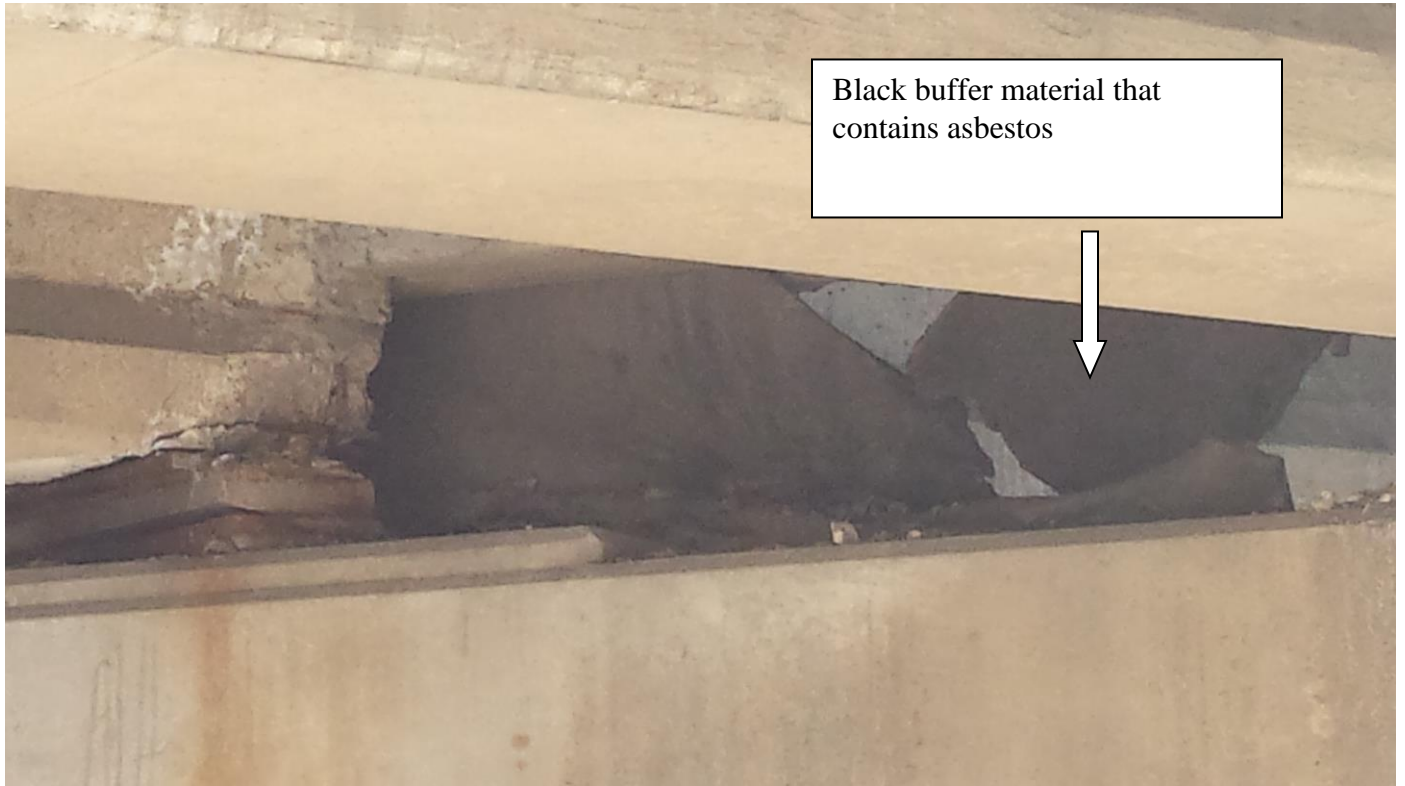
On February 21, 2017 ARM Environmental completed an asbestos inspection for a structure, the US-29 (E. Cherokee St.) Bridge over I-85 at Exit 106 in Cherokee County, South Carolina. **The results of the asbestos survey indicate that the black buffer material between concrete deck sections contains asbestos.** In its present condition, and without significant disturbance, there is a low potential for significant concentrations of asbestos fibers to be released from this material. However, it is recommended that this material be removed prior to any renovation, demolition, or other process that might disturb the material, or render it friable. Based on the potential for the ACM to be rendered friable during the removal process, it is recommended that the removal of this material be conducted by a licensed abatement contractor. No other asbestos containing materials were identified on the bridge structure.

Black buffer material that contains asbestos

**Photograph 6** – View of the black buffer material between the concrete deck sections that contains asbestos.

Prior to the commencement of any asbestos abatement activities, material quantities should be verified by the abatement contractor. It is recommended that personnel who may be involved with renovation/demolition activities be advised of the presence of asbestos, and that the referenced materials be handled in accordance with applicable State and Federal regulations, including all OSHA regulations that apply. DHEC
