# Asbestos & Lead Paint Survey Report

Interstate 20 Bridges Over Wateree River  
Kershaw County, South Carolina  
Bridge Nos. 05779 & 05784

March 11, 2022  
Terracon Project No. 7321P043A  
SCDOT Project ID P029450

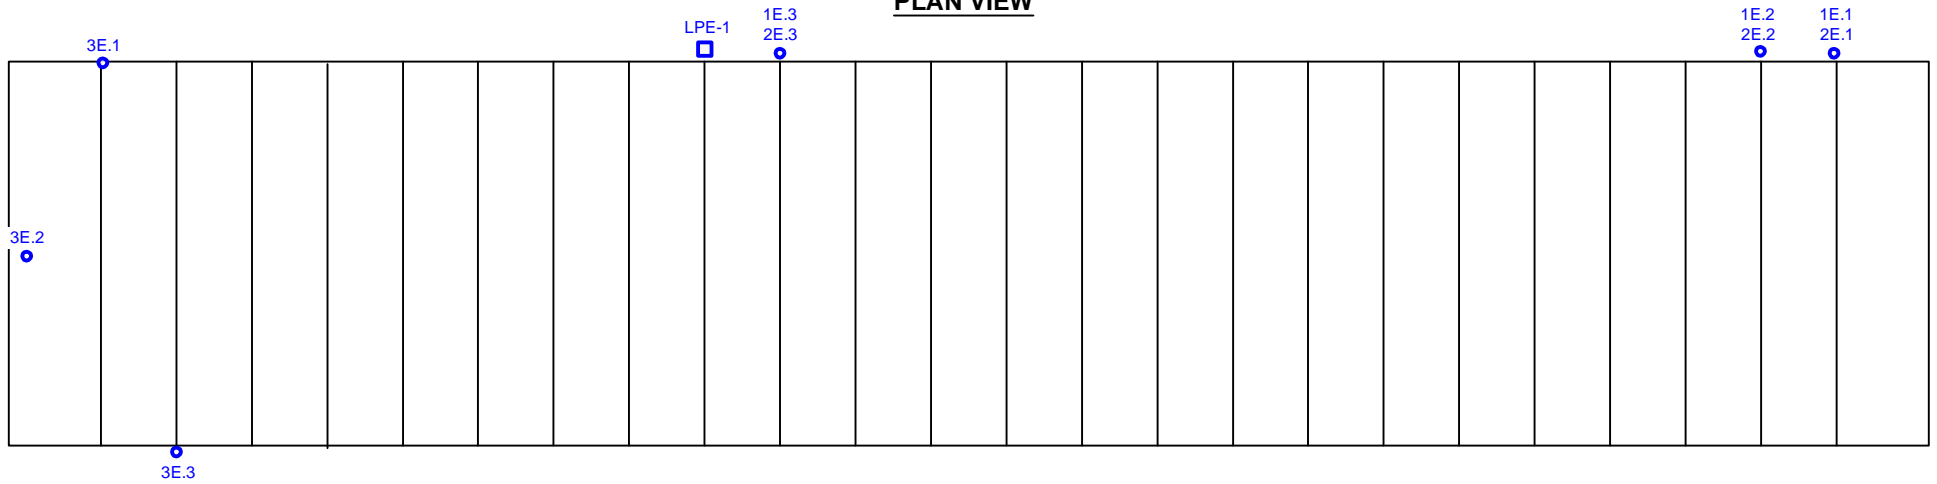
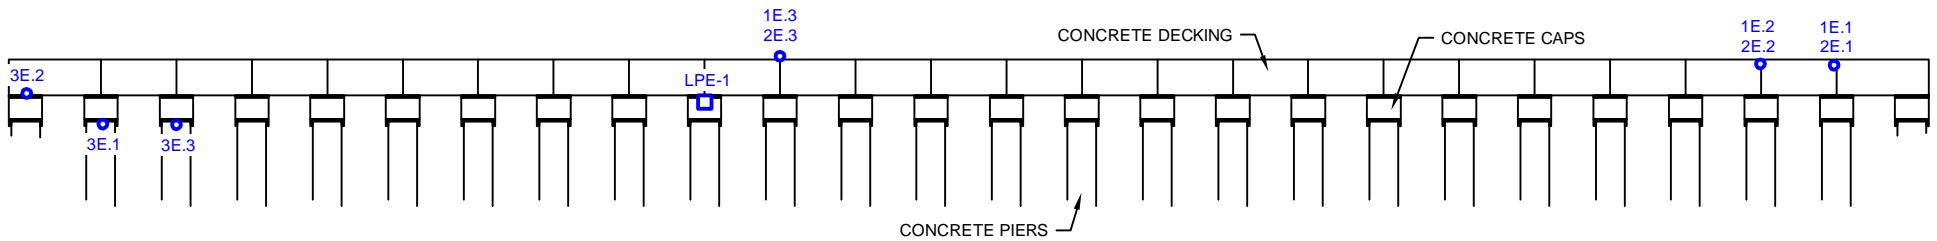
**Exhibit 2 – Sample Location Plan - Eastbound**

I-20 WATEREE RIVER BRIDGE REPAIRS  
I-20  
KERSHAW COUNTY, SOUTH CAROLINA  
BRIDGE #5779

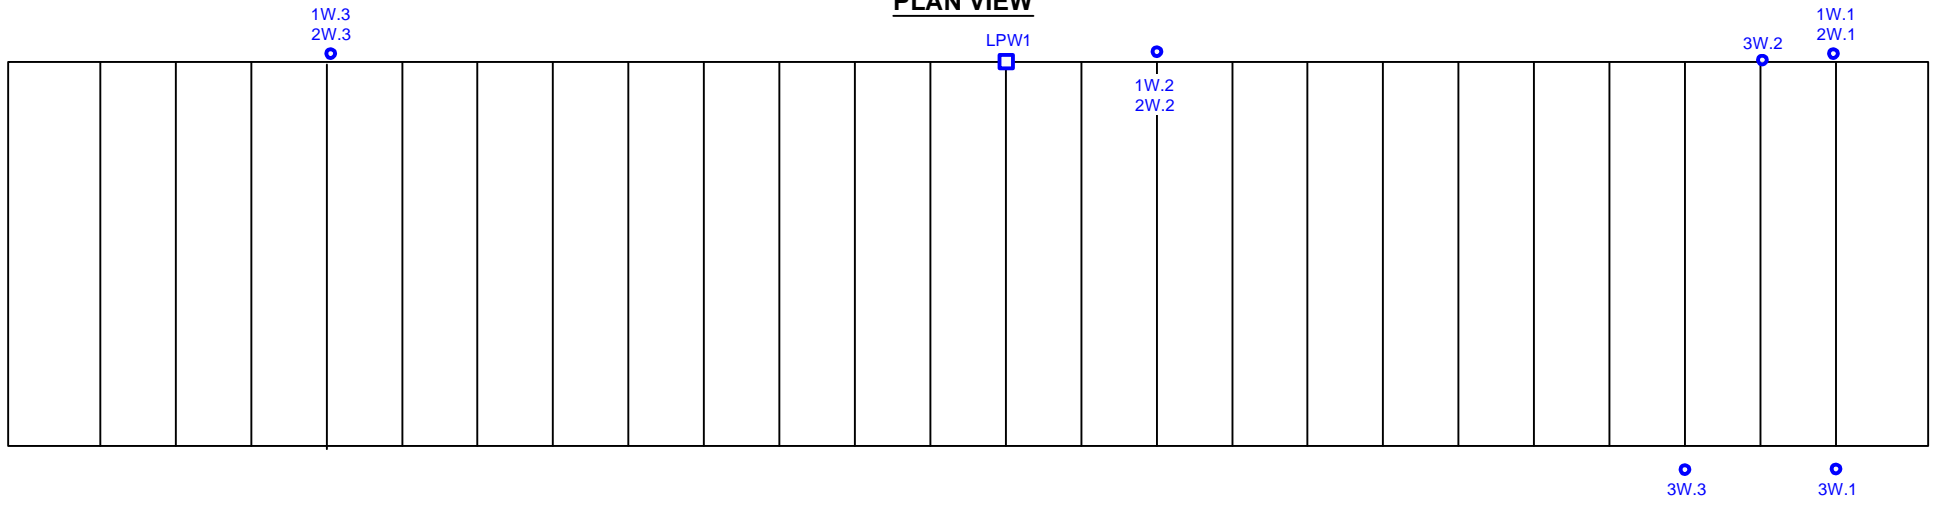
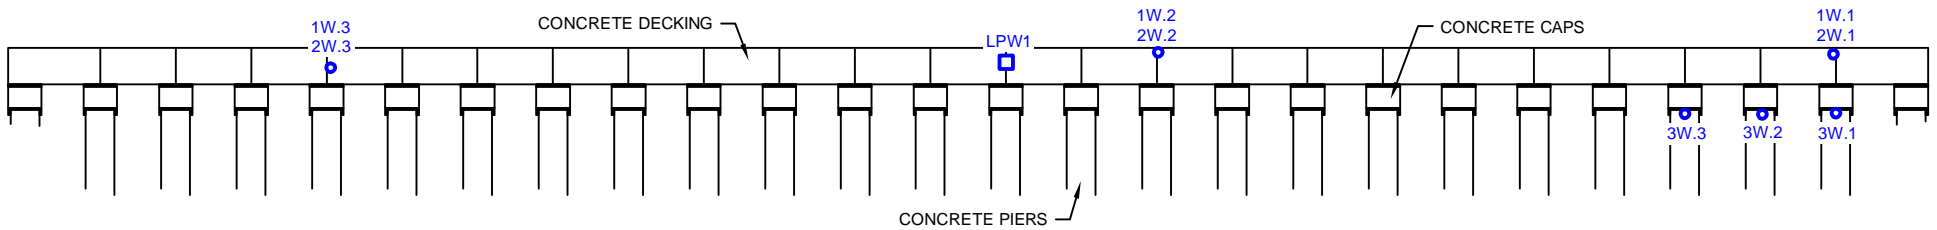
**Exhibit 3 – Sample Location Plan - Westbound**

I-20 WATEREE RIVER BRIDGE REPAIRS  
I-20  
KERSHAW COUNTY, SOUTH CAROLINA  
BRIDGE #5784

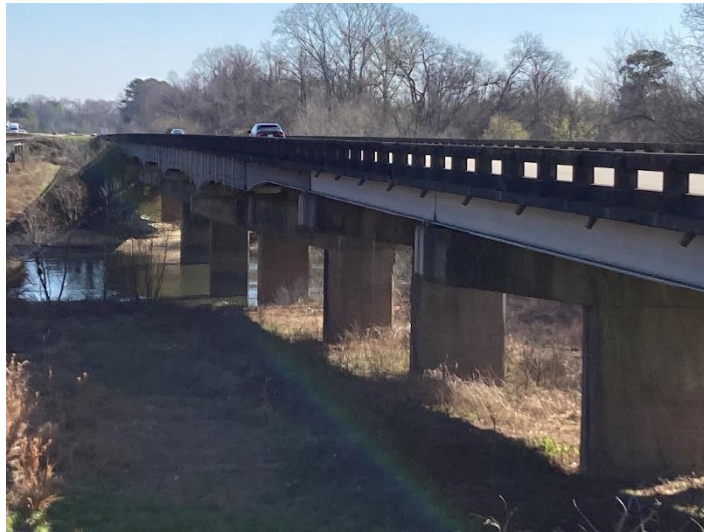
**Photo 3:** Side view of bridge facing eastbound (05779)

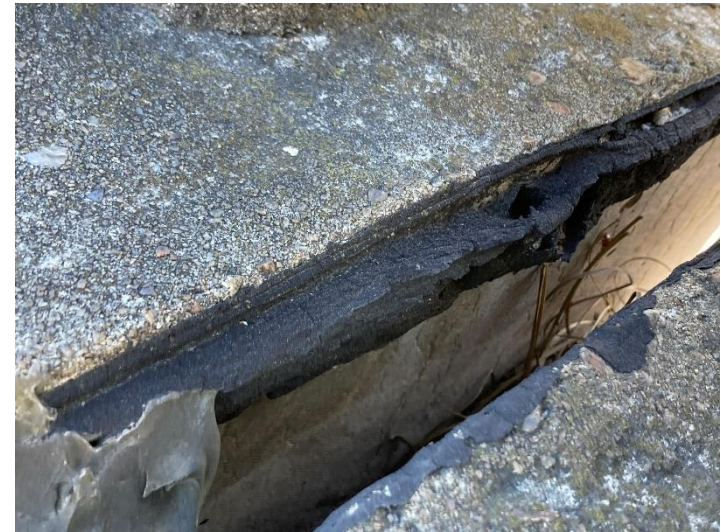
HA	Approx. Quantity	Sample Number	Description	Sample Location	Lab Result	Category	Condition
1	900 LF	1E.1	Tar	Expansion Joints	NAD	NF, MISC	Good
		1E.2	Tar	Expansion Joints	NAD	NF, MISC	Good
		1E.3	Tar	Expansion Joints	TEM - NAD	NF, MISC	Good
2	150 LF	2E.1	Putty	Expansion Joints	NAD	NF, MISC	Good
		2E.2	Putty	Expansion Joints	NAD	NF, MISC	Good
		2E.3	Putty	Expansion Joints	TEM - NAD	NF, MISC	Good
3	520 SF	3E.1	Vibration Dampener	Between decking beams/pier caps	NAD	NF, MISC	Good
		3E.2	Vibration Dampener	Between decking beams/pier caps	NAD	NF, MISC	Good
		3E.3	Vibration Dampener	Between decking beams/pier caps	TEM - NAD	NF, MISC	Good

**Photo 4:** HA #1E and HA #1W Tar expansion joint (05779 + 05784)

Based on the results of laboratory analyses, **no asbestos was detected** in the expansion joint and friction barrier samples collected from the bridges. These results were confirmed by TEM analysis. Asbestos laboratory analytical reports are included in Appendix B.

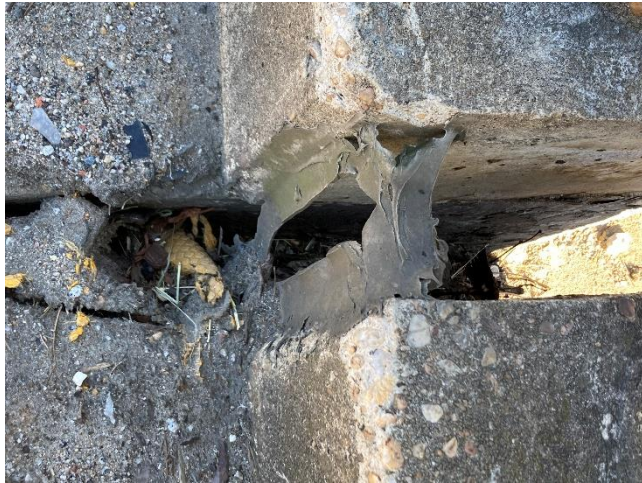
**Photo 5:** HA #2E and HA #2W Putty expansion joint (05779 + 05784)

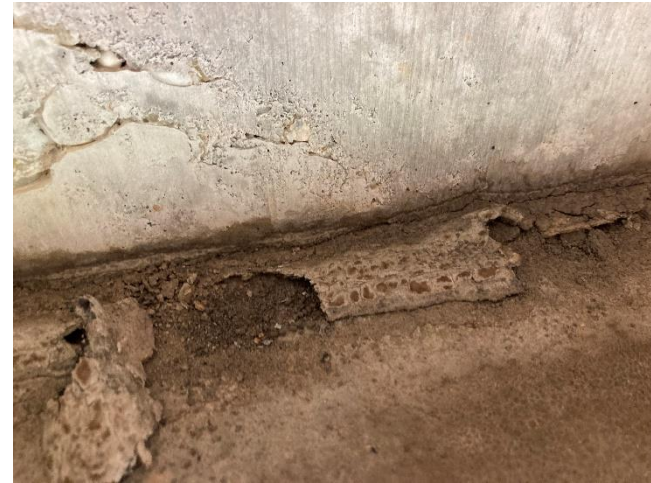
**Photo 6:** HA #3E and HA #3W Shingle vibration dampener (05779+ 05784)

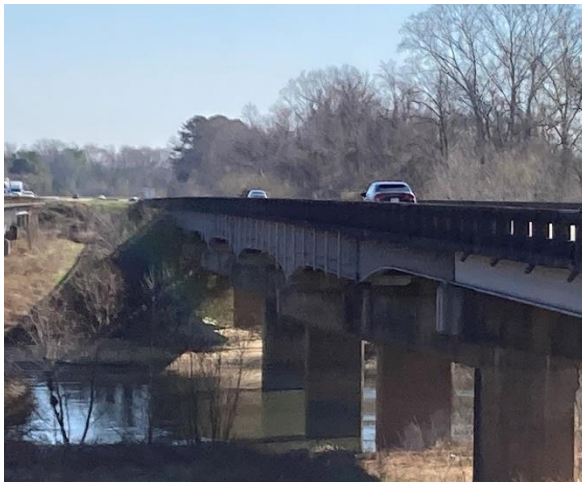
Laboratory analysis detected lead concentrations in both samples at 0.014% by weight. This concentration is below the SCDHEC threshold of 0.06% by weight and the EPA threshold of 0.5% by weight for definition as lead-based paint.

**Photo 7:** LPE-1 and LPW-1 Grey paint on side of bridges (05779+ 05784)

SCDHEC regulations require that lead painted demolition debris be disposed in a permitted Class II landfill. Landfills should be contacted to determine their specific disposal requirements. Metal components painted with lead-based paint may be recycled however the recycler should be contacted to determine their specific requirements. Additionally, the provisions in the OSHA Standard for Lead (29 CFR 1926.62) should be followed by contractor personnel conducting work activity during the demolition. A summary of the lead paint laboratory results is presented in Table 2 in Appendix A. The analytical report is included in Appendix B.

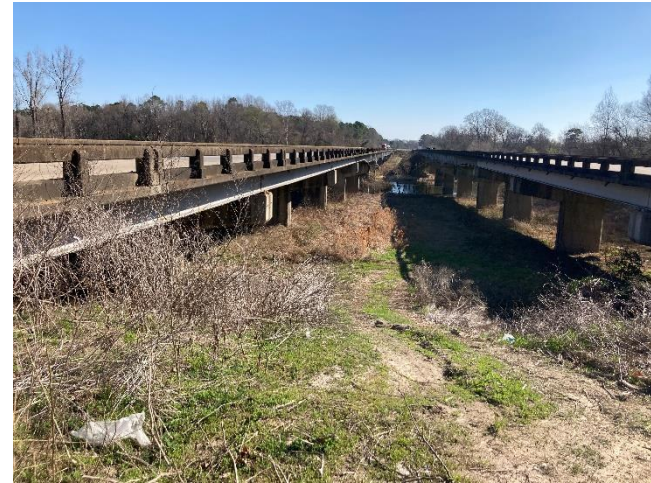
**Photo 10:** View of side of bridge (05784)
