S-23-41 (Gap Creek Road) Bridge Replacement over Middle Saluda River

Geotechnical Subsurface Data Report

October 30, 2024 | SCDOT Project ID: P041159
Terracon Project No.: 8623P180 Revision 1

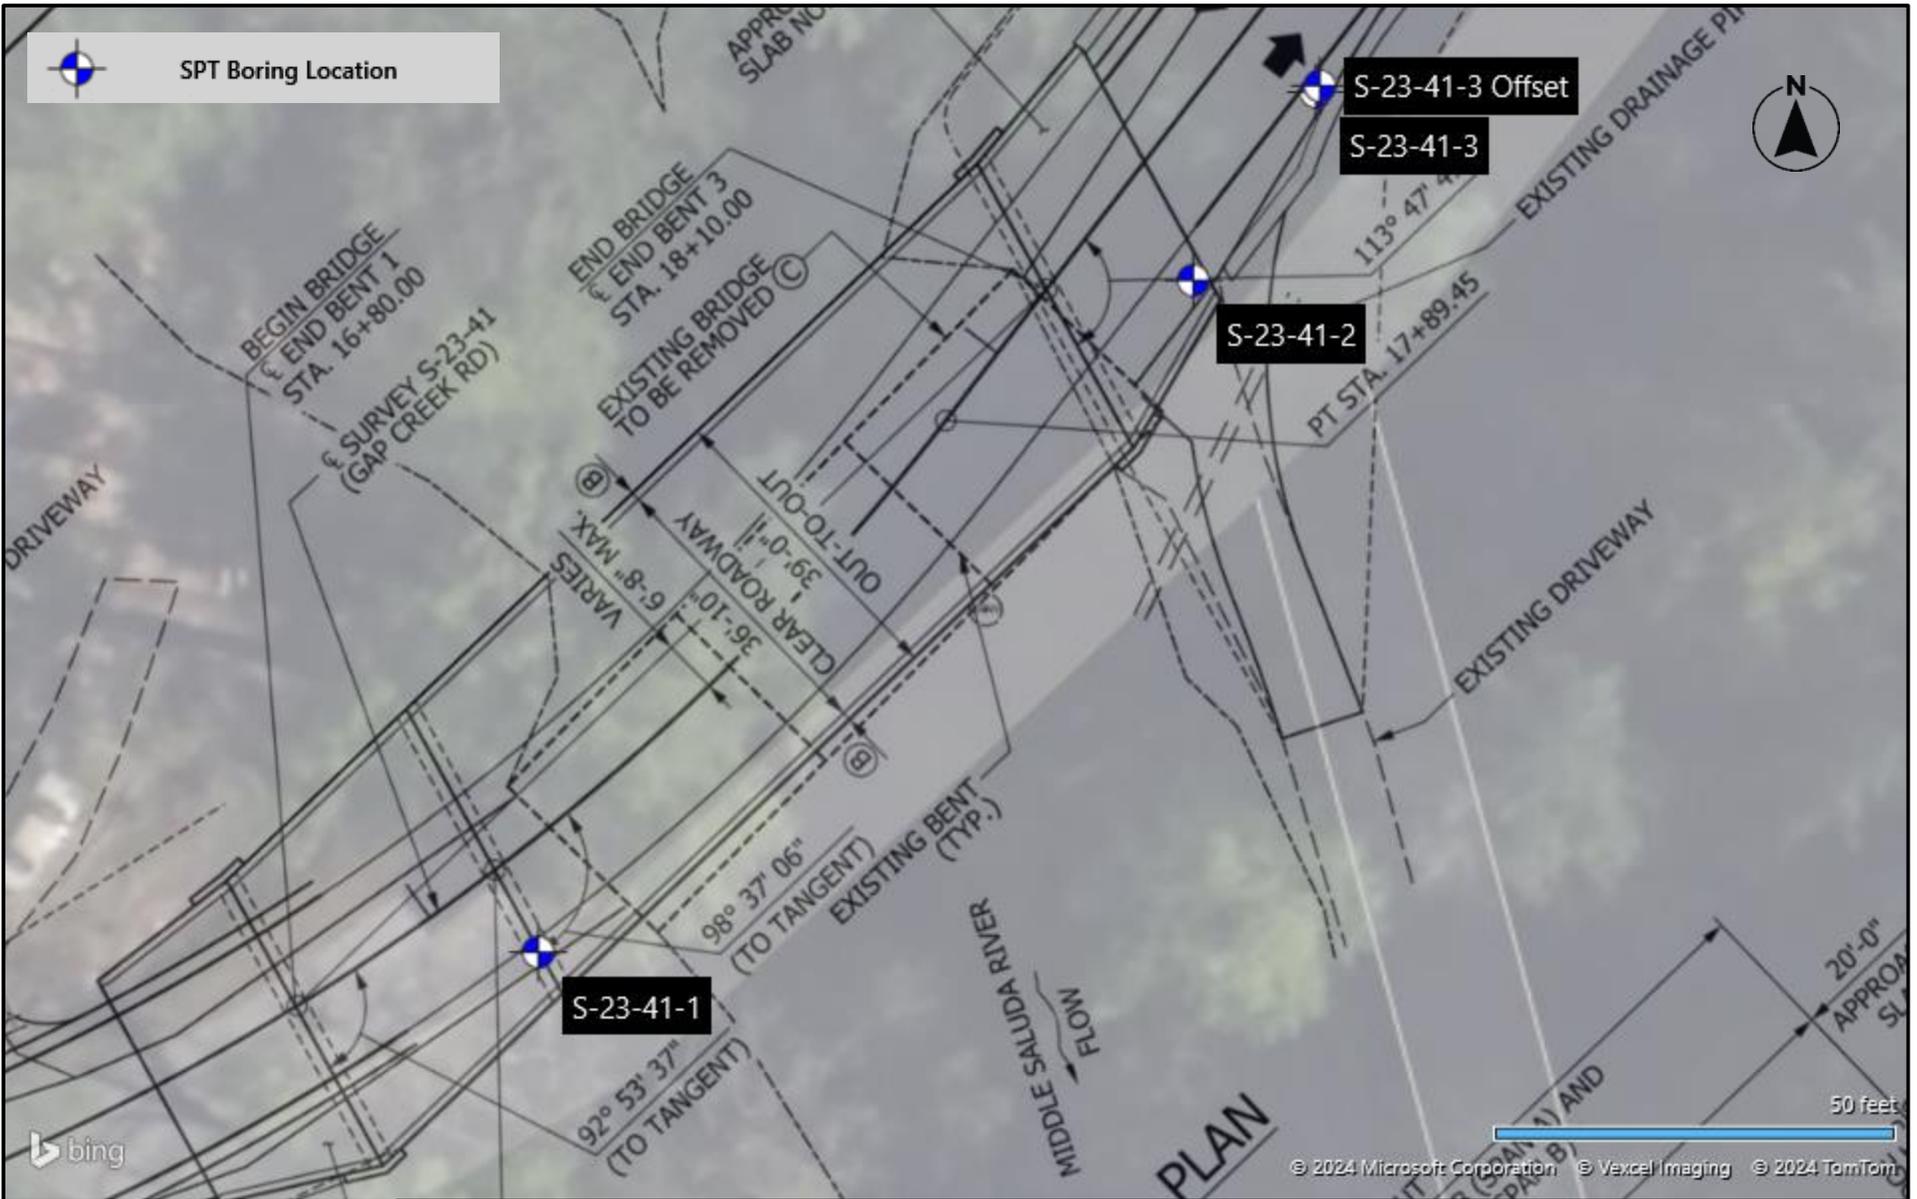
A-2

PRELIMINARY SITE PLAN PROVIDED BY HNTB

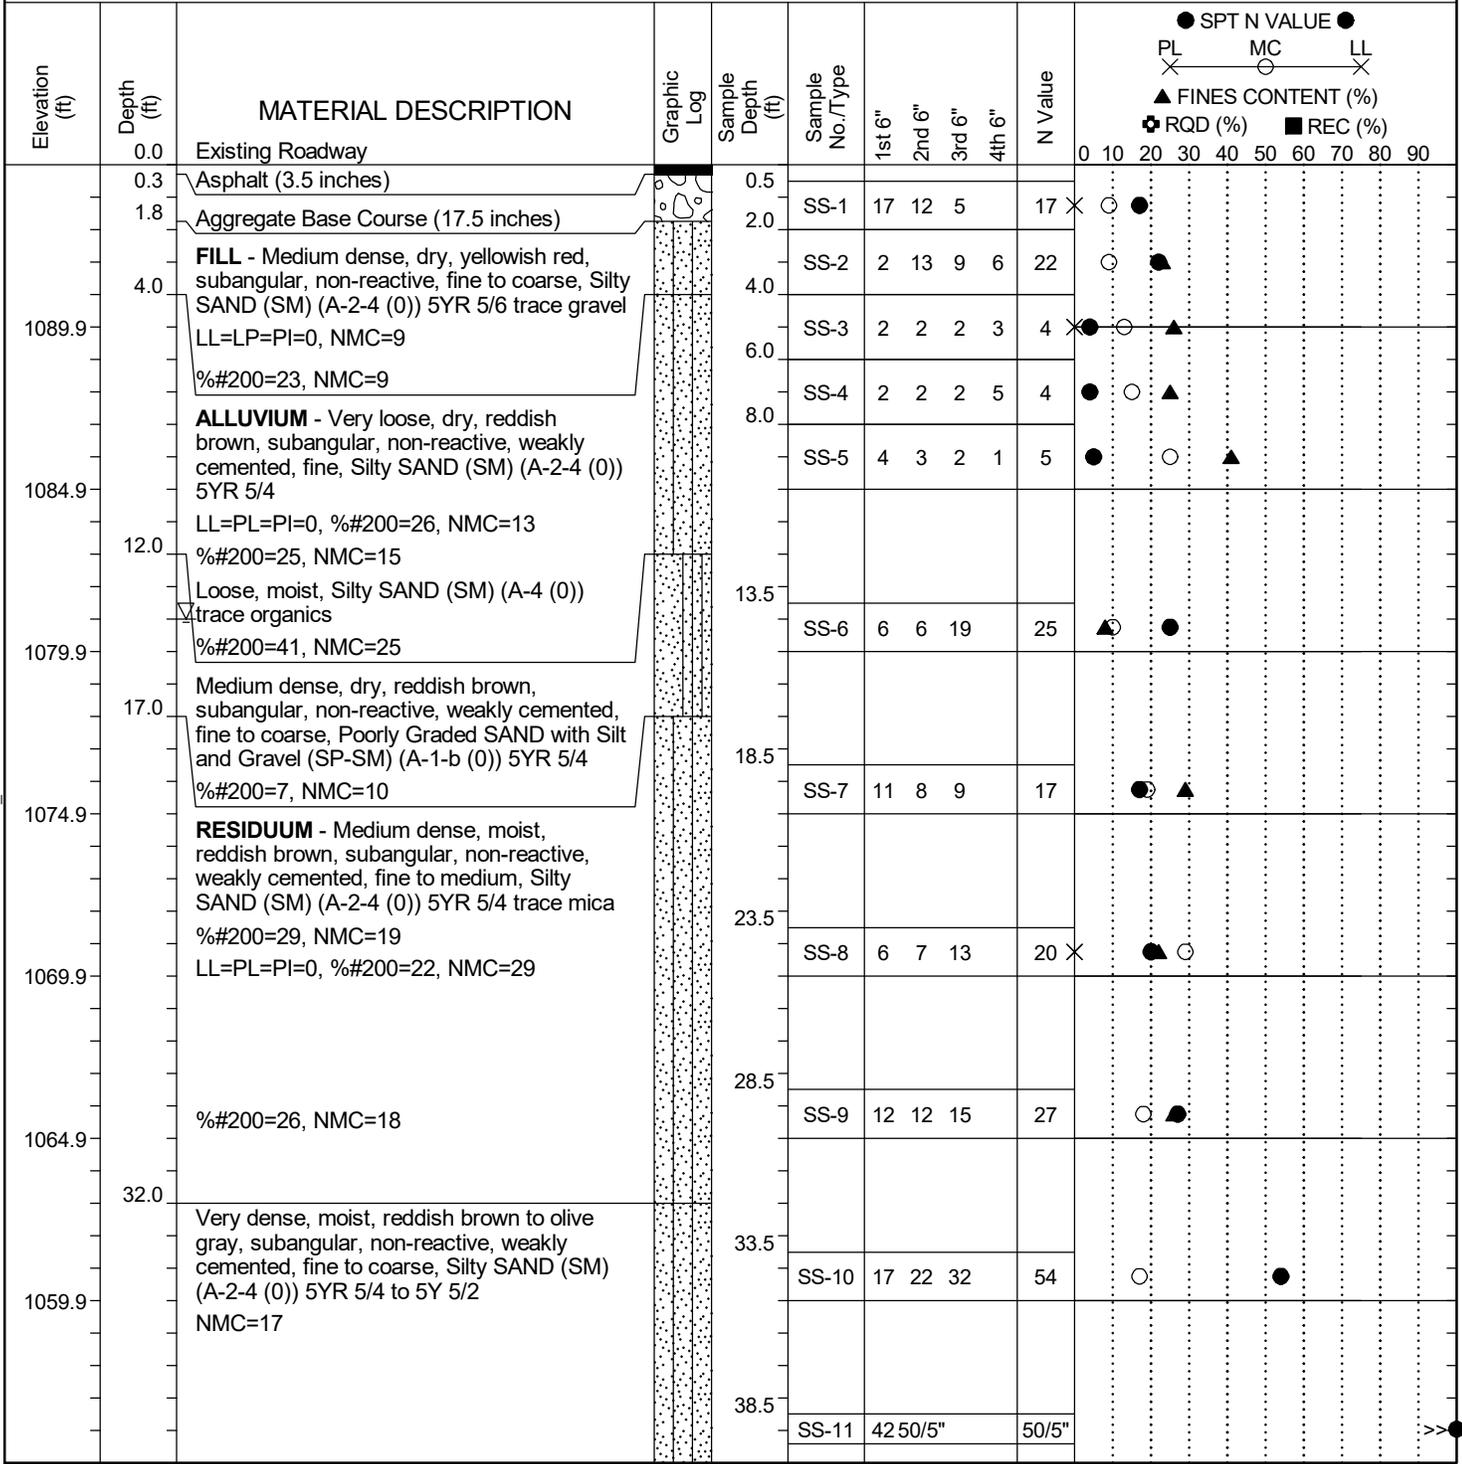
Project ID: P041159	County: Greenville	Boring No.: S-23-41-1
Site Description: S-23-41 BRO Middle Saluda River		Route: S-23-41
Eng./Geo.: S. Greaber	Boring Location: 17+10	Offset: 11 R
Alignment: Existing	Date Started: 8/23/2024	Date Completed: 8/23/2024
Elev.: 1094.9 ft	Latitude: 35.12028	Longitude: -82.53771
Total Depth: 78.5 ft	Soil Depth: 63.5 ft	Core Depth: 15 ft
Bore Hole Diameter (in): 4	Sampler Configuration	Liner Required: Y (N)
Liner Used: Y (N)	Drill Machine: DR#1327	Drill Method: RW/RC
Hammer Type: Automatic	Energy Ratio: 92.6%	Groundwater: TOB
Core Size: NQ2	Driller: B. Burnette	14 (After 1hr) 24HR N.M.

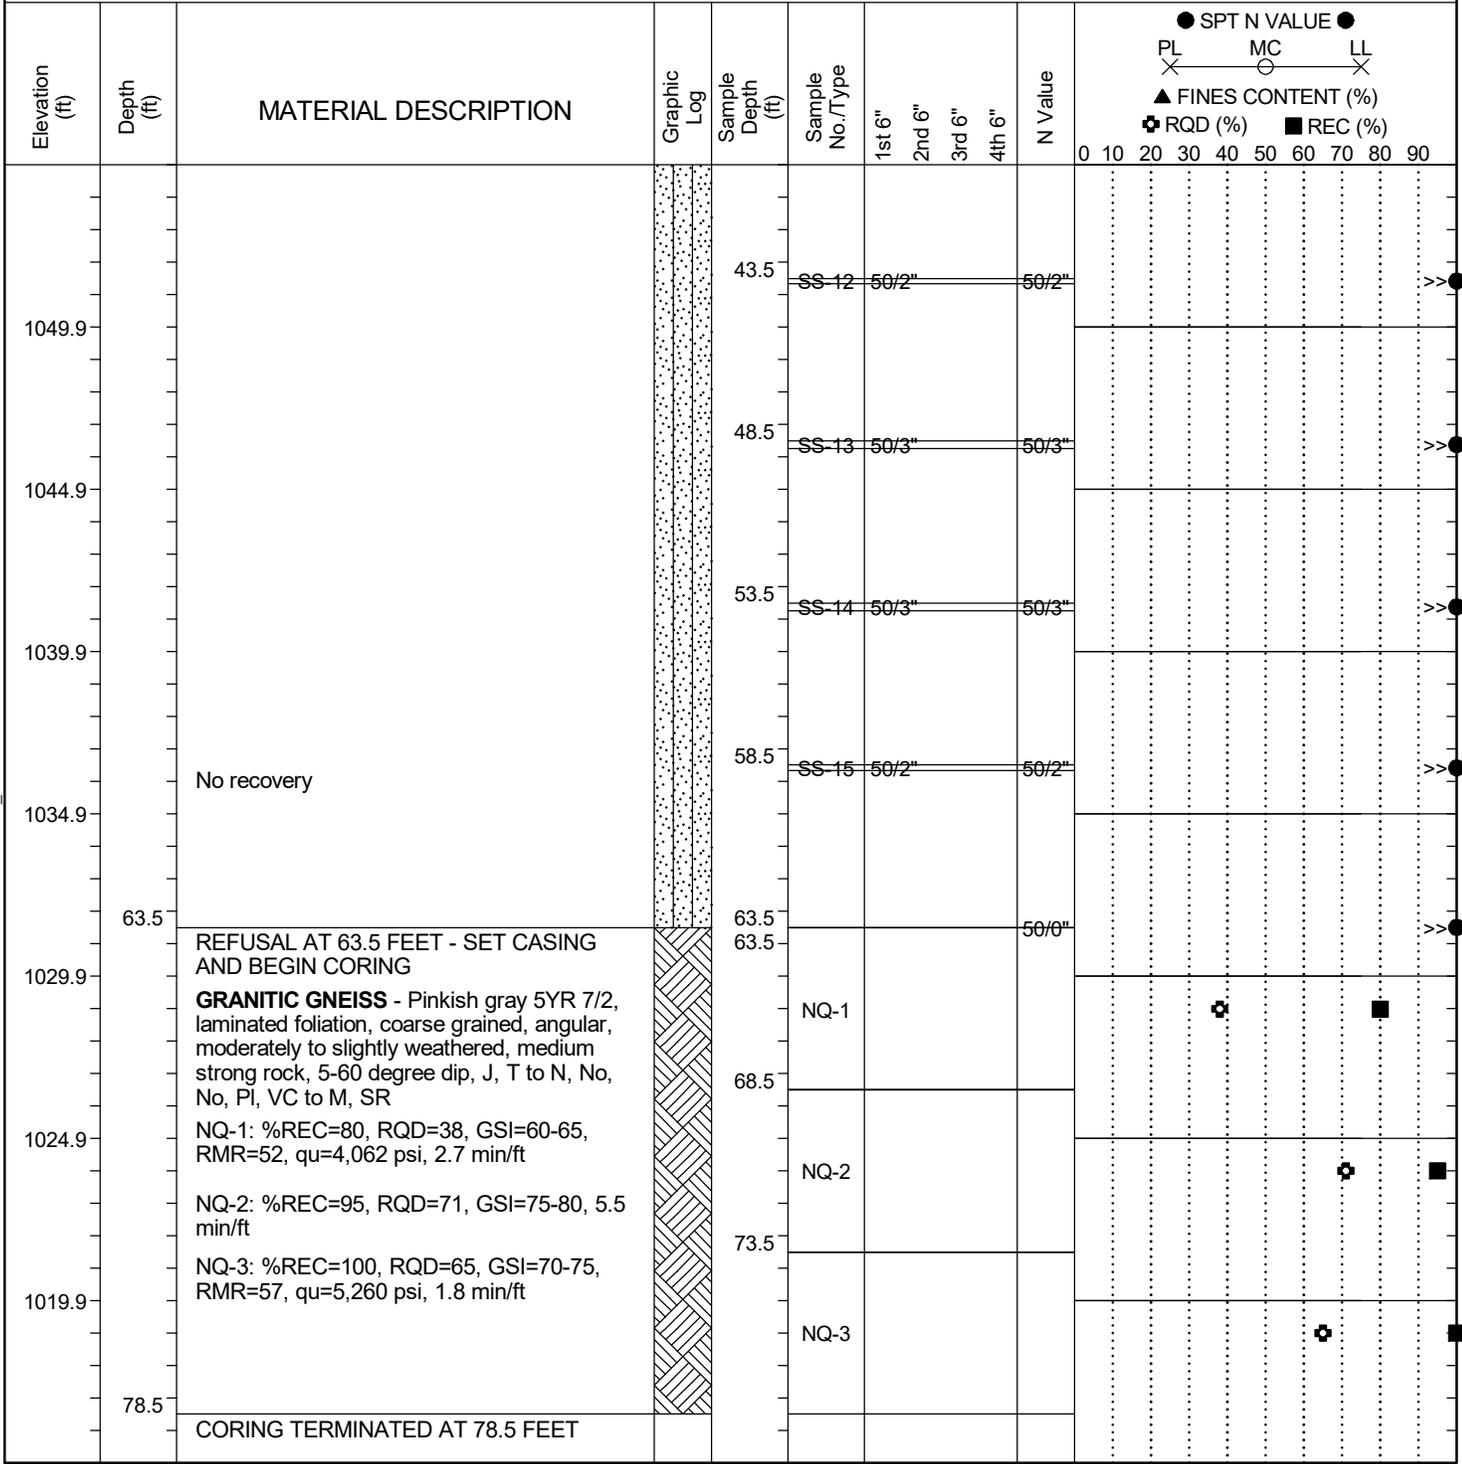
Project ID: P041159	County: Greenville	Boring No.: S-23-41-1
Site Description: S-23-41 BRO Middle Saluda River	Route: S-23-41	
Eng./Geo.: S. Greaber	Boring Location: 17+10	Offset: 11 R
Alignment: Existing		
Elev.: 1094.9 ft	Latitude: 35.12028	Longitude: -82.53771
Date Started: 8/23/2024		
Total Depth: 78.5 ft	Soil Depth: 63.5 ft	Core Depth: 15 ft
Date Completed: 8/23/2024		
Bore Hole Diameter (in): 4	Sampler Configuration	Liner Required: Y (N)
Liner Used: Y (N)		
Drill Machine: DR#1327	Drill Method: RW/RC	Hammer Type: Automatic
Energy Ratio: 92.6%		
Core Size: NQ2	Driller: B. Burnette	Groundwater: TOB 14 (After 1hr) 24HR N.M.

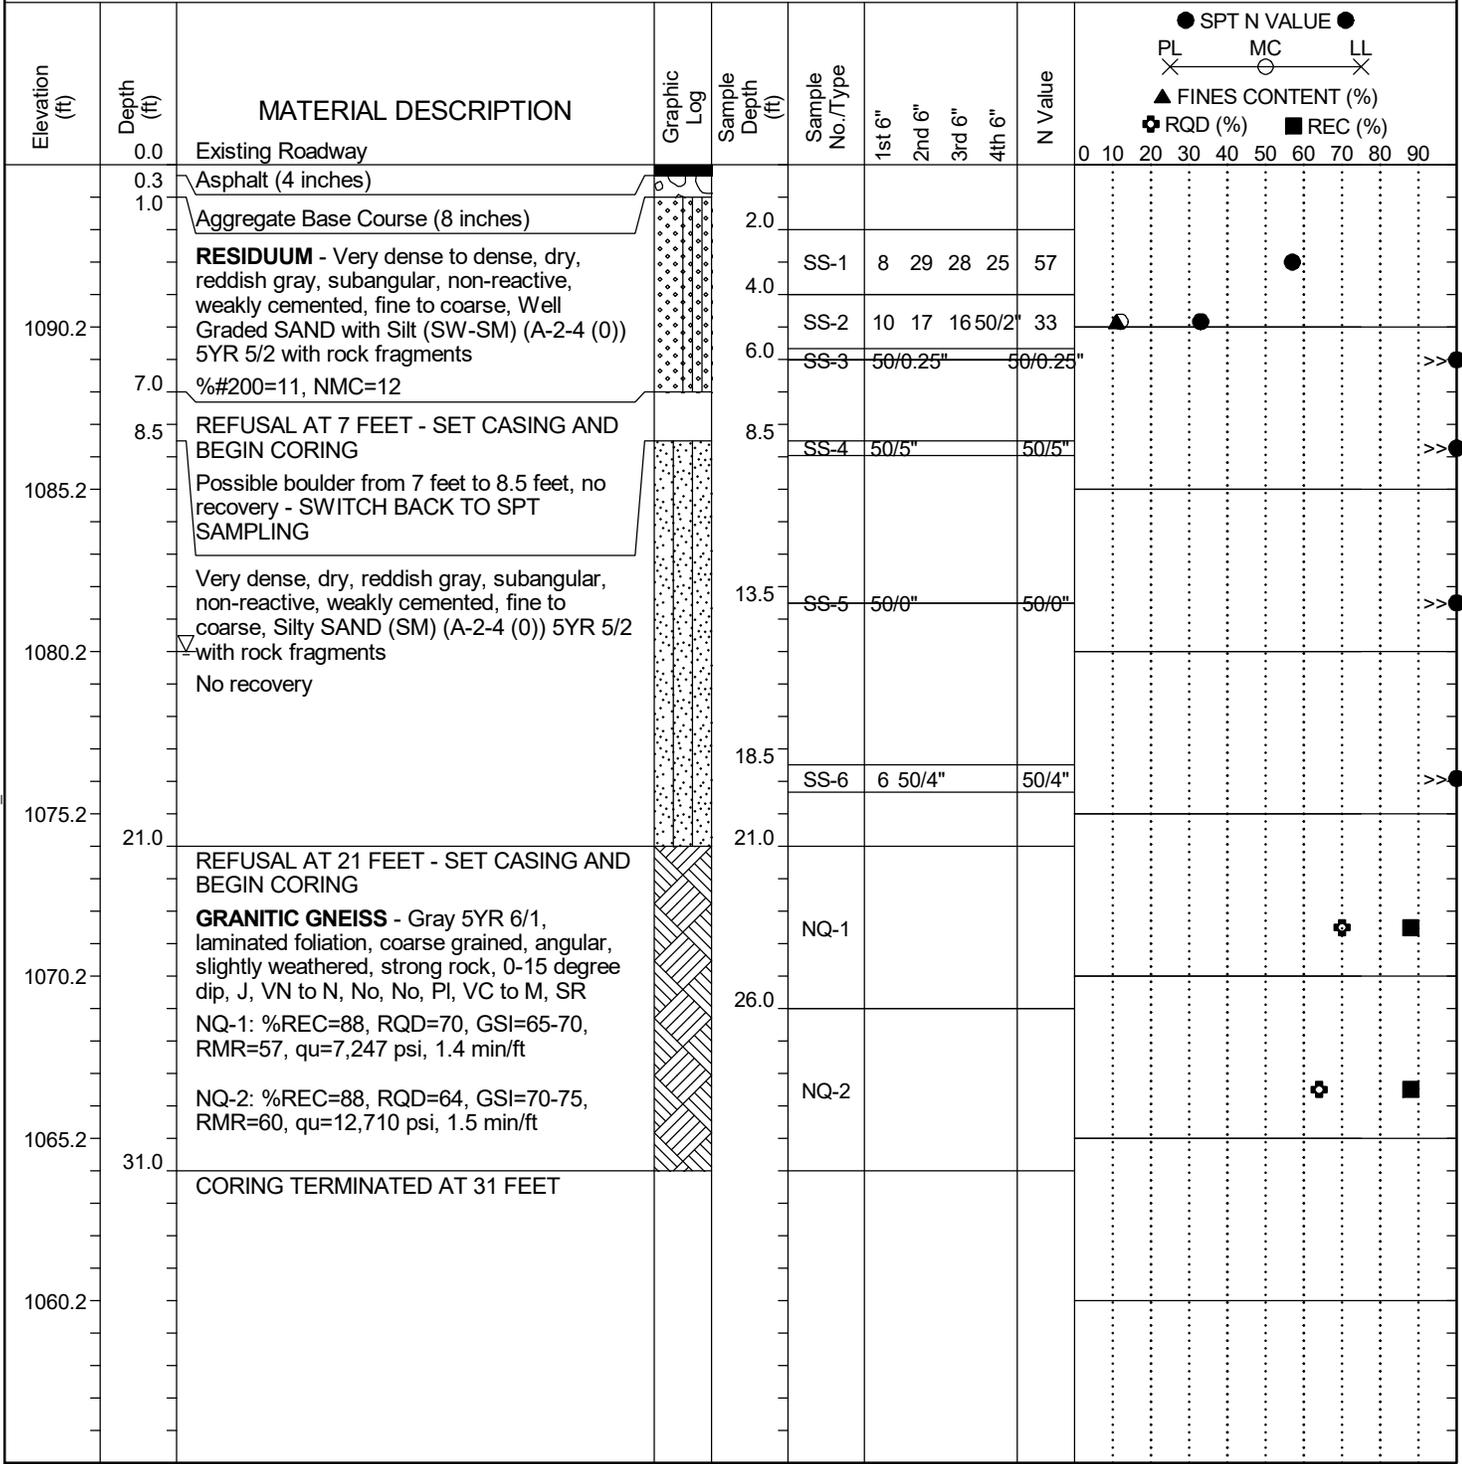
Project ID: P041159	County: Greenville	Boring No.: S-23-41-2
Site Description: S-23-41 BRO Middle Saluda River		Route: S-23-41
Eng./Geo.: S. Greaber	Boring Location: 18+28	Offset: 14 R
Alignment: Existing	Date Started: 8/23/2024	Date Completed: 8/27/2024
Elev.: 1095.2 ft	Latitude: 35.12051	Longitude: -82.53742
Total Depth: 31 ft	Soil Depth: 21 ft	Core Depth: 10 ft
Bore Hole Diameter (in): 4	Sampler Configuration	Liner Required: Y (N)
Liner Used: Y (N)	Drill Machine: DR#554	Drill Method: RW/RC
Hammer Type: Automatic	Energy Ratio: 88.5%	Groundwater: TOB
Core Size: NQ2	Driller: G. Robinson	15 (After 2hr): 34HR
		N.M.

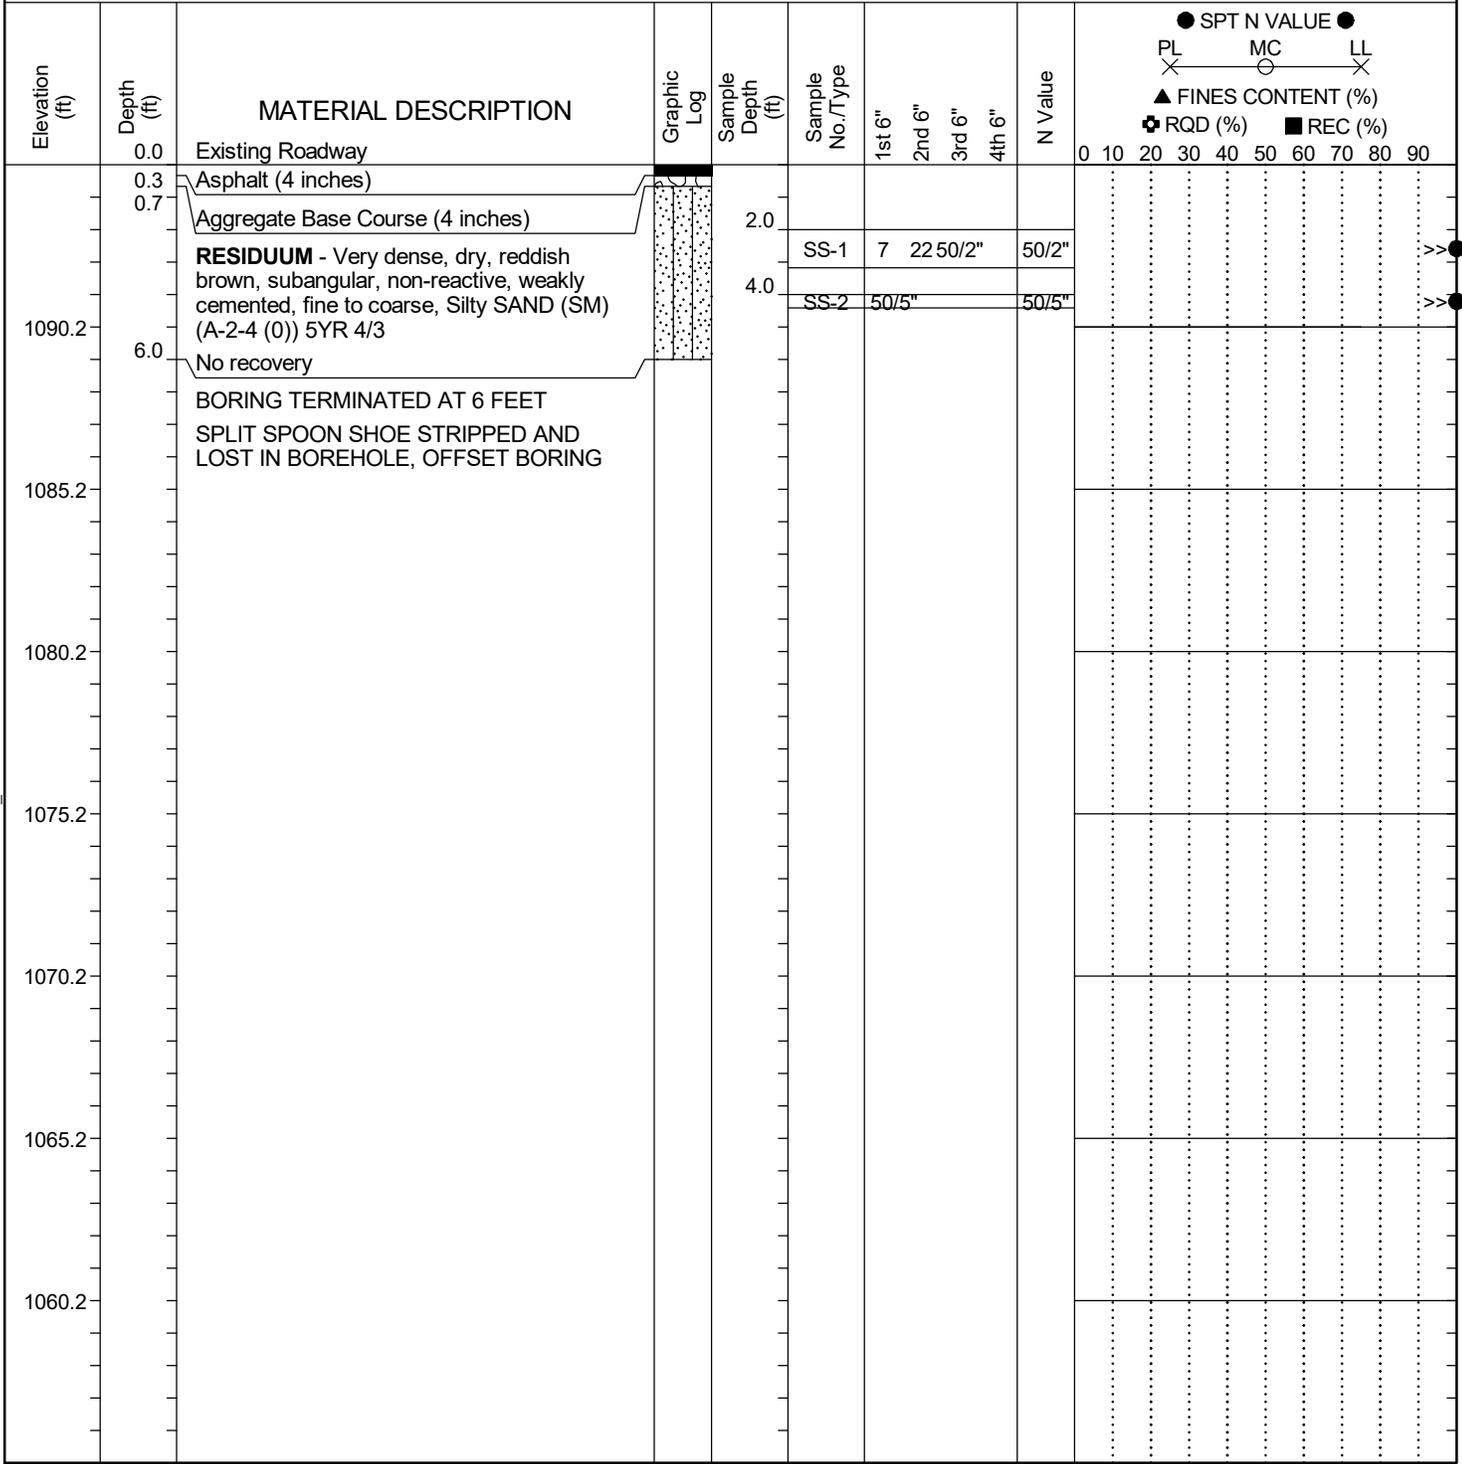
Project ID: P041159	County: Greenville	Boring No.: S-23-41-3
Site Description: S-23-41 BRO Middle Saluda River	Route: S-23-41	
Eng./Geo.: M. McKenney	Boring Location: 18+55	Offset: 11 R
Alignment: Existing		
Elev.: 1095.2 ft	Latitude: 35.12058	Longitude: -82.53738
Date Started: 8/23/2024		
Total Depth: 6 ft	Soil Depth: 6 ft	Core Depth: 0 ft
Date Completed: 8/27/2024		
Bore Hole Diameter (in): 4	Sampler Configuration	Liner Required: Y (N)
Liner Used: Y (N)		
Drill Machine: DR#554	Drill Method: RW	Hammer Type: Automatic
Energy Ratio: 88.5%		
Core Size: N/A	Driller: G. Robinson	Groundwater: TOB N.M.
24HR: N.M.

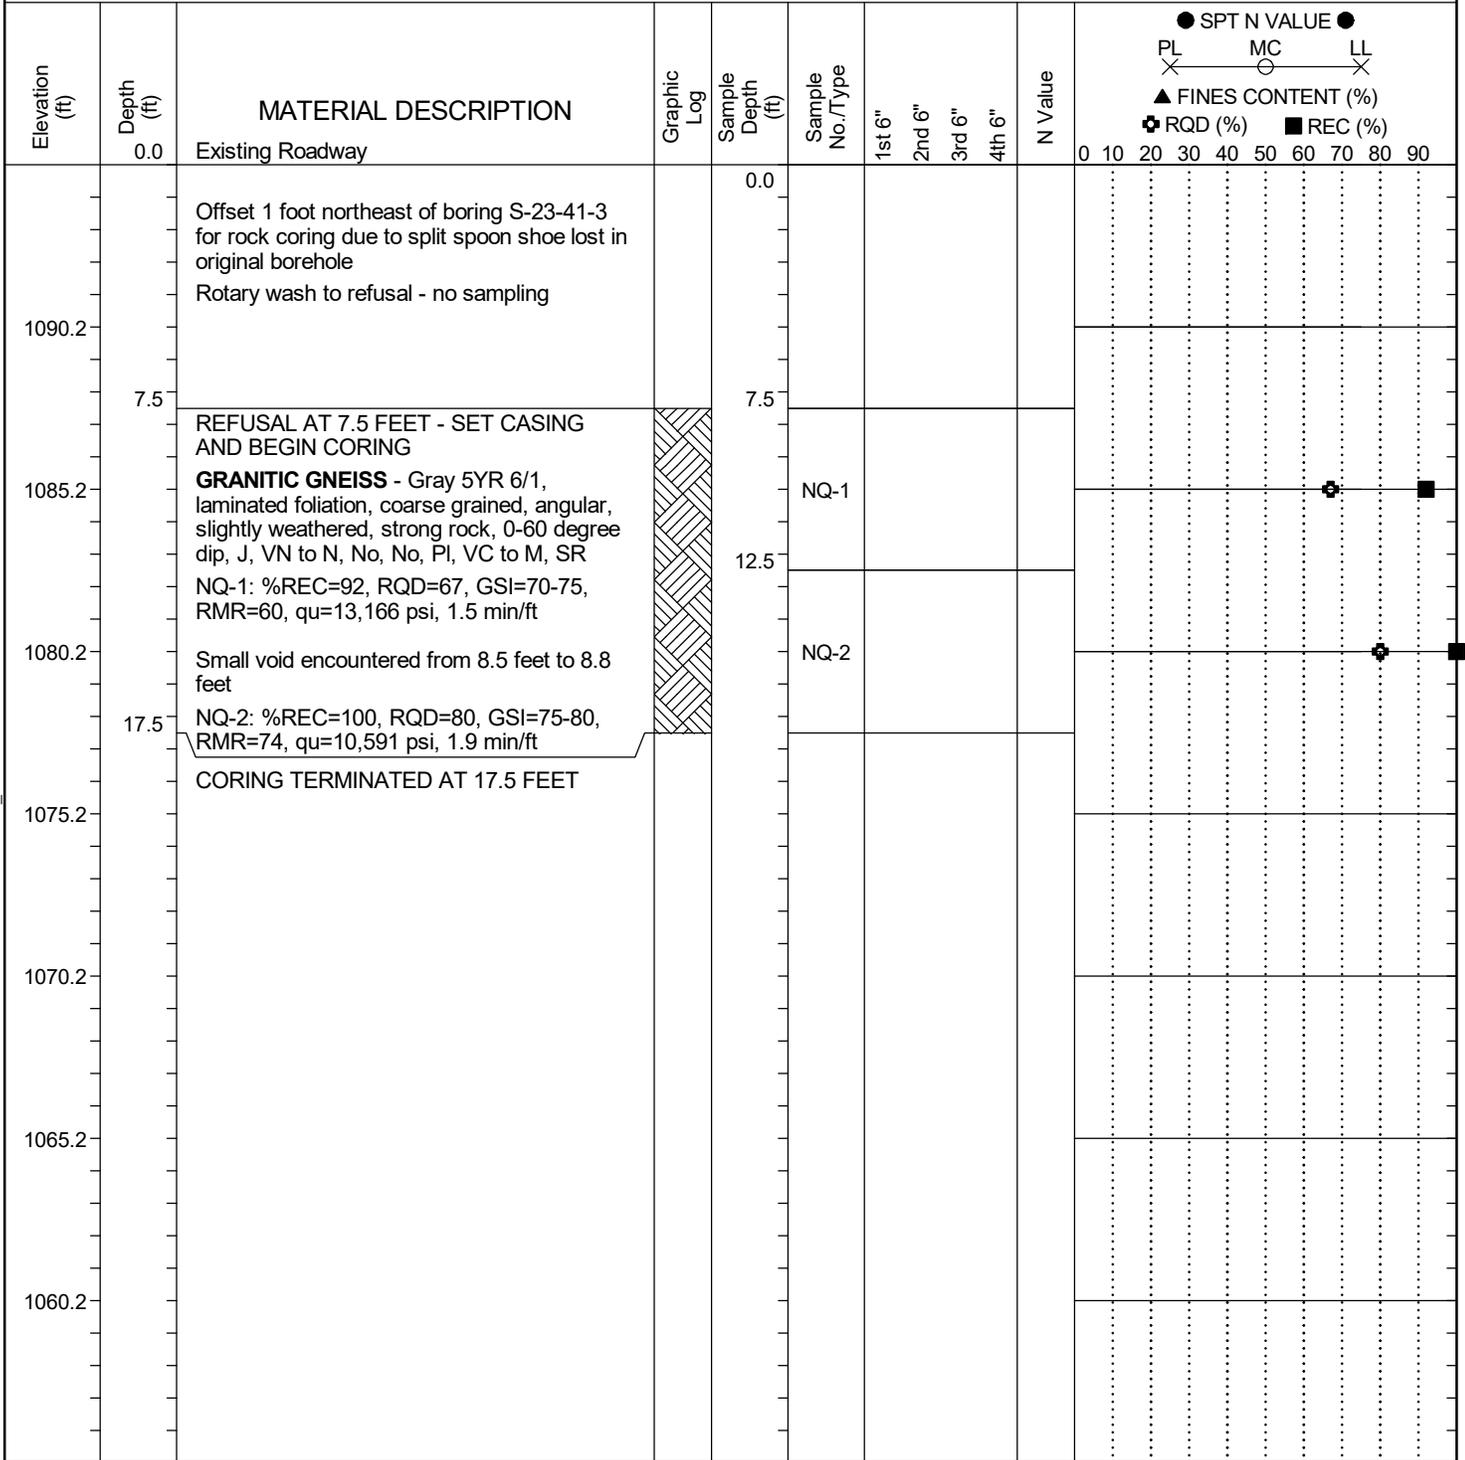
Project ID: P041159	County: Greenville	Boring No.: S-23-41-3 Offset
Site Description: S-23-41 BRO Middle Saluda River	Route: S-23-41	
Eng./Geo.: S. Greaber	Boring Location: 18+56	Offset: 11 R
Alignment: Existing		
Elev.: 1095.2 ft	Latitude: 35.12058	Longitude: -82.53738
Date Started: 8/27/2024		
Total Depth: 17.5 ft	Soil Depth: 7.5 ft	Core Depth: 10 ft
Date Completed: 8/27/2024		
Bore Hole Diameter (in): 4	Sampler Configuration	Liner Required: Y (N)
Liner Used: Y (N)		
Drill Machine: DR#554	Drill Method: RW/RC	Hammer Type: Automatic
Energy Ratio: 88.5%		
Core Size: NQ2	Driller: G. Robinson	Groundwater: TOB N.M.
24HR: N.M.

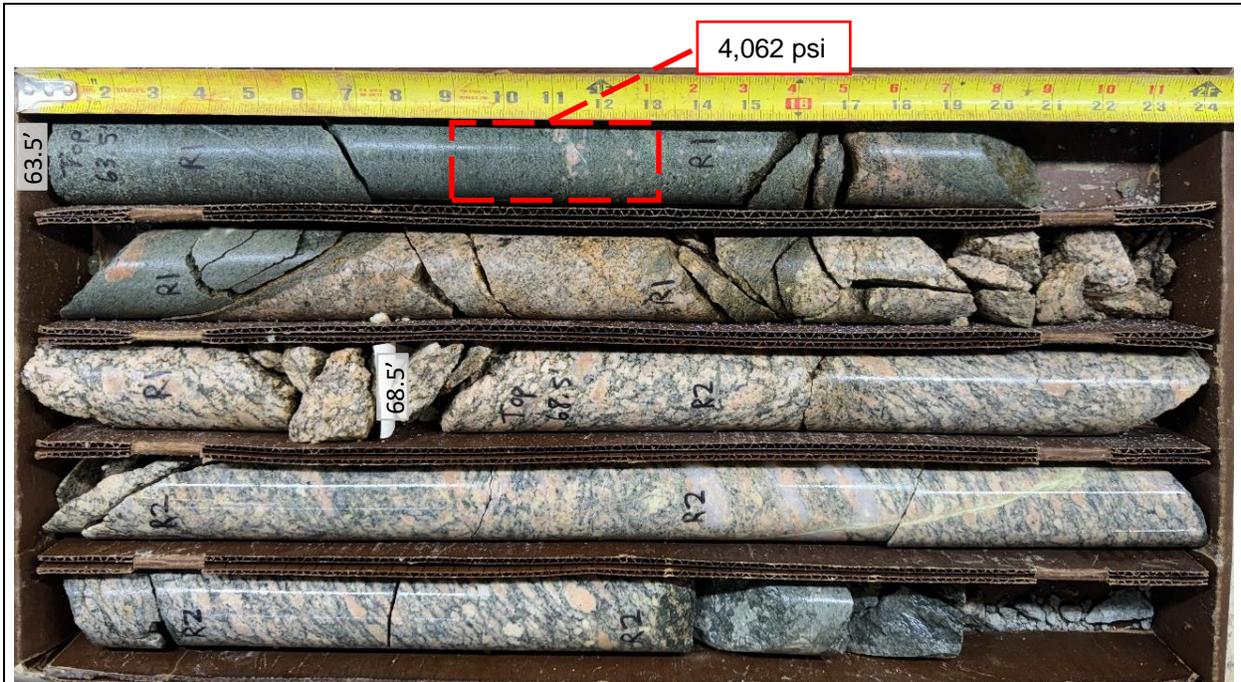
S-23-41-1, NQ-1 and NQ-2 (63.5 to 73.5 feet)

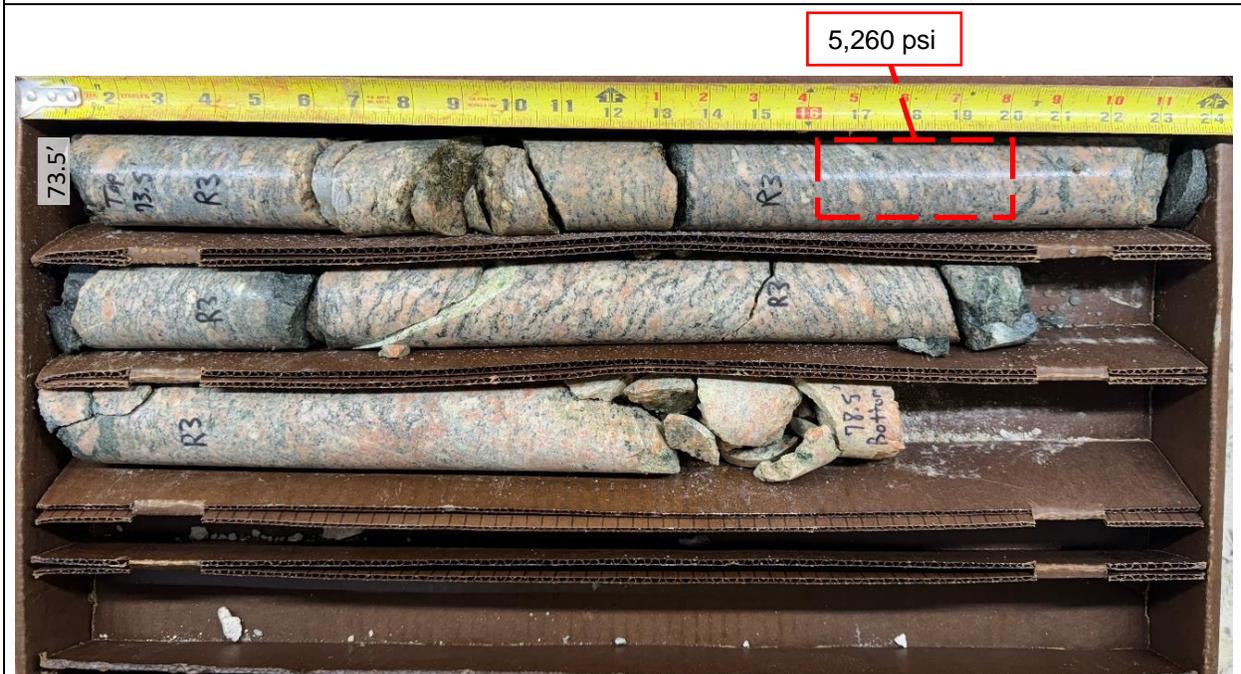
S-23-41-1, NQ-3 (73.5 to 78.5 feet)

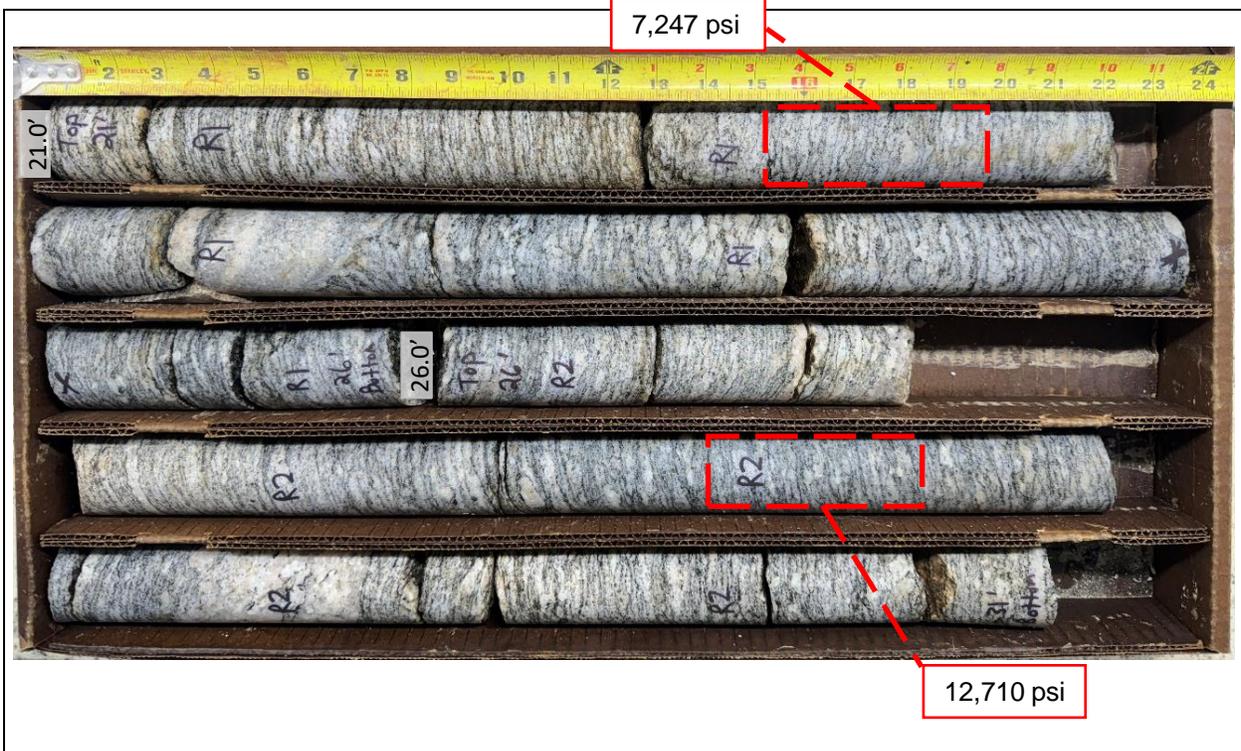
S-23-41-2, NQ-1 and NQ-2 (21 to 31 feet)

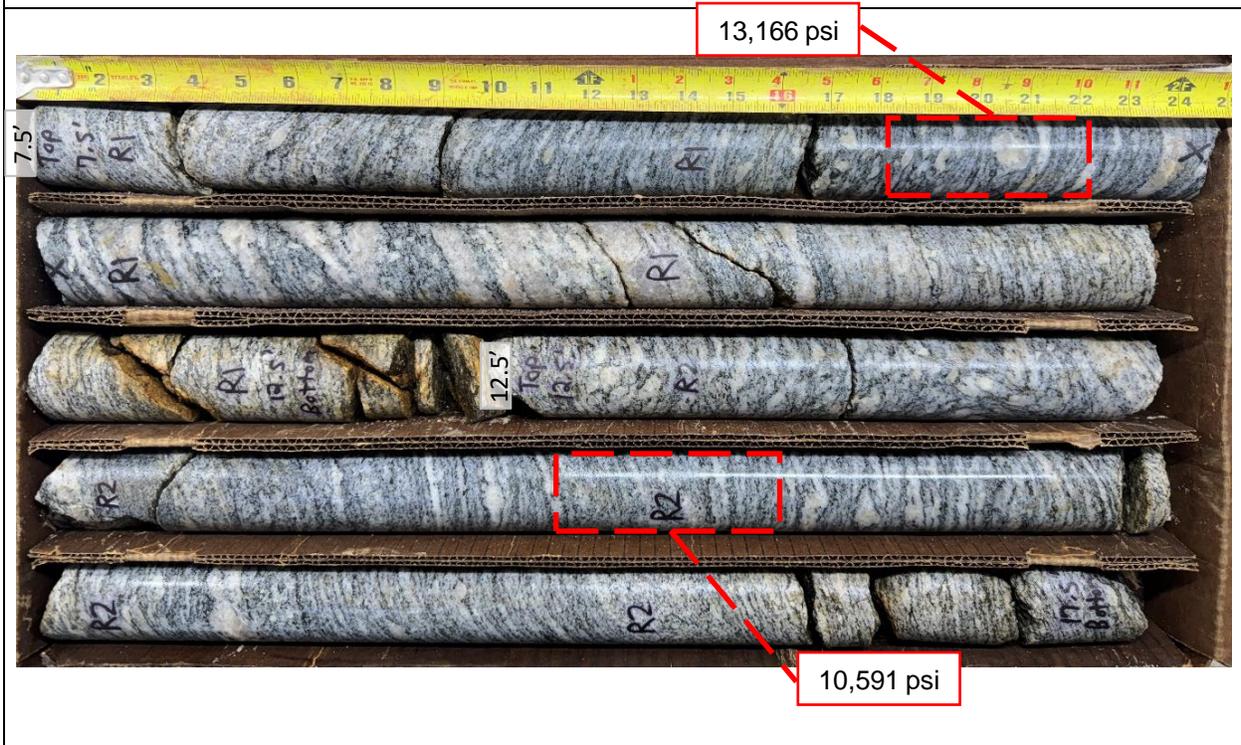
S-23-41-3, NQ-1 and NQ-2 (7.5 to 17.5 feet)

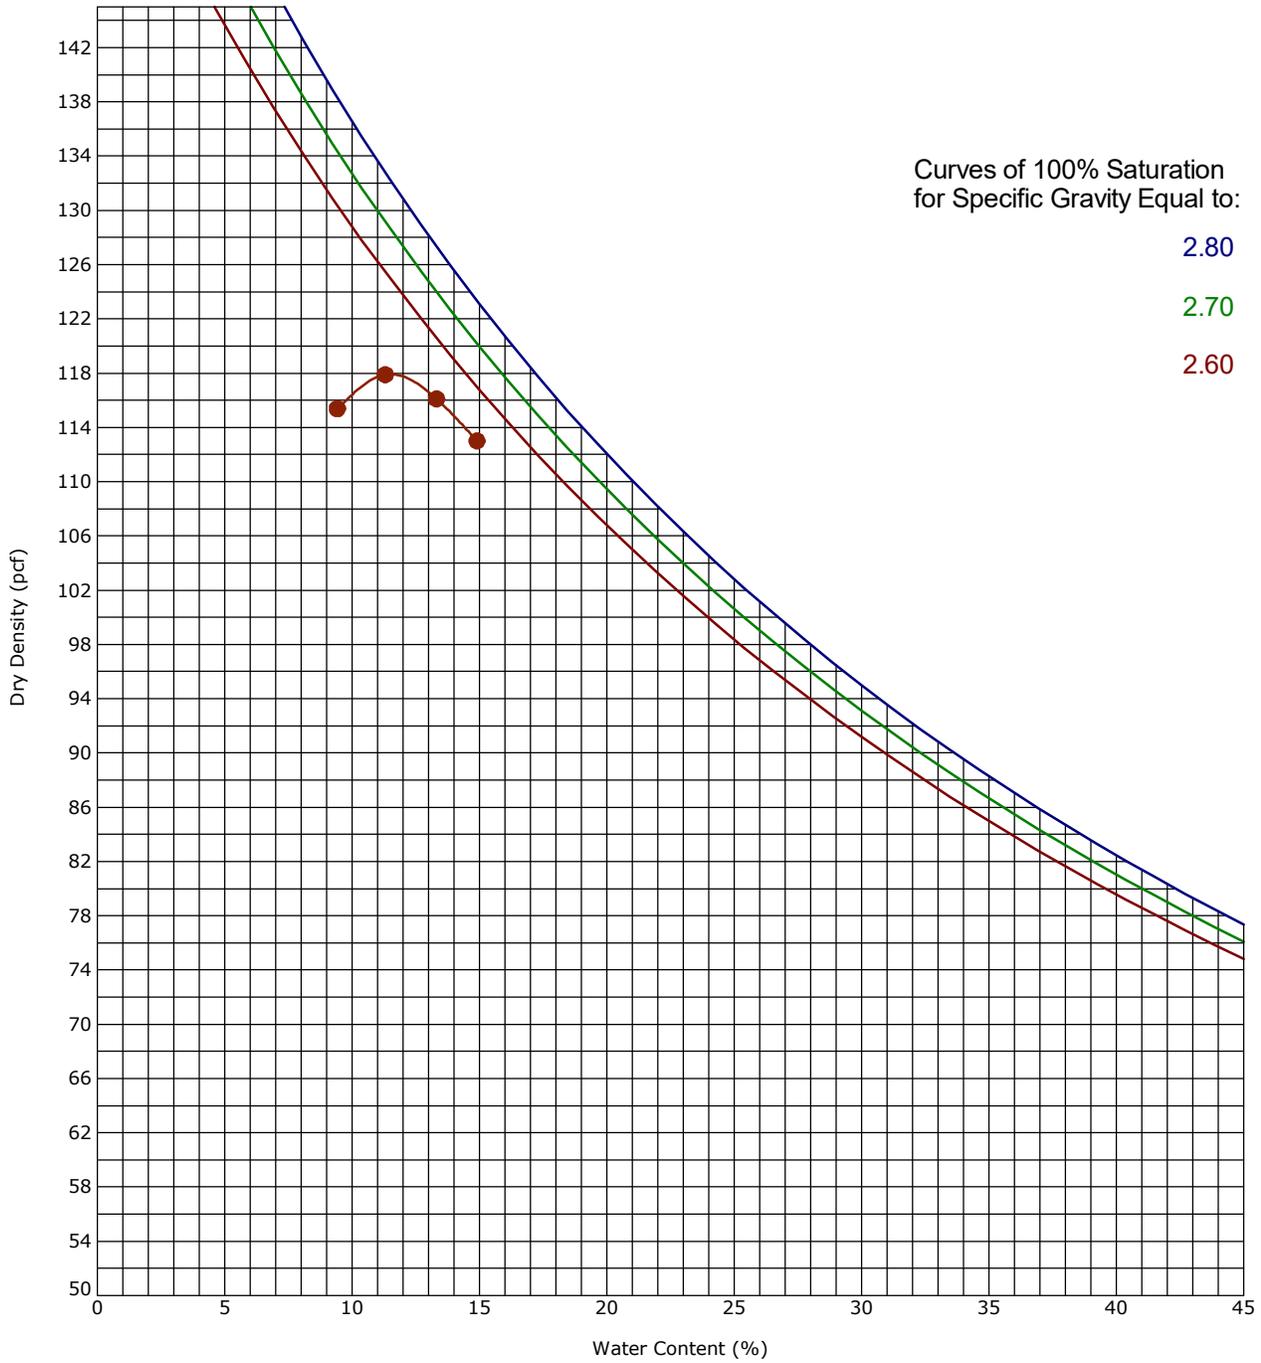
Moisture-Density Relationship

Boring ID		Depth (Ft)		Description of Materials				
S-23-41-1 Offset		0 - 5		SILTY SAND(SM)				
Fines (%)	Fraction > mm size	LL	PL	PI	Test Method	Maximum Dry Density (pcf)	Optimum Water Content (%)	
26	0.0	NP	NP	NP	ASTM D698-Method B	117.9	11.5

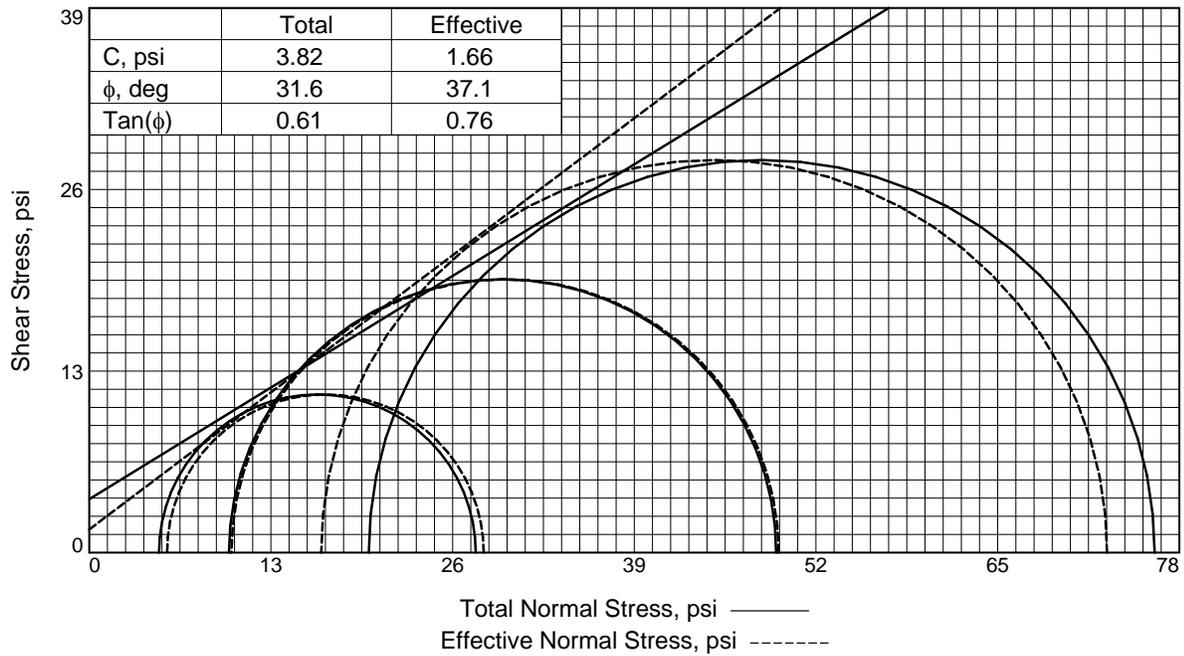
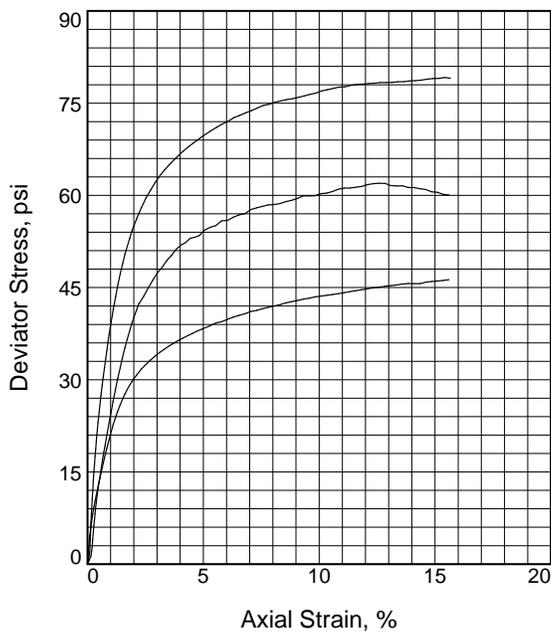
Sample No.		1	2	3
Initial	Water Content, %	11.3	11.4	11.4
	Dry Density, pcf	112.3	112.5	112.4
	Saturation, %	61.1	61.6	61.9
	Void Ratio	0.5013	0.4985	0.4990
	Diameter, in.	2.80	2.80	2.80
	Height, in.	5.62	5.62	5.62
At Test	Water Content, %	17.2	17.0	16.8
	Dry Density, pcf	115.1	115.6	116.0
	Saturation, %	100.0	100.0	100.0
	Void Ratio	0.4642	0.4583	0.4531
	Diameter, in.	2.77	2.77	2.77
	Height, in.	5.58	5.58	5.56
Strain rate, in./min.		0.001	0.001	0.001
Back Pressure, psi		50.0	50.0	50.0
Cell Pressure, psi		55.0	60.0	70.0
Fail. Stress, psi		22.7	39.2	56.2
Excess Pore Pr., psi		-0.6	-0.2	3.4
Ult. Stress, psi		46.1	60.5	79.0
Excess Pore Pr., psi		-10.5	-11.1	-7.6
$\bar{\sigma}_1$ Failure, psi		28.2	49.3	72.8
$\bar{\sigma}_3$ Failure, psi		5.6	10.2	16.6

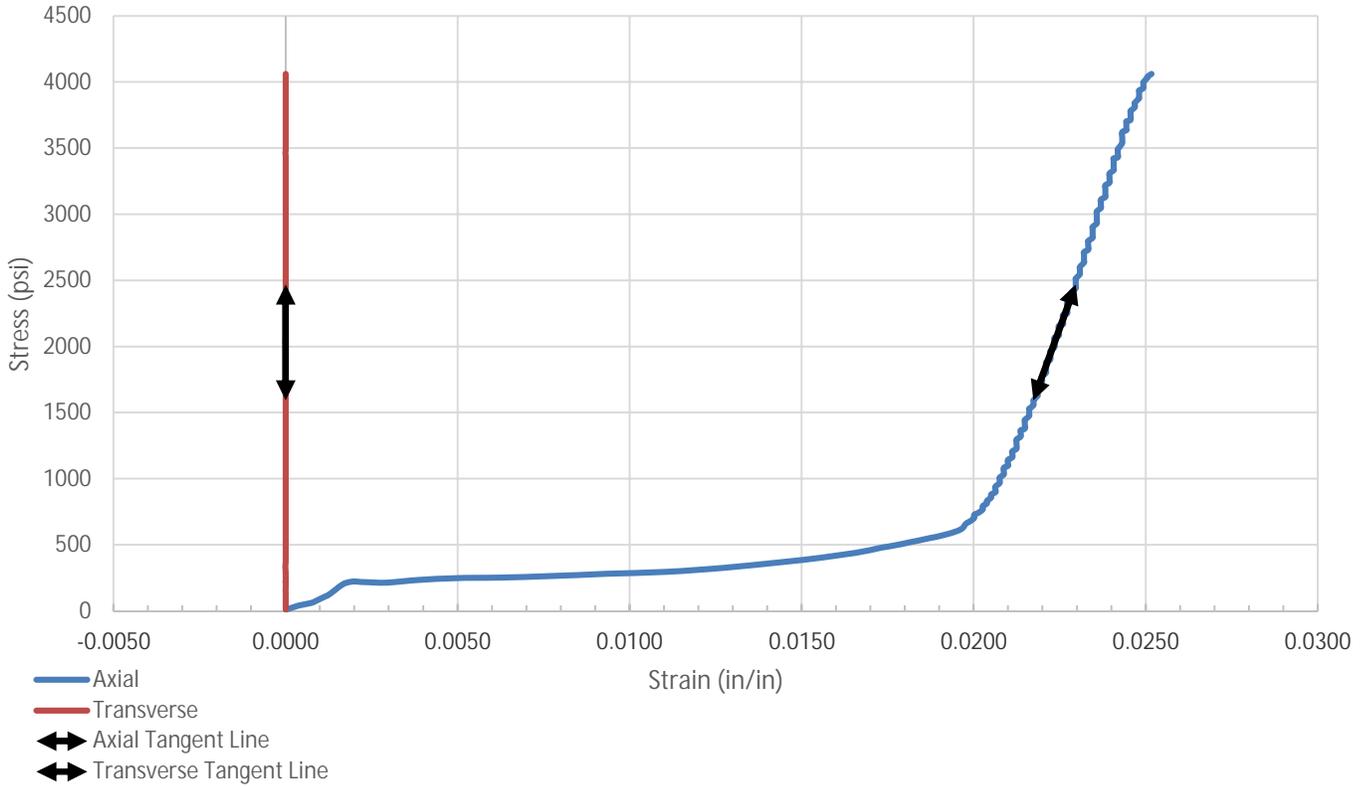
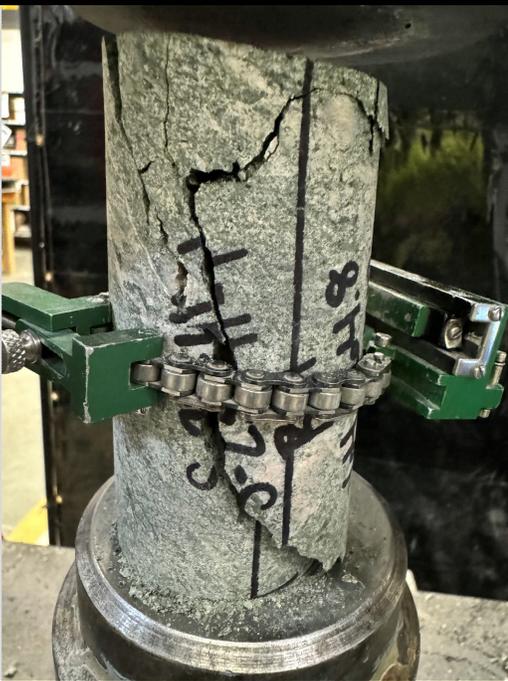
ASTM D7012 Stress/ Strain Curve

Failure Load (lbs):	12634
Failure Strain (%):	3.67
Unconfined Compressive Strength (psi):	4,062
Elastic Modulus, E, (ksi):	712
Poisson's Ratio, u:	0.0013
Time of Failure (min):	00:37
Rate of Loading (psi/sec):	109.788
Moisture Content Post-break:	0.01%
