S-23-41 (Gap Creek Road) Bridge Replacement over Middle Saluda River

Geotechnical Subsurface Data Report

October 30, 2024 | SCDOT Project ID: P041159
Terracon Project No.: 8623P180 Revision 1

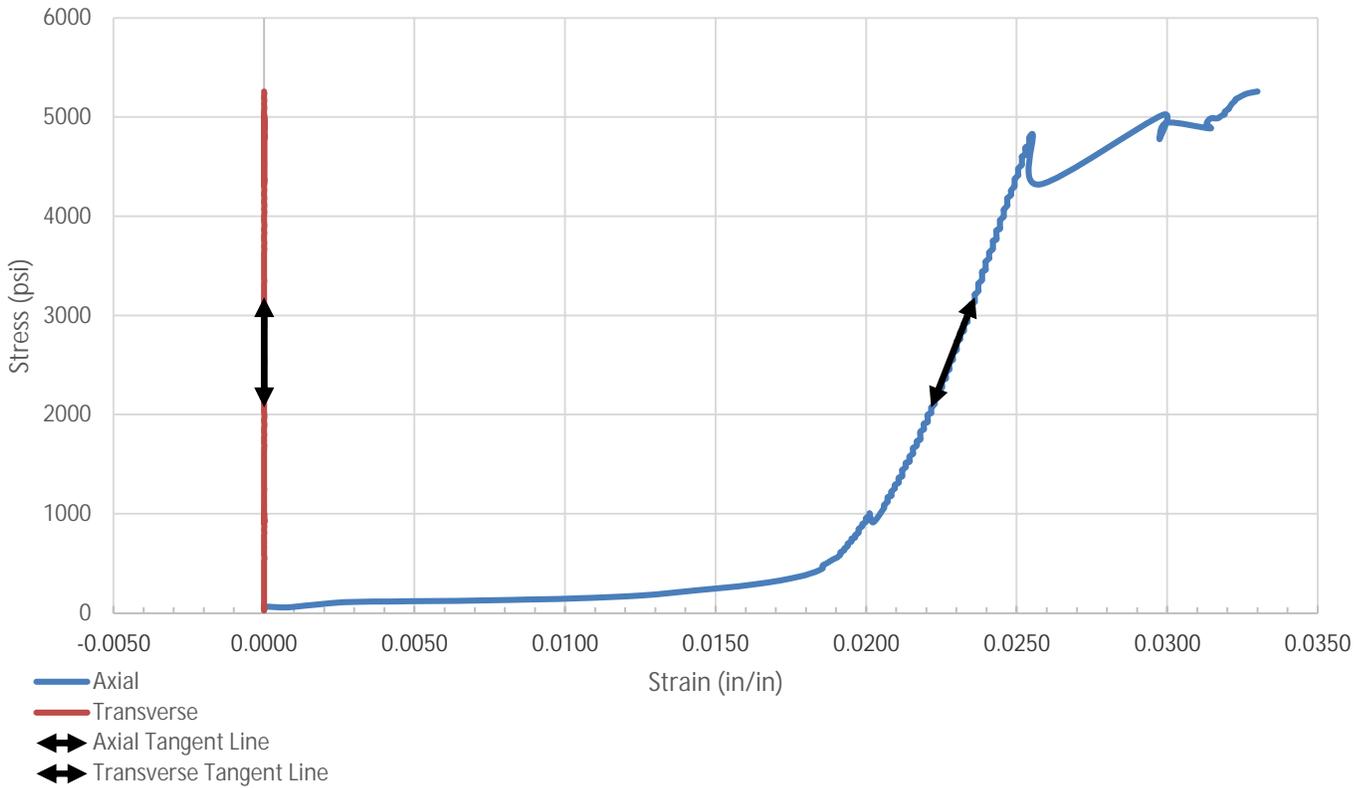
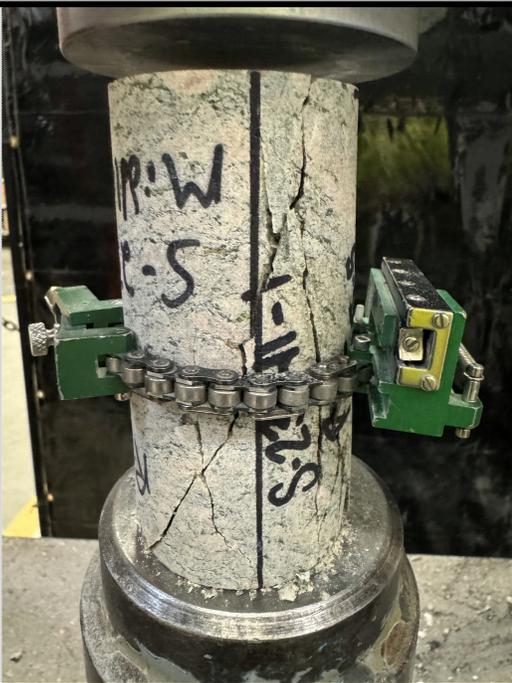
ASTM D7012 Stress/ Strain Curve

Failure Load (lbs):	16359
Failure Strain (%):	3.53
Unconfined Compressive Strength (psi):	5,260
Elastic Modulus, E, (ksi):	768
Poisson's Ratio, u:	0.000
Time of Failure (min):	00:48
Rate of Loading (psi/sec):	110.035
Moisture Content Post-break:	0.01%

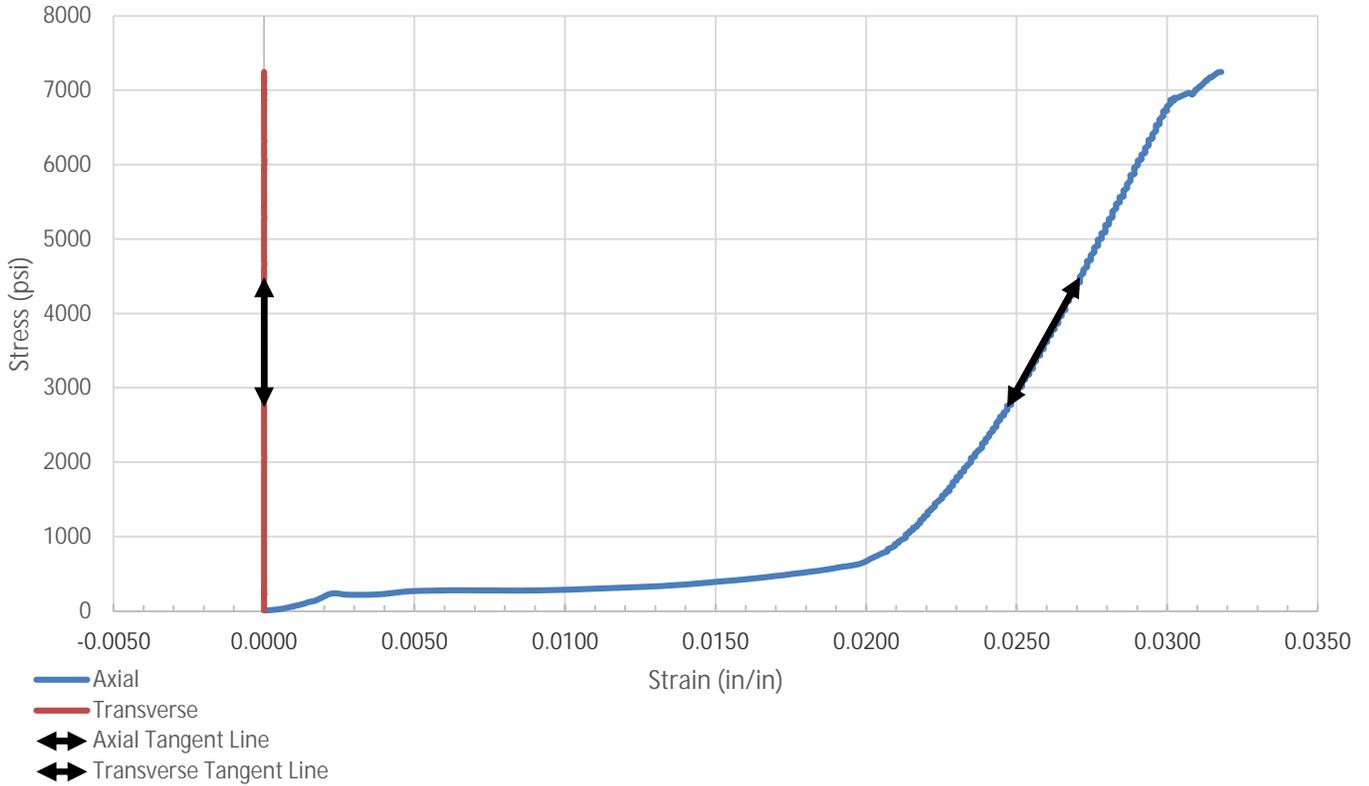
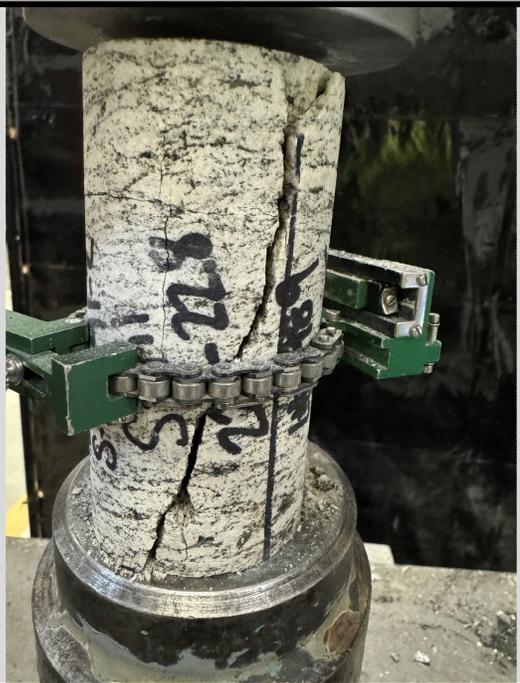
ASTM D7012 Stress/ Strain Curve

Failure Load (lbs):	22315
Failure Strain (%):	3.22
Unconfined Compressive Strength (psi):	7,247
Elastic Modulus, E, (ksi):	725
Poisson's Ratio, u:	0.001
Time of Failure (min):	01:06
Rate of Loading (psi/sec):	109.476
Moisture Content Post-break:	0.01%

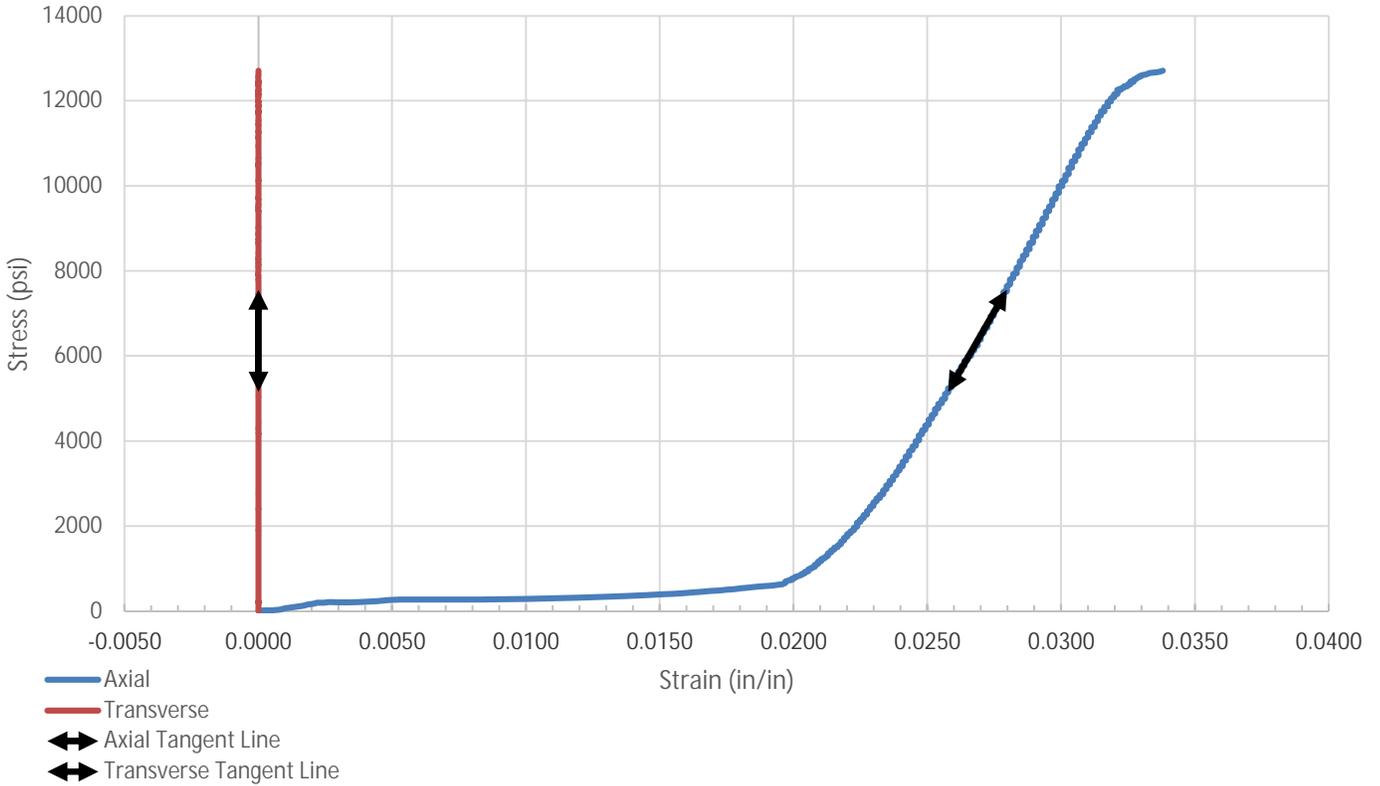
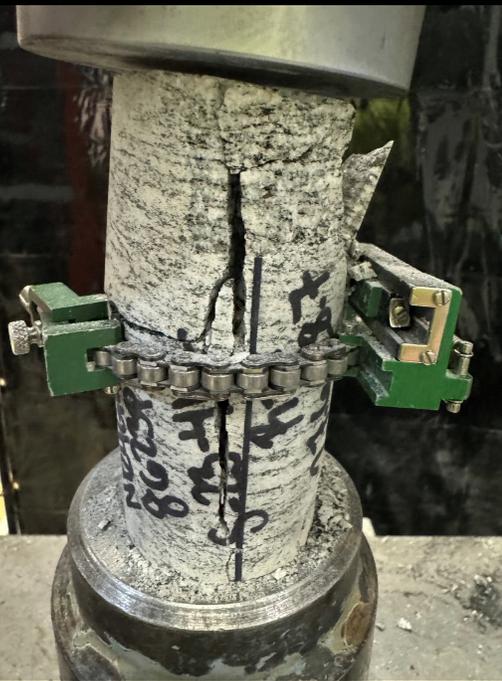
ASTM D7012 Stress/ Strain Curve

Failure Load (lbs):	39134
Failure Strain (%):	3.89
Unconfined Compressive Strength (psi):	12,710
Elastic Modulus, E, (ksi):	1095
Poisson's Ratio, u:	0.001
Time of Failure (min):	01:57
Rate of Loading (psi/sec):	108.816
Moisture Content Post-break:	0.012%

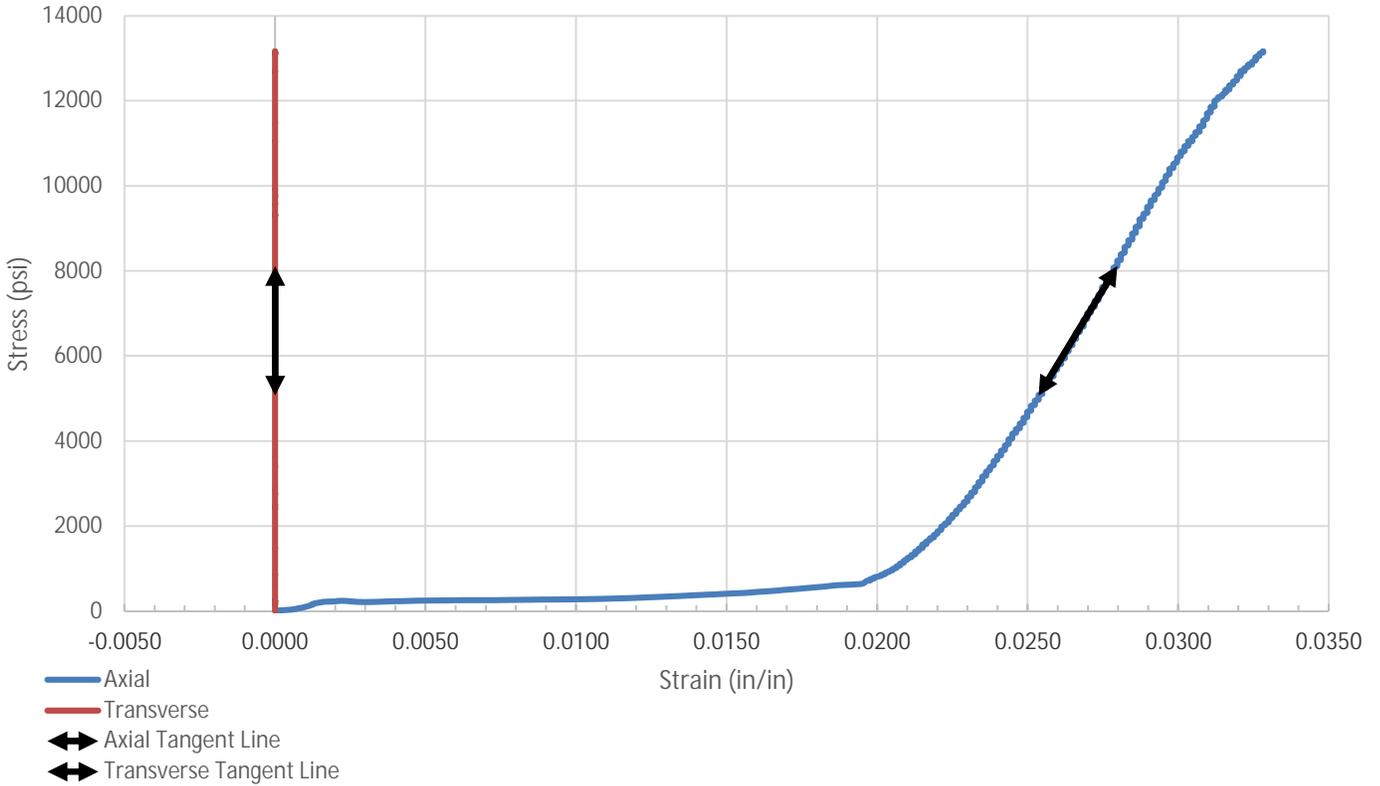
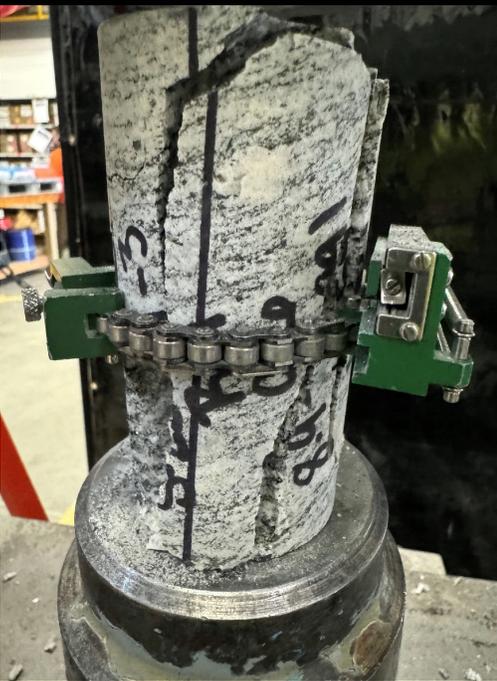
ASTM D7012 Stress/ Strain Curve

Failure Load (lbs):	40538
Failure Strain (%):	3.41
Unconfined Compressive Strength (psi):	13,166
Elastic Modulus, E, (ksi):	1168
Poisson's Ratio, u:	0.0002
Time of Failure (min):	02:00
Rate of Loading (psi/sec):	109.350
Moisture Content Post-break:	0.01%

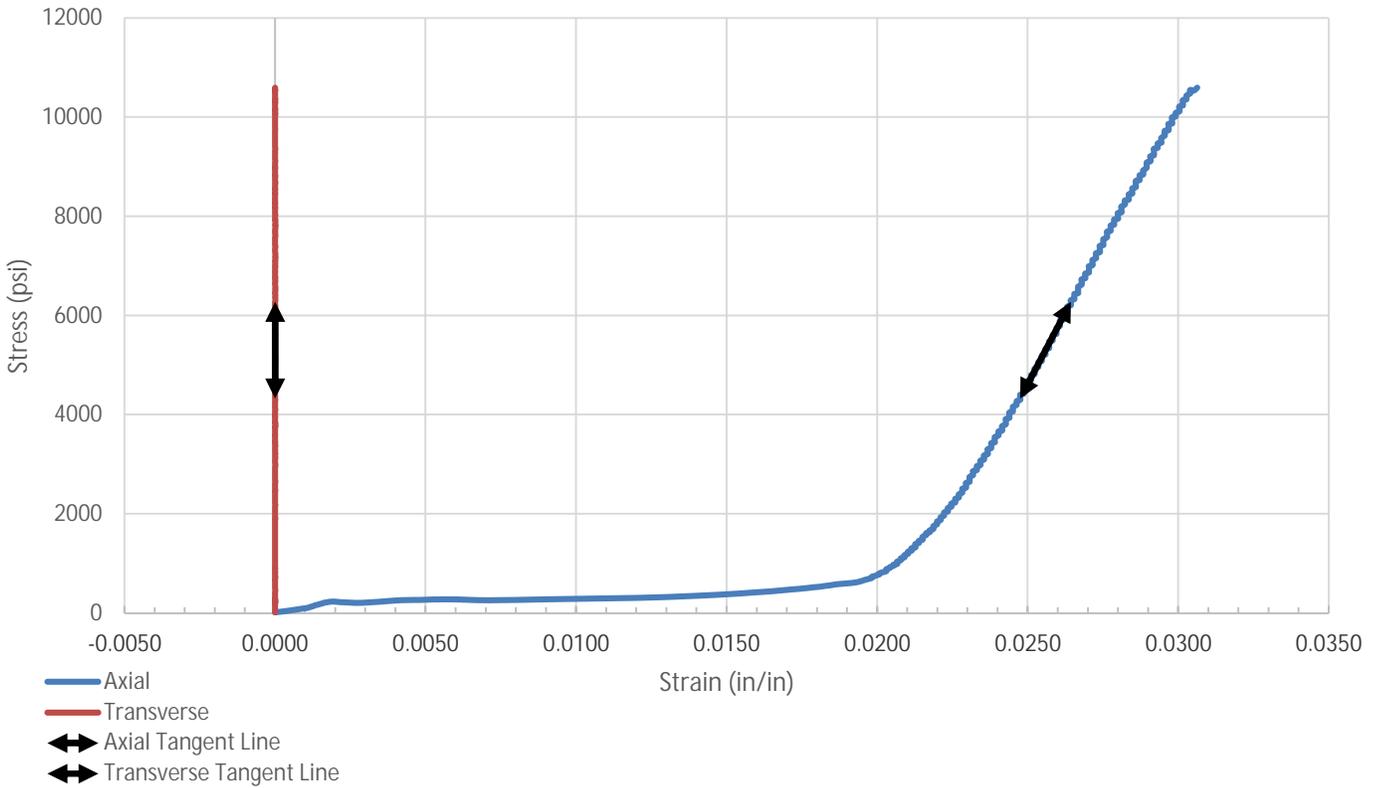
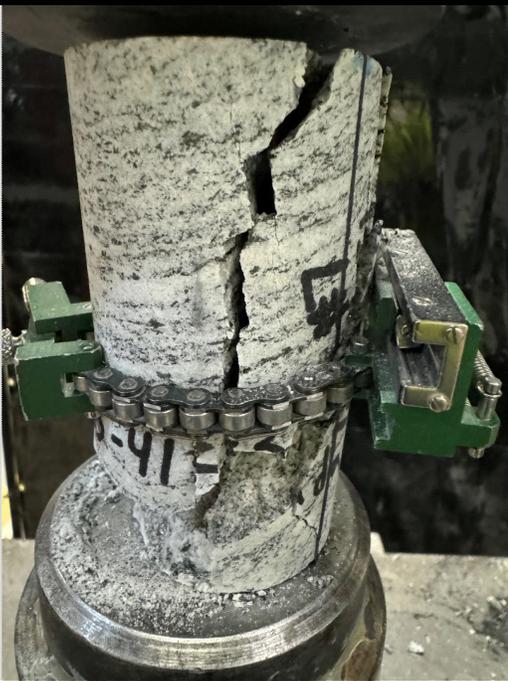
ASTM D7012 Stress/ Strain Curve

Failure Load (lbs):	32610
Failure Strain (%):	3.44
Unconfined Compressive Strength (psi):	10,591
Elastic Modulus, E, (ksi):	1158
Poisson's Ratio, u:	0.001
Time of Failure (min):	01:36
Rate of Loading (psi/sec):	109.863
Moisture Content Post-break:	0.01%

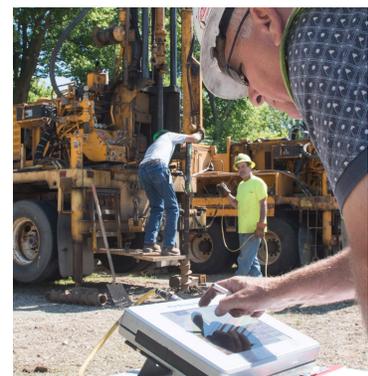
- Calculates energy transferred by SPT hammers using force and velocity measurements
- Determines N value to help improve reliability of soil strength estimates
- Offers simplified reporting and analysis option to speed testing results
- Operates in English, SI, or Metric units

The SPT Analyzer is compliant with EN ISO 22476-3:2005. ASTM D1586 recommends normalizing results from any SPT test using energy measurements. When these tests are performed to determine the liquefaction potential of sands, ASTM D6066 not only recommends but mandates the normalization. ASTM D4633 states that the only acceptable method of determining energy for normalization of N values is by force and velocity measurements.

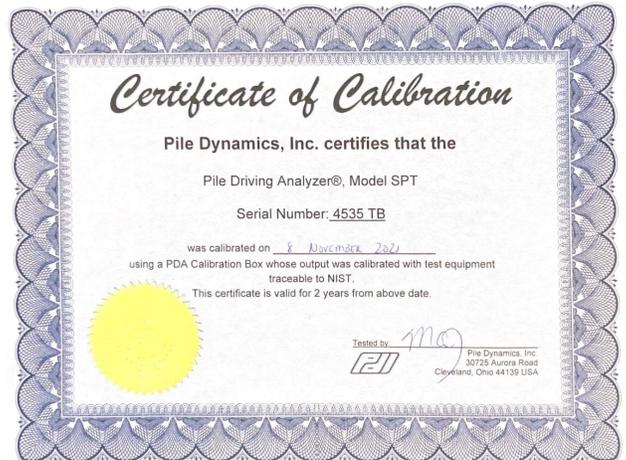
Exhibit B
PDA Equipment Calibration

648AWJ		Cycle 1		
Sample	Force (lb)	Strain (µE)	Bridge 1 (V)	Bridge 2 (V)
1	0.00	0.00	0.00	0.00
2	799.99	21.12	0.10	0.10
3	2111.63	58.22	0.26	0.26
4	2997.39	82.70	0.37	0.37
5	3848.07	106.26	0.47	0.47
6	5131.83	143.07	0.63	0.63
7	6017.79	167.81	0.74	0.75
8	6872.07	192.74	0.85	0.85
9	7783.57	218.15	0.96	0.96
10	9136.93	255.02	1.12	1.13
11	10026.70	280.73	1.24	1.24

Bridge 1		Bridge 2	
Force Calibration (lb/V)	8120.30	Force Calibration (lb/V)	8089.75
Offset	-4.24	Offset	-2.24
Correlation	0.999998	Correlation	0.999995
Strain Calibration (µE/V)	228.56	Strain Calibration (µE/V)	227.70
Offset	-1.57	Offset	-1.51
Correlation	0.999991	Correlation	0.999983

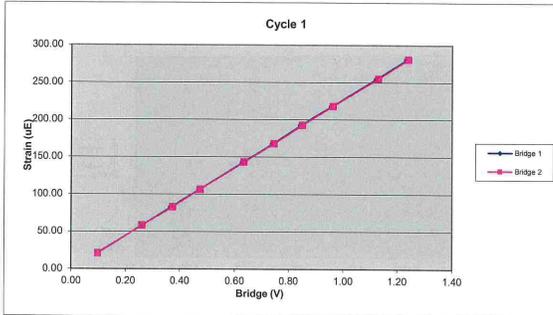
Force Strain Calibration	
EA (Kips)	35527.98
Offset	51.69
Correlation	0.999986

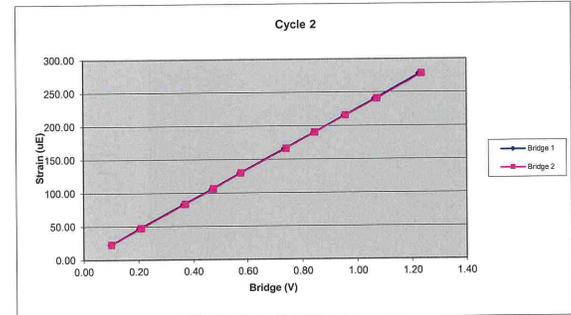
Force Strain Calibration	
EA (Kips)	36073.41
Offset	-2.66
Correlation	0.999993

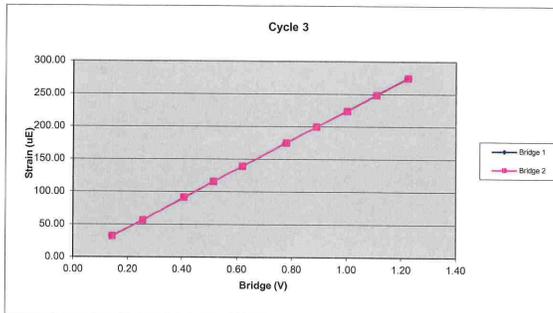
Force Strain Calibration	
EA (Kips)	36175.62
Offset	0.42
Correlation	0.999984
