S-23-102 (Keeler Mill Road) Bridge Replacement over Armstrong Creek Greenville County, SC

Geotechnical Subsurface Data Report

October 30, 2024 | SCDOT Project ID: P041161
Terracon Project No.: 8623P180 Revision 1

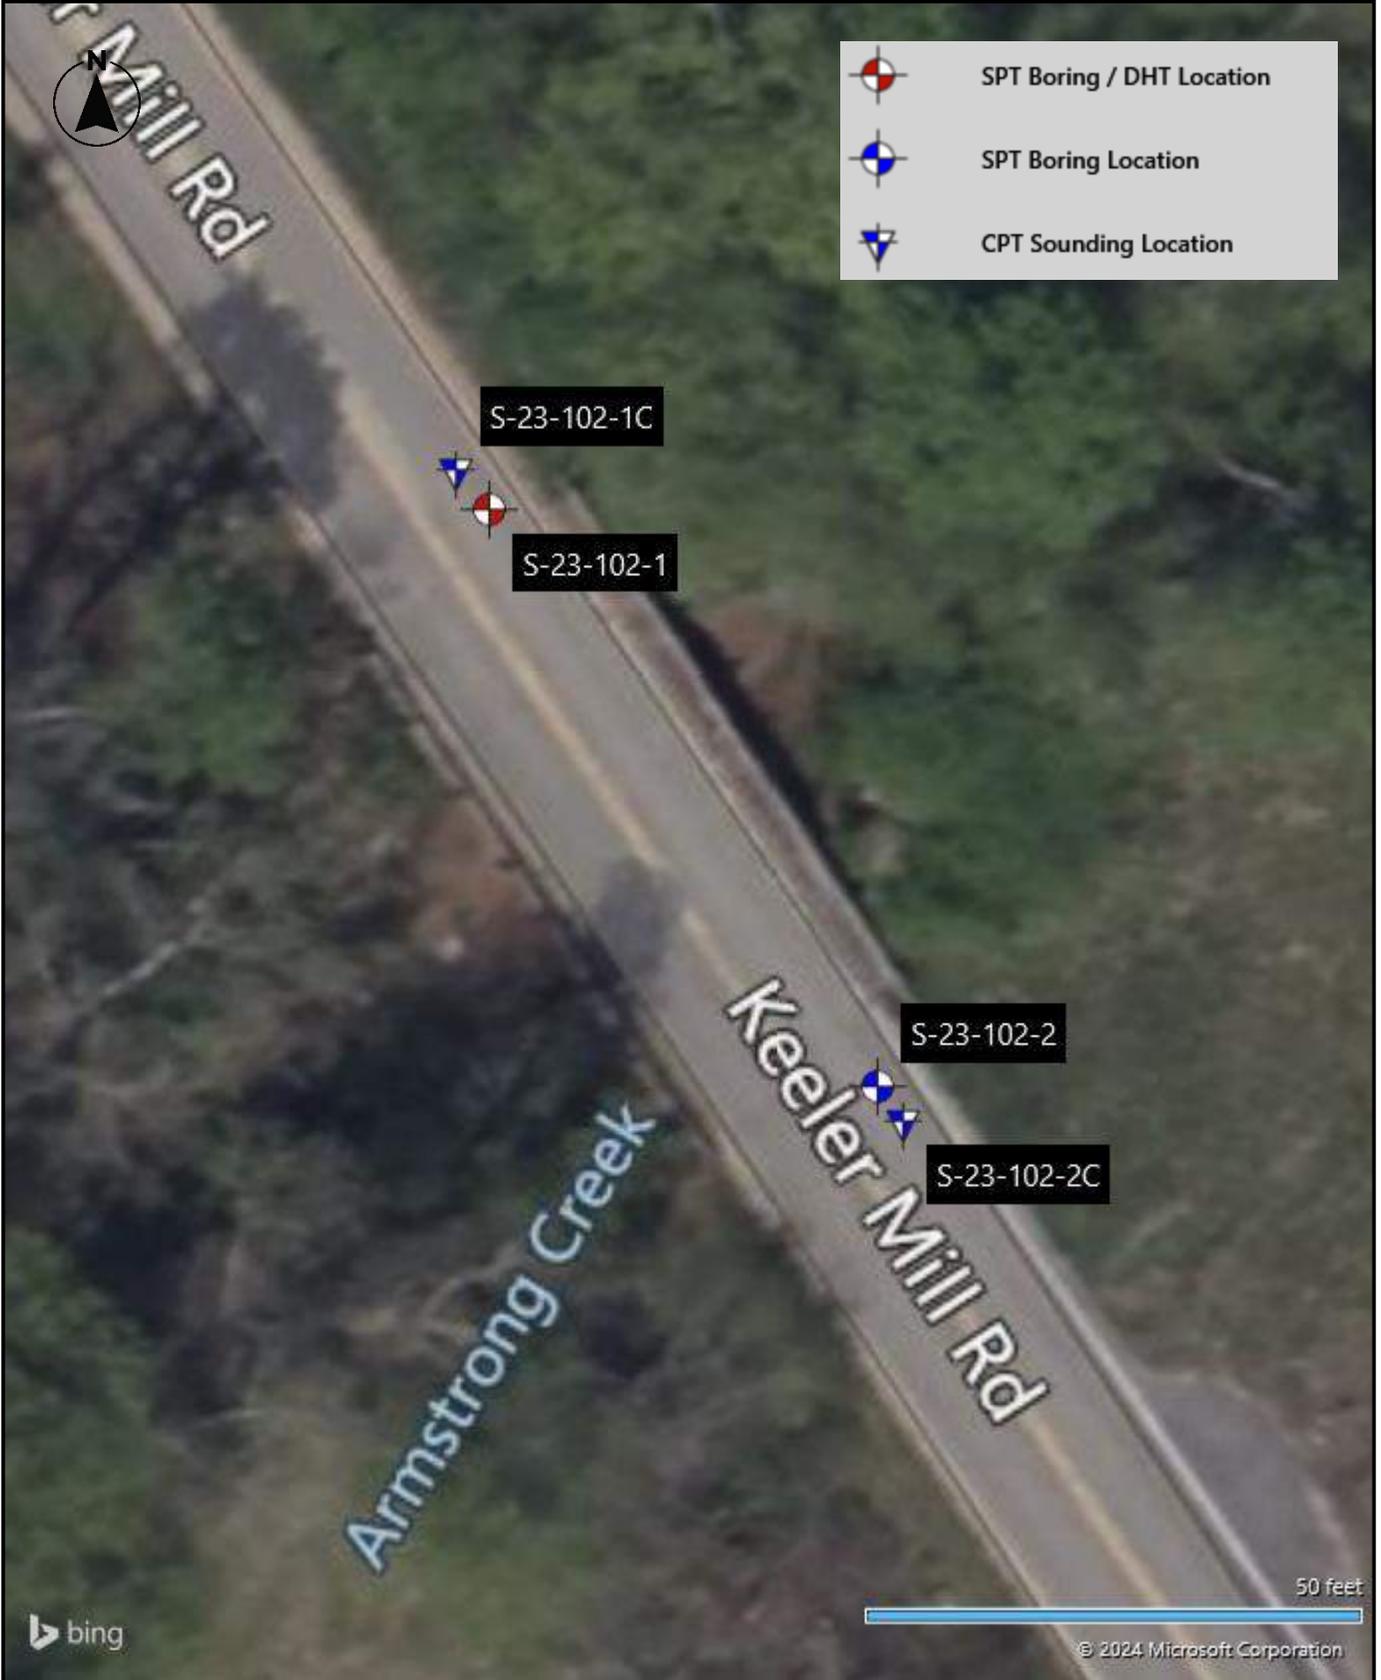
Exhibit

EXPLORATION PLAN

S-23-102 BRO Armstrong Creek
Keeler Mill Road
Greenville County, SC

The tests were performed at the approximate locations as approved by SCDOT. A description of our testing methods and graphical logs outlining the soil conditions at each test location are presented in Appendix A. The test locations were established in the field by Terracon and surveyed by Thomas & Hutton, LLC after completion. Station and offset are based on the plans provided at the time the tests were performed.

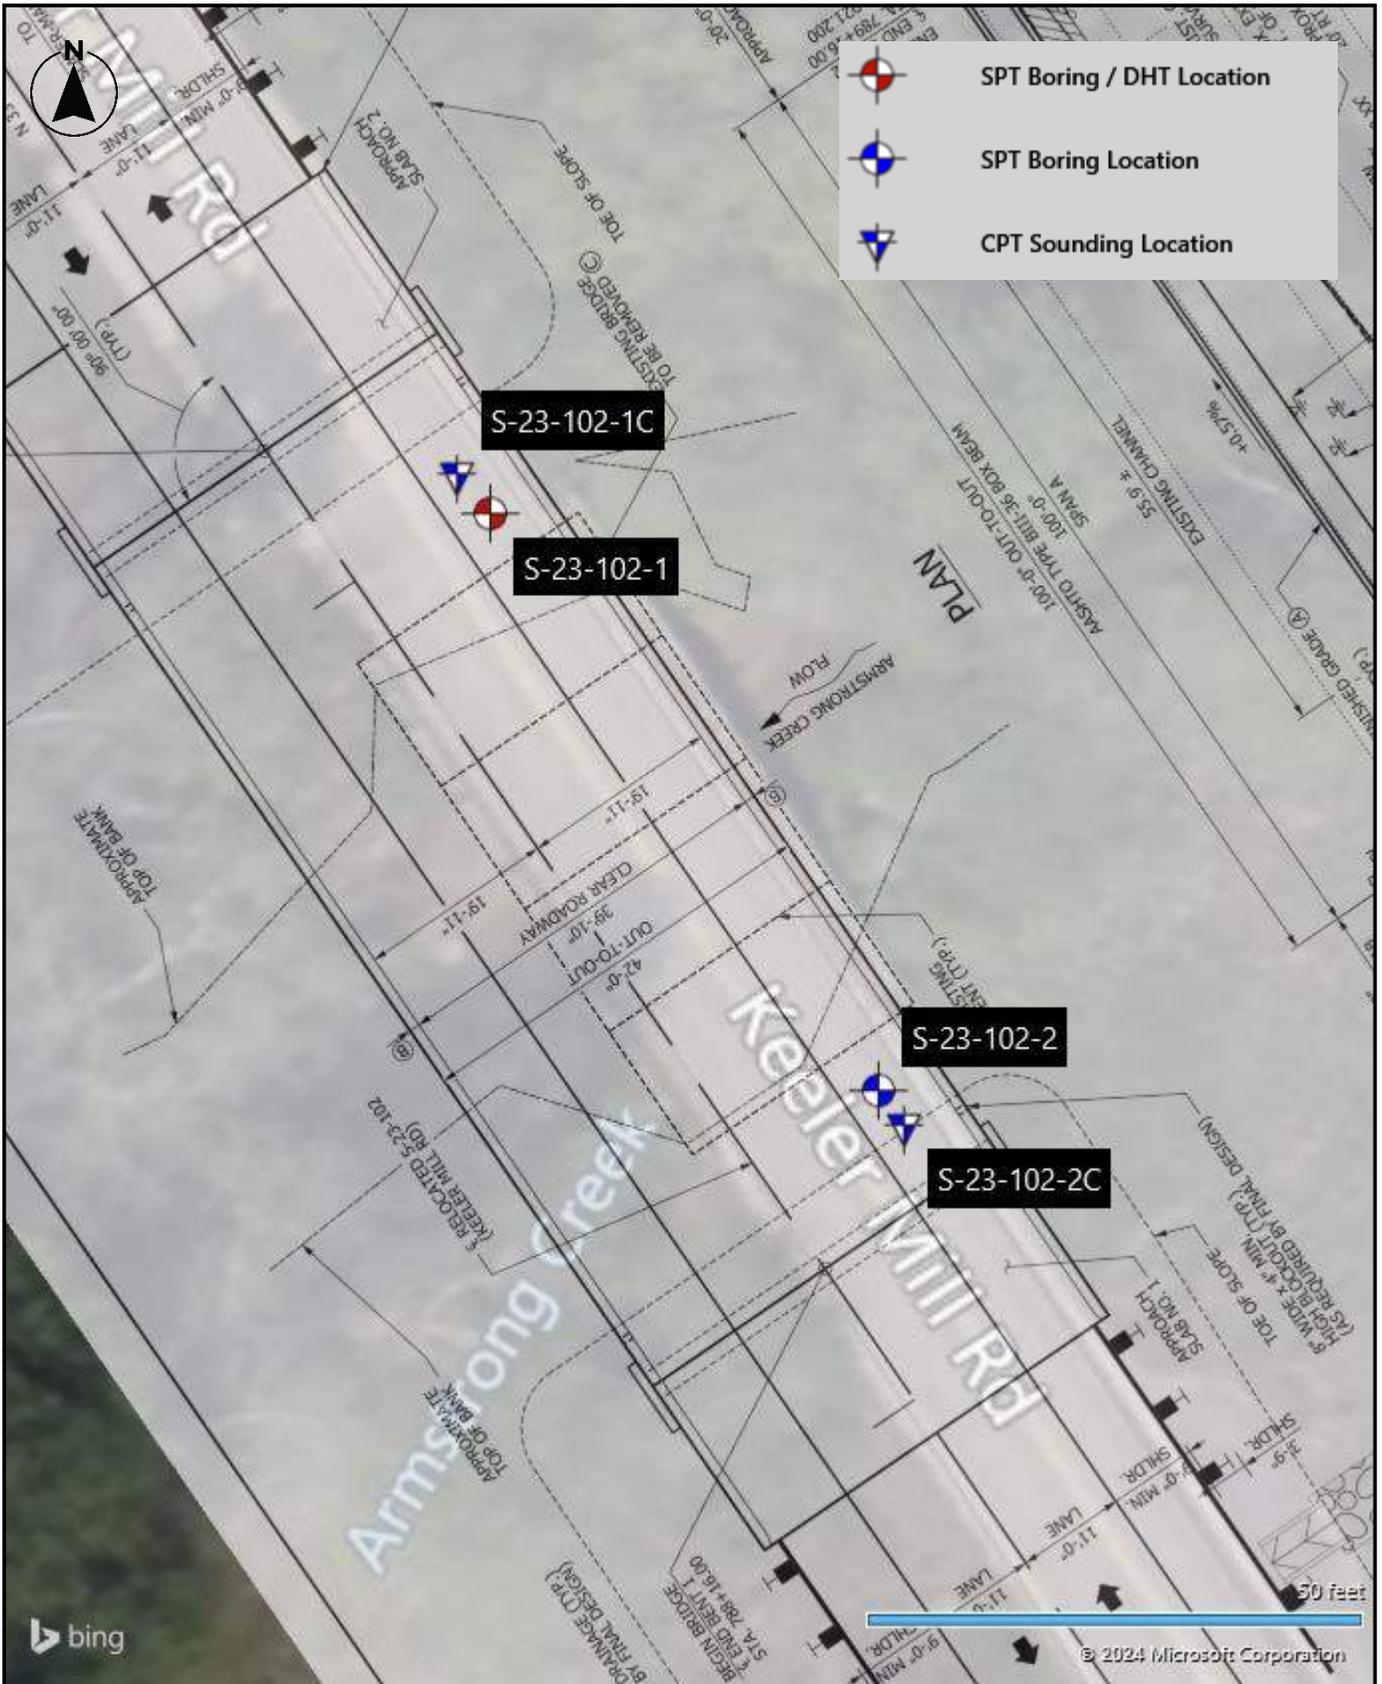
A-2

EXPLORATION PLAN

S-23-102 BRO Armstrong Creek
Keeler Mill Road
Greenville County, SC

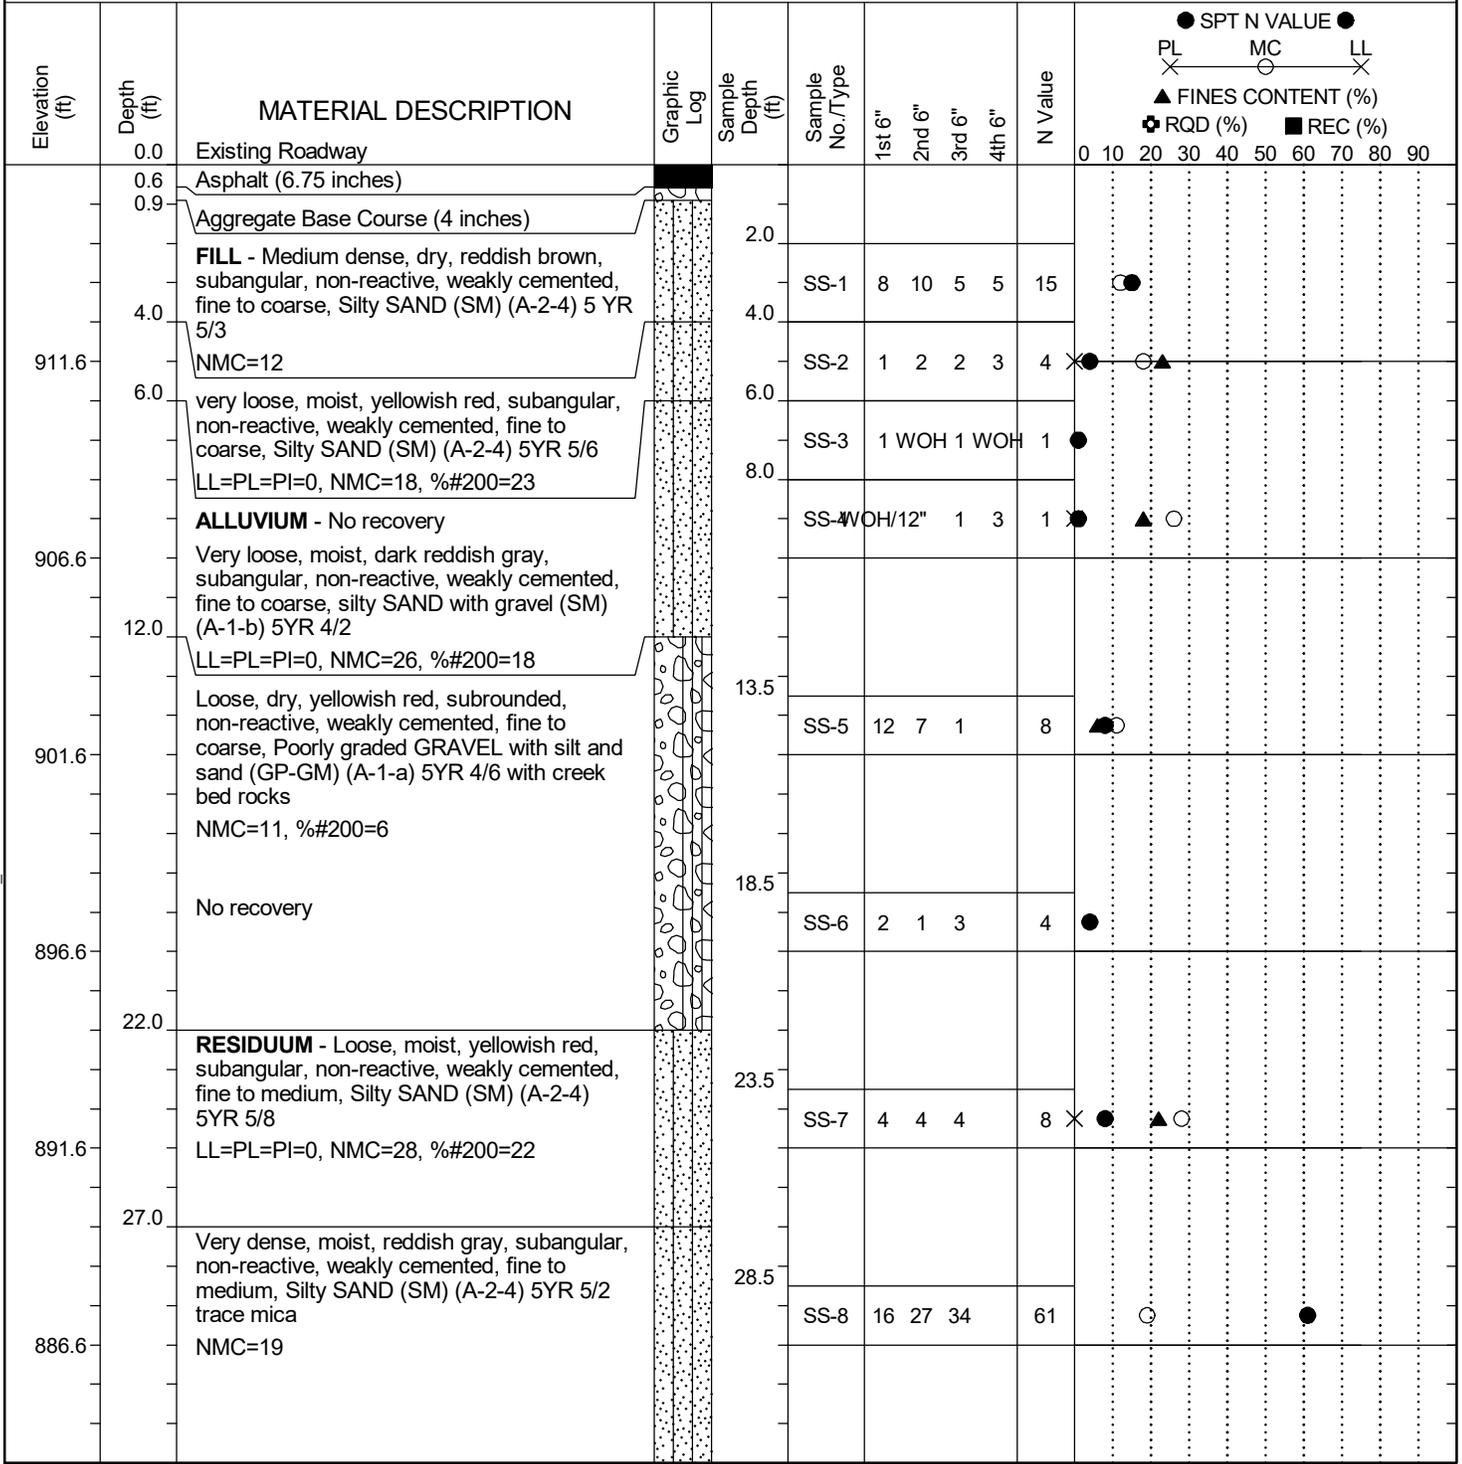
Project ID: P041161	County: Greenville	Boring No.: S-23-102-1
Site Description: S-23-102 BRO Armstrong Creek		Route: S-23-102
Eng./Geo.: S. Greaber	Boring Location: 788+98	Offset: 15 R
Alignment: Proposed	Date Started: 6/3/2024	
Elev.: 916.6 ft	Latitude: 34.9420005	Longitude: -82.4926575
Total Depth: 64 ft	Soil Depth: 49 ft	Core Depth: 15 ft
Date Completed: 6/3/2024		
Bore Hole Diameter (in): 4	Sampler Configuration	Liner Required: Y (N)
Liner Used: Y (N)		
Drill Machine: DR#554	Drill Method: RW/RC	Hammer Type: Automatic
Energy Ratio: 88.5%		
Core Size: NQ2	Driller: B. Burnette	Groundwater: TOB N.M.
24HR: N.M.

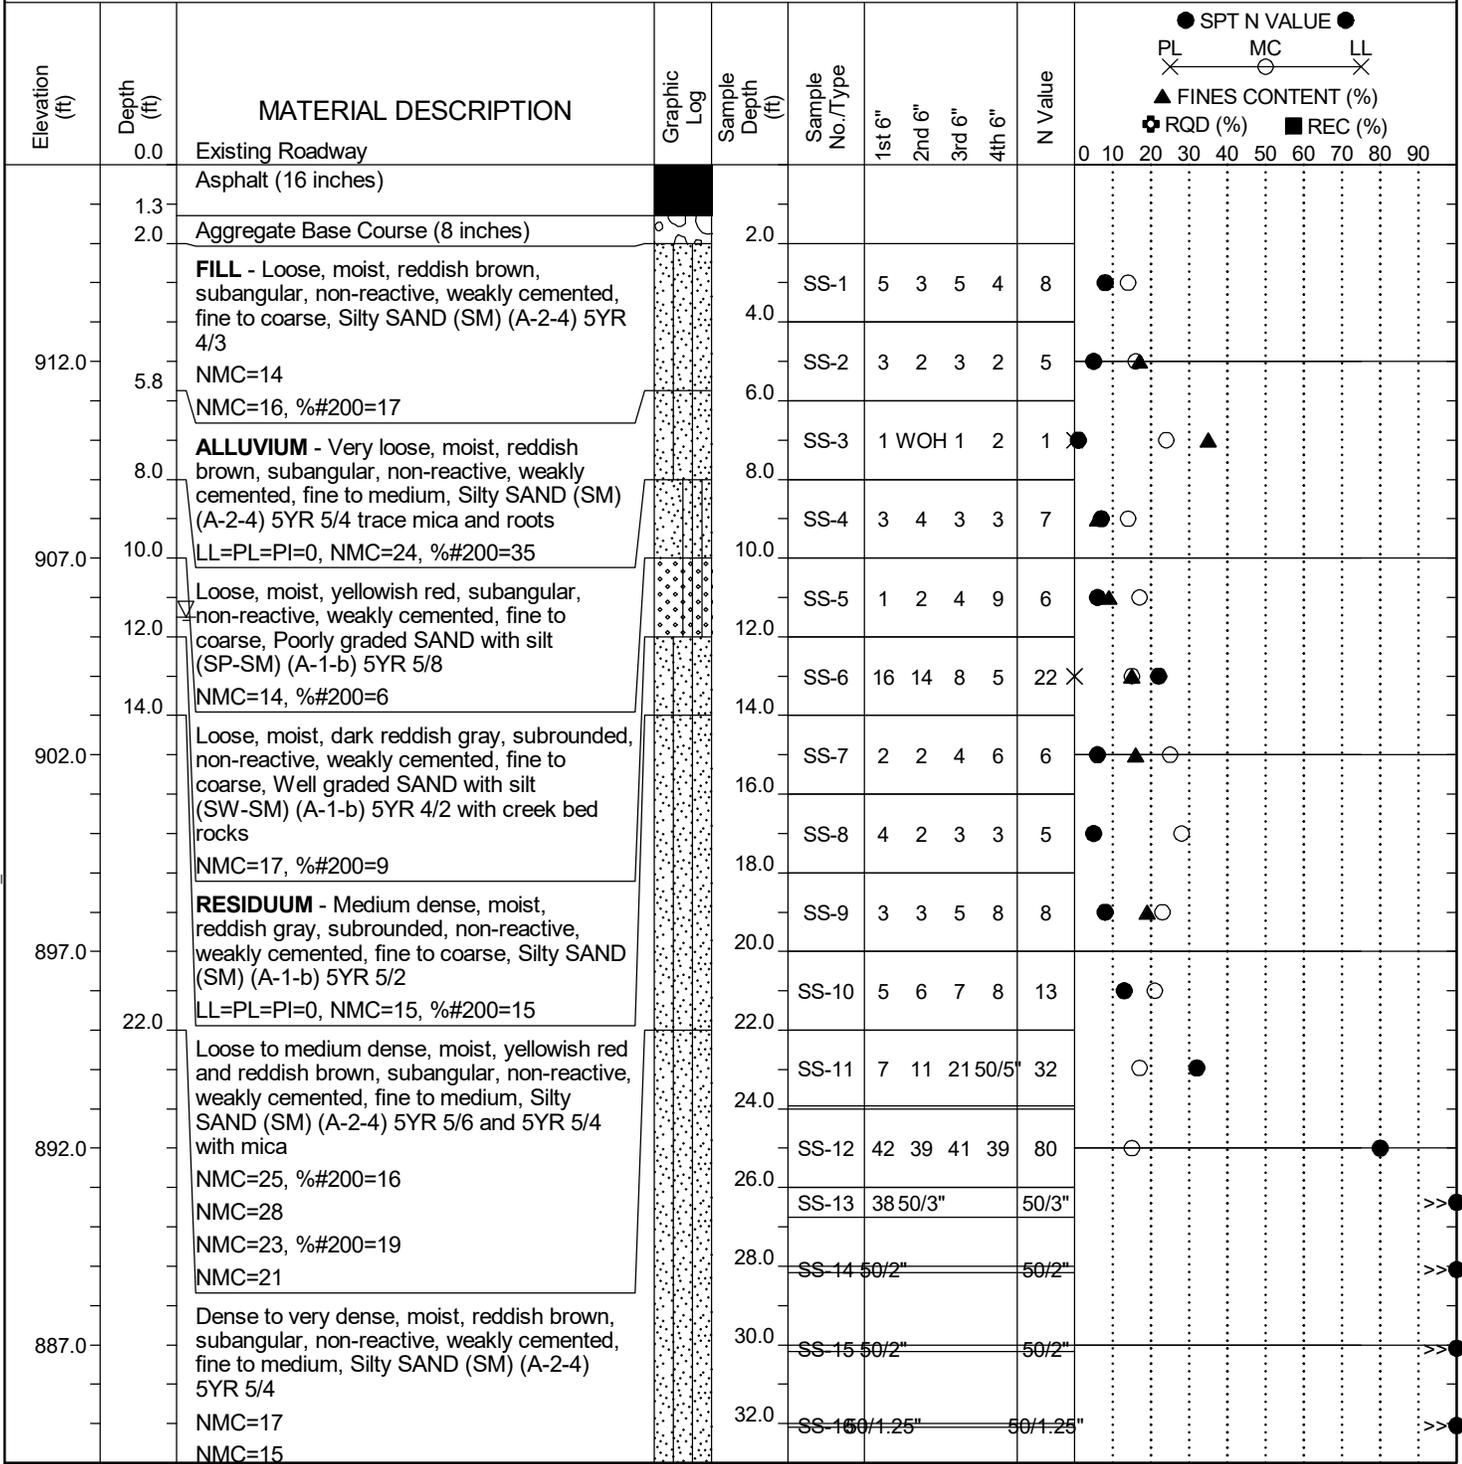
Project ID: P041161	County: Greenville	Boring No.: S-23-102-2
Site Description: S-23-102 BRO Armstrong Creek		Route: S-23-102
Eng./Geo.: S. Greaber	Boring Location: 788+28	Offset: 15 R
Alignment: Proposed	Date Started: 6/4/2024	
Elev.: 917.0 ft	Latitude: 34.9418411	Longitude: -82.4925268
Total Depth: 43.5 ft	Soil Depth: 33.5 ft	Core Depth: 10 ft
Date Completed: 6/4/2024		
Bore Hole Diameter (in): 4	Sampler Configuration	Liner Required: Y (N)
Liner Used: Y (N)		
Drill Machine: DR#554	Drill Method: RW/RC	Hammer Type: Automatic
Energy Ratio: 88.5%		
Core Size: NQ2	Driller: B. Burnette	Groundwater: TOB 11.5 ft
24HR: N.M.

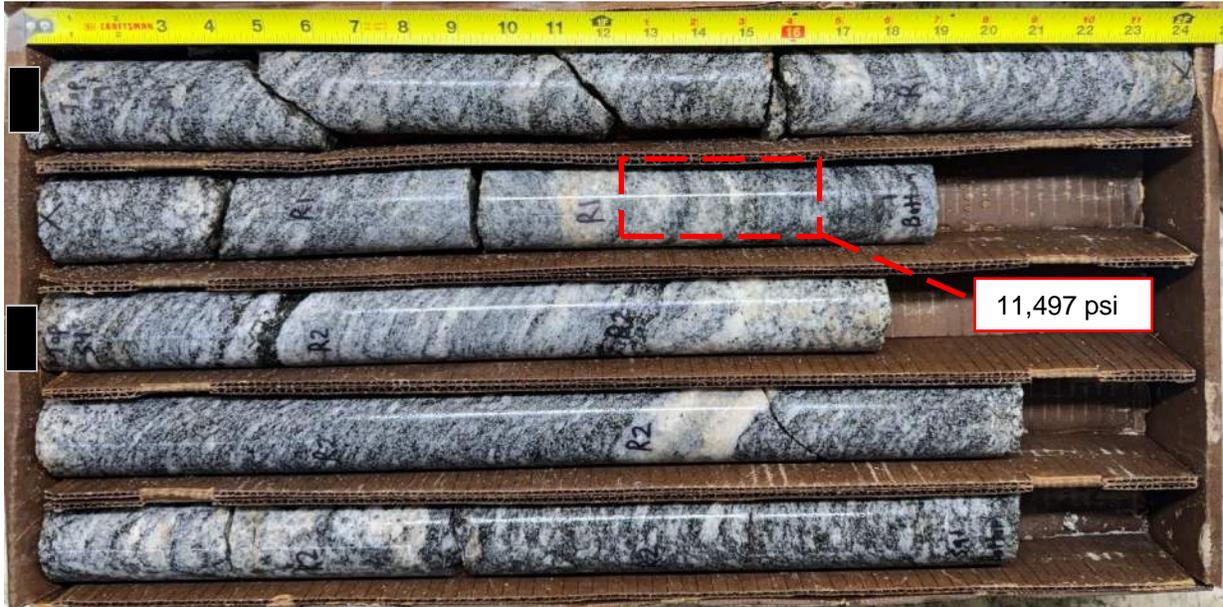
S-23-102-1, NQ-1 and NQ-2 (49 to 59 feet)

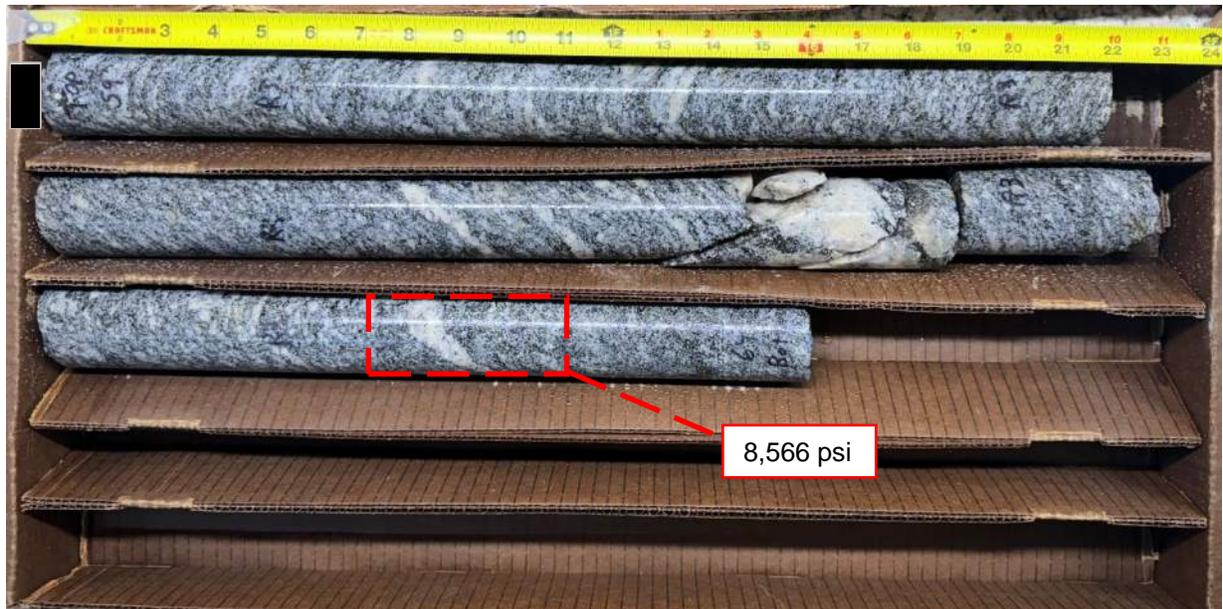
S-23-102-1, NQ-3 (59 to 64 feet)

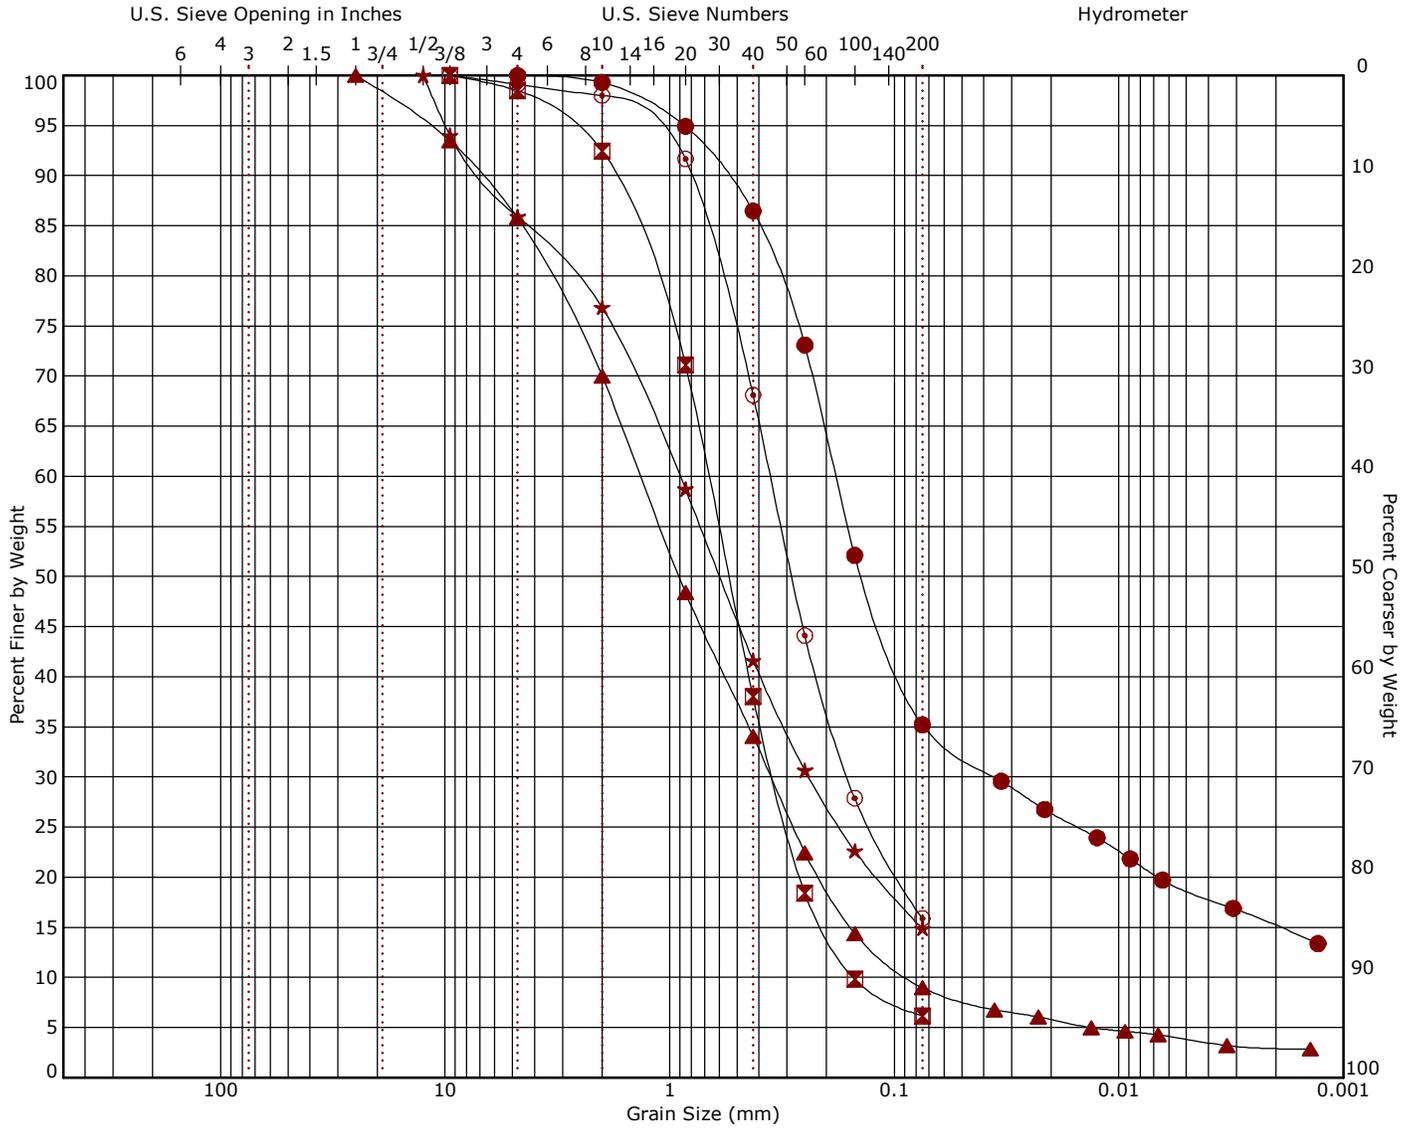
Boring ID	Depth (Ft)	USCS Classification	USCS	AASHTO	LL	PL	PI	Cc	Cu
● S-23-102-2	6 - 8	SILTY SAND	SM	A-2-4 (0)	NP	NP	NP		
■ S-23-102-2	8 - 10	POORLY GRADED SAND W/ SILT	SP-SM	A-1-b				1.15	4.44
▲ S-23-102-2	10 - 12	WELL GRADED SAND W/ SILT	SW-SM	A-1-b				1.08	15.75
★ S-23-102-2	12 - 14	SILTY SAND	SM	A-1-b (0)	NP	NP	NP		
⊙ S-23-102-2	14 - 16	SILTY SAND	SM	A-2-4

Boring ID	Depth (Ft)	D ₁₀₀	D ₆₀	D ₃₀	D ₁₀	%Cobbles	%Gravel	%Sand	%Fines	%Silt	%Clay
● S-23-102-2	6 - 8	4.75	0.182	0.035		0.0	0.0	64.8		16.5	18.8
■ S-23-102-2	8 - 10	9.5	0.673	0.342	0.152	0.0	1.5	92.3	6.2		
▲ S-23-102-2	10 - 12	25	1.345	0.353	0.085	0.0	14.2	76.8		5.1	3.8
★ S-23-102-2	12 - 14	12.5	0.903	0.24		0.0	14.1	71.0	14.9		
⊙ S-23-102-2	14 - 16	9.5	0.355	0.16		0.0	0.9	83.2	15.9

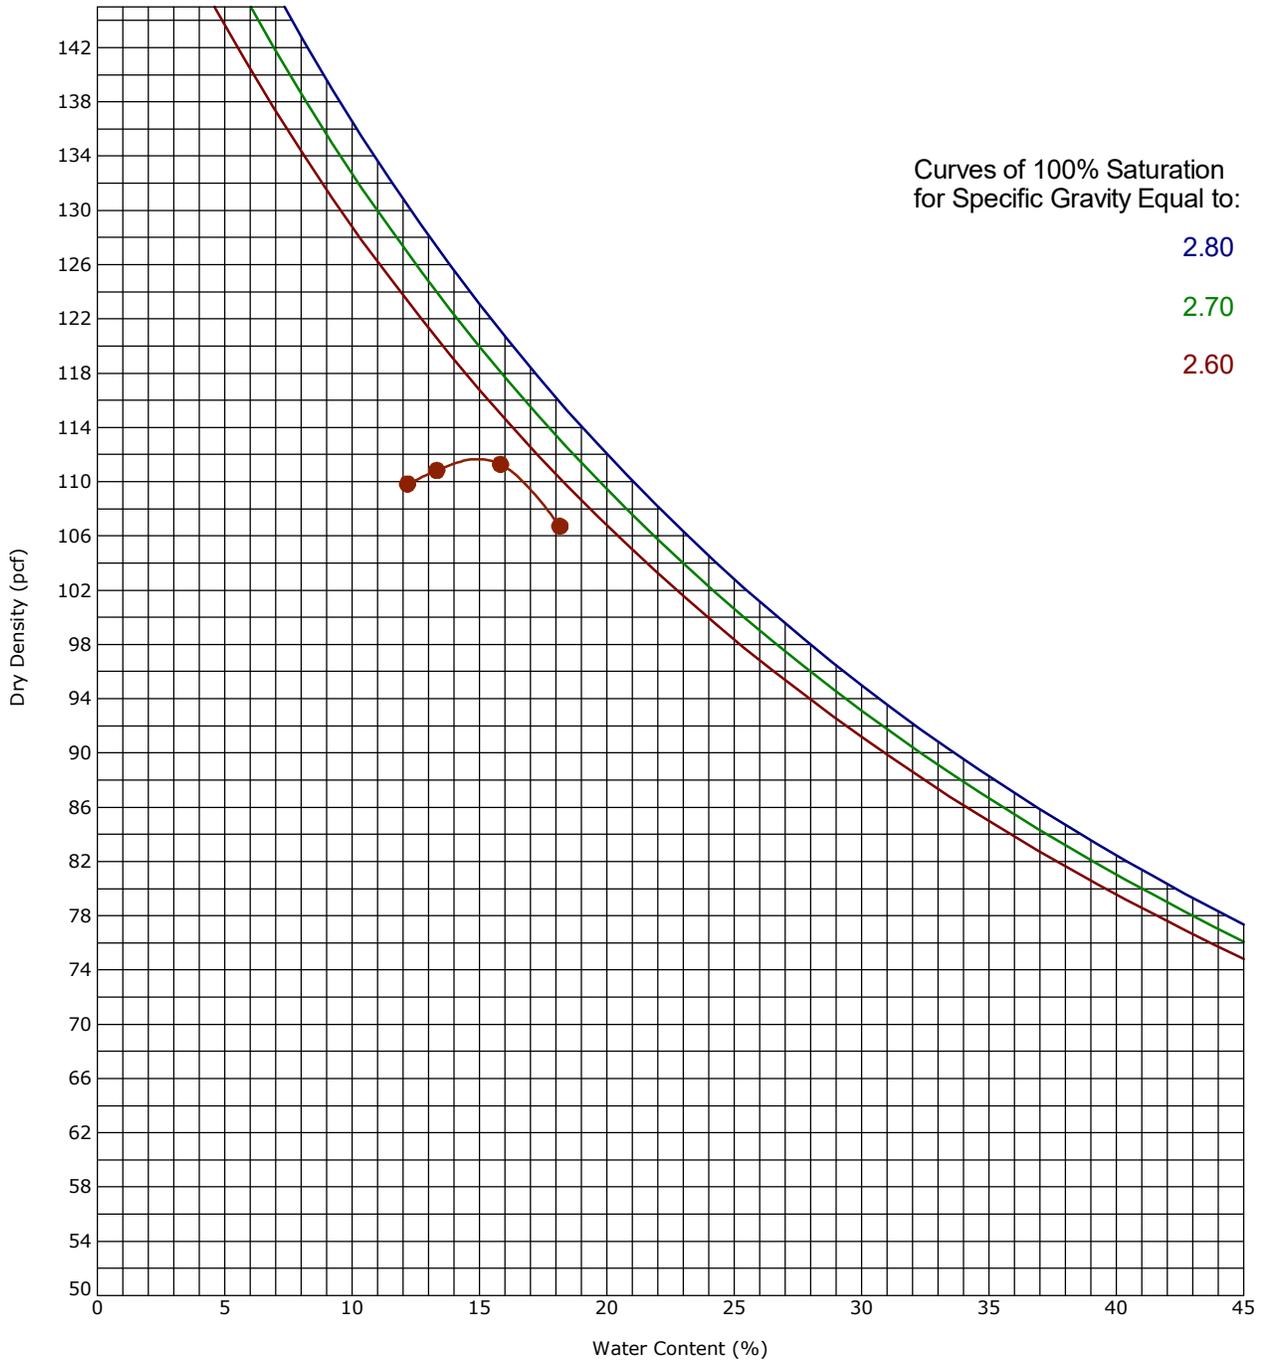
Moisture-Density Relationship

Boring ID		Depth (Ft)		Description of Materials				
S-23-102-2 Offset		0 - 5		CLAYEY SAND(SC)				
Fines (%)	Fraction > mm size	LL	PL	PI	Test Method	Maximum Dry Density (pcf)	Optimum Water Content (%)	
29	0.0	33	23	10	ASTM D698-Method B	111.7	14.9

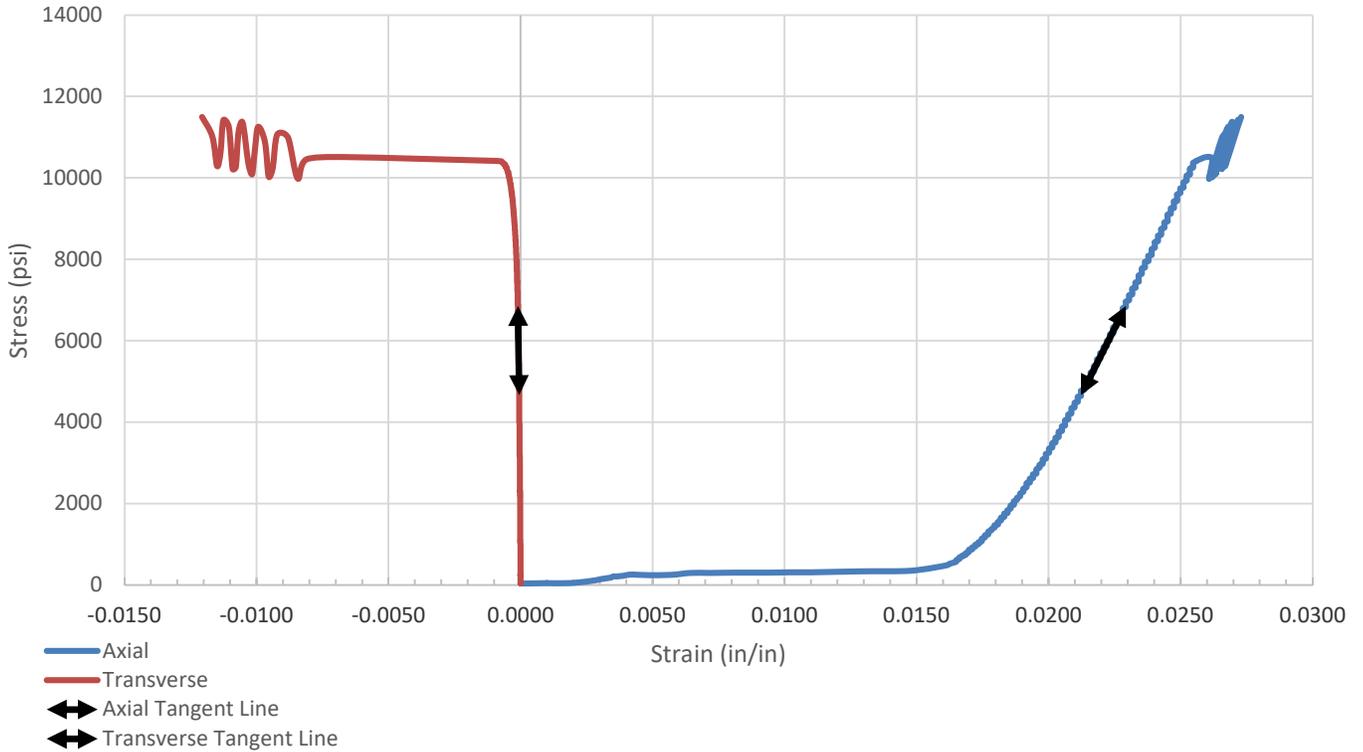
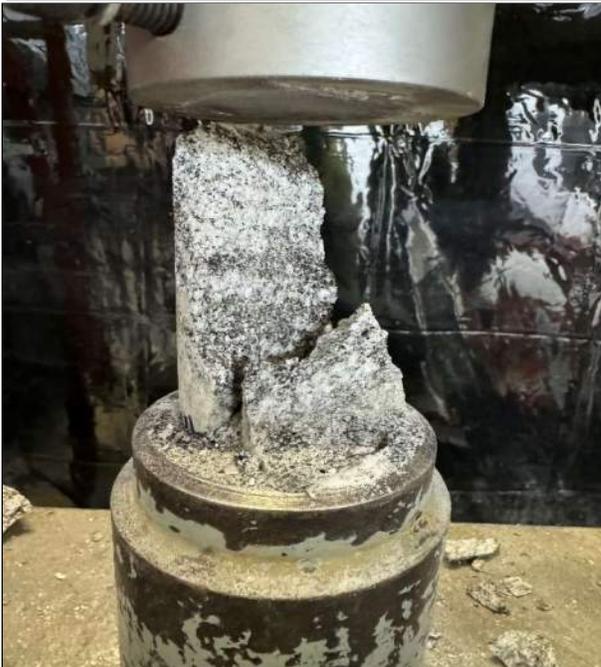
ASTM D7012 Stress/ Strain Curve

Site:	S-23-102 (Keeler Mill Road)		
Description:	Gneiss		
Boring:	S-23-102-1	Depth (feet):	53.2-54.0

Failure Load (lbs):	34337
Failure Strain (%):	2.78
Unconfined Compressive Strength (psi):	11,497
Elastic Modulus, E, (ksi):	1290
Poisson's Ratio, u:	0.029
Time of Failure (min):	01:39
Rate of Loading (psi/sec):	0.041
Moisture Content Post-break:	0.008

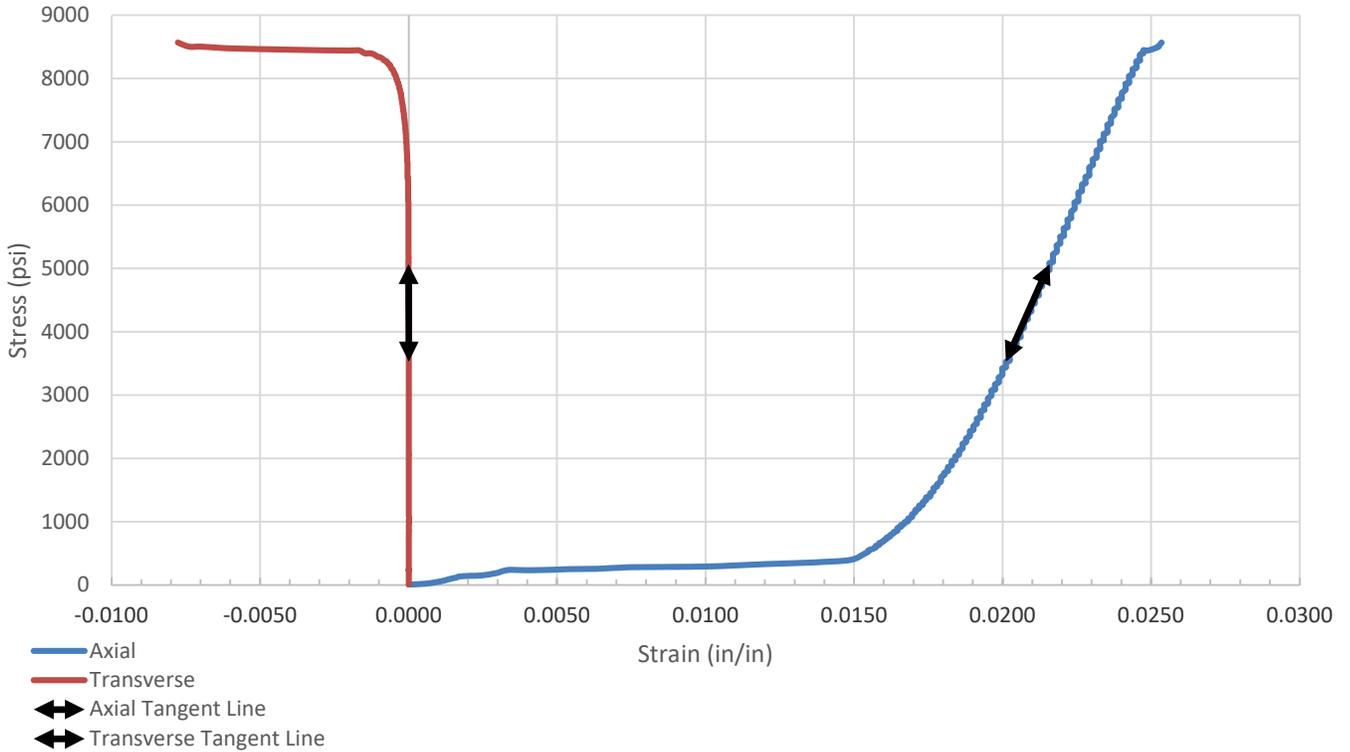
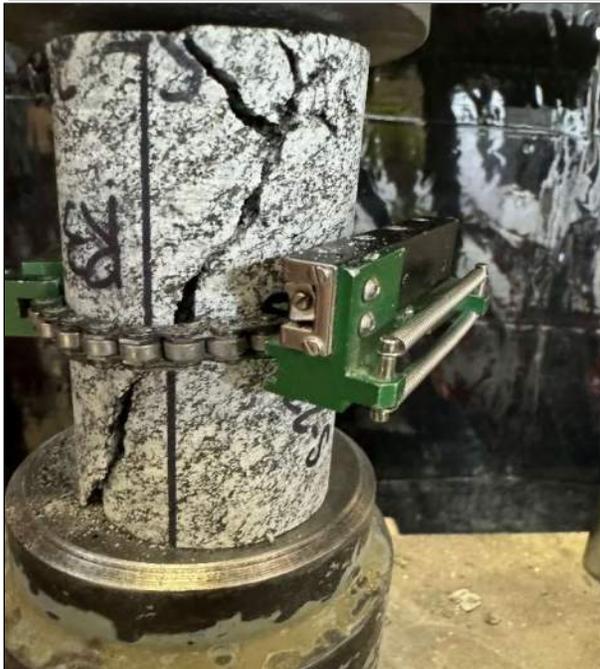
ASTM D7012 Stress/ Strain Curve

Site:	S-23-102 (Keeler Mill Road)		
Description:	Gneiss		
Boring:	S-23-102-1	Depth (feet):	62.7-64.0

Failure Load (lbs):	25583
Failure Strain (%):	2.57
Unconfined Compressive Strength (psi):	8,566
Elastic Modulus, E, (ksi):	1052
Poisson's Ratio, u:	0.006
Time of Failure (min):	01:18
Rate of Loading (psi/sec):	0.041
Moisture Content Post-break:	0.0019

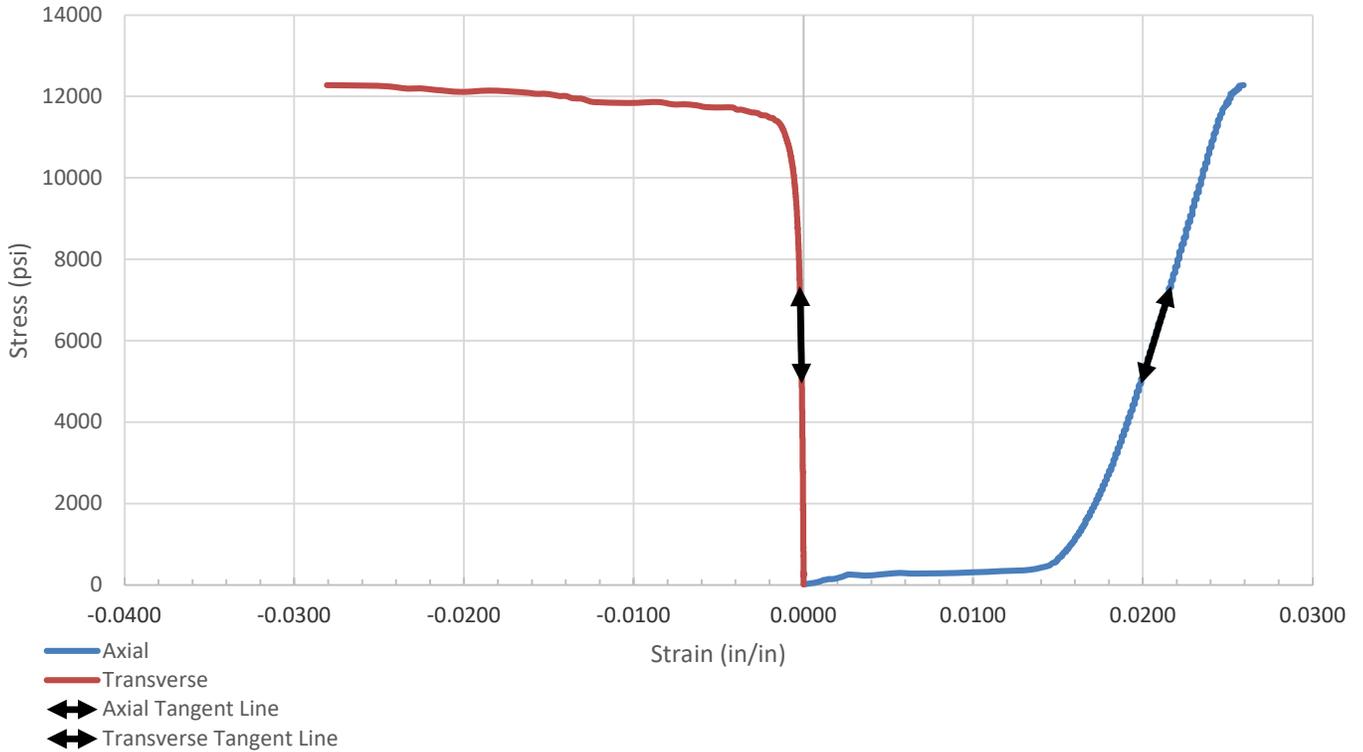
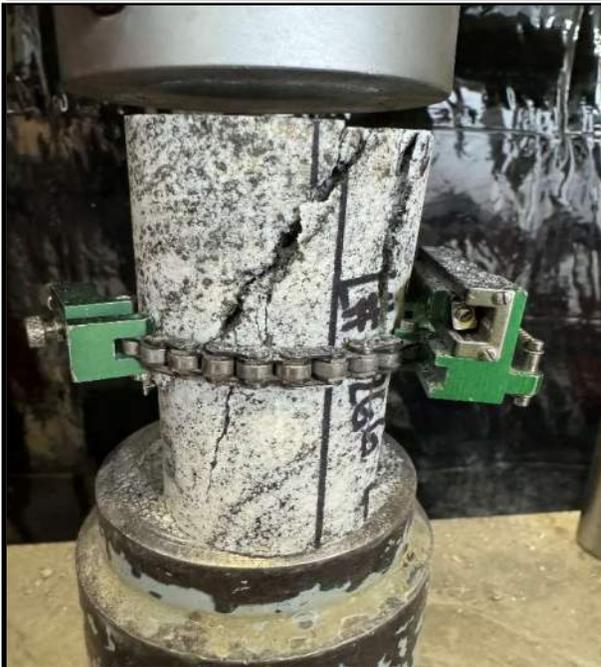
ASTM D7012 Stress/ Strain Curve

Site:	S-23-102 (Keeler Mill Road)		
Description:	Granite		
Boring:	S-23-102-2	Depth (feet):	34.5-35.6

Failure Load (lbs):	36302
Failure Strain (%):	3.05
Unconfined Compressive Strength (psi):	12,281
Elastic Modulus, E, (ksi):	1358
Poisson's Ratio, u:	0.066
Time of Failure (min):	01:52
Rate of Loading (psi/sec):	0.040
Moisture Content Post-break:	0.0014

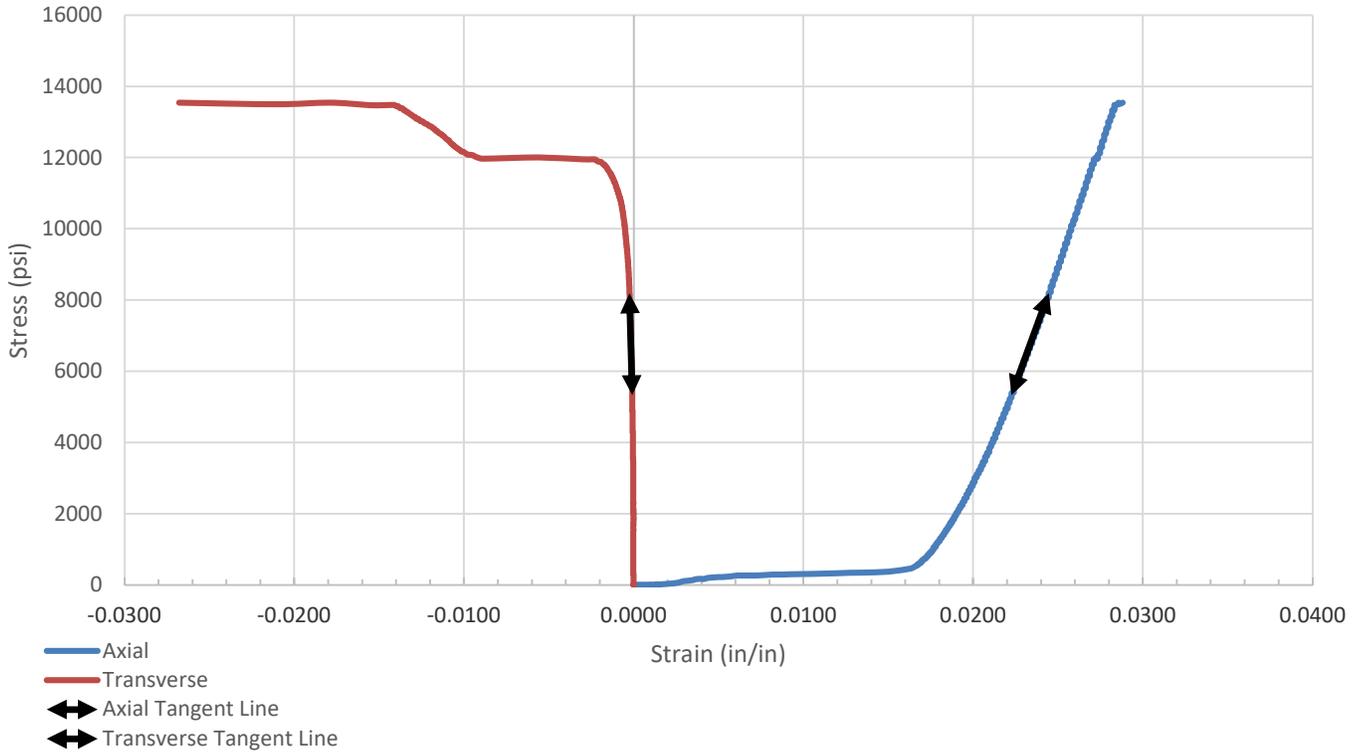
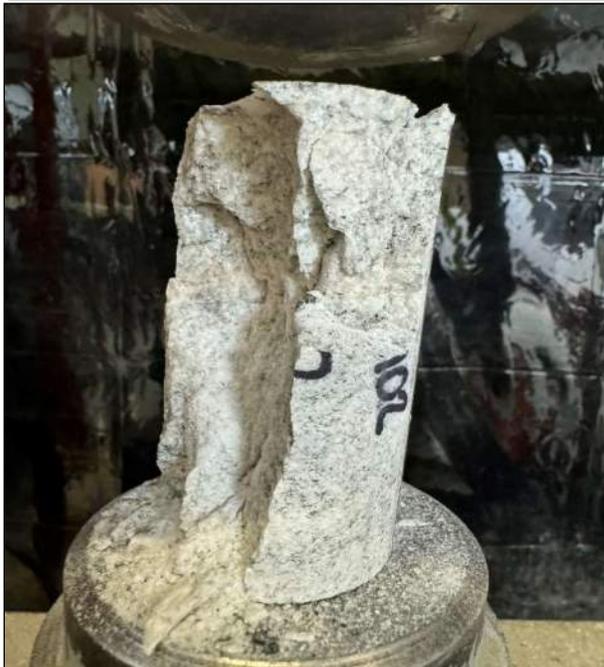
ASTM D7012 Stress/ Strain Curve

Site:	S-23-102 (Keeler Mill Road)		
Description:	Gneiss		
Boring:	S-23-102-2	Depth (feet):	41.5-42.5

Failure Load (lbs):	40457
Failure Strain (%):	2.88
Unconfined Compressive Strength (psi):	13,547
Elastic Modulus, E, (ksi):	1310
Poisson's Ratio, u:	0.072
Time of Failure (min):	02:06
Rate of Loading (psi/sec):	0.041
Moisture Content Post-break:	0.0017

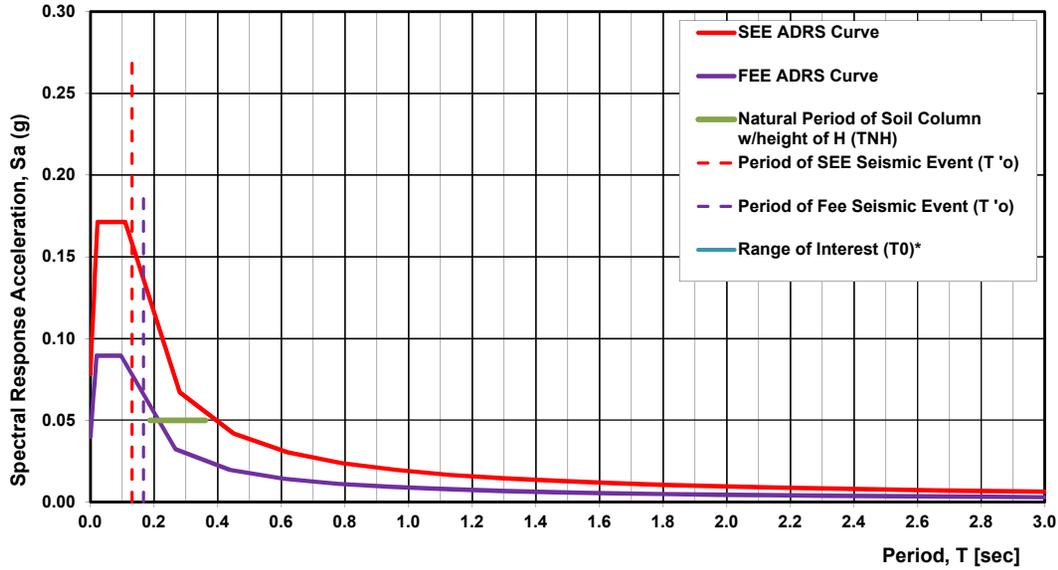
SC Seismic ADRS Curve

Damping:	5%
Geologic Condition:	Geologically Realistic (Q = 100)*
ADRS Location within Soil Column:	At Ground Surface

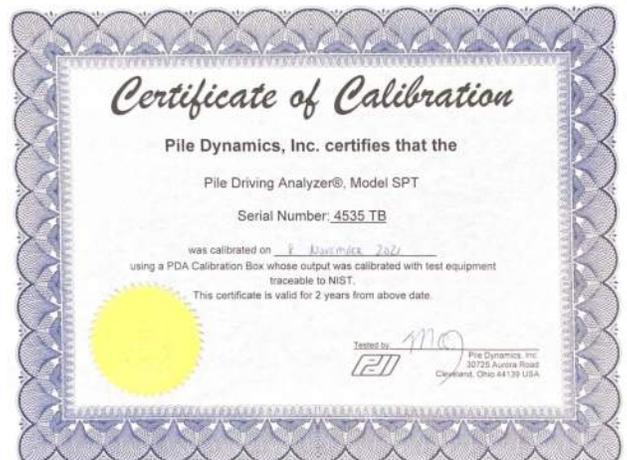
Exhibit B
PDA Equipment Calibration

648AWJ		Cycle 1			
Sample	Force (lb)	Strain (µE)	Bridge 1 (V)	Bridge 2 (V)	
1	0.00	0.00	0.00	0.00	
2	799.99	21.12	0.10	0.10	
3	2111.63	58.22	0.26	0.26	
4	2997.39	82.70	0.37	0.37	
5	3848.07	106.26	0.47	0.47	
6	5131.83	143.07	0.63	0.63	
7	6017.79	167.81	0.74	0.75	
8	6872.07	192.74	0.85	0.85	
9	7783.57	218.15	0.96	0.96	
10	9136.93	255.02	1.12	1.13	
11	10026.70	280.73	1.24	1.24

Bridge 1		Bridge 2	
Force Calibration (lb/V)	8120.30	Force Calibration (lb/V)	8089.75
Offset	-4.24	Offset	-2.24
Correlation	0.999998	Correlation	0.999995
Strain Calibration (µE/V)	228.56	Strain Calibration (µE/V)	227.70
Offset	-1.57	Offset	-1.51
Correlation	0.999991	Correlation	0.999983
