# S-23-102 (Keeler Mill Road) Bridge Replacement over Armstrong Creek

Project ID: P041161

## **Project Description:**

South Carolina Department of Transportation (SCDOT) proposes to replace the S-23-102 (Keeler Mill Road) Bridge over Armstrong Creek in Greenville County.

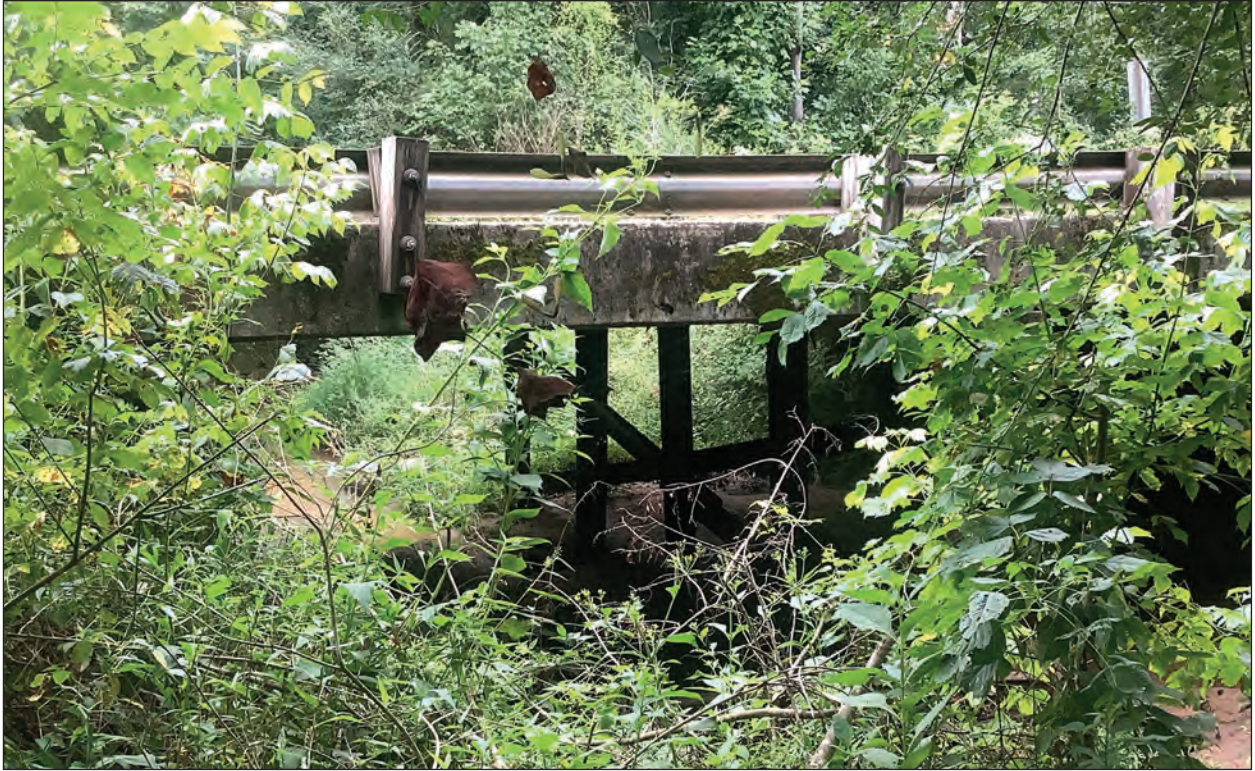
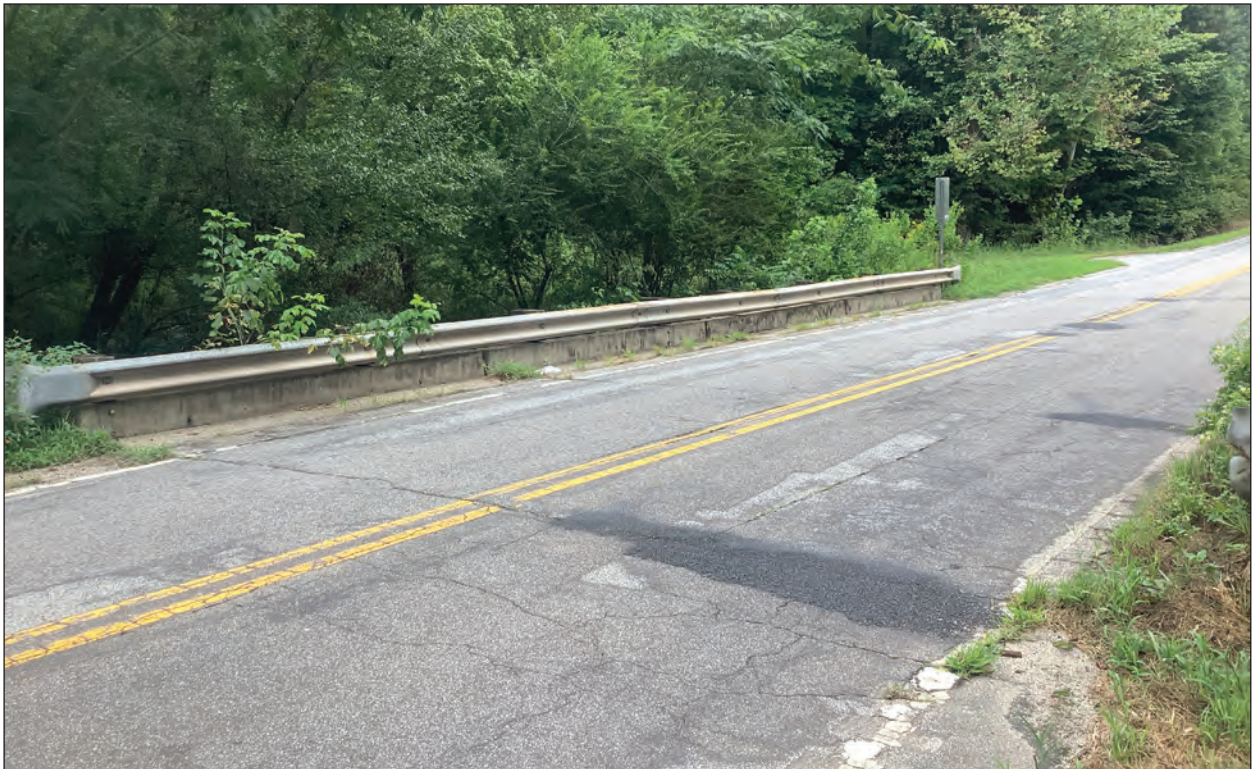
Figure 9.  
S-23-102 Bridge over Armstrong Creek, Built 1960 and Not Assessed

A. Bridge Structure, Looking Northeast

B. Bridge Surface, Looking Northeast

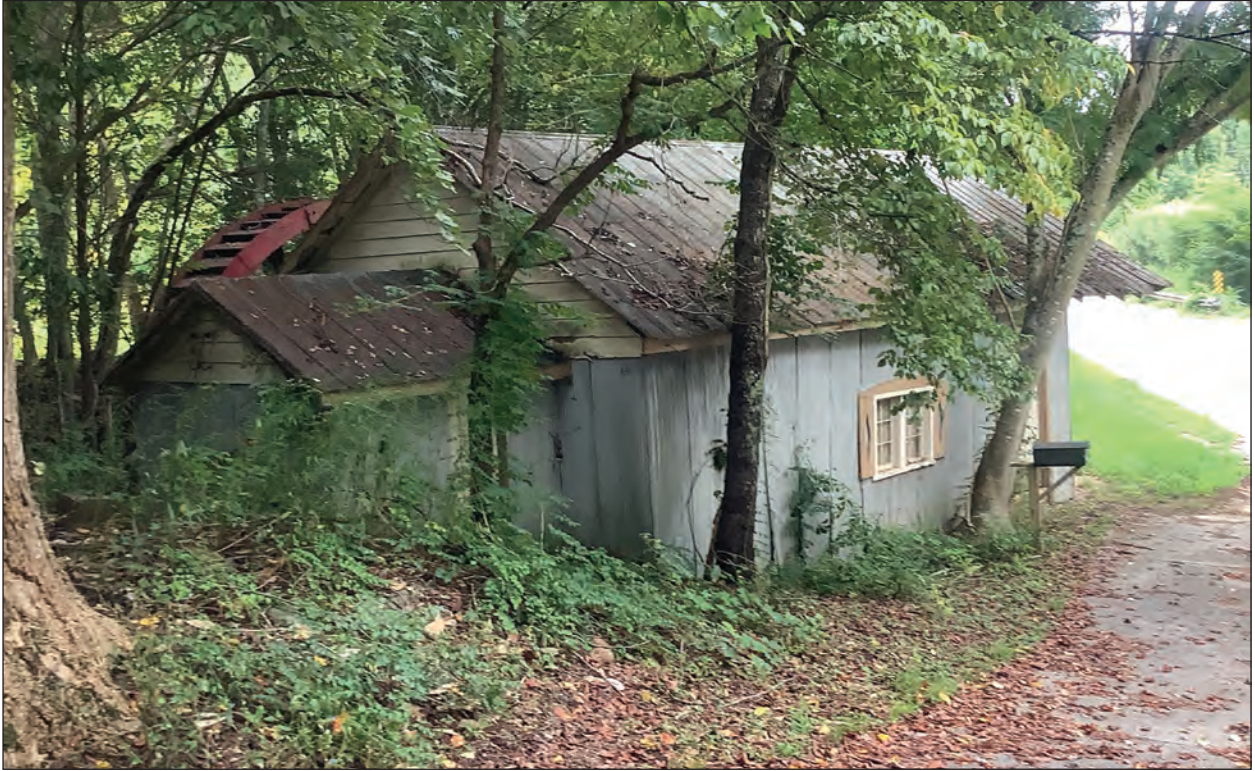
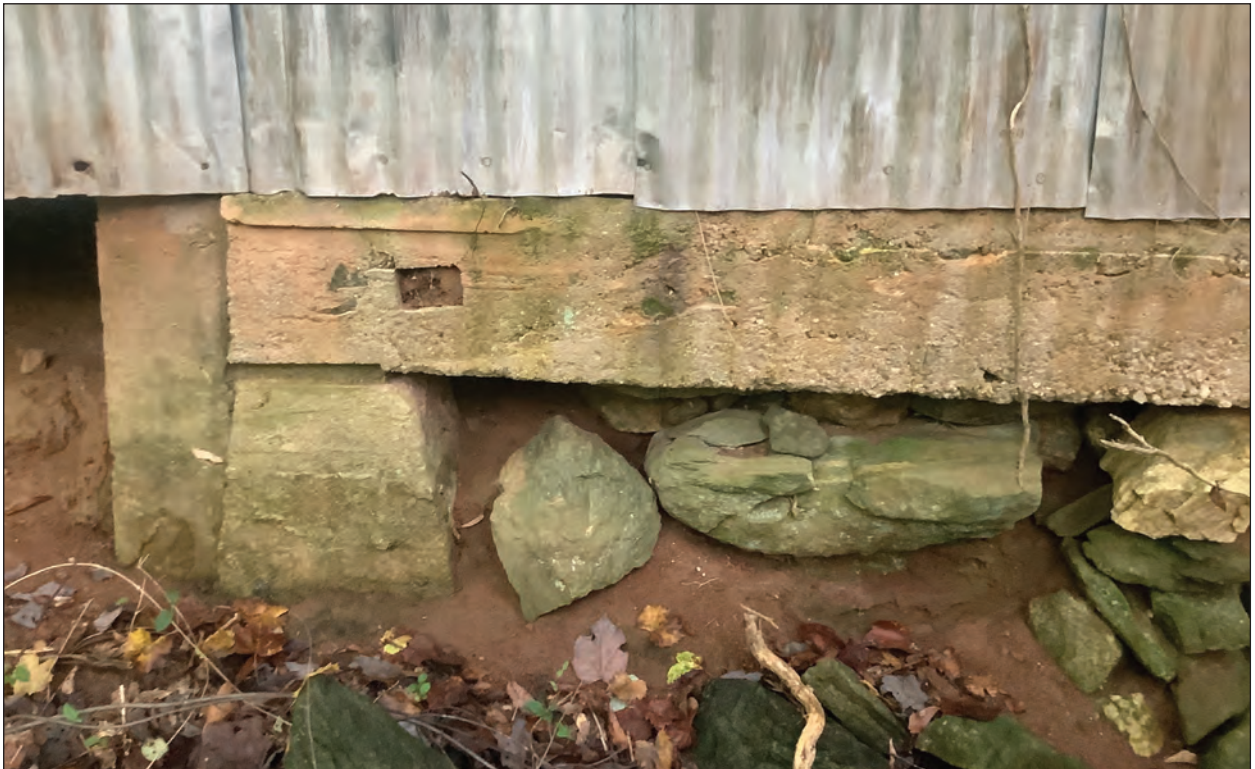
Figure 16.  
SHPO Site Number 6407 – 2185 Keeler Mill Road - Forrester Mill, 2 of 2

A. Rear Oblique, Looking Southeast

B. Foundation Detail on East Elevation

SHPO Site Number 6407, the Forrester Mill, retains integrity in location, design, materials, workmanship, and feeling. Almost all materials are either historic or in-kind replacements. Portions of the corrugated metal siding appear modern, as do the poured concrete sections of the foundation. These changes may date to the Rimer-era refurbishment of the mill in the 1980s. Additionally, the shift of the path of Armstrong Creek to the south has affected integrity of setting and association. The setting remains rural, but the mill is no longer adjacent to the creek. However, this does not ultimately affect the resource's ability to convey its significance as a late example of a rural Piedmont grist mill. Additionally, other local mills appear to no longer be extant, including the Z.P. Baston Mill. SHPO Site Number 6407 is recommended as eligible for the NRHP under Criterion A: Industry on the local level with a period of significance from circa 1926, when Mack Duffie Forrester bought the property, until 1957, when the mill was last known to be operational. The proposed NRHP boundary follows the parcel boundary (Figure 24). The parcel is of an unusual shape. It extends narrowly to the northeast, where it has clearly been drawn to carve out as much of Armstrong Creek as possible from the surrounding land. This creek was an integral component of the milling operation and should be retained within the NRHP boundary. The size of the property is within one acre of its original, 1926 size, and the current boundaries are consistent with historic descriptions. The Forrester Mill was considered for the NRHP under Criterion C but the bar for integrity is higher under this criterion, and concerns such as the replacement siding preclude its eligibility for architecture.

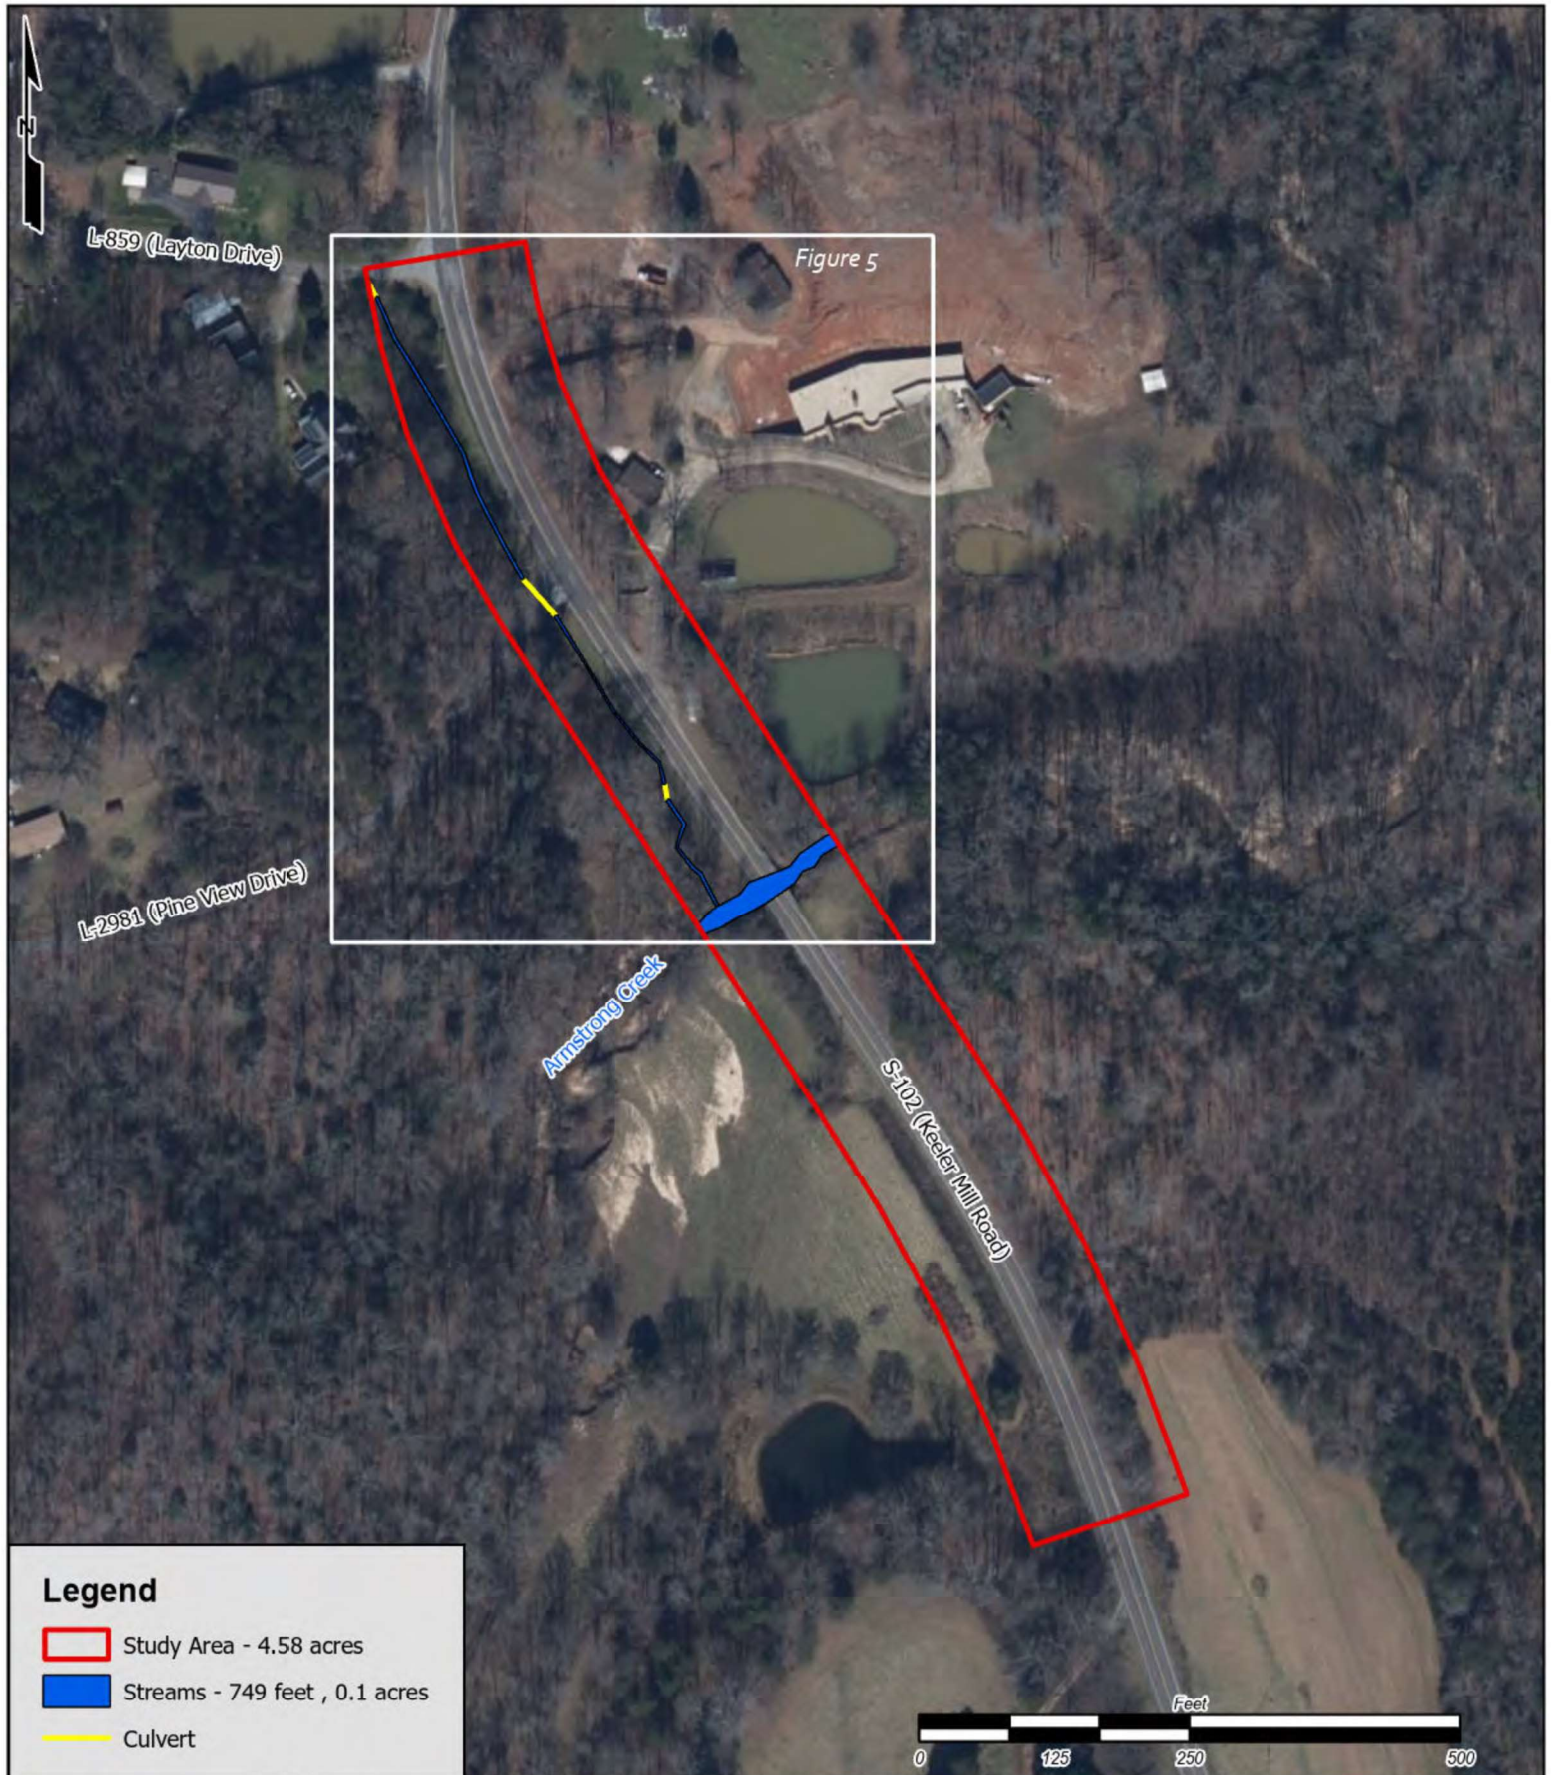
<small>DRAWN BY: TRC</small>	<small>DATE: 10/30/2023</small>
<b>APPROXIMATE BOUNDARIES OF WOTUS</b>	
<b>FIGURE 4</b>

- Study Area - 4.58 acres
- Streams - 749 feet , 0.1 acres
- Culvert

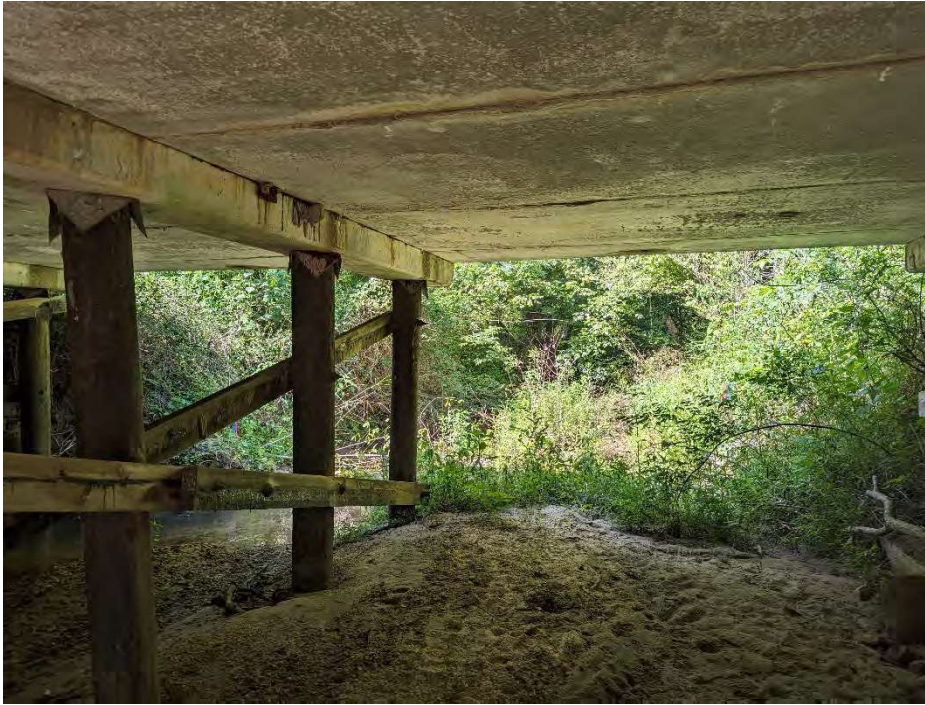
Photograph 3

Under S-102 bridge

Suitable habitat for tri-colored bat exists in the PSA. Roosting habitat exists under the existing S-102 bridge and in cavities and crevices of trees within the PSA. A structure survey of the existing S-102 bridge found no evidence of bat roosting. Additionally, a visual inspection and borescope review of cavities and crevices in trees within the PSA did not indicate the presence of any bat species. A Structures Survey Data Sheet and Habitat Assessment Data Sheet are included in Attachment D.

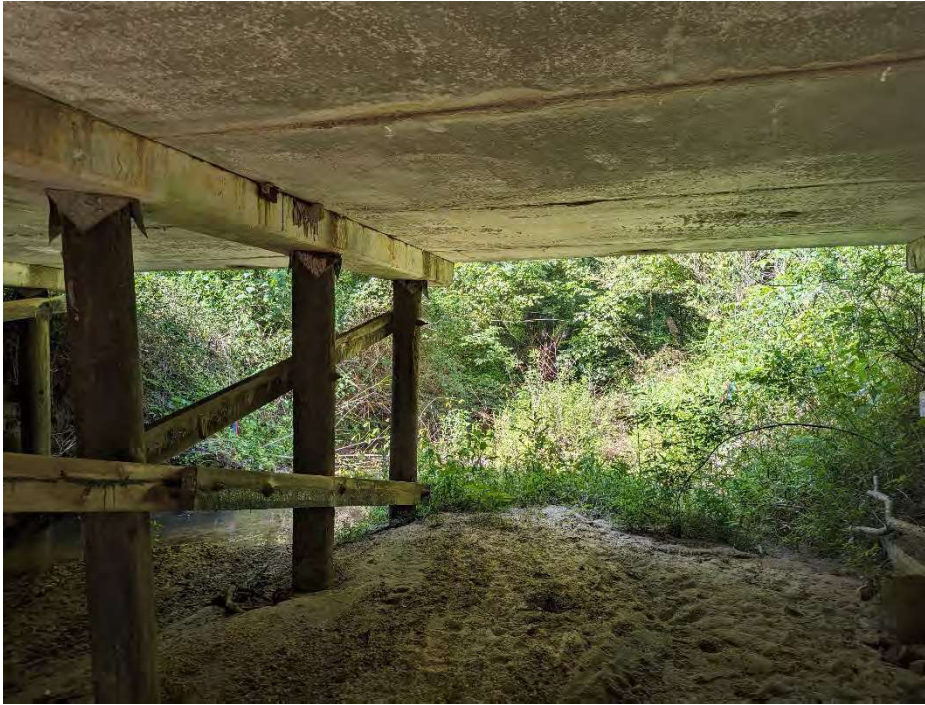
Photograph 1

Underneath bridge

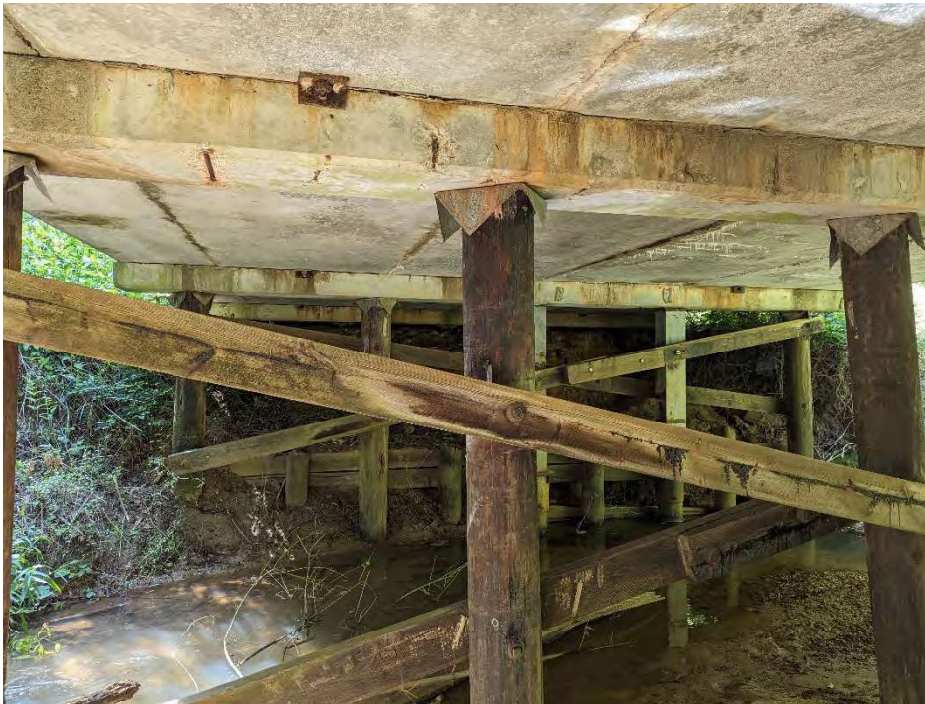
Photograph 2

North end bent

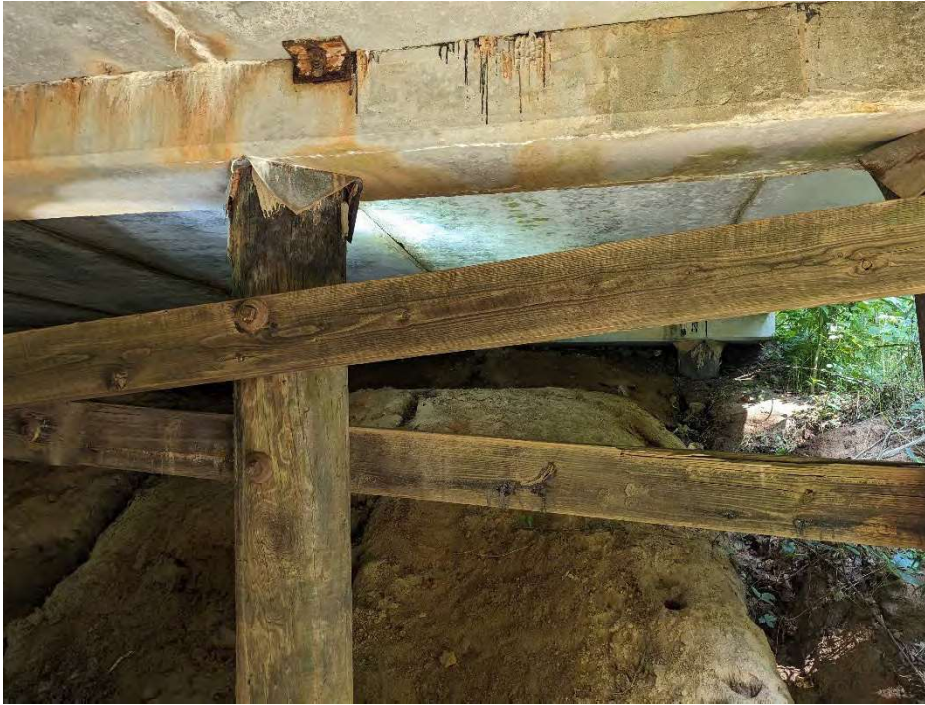
Photograph 3

South end bent

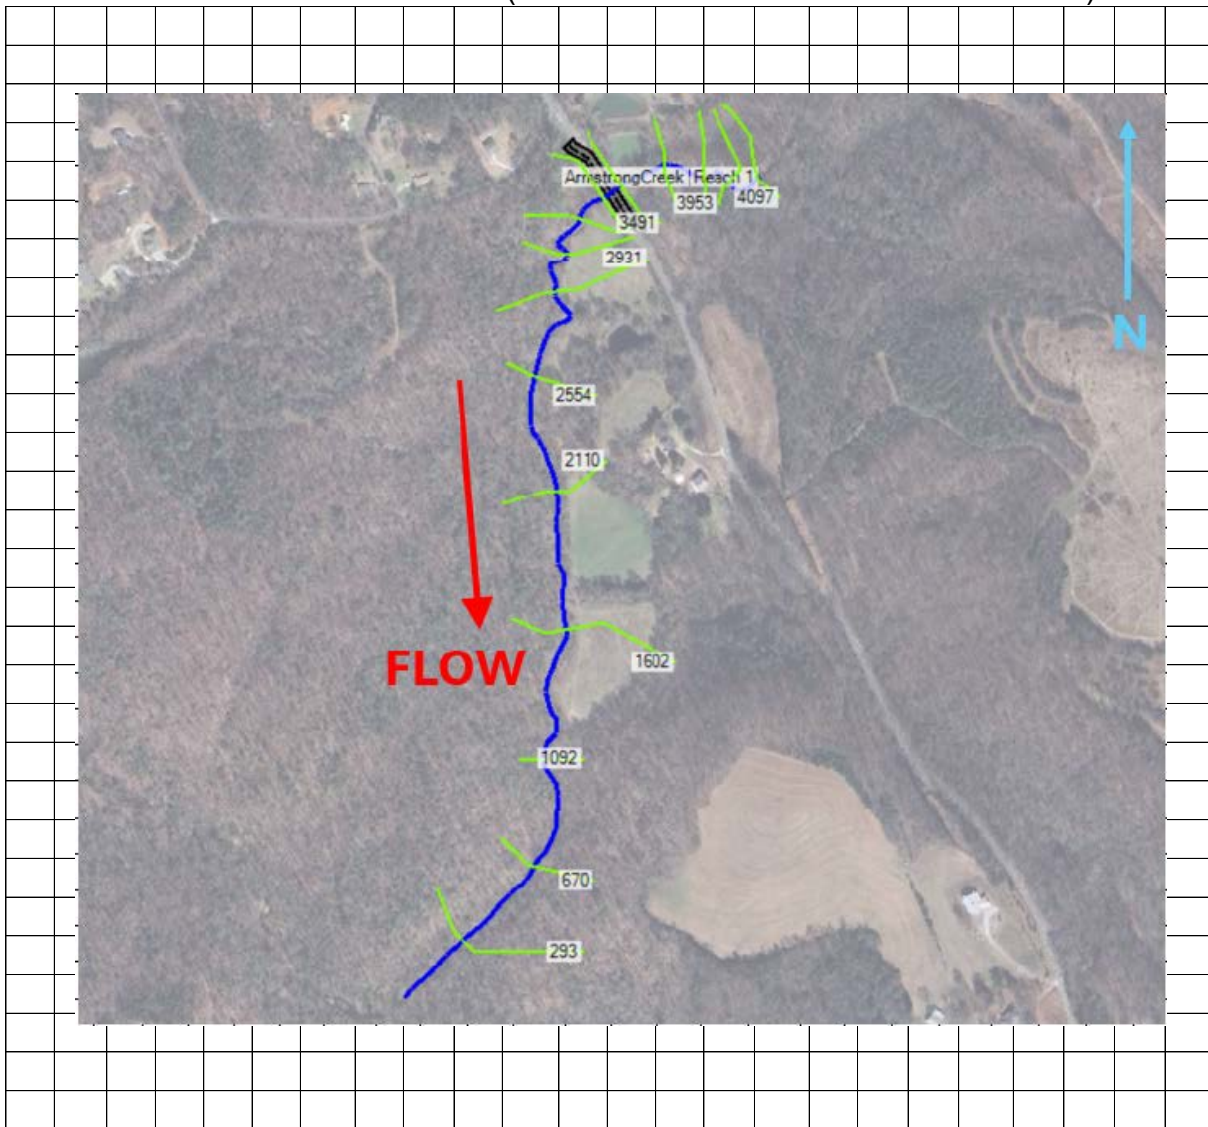
BRIDGE SITE DIAGRAM: (Show North Arrow and Direction of Flow)

Notes: Proposed minimum low chord elevation is 916.59'. Proposed minimum profile/deck elevation is 920.41'. Proposed 36" deep box beam superstructure with asphalt surface course.
