S-23-310 (Crestwood Drive) Bridge Replacement over Langston Tributary

Project ID: P041162

TITLE: Phase I Cultural Resources Survey of Proposed Improvements to the S-23-310 Bridge over Langston Tributary

Natural Resources Technical Memorandum

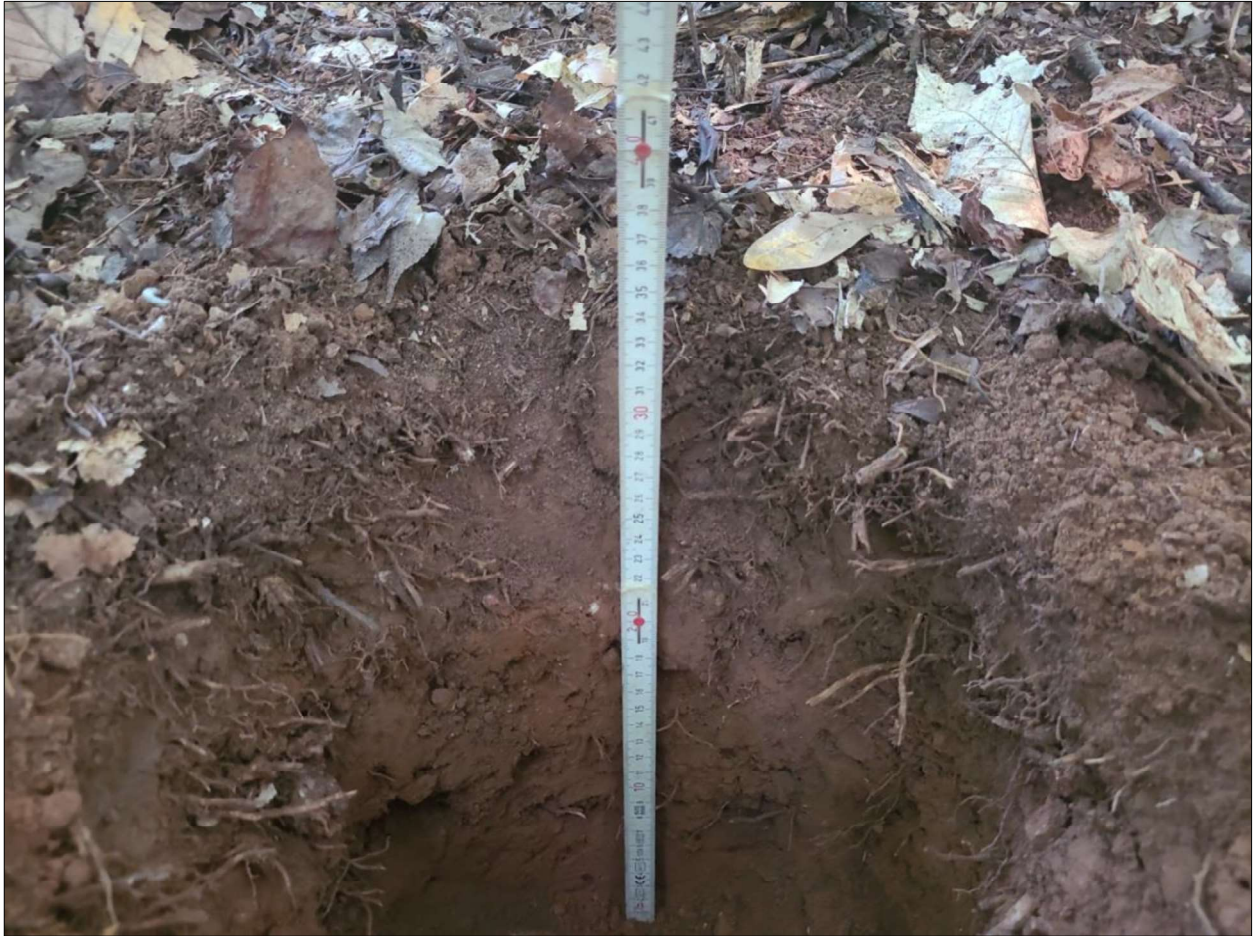
Figure 8. Soil Profile of STP 11, Looking North

One general soil profile was noted, consisting of approximately 15 centimeters of brown (7.5YR 4/3) sandy loam Ap horizon overlying a reddish brown (5YR 5/4) sandy clay subsoil containing 50–75 percent pebbles (Figure 8). No archaeological sites or isolated finds were identified in the project area.

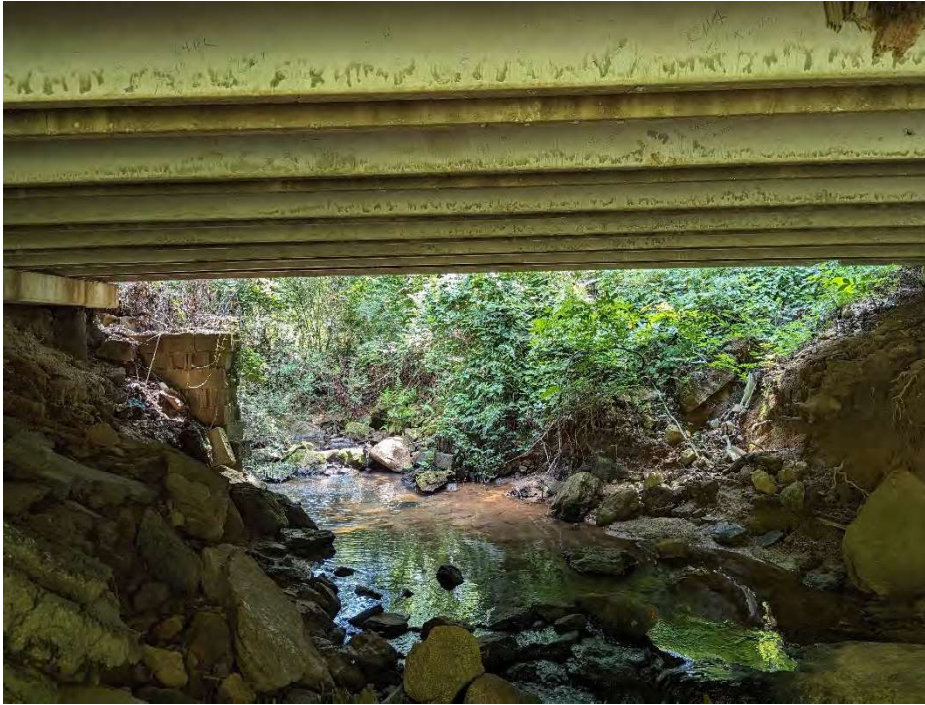
Photograph 1

Underneath bridge,
facing upstream

Conditions Under Bridge (check all that apply):			
<input checked="" type="checkbox"/> Bare Ground/Sediment	<input checked="" type="checkbox"/> Concrete	<input checked="" type="checkbox"/> Rip Rap	<input checked="" type="checkbox"/> Flowing Water
<input type="checkbox"/> Standing Water	<input checked="" type="checkbox"/> Open Vegetation (not obstructing flight path)	<input type="checkbox"/> Closed Vegetation (may obstruct flight path)	<input type="checkbox"/> Two Lanes
<input type="checkbox"/> Four (+) Lanes	<input type="checkbox"/> Unpaved Road	<input type="checkbox"/> Railroad	<input type="checkbox"/> Other:

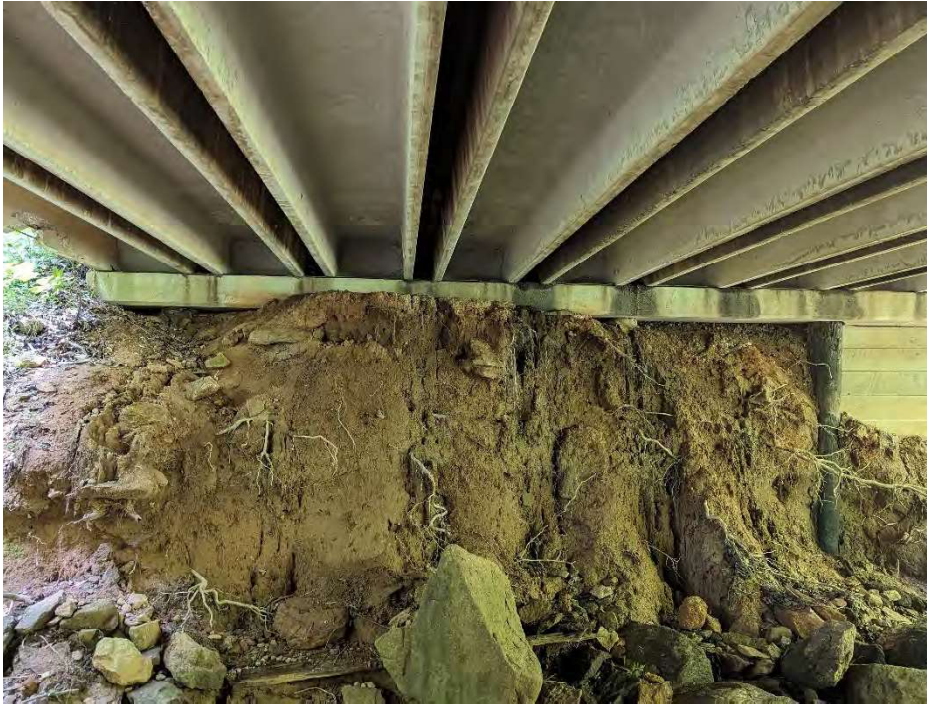
Photograph 3

East end bent

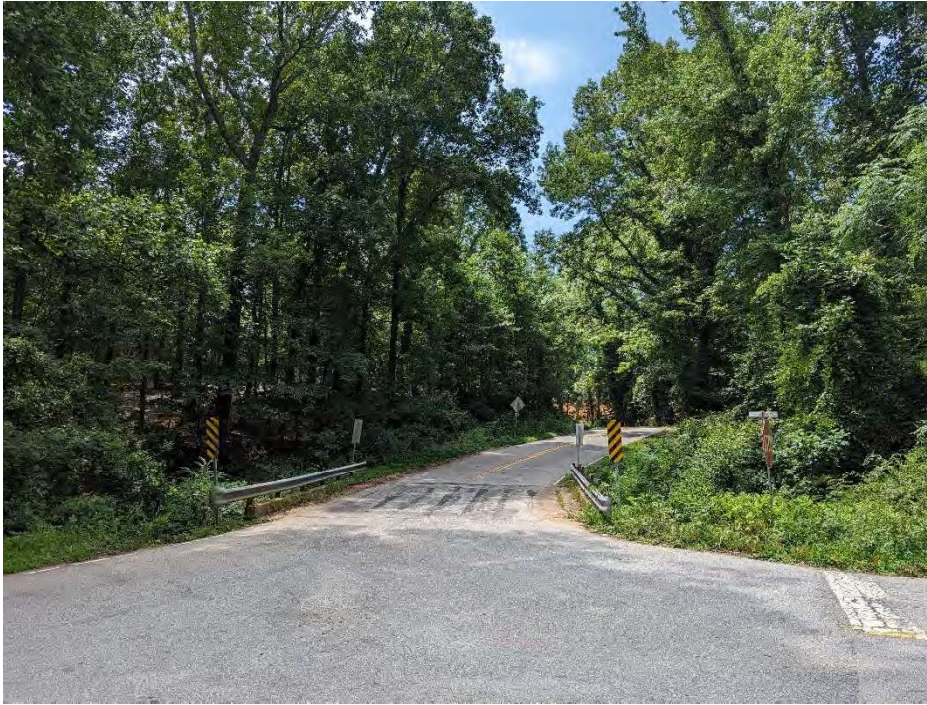
Photograph 1

S-310 Roadway and bridge
