# S-23-40 (Pace Bridge Road) Bridge Replacement over South Saluda River

Project ID: P041160

South Carolina Department of Transportation (SCDOT) proposes to replace the S-23-40 (Pace Bridge Road) Bridge over South Saluda River in Greenville County.

**TITLE:** Phase I Cultural Resources Survey of Proposed Improvements to the S-23-40 Bridge over South Saluda River

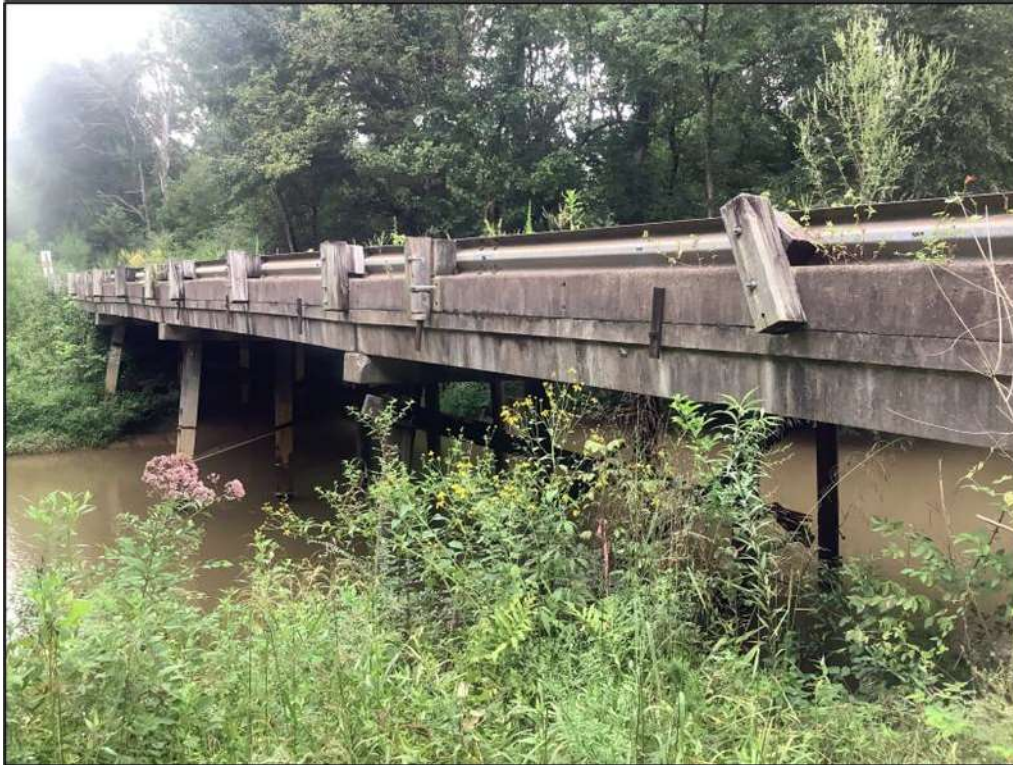
*Figure 9: S-23-40 Bridge over South Saluda River, Built in 1957 and Not Assessed*

a. Bridge Structure, Looking Northeast

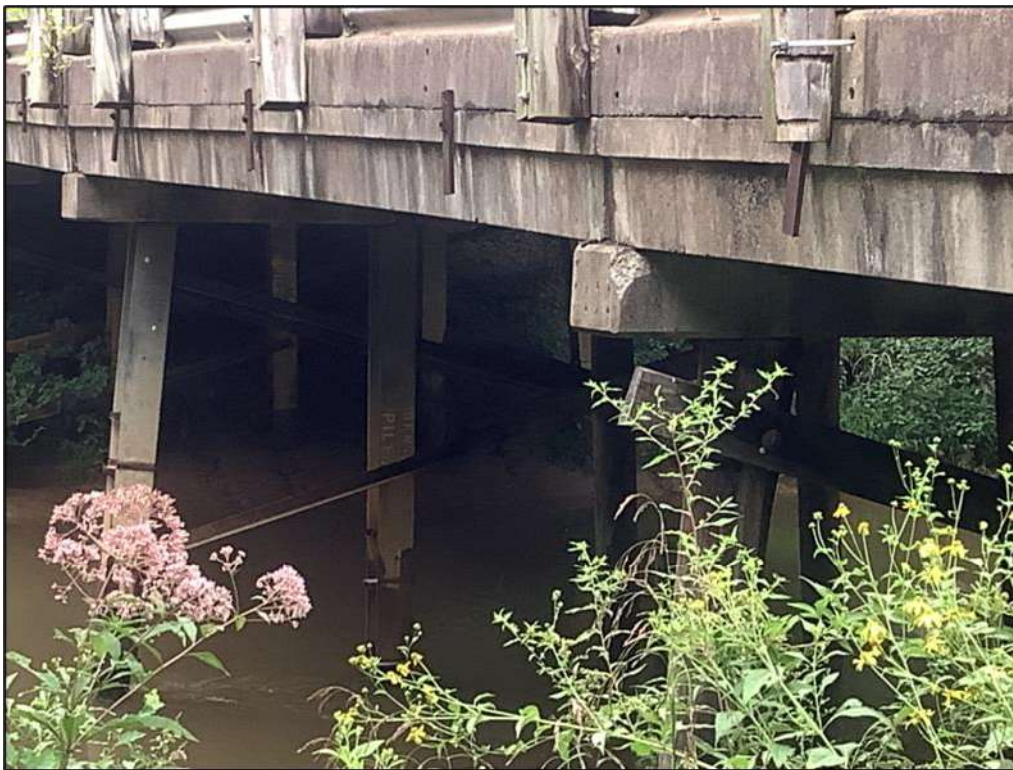
b. Bridge Structure Detail, Looking Northeast

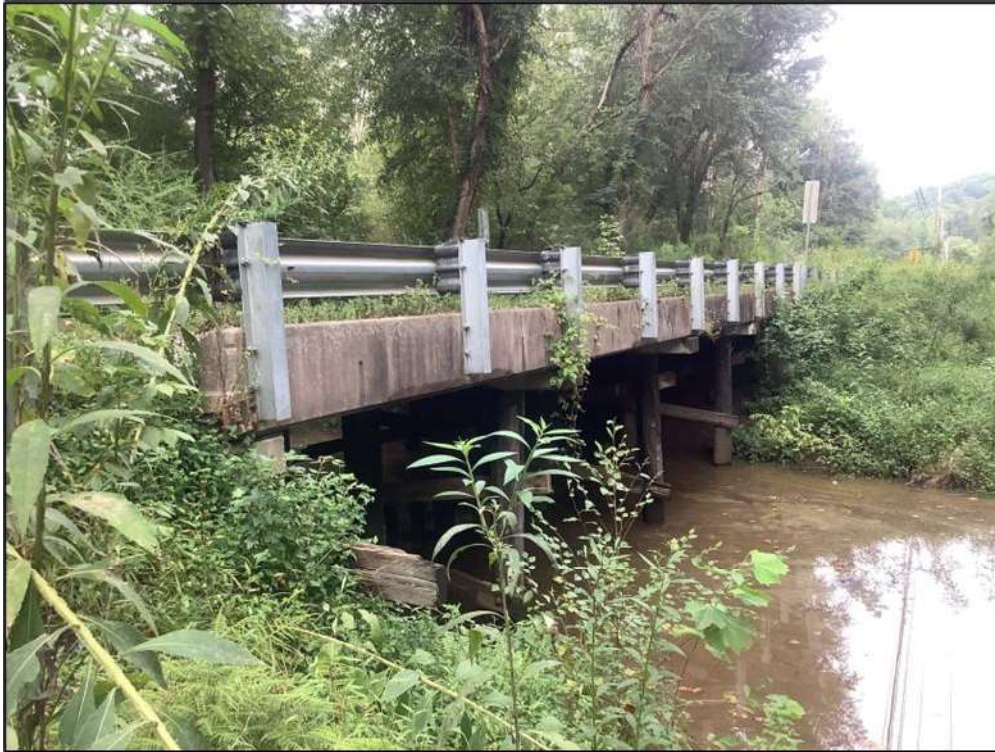
*Figure 10: S-23-40 Bridges over South Saluda River Overflow Channels, Not Assessed*

a. Northern Overflow Bridge (Built 1957), Looking Southeast

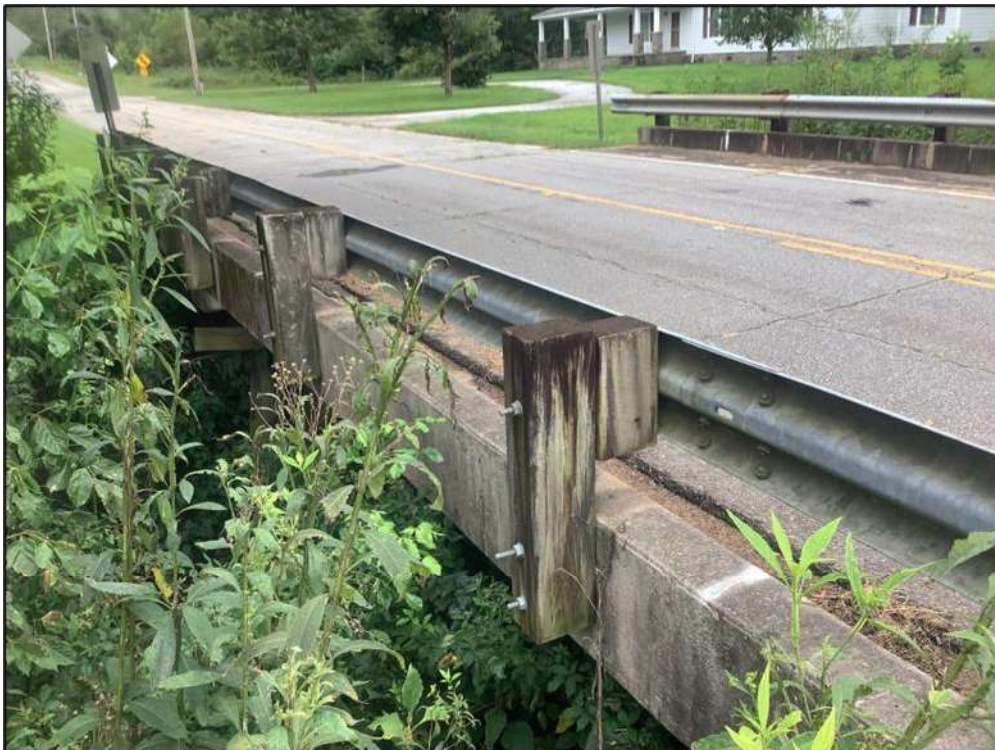
b. Southern Overflow Bridge (Built 1969), Looking Southwest

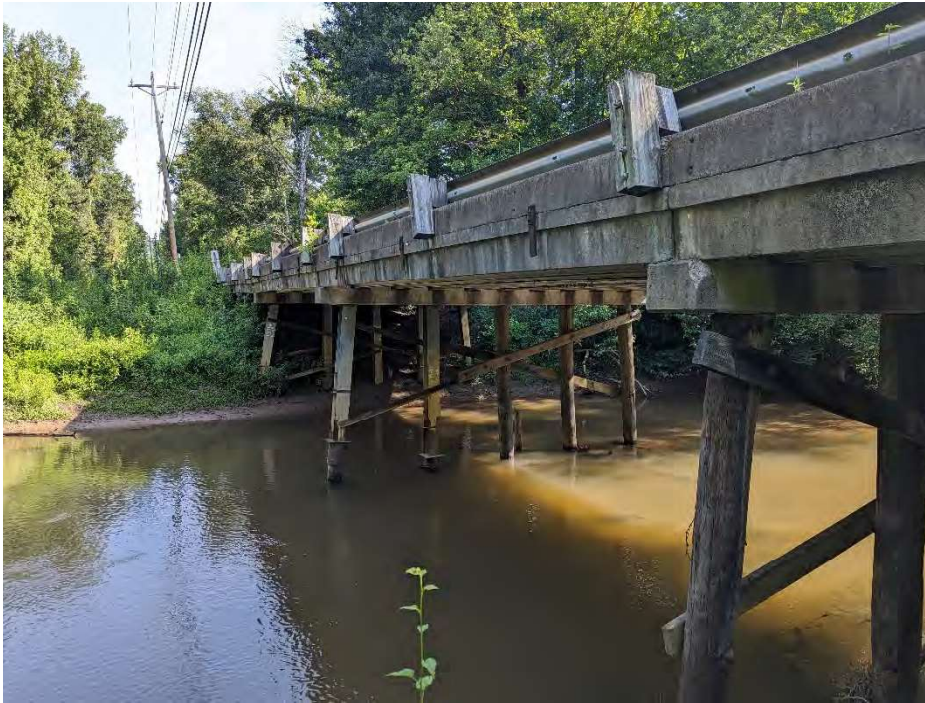
Photograph 1

S-40 over S Saluda River

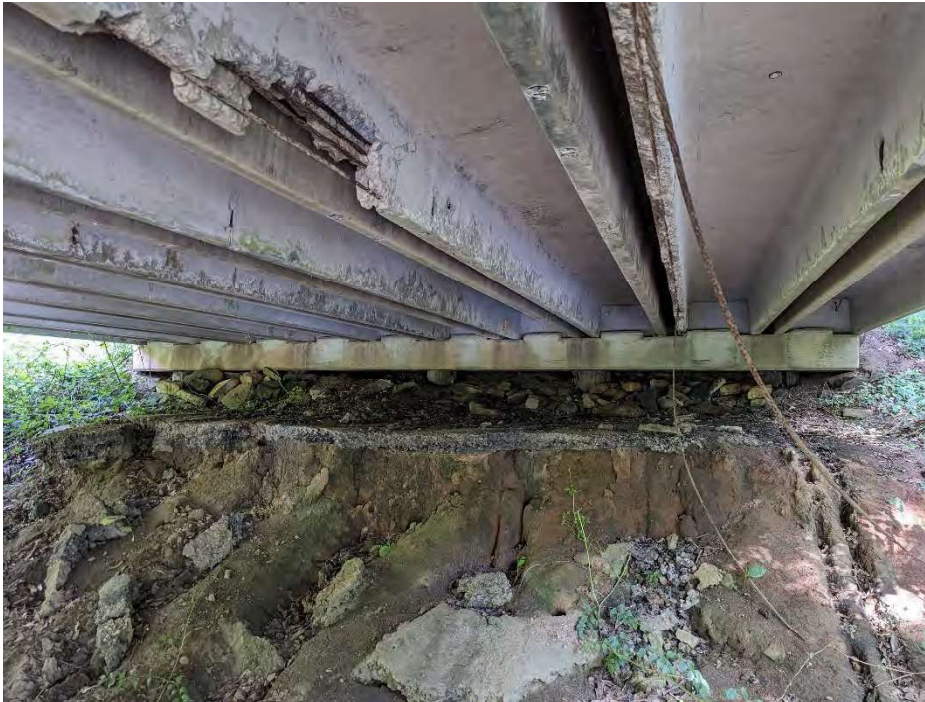
Photograph 2

Underneath S-40 over S Saluda River

Suitable habitat for tricolored bat exists in the PSA. Roosting habitat exists under the existing S-40 and S-26 bridges and in cavities and crevices of trees within the PSA. A structure survey of the existing bridges found no evidence of bat roosting. Additionally, a visual inspection and borescope review of cavities and crevices in trees within the PSA did not indicate the presence of any bat species. A Structures Survey Data Sheet and Habitat Assessment Data Sheet are included in Attachment D.

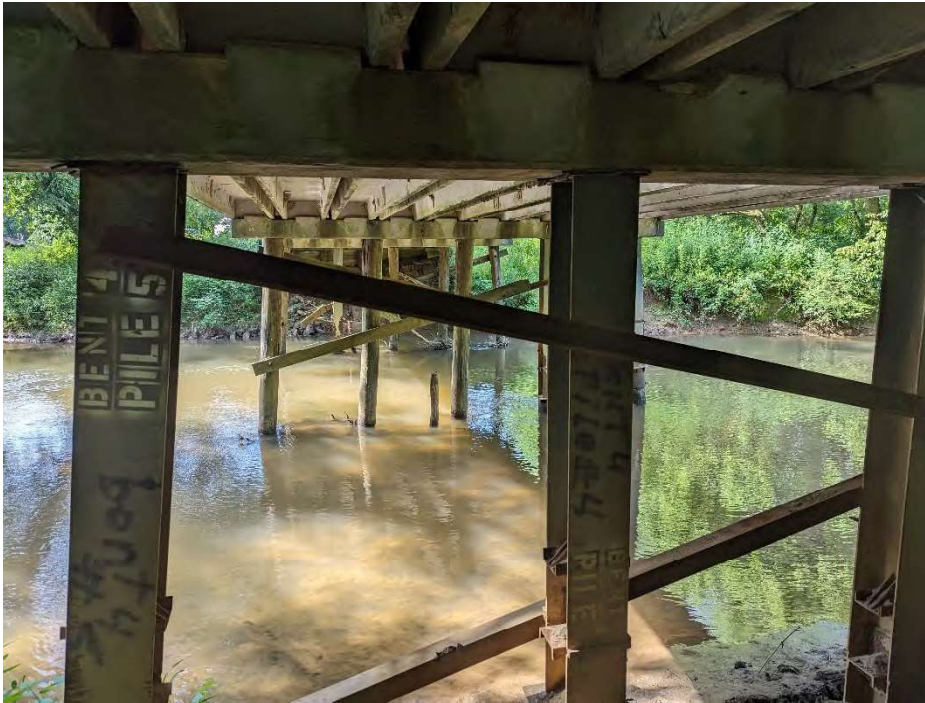
Photograph 3

Underneath S-40 over S  
Saluda River

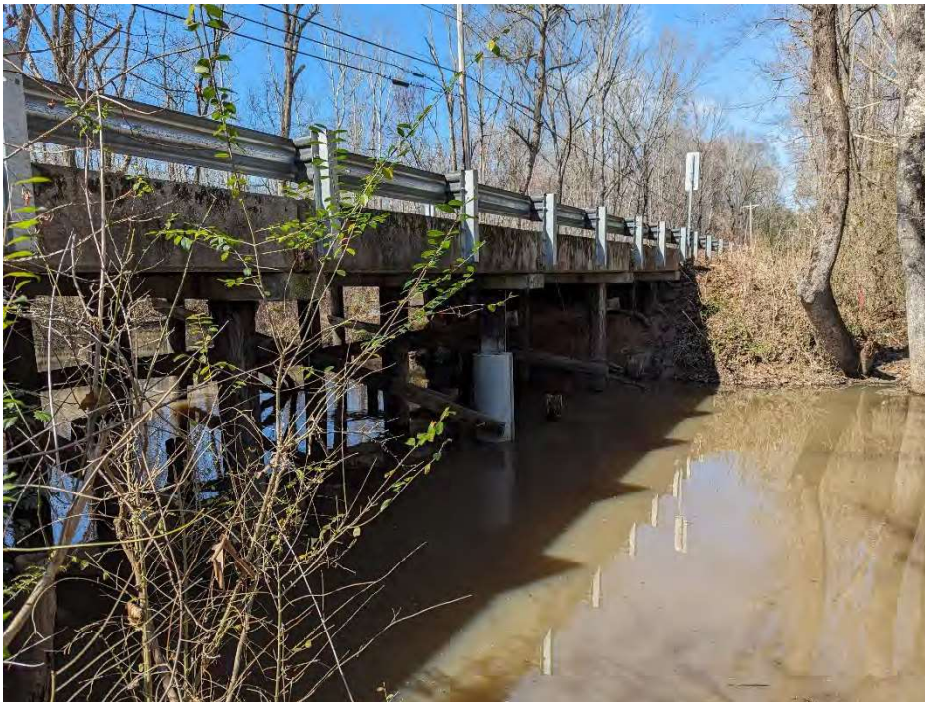
Photograph 4

S-40 over Saluda  
Overflow

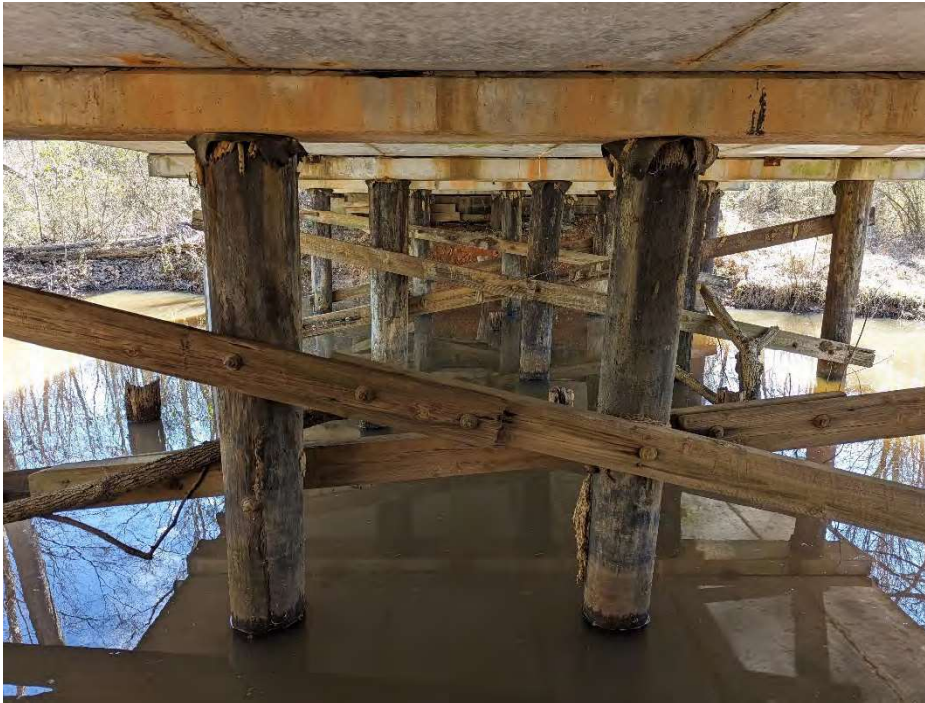
Photograph 5

Underneath S-40 over  
Saluda Overflow
