# S-23-40 (Pace Bridge Road) Bridge Replacement over South Saluda Overflow and S-39-26 (Pace Bridge Road) over Trib. to South Saluda River

Project ID: P043137 and P043138

## **Project Description:**

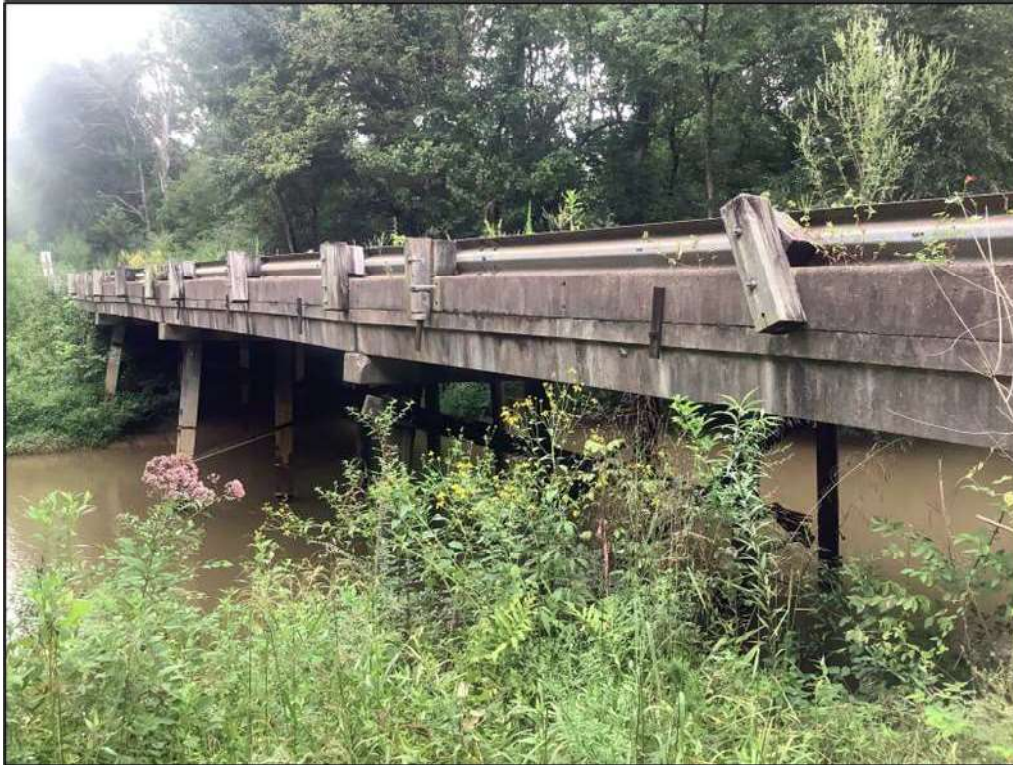
*Figure 9: S-23-40 Bridge over South Saluda River, Built in 1957 and Not Assessed*

a. Bridge Structure, Looking Northeast

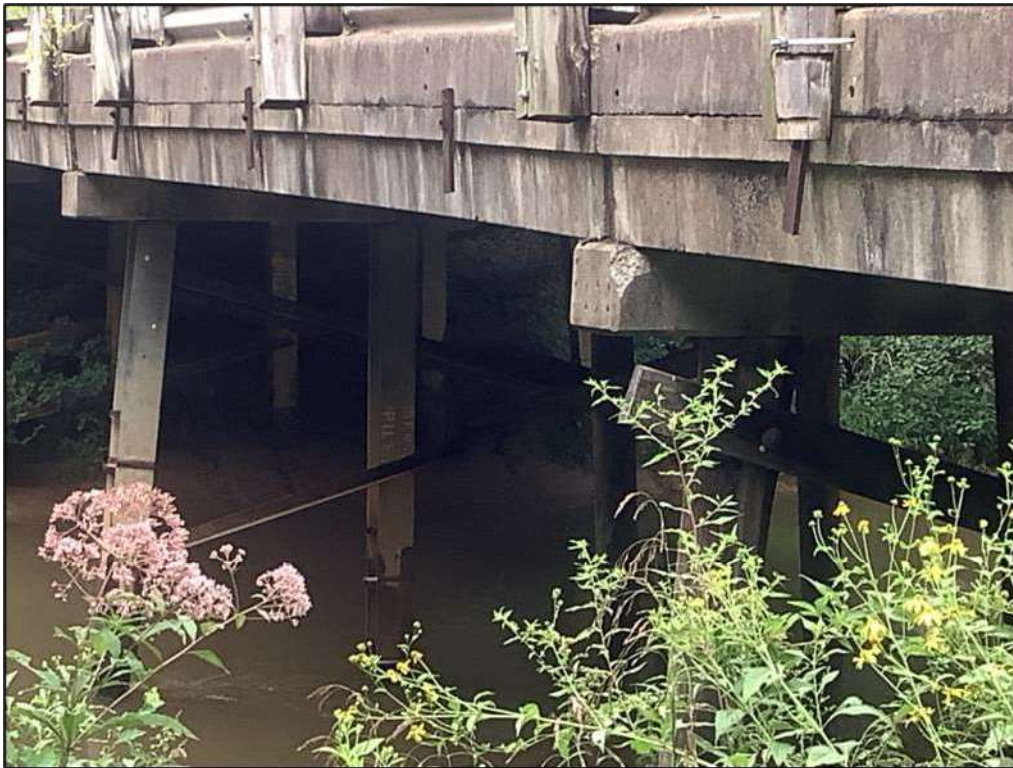
b. Bridge Structure Detail, Looking Northeast

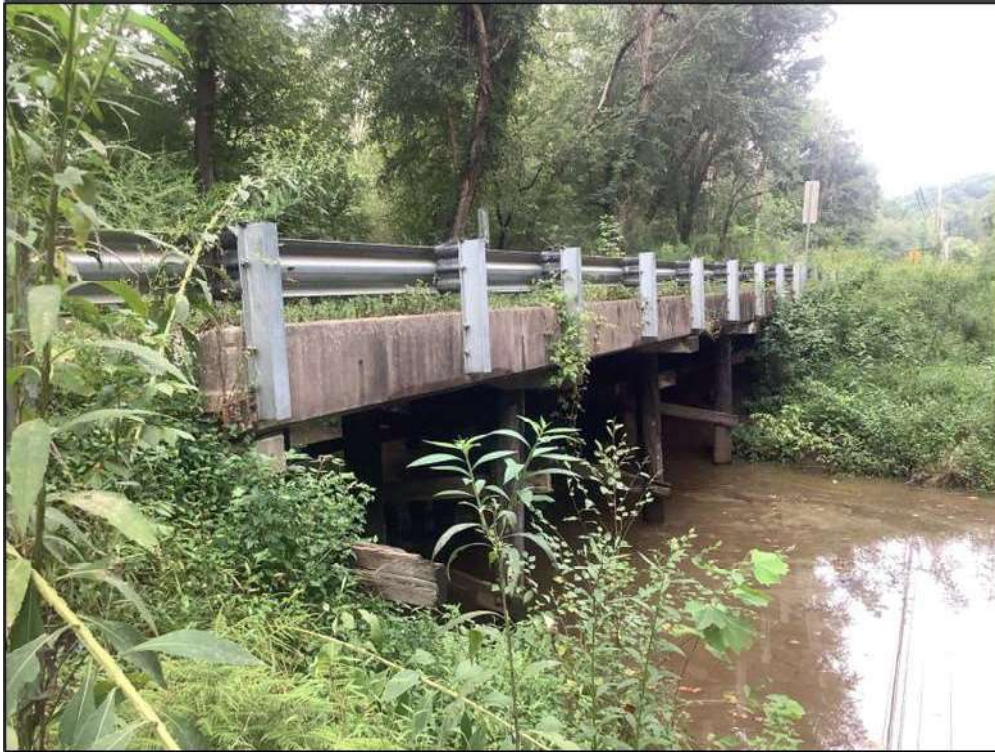
*Figure 10: S-23-40 Bridges over South Saluda River Overflow Channels, Not Assessed*

a. Northern Overflow Bridge (Built 1957), Looking Southeast

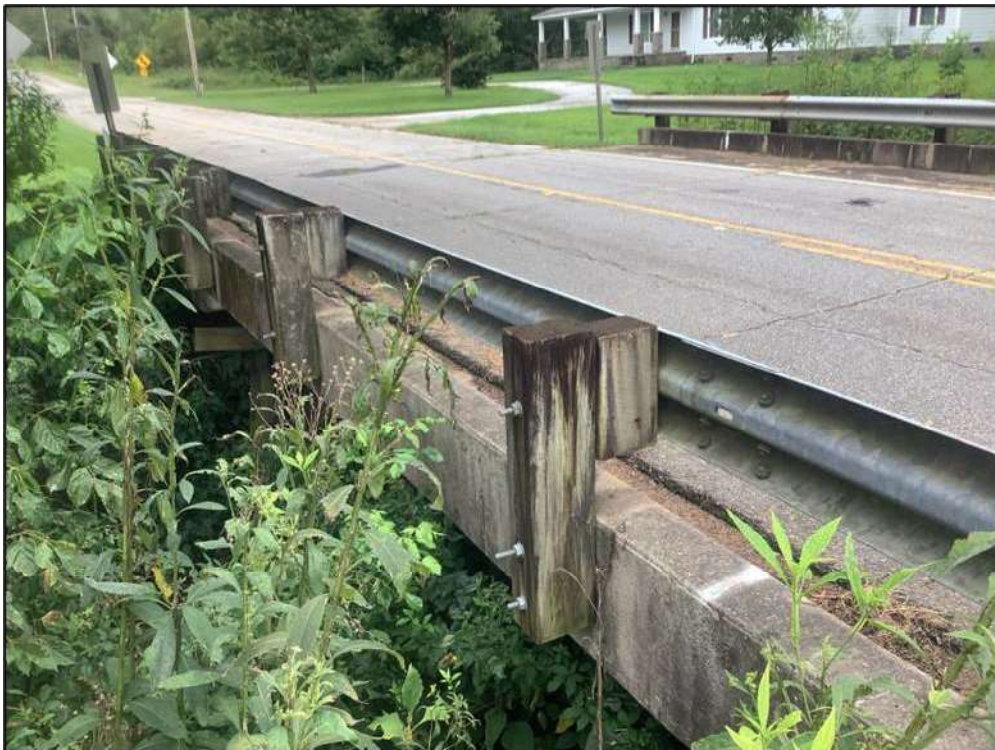
b. Southern Overflow Bridge (Built 1969), Looking Southwest

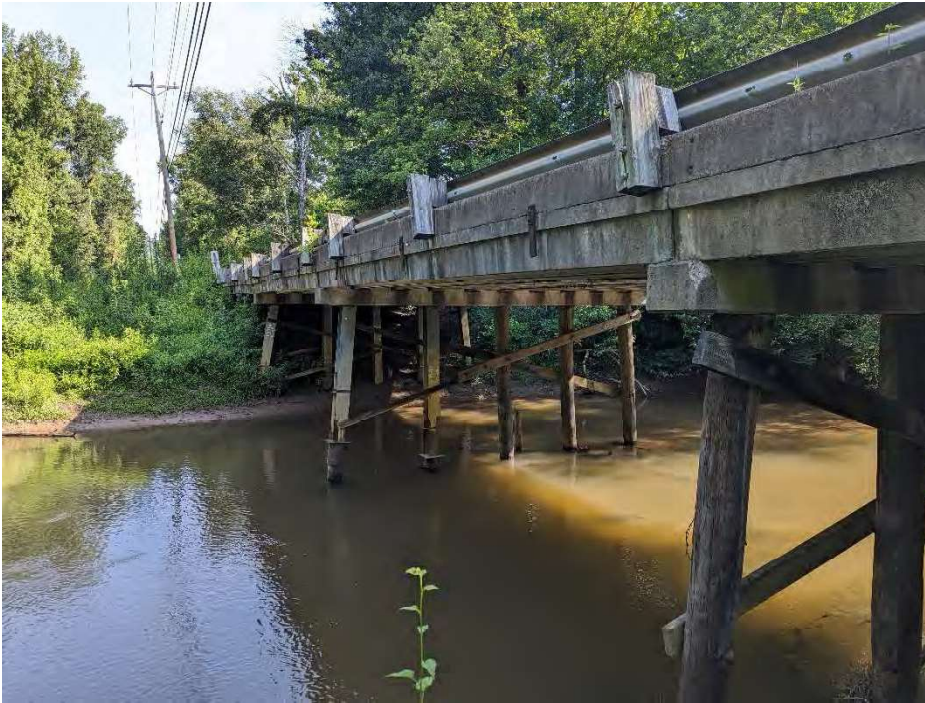
Photograph 1

S-40 over S Saluda River

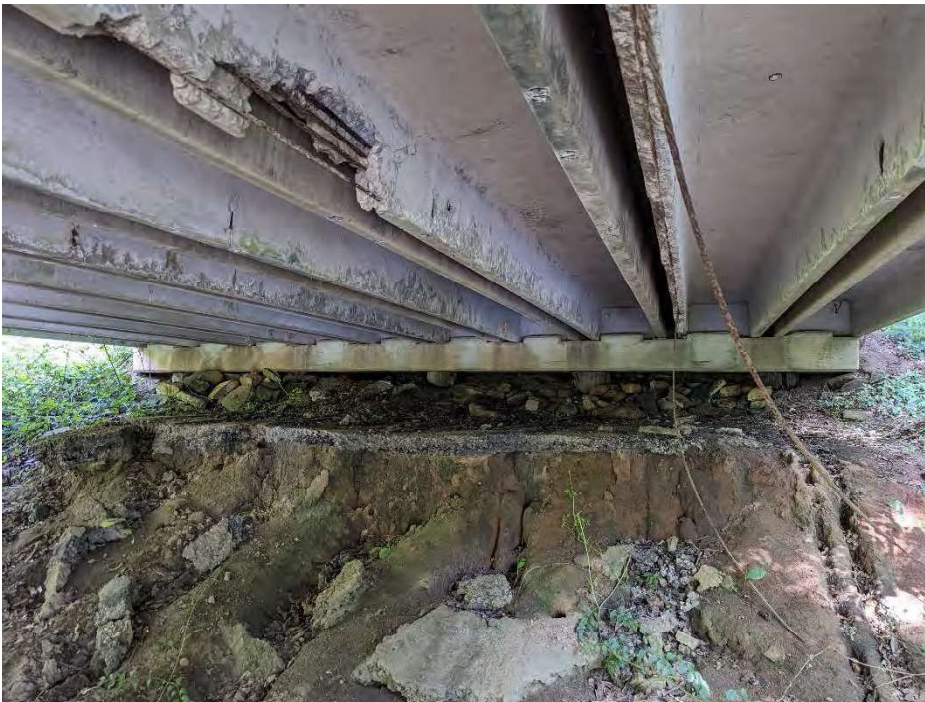
Photograph 2

Underneath S-40 over S Saluda River

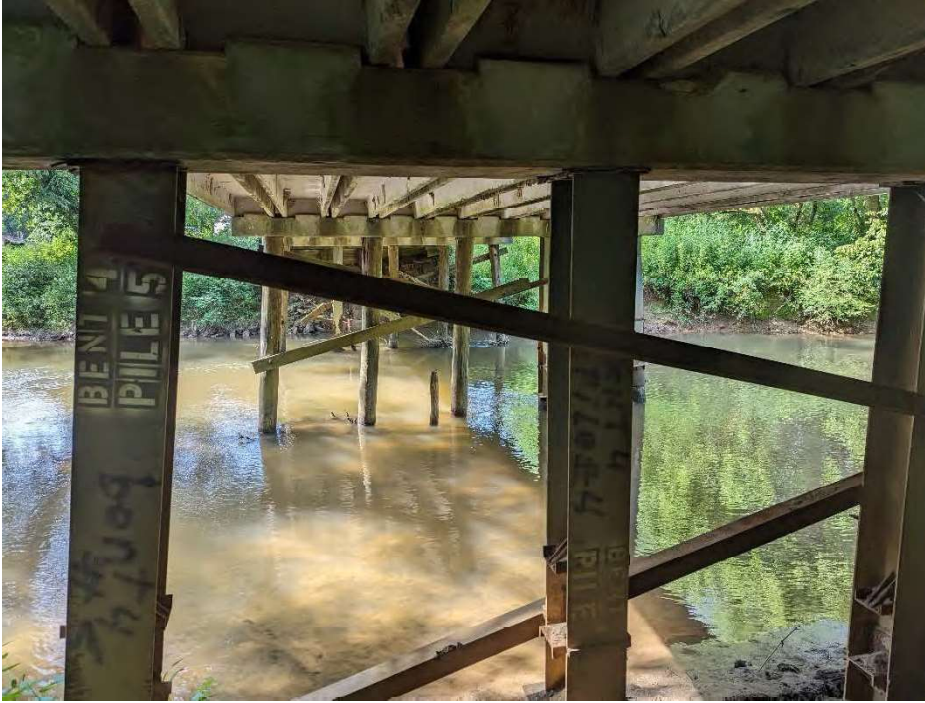
Photograph 3

Underneath S-40 over S  
Saluda River

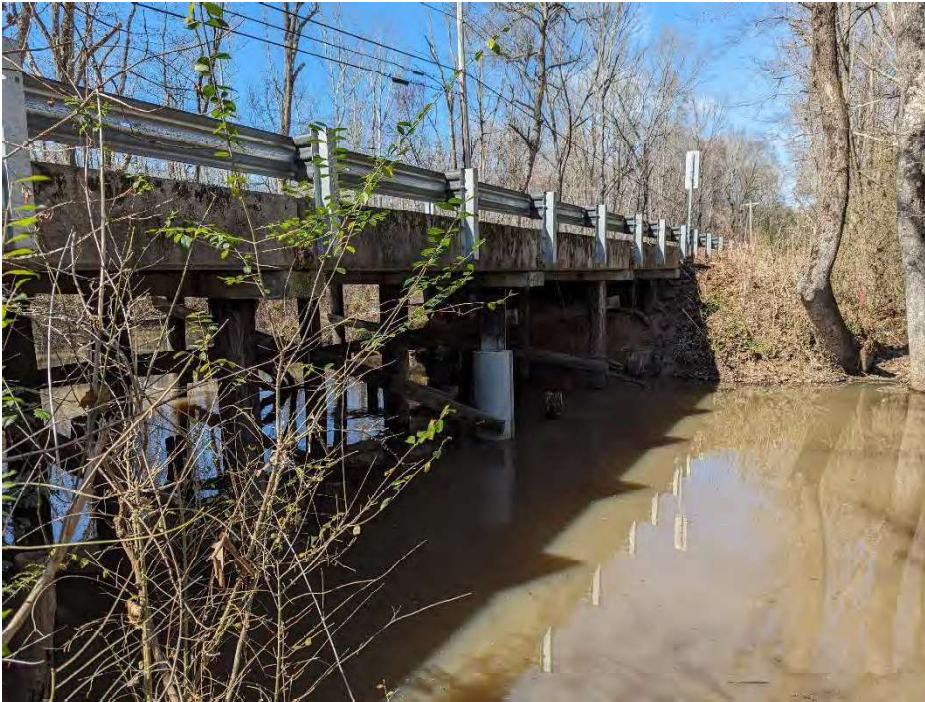
Photograph 4

S-40 over Saluda  
Overflow

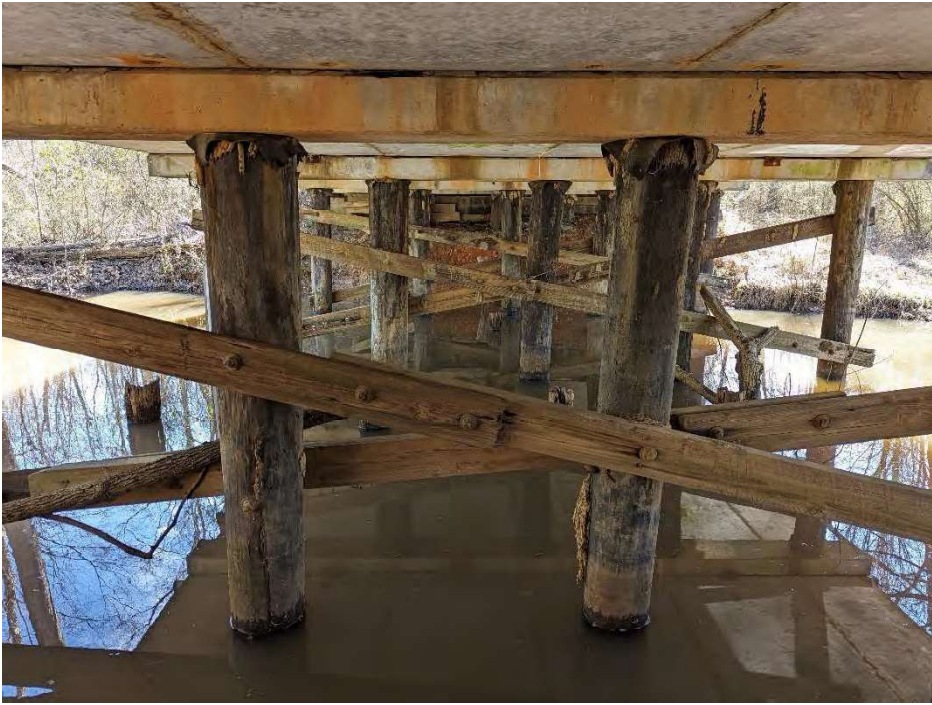
Photograph 5

Underneath S-40 over Saluda Overflow
