# S-39-26 (Pace Bridge Road) Bridge Replacement over Tributary to South Saluda River

Pickens County, SC

## Geotechnical Baseline Report

October 30, 2024 | SCDOT Project ID: P043138  
Terracon Project No.: 8623P180 Revision 1

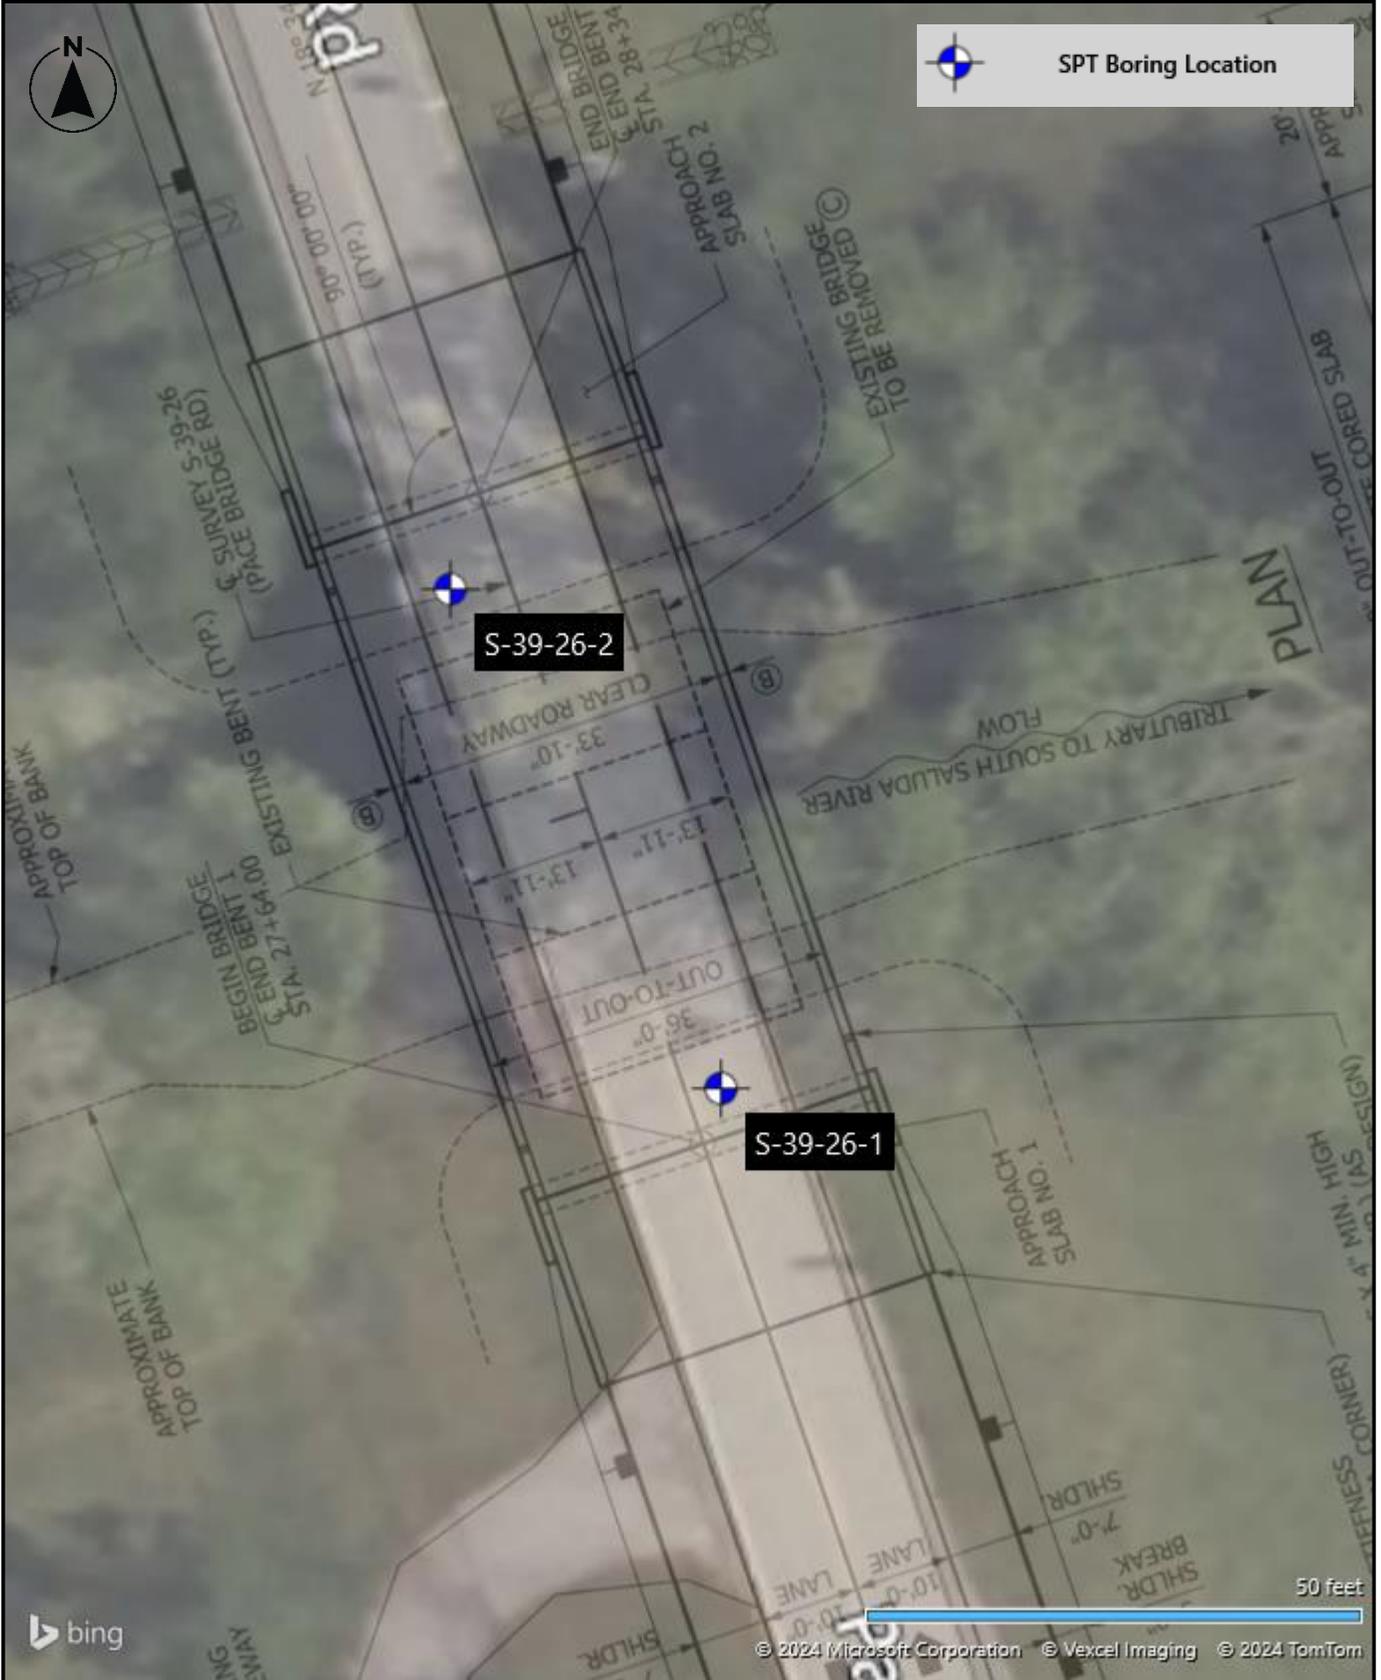
**A-2**

DIAGRAM IS FOR GENERAL LOCATION ONLY, AND IS NOT INTENDED FOR CONSTRUCTION PURPOSES

PRELIMINARY SITE PLAN PROVIDED BY HNTB

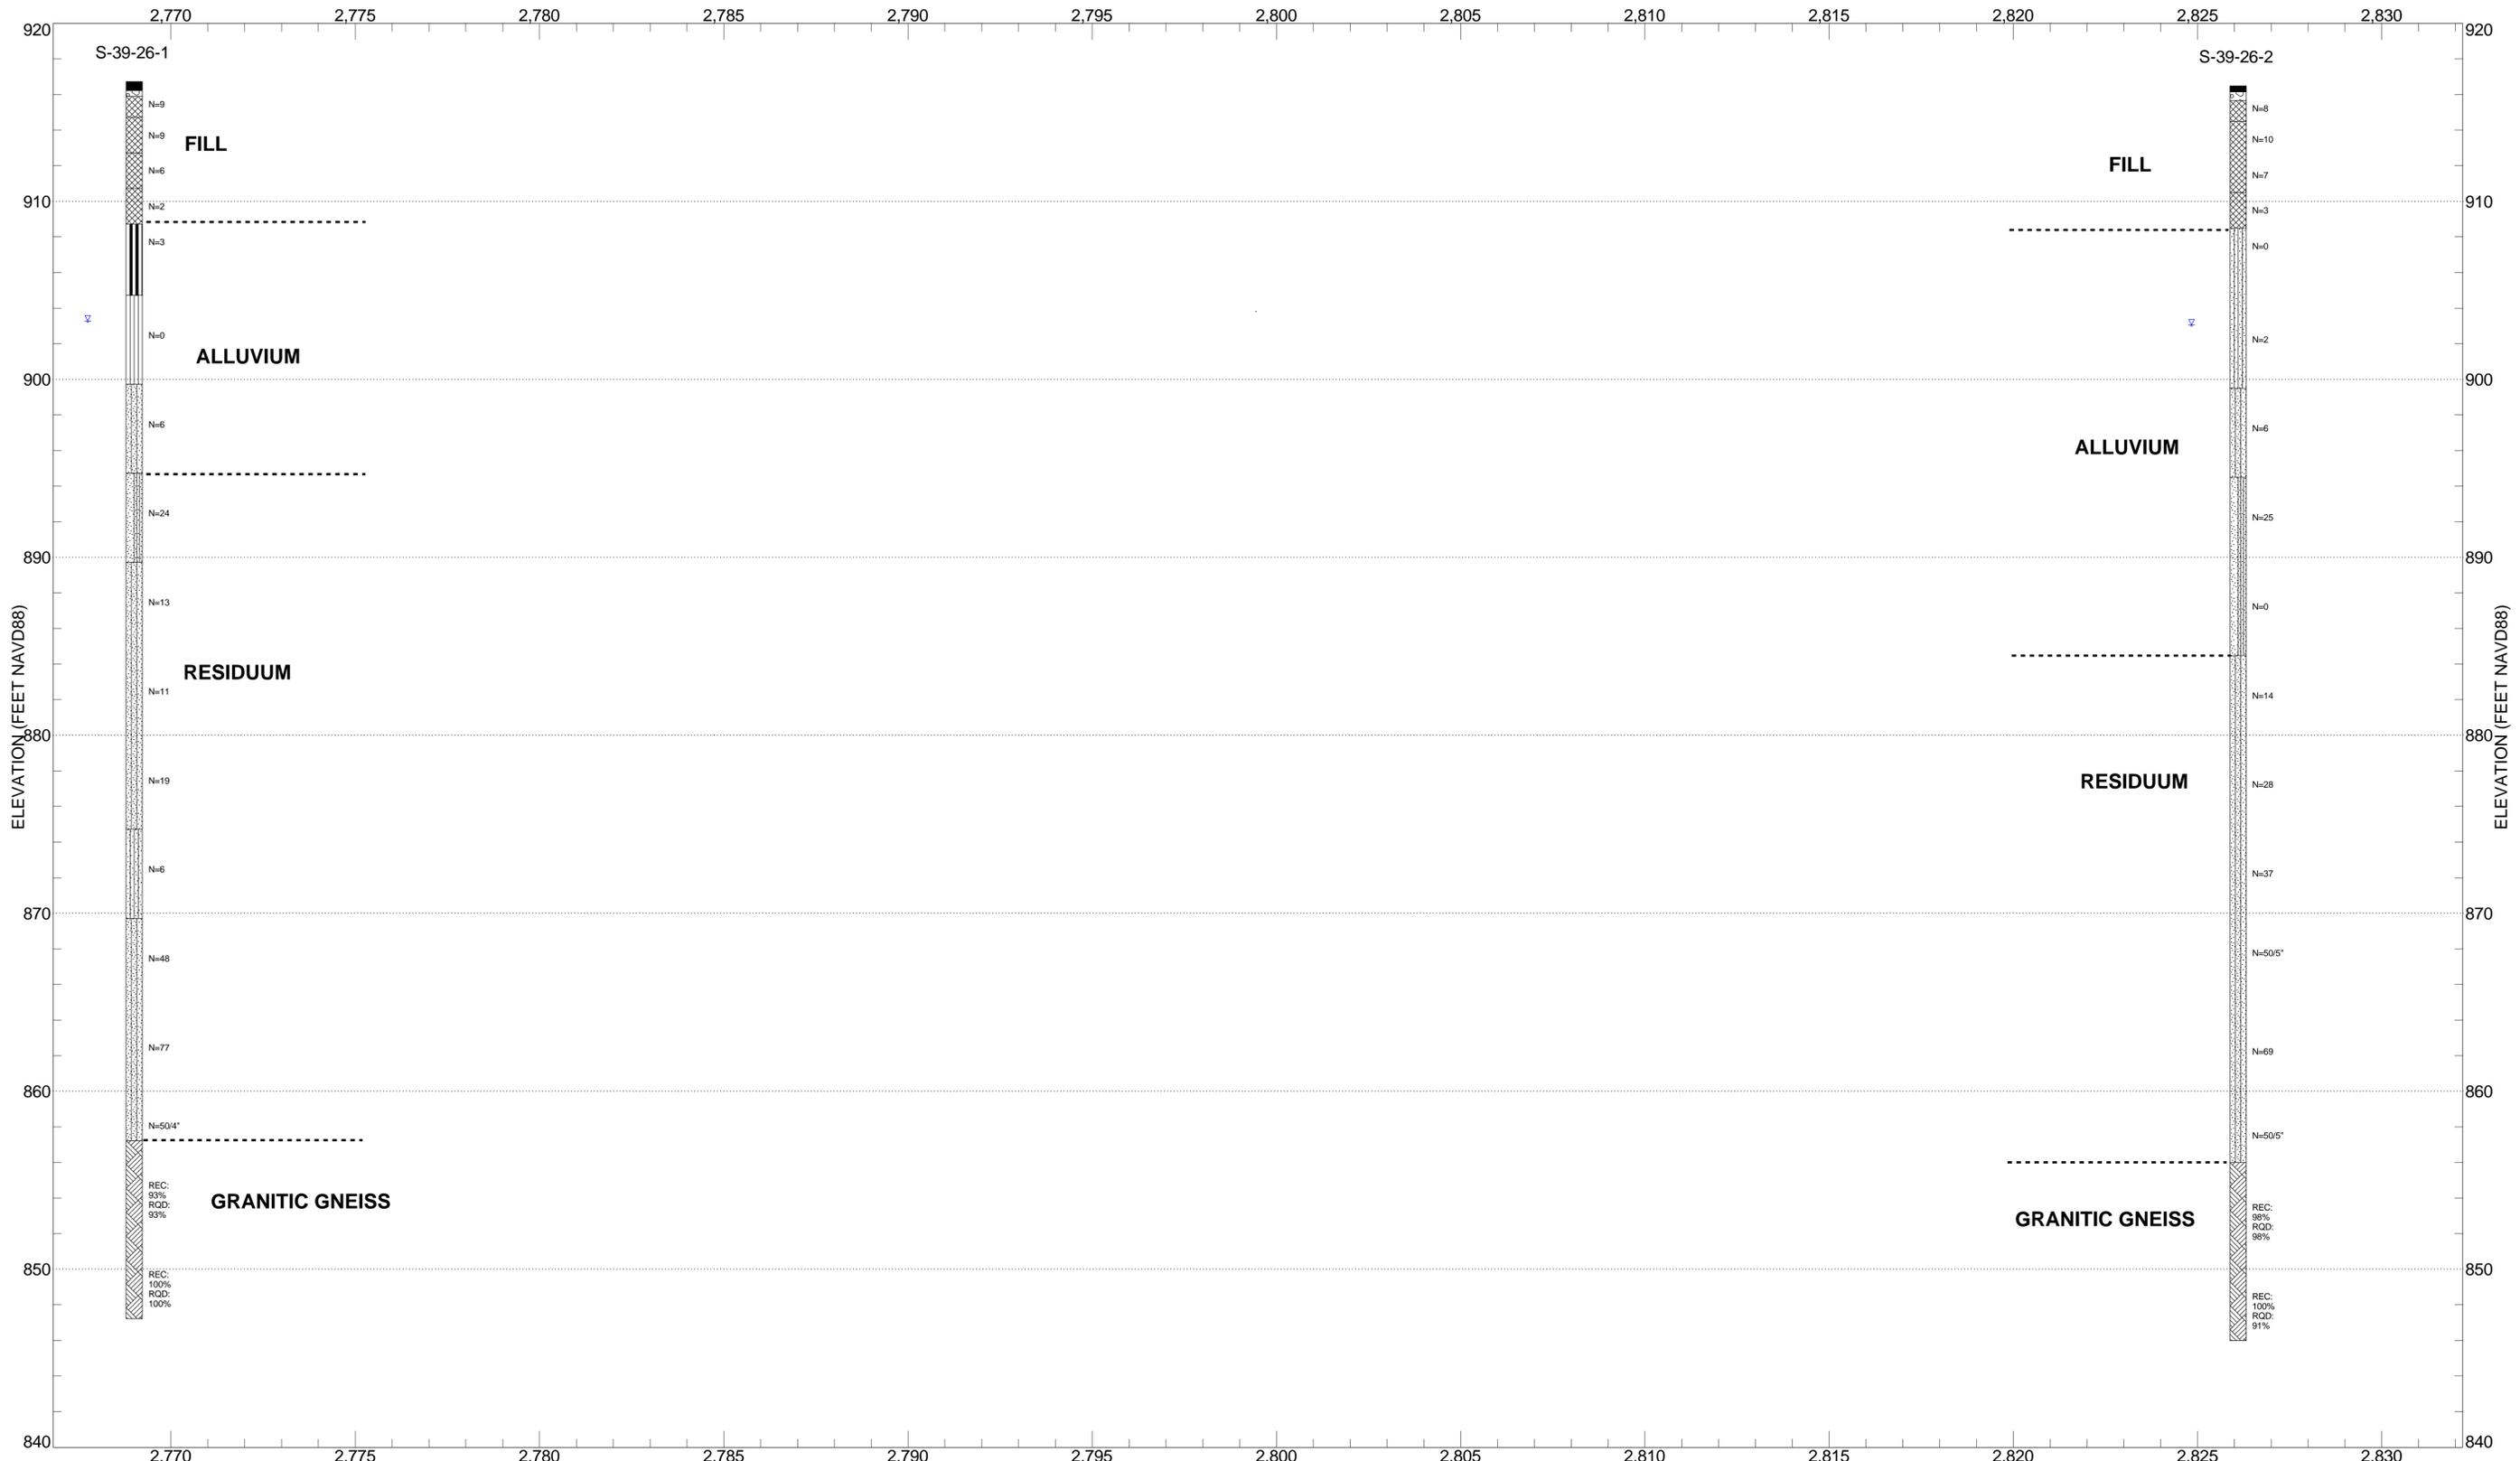
DISTANCE ALONG PROFILE (FEET)

- Legend for USCS Classification Graphic Symbols
- SCDOT-ASPHALT
  - SCDOT-GP
  - SCDOT-FILL
  - SCDOT-MH
  - SCDOT-ML
  - SCDOT-SM
  - SCDOT-SP-SM
  - SCDOT-MLS
  - SCDOT-BEDROCK

We have observed variability in the top of rock and thickness of IGM, as seen in **Soil and Rock Stratification**. Therefore, we expect variability in tip elevations at each bent location. Resistance of piles driven to practical refusal in IGM or rock will be limited by their structural resistance. Therefore, likely reinforced pile tips will be required to penetrate to IGM and rock. Pile drivability using the wave equation should be performed along with estimating stresses during driving and, in general, verifying the ability of the Contractor’s selected hammer to drive the piles to the desired penetration while preventing overstressing.

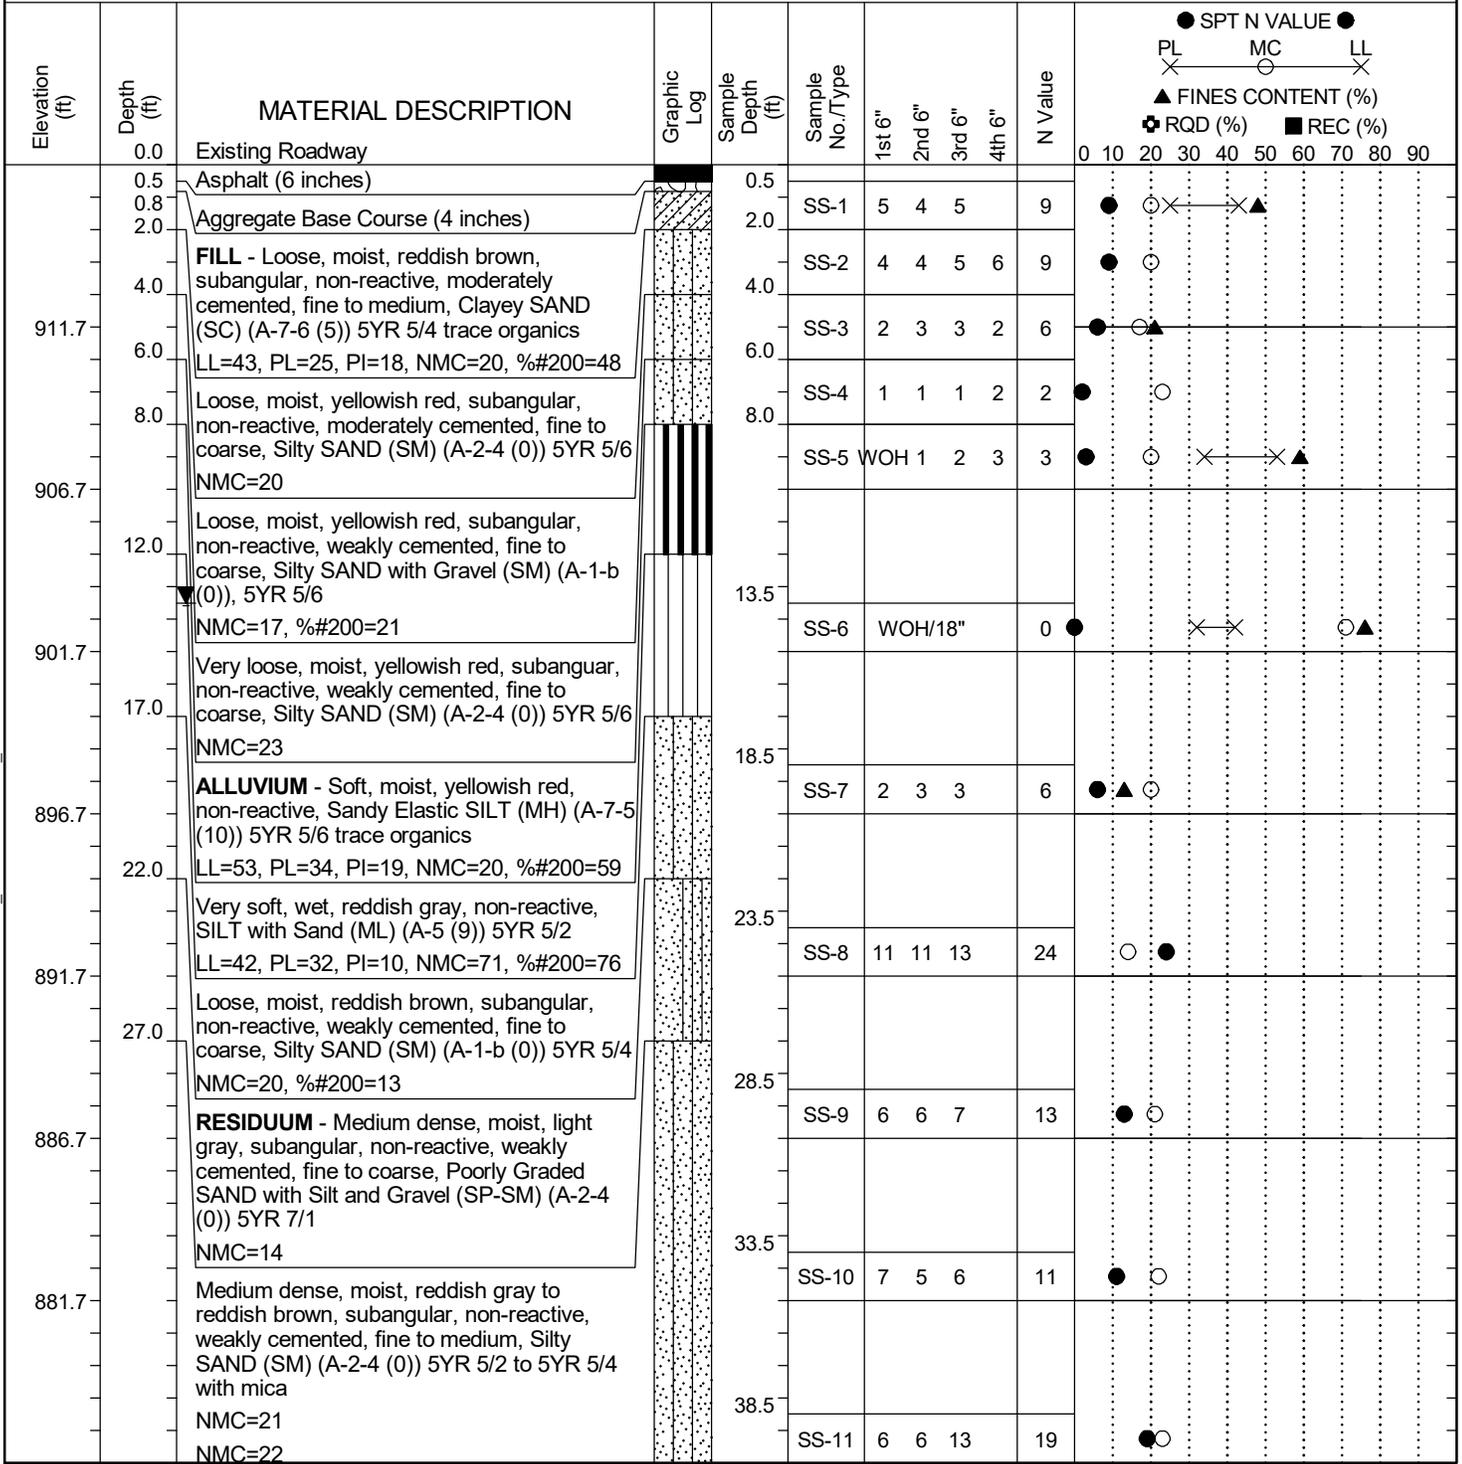
# SCDOT Soil Test Log

<b>Project ID:</b> P043138	<b>County:</b> Pickens	<b>Boring No.:</b> S-39-26-1
<b>Site Description:</b> S-39-26 BRO Tributary to South Saluda River		<b>Route:</b> S-39-26
<b>Eng./Geo.:</b> S. Greaber	<b>Boring Location:</b> 27+69	<b>Offset:</b> 4 R
<b>Alignment:</b> Existing	<b>Elev.:</b> 916.7 ft	<b>Latitude:</b> 35.01125
<b>Longitude:</b> -82.57016	<b>Date Started:</b> 8/14/2024	<b>Total Depth:</b> 69.5 ft
<b>Soil Depth:</b> 59.5 ft	<b>Core Depth:</b> 10 ft	<b>Date Completed:</b> 8/14/2024
<b>Bore Hole Diameter (in):</b> 4	<b>Sampler Configuration</b>	<b>Liner Required:</b> Y (N)
<b>Liner Used:</b> Y (N)	<b>Drill Machine:</b> DR#1327	<b>Drill Method:</b> RW/RC
<b>Hammer Type:</b> Automatic	<b>Energy Ratio:</b> 92.6%	<b>Core Size:</b> NQ2
<b>Driller:</b> B. Burnette	<b>Groundwater:</b> TOB N.M.	<b>24HR:</b> 13.5 ft

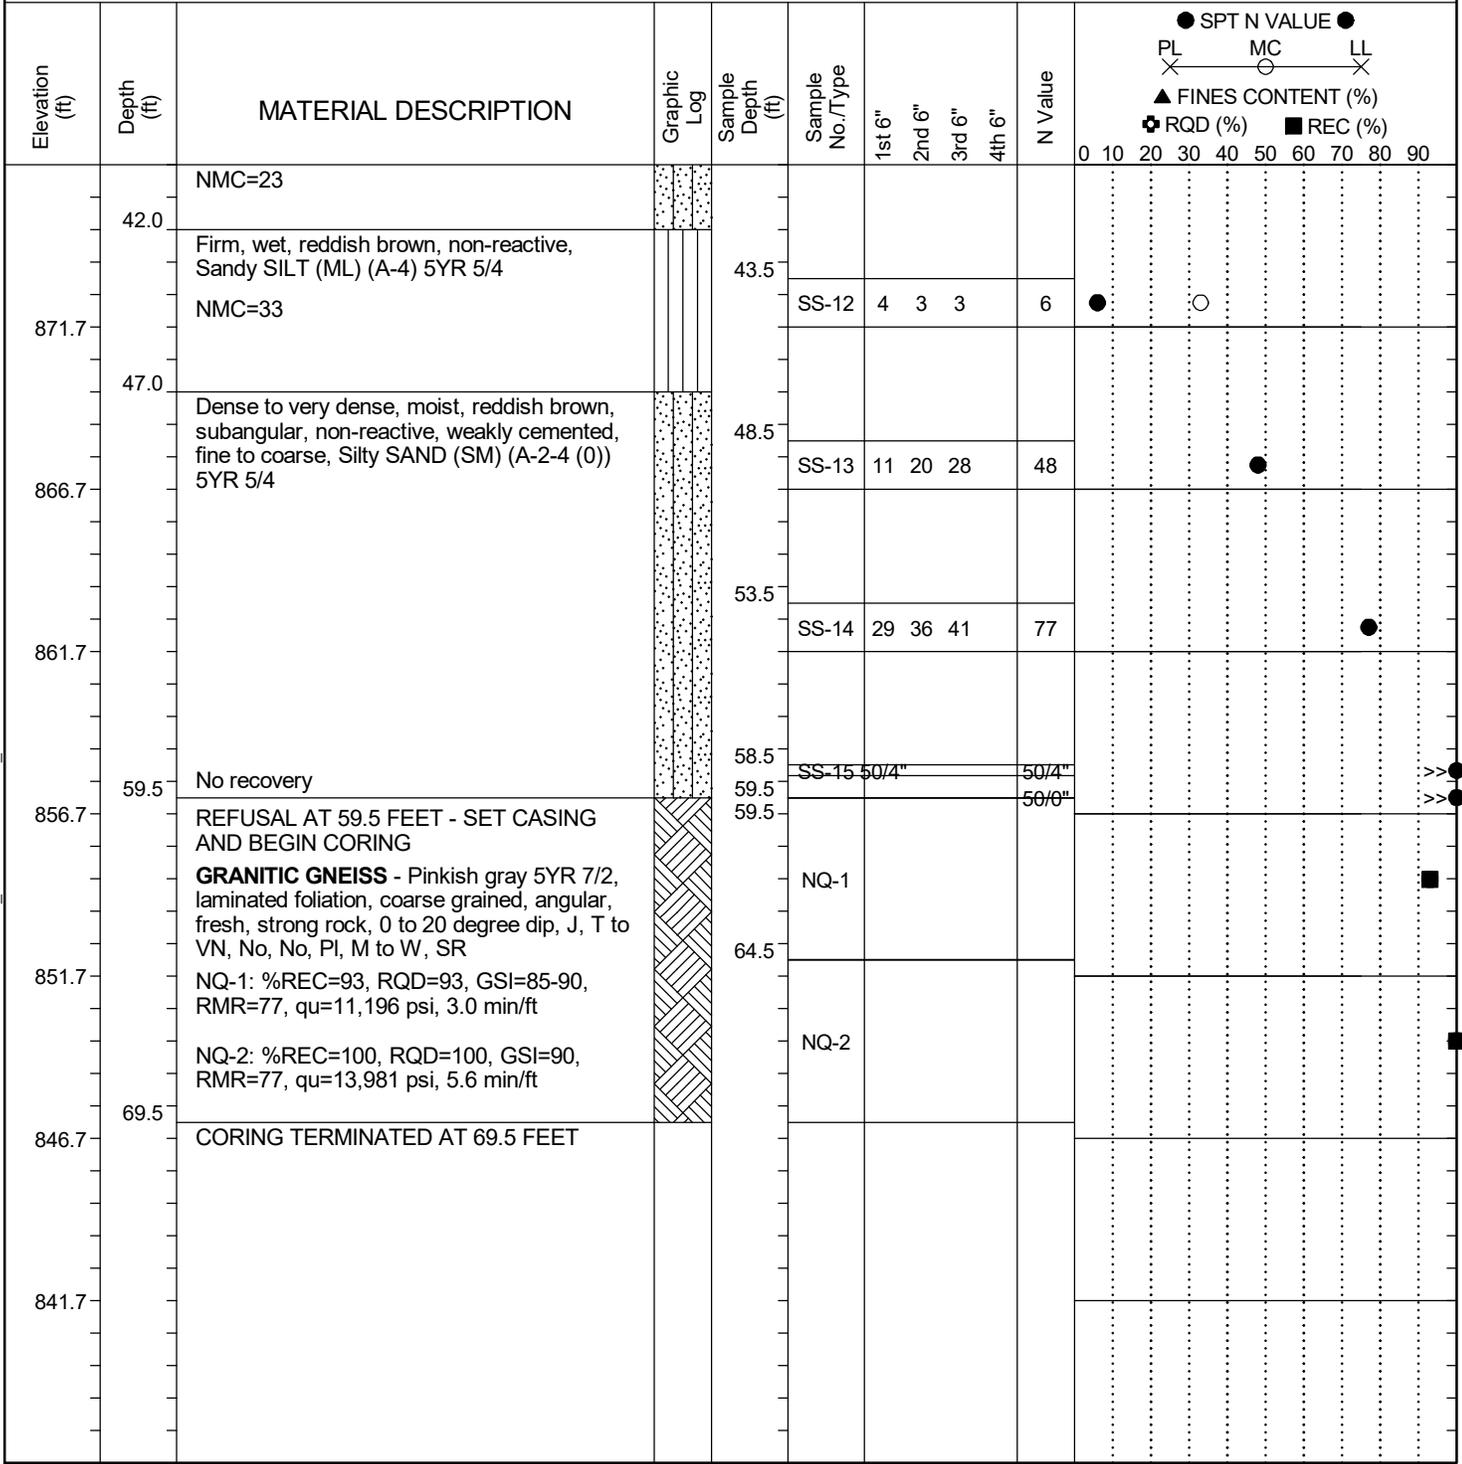
# SCDOT Soil Test Log

<b>Project ID:</b> P043138	<b>County:</b> Pickens	<b>Boring No.:</b> S-39-26-1
<b>Site Description:</b> S-39-26 BRO Tributary to South Saluda River		<b>Route:</b> S-39-26
<b>Eng./Geo.:</b> S. Greaber	<b>Boring Location:</b> 27+69	<b>Offset:</b> 4 R
<b>Alignment:</b> Existing		
<b>Elev.:</b> 916.7 ft	<b>Latitude:</b> 35.01125	<b>Longitude:</b> -82.57016
<b>Date Started:</b> 8/14/2024		
<b>Total Depth:</b> 69.5 ft	<b>Soil Depth:</b> 59.5 ft	<b>Core Depth:</b> 10 ft
<b>Date Completed:</b> 8/14/2024		
<b>Bore Hole Diameter (in):</b> 4	<b>Sampler Configuration</b>	<b>Liner Required:</b> Y (N)
<b>Liner Used:</b> Y (N)		
<b>Drill Machine:</b> DR#1327	<b>Drill Method:</b> RW/RC	<b>Hammer Type:</b> Automatic
<b>Energy Ratio:</b> 92.6%		
<b>Core Size:</b> NQ2	<b>Driller:</b> B. Burnette	<b>Groundwater:</b> TOB N.M.
<b>24HR:</b> 13.5 ft

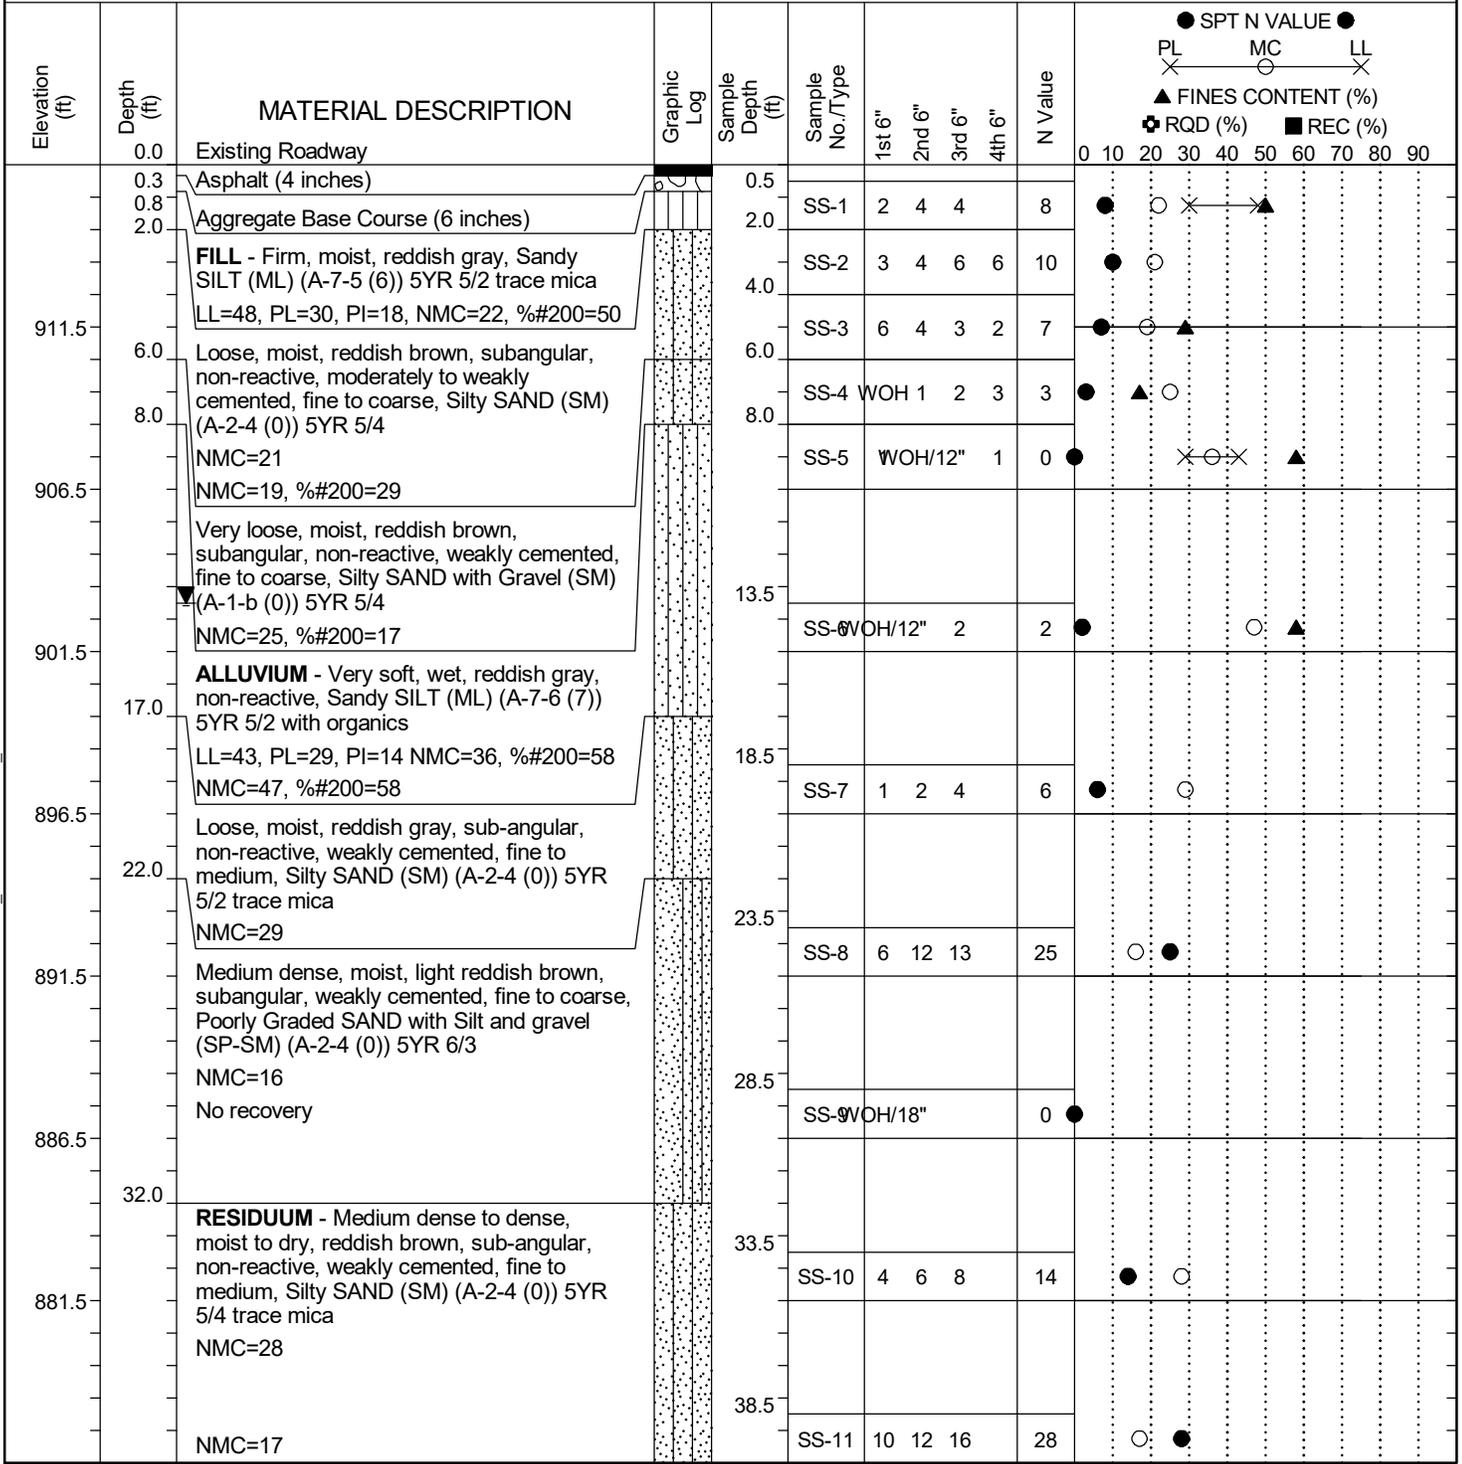
<b>Project ID:</b> P043138	<b>County:</b> Pickens	<b>Boring No.:</b> S-39-26-2
<b>Site Description:</b> S-39-26 BRO Tributary to South Saluda River	<b>Route:</b> S-39-26	
<b>Eng./Geo.:</b> S. Greaber	<b>Boring Location:</b> 28+26	<b>Offset:</b> 5 L
<b>Alignment:</b> Existing		
<b>Elev.:</b> 916.5 ft	<b>Latitude:</b> 35.01138	<b>Longitude:</b> -82.57025
<b>Date Started:</b> 8/20/2024		
<b>Total Depth:</b> 70.5 ft	<b>Soil Depth:</b> 60.5 ft	<b>Core Depth:</b> 10 ft
<b>Date Completed:</b> 8/20/2024		
<b>Bore Hole Diameter (in):</b> 4	<b>Sampler Configuration</b>	<b>Liner Required:</b> Y (N)
<b>Liner Used:</b> Y (N)		
<b>Drill Machine:</b> DR#1327	<b>Drill Method:</b> RW/RC	<b>Hammer Type:</b> Automatic
<b>Energy Ratio:</b> 92.6%		
<b>Core Size:</b> NQ2	<b>Driller:</b> B. Burnette	<b>Groundwater:</b> TOB N.M.
<b>24HR:</b> 13.5 ft

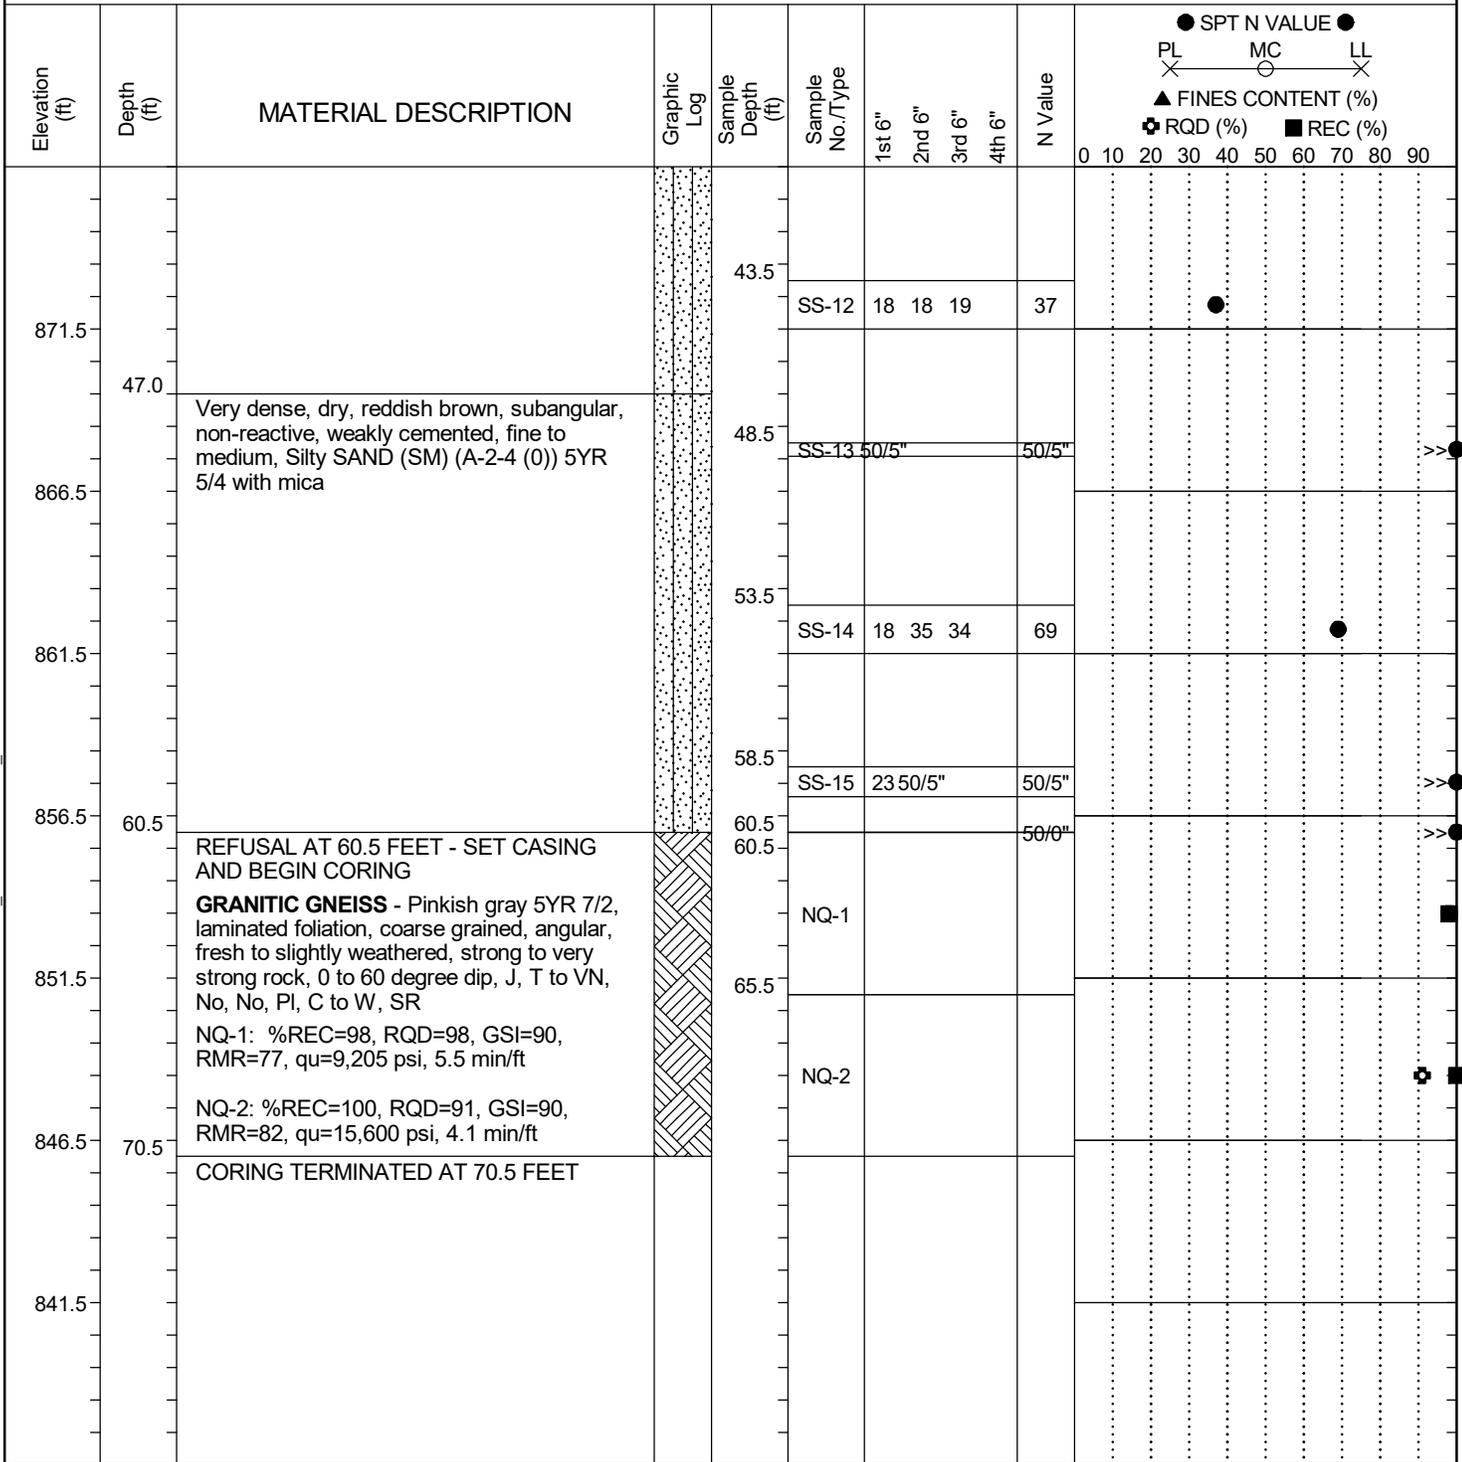
<b>Project ID:</b> P043138	<b>County:</b> Pickens	<b>Boring No.:</b> S-39-26-2
<b>Site Description:</b> S-39-26 BRO Tributary to South Saluda River		<b>Route:</b> S-39-26
<b>Eng./Geo.:</b> S. Greaber	<b>Boring Location:</b> 28+26	<b>Offset:</b> 5 L
<b>Alignment:</b> Existing		
<b>Elev.:</b> 916.5 ft	<b>Latitude:</b> 35.01138	<b>Longitude:</b> -82.57025
<b>Date Started:</b> 8/20/2024		
<b>Total Depth:</b> 70.5 ft	<b>Soil Depth:</b> 60.5 ft	<b>Core Depth:</b> 10 ft
<b>Date Completed:</b> 8/20/2024		
<b>Bore Hole Diameter (in):</b> 4	<b>Sampler Configuration</b>	<b>Liner Required:</b> Y (N)
<b>Liner Used:</b> Y (N)		
<b>Drill Machine:</b> DR#1327	<b>Drill Method:</b> RW/RC	<b>Hammer Type:</b> Automatic
<b>Energy Ratio:</b> 92.6%		
<b>Core Size:</b> NQ2	<b>Driller:</b> B. Burnette	<b>Groundwater:</b> TOB N.M.
<b>24HR:</b> 13.5 ft

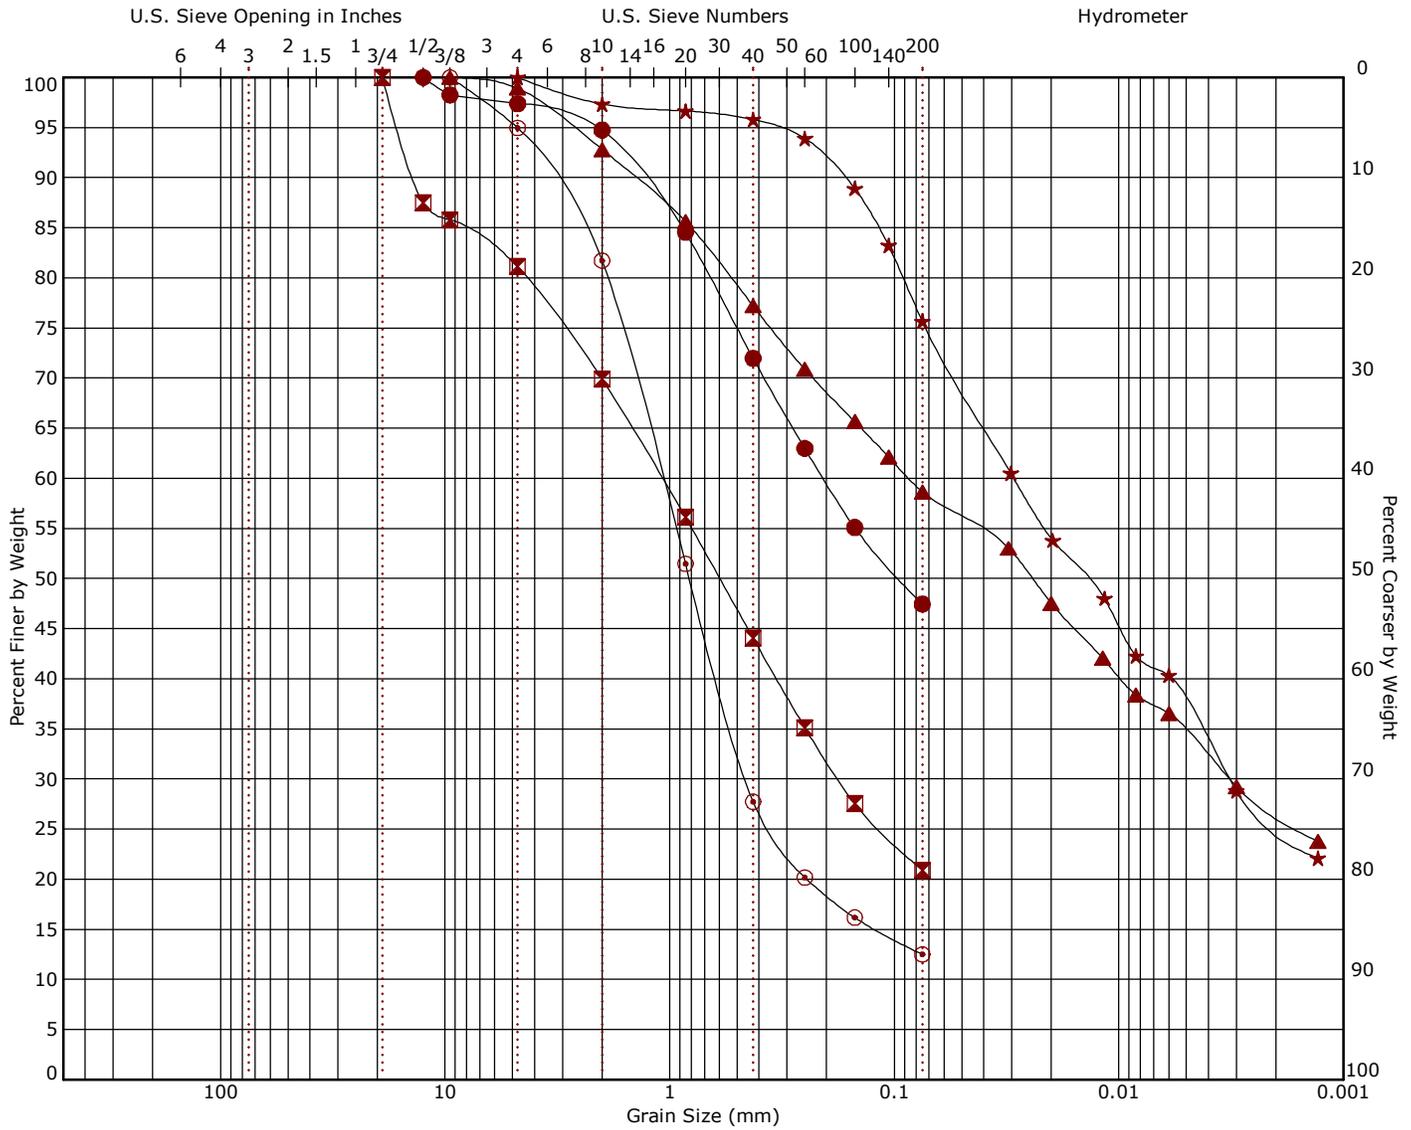
### ASTM D422 / ASTM C136

Boring ID	Depth (Ft)	USCS Classification					USCS	AASHTO	LL	PL	PI	Cc	Cu
		Cobbles	Gravel (coarse, fine)	Sand (coarse, medium, fine)	Silt or Clay								
● S-39-26-1	0.5 - 2	CLAYEY SAND					SC	A-7-6 (5)	43	25	18		
⊠ S-39-26-1	4 - 6	SILTY SAND with GRAVEL					SM	A-1-b (0)					
▲ S-39-26-1	8 - 10	SANDY ELASTIC SILT					MH	A-7-5 (10)	53	34	19		
★ S-39-26-1	13.5 - 15	SILT with SAND					ML	A-5 (9)	42	32	10		
⊙ S-39-26-1	18.5 - 20	SILTY SAND					SM	A-1-b (0)

Boring ID	Depth (Ft)	D <sub>100</sub>	D <sub>60</sub>	D <sub>30</sub>	D <sub>10</sub>	%Cobbles	%Gravel	%Sand	%Fines	%Silt	%Clay
● S-39-26-1	0.5 - 2	12.5	0.206			0.0	2.6	49.9	47.5		
⊠ S-39-26-1	4 - 6	19	1.081	0.177		0.0	18.9	60.2	20.9		
▲ S-39-26-1	8 - 10	9.5	0.086	0.003		0.0	1.1	40.3		24.0	34.6
★ S-39-26-1	13.5 - 15	4.75	0.029	0.003		0.0	0.0	24.3		38.4	37.3
⊙ S-39-26-1	18.5 - 20	9.5	1.082	0.454		0.0	5.0	82.5	12.5

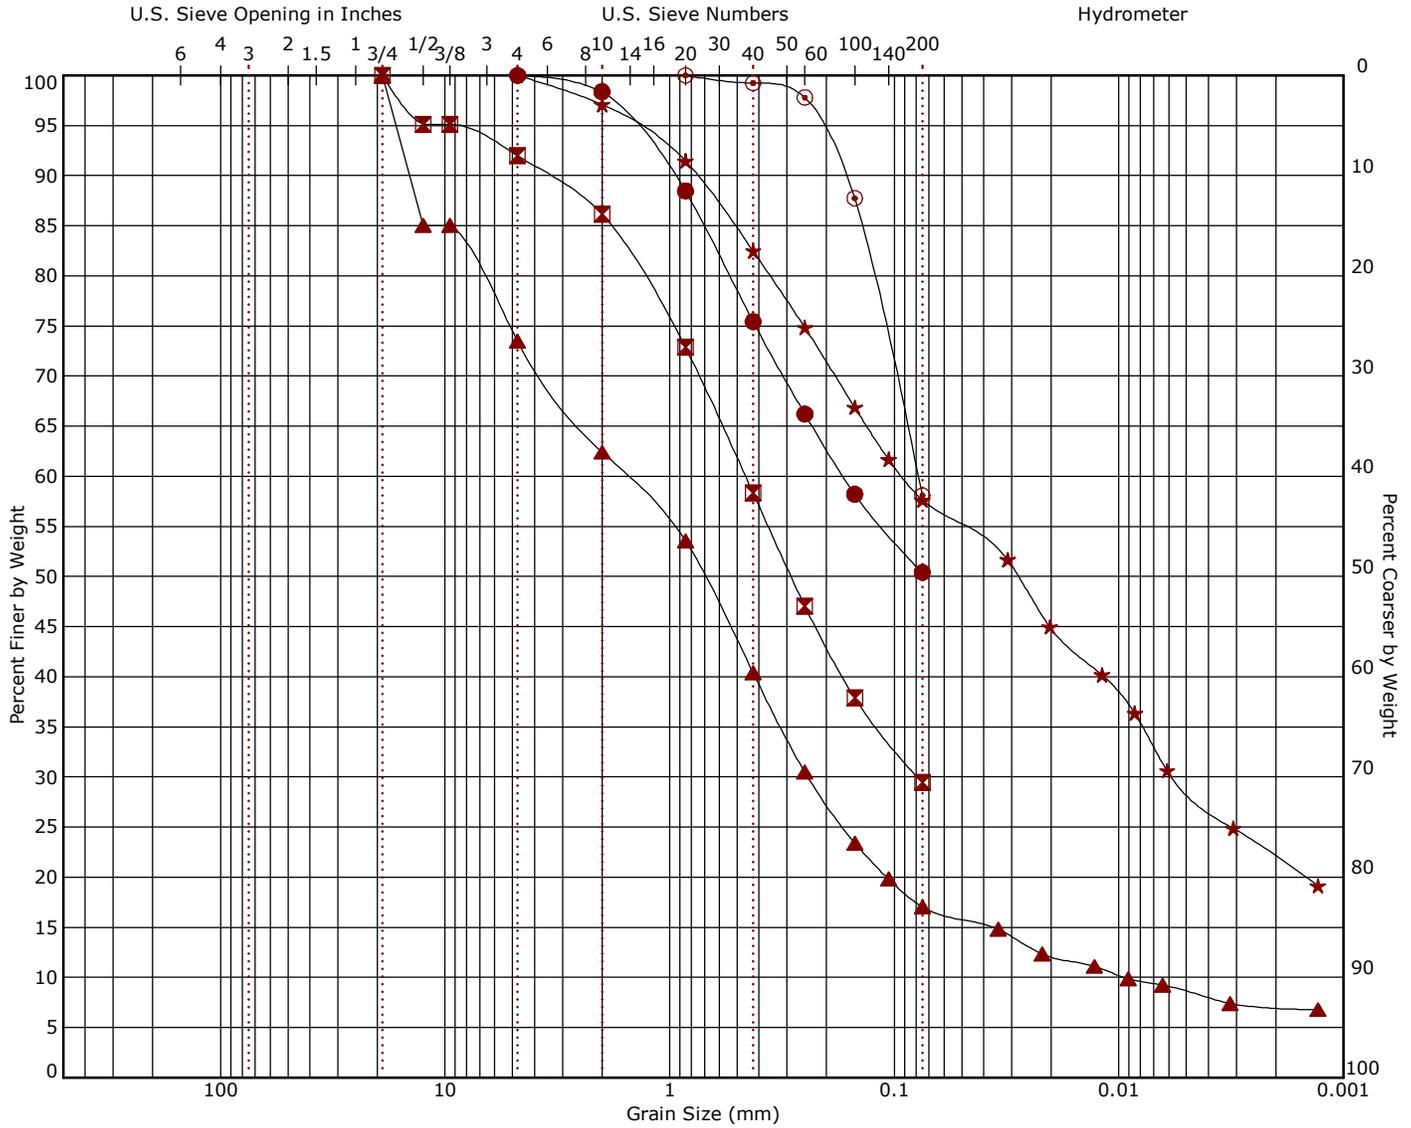
### ASTM D422 / ASTM C136

Boring ID	Depth (Ft)	USCS Classification					USCS	AASHTO	LL	PL	PI	Cc	Cu
		Cobbles	Gravel (coarse, fine)	Sand (coarse, medium, fine)	Silt or Clay								
● S-39-26-2	0.5 - 2	SANDY SILT					ML	A-7-5 (6)	48	30	18		
⊠ S-39-26-2	4 - 6	SILTY SAND					SM	A-2-4 (0)					
▲ S-39-26-2	6 - 8	SILTY SAND with GRAVEL					SM	A-1-b (0)				3.90	167.98
★ S-39-26-2	8 - 10	SANDY SILT					ML	A-7-6 (7)	43	29	14		
⊙ S-39-26-2	13.5 - 15	SANDY SILT					ML	A-7-6 (7)

Boring ID	Depth (Ft)	D <sub>100</sub>	D <sub>60</sub>	D <sub>30</sub>	D <sub>10</sub>	%Cobbles	%Gravel	%Sand	%Fines	%Silt	%Clay
● S-39-26-2	0.5 - 2	4.75	0.168			0.0	0.0	49.6	50.4		
⊠ S-39-26-2	4 - 6	19	0.46	0.079		0.0	8.0	62.6	29.4		
▲ S-39-26-2	6 - 8	19	1.584	0.241	0.009	0.0	26.5	56.5		8.4	8.6
★ S-39-26-2	8 - 10	4.75	0.092	0.006		0.0	0.0	42.4		28.7	28.9
⊙ S-39-26-2	13.5 - 15	0.85	0.078			0.0	0.0	41.9	58.1

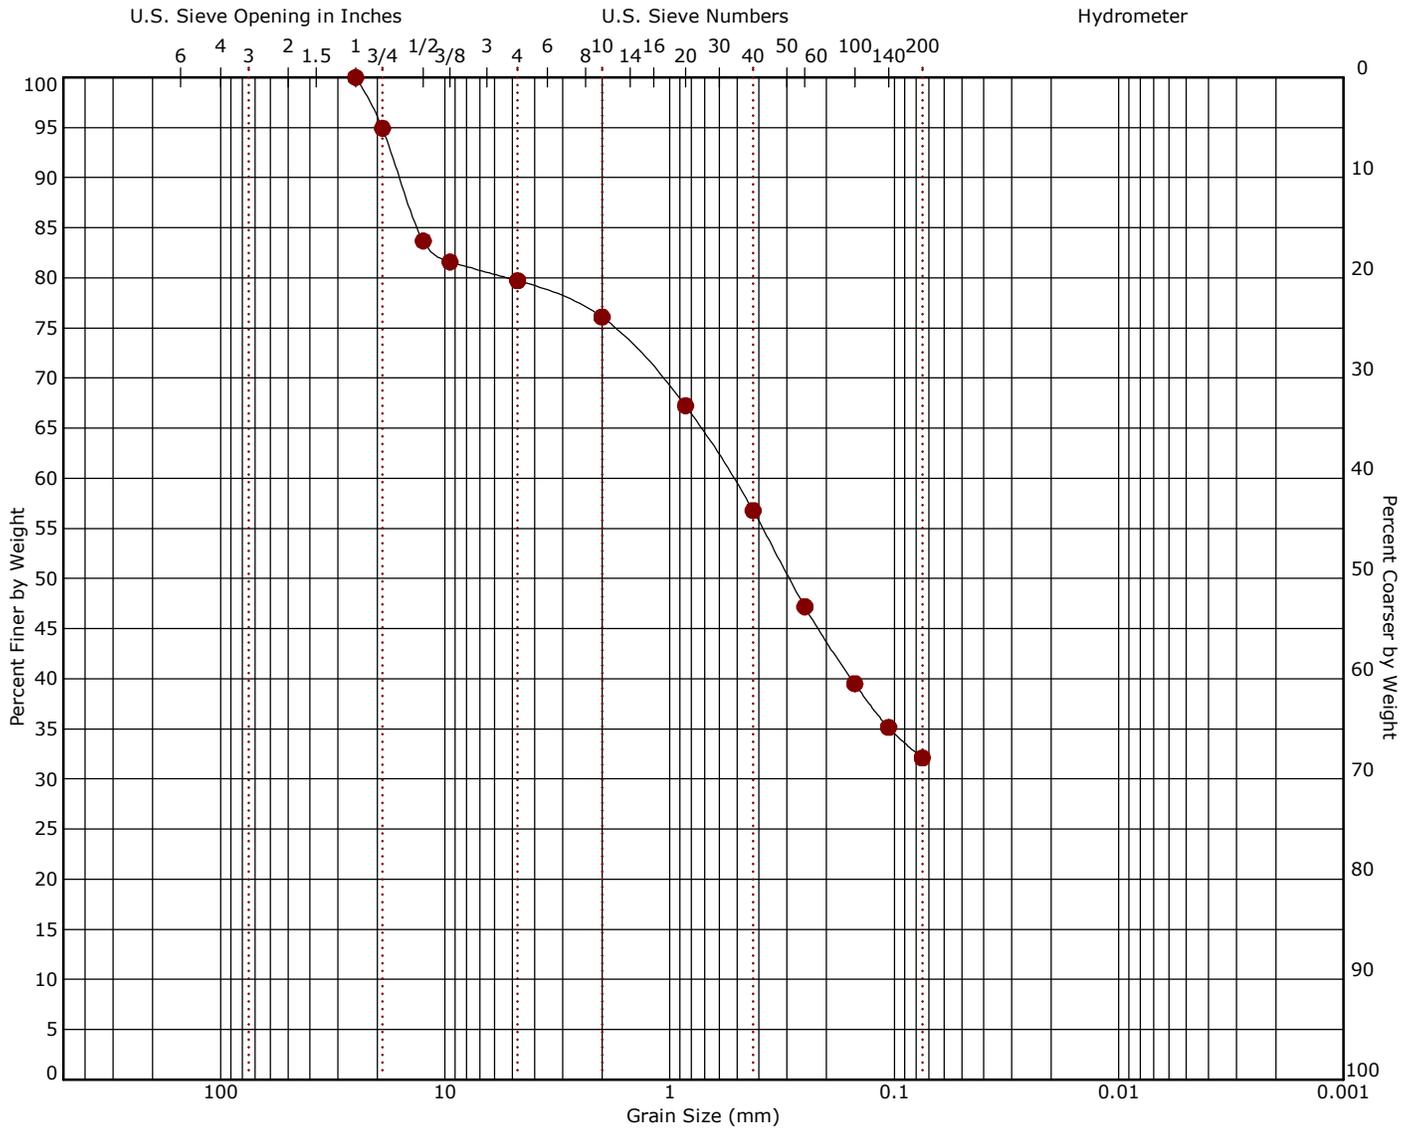
### ASTM D422 / ASTM C136

Boring ID	Depth (Ft)	USCS Classification	USCS	AASHTO	LL	PL	PI	Cc	Cu
S-39-26-1/2 Offset	0 - 5	SILTY SAND with GRAVEL	SM	A-2-4 (0)	NP	NP	NP

Boring ID	Depth (Ft)	D <sub>100</sub>	D <sub>60</sub>	D <sub>30</sub>	D <sub>10</sub>	%Cobbles	%Gravel	%Sand	%Fines	%Silt	%Clay
S-39-26-1/2 Offset	0 - 5	25	0.526			0.0	20.3	47.6	32.1

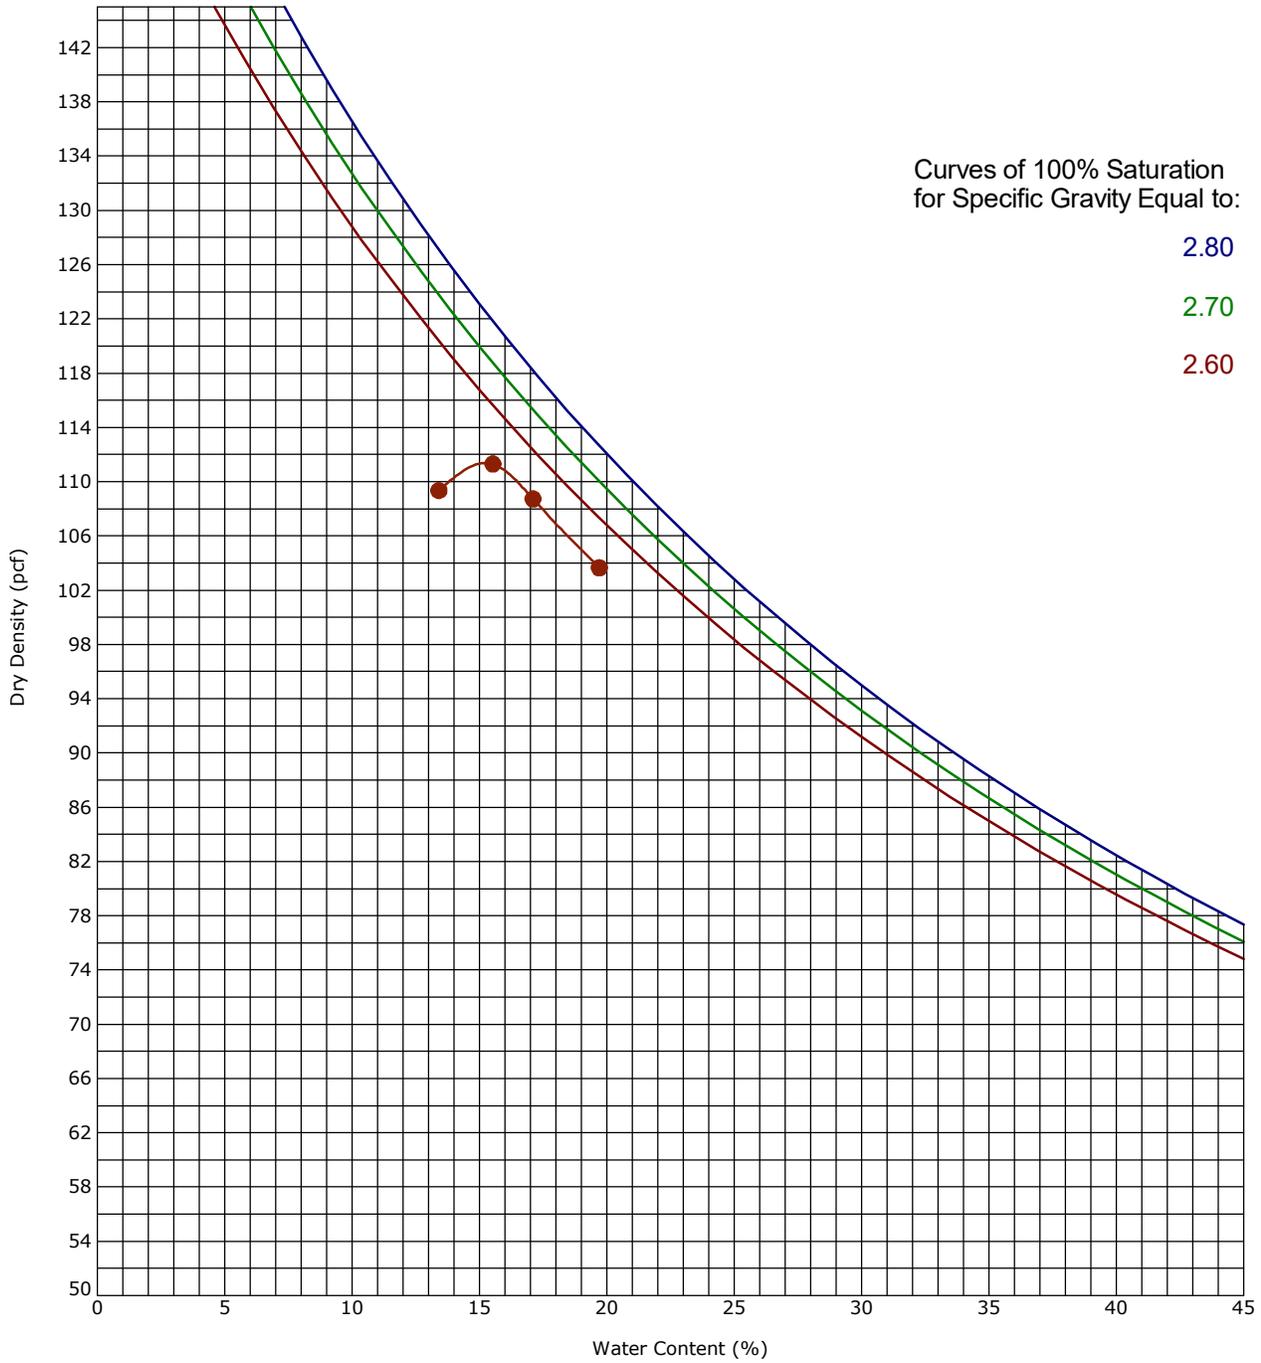
### ASTM D698-Method B

Boring ID		Depth (Ft)		Description of Materials				
S-39-26-1/2 Offset		0 - 5		SILTY SAND with GRAVEL(SM)				
Fines (%)	Fraction > mm size	LL	PL	PI	Test Method	Maximum Dry Density (pcf)	Optimum Water Content (%)	
32	0.0	NP	NP	NP	ASTM D698-Method B	111.4	15.2
