# S-39-26 (Pace Bridge Road) Bridge Replacement over Tributary to South Saluda River

Pickens County, SC

## Geotechnical Baseline Report

October 30, 2024 | SCDOT Project ID: P043138  
Terracon Project No.: 8623P180 Revision 1

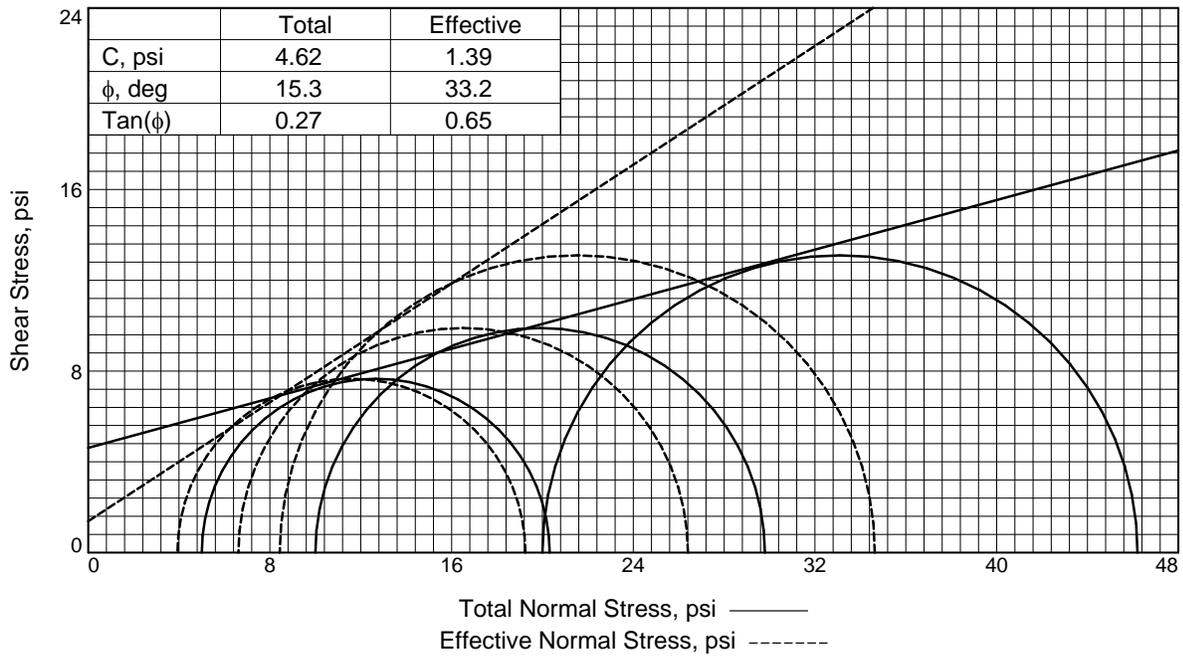
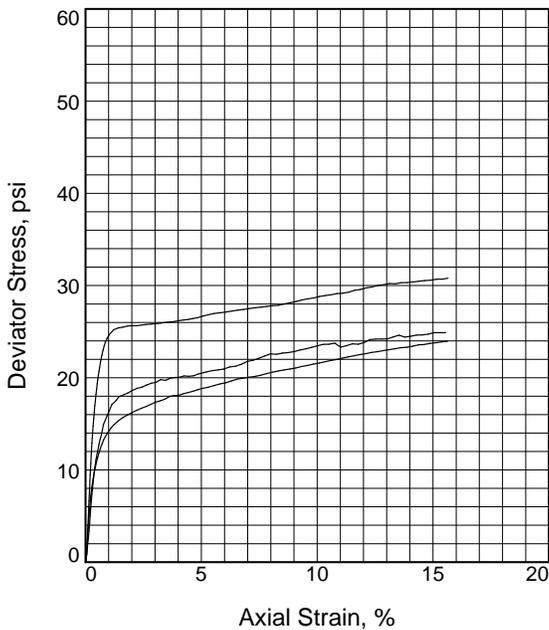
Sample No.	1	2	3	
Initial	Water Content, %	15.0	14.9	15.3
	Dry Density, pcf	106.2	106.4	106.0
	Saturation, %	69.1	68.6	70.2
	Void Ratio	0.5868	0.5848	0.5896
	Diameter, in.	2.80	2.80	2.80
	Height, in.	5.62	5.62	5.62
At Test	Water Content, %	20.0	20.0	19.9
	Dry Density, pcf	109.4	109.4	109.7
	Saturation, %	100.0	100.0	100.0
	Void Ratio	0.5409	0.5412	0.5369
	Diameter, in.	2.77	2.77	2.76
	Height, in.	5.58	5.58	5.57
Strain rate, in./min.	0.001	0.001	0.001	
Back Pressure, psi	50.0	50.0	50.0	
Cell Pressure, psi	55.0	60.0	70.0	
Fail. Stress, psi	15.3	19.8	26.2	
Excess Pore Pr., psi	1.1	3.4	11.6	
Ult. Stress, psi	23.8	24.9	30.7	
Excess Pore Pr., psi	-2.4	1.4	9.6	
$\bar{\sigma}_1$ Failure, psi	19.2	26.4	34.6	
$\bar{\sigma}_3$ Failure, psi	3.9	6.6	8.4

Sample No.	Station	Offset (ft)	Sample Depth (ft)	USCS Soil Type	Compaction		Shear Strength <sup>1</sup>	
					Optimum Moisture (%)	Max Dry Density (pcf)	Total	Effective
S-39-26-1/2 Offset	27+69 and 28+26	4 L and 6 R	0 - 5	SM	15.2	111.4	c=4.6 psi $\phi=15^\circ$	c'=1.4 psi $\phi'=33^\circ$

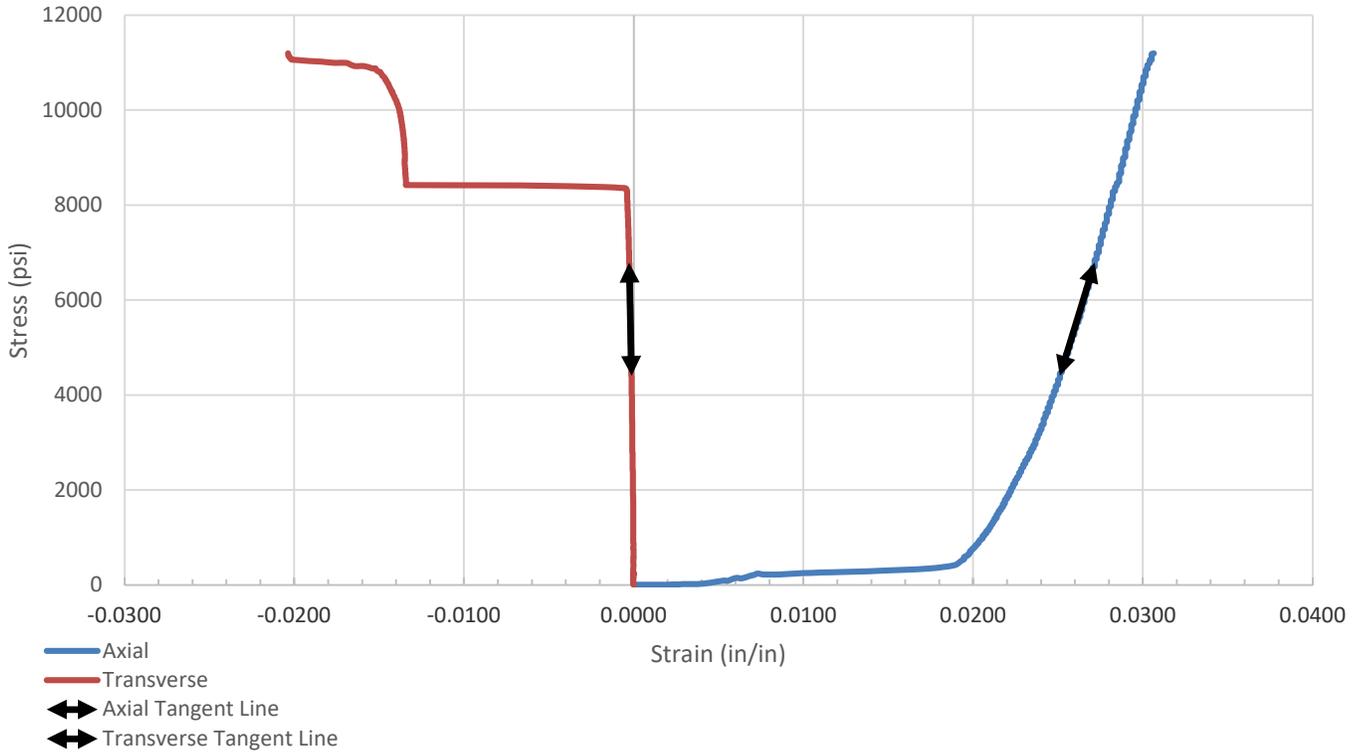
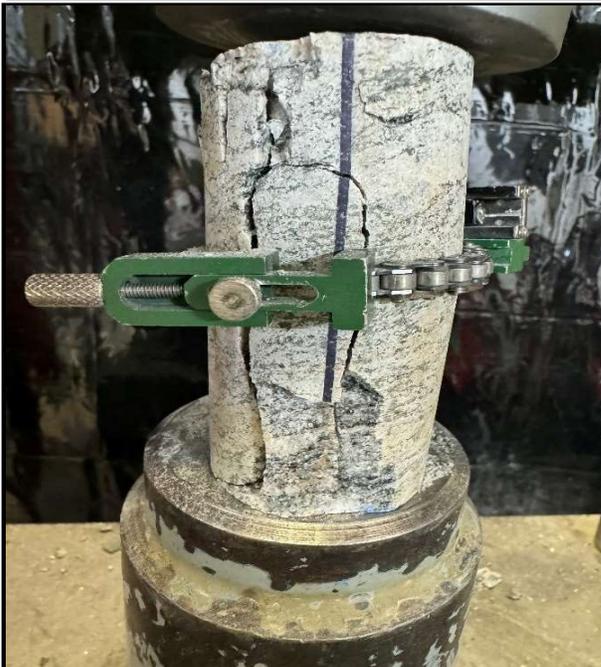
ASTM D7012 Stress/ Strain Curve

Site:	SCDOT Bridge Package 19		
Description:	Gneiss		
Boring:	S-39-26-1	Depth (feet):	61.6-62.8

Failure Load (lbs):	33782
Failure Strain (%):	3.06
Unconfined Compressive Strength (psi):	11,196
Elastic Modulus, E, (ksi):	1167
Poisson's Ratio, u:	0.065
Time of Failure (min):	01:45
Rate of Loading (psi/sec):	0.042
Moisture Content Post-break:	0.0014

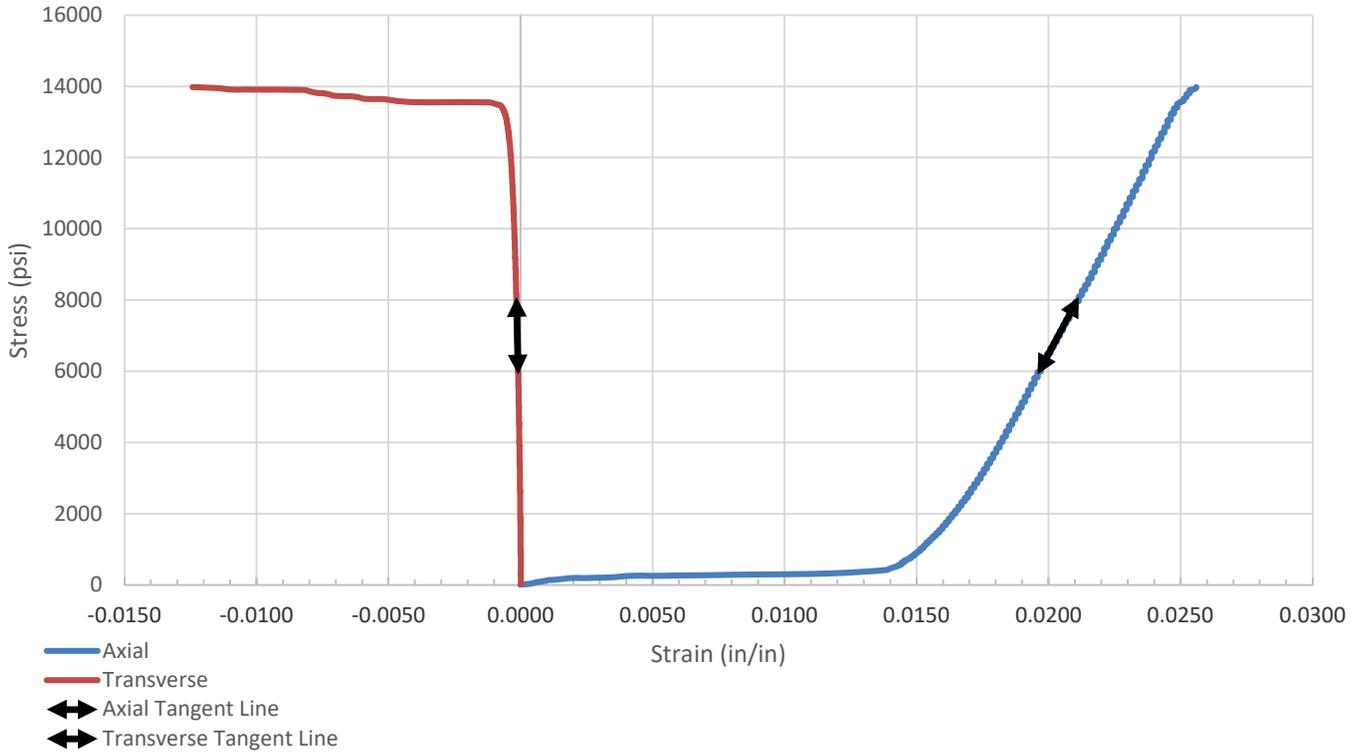
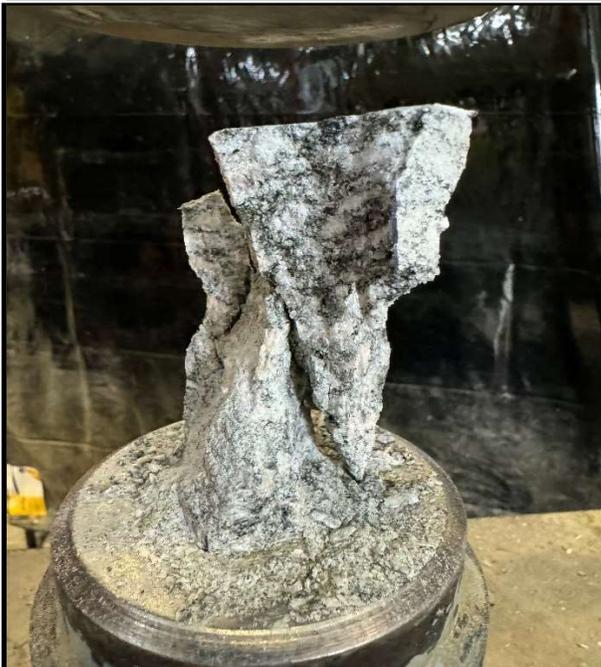
ASTM D7012 Stress/ Strain Curve

Site:	SCDOT Bridge Package 19		
Description:	Gneiss		
Boring:	S-39-26-1	Depth (feet):	68.2-69.5

Failure Load (lbs):	42184
Failure Strain (%):	2.94
Unconfined Compressive Strength (psi):	13,981
Elastic Modulus, E, (ksi):	1394
Poisson's Ratio, u:	0.044
Time of Failure (min):	02:08
Rate of Loading (psi/sec):	0.042
Moisture Content Post-break:	0.0012

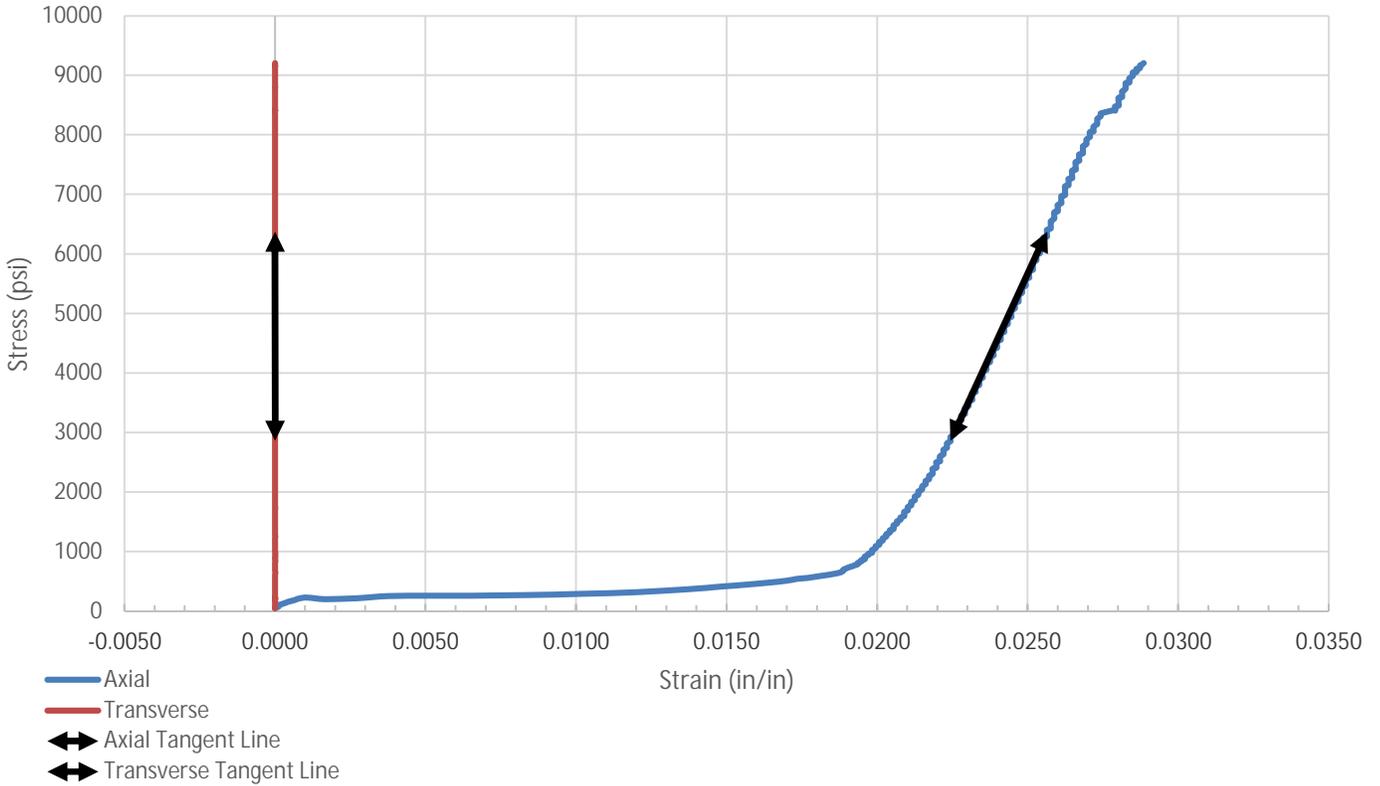
ASTM D7012 Stress/ Strain Curve

Site:	SCDOT Bridge Package 19		
Rock Type:	Granite		
Boring:	S-39-26-2	Depth (feet):	60.5-61.5

Failure Load (lbs):	28630
Failure Strain (%):	3.26
Unconfined Compressive Strength (psi):	9,205
Elastic Modulus, E, (ksi):	1095
Poisson's Ratio, u:	0.001
Time of Failure (min):	01:24
Rate of Loading (psi/sec):	109.845
Moisture Content Post-break:	0.01%

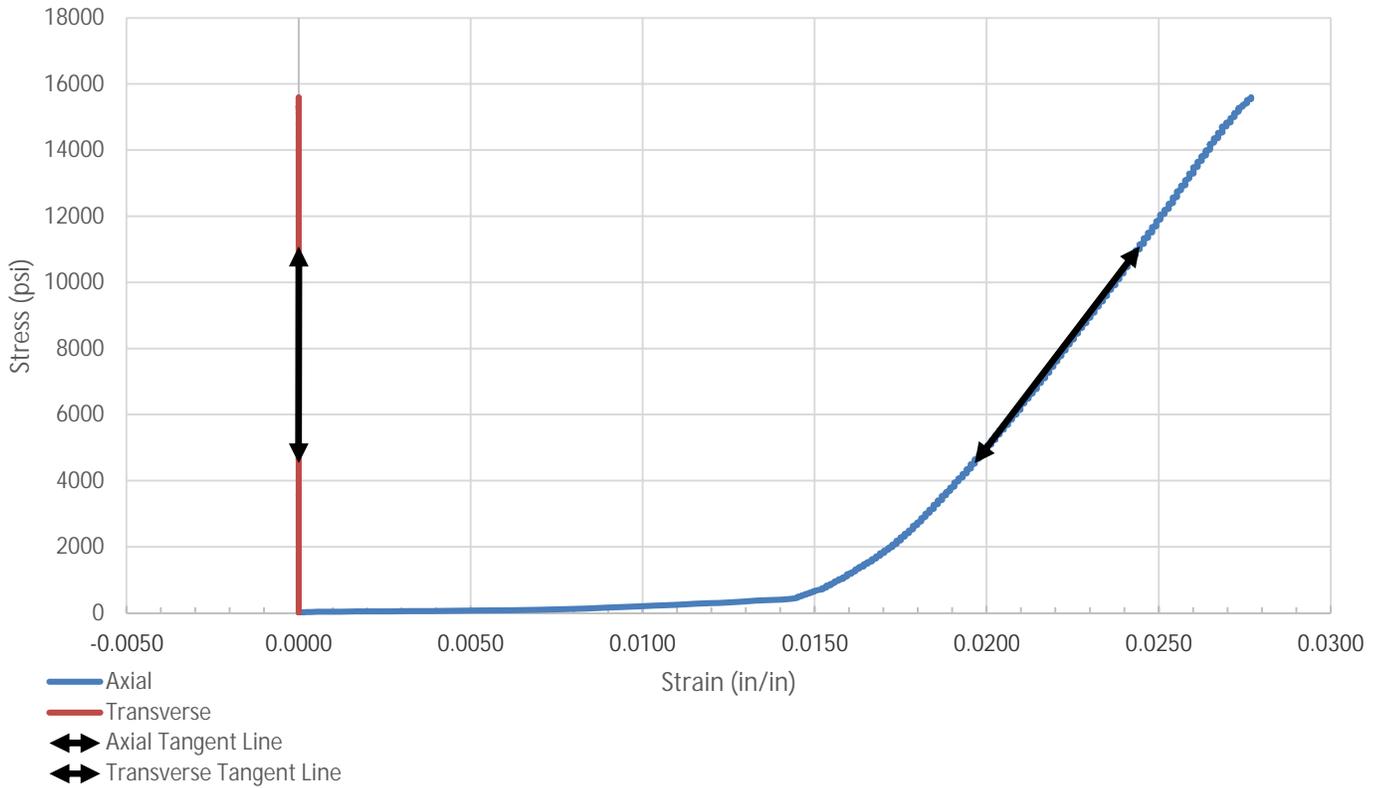
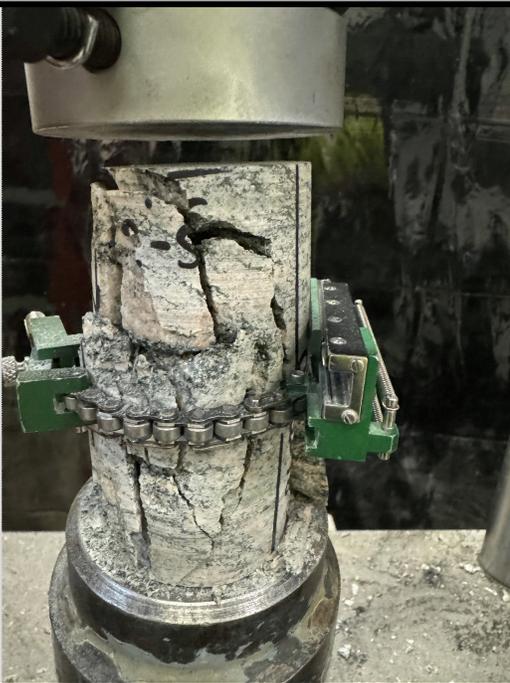
ASTM D7012 Stress/ Strain Curve

Site:	SCDOT Bridge Package 19		
Rock Type:	Granite		
Boring:	S-39-26-2	Depth (feet):	66-66.8

Failure Load (lbs):	48519
Failure Strain (%):	3.43
Unconfined Compressive Strength (psi):	15,600
Elastic Modulus, E, (ksi):	1366
Poisson's Ratio, u:	0.001
Time of Failure (min):	02:23
Rate of Loading (psi/sec):	109.089
Moisture Content Post-break:	0.01%

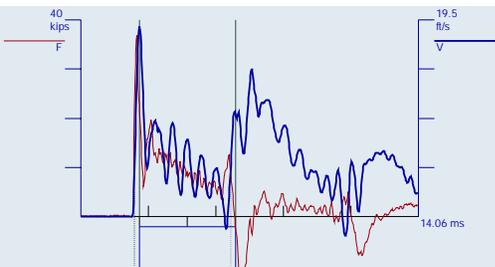
BN 13  
 05Sep2024 10:07:23 AM

CSX	32.1 ksi
DMX	1.11 in
EFV	331 ft-lb
ETR	94.7 %
BPM	53.8 bpm
RAT	1.0
VMX	18.9 ft/s
FMX	37 kips
DFN	1.00 in
MEX	1070 µE
AMX	3001 g/s
FVP	0.6
LE	33.70 ft
AR	1.15 in <sup>2</sup>
EM	30000 ksi
SP	0.492 k-ft/3
WS	16807.9 ft/s
WC	16766.2 ft/s
JC	0.90
JF	1.00

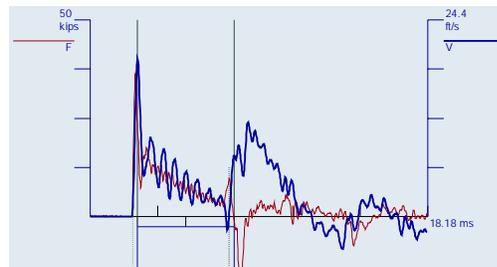
BN 25  
 05Sep2024 10:24:35 AM

CSX	31.7 ksi
DMX	0.66 in
EFV	324 ft-lb
ETR	92.6 %
BPM	53.4 bpm
RAT	1.1
VMX	19.6 ft/s
FMX	36 kips
DFN	0.60 in
MEX	1056 µE
AMX	3358 g/s
LE	43.70 ft
AR	1.15 in <sup>2</sup>
EM	30000 ksi
SP	0.492 k-ft/3
WS	16807.9 ft/s
WC	16807.7 ft/s
JC	0.90
JF	1.00

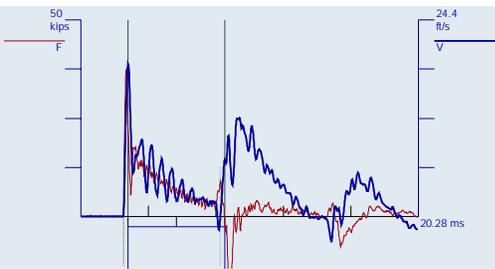
BN 14  
05Sep2024 10:32:57 AM

CSX	32.6 ksi
DMX	0.91 in
EFV	325 ft-lb
ETR	92.8 %
BPM	53.4 bpm
RAT	1.0
VMX	19.0 ft/s
FMX	37 kips
DFN	0.86 in
MEX	1086 µE
AMX	3426 g's
LE	48.70 ft
AR	1.15 m <sup>2</sup>
EM	30000 ksi
SP	0.492 k-ft <sup>3</sup>
WS	16807.9 ft/s
WC	16793.1 ft/s
JC	0.90
JF	1.00

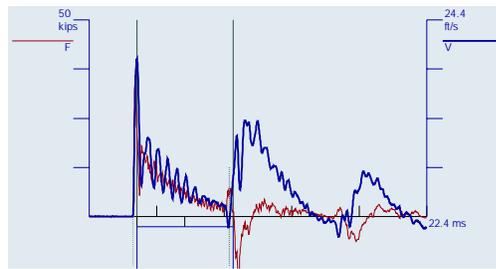
BN 13  
05Sep2024 10:42:13 AM

CSX	31.5 ksi
DMX	1.01 in
EFV	320 ft-lb
ETR	91.4 %
BPM	53.7 bpm
RAT	1.1
VMX	19.6 ft/s
FMX	36 kips
DFN	0.86 in
MEX	1049 µE
AMX	4077 g's
LE	53.70 ft
AR	1.15 m <sup>2</sup>
EM	30000 ksi
SP	0.492 k-ft <sup>3</sup>
WS	16807.9 ft/s
WC	16781.3 ft/s
JC	0.90
JF	1.00

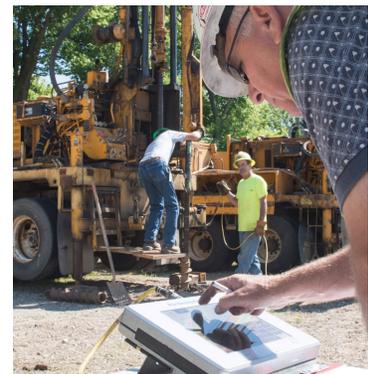
- Calculates energy transferred by SPT hammers using force and velocity measurements
- Determines N value to help improve reliability of soil strength estimates
- Offers simplified reporting and analysis option to speed testing results
- Operates in English, SI, or Metric units

The SPT Analyzer is compliant with EN ISO 22476-3:2005. ASTM D1586 recommends normalizing results from any SPT test using energy measurements. When these tests are performed to determine the liquefaction potential of sands, ASTM D6066 not only recommends but mandates the normalization. ASTM D4633 states that the only acceptable method of determining energy for normalization of N values is by force and velocity measurements.

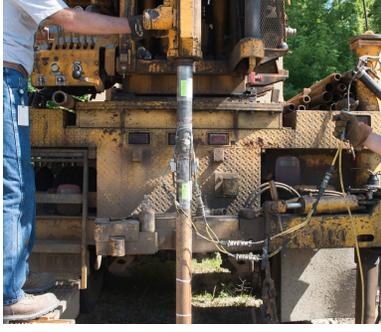
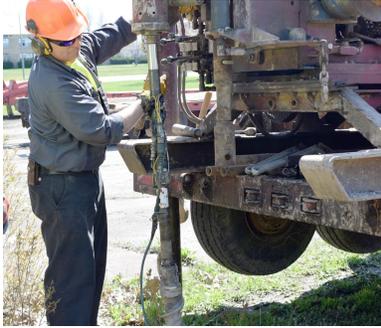
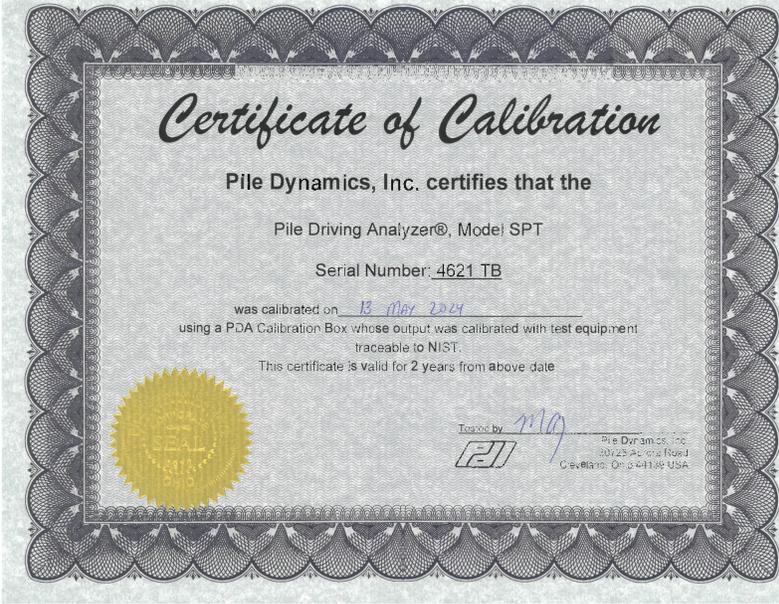
SPT Analyzer data is stored and transferred to a computer via USB memory stick. The software furnished with the SPT Analyzer has a Report Creation Option that makes it quick and easy to summarize results and create output graphs of Force, Velocity, Energy and Displacement versus Time, as well as numerical, statistical, and graphical results for each data set. The software is fully customizable.
