# S-39-32 (Shady Grove Road) Bridge Replacement over Crow Creek

### Geotechnical Baseline Report

October 30, 2024 | SCDOT Project ID: P041168

Terracon Project No.: 8623P180 Revision 1

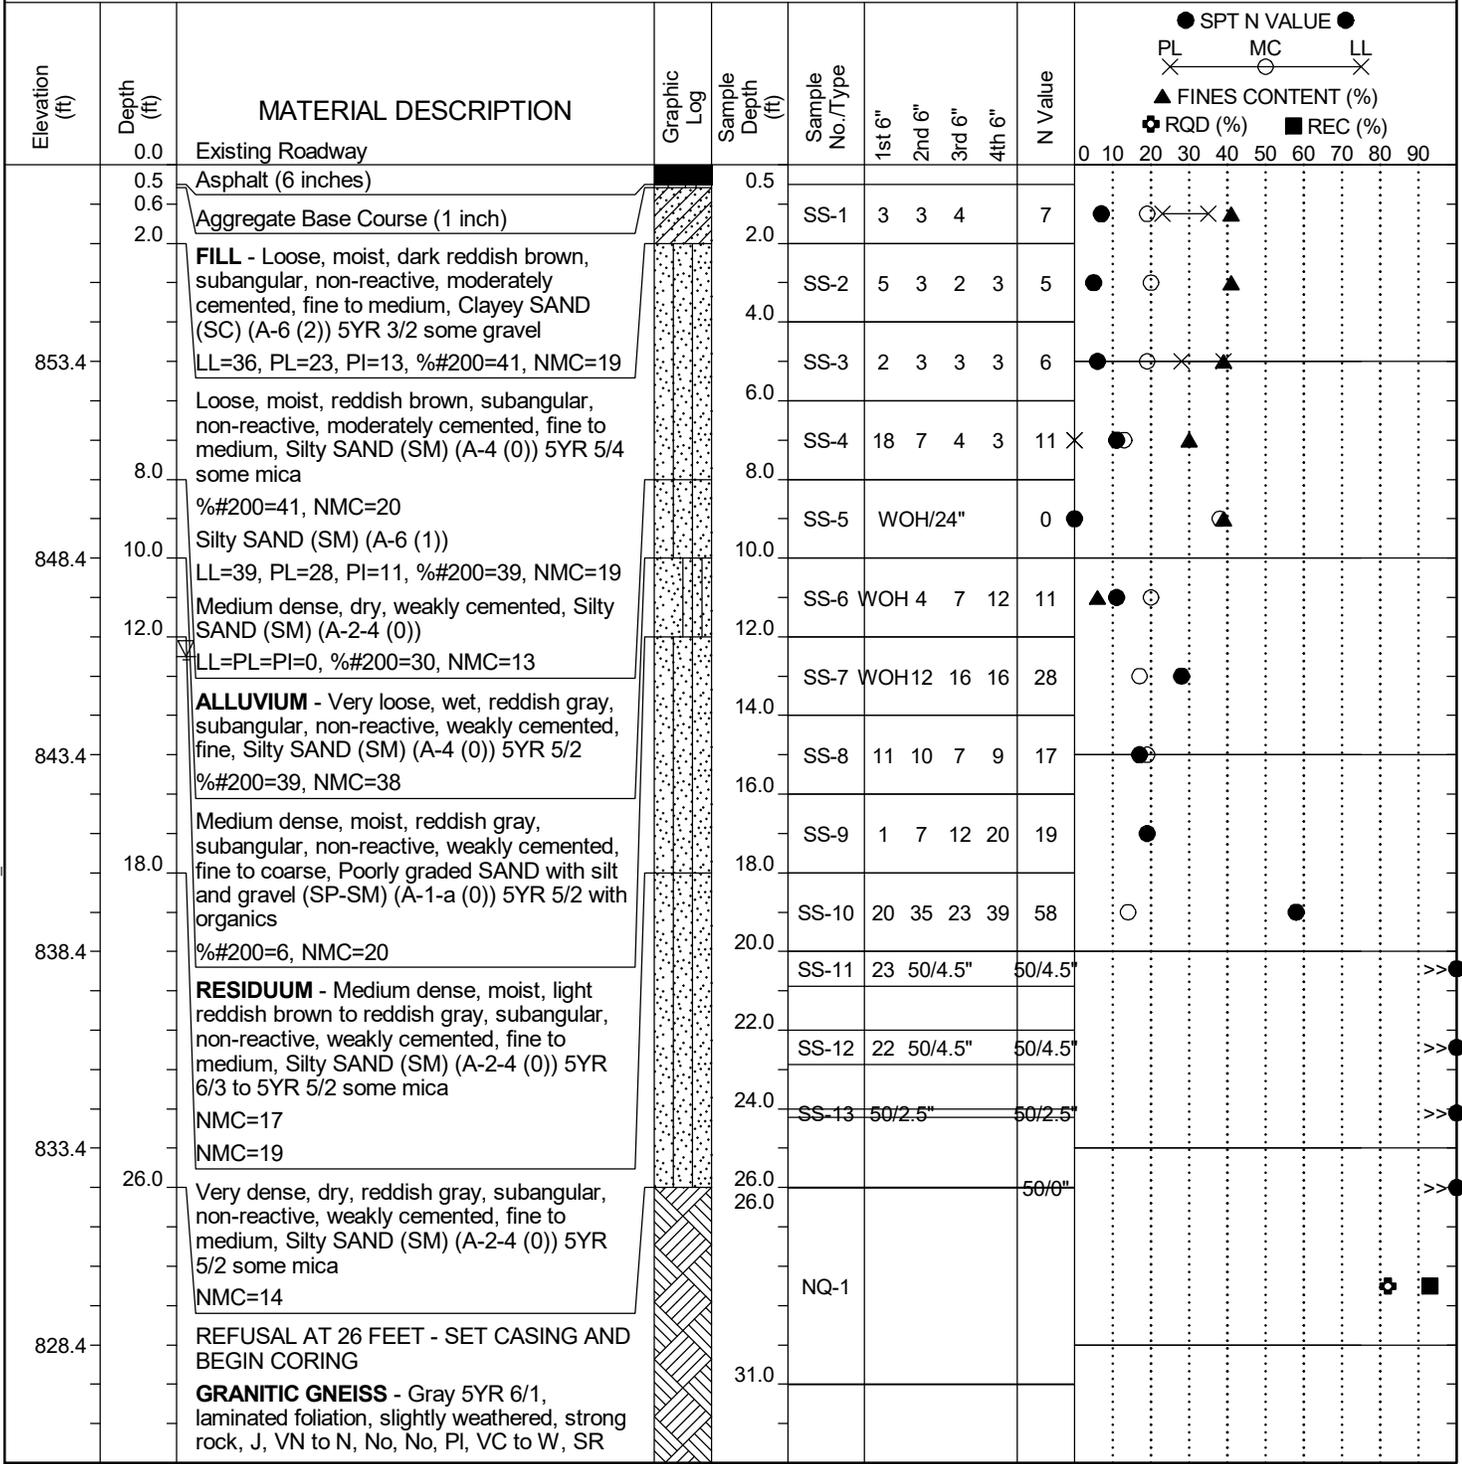
<b>Project ID:</b> P041168	<b>County:</b> Pickens	<b>Boring No.:</b> S-39-32-1
<b>Site Description:</b> S-39-32 BRO Crow Creek	<b>Route:</b> S-39-32	
<b>Eng./Geo.:</b> S. Greaber	<b>Boring Location:</b> 375+34	<b>Offset:</b> 7 L
<b>Alignment:</b> Existing		
<b>Elev.:</b> 858.4 ft	<b>Latitude:</b> 34.9172856	<b>Longitude:</b> -82.8320644
<b>Date Started:</b> 8/16/24		
<b>Total Depth:</b> 36 ft	<b>Soil Depth:</b> 26 ft	<b>Core Depth:</b> 10 ft
<b>Date Completed:</b> 8/16/2024		
<b>Bore Hole Diameter (in):</b> 4	<b>Sampler Configuration</b>	<b>Liner Required:</b> Y (N)
<b>Liner Used:</b> Y (N)		
<b>Drill Machine:</b> DR#554	<b>Drill Method:</b> RW/RC	<b>Hammer Type:</b> Automatic
<b>Energy Ratio:</b> 88.5%		
<b>Core Size:</b> NQ2	<b>Driller:</b> G. Robinson	<b>Groundwater:</b> TOB 12.5 ft
<b>24HR:</b> N.M.

Both borings encountered 6 to 7 inches of asphalt followed by 1 to 8 inches of gravel on the surface of the site. Beneath the surface covering, a layer of fill soil consisting of loose to medium dense silty or clayey sand was encountered to around 8 to 12 feet below the existing ground surface in both borings. Under the fill soils, both borings encountered a layer of alluvial soil consisting of very loose to medium dense silty sand or poorly graded sand with silt and gravel to depth of around 12 to 17 feet below the existing ground surface. Below the alluvium, residual soils consisting of medium dense to very dense silty sand were encountered and continued to between 26 to 30 feet below ground surface, with some residual soils characterized as being intermediate geomaterials (IGM) exhibiting SPT results more than 100 bpf, followed by bedrock. Bedrock was present to the maximum depth explored of 36 feet and 50 feet at Boring S-39-32-1 and S-39-32-2, respectively.

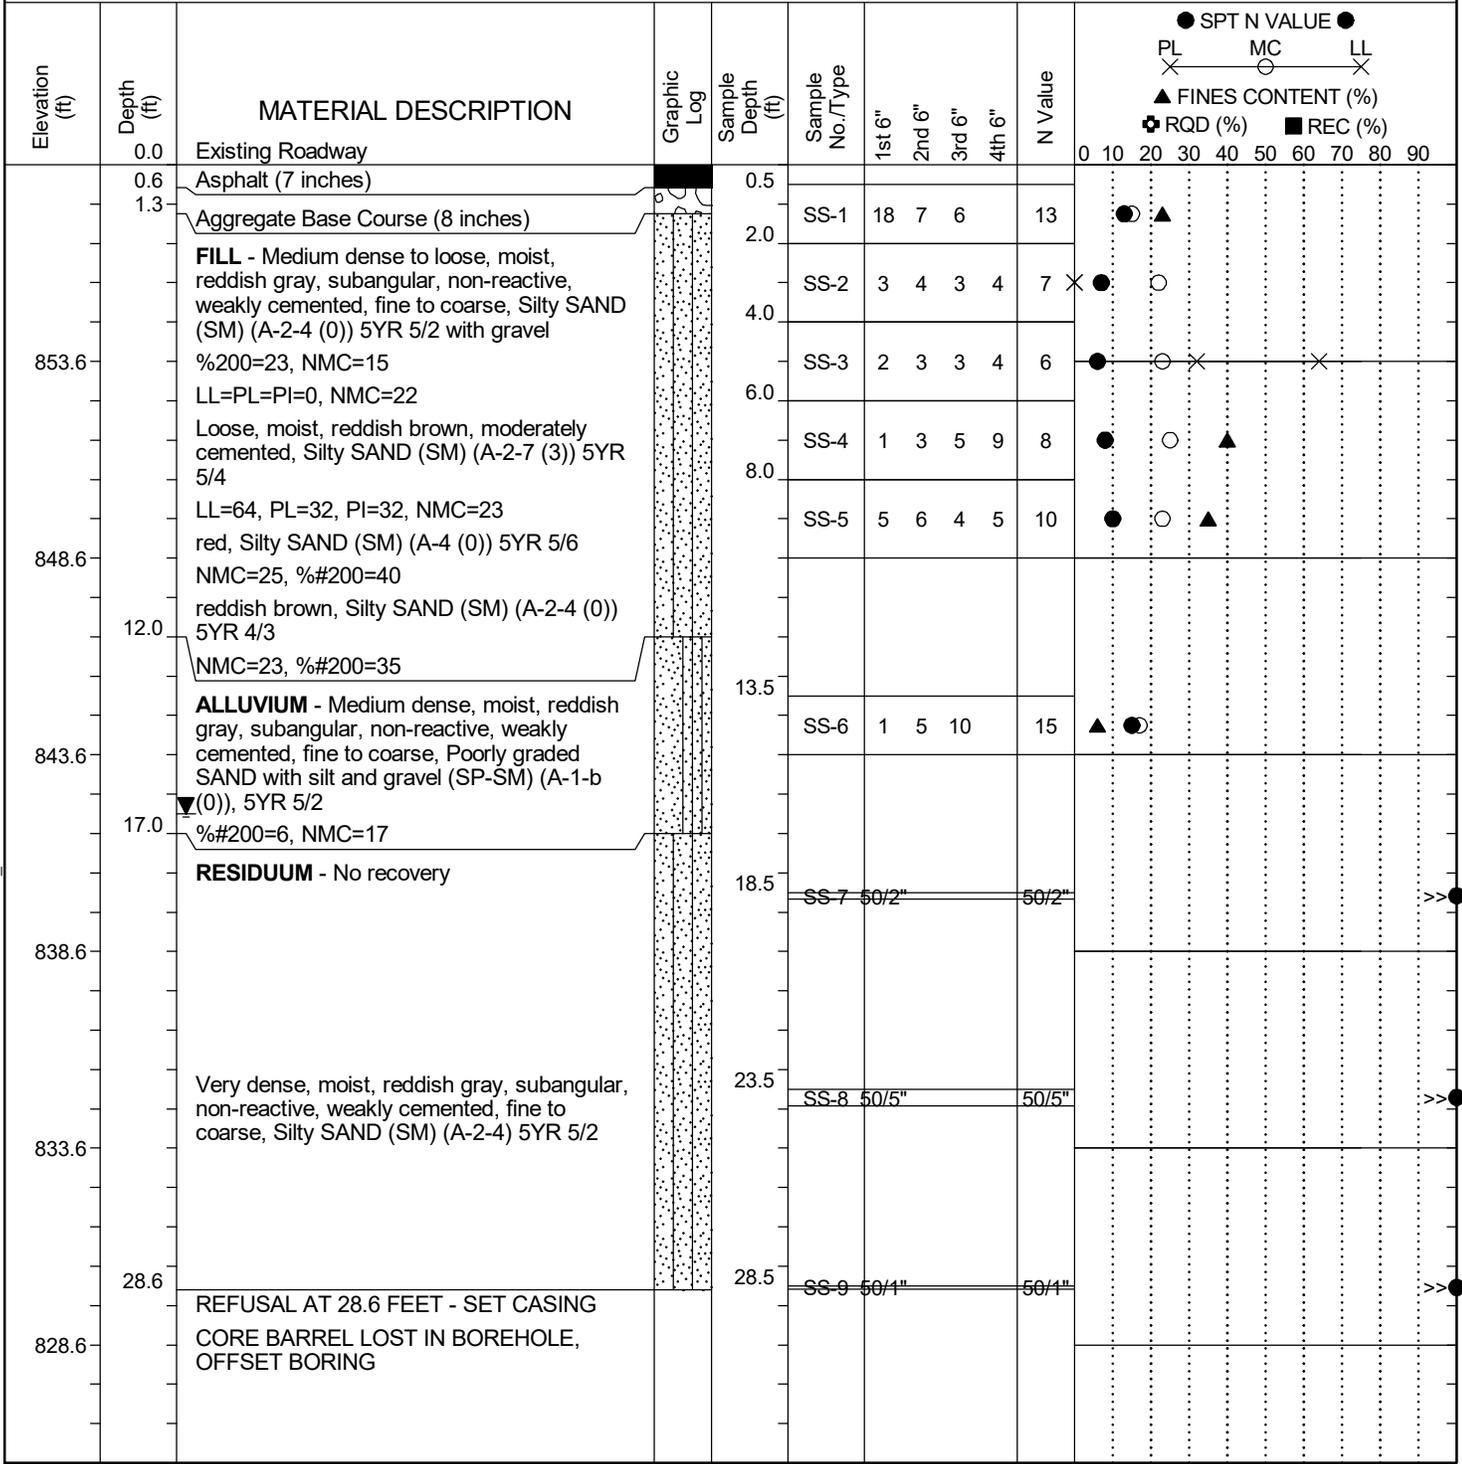
<b>Project ID:</b> P041168	<b>County:</b> Pickens	<b>Boring No.:</b> S-39-32-2
<b>Site Description:</b> S-39-32 BRO Crow Creek	<b>Route:</b> S-39-32	
<b>Eng./Geo.:</b> M. McKenney	<b>Boring Location:</b> 376+13	<b>Offset:</b> 8 L
<b>Alignment:</b> Existing		
<b>Elev.:</b> 858.6 ft	<b>Latitude:</b> 34.917115	<b>Longitude:</b> -82.8322245
<b>Date Started:</b> 8/15/24		
<b>Total Depth:</b> 28.6 ft	<b>Soil Depth:</b> 28.6 ft	<b>Core Depth:</b> 0 ft
<b>Date Completed:</b> 8/15/2024		
<b>Bore Hole Diameter (in):</b> 4	<b>Sampler Configuration</b>	<b>Liner Required:</b> Y (N)
<b>Liner Used:</b> Y (N)		
<b>Drill Machine:</b> DR#1327	<b>Drill Method:</b> RW	<b>Hammer Type:</b> Automatic
<b>Energy Ratio:</b> 92.6%		
<b>Core Size:</b> N/A	<b>Driller:</b> B. Burnette	<b>Groundwater:</b> TOB N.M.
<b>24HR:</b> 16.5 ft

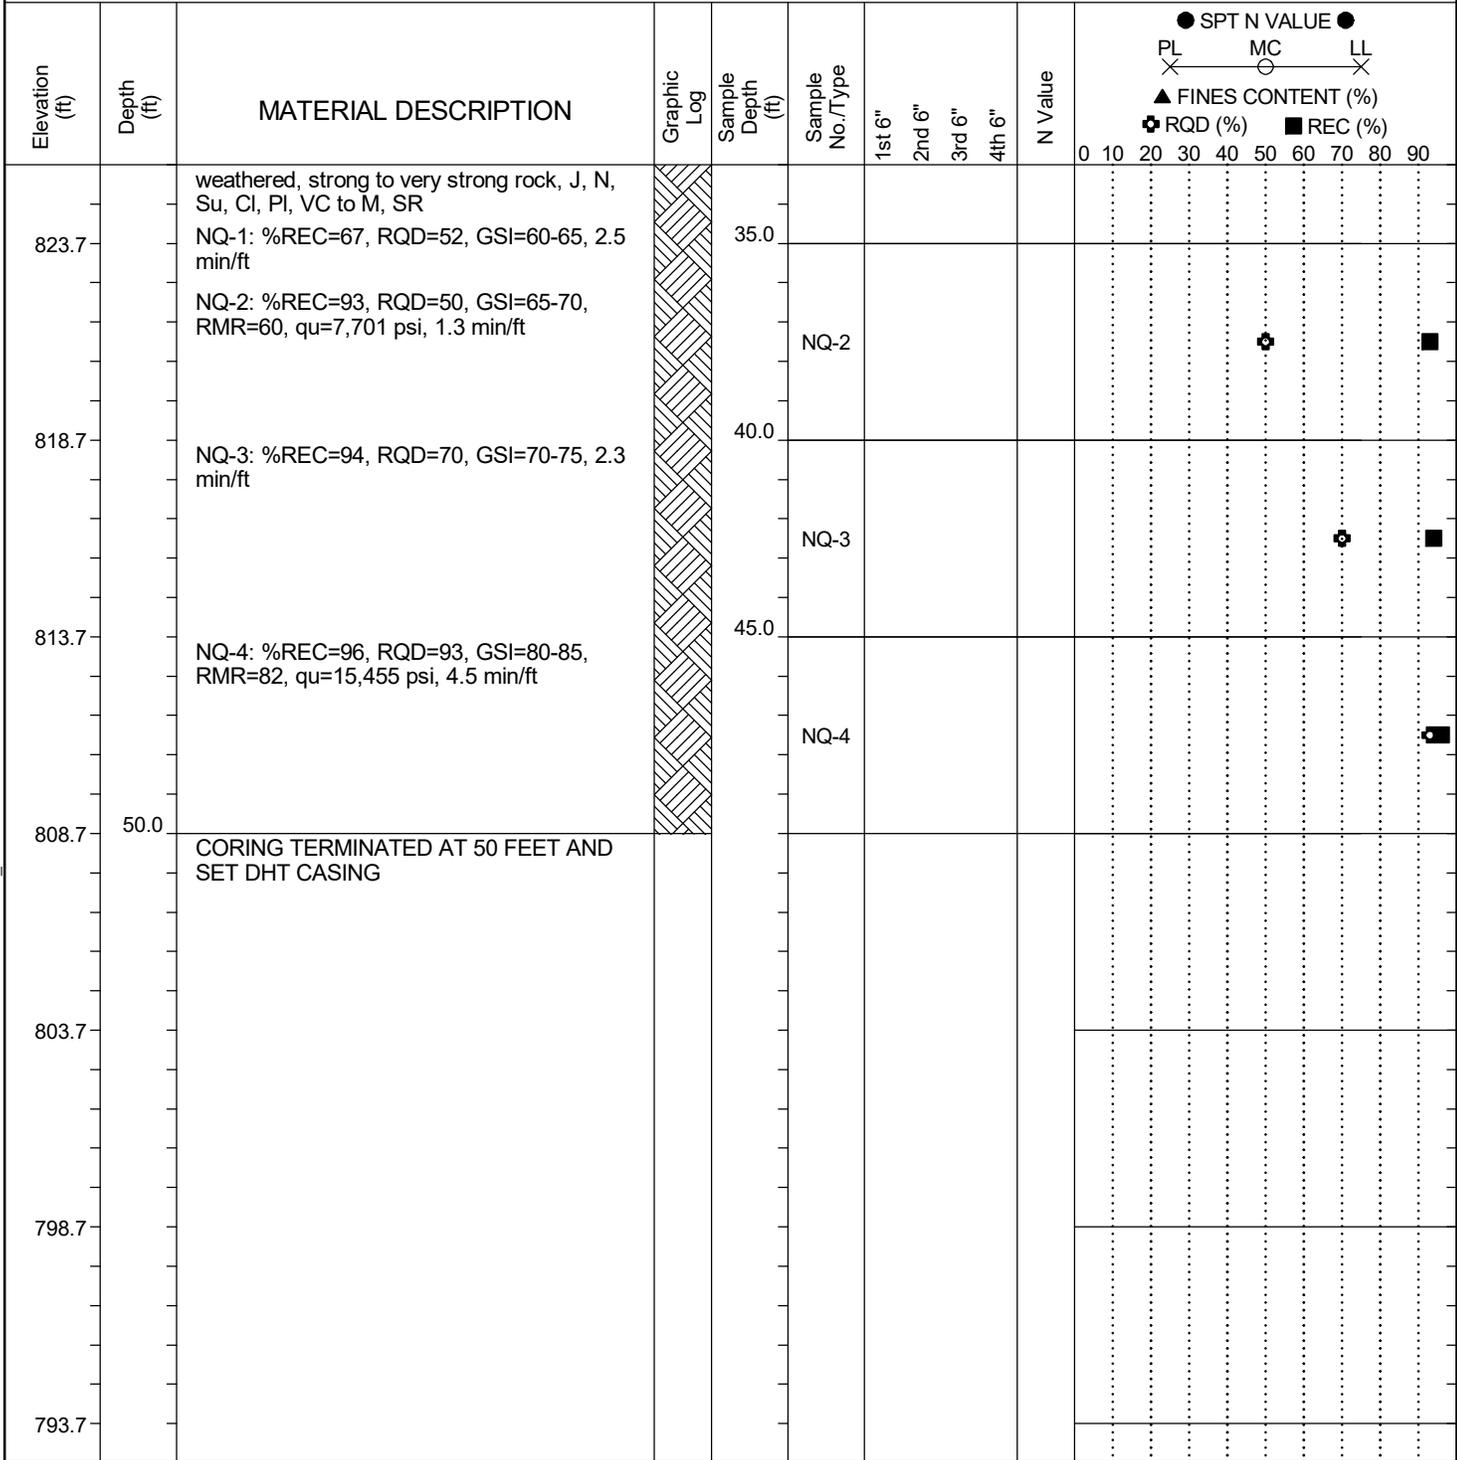
<b>Project ID:</b> P041168	<b>County:</b> Pickens	<b>Boring No.:</b> S-39-32-2 Offset
<b>Site Description:</b> S-39-32 BRO Crow Creek	<b>Route:</b> S-39-32	
<b>Eng./Geo.:</b> S. Greaber	<b>Boring Location:</b> 376+15	<b>Offset:</b> 8 L
<b>Alignment:</b> Existing		
<b>Elev.:</b> 858.7 ft	<b>Latitude:</b> 34.9171106	<b>Longitude:</b> -82.8322288
<b>Date Started:</b> 8/16/2024		
<b>Total Depth:</b> 50 ft	<b>Soil Depth:</b> 30 ft	<b>Core Depth:</b> 20 ft
<b>Date Completed:</b> 8/16/2024		
<b>Bore Hole Diameter (in):</b> 4	<b>Sampler Configuration</b>	<b>Liner Required:</b> Y (N)
<b>Liner Used:</b> Y (N)		
<b>Drill Machine:</b> DR#1327	<b>Drill Method:</b> RW/RC	<b>Hammer Type:</b> Automatic
<b>Energy Ratio:</b> 92.6%		
<b>Core Size:</b> NQ2	<b>Driller:</b> B. Burnette	<b>Groundwater:</b> TOB N.M.
<b>24HR:</b> N.M.

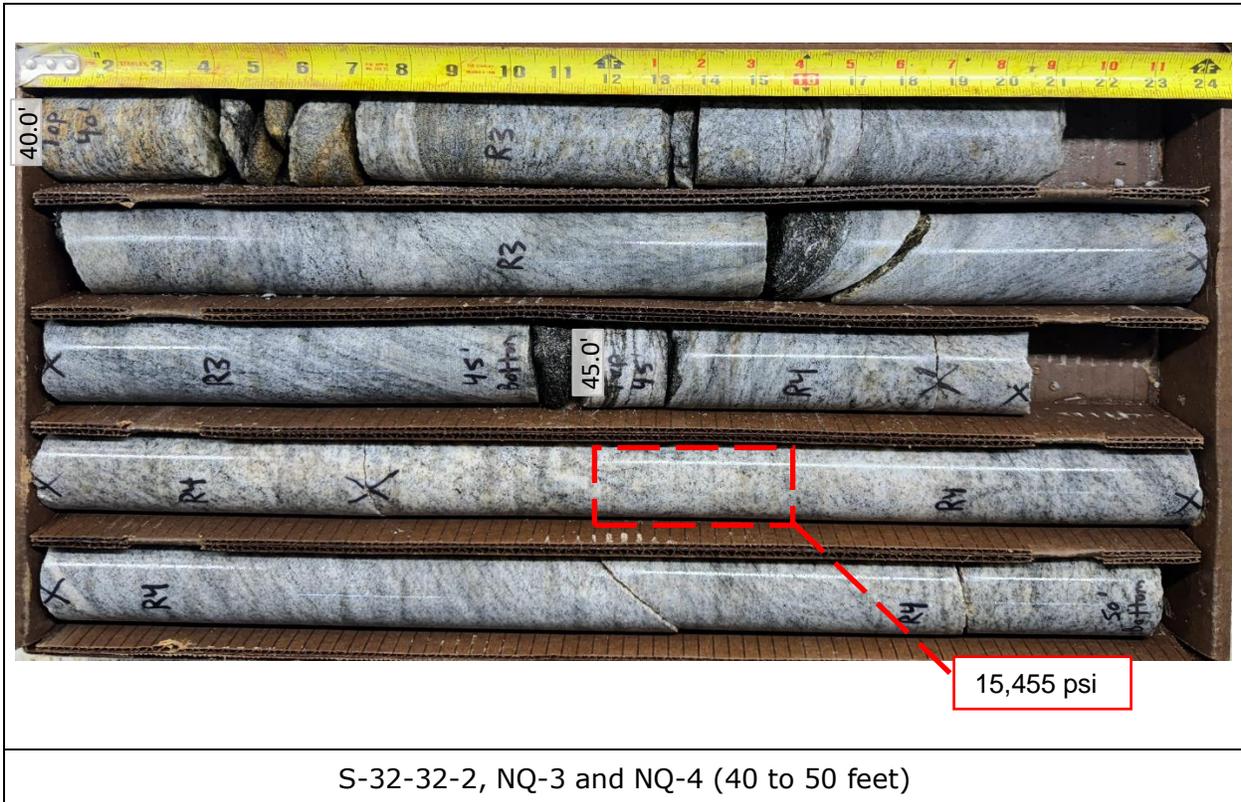
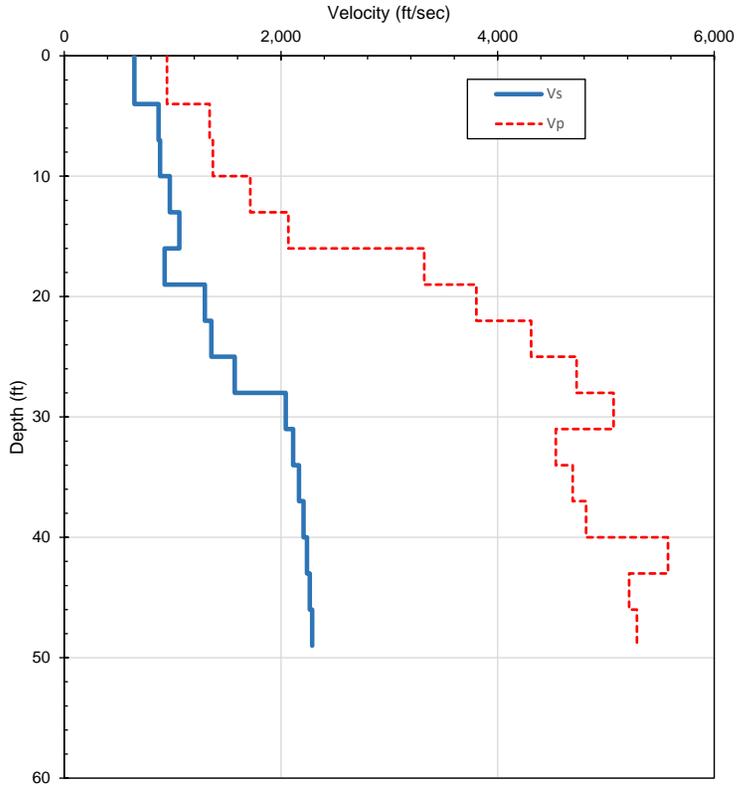
### Downhole Seismic Velocity Fixed Interval Method

Depth (ft)	Vp (ft/sec)	Vs (ft/sec)	$\Delta t$ (ft)	$\Delta t$ (sec)	Est. In-Situ Unit Wt (pcf)
4	948	647	4	0.00618	100
7	1342	870	3	0.00345	
10	1372	885	3	0.00339	
13	1717	975	3	0.00308	125
16	2068	1062	3	0.00282	
19	3323	927	3	0.00324	130
22	3805	1297	3	0.00231	
25	4309	1357	3	0.00221	
28	4729	1573	3	0.00191	
31	5070	2045	3	0.00147	
34	4537	2113	3	0.00142	165
37	4693	2166	3	0.00139	
40	4817	2208	3	0.00136	
43	5573	2241	3	0.00134	
46	5215	2267	3	0.00132	
49	5286	2289	3	0.00131	
100		2250	51	0.02267	
Sum of Data Over Profile			49	0.03819	
<b>Weighted Average Shear Wave Velocity Over Profile</b>				<b>1,283 ft/sec</b>	
<b>Est. Weighted Average Shear Wave Velocity Over 100-Ft<sup>1</sup></b>				<b>1,643 ft/sec</b>

The shear wave and compression wave velocity results, as measured at Boring S-39-32-2 using downhole seismic tests, were provided to SCDOT. SCDOT used these velocity measurements to develop Acceleration Design Response Spectrum (ADRS) curves by determining the seismic hazard and evaluating the local site effects on the response spectra.

Shear Wave Velocity Test Results shows the downhole shear wave velocity and compressive wave velocity test results. The data was evaluated using the Fixed Interval method. S-wave arrival times using the Interval method were picked based on the onset of the signal (first break) as observed in the software package TomTime by GeoTom.

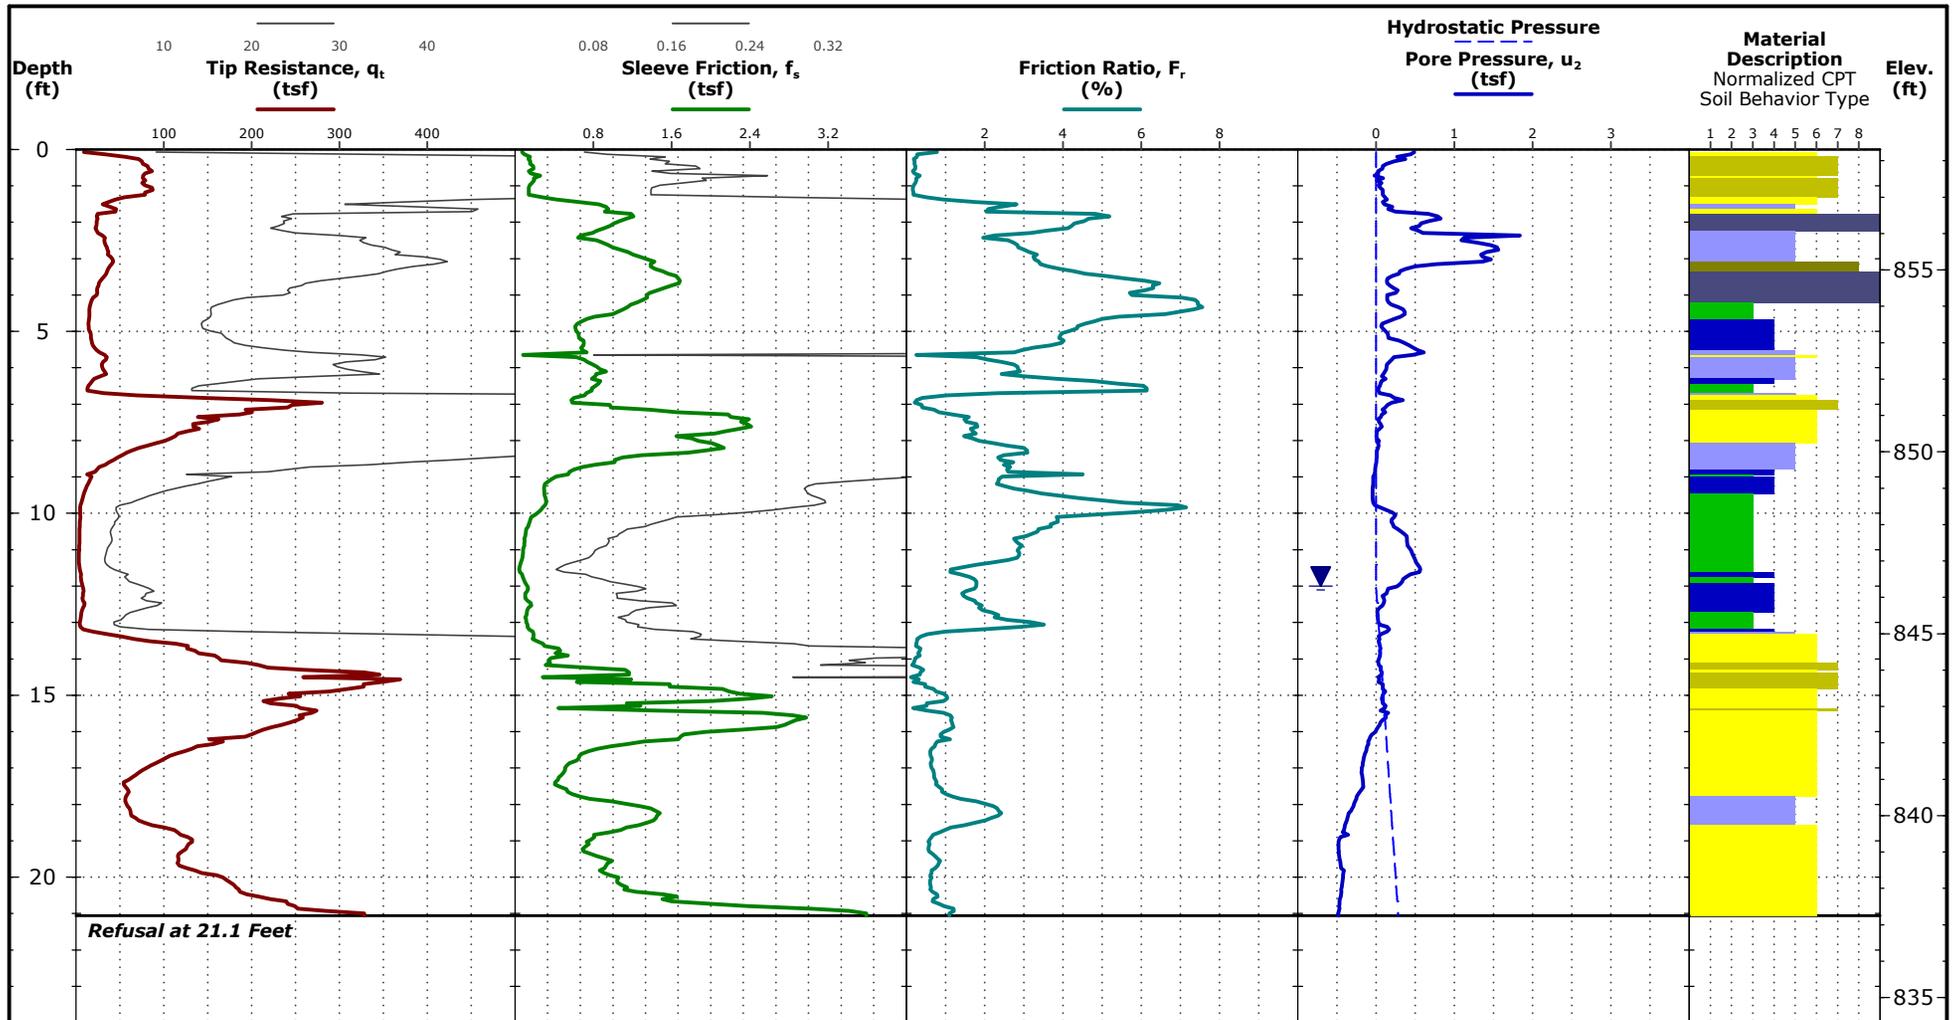
Latitude: 34.917275° Longitude: -82.832074°  
 Station: 375+39 Offset: 7 R

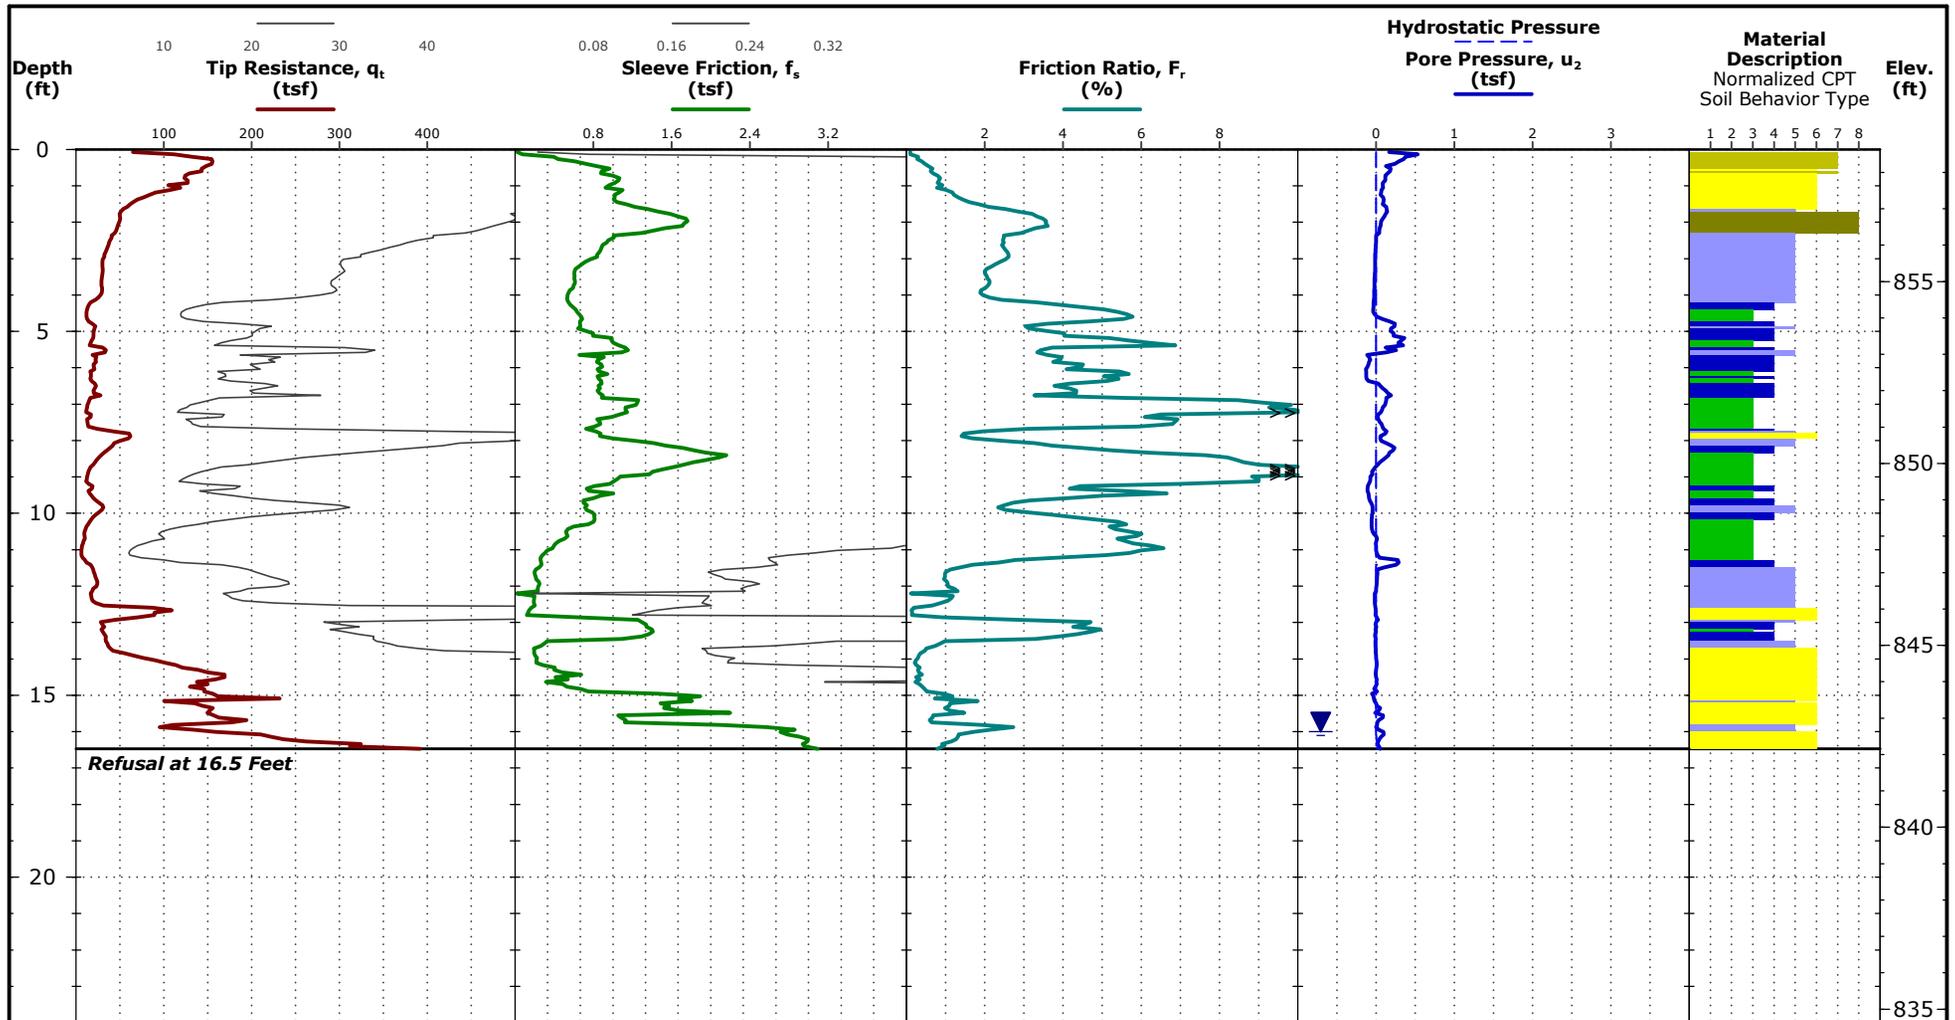
Latitude: 34.917123° Longitude: -82.832219°  
 Station: 376+10 Offset: 7 R

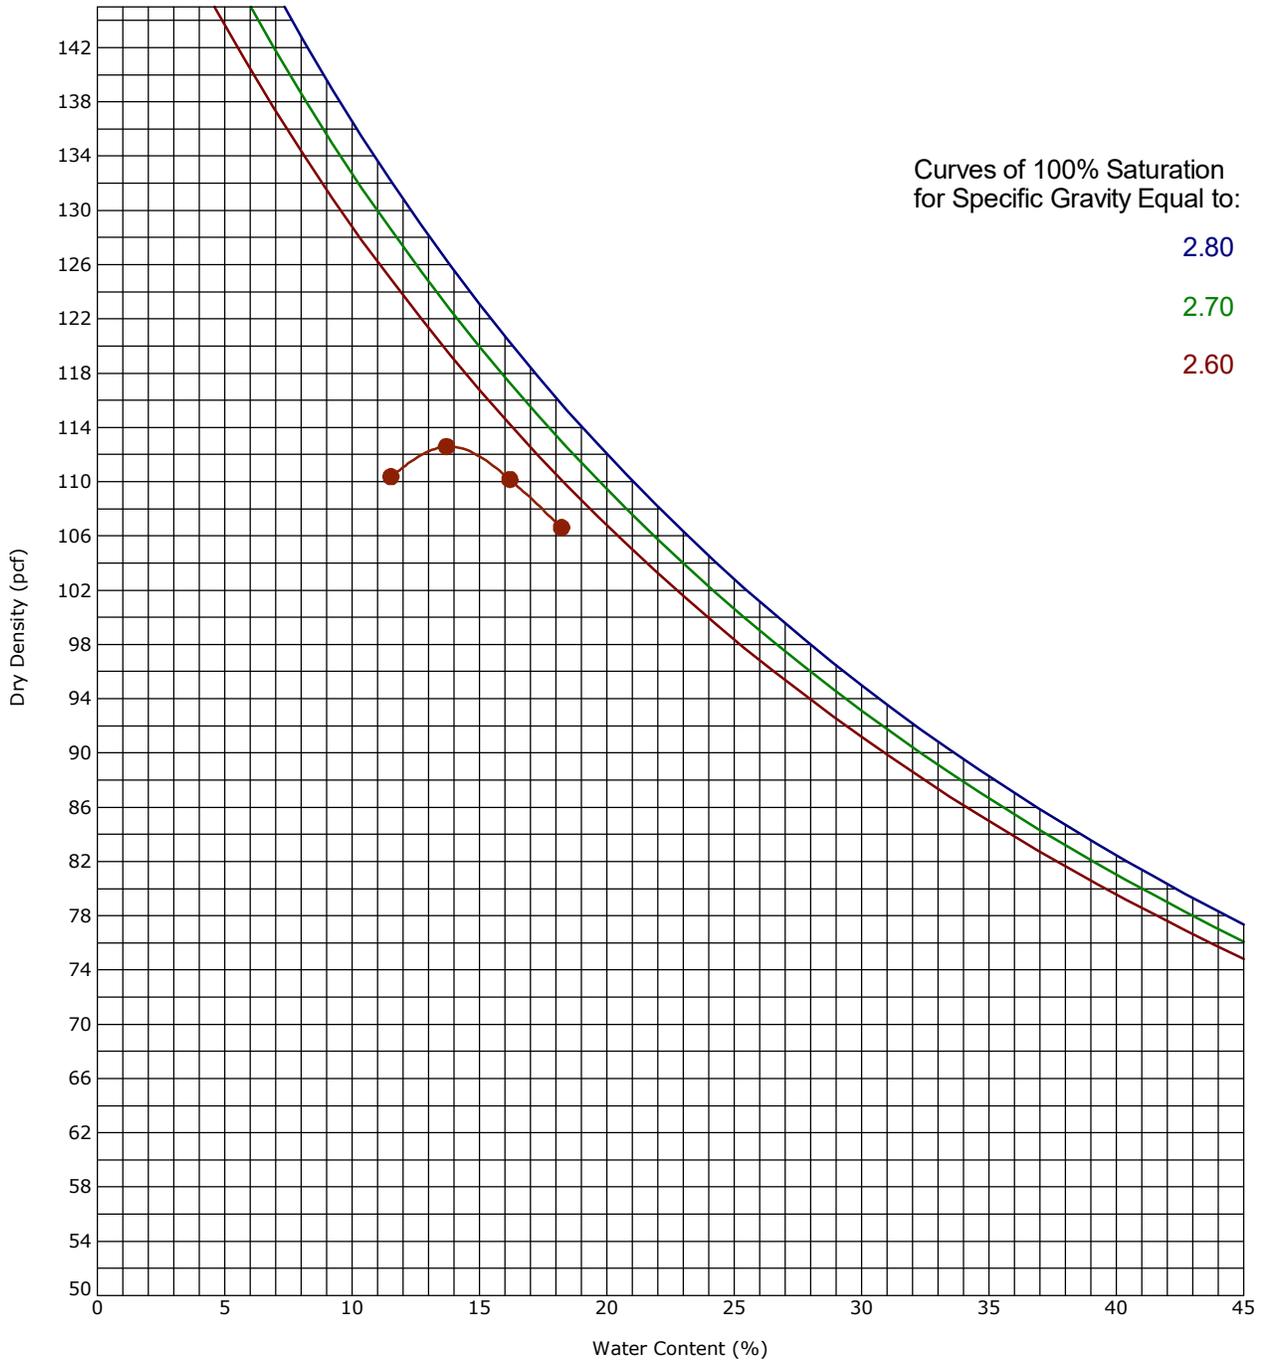
### ASTM D698-Method B

Boring ID		Depth (Ft)		Description of Materials				
S-39-32-1/2 Offset		0-5		SILTY SAND(SM)				
Fines (%)	Fraction > mm size	LL	PL	PI	Test Method	Maximum Dry Density (pcf)	Optimum Water Content (%)	
34	0.0	NP	NP	NP	ASTM D698-Method B	112.6	13.8

Sample No.	Station	Offset (ft)	Sample Depth (ft)	USCS Soil Type	Compaction		Shear Strength <sup>1</sup>	
					Optimum Moisture (%)	Max Dry Density (pcf)	Total	Effective
S-39-32-1/2 Offset	375+29 and 376+18	8 L	0 – 5	SM	13.8	112.6	c=2.4 psi ϕ=22°	c'=0.8 psi ϕ'=35°

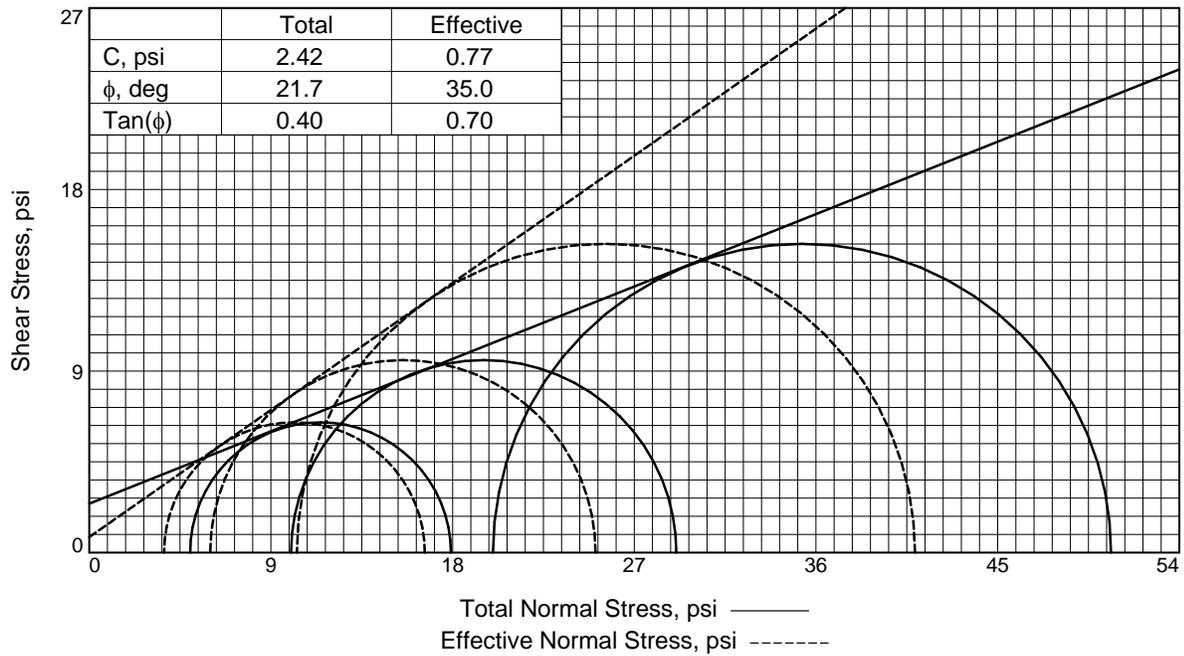
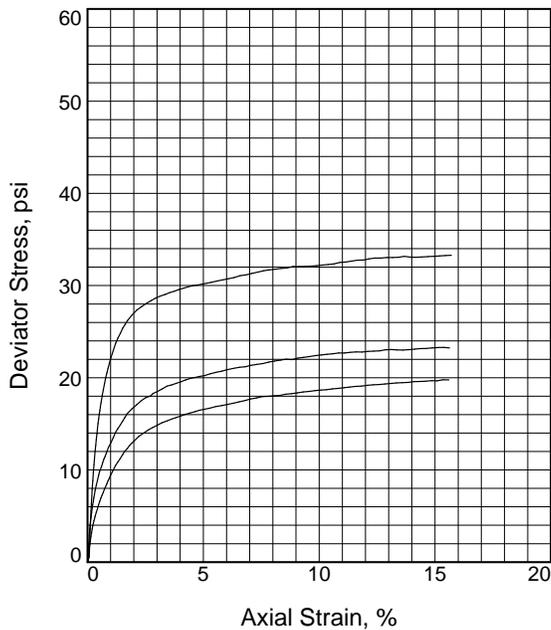
Sample No.	1	2	3	
Initial	Water Content, %	13.8	14.0	14.0
	Dry Density, pcf	106.8	107.4	107.0
	Saturation, %	64.4	66.3	65.8
	Void Ratio	0.5782	0.5700	0.5755
	Diameter, in.	2.80	2.80	2.80
	Height, in.	5.62	5.62	5.62
At Test	Water Content, %	20.0	20.2	18.9
	Dry Density, pcf	109.5	109.1	111.5
	Saturation, %	100.0	100.0	100.0
	Void Ratio	0.5396	0.5456	0.5112
	Diameter, in.	2.77	2.79	2.76
	Height, in.	5.59	5.58	5.55
Strain rate, in./min.	0.001	0.001	0.001	
Back Pressure, psi	50.0	50.0	50.0	
Cell Pressure, psi	55.0	60.0	70.0	
Fail. Stress, psi	12.9	19.1	30.6	
Excess Pore Pr., psi	1.3	4.0	9.7	
Ult. Stress, psi	19.7	23.3	33.2	
Excess Pore Pr., psi	-2.3	0.7	8.3	
$\bar{\sigma}_1$ Failure, psi	16.6	25.1	40.9	
$\bar{\sigma}_3$ Failure, psi	3.7	6.0	10.3

1. Based on a maximum deviator stress failure criterion

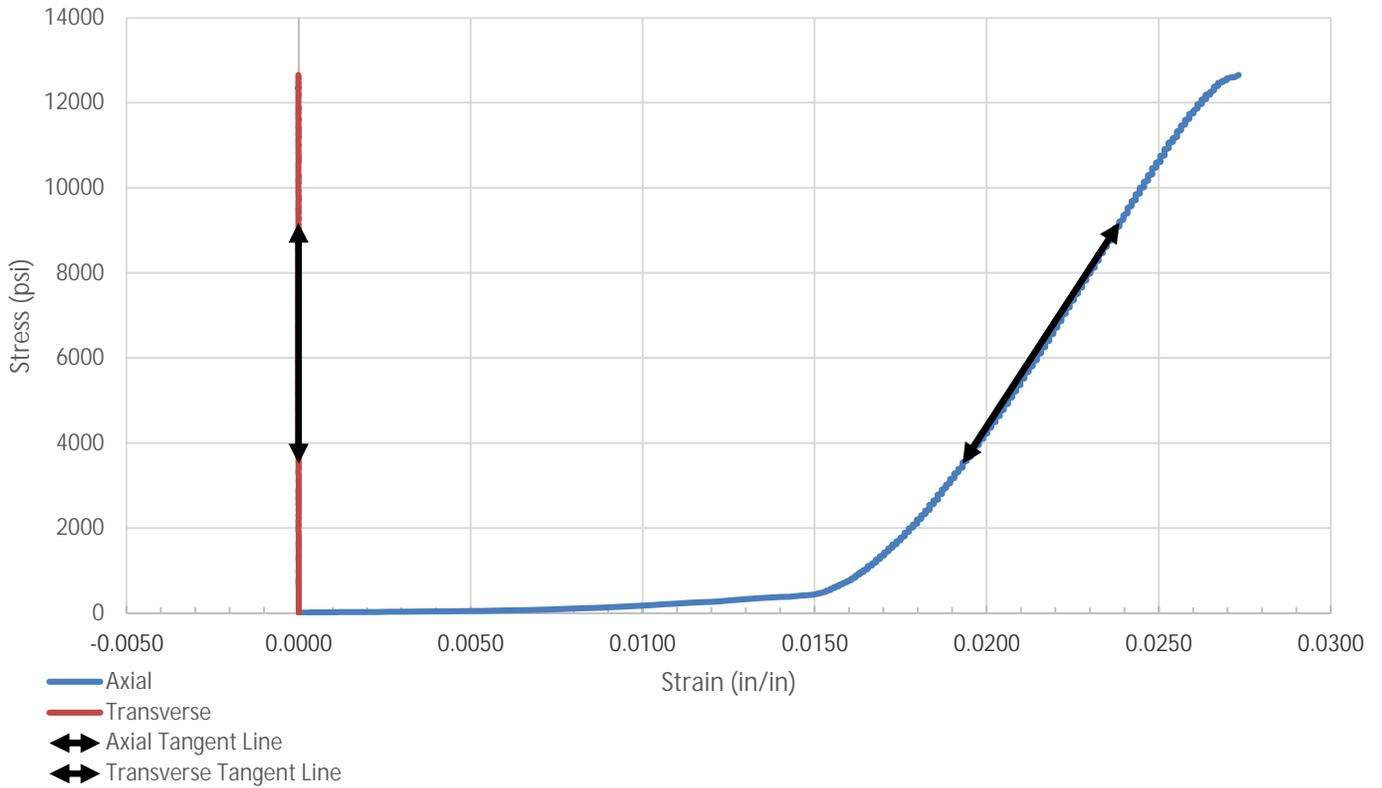
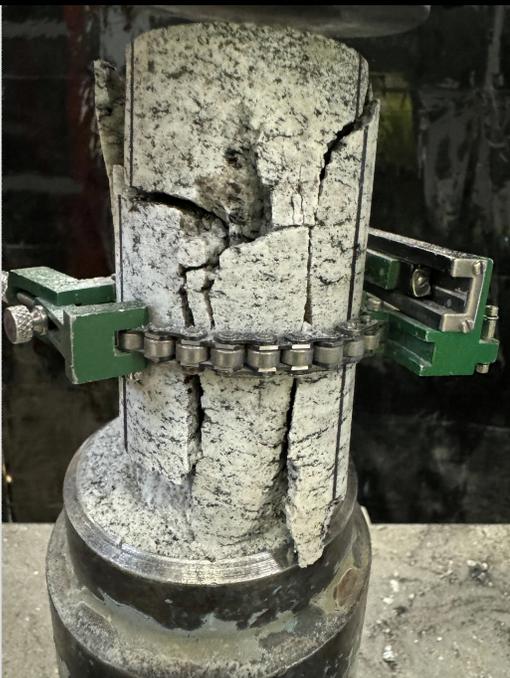
ASTM D7012 Stress/ Strain Curve

Failure Load (lbs):	38977
Failure Strain (%):	3.12
Unconfined Compressive Strength (psi):	12,659
Elastic Modulus, E, (ksi):	1243
Poisson's Ratio, u:	0.001
Time of Failure (min):	01:58
Rate of Loading (psi/sec):	107.459
Moisture Content Post-break:	0.01%

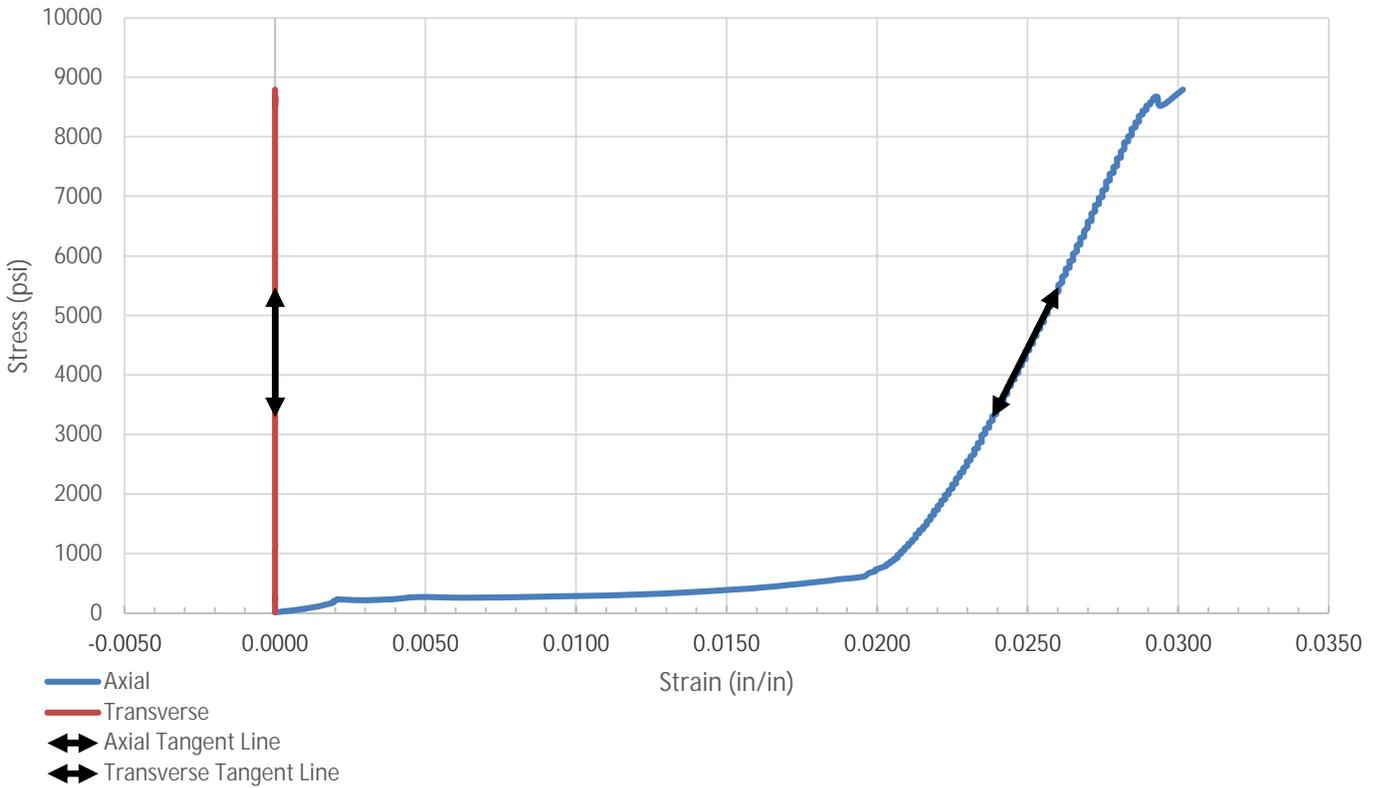
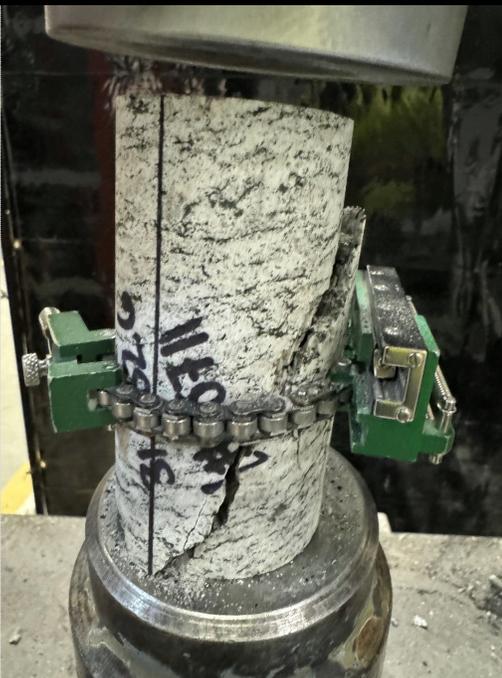
ASTM D7012 Stress/ Strain Curve

Failure Load (lbs):	27359
Failure Strain (%):	3.53
Unconfined Compressive Strength (psi):	8,796
Elastic Modulus, E, (ksi):	1000
Poisson's Ratio, u:	0.0005
Time of Failure (min):	01:19
Rate of Loading (psi/sec):	110.787
Moisture Content Post-break:	0.01%

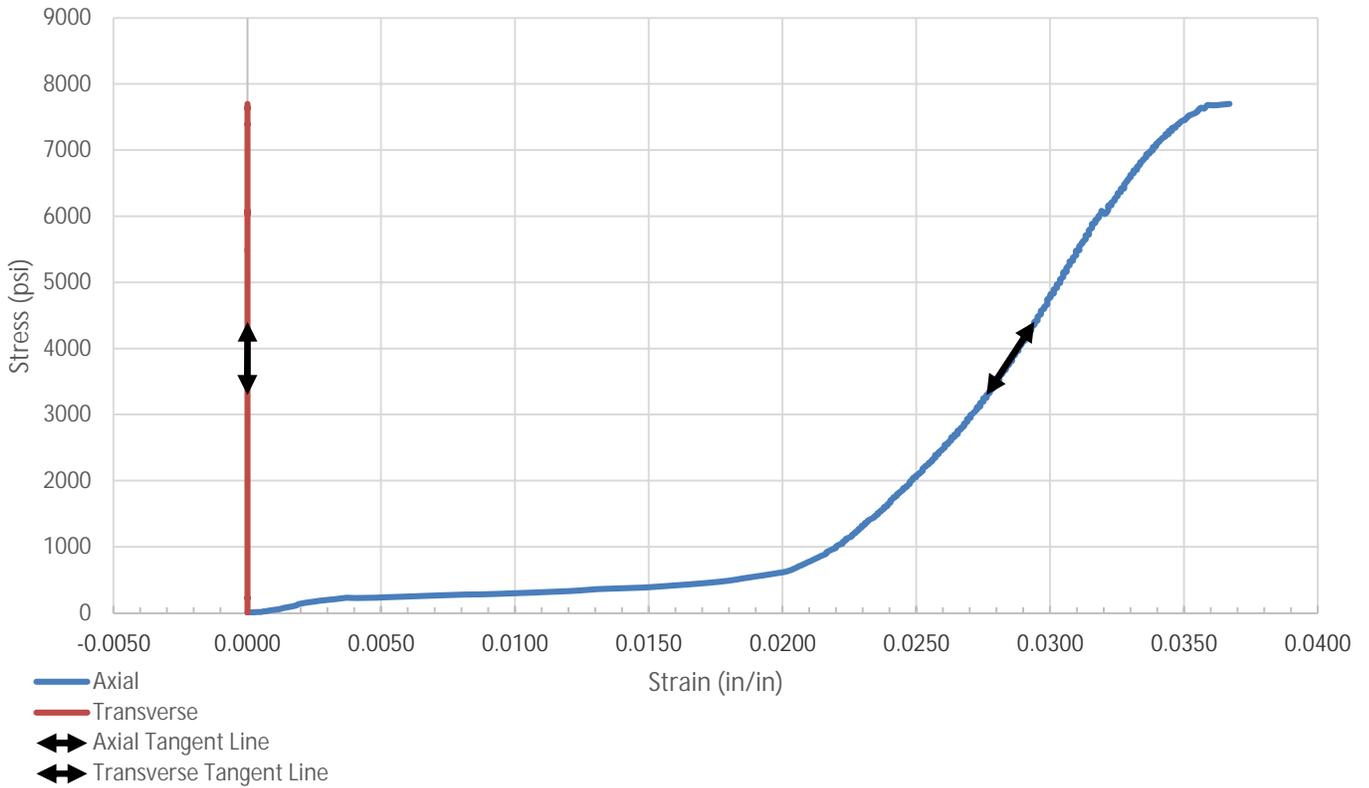
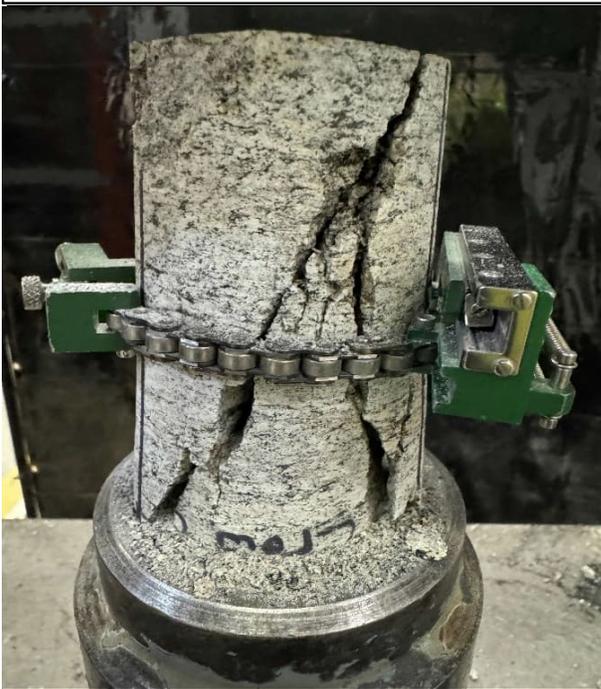
ASTM D7012 Stress/ Strain Curve

Failure Load (lbs):	23713
Failure Strain (%):	3.96
Unconfined Compressive Strength (psi):	7,701
Elastic Modulus, E, (ksi):	617
Poisson's Ratio, u:	0.003
Time of Failure (min):	01:11
Rate of Loading (psi/sec):	108.167
Moisture Content Post-break:	0.01%

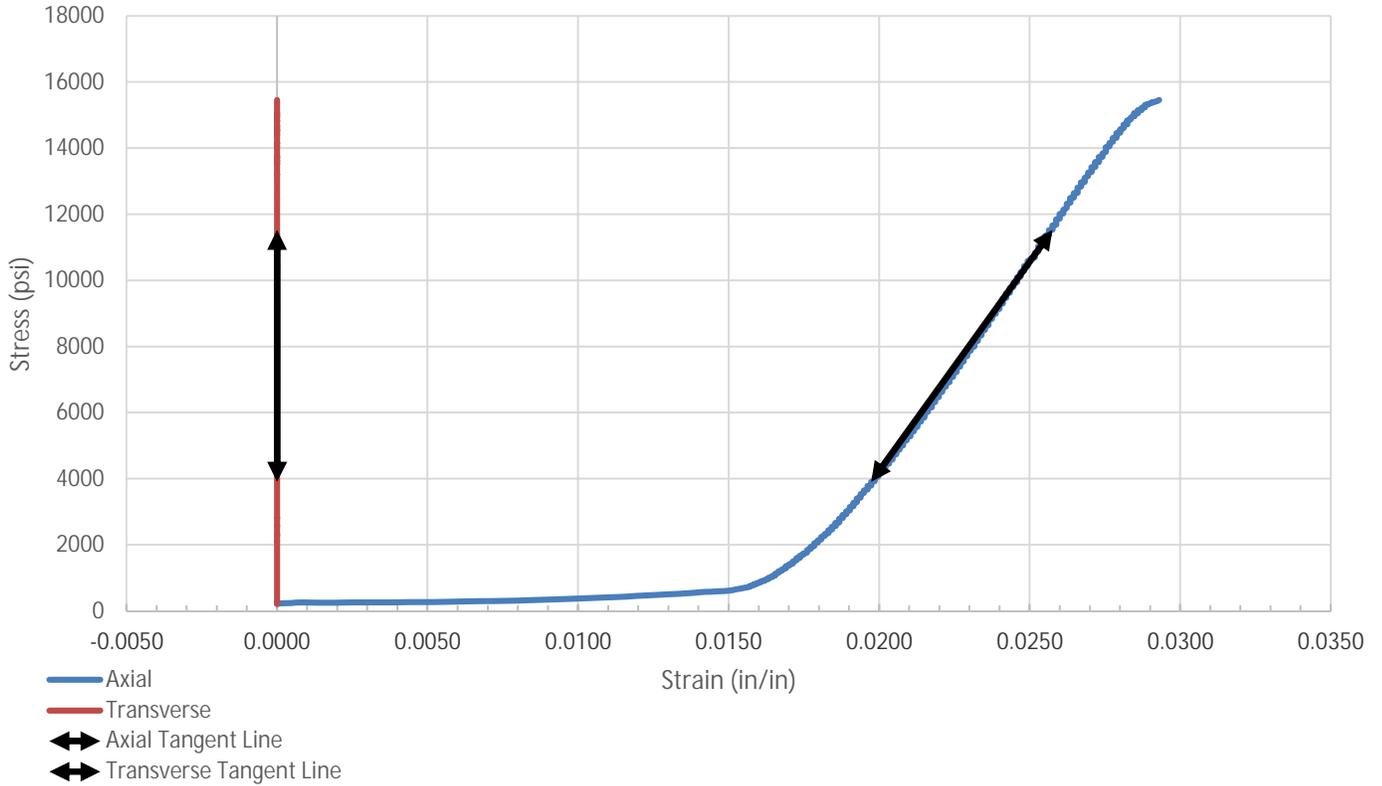
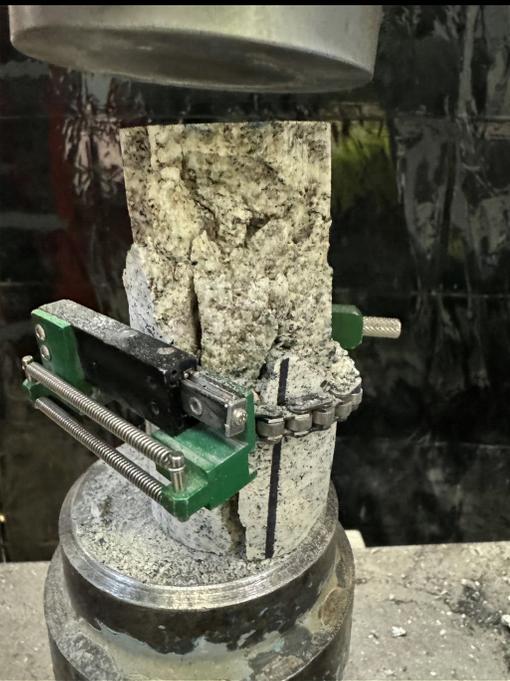
ASTM D7012 Stress/ Strain Curve

Failure Load (lbs):	47586
Failure Strain (%):	3.34
Unconfined Compressive Strength (psi):	15,455
Elastic Modulus, E, (ksi):	1264
Poisson's Ratio, u:	0.0003
Time of Failure (min):	02:20
Rate of Loading (psi/sec):	110.706
Moisture Content Post-break:	0.01%

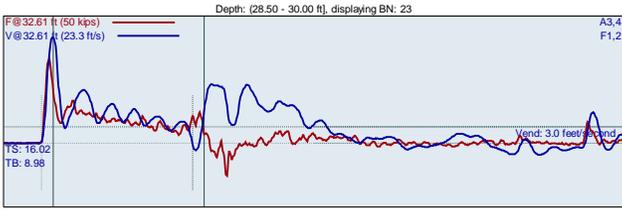
GP554-3126 28.530  
JIM SMITH Interval start: 8/21/2023  
TB-1  
AR: 1.20 in/2 SP: 0.492 k/ft3  
LE: 32.61 ft EM: 30000 ksi  
WS: 16807.9 fts

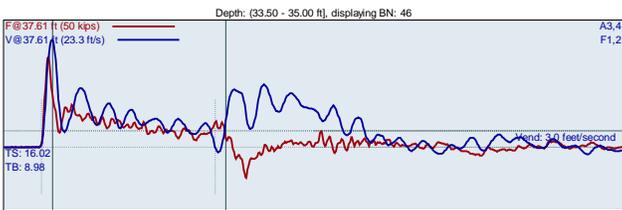
GP554-3126 28.530  
JIM SMITH Interval start: 8/21/2023  
TB-1  
AR: 1.20 in/2 SP: 0.492 k/ft3  
LE: 37.61 ft EM: 30000 ksi  
WS: 16807.9 fts
