# S-39-32 (Shady Grove Road) Bridge Replacement over Crow Creek

### Geotechnical Baseline Report

October 30, 2024 | SCDOT Project ID: P041168

Terracon Project No.: 8623P180 Revision 1

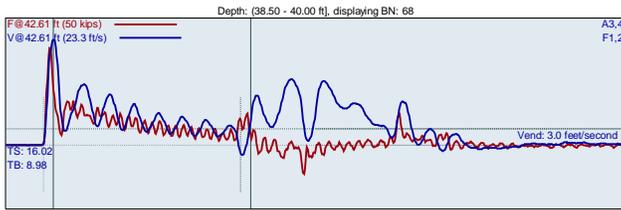
GP554-3126 28.5-30  
JIM SMITH Interval start: 8/21/2023  
TB-1 SP: 0.492 k/ft  
AR: 1.20 in/2 EM: 30000 ksi  
LE: 42.61 ft  
WS: 16807.9 ft/s

BL#	BC /6"	FMX kips	VMX ft/s	BPM bpm	EFV ft-lb	ETR %
49	5	34	19.6	1.9	307	87.6
50	5	34	19.3	52.0	301	86.1
51	5	27	16.5	52.7	279	79.4
52	5	33	19.9	52.5	310	88.6
53	5	29	17.7	52.7	288	82.2
54	8	29	18.6	52.5	295	84.2
55	8	23	15.6	52.9	287	82.0
56	8	34	20.1	52.6	323	92.2
57	8	28	18.1	52.8	295	84.3
58	8	38	18.8	53.1	312	89.1
59	8	35	19.2	52.6	329	94.0
60	8	36	19.3	52.9	327	93.3
61	8	40	19.7	52.8	323	92.4
62	9	35	18.8	53.0	320	91.3
63	9	37	19.1	52.7	320	91.3
64	9	35	19.9	52.9	327	93.4
65	9	29	18.8	52.7	314	89.7
66	9	35	19.7	53.0	342	97.8
67	9	36	19.9	52.8	331	94.5
68	9	38	19.3	52.8	335	95.8
69	9	36	19.9	52.5	325	92.9
70	9	39	19.5	52.9	329	94.0
Average		34	19.1	52.8	320	91.3
Std Dev		4	1.0	0.2	15	4.1
Maximum		40	20.1	53.1	342	97.8
Minimum		23	15.6	52.5	287	82.0
N-value: 17
