S-23-40 (Pace Bridge Road) Bridge Replacement over South Saluda River Overflow

Geotechnical Baseline Report

October 30, 2024 | SCDOT Project ID: P043137
Terracon Project No.: 8623P180 Revision 1

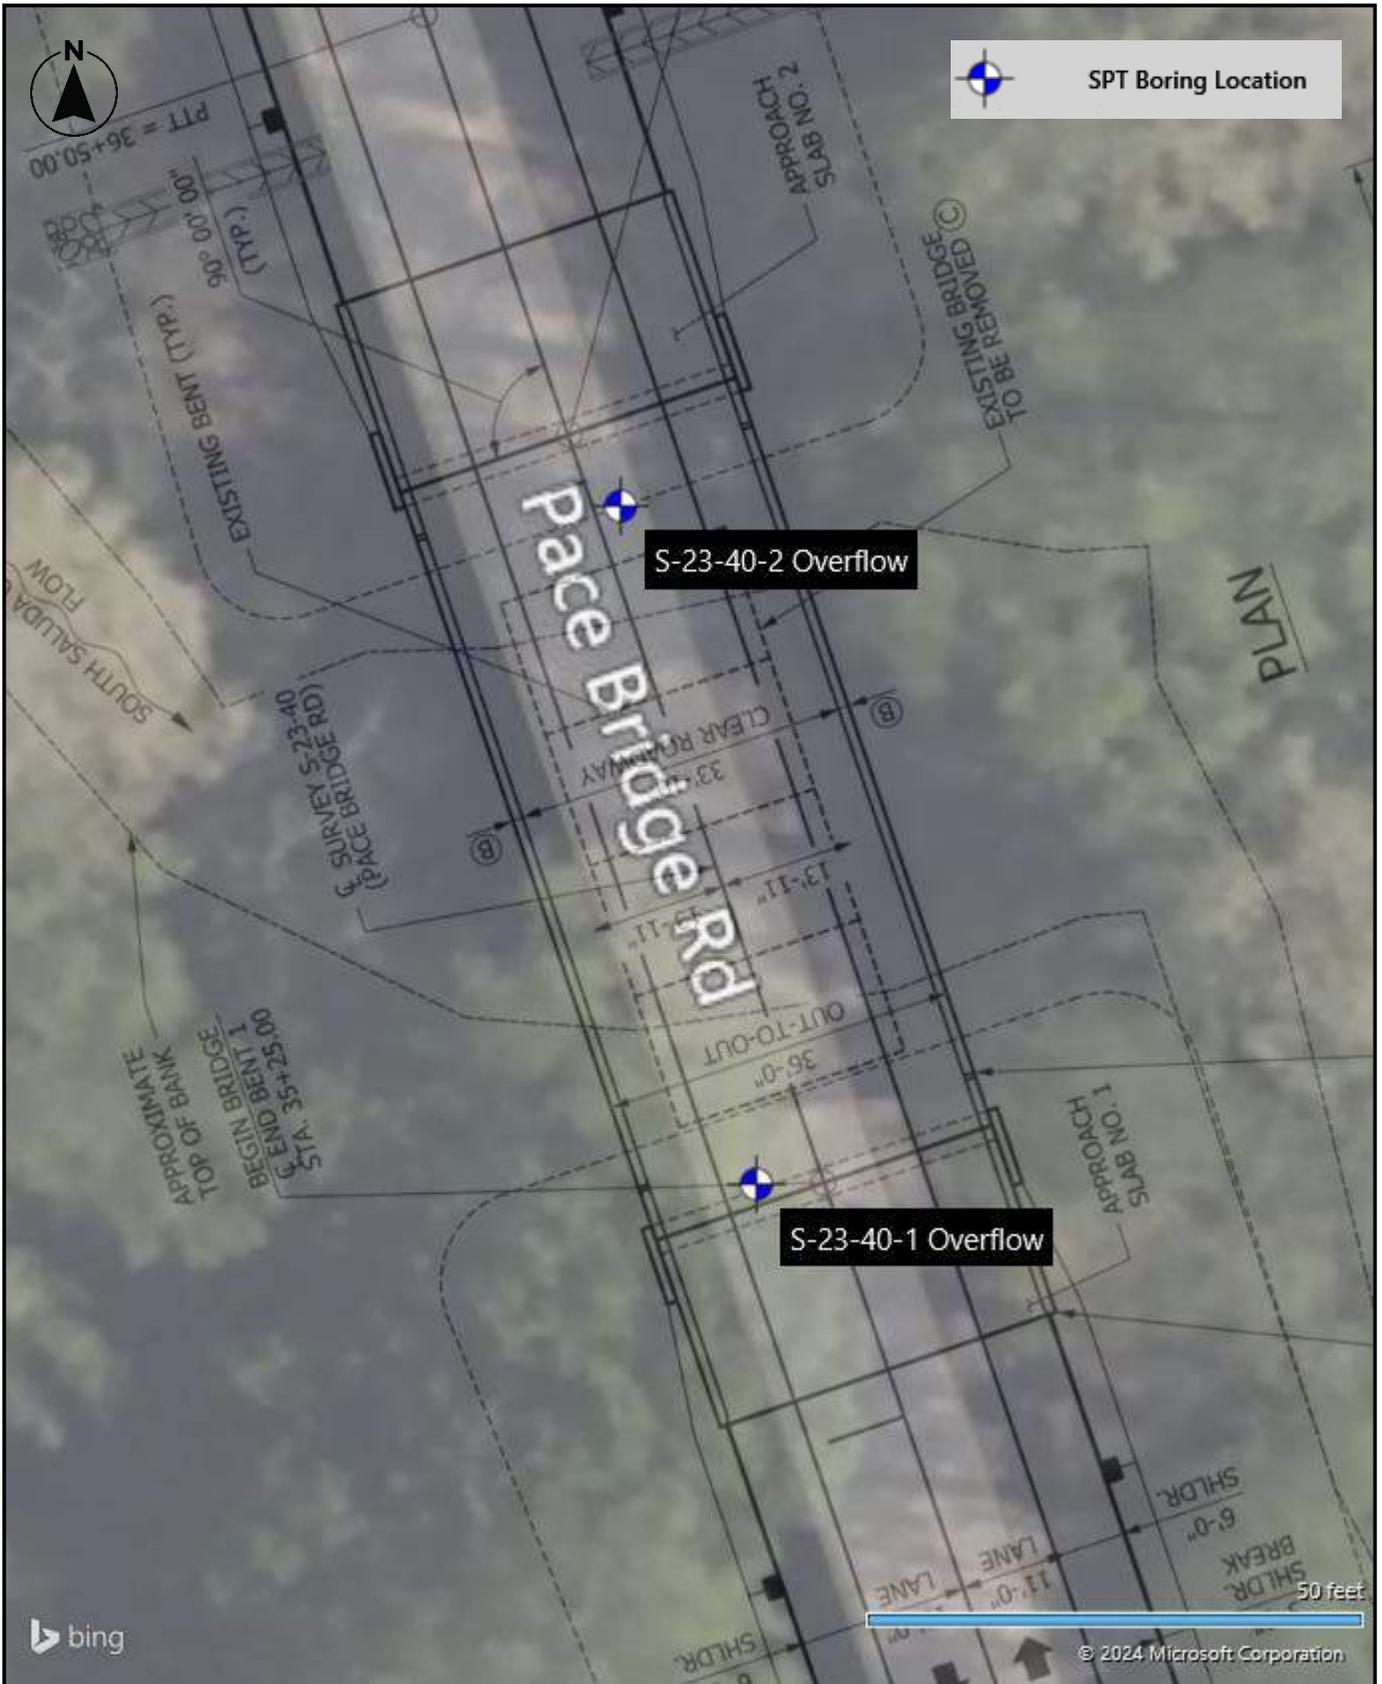
Exhibit
A-2

PRELIMINARY SITE PLAN PROVIDED BY HNTB

The tests were performed at the approximate locations as approved by SCDOT. A description of our testing methods and graphical logs outlining the soil conditions at each test location are presented in Appendix A. The test locations were established in the field by Terracon and surveyed by Thomas & Hutton after completion. Station and offset are based on the plans provided at the time the tests were performed.

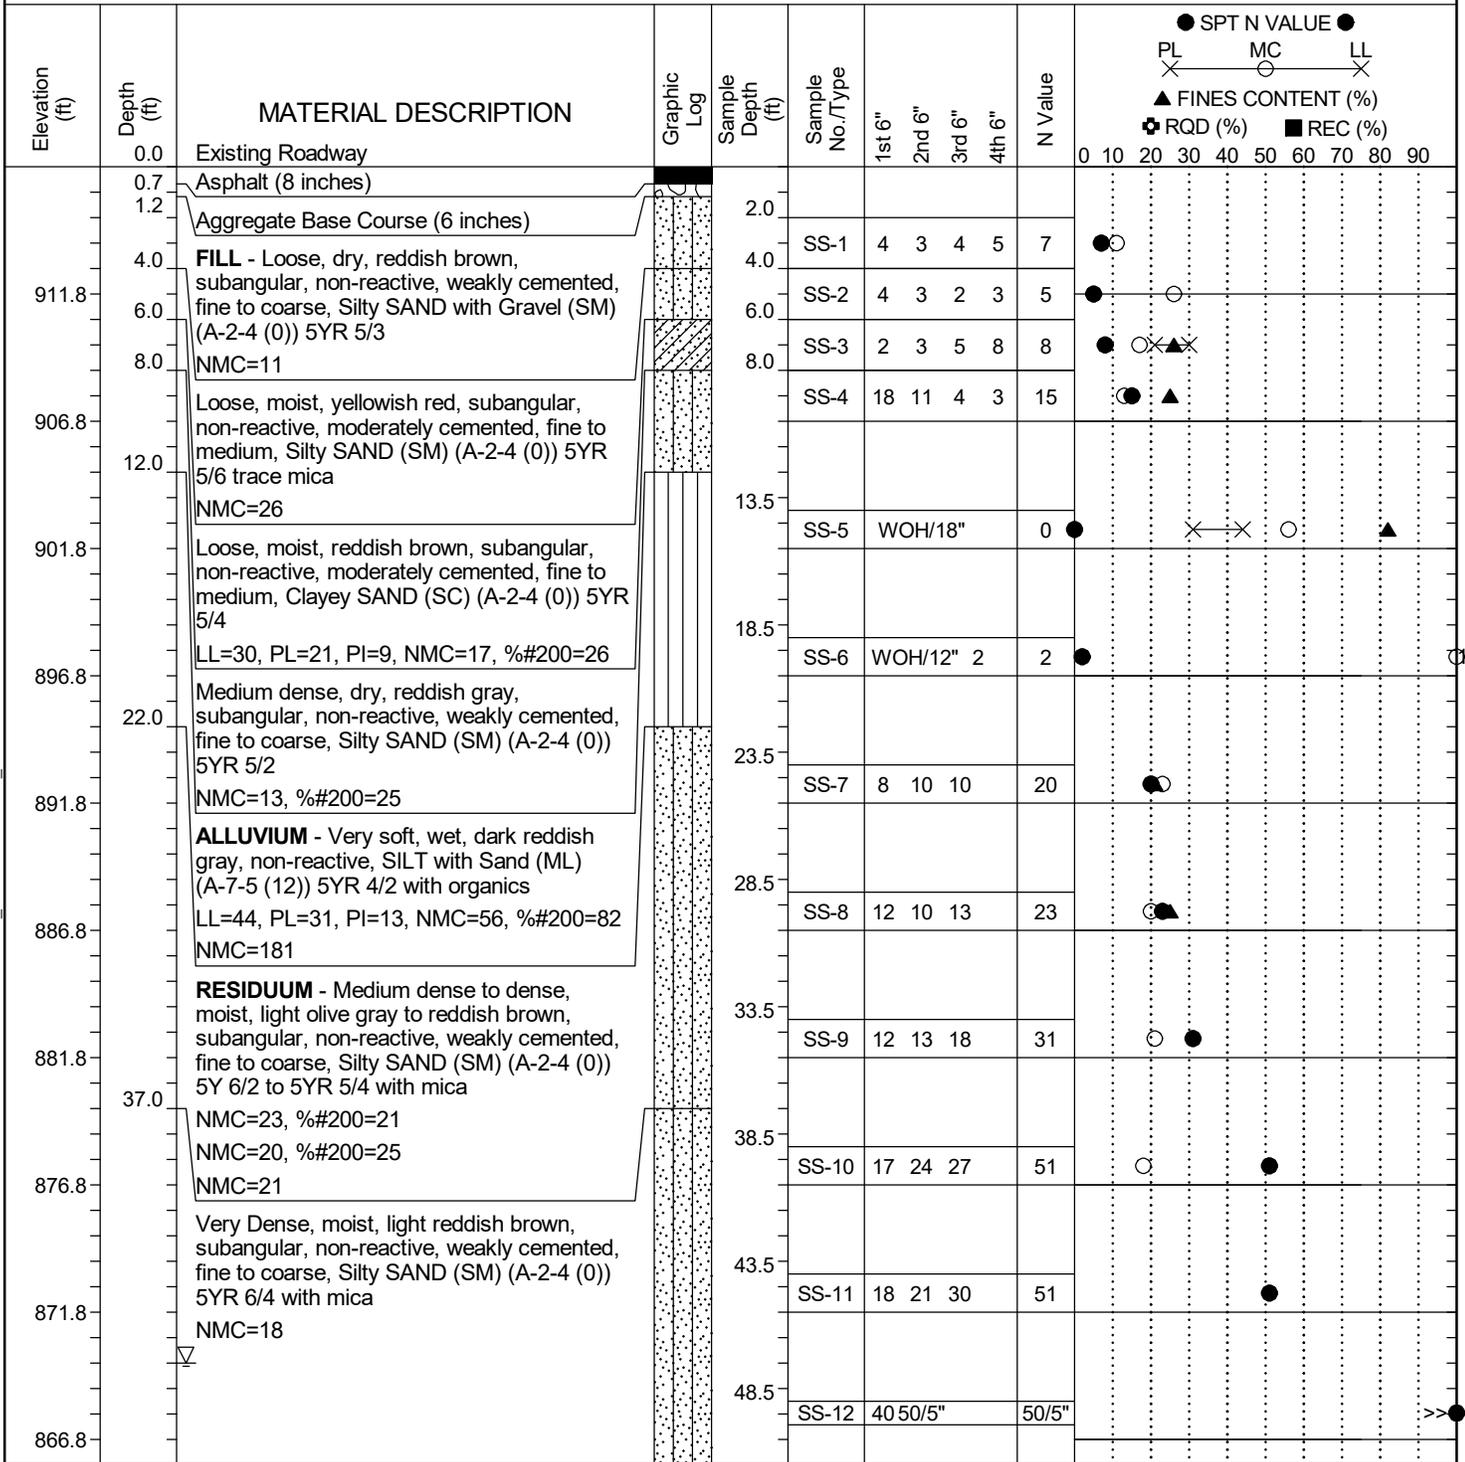
SCDOT Soil Test Log

Project ID: P043137	County: Greenville	Boring No.: S-23-40-1 Overflow
Site Description: S-23-40 BRO South Saluda Overflow		Route: S-23-40
Eng./Geo.: S. Greaber	Boring Location: 35+27	Offset: 6 L
Alignment: Existing	Date Started: 8/21/2024	Date Completed: 8/21/2024
Elev.: 916.8 ft	Latitude: 35.0132	Longitude: -82.57104
Total Depth: 100 ft	Soil Depth: 100 ft	Core Depth: 0 ft
Bore Hole Diameter (in): 4	Sampler Configuration	Liner Required: Y (N)
Liner Used: Y (N)	Drill Machine: DR#1327	Drill Method: RW
Hammer Type: Automatic	Energy Ratio: 92.6%	Groundwater: TOB 47 (After 1hr) 24HR N.M.
Core Size: N/A	Driller: B. Burnette

Both borings encountered a surface covering of 8 inches of asphalt followed by 6 to 7 inches of gravel. Following the surface covering both borings encountered a layer of fill soils that were characterized as loose to medium dense silty or clayey sand to a depth of 8 to 12 feet below current surface grades. Underlying the fill soils, a layer of alluvial soil classified as very soft silt or very loose to loose silty sand or poorly graded sand with silt and gravel was encountered to depths of 22 to 27 feet below current site grades. Beneath the alluvium, residual medium dense to dense silty sand soils were encountered extending to a depth of about 47 feet overlying very dense residual soils/IGM materials that exhibited blow counts greater than 100 bpf extending to the boring termination depths of about 100 feet. No materials considered bedrock were encountered in either boring. Boring S-23-40-1 Overflow encountered free water at a depth of about 47 feet and boring S-23-40-2 encountered groundwater at a depth of about 13 feet, both measurements were taken about one hour after drilling was completed.

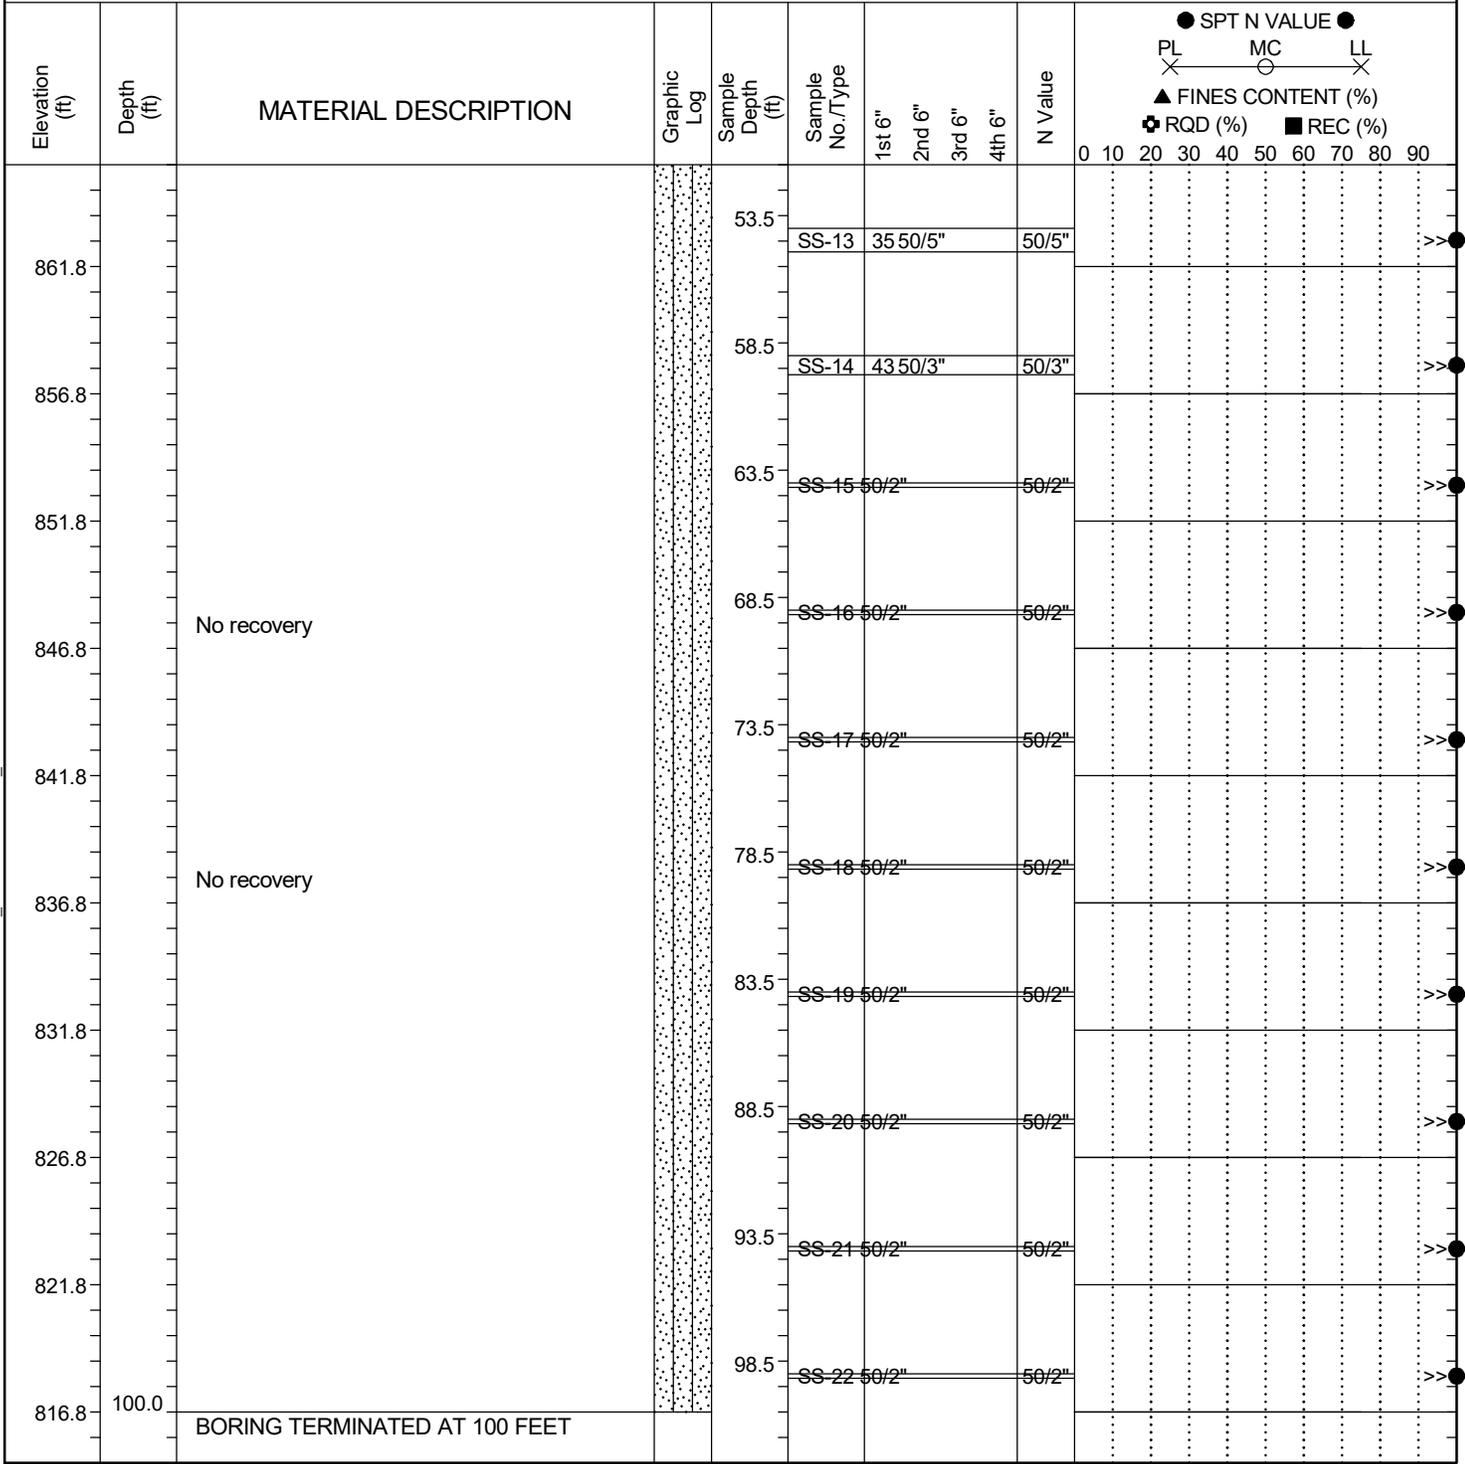
SCDOT Soil Test Log

Project ID: P043137	County: Greenville	Boring No.: S-23-40-1 Overflow
Site Description: S-23-40 BRO South Saluda Overflow		Route: S-23-40
Eng./Geo.: S. Greaber	Boring Location: 35+27	Offset: 6 L
Alignment: Existing		
Elev.: 916.8 ft	Latitude: 35.0132	Longitude: -82.57104
Date Started: 8/21/2024		
Total Depth: 100 ft	Soil Depth: 100 ft	Core Depth: 0 ft
Date Completed: 8/21/2024		
Bore Hole Diameter (in): 4	Sampler Configuration	Liner Required: Y (N)
Liner Used: Y (N)		
Drill Machine: DR#1327	Drill Method: RW	Hammer Type: Automatic
Energy Ratio: 92.6%		
Core Size: N/A	Driller: B. Burnette	Groundwater: TOB 47 (After 1hr) 24HR N.M.

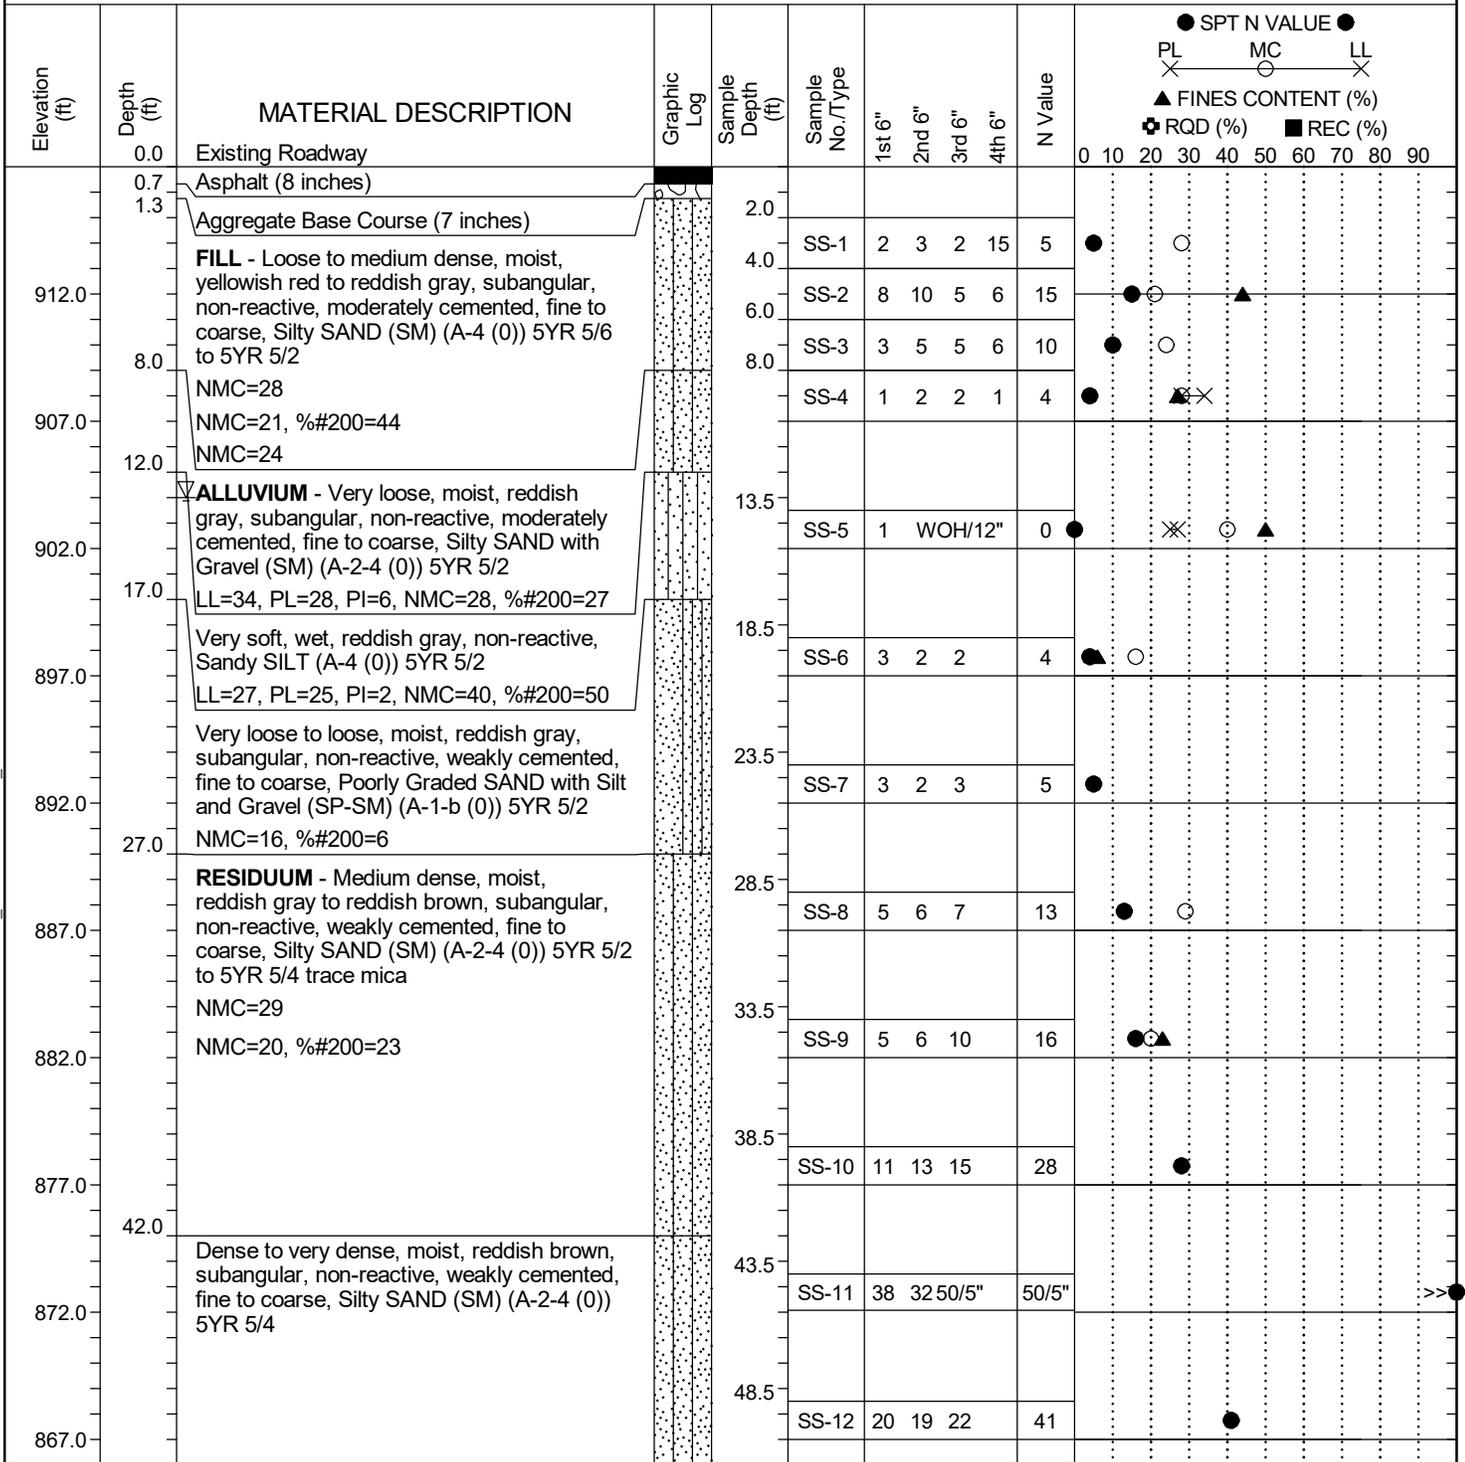
SCDOT Soil Test Log

Project ID: P043137	County: Greenville	Boring No.: S-23-40-2 Overflow
Site Description: S-23-40 BRO South Saluda Overflow	Route: S-23-40	
Eng./Geo.: S. Greaber	Boring Location: 35+97	Offset: 3 R
Elev.: 917.0 ft	Latitude: 35.01338	Longitude: -82.57108
Total Depth: 100 ft	Soil Depth: 100 ft	Core Depth: 0 ft
Bore Hole Diameter (in): 4	Sampler Configuration	Liner Required: Y (N)
Drill Machine: DR#1327	Drill Method: RW	Energy Ratio: 92.6%
Core Size: N/A	Driller: B. Burnette	Groundwater: TOB 13 (After 1hr) 24HR N.M.

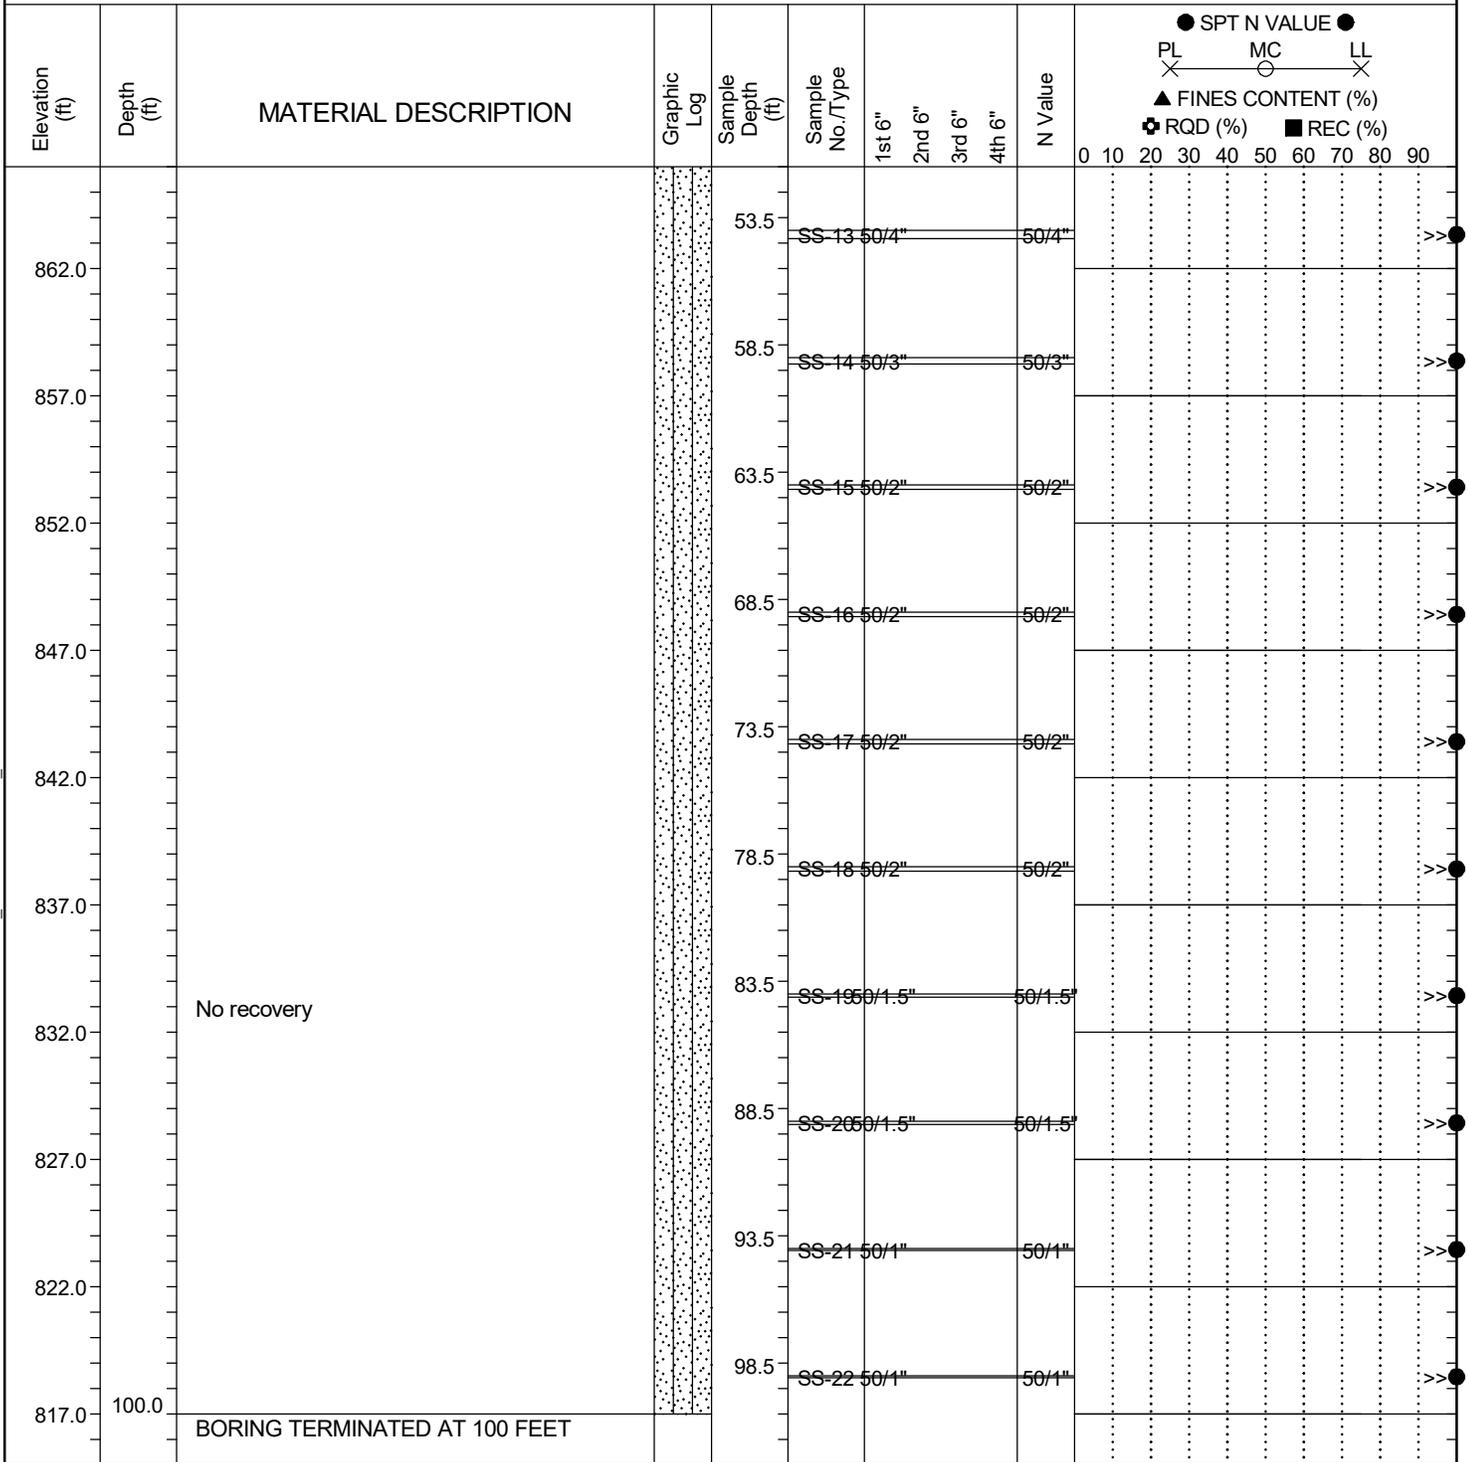
SCDOT Soil Test Log

Project ID: P043137	County: Greenville	Boring No.: S-23-40-2 Overflow
Site Description: S-23-40 BRO South Saluda Overflow	Route: S-23-40	
Eng./Geo.: S. Greaber	Boring Location: 35+97	Offset: 3 R
Alignment: Existing		
Elev.: 917.0 ft	Latitude: 35.01338	Longitude: -82.57108
Date Started: 8/21/2024		
Total Depth: 100 ft	Soil Depth: 100 ft	Core Depth: 0 ft
Date Completed: 8/22/2024		
Bore Hole Diameter (in): 4	Sampler Configuration	Liner Required: Y (N)
Liner Used: Y (N)		
Drill Machine: DR#1327	Drill Method: RW	Hammer Type: Automatic
Energy Ratio: 92.6%		
Core Size: N/A	Driller: B. Burnette	Groundwater: TOB 13 (After 1hr) 24HR N.M.

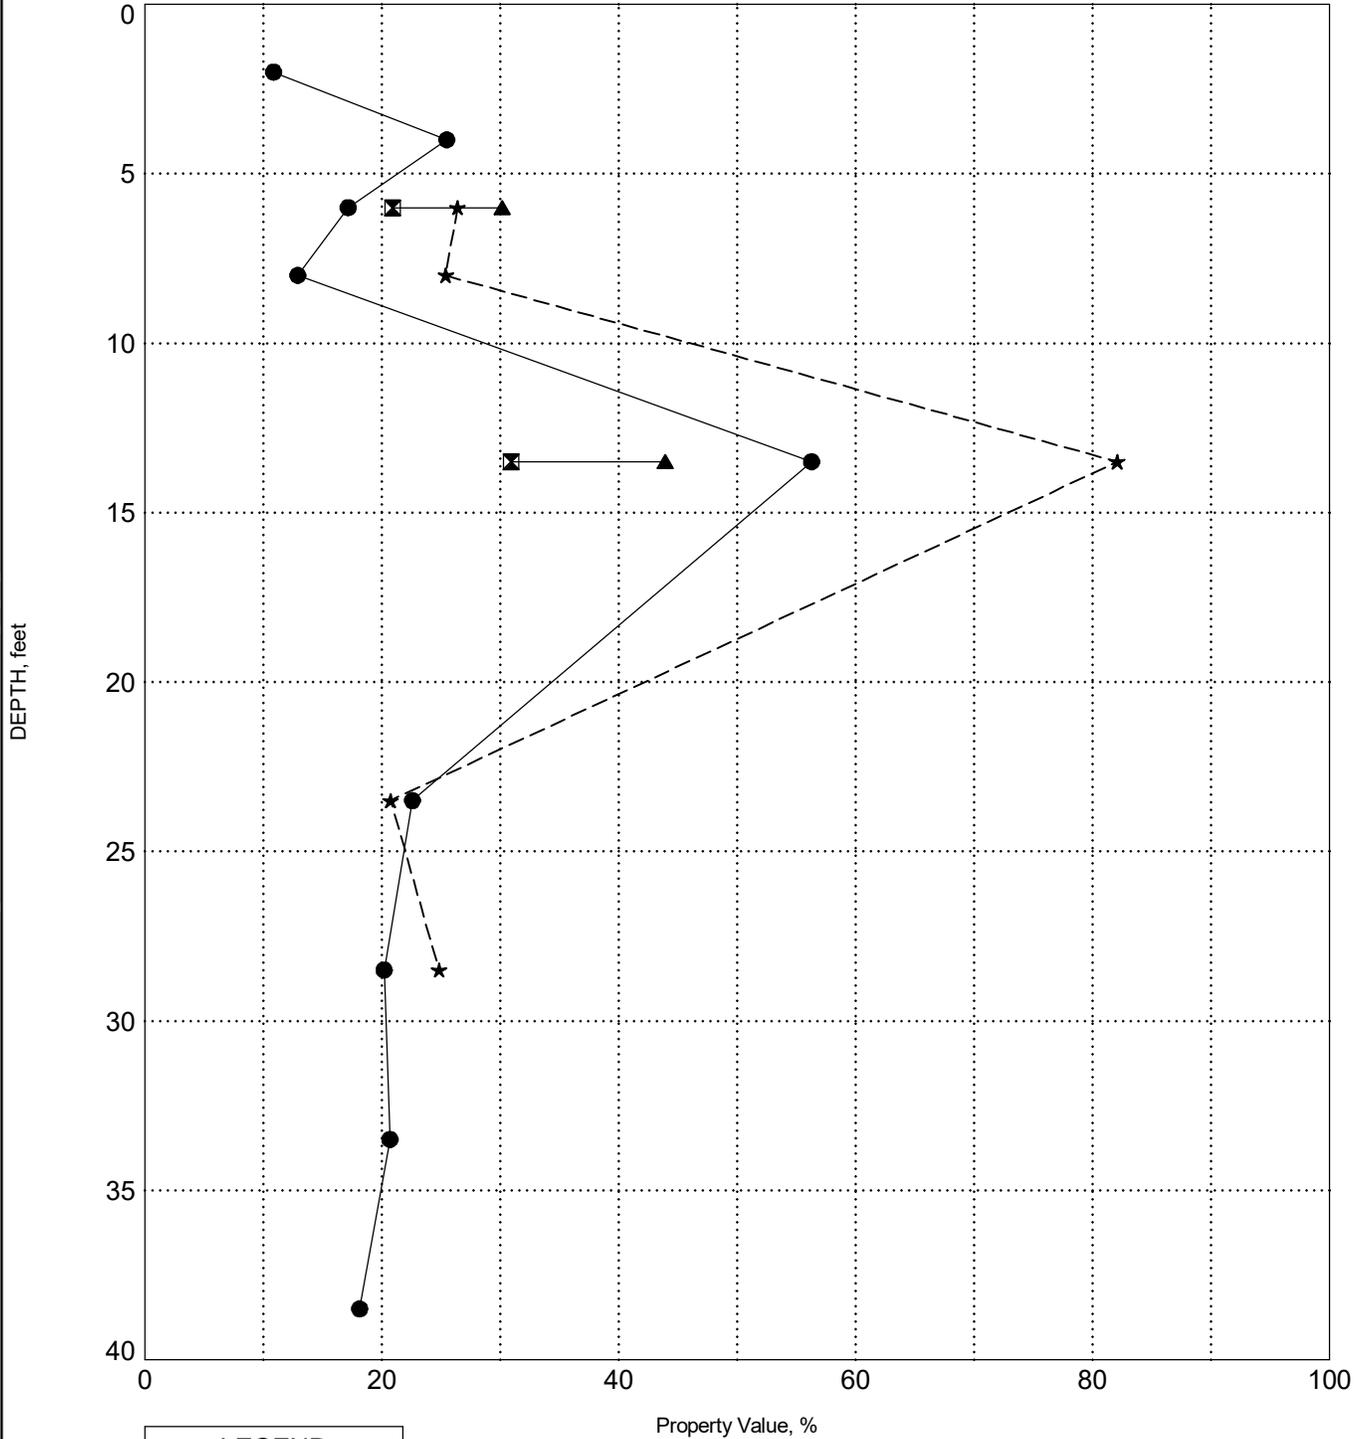
BORING S-23-40-1 Overflow

SURFACE ELEVATION: 916.8

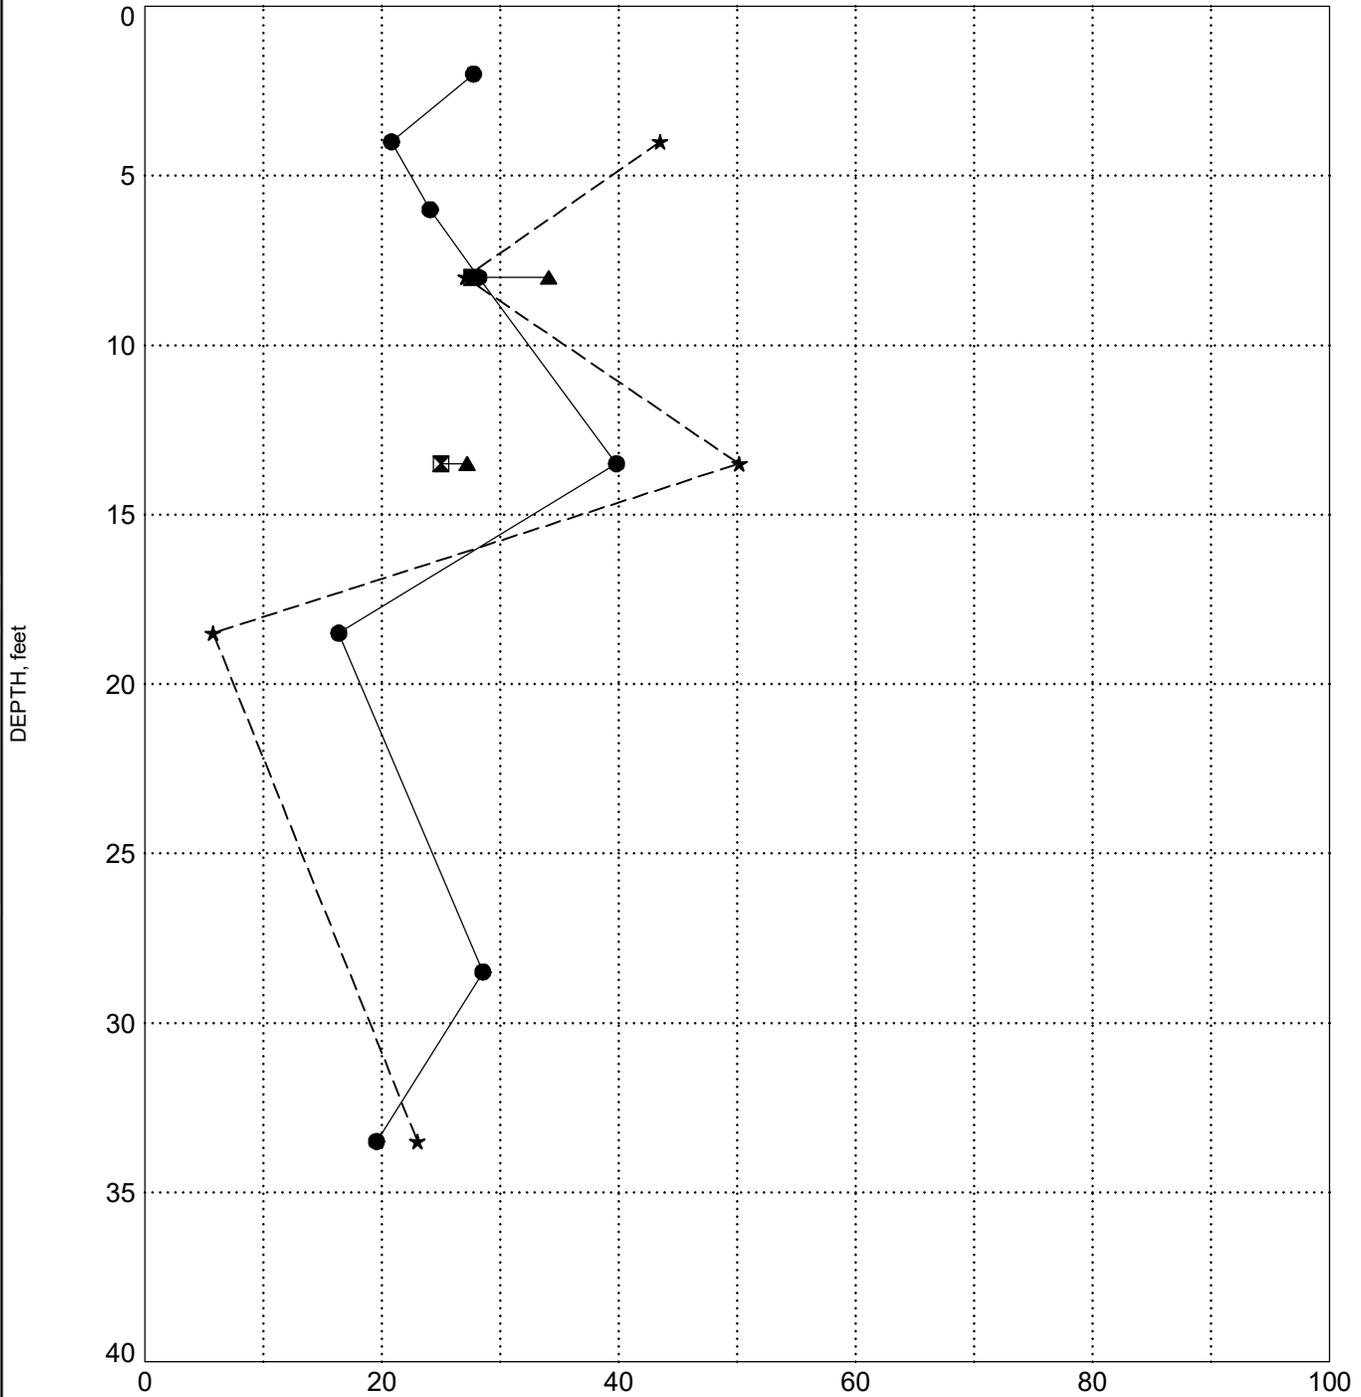
BORING S-23-40-2 Overflow

SURFACE ELEVATION: 917.0

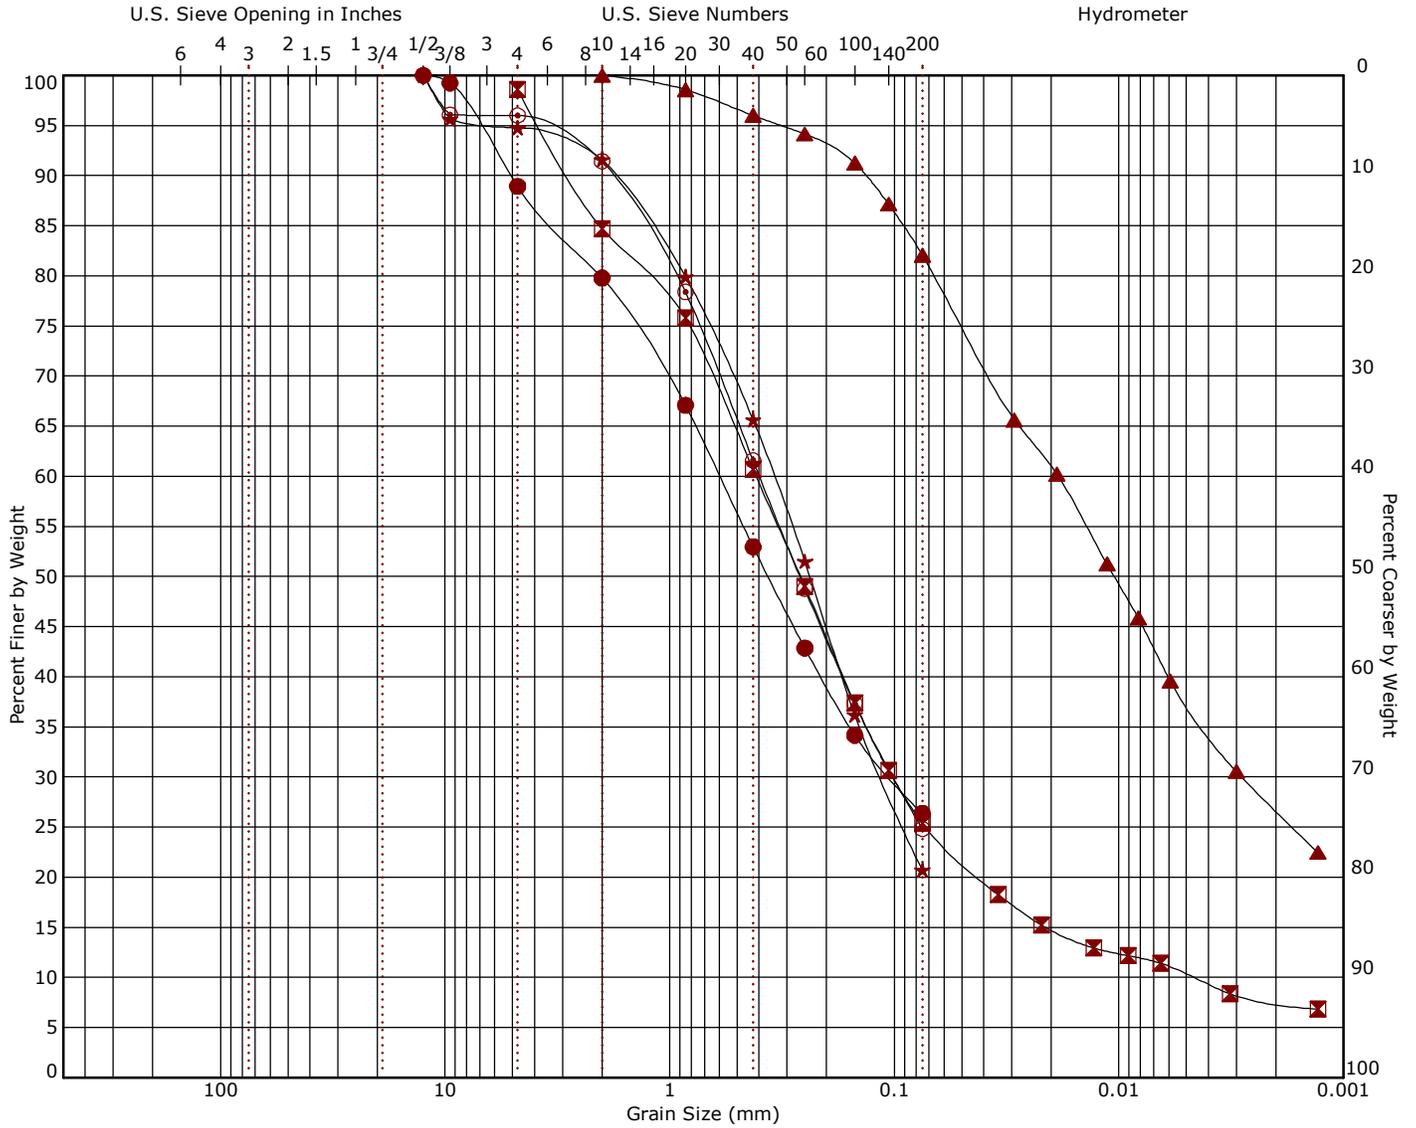
Grain Size Distribution

Boring ID	Depth (Ft)	USCS Classification	USCS	AASHTO	LL	PL	PI	Cc	Cu
● S-23-40-1 Overflow	6 - 8	CLAYEY SAND	SC	A-2-4 (0)	30	21	9		
⊠ S-23-40-1 Overflow	8 - 10	SILTY SAND	SM	A-2-4 (0)				5.35	88.08
▲ S-23-40-1 Overflow	13.5 - 15	SILT with SAND	ML	A-7-5 (12)	44	31	13		
★ S-23-40-1 Overflow	23.5 - 25	SILTY SAND	SM	A-2-4 (0)					
⊙ S-23-40-1 Overflow	28.5 - 30	SILTY SAND	SM	A-2-4 (0)

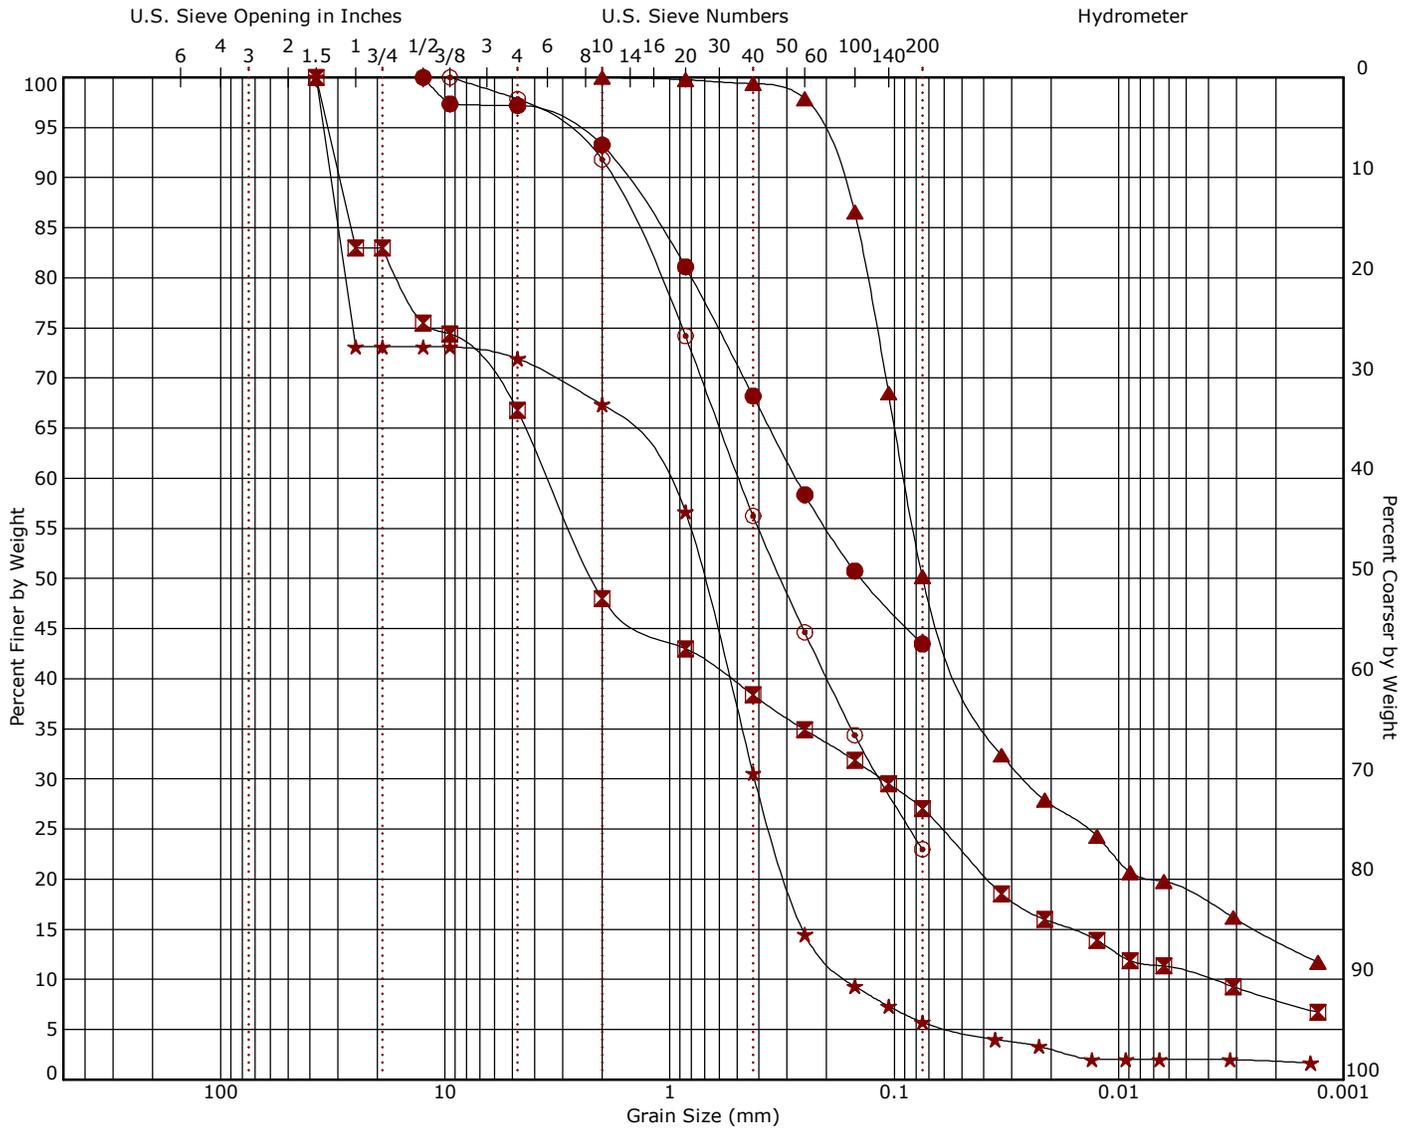
Grain Size Distribution

Boring ID	Depth (Ft)	USCS Classification	USCS	AASHTO	LL	PL	PI	Cc	Cu
● S-23-40-2 Overflow	4 - 6	SILTY SAND	SM	A-4 (0)					
☒ S-23-40-2 Overflow	8 - 10	SILTY SAND with GRAVEL	SM	A-2-4 (0)	34	28	6	0.94	875.82
▲ S-23-40-2 Overflow	13.5 - 15	SANDY SILT	ML	A-4 (0)	27	25	2		
★ S-23-40-2 Overflow	18.5 - 20	POORLY GRADED SAND with SILT and GRAVEL	SP-SM	A-1-b (0)				0.98	6.92
⊙ S-23-40-2 Overflow	33.5 - 35	SILTY SAND	SM	A-2-4 (0)

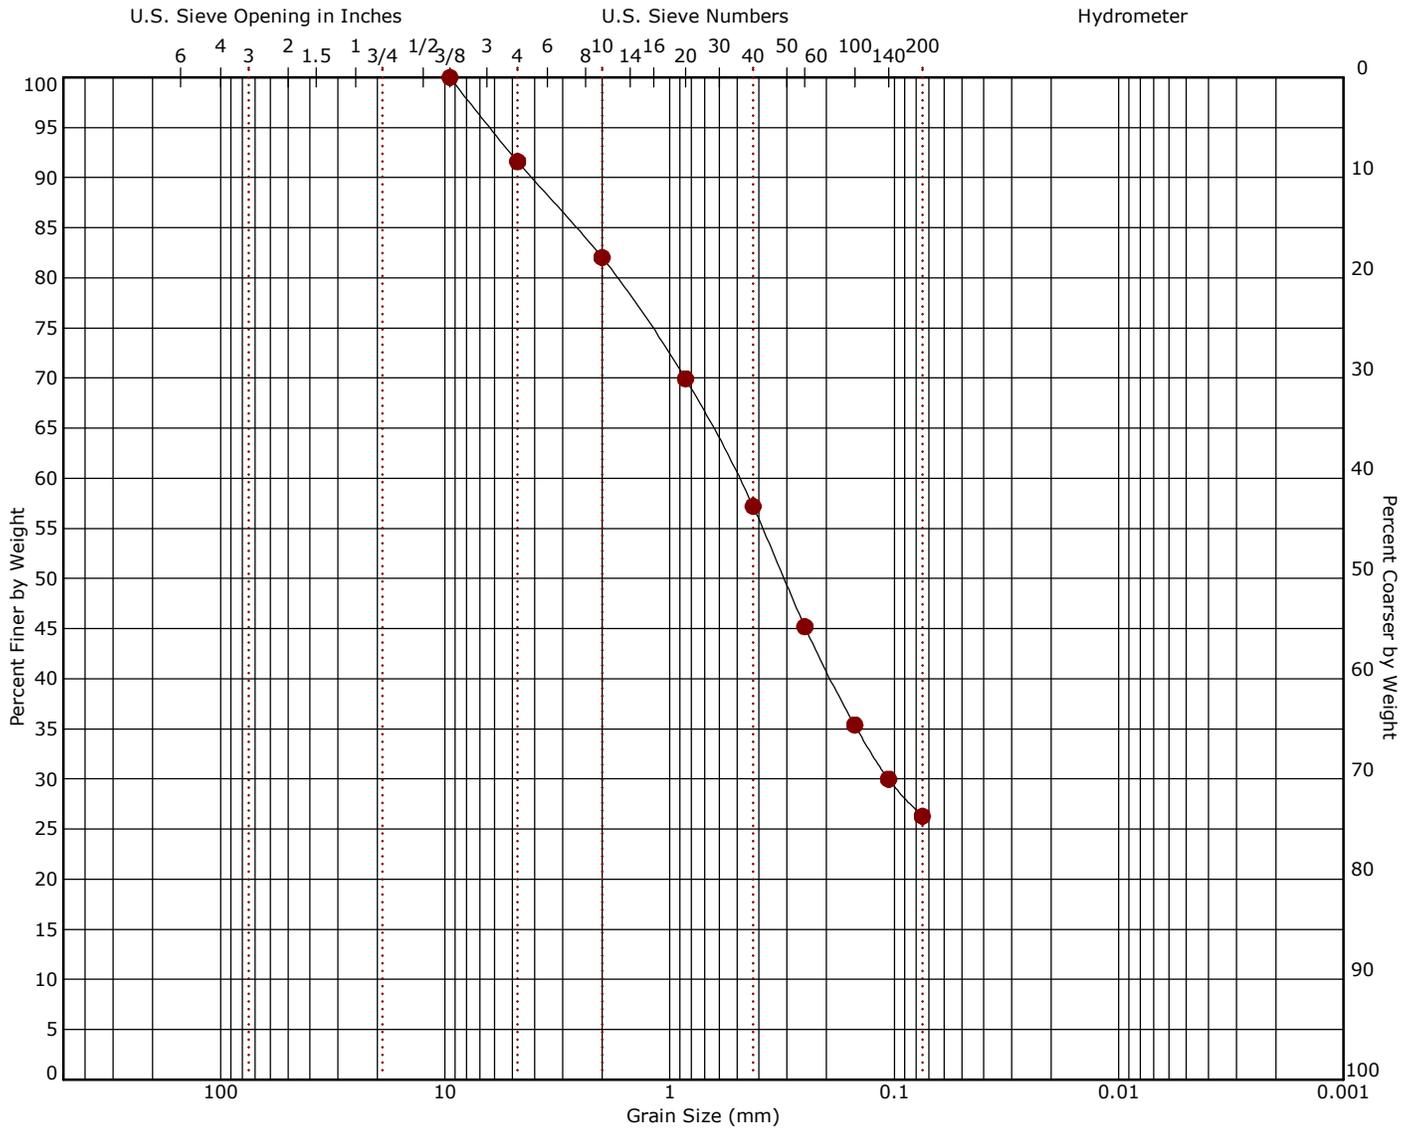
Grain Size Distribution

Boring ID	Depth (Ft)	USCS Classification	USCS	AASHTO	LL	PL	PI	Cc	Cu
● S-23-40-1/2 Overflow Offset	0 - 5	CLAYEY SAND	SC	A-2-4 (0)	30	20	10

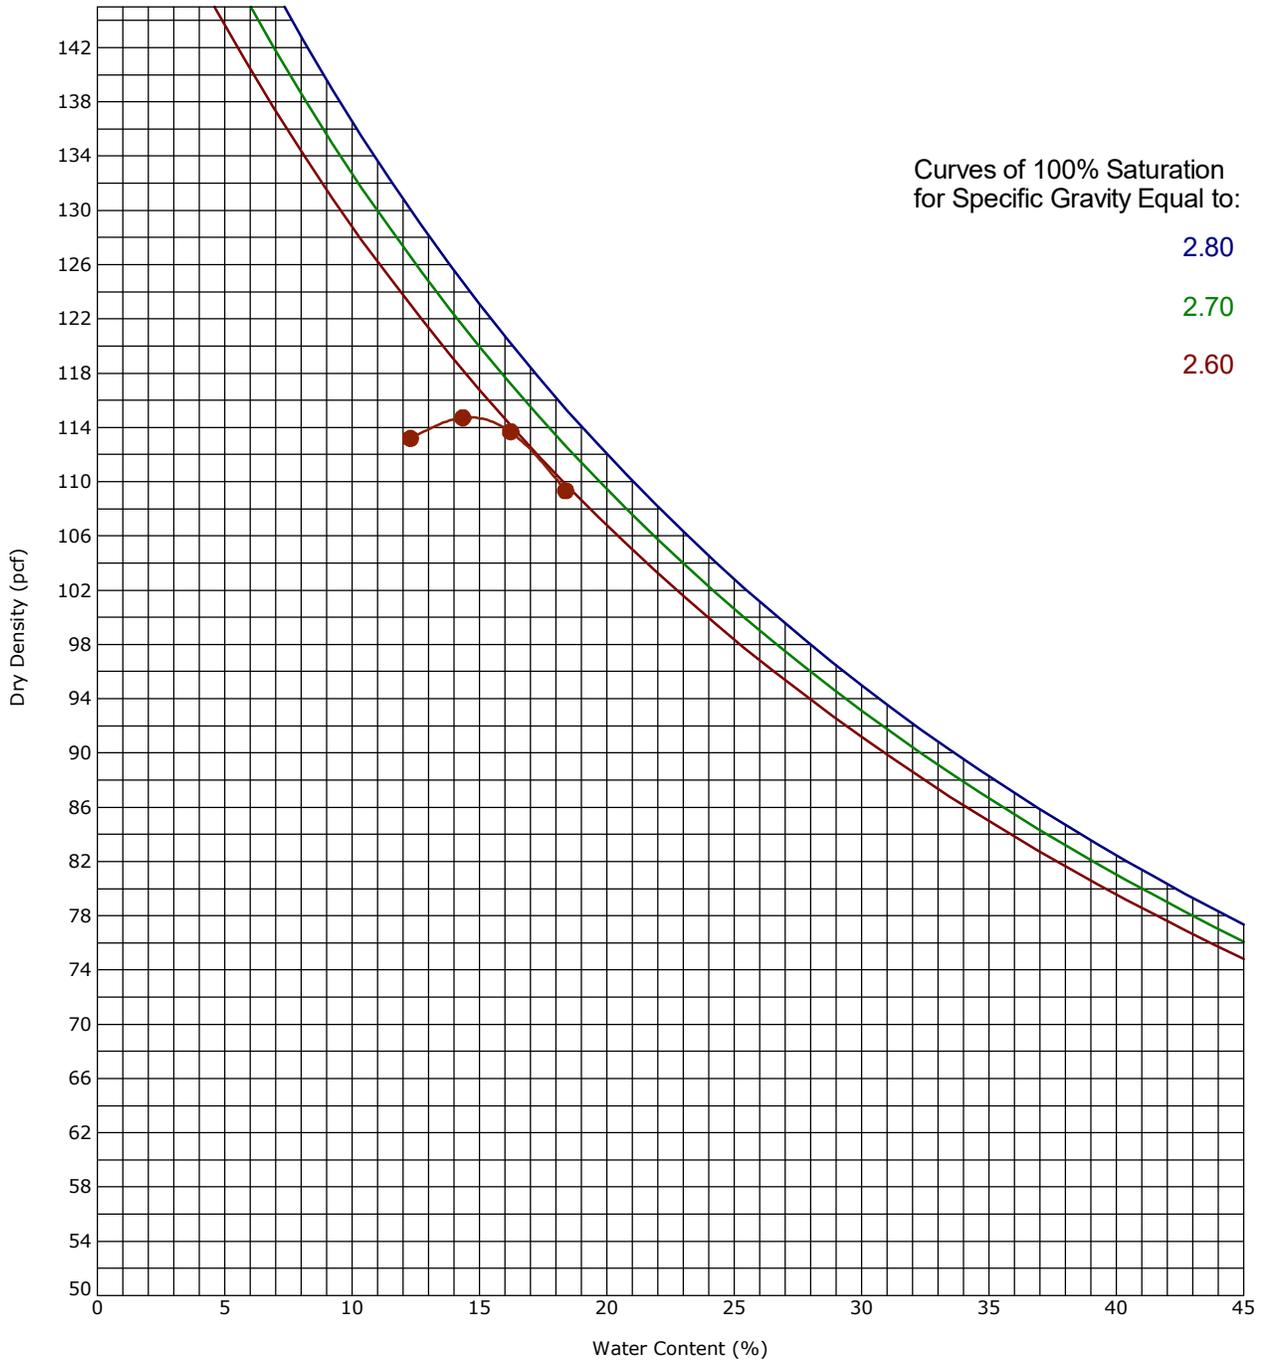
Moisture-Density Relationship

Boring ID		Depth (Ft)		Description of Materials				
S-23-40-1/2 Overflow Offset		0 - 5		CLAYEY SAND(SC)				
Fines (%)	Fraction > mm size	LL	PL	PI	Test Method	Maximum Dry Density (pcf)	Optimum Water Content (%)	
26	0.0	30	20	10	ASTM D698-Method B	114.7	14.6

Based on the conceptual plans by HNTB, 2 to 3 feet of will be placed to support the bridge approach slabs with some cut excavation below the bridge to establish a bench and relatively short (less than 10 feet tall) 2H:1V rip rap lined fill slopes shown at the end abutment positions. Bulk samples were obtained near End Bent 1 and 2 (composite) from the top 5 feet of existing embankment material. Per our scope, a bulk sample was tested for soil classification and was remolded to about 95% of the Standard-effort Proctor prior to being tested for shear strength envelopes under CU Triaxial Compression with pore pressure readings. Test results are presented in Appendix B and summarized in the table below.
