S-23-40 (Pace Bridge Road) Bridge Replacement over South Saluda River Overflow

Geotechnical Baseline Report

October 30, 2024 | SCDOT Project ID: P043137
Terracon Project No.: 8623P180 Revision 1

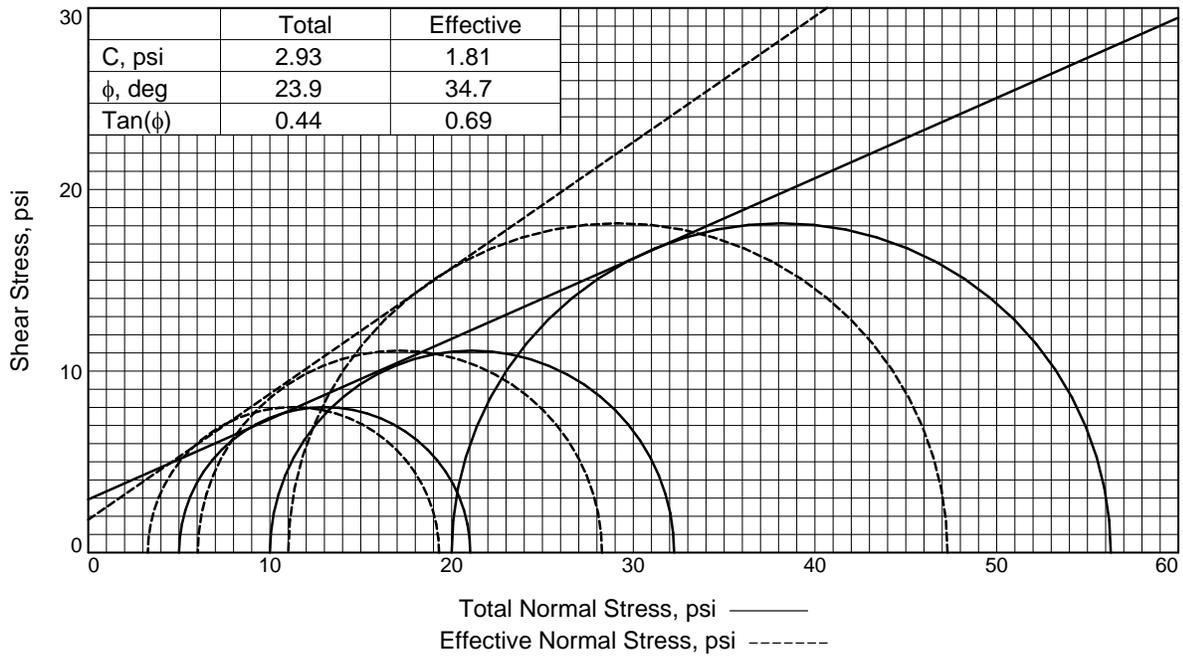
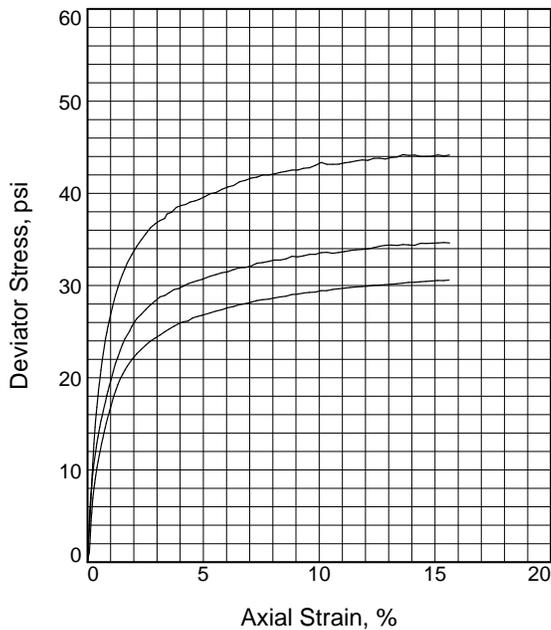
Sample No.		1	2	3
Initial	Water Content, %	14.4	14.4	14.4
	Dry Density, pcf	109.4	109.6	109.6
	Saturation, %	71.7	72.3	72.0
	Void Ratio	0.5409	0.5376	0.5382
	Diameter, in.	2.80	2.80	2.80
	Height, in.	5.62	5.62	5.62
At Test	Water Content, %	18.8	19.1	18.6
	Dry Density, pcf	111.9	111.2	112.2
	Saturation, %	100.0	100.0	100.0
	Void Ratio	0.5069	0.5152	0.5027
	Diameter, in.	2.77	2.79	2.77
	Height, in.	5.58	5.58	5.58
Strain rate, in./min.		0.001	0.001	0.001
Back Pressure, psi		50.0	50.0	50.0
Cell Pressure, psi		55.0	60.0	70.0
Fail. Stress, psi		16.0	22.2	36.3
Excess Pore Pr., psi		1.7	4.0	9.0
Ult. Stress, psi		30.5	34.6	44.2
Excess Pore Pr., psi		-4.4	-2.6	5.0
$\bar{\sigma}_1$ Failure, psi		19.3	28.3	47.3
$\bar{\sigma}_3$ Failure, psi		3.3	6.0	11.0

Sample No.	Station	Offset (ft)	Sample Depth (ft)	USCS Soil Type	Compaction		Shear Strength ¹	
					Optimum Moisture (%)	Max Dry Density (pcf)	Total	Effective
S-23-40-1/2 Overflow Offset	35+29 and 35+97	5 L and 3 L	0 – 5	SC	14.6	114.7	c=2.9 psi ø=24°	c’=1.8 psi ø’=35°

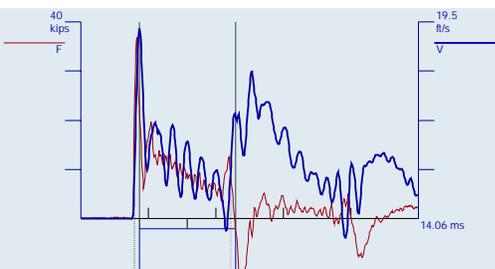
BN 13
05Sep2024 10:07:23 AM

CSX	32.1 ksi
DMX	1.11 in
EFV	331 ft-lb
ETR	94.7 %
BPM	53.8 bpm
RAT	1.0
VMX	18.9 ft/s
FMX	37 kips
DFN	1.00 in
MEX	1070 µE
AMX	3001 g/s
FVP	0.6
LE	33.70 ft
AR	1.15 in ²
EM	30000 ksi
SP	0.492 k-ft/3
WS	16807.9 ft/s
WC	16766.2 ft/s
JC	0.90
JF	1.00

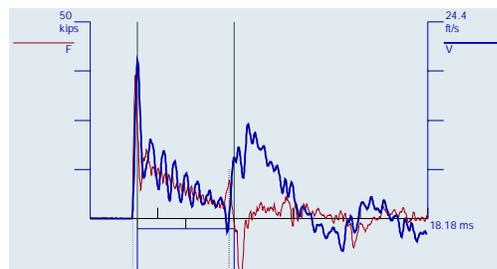
BN 25
05Sep2024 10:24:35 AM

CSX	31.7 ksi
DMX	0.66 in
EFV	324 ft-lb
ETR	92.6 %
BPM	53.4 bpm
RAT	1.1
VMX	19.6 ft/s
FMX	36 kips
DFN	0.60 in
MEX	1056 µE
AMX	3358 g/s
LE	43.70 ft
AR	1.15 in ²
EM	30000 ksi
SP	0.492 k-ft/3
WS	16807.9 ft/s
WC	16807.7 ft/s
JC	0.90
JF	1.00

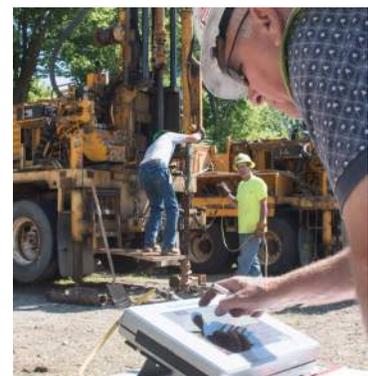
- Calculates energy transferred by SPT hammers using force and velocity measurements
- Determines N value to help improve reliability of soil strength estimates
- Offers simplified reporting and analysis option to speed testing results
- Operates in English, SI, or Metric units

The SPT Analyzer is compliant with EN ISO 22476-3:2005. ASTM D1586 recommends normalizing results from any SPT test using energy measurements. When these tests are performed to determine the liquefaction potential of sands, ASTM D6066 not only recommends but mandates the normalization. ASTM D4633 states that the only acceptable method of determining energy for normalization of N values is by force and velocity measurements.

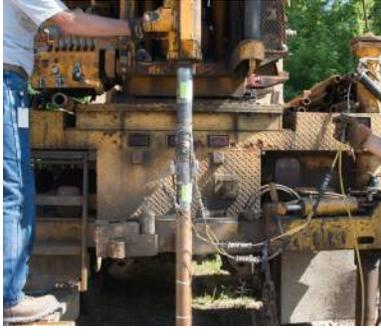
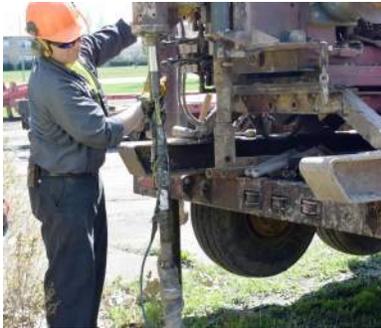
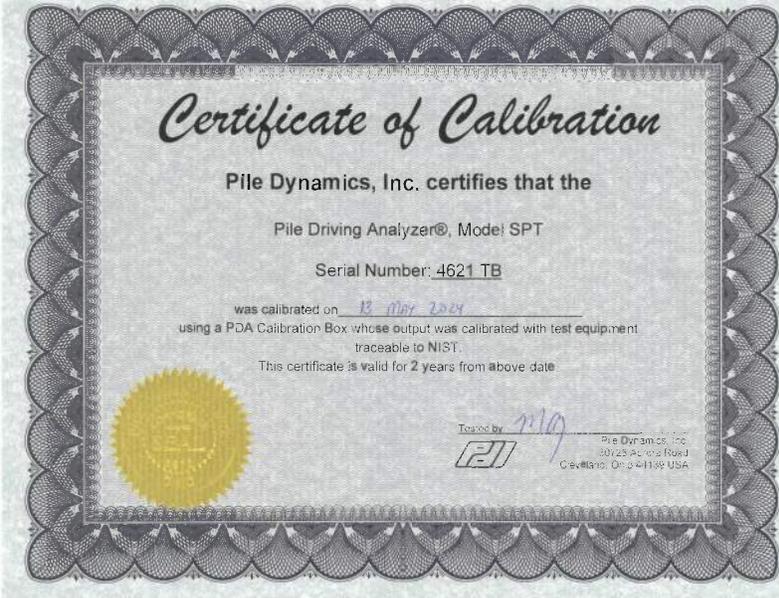
SPT Analyzer data is stored and transferred to a computer via USB memory stick. The software furnished with the SPT Analyzer has a Report Creation Option that makes it quick and easy to summarize results and create output graphs of Force, Velocity, Energy and Displacement versus Time, as well as numerical, statistical, and graphical results for each data set. The software is fully customizable.
