# S-23-102 (Keeler Mill Road) Bridge Replacement over Armstrong Creek

### Geotechnical Baseline Report

October 30, 2024 | SCDOT Project ID: P041161  
Terracon Project No.: 8623P180 Revision 1

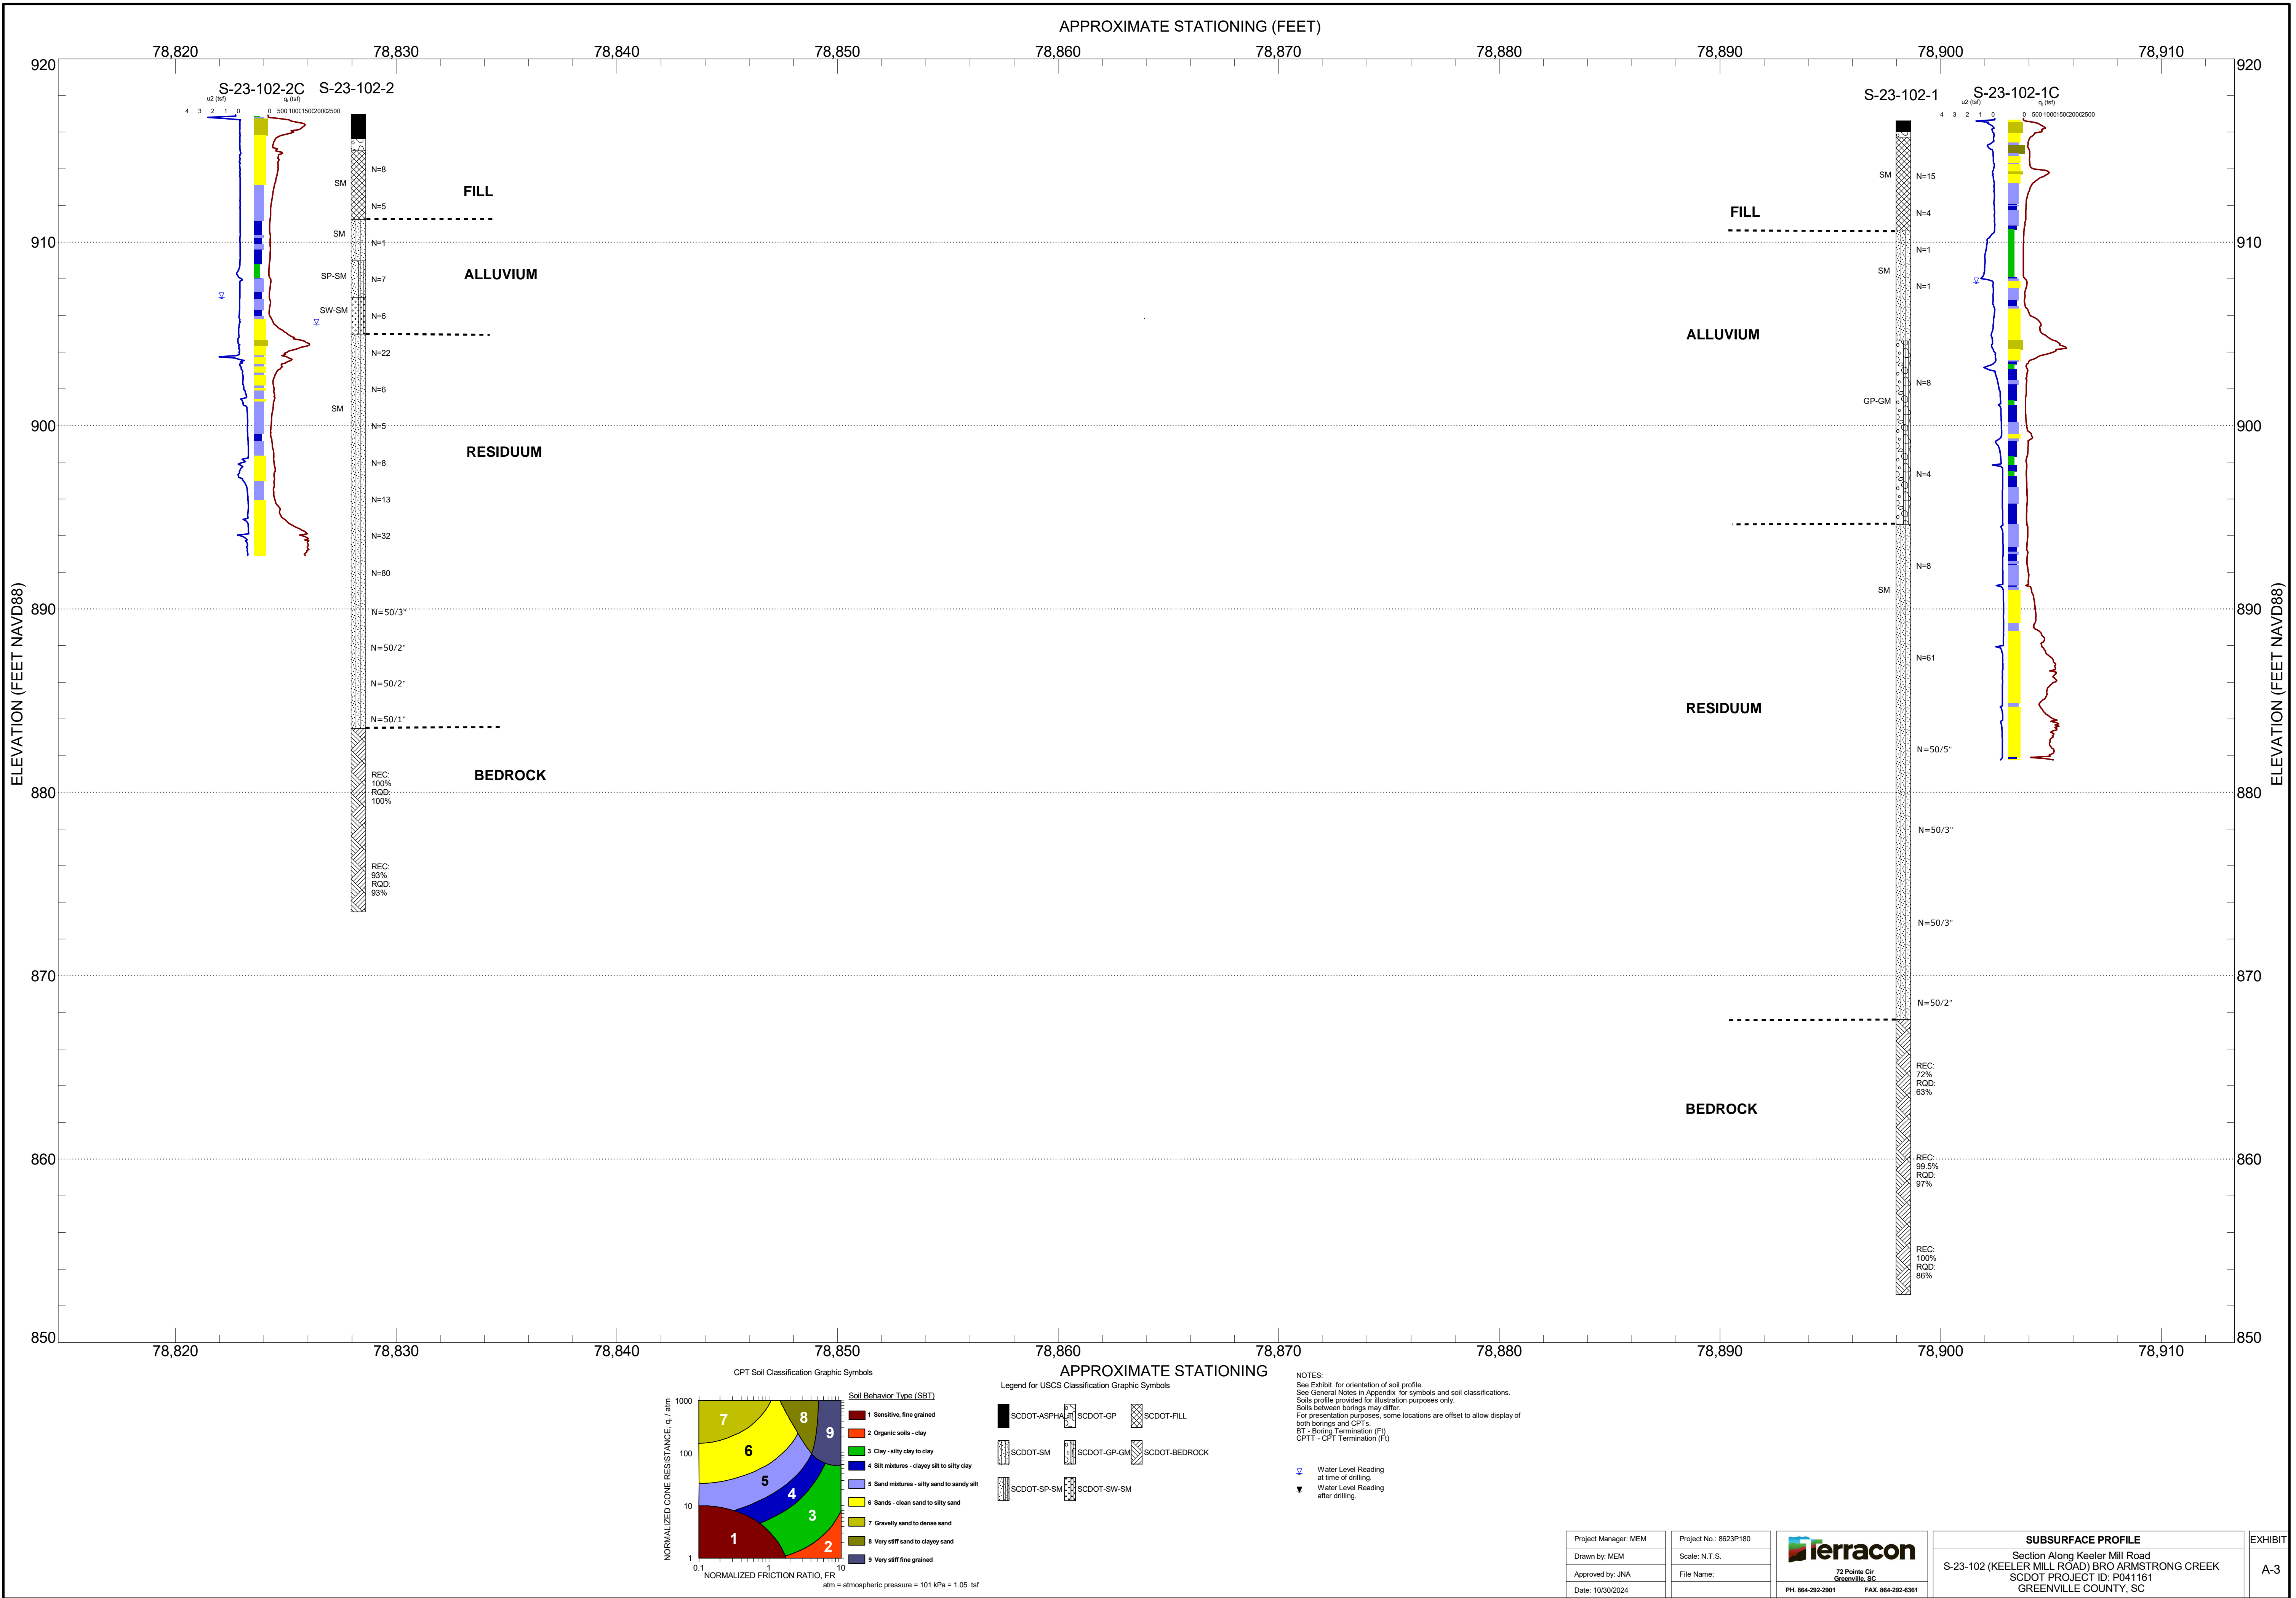
## Summary of Boring Data – Exhibit A-4

EXISTING ROADWAY EMBANKMENT INFORMATION			
Begin Project Sta:	786+30	Begin Bridge Embankment Sta:	787+16
Accessibility Issues:	None Observed		
Ground Cover:	Asphalt pavement and grassed shoulders		
Existing Fill Height:	6 feet, sloping	Approx Existing Slope Angle:	2H:1V
Local Development:	developed - residential		
Topography:	graded slope to creek		
Traffic Control Necessary:	Yes, lane closure		
Surface Soils:	silty sand	Muck:	No
Exposed Rock in Stream Bed:	Yes	Exposed Rock in banks:	No
Wetlands on Site:	Yes	Wetland Adjacent:	Yes
Depth FG to Water:	10 feet	Water Depth:	2 to 3 feet
Depth to Existing Ground:	approximately 13 feet at center of bridge		
Scour Condition at EB:	Critical	Scour Condition at IB:	Critical
End Bridge Embankment Sta:	790+16	End Project Sta:	792+40
Accessibility Issues:	None Observed		
Ground Cover:	Asphalt pavement and grassed shoulders		
Existing Fill Height:	6 feet, sloping	Approx Existing Slope Angle:	2H:1V

Local Development:	developed - residential		
Topography:	graded slope to creek		
Traffic Control Necessary:	Yes, lane closure		
Surface Soils:	silty sand	Muck:	No
Exposed Rock in Stream Bed:	Yes	Exposed Rock in banks:	No
Wetlands on Site:	Yes	Wetland Adjacent:	Yes
Depth FG to Water:	10 feet	Water Depth:	2 to 3 feet
Depth to Existing Ground:	approximately 13 feet at center of bridge		
Scour Condition at EB:	Critical	Scour Condition at IB:	Critical

UTILITIES INFORMATION	
Attached:	N/A
Above Ground:	Overhead power was observed on the southwest side of the road
Underground:	An underground waterline was observed in the southwest shoulder

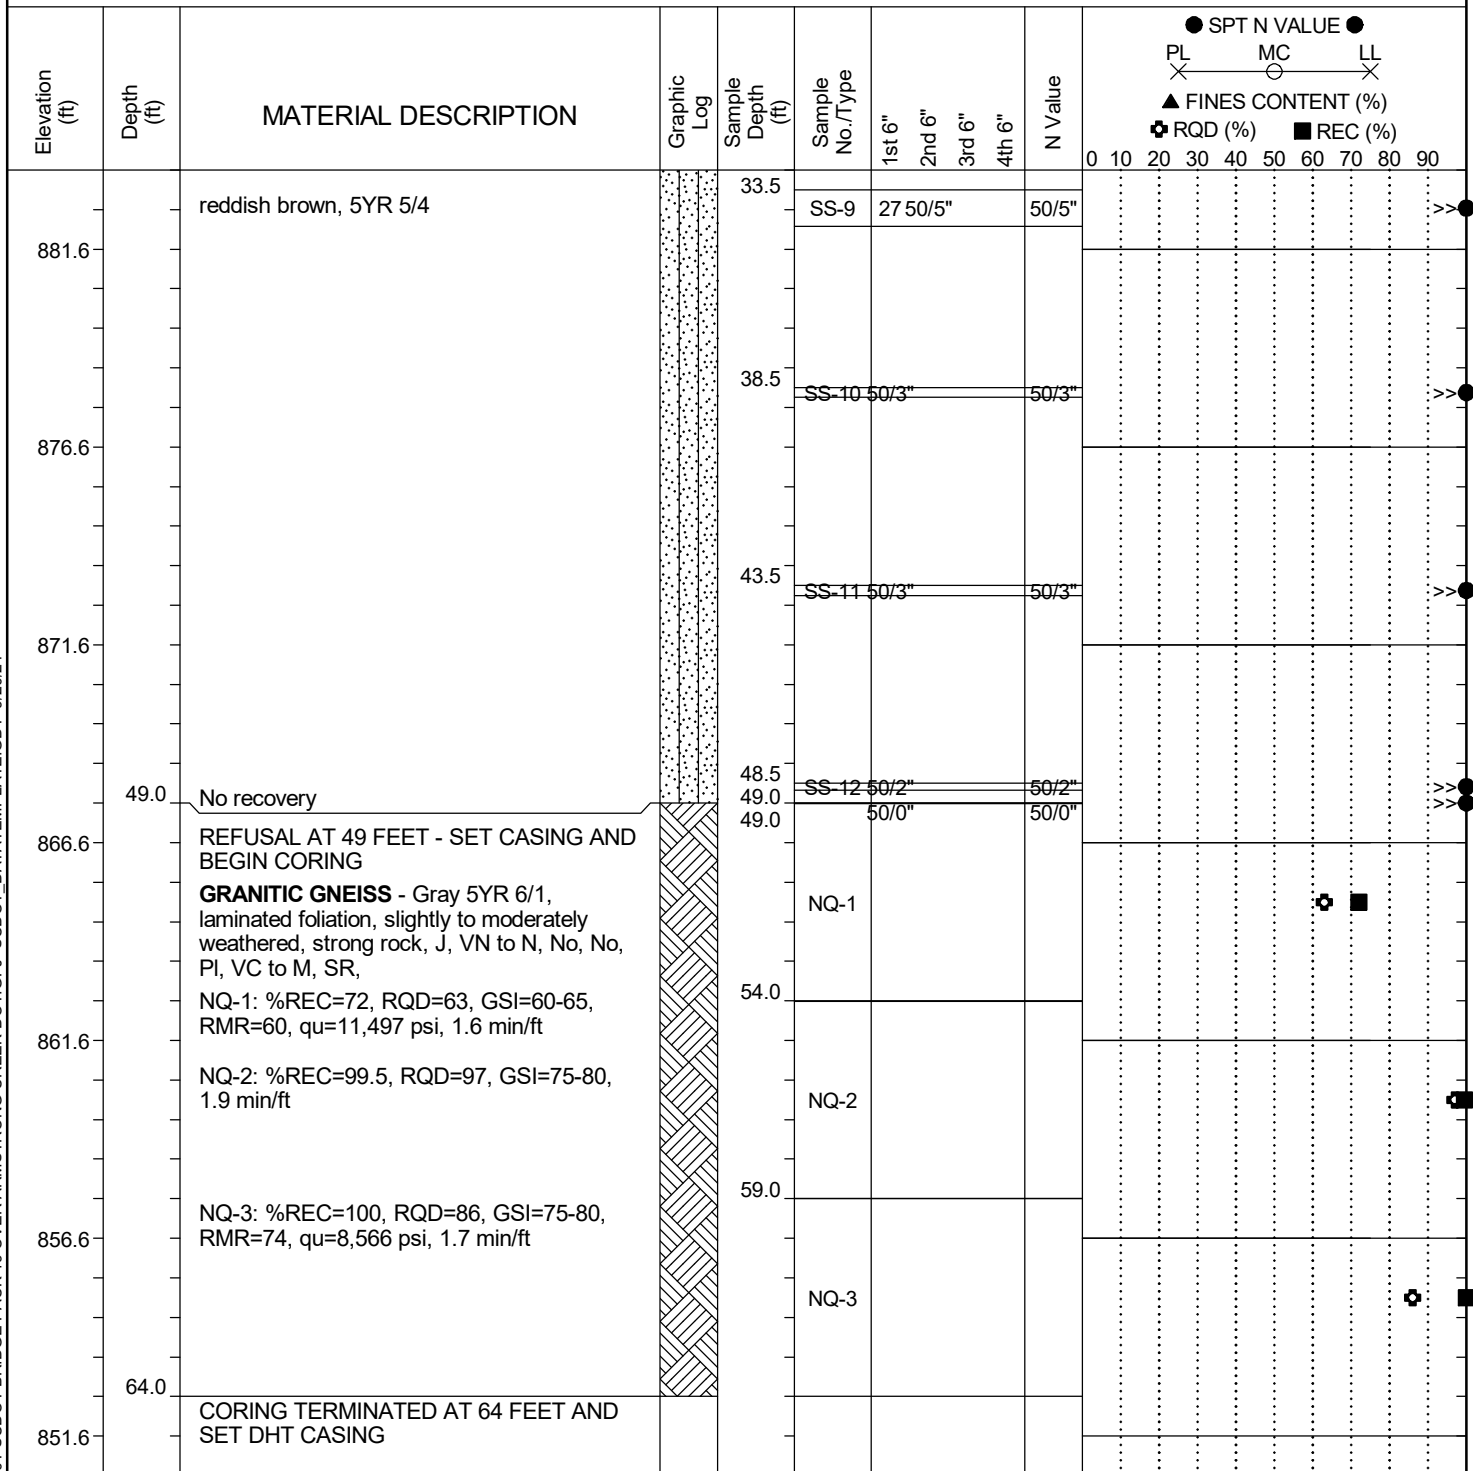
# SCDOT Soil Test Log

<b>Project ID:</b>	P041161	<b>County:</b>	Greenville	<b>Boring No.:</b>	S-23-102-1
<b>Site Description:</b>	S-23-102 BRO Armstrong Creek			<b>Route:</b>	S-23-102
<b>Eng./Geo.:</b>	S. Greaber	<b>Boring Location:</b>	788+98	<b>Offset:</b>	15 R
<b>Elev.:</b>	916.6 ft	<b>Latitude:</b>	34.9420005	<b>Longitude:</b>	-82.4926575
<b>Date Started:</b>	6/3/2024				
<b>Total Depth:</b>	64 ft	<b>Soil Depth:</b>	49 ft	<b>Core Depth:</b>	15 ft
<b>Date Completed:</b>	6/3/2024				
<b>Bore Hole Diameter (in):</b>	4	<b>Sampler Configuration</b>		<b>Liner Required:</b>	Y (N)
<b>Liner Used:</b>	Y (N)				
<b>Drill Machine:</b>	DR#554	<b>Drill Method:</b>	RW/RC	<b>Hammer Type:</b>	Automatic
<b>Energy Ratio:</b>	88.5%				
<b>Core Size:</b>	NQ2	<b>Driller:</b>	B. Burnette	<b>Groundwater:</b>	TOB N.M.
<b>24HR:</b>	N.M.

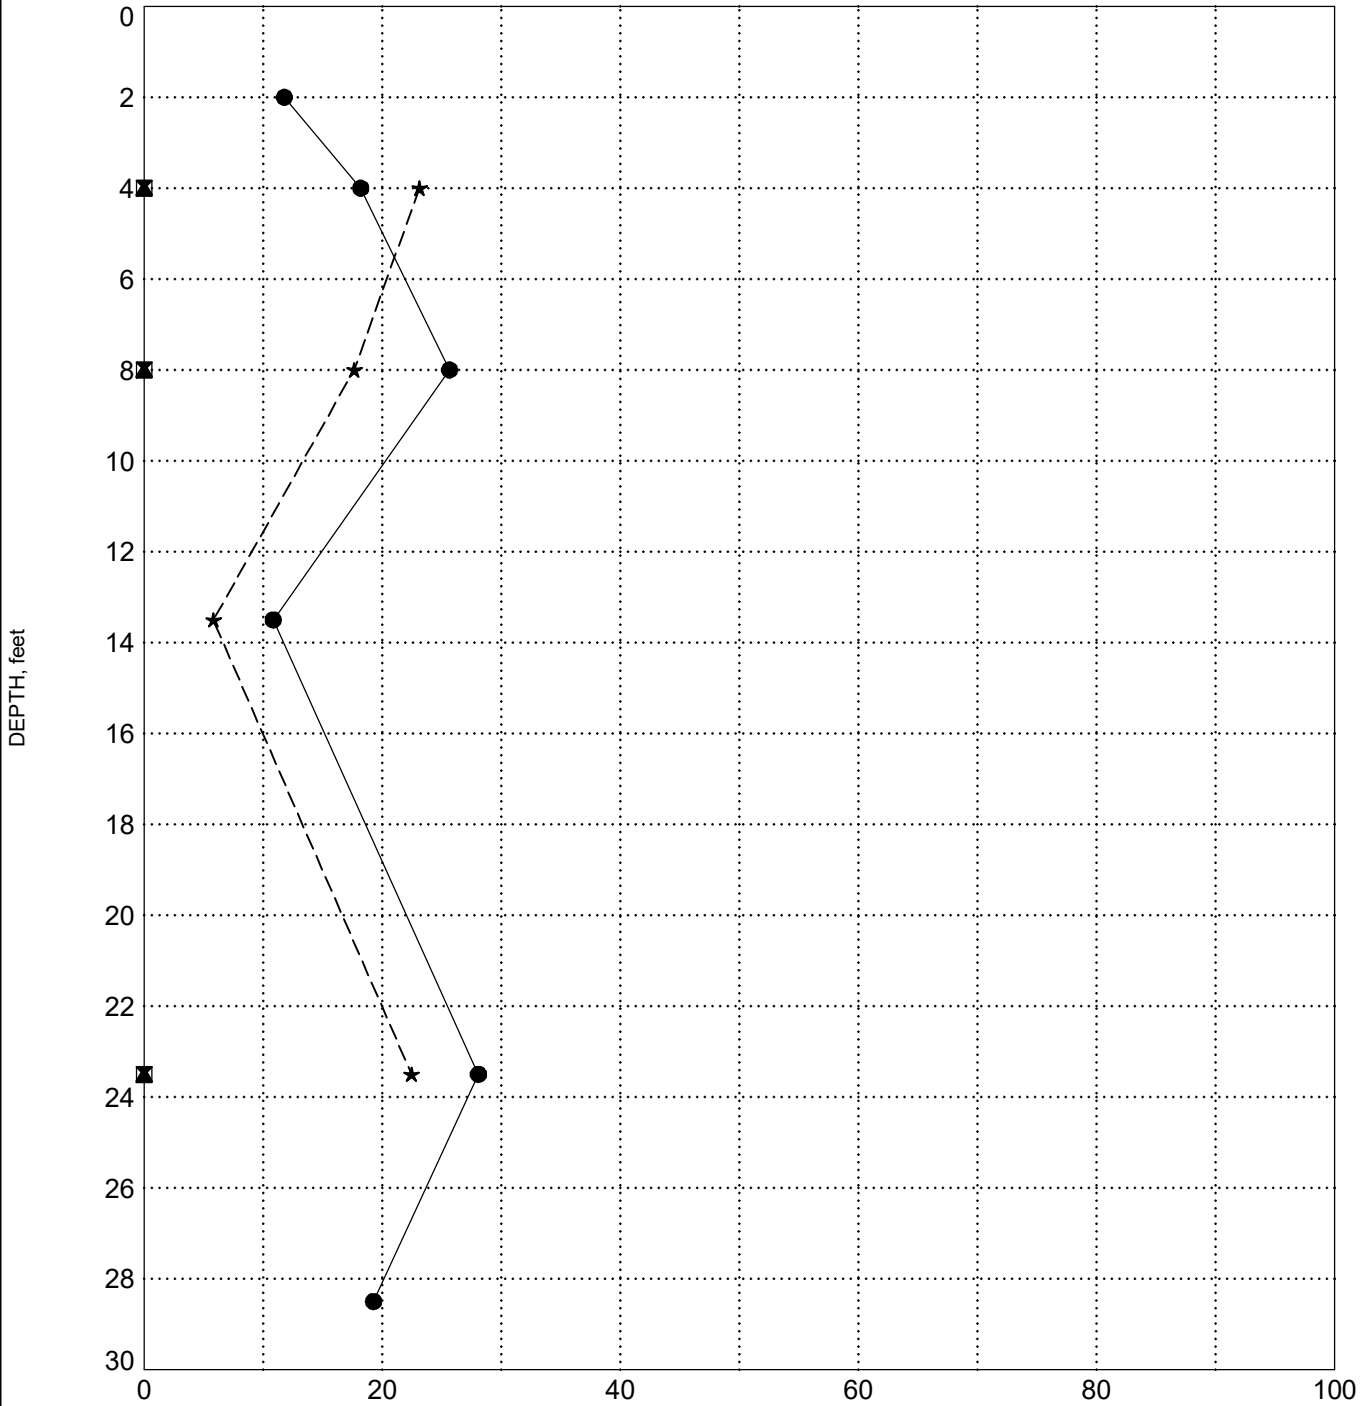
## BORING S-23-102-1

SURFACE ELEVATION: 916.6

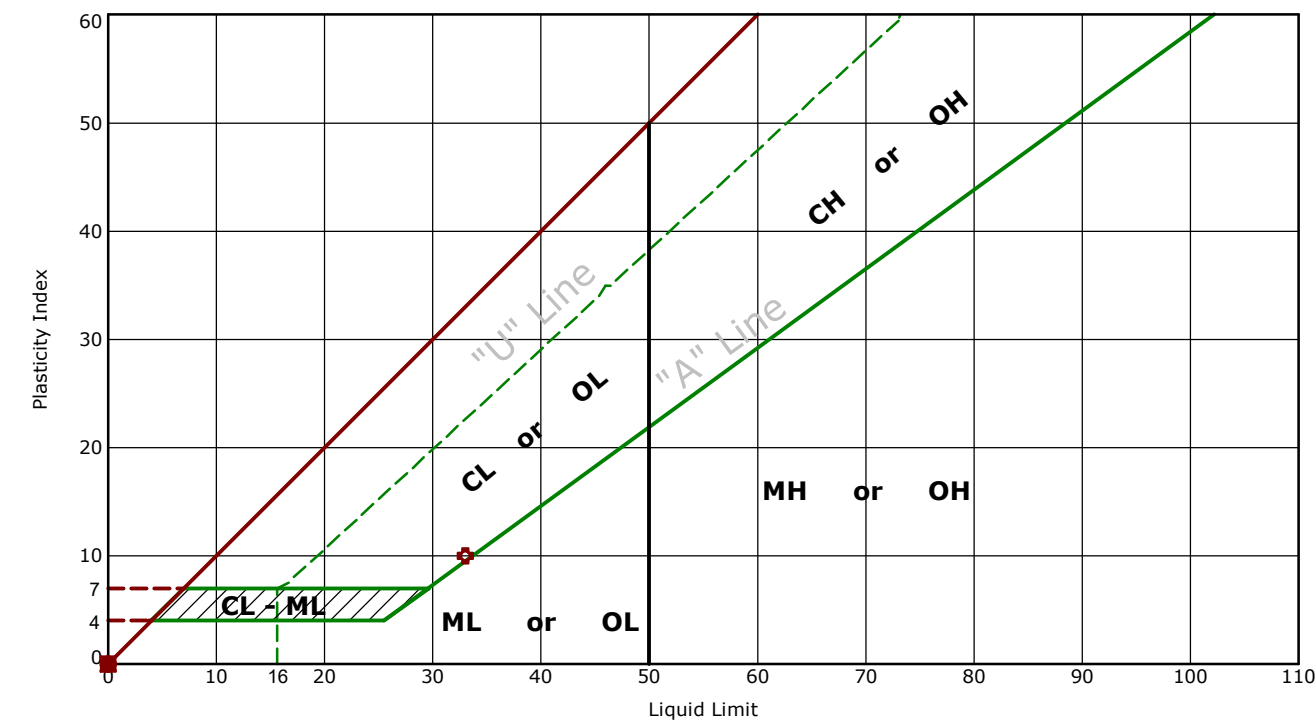
# Atterberg Limit Results

Boring ID	Depth (Ft)	LL	PL	PI	Fines	AASHTO	Description
●	S-23-102-1	4 - 6	NP	NP	NP	23.1	A-2-4 (0)	SILTY SAND
⊠	S-23-102-1	8 - 10	NP	NP	NP	17.6	A-1-b (0)	SILTY SAND with GRAVEL
▲	S-23-102-1	23.5 - 25	NP	NP	NP	22.4	A-2-4 (0)	SILTY SAND
★	S-23-102-2	6 - 8	NP	NP	NP	35.2	A-2-4 (0)	SILTY SAND
⊙	S-23-102-2	12 - 14	NP	NP	NP	14.9	A-1-b (0)	SILTY SAND
⊕	S-23-102-2 Offset	0 - 5	33	23	10	29.4	A-2-4 (0)	CLAYEY SAND

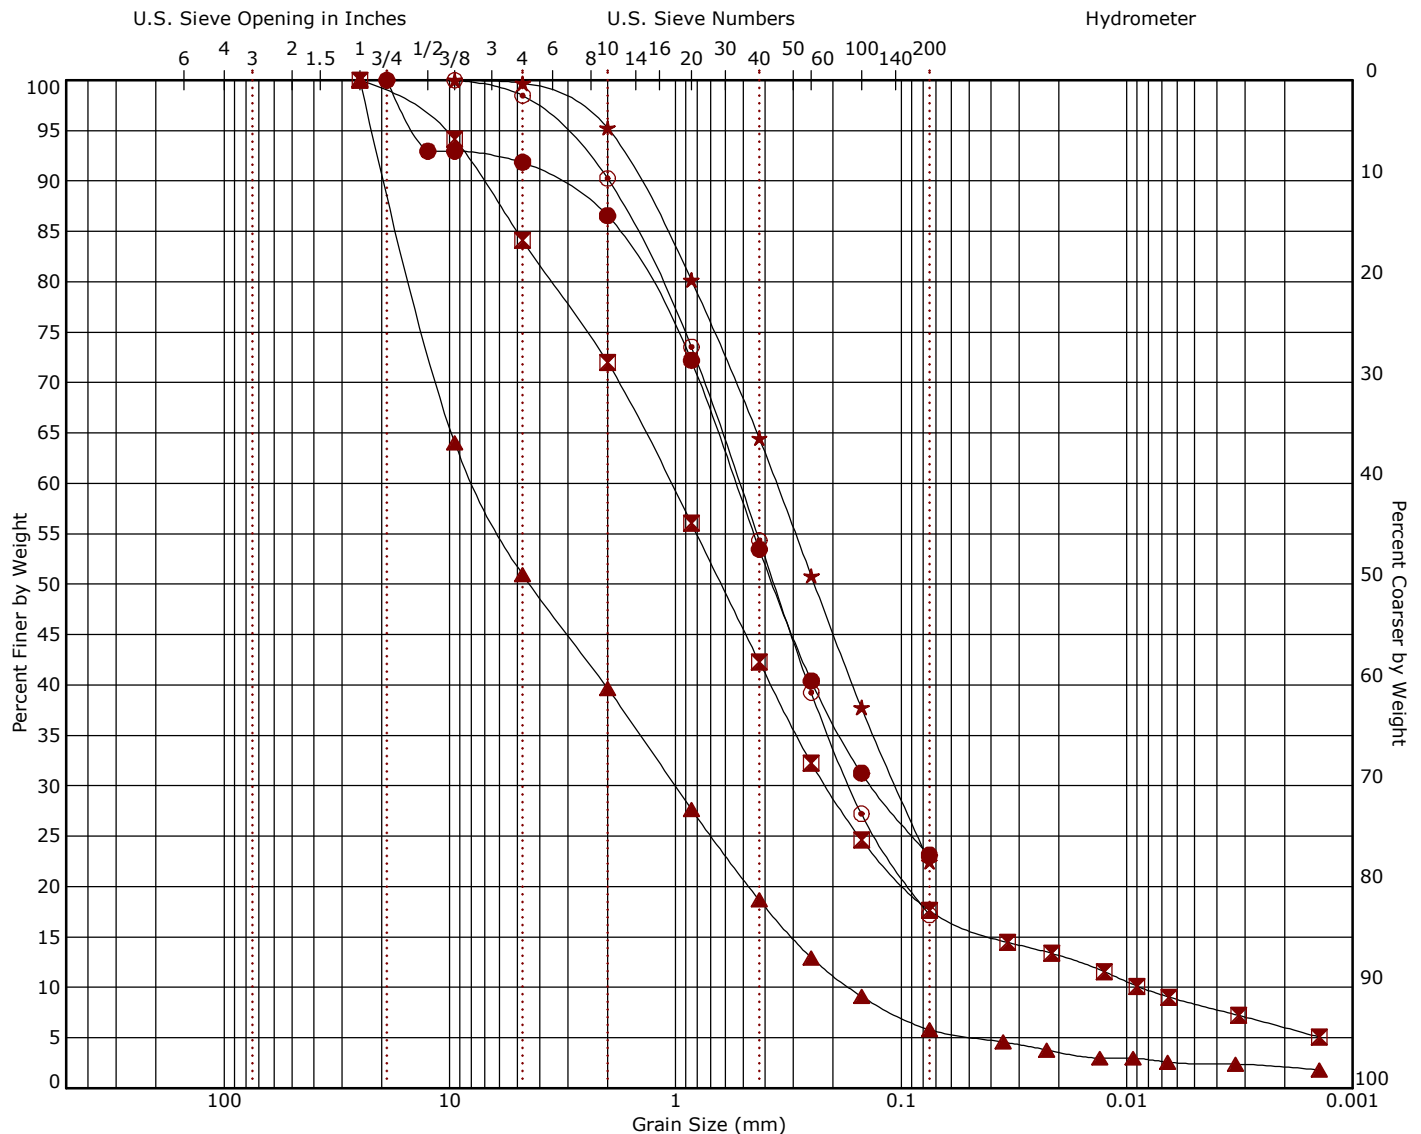
## Grain Size Distribution

Boring ID	Depth (Ft)	USCS Classification	USCS	AASHTO	LL	PL	PI	Cc	Cu
●S-23-102-1	4 - 6	SILTY SAND	SM	A-2-4 (0)	NP	NP	NP		
☒S-23-102-1	8 - 10	SILTY SAND with GRAVEL	SM	A-1-b (0)	NP	NP	NP	5.06	121.15
▲S-23-102-1	13.5 - 15	POORLY GRADED GRAVEL W/ SILT & SAND	GP-GM	A-1-a				0.78	45.45
★S-23-102-1	23.5 - 25	SILTY SAND	SM	A-2-4 (0)	NP	NP	NP		
⊙S-23-102-2	4 - 6	SILTY SAND	SM	A-2-4

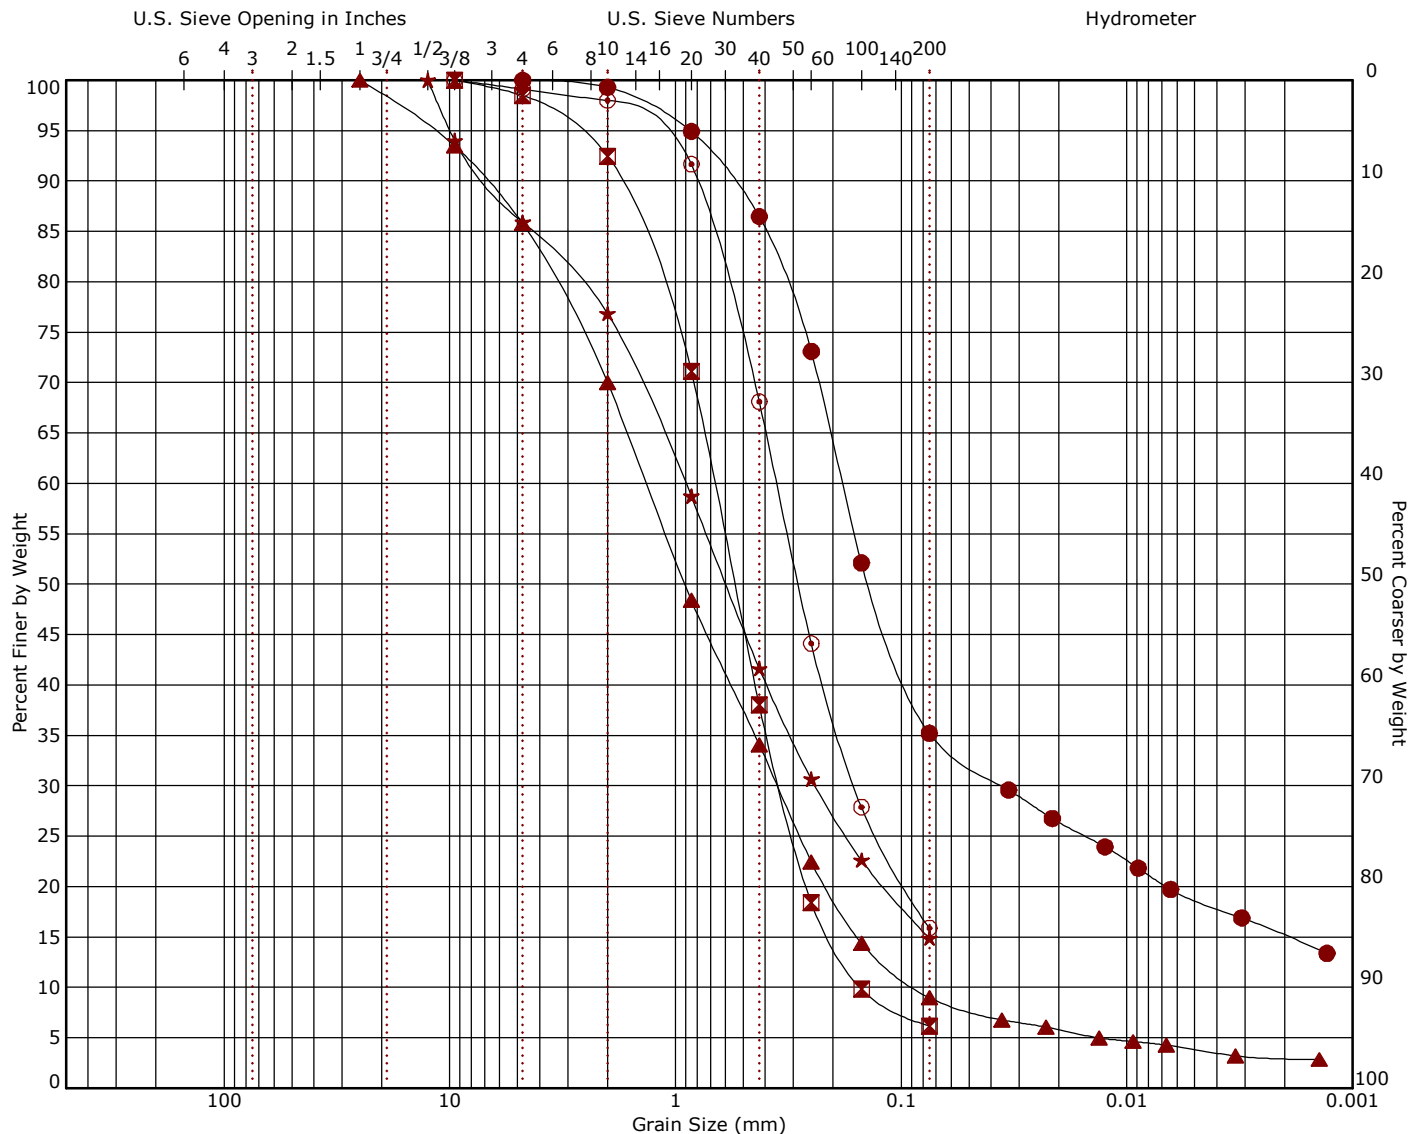
Boring ID	Depth (Ft)	USCS Classification	USCS	AASHTO	LL	PL	PI	Cc	Cu
● S-23-102-2	6 - 8	SILTY SAND	SM	A-2-4 (0)	NP	NP	NP		
⊠ S-23-102-2	8 - 10	POORLY GRADED SAND W/ SILT	SP-SM	A-1-b				1.15	4.44
▲ S-23-102-2	10 - 12	WELL GRADED SAND W/ SILT	SW-SM	A-1-b				1.08	15.75
★ S-23-102-2	12 - 14	SILTY SAND	SM	A-1-b (0)	NP	NP	NP		
⊙ S-23-102-2	14 - 16	SILTY SAND	SM	A-2-4

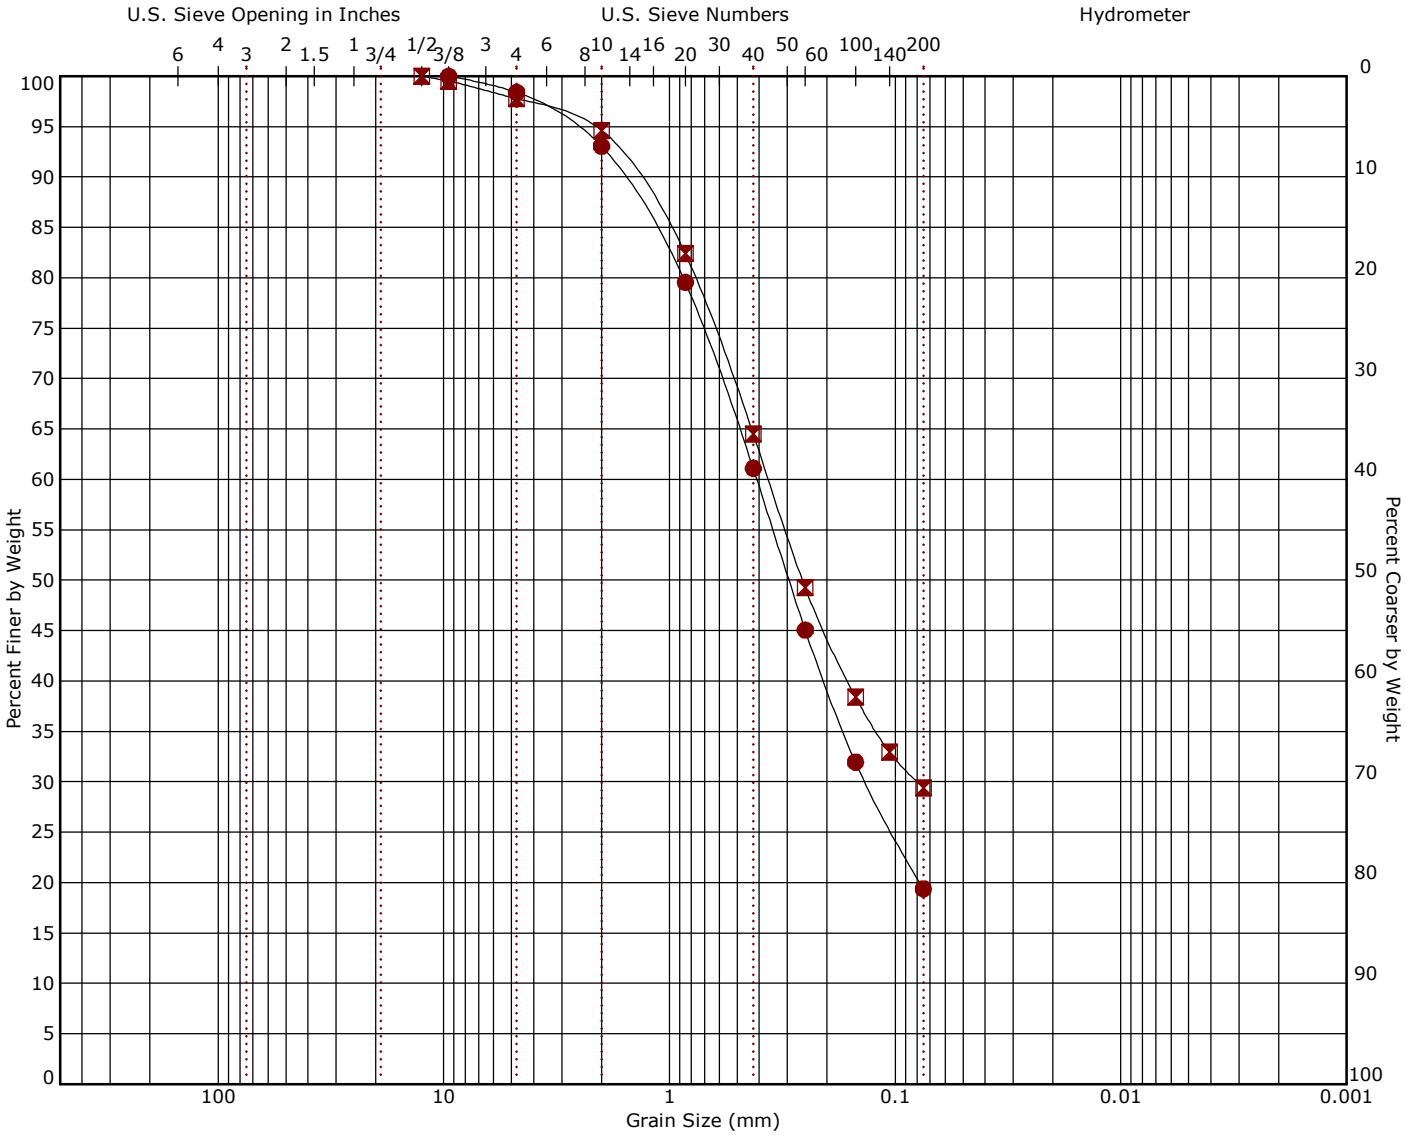
## ASTM D422 / ASTM C136

Cobbles		Gravel		Sand			Silt or Clay					
		coarse	fine	coarse	medium	fine						
Boring ID	Depth (Ft)	USCS Classification				USCS	AASHTO	LL	PL	PI	Cc	Cu
● S-23-102-2	18 - 20	SILTY SAND				SM	A-2-4					
✖ S-23-102-2	0 - 5	CLAYEY SAND				SC	A-2-4 (0)	33	23	10		
Offset												
Boring ID	Depth (Ft)	D <sub>100</sub>	D <sub>60</sub>	D <sub>30</sub>	D <sub>10</sub>	%Cobbles	%Gravel	%Sand	%Fines	%Silt	%Clay	
● S-23-102-2	18 - 20	9.5	0.41	0.135		0.0	1.6	79.0	19.4			
✖ S-23-102-2	0 - 5	12.5	0.363	0.079		0.0	2.2	68.4	29.4			
Offset

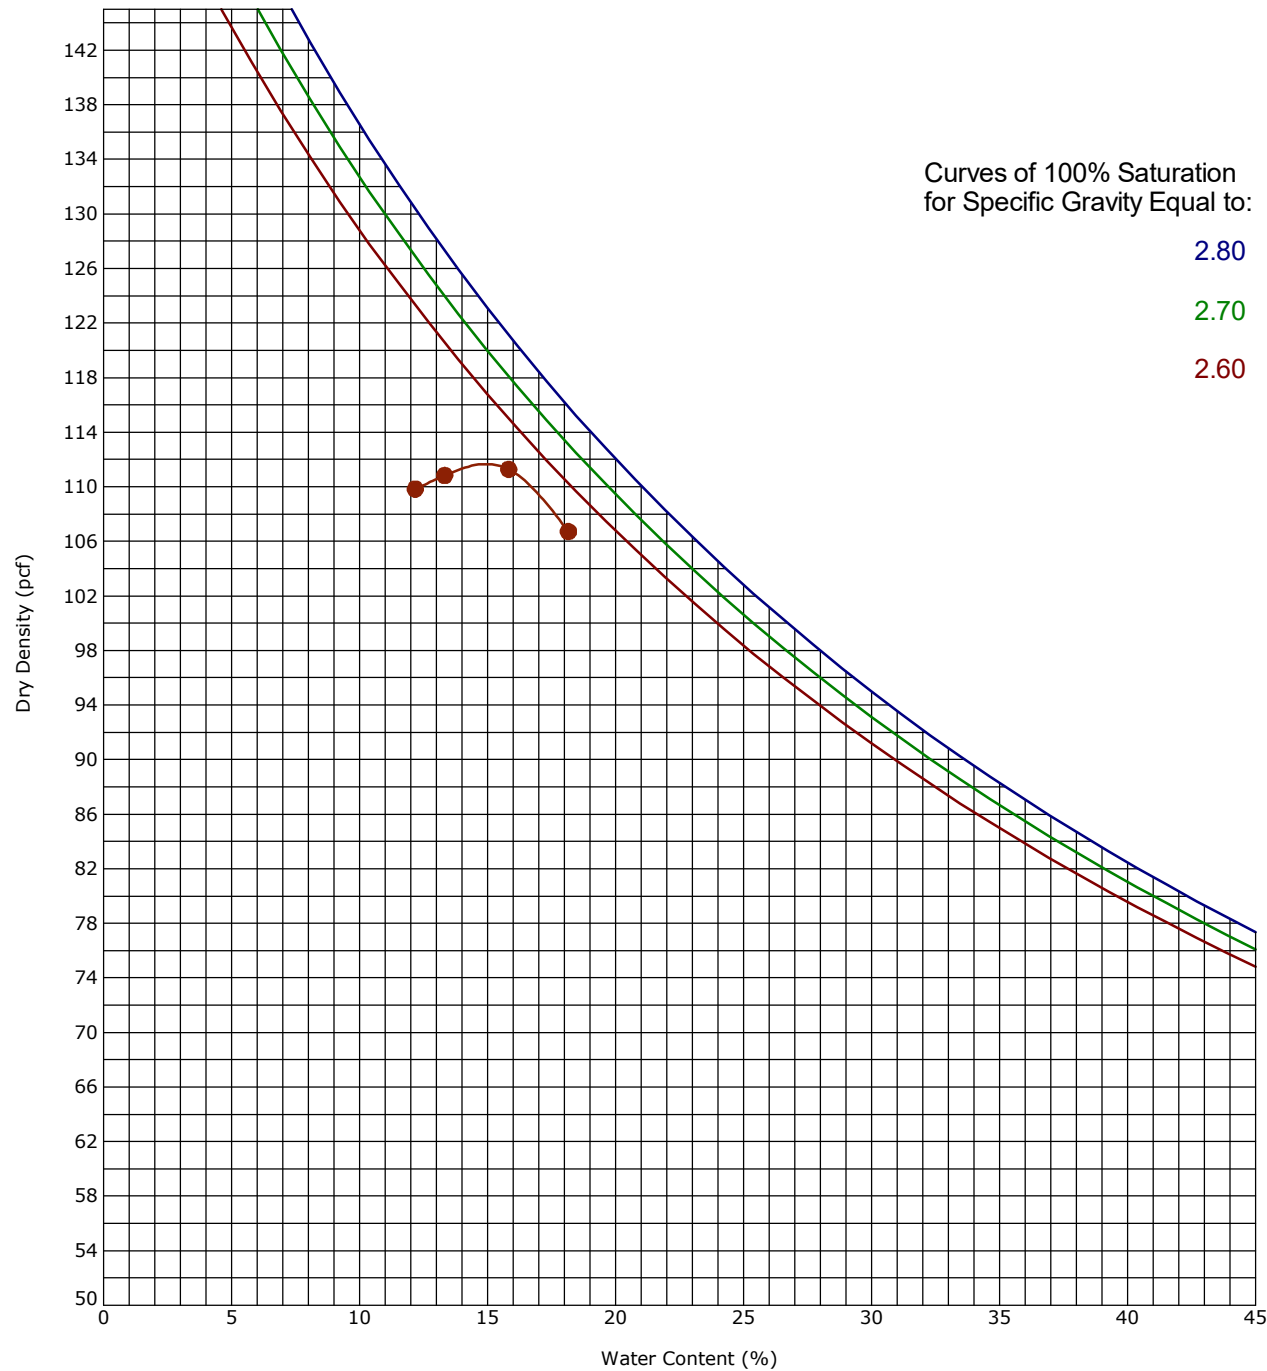
# Moisture-Density Relationship

Boring ID		Depth (Ft)		Description of Materials			
S-23-102-2 Offset		0 - 5		CLAYEY SAND(SC)			
Fines (%)	Fraction > mm size	LL	PL	PI	Test Method	Maximum Dry Density (pcf)	Optimum Water Content (%)
29	0.0	33	23	10	ASTM D698-Method B	111.7	14.9

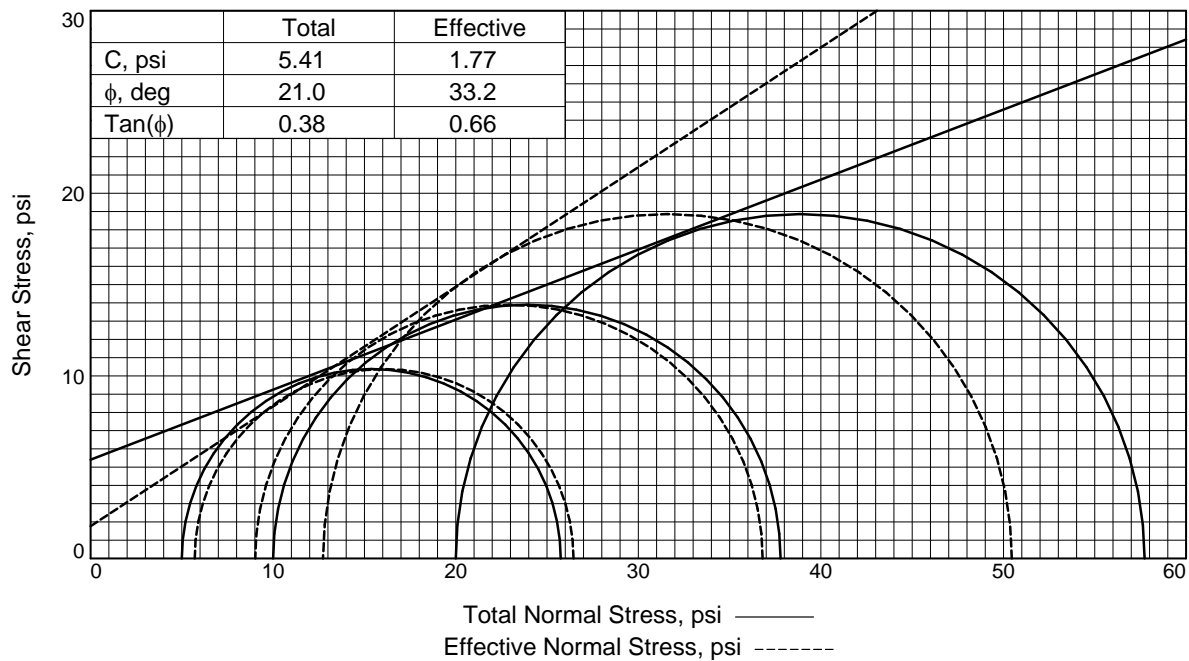
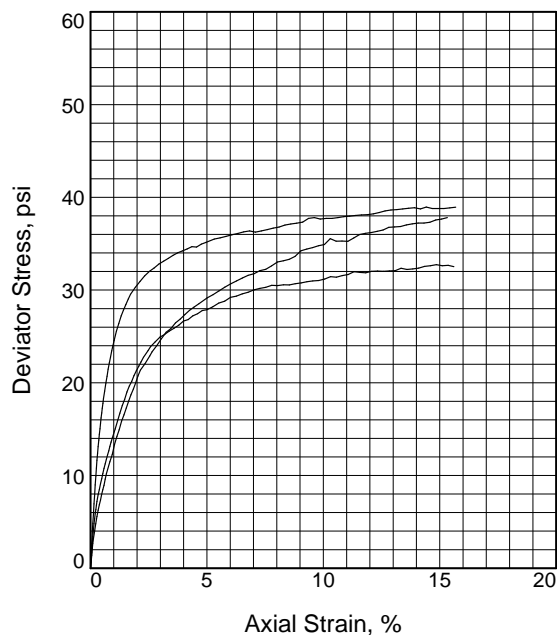
Sample No.		1	2	3
Initial	Water Content, %	15.0	14.8	15.2
	Dry Density, pcf	106.3	106.3	106.1
	Saturation, %	69.1	68.3	69.8
	Void Ratio	0.5853	0.5861	0.5880
	Diameter, in.	2.80	2.80	2.80
	Height, in.	5.62	5.62	5.62
At Test	Water Content, %	20.5	20.7	20.5
	Dry Density, pcf	108.6	108.2	108.5
	Saturation, %	100.0	100.0	100.0
	Void Ratio	0.5527	0.5576	0.5530
	Diameter, in.	2.78	2.78	2.78
	Height, in.	5.58	5.57	5.55
Strain rate, in./min.		0.001	0.001	0.001
Back Pressure, psi		50.0	50.0	50.0
Cell Pressure, psi		55.0	60.0	70.0
Fail. Stress, psi		20.7	27.8	37.7
Excess Pore Pr., psi		-0.7	1.0	7.3
Ult. Stress, psi		37.7	32.6	38.8
Excess Pore Pr., psi		-7.6	-2.1	5.5
$\bar{\sigma}_1$ Failure, psi		26.4	36.8	50.5
$\bar{\sigma}_3$ Failure, psi		5.7	9.0	12.7

Sample No.	Station	Offset (ft)	Sample Depth (ft)	USCS Soil Type	Compaction		Shear Strength <sup>1</sup>	
					Optimum Moisture (%)	Max Dry Density (pcf)	Total	Effective
S-23-102-2 Offset	788+32	22 R	0 – 5	SC	14.9	111.7	c=5.4 psi $\phi=21^{\circ}$	c'=1.8 psi $\phi'=33^{\circ}$

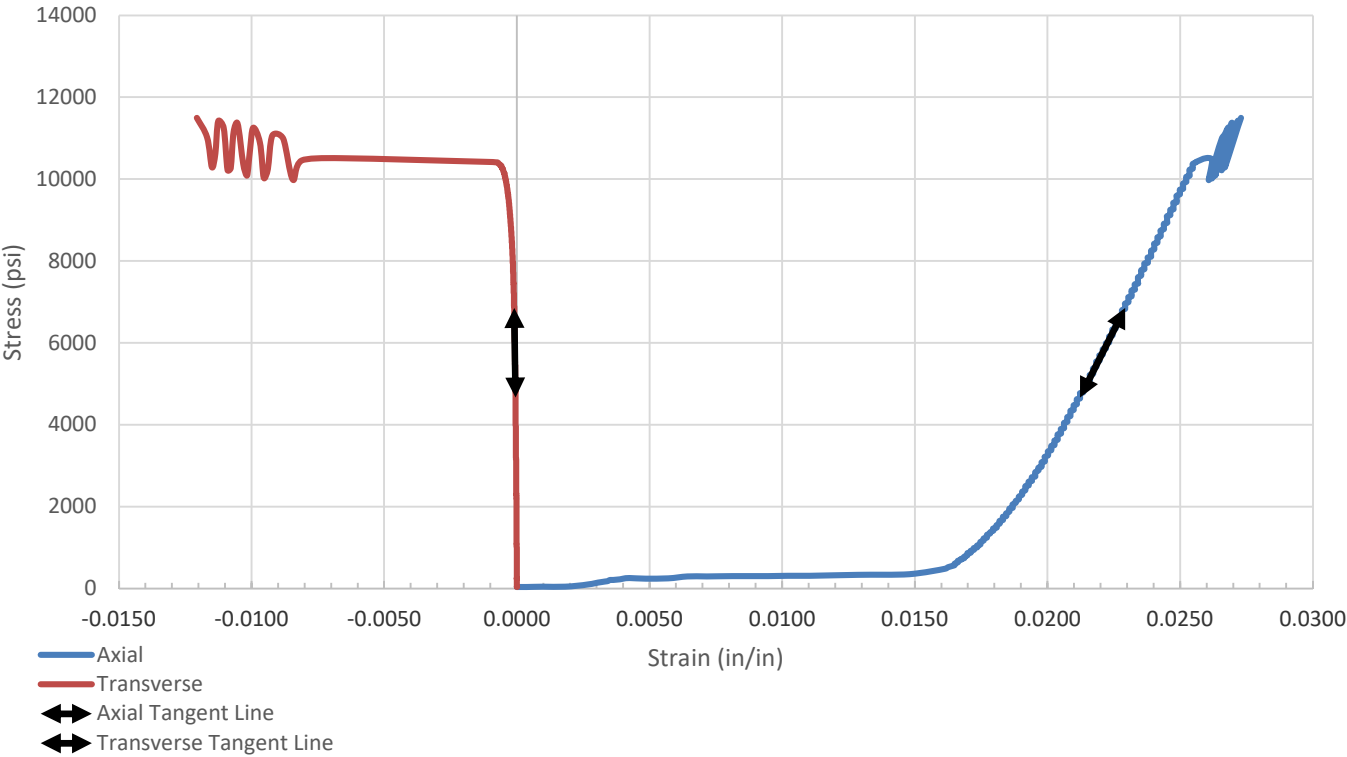
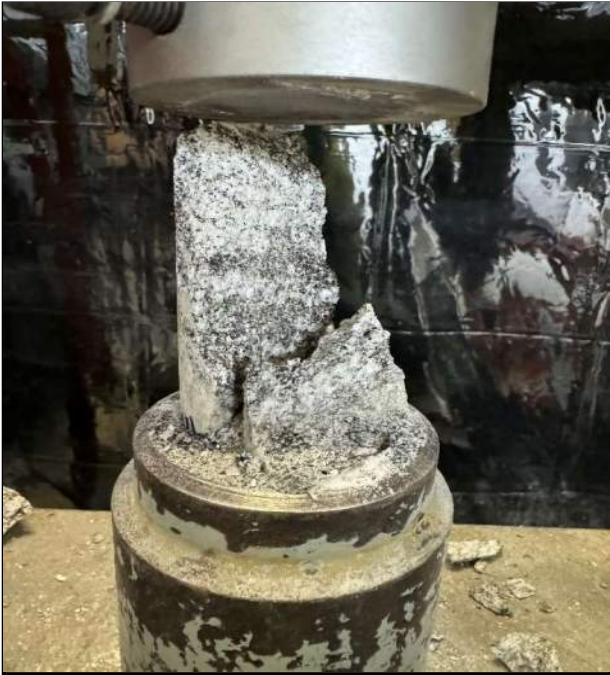
ASTM D7012 Stress/ Strain Curve

SAMPLE LOCATION			
Site:	S-23-102 (K eeler Mill Road)		
Description:	Gneiss		
Boring:	S-23-102-1	Depth (feet):	53.2-54.0
SPECIMEN INFORMATION			
Sample No.:	R1	Mass (g):	546.26
Length (in.):	4.13	Diameter (in.):	1.95
L/D Ratio:	2.12	Density (pcf):	168.72
TEST RESULTS			
Failure Load (lbs):		34337	
Failure Strain (%):		2.78	
Unconfined Compressive Strength (psi):		11,497	
Elastic Modulus, E, (ksi):		1290	
Poisson's Ratio, u:		0.029	
Time of Failure (min):		01:39	
Rate of Loading (psi/sec):		0.041	
Moisture Content Post-break:		0.008

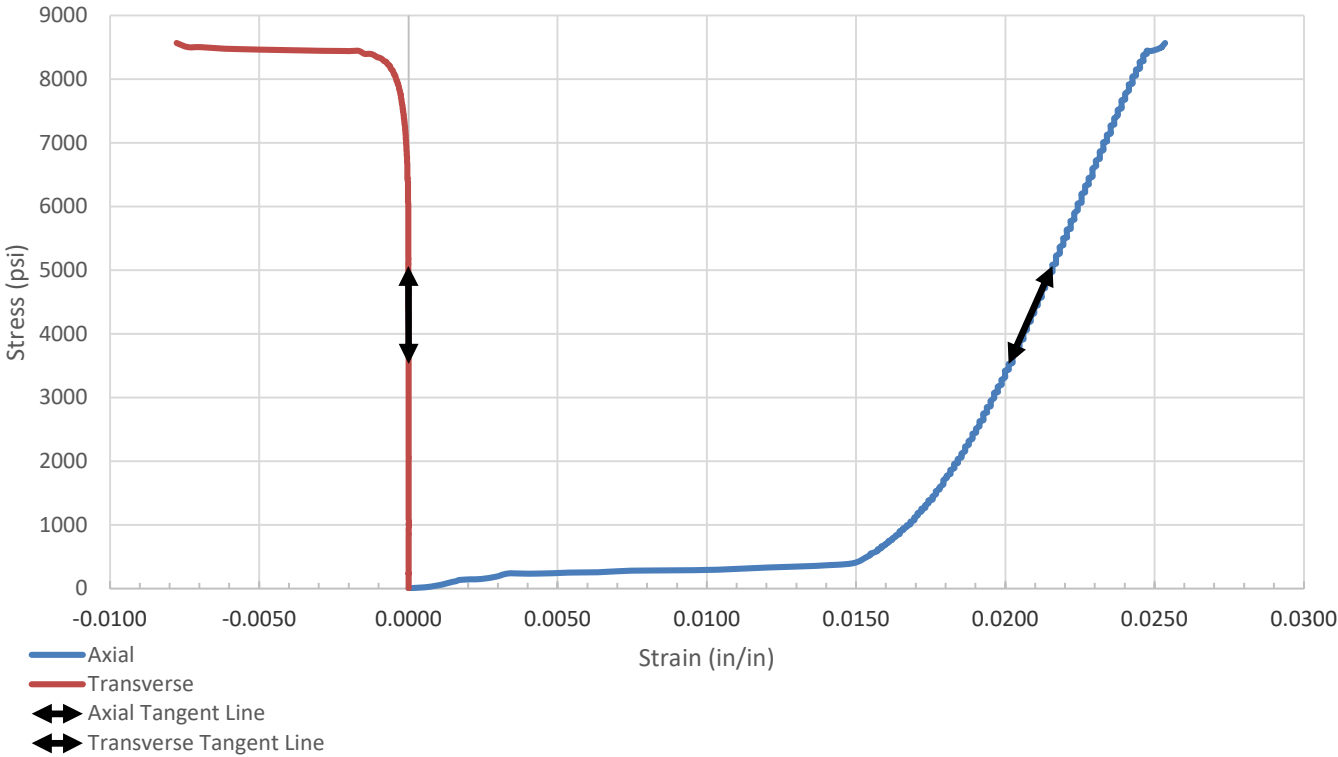
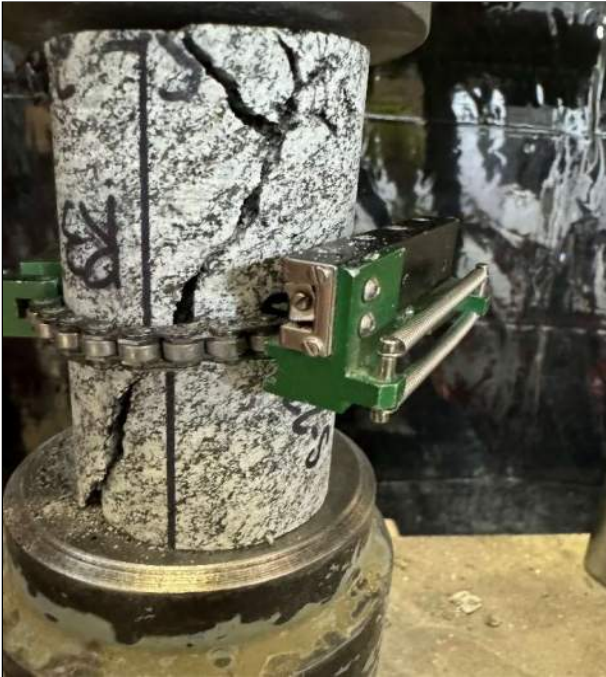
ASTM D7012 Stress/ Strain Curve

Site:	S-23-102 (K eeler Mill Road)		
Description:	Gneiss		
Boring:	S-23-102-1	Depth (feet):	62.7-64.0

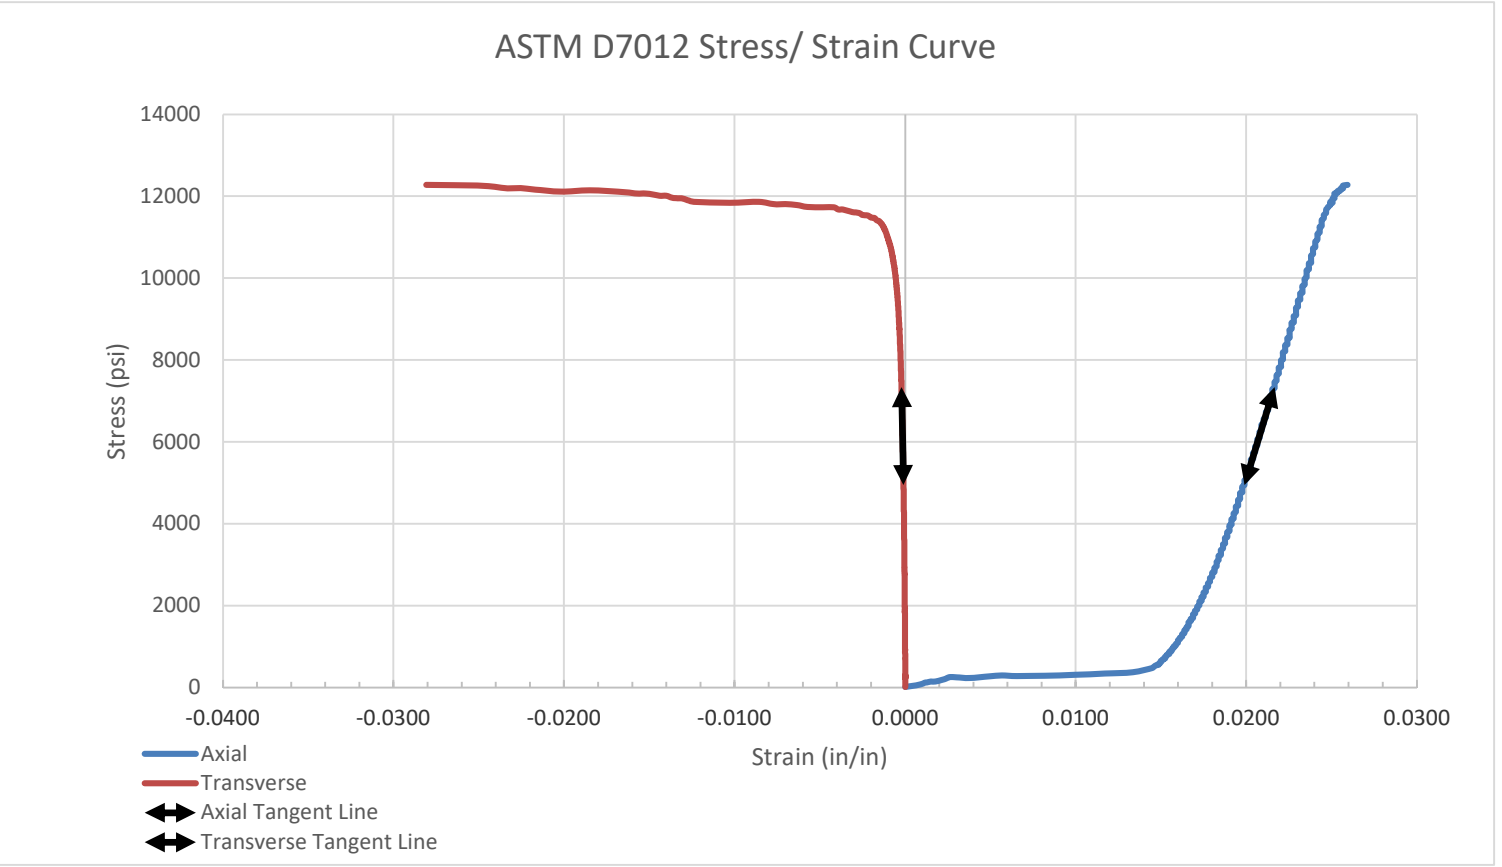
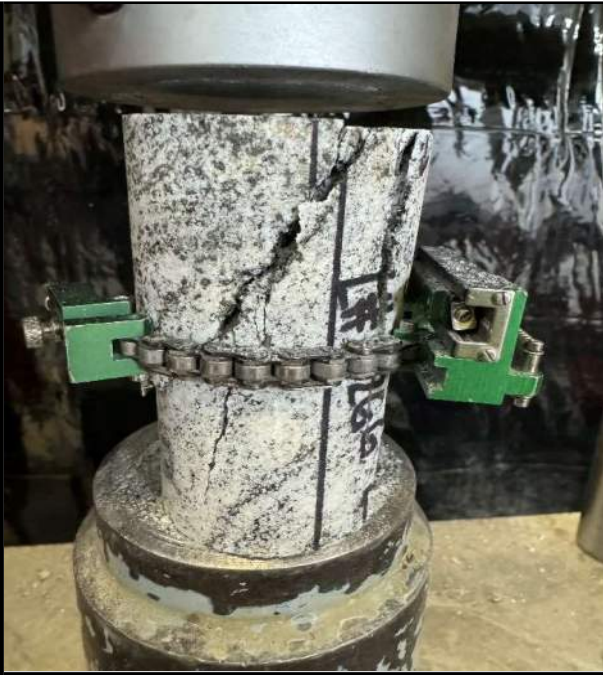
SAMPLE LOCATION			
Site:	S-23-102 (Keeler Mill Road)		
Description:	Granite		
Boring:	S-23-102-2	Depth (feet):	34.5-35.6
SPECIMEN INFORMATION			
Sample No.:	R1	Mass (g):	521.4
Length (in.):	3.98	Diameter (in.):	1.94
L/D Ratio:	2.05	Density (pcf):	168.84
TEST RESULTS			
Failure Load (lbs):		36302	
Failure Strain (%):		3.05	
Unconfined Compressive Strength (psi):		12,281	
Elastic Modulus, E, (ksi):		1358	
Poisson's Ratio, u:		0.066	
Time of Failure (min):		01:52	
Rate of Loading (psi/sec):		0.040	
Moisture Content Post-break:		0.0014
