# S-23-102 (Keeler Mill Road) Bridge Replacement over Armstrong Creek

### Geotechnical Baseline Report

October 30, 2024 | SCDOT Project ID: P041161  
Terracon Project No.: 8623P180 Revision 1

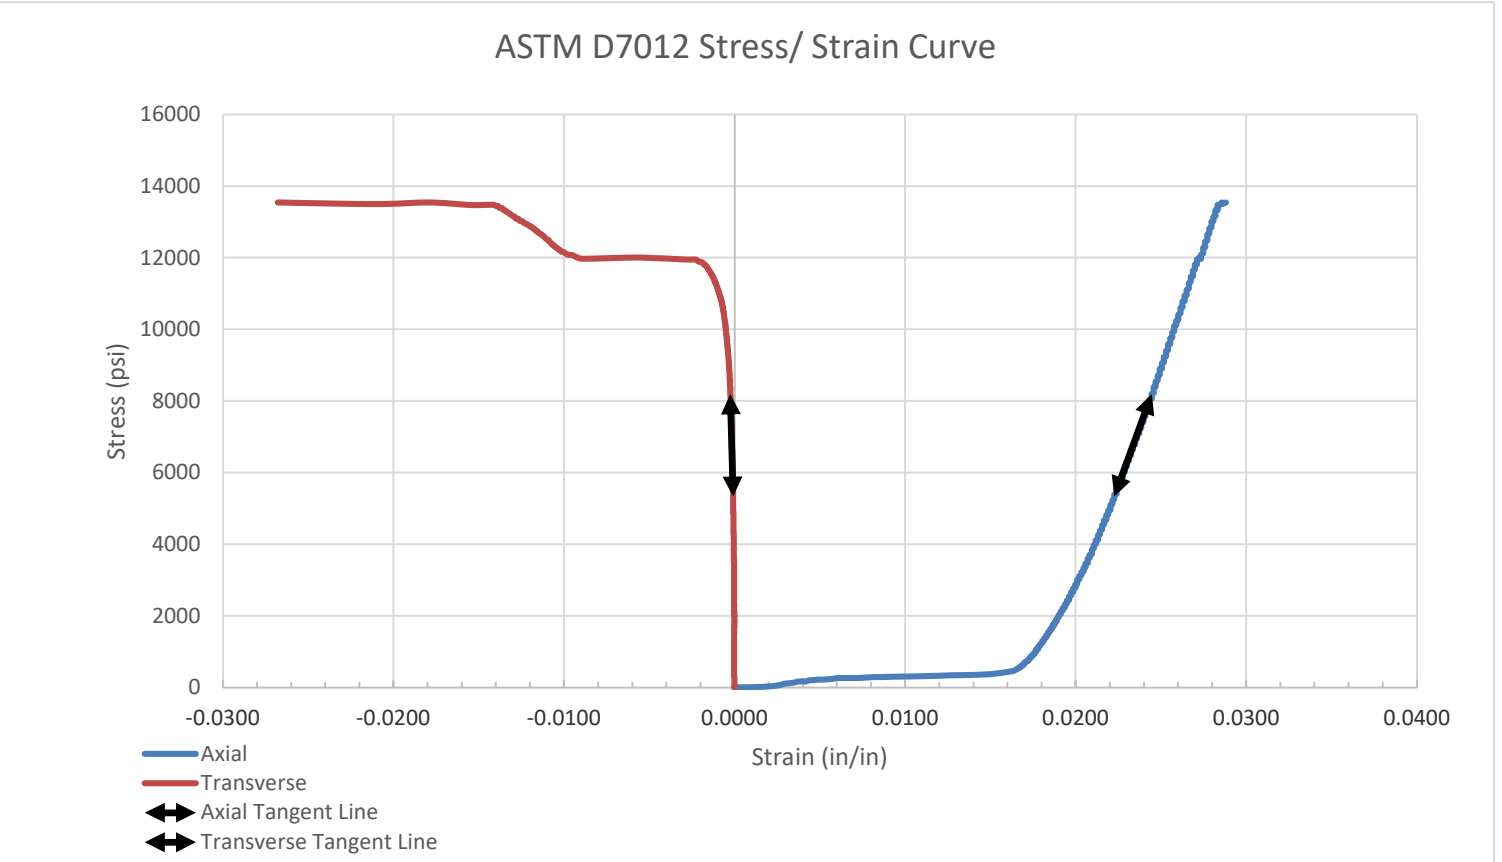
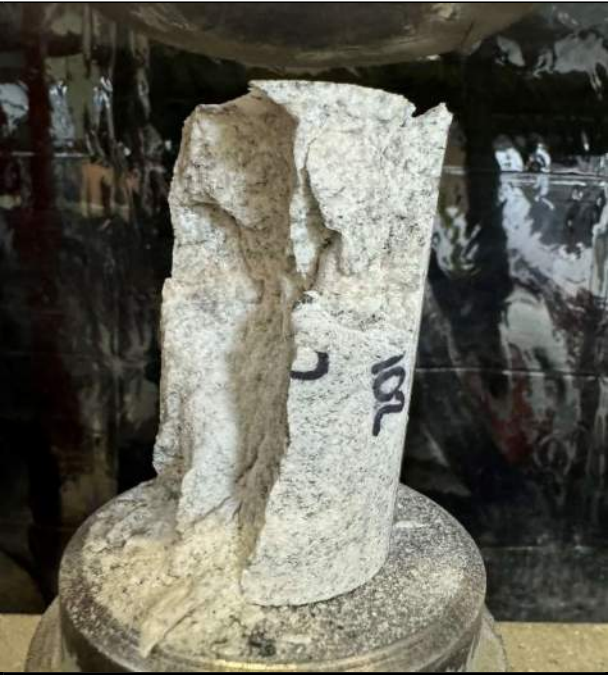
SAMPLE LOCATION			
Site:	S-23-102 (Keeler Mill Road)		
Description:	Gneiss		
Boring:	S-23-102-2	Depth (feet):	41.5-42.5
SPECIMEN INFORMATION			
Sample No.:	R2	Mass (g):	531.66
Length (in.):	4.14	Diameter (in.):	1.95
L/D Ratio:	2.12	Density (pcf):	163.81
TEST RESULTS			
Failure Load (lbs):		40457	
Failure Strain (%):		2.88	
Unconfined Compressive Strength (psi):		13,547	
Elastic Modulus, E, (ksi):		1310	
Poisson's Ratio, u:		0.072	
Time of Failure (min):		02:06	
Rate of Loading (psi/sec):		0.041	
Moisture Content Post-break:		0.0017

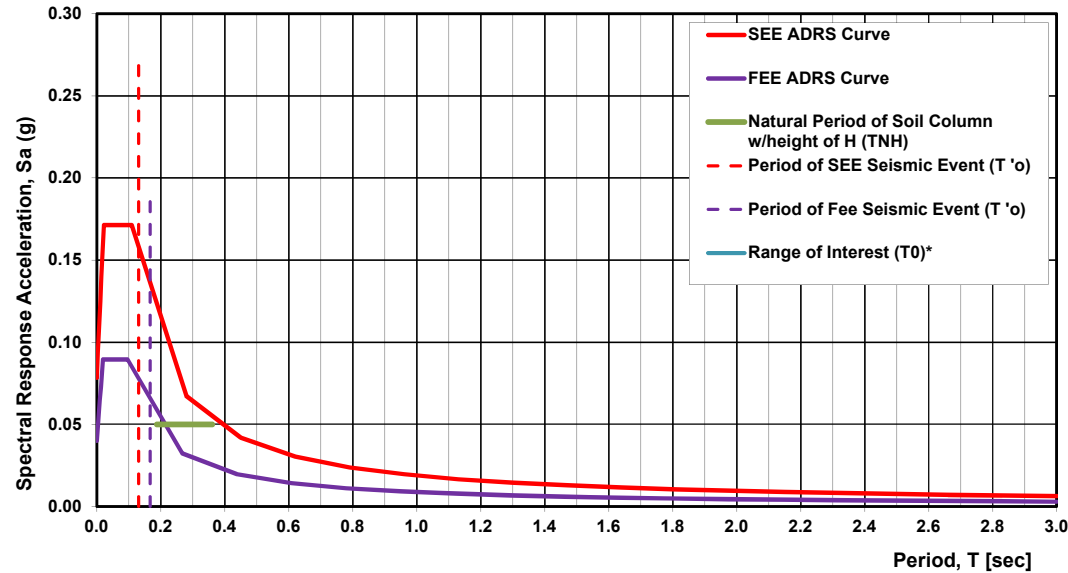
### SC Seismic ADRS Curve

T	S <sub>a</sub>
0.00	0.040
0.00	0.048
0.01	0.056
0.01	0.065
0.01	0.073
0.02	0.081
0.02	0.089
0.03	0.089
0.03	0.089
0.04	0.089
0.05	0.089
0.05	0.089
0.06	0.089
0.06	0.089
0.07	0.089
0.08	0.089
0.08	0.089
0.09	0.089
0.09	0.089
0.10	0.089
0.10	0.089
0.27	0.032
0.44	0.020
0.61	0.014
0.78	0.011
0.95	0.009
1.12	0.008
1.29	0.007
1.46	0.006
1.63	0.005
1.80	0.005
1.98	0.004
2.15	0.004
2.32	0.004
2.49	0.003
2.66	0.003
2.83	0.003
3.00	0.003

SCDOT provided "3-Point Acceleration Design Response Spectrum" curves along with a table that included pseudo-spectral accelerations (PSA) for 5% critical damping and at selected frequencies, consistent with a Geologically Realistic (B-C Boundary) condition (shear wave velocity,  $V_s = 2,500$  feet per second). PSA values were provided for the:

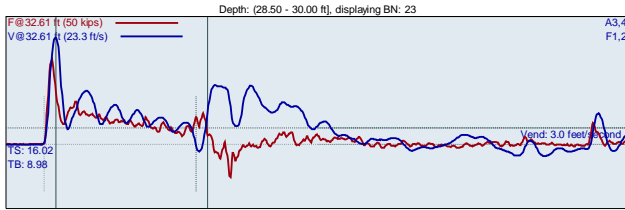
GP554-3126 28.5/30  
JIM SMITH Interval start: 8/21/2023  
TB-1  
AR: 1.20 in/2 SP: 0.492 k/ft3  
LE: 32.61 ft EM: 30000 ksi  
WS: 16807.9 fts

F1 : [648AWJ1] 226.21 PDICAL (1) FF1 A3 (PR): [K4483] 410.187 mv/6.4v/5000g (1) VF1  
F2 : [648AWJ2] 225.58 PDICAL (1) FF1 A4 (PR): [K10491] 421.907 mv/6.4v/5000g (1) VF1

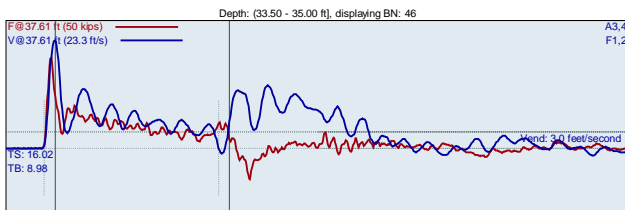
GP554-3126 28.5/30  
JIM SMITH Interval start: 8/21/2023  
TB-1  
AR: 1.20 in/2 SP: 0.492 k/ft3  
LE: 37.61 ft EM: 30000 ksi  
WS: 16807.9 fts

BL#	BC /6"	FMX kips	VMX ft/s	BPM bpm	EFV ft-lb	ETR %
26	5	38	19.1	1.9	302	86.4
27	5	35	18.9	52.0	301	86.1
28	5	29	18.8	52.0	299	85.5
29	5	35	19.2	52.7	299	85.5
30	5	37	19.4	52.5	297	84.8
31	8	37	19.5	52.4	307	87.7
32	8	26	16.4	52.7	282	80.5
33	8	34	19.5	52.4	307	87.6
34	8	40	19.1	52.2	307	87.6
35	8	37	19.4	52.6	299	85.5
36	8	40	20.6	52.4	321	91.7
37	8	41	19.6	52.8	308	87.9
38	8	40	19.8	52.7	313	89.5
39	10	34	20.2	52.2	323	92.2
40	10	32	19.4	52.8	297	84.9
41	10	36	19.8	52.6	311	88.8
42	10	37	19.7	52.5	317	90.7
43	10	35	20.0	52.6	324	92.6
44	10	38	19.5	52.7	308	88.1
45	10	34	20.1	52.4	322	92.0
46	10	35	19.7	52.4	322	92.0
47	10	37	19.9	52.6	314	89.7
48	10	37	19.8	52.7	332	94.8
Average		36	19.6	52.6	312	89.1
Std Dev		3	0.8	0.2	12	3.3
Maximum		41	20.6	52.8	332	94.8
Minimum		26	16.4	52.2	282	80.5
N-value: 18

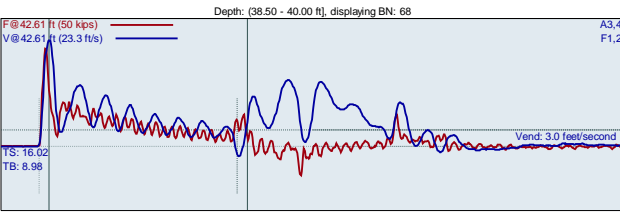
GP554-3126 28.5-30  
JIM SMITH Interval start: 8/21/2023  
TB-1  
AR: 1.20 in/2 SP: 0.492 k/ft3  
LE: 42.61 ft EM: 30000 ksi  
WS: 16807.9 ft/s

F1 : [648AWJ1] 226.21 PDICAL (1) FF1		A3 (PR): [K4483] 410.187 mm/6.4v/5000g (1) VF1				
F2 : [648AWJ2] 225.58 PDICAL (1) FF1		A4 (PR): [K10491] 421.907 mm/6.4v/5000g (1) VF1				
BL#	BC /6"	FMX kips	VMX ft/s	BPM bpm	EFV ft-lb	ETR %
49	5	34	19.6	1.9	307	87.6
50	5	34	19.3	52.0	301	86.1
51	5	27	16.5	52.7	278	79.4
52	5	33	19.9	52.5	310	88.6
53	5	29	17.7	52.7	288	82.2
54	8	29	18.6	52.5	295	84.2
55	8	23	15.6	52.9	287	82.0
56	8	34	20.1	52.6	323	92.2
57	8	28	18.1	52.8	295	84.3
58	8	38	18.8	53.1	312	89.1
59	8	35	19.2	52.6	329	94.0
60	8	36	19.3	52.9	327	93.3
61	8	40	19.7	52.8	323	92.4
62	9	35	18.8	53.0	320	91.3
63	9	37	19.1	52.7	320	91.3
64	9	35	19.9	52.9	327	93.4
65	9	29	18.8	52.7	314	89.7
66	9	35	19.7	53.0	342	97.8
67	9	36	19.9	52.8	331	94.5
68	9	38	19.3	52.8	335	95.8
69	9	36	19.9	52.5	325	92.9
70	9	39	19.5	52.9	329	94.0
Average		34	19.1	52.8	320	91.3
Std Dev		4	1.0	0.2	15	4.1
Maximum		40	20.1	53.1	342	97.8
Minimum		23	15.6	52.5	287	82.0

N-value: 17

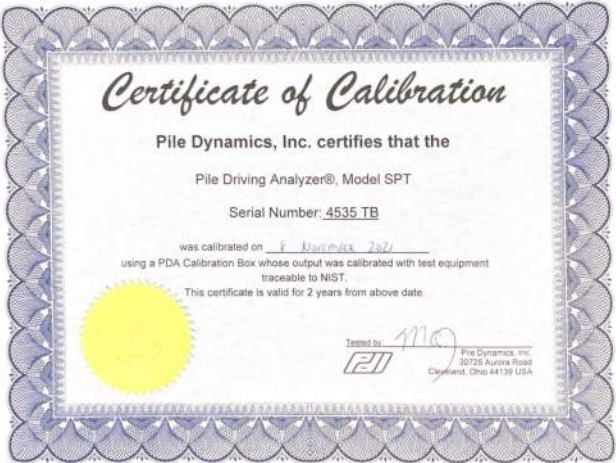
PDA Equipment Calibration

648AWJ		Cycle 1		
Sample	Force (lb)	Strain (µE)	Bridge 1 (V)	Bridge 2 (V)
1	0.00	0.00	0.00	0.00
2	799.99	21.12	0.10	0.10
3	2111.63	58.22	0.26	0.26
4	2997.39	82.70	0.37	0.37
5	3848.07	106.26	0.47	0.47
6	5131.83	143.07	0.63	0.63
7	6017.79	167.81	0.74	0.75
8	6872.07	192.74	0.85	0.85
9	7783.57	218.15	0.96	0.96
10	9136.93	255.02	1.12	1.13
11	10026.70	280.73	1.24	1.24

Bridge 1		Bridge 2	
Force Calibration (lb/V)	8120.30	Force Calibration (lb/V)	8089.75
Offset	-4.24	Offset	-2.24
Correlation	0.999998	Correlation	0.999995
Strain Calibration (µE/V)	228.56	Strain Calibration (µE/V)	227.70
Offset	-1.57	Offset	-1.51
Correlation	0.999991	Correlation	0.999983

Force Strain Calibration	
EA (Kips)	35527.98
Offset	51.69
Correlation	0.999986
