S-23-41 (Gap Creek Road) Bridge Replacement over Middle Saluda River

Geotechnical Baseline Report

October 30, 2024 | SCDOT Project ID: P041159
Terracon Project No.: 8623P180 Revision 1

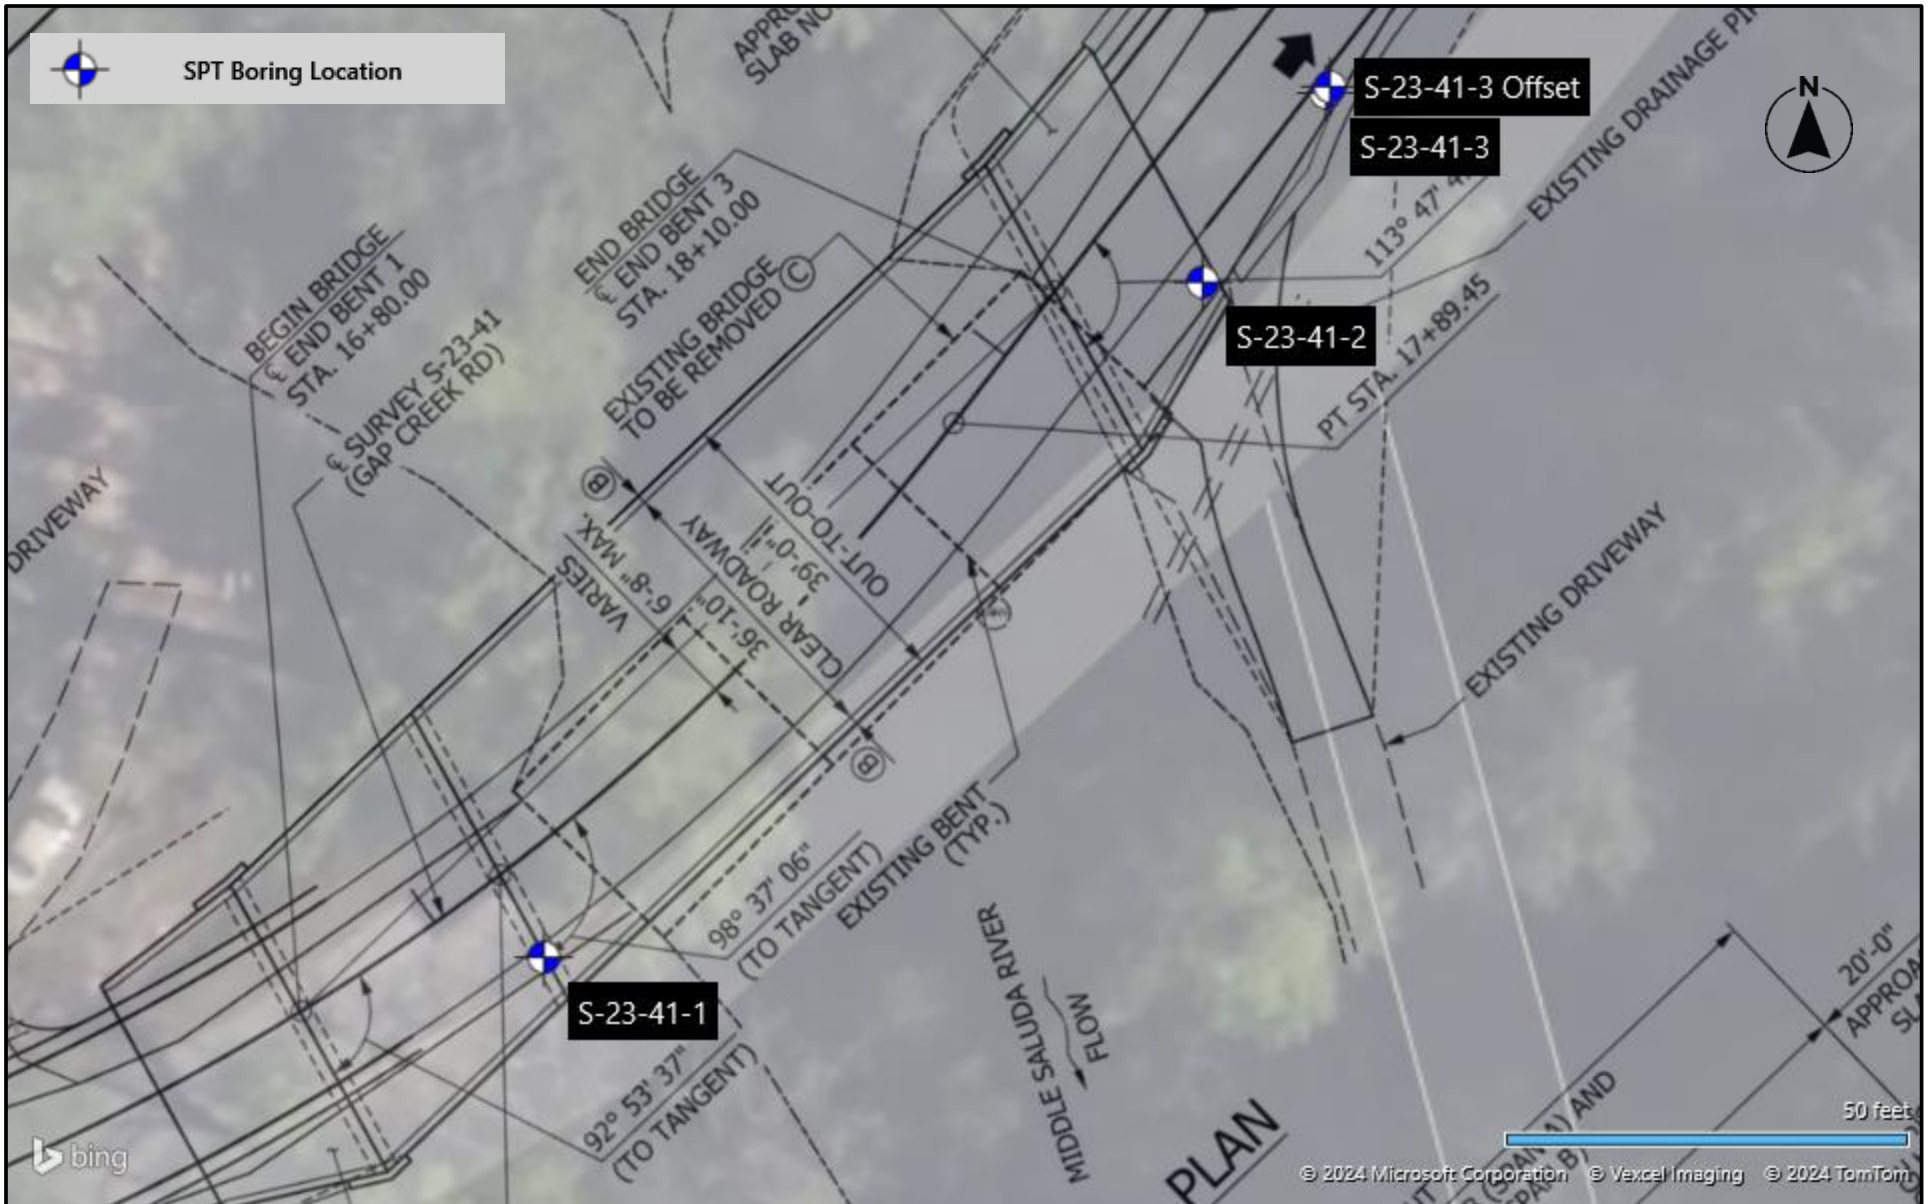
A-2

PRELIMINARY SITE PLAN PROVIDED BY HNTB

The project site is located at the S-23-41 (Gap Creek Road) crossing over Middle Saluda River in Greenville County, South Carolina. Site location and exploration plans are presented in

The tests were performed at the approximate locations as approved by SCDOT. A description of our testing methods and graphical logs outlining the soil conditions at each test location are presented in Appendix A. The test locations were established in the field by Terracon and surveyed by Thomas & Hutton after completion. Station and offset are based on the plans provided at the time the tests were performed.

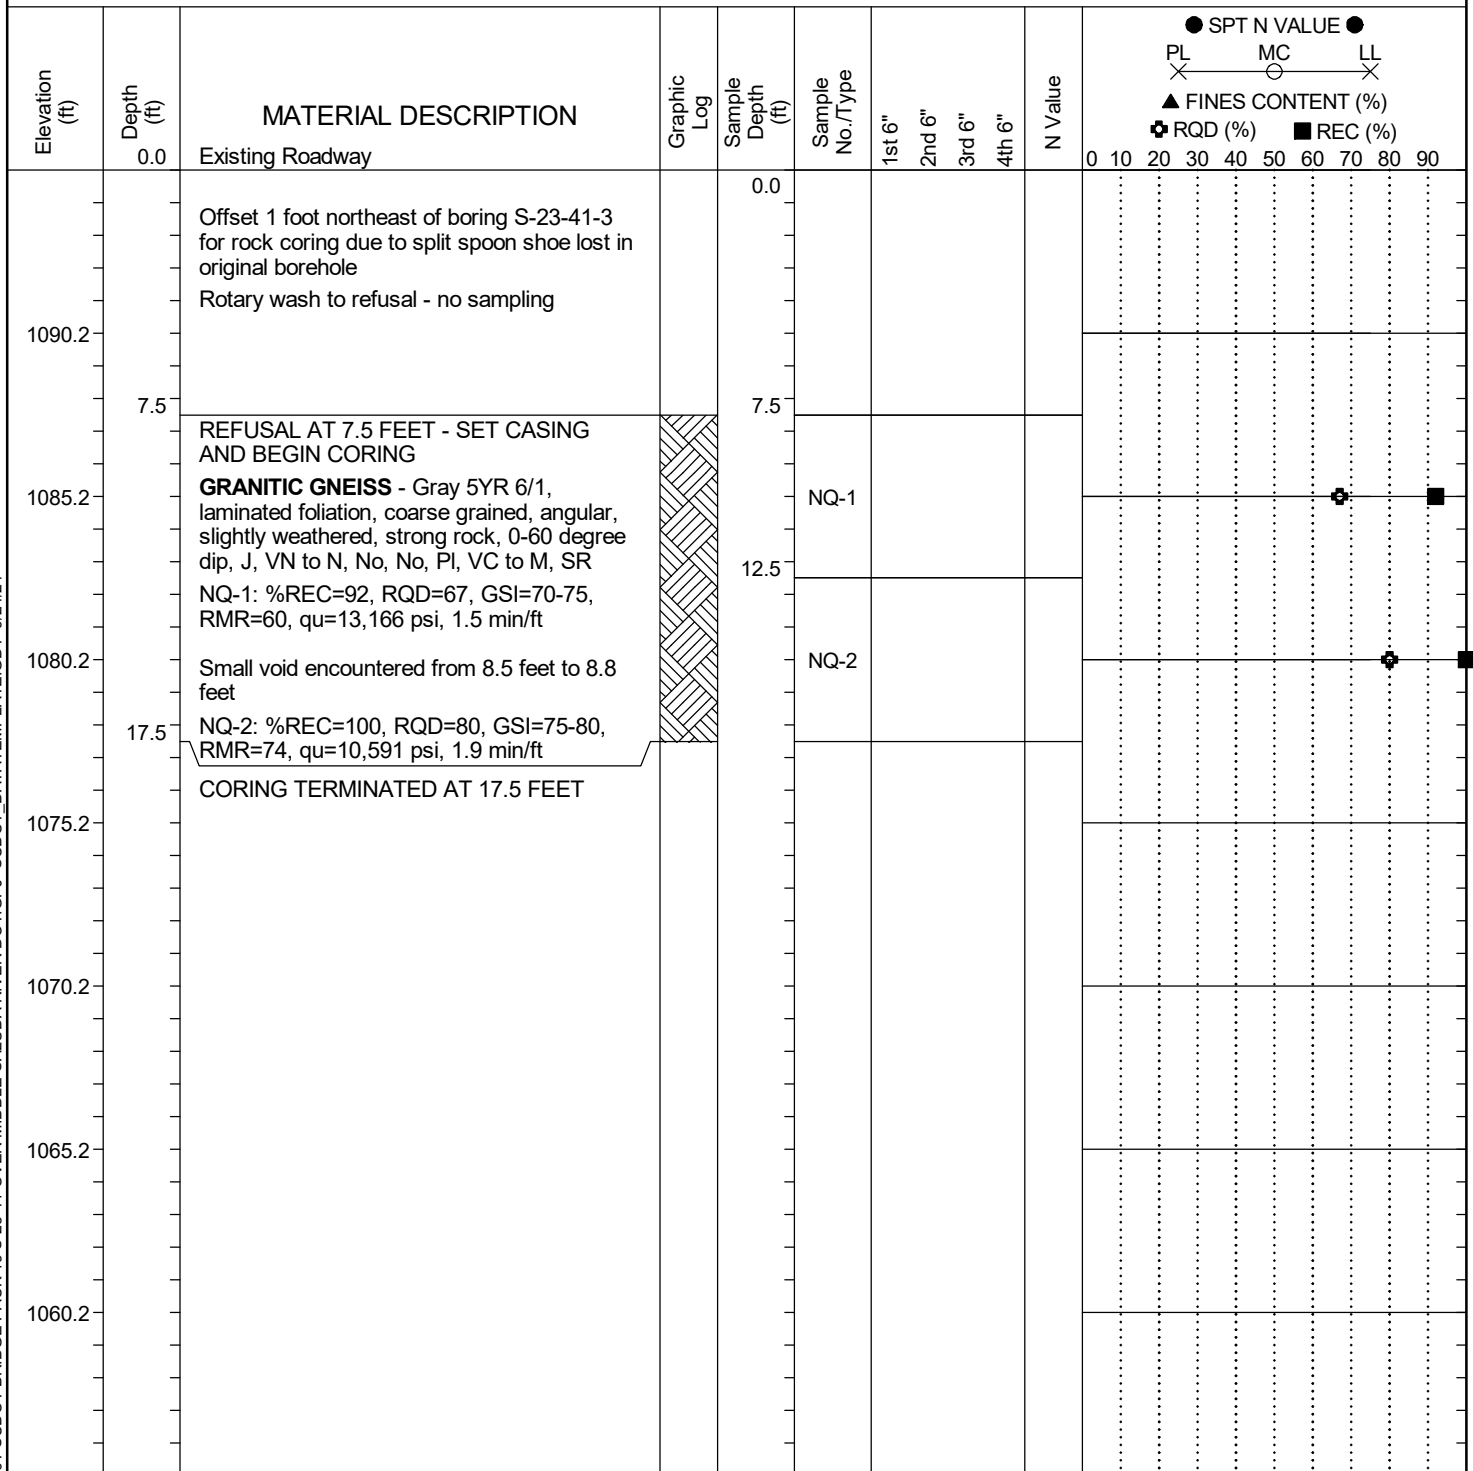
Project ID:	P041159	County:	Greenville	Boring No.:	S-23-41-3 Offset
Site Description:	S-23-41 BRO Middle Saluda River			Route:	S-23-41
Eng./Geo.:	S. Greaber	Boring Location:	18+56	Offset:	11 R
Elev.:	1095.2 ft	Latitude:	35.12058	Longitude:	-82.53738
Date Started:	8/27/2024				
Total Depth:	17.5 ft	Soil Depth:	7.5 ft	Core Depth:	10 ft
Date Completed:	8/27/2024				
Bore Hole Diameter (in):	4	Sampler Configuration	Liner Required: Y (N)		Liner Used: Y (N)
Drill Machine:	DR#554	Drill Method:	RW/RC	Hammer Type:	Automatic
Energy Ratio:	88.5%				
Core Size:	NQ2	Driller:	G. Robinson	Groundwater:	TOB N.M.
24HR	N.M.

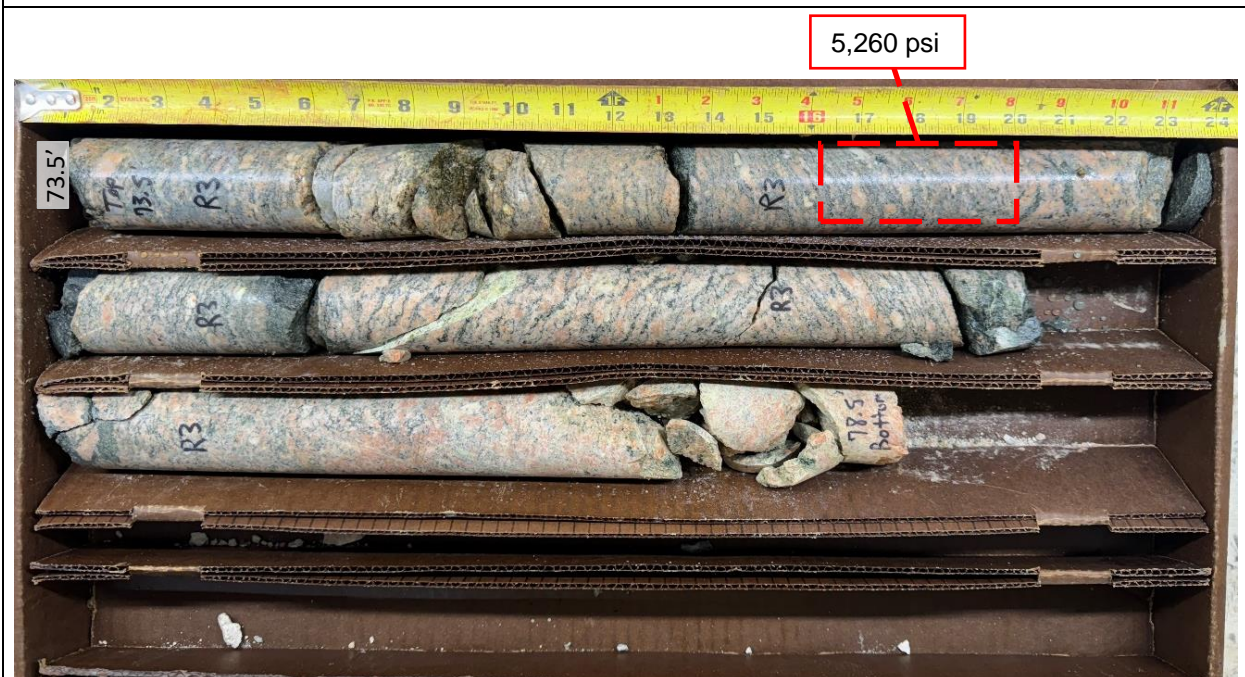
S-23-41-1, NQ-3 (73.5 to 78.5 feet)

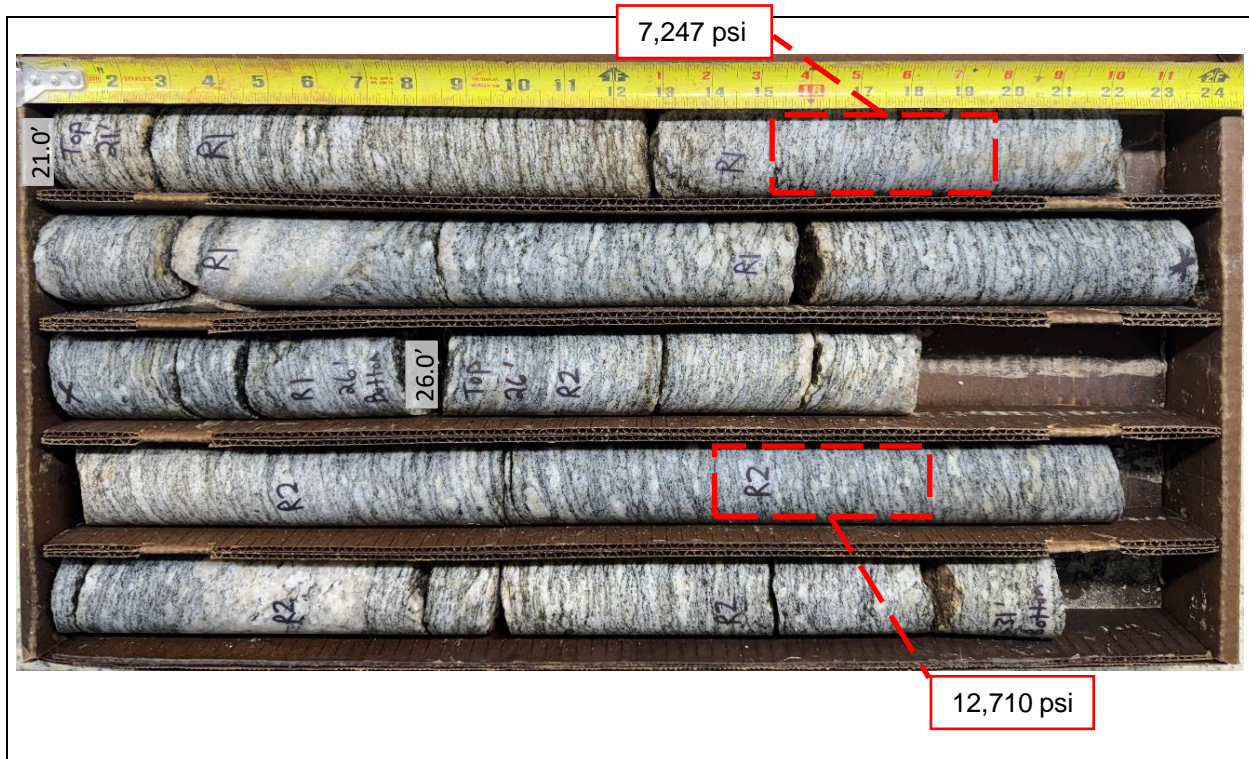
S-23-41-2, NQ-1 and NQ-2 (21 to 31 feet)

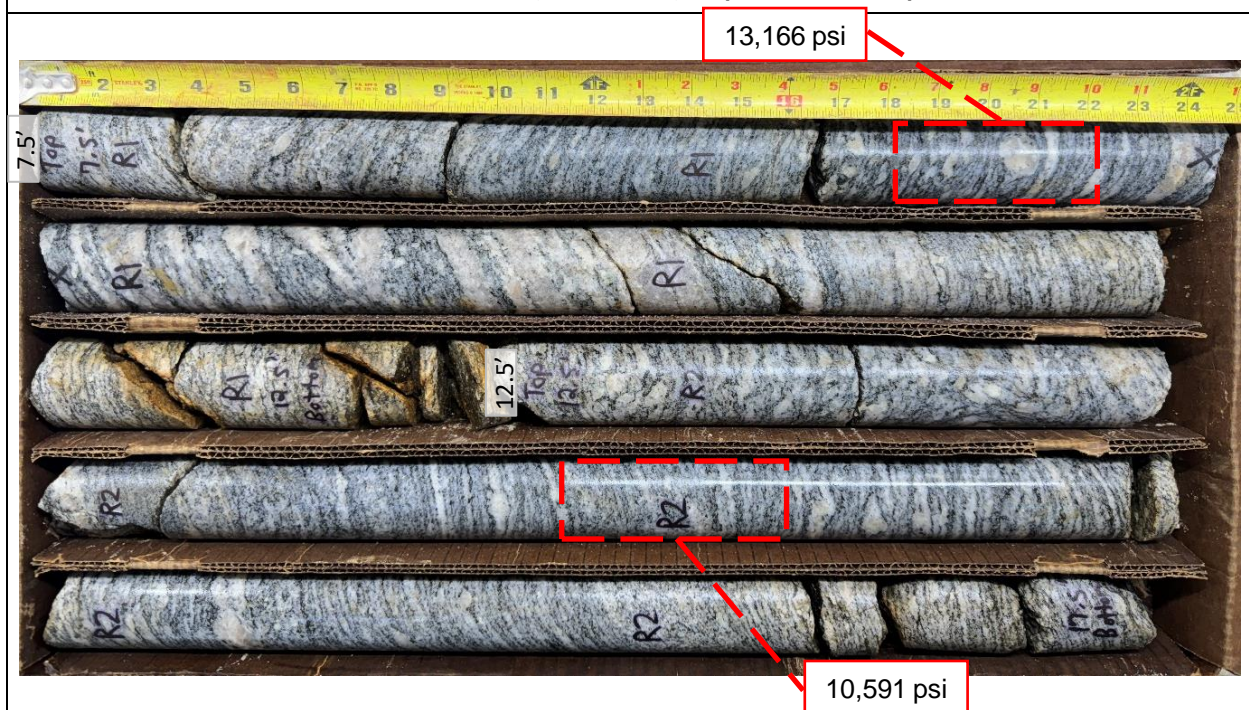
S-23-41-3, NQ-1 and NQ-2 (7.5 to 17.5 feet)

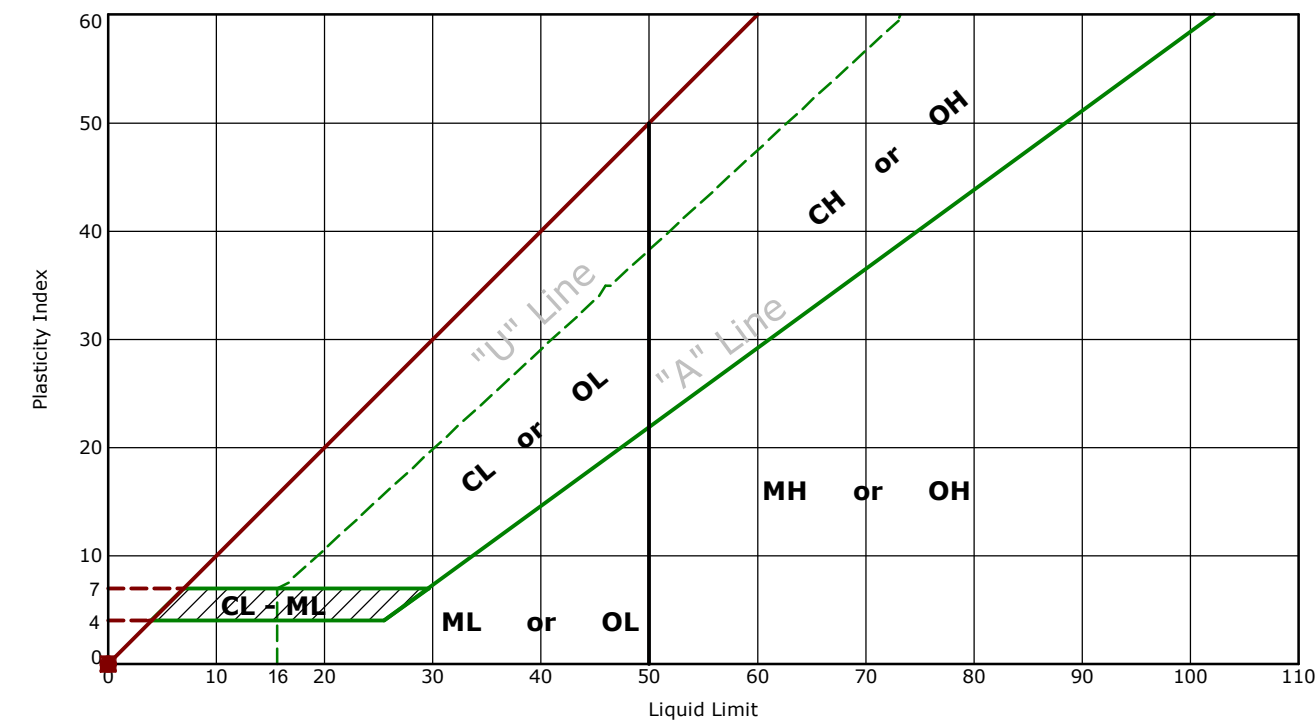
ASTM D4318

Boring ID	Depth (Ft)	LL	PL	PI	Fines	AASHTO	Description
●	S-23-41-1	0.5 - 2	NP	NP	NP		A-2-4 (0)	SILTY SAND
⊠	S-23-41-1	4 - 6	NP	NP	NP	26.0	A-2-4 (0)	SILTY SAND
▲	S-23-41-1	23.5 - 25	NP	NP	NP	22.0	A-2-4 (0)	SILTY SAND
★	S-23-41-1 Offset	0 - 5	NP	NP	NP	25.8	A-2-4 (0)	SILTY SAND

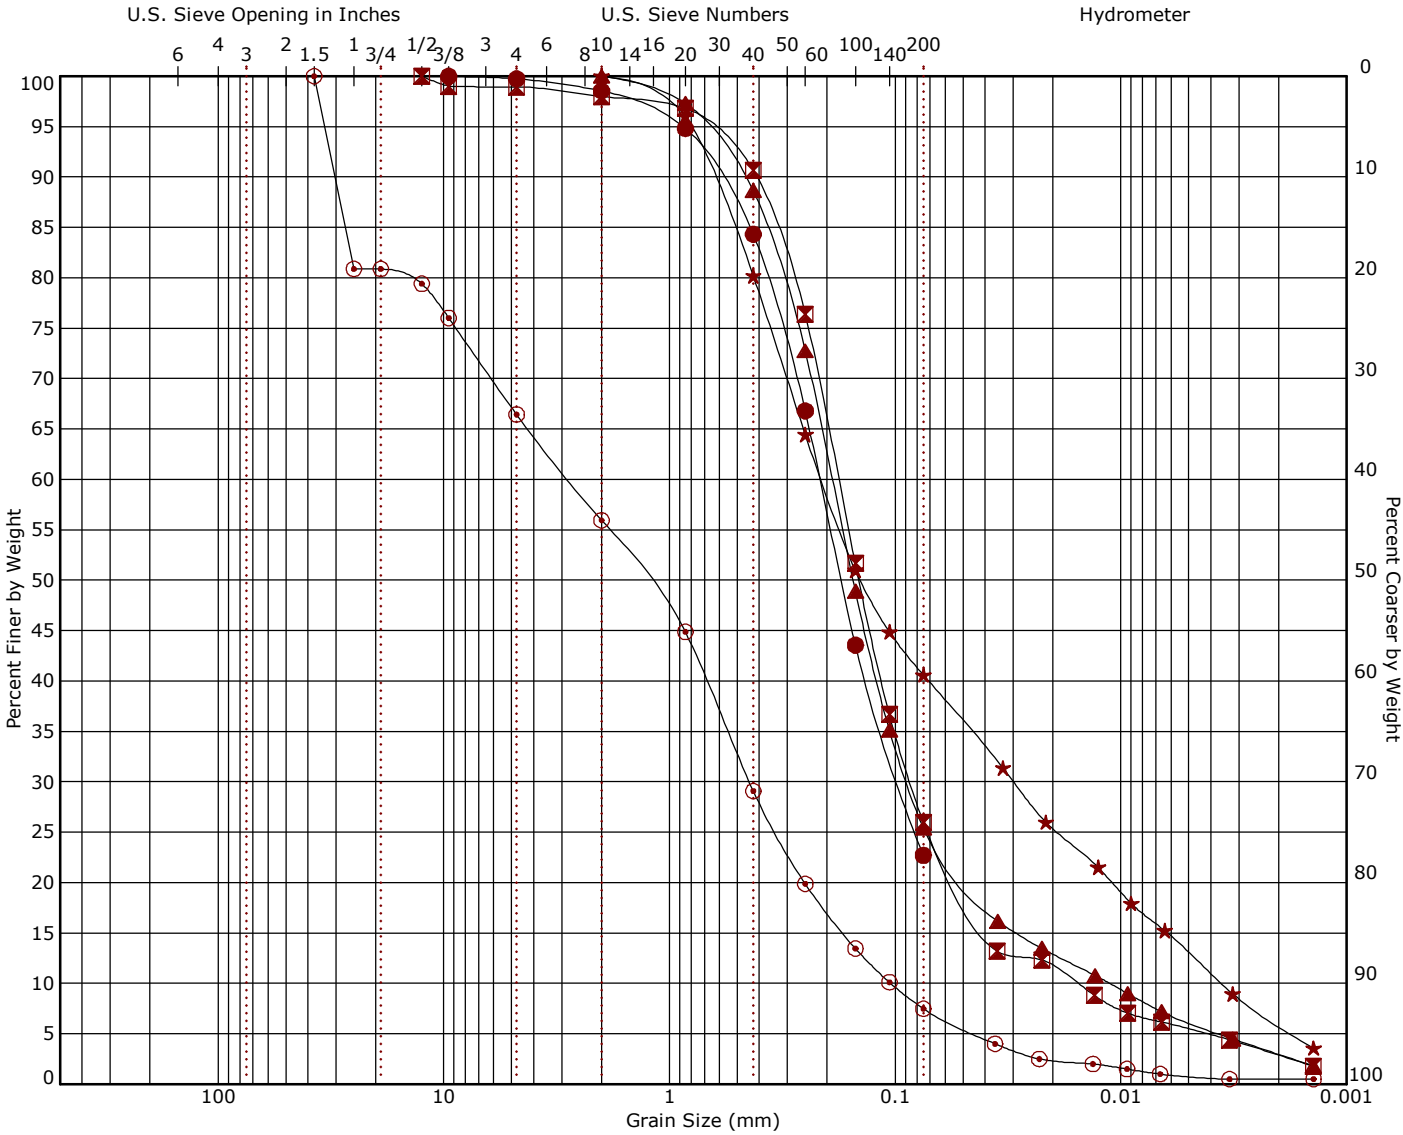
Grain Size Distribution
ASTM D422 / ASTM C136

Cobbles		Gravel		Sand			Silt or Clay				
		coarse	fine	coarse	medium	fine					
Boring ID	Depth (Ft)	USCS Classification			USCS	AASHTO	LL	PL	PI	Cc	Cu
● S-23-41-1	2 - 4	SILTY SAND			SM	A-2-4 (0)					
☒ S-23-41-1	4 - 6	SILTY SAND			SM	A-2-4 (0)	NP	NP	NP	2.60	11.34
▲ S-23-41-1	6 - 8	SILTY SAND			SM	A-2-4 (0)				3.65	16.91
★ S-23-41-1	8 - 10	SILTY SAND			SM	A-4 (0)				1.17	58.86
⊙ S-23-41-1	13.5 - 15	POORLY GRADED SAND with SILT and GRAVEL			SP-SM	A-1-b (0)				0.67	26.75
Boring ID	Depth (Ft)	D ₁₀₀	D ₆₀	D ₃₀	D ₁₀	%Cobbles	%Gravel	%Sand	%Fines	%Silt	%Clay
● S-23-41-1	2 - 4	9.5	0.215	0.096		0.0	0.3	77.0	22.7		
☒ S-23-41-1	4 - 6	12.5	0.178	0.085	0.016	0.0	1.1	72.9		20.5	5.5
▲ S-23-41-1	6 - 8	2	0.19	0.088	0.011	0.0	0.0	74.6		19.3	6.2
★ S-23-41-1	8 - 10	2	0.211	0.03	0.004	0.0	0.0	59.4		27.6	13.0
⊙ S-23-41-1	13.5 - 15	37.5	2.793	0.442	0.104	0.0	33.6	59.0		6.7	0.8

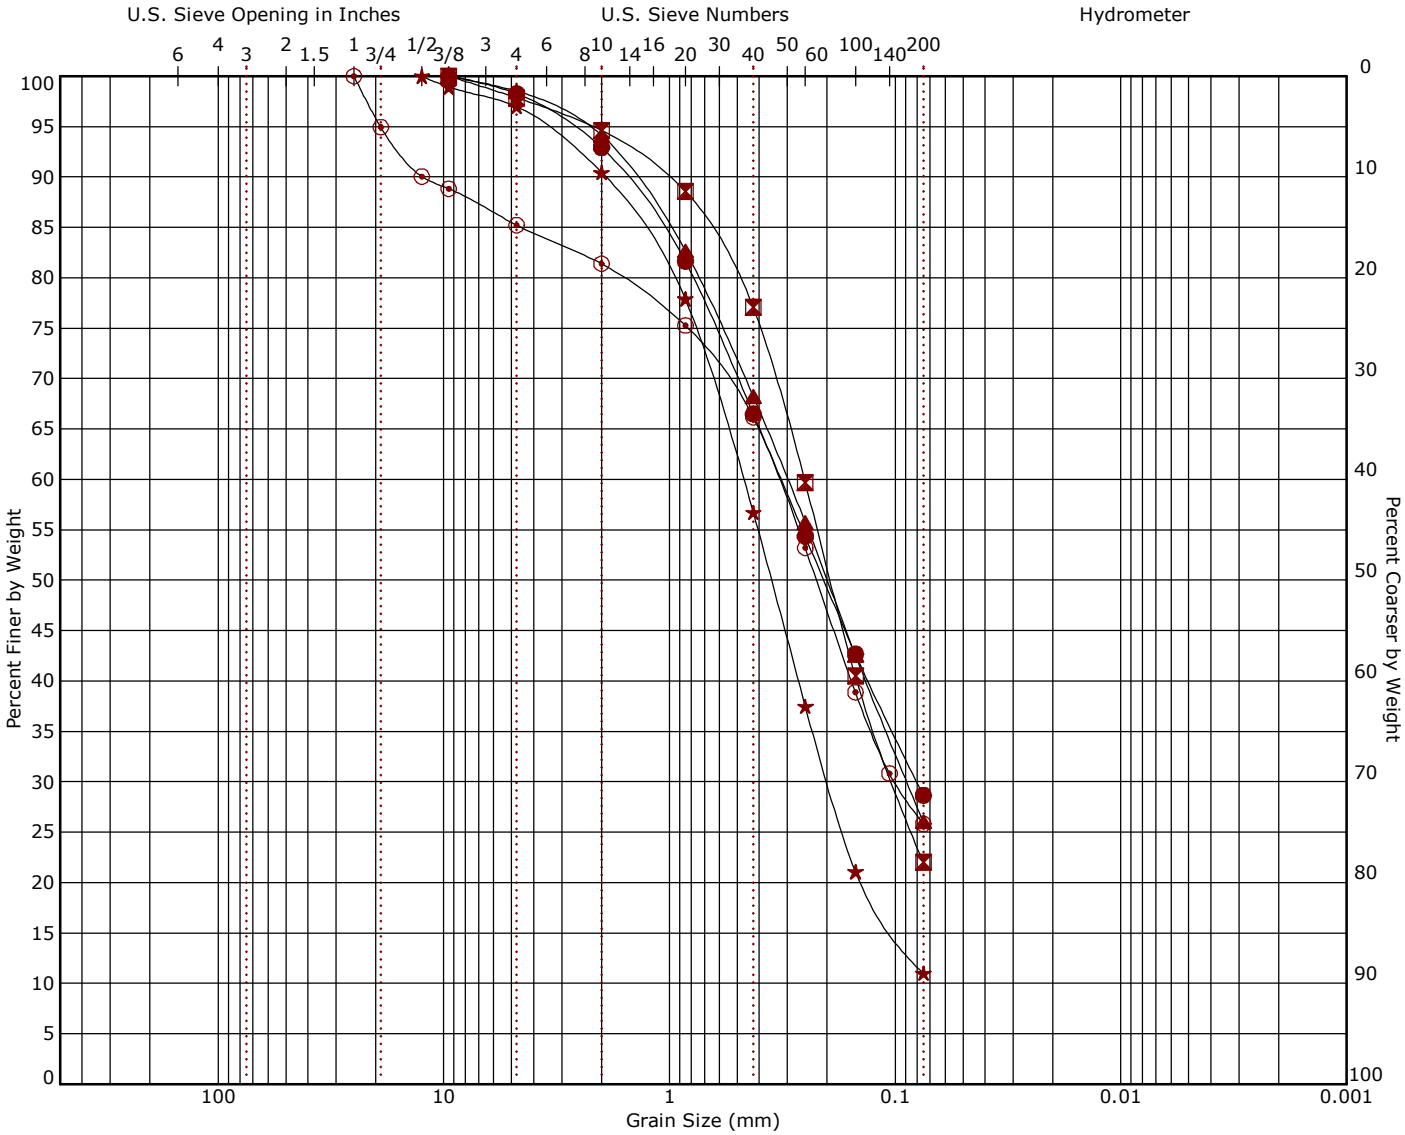
Grain Size Distribution
ASTM D422 / ASTM C136

Boring ID	Depth (Ft)	Grain Size Classification					Liquid Limit / Plasticity				
		coarse	fine	coarse	medium	fine	LL	PL	PI	Cc	Cu
S-23-41-1	18.5 - 20	SILTY SAND					SM	A-2-4 (0)			
S-23-41-1	23.5 - 25	SILTY SAND					SM	A-2-4 (0)	NP	NP	NP
S-23-41-1	28.5 - 30	SILTY SAND					SM	A-2-4 (0)			
S-23-41-2	4 - 5.7	WELL GRADED SAND with SILT					SW-SM	A-2-4 (0)		1.18	6.76
S-23-41-1 Offset	0 - 5	SILTY SAND					SM	A-2-4 (0)	NP	NP	NP
Boring ID	Depth (Ft)	D ₁₀₀	D ₆₀	D ₃₀	D ₁₀	%Cobbles	%Gravel	%Sand	%Fines	%Silt	%Clay
S-23-41-1	18.5 - 20	9.5	0.32	0.08		0.0	1.7	69.6	28.7		
S-23-41-1	23.5 - 25	9.5	0.252	0.101		0.0	2.1	75.9	22.0		
S-23-41-1	28.5 - 30	9.5	0.3	0.089		0.0	1.5	72.5	26.0		
S-23-41-2	4 - 5.7	12.5	0.473	0.198		0.0	3.0	86.0	11.0		
S-23-41-1 Offset	0 - 5	25	0.33	0.1		0.0	14.8	59.4	25.8

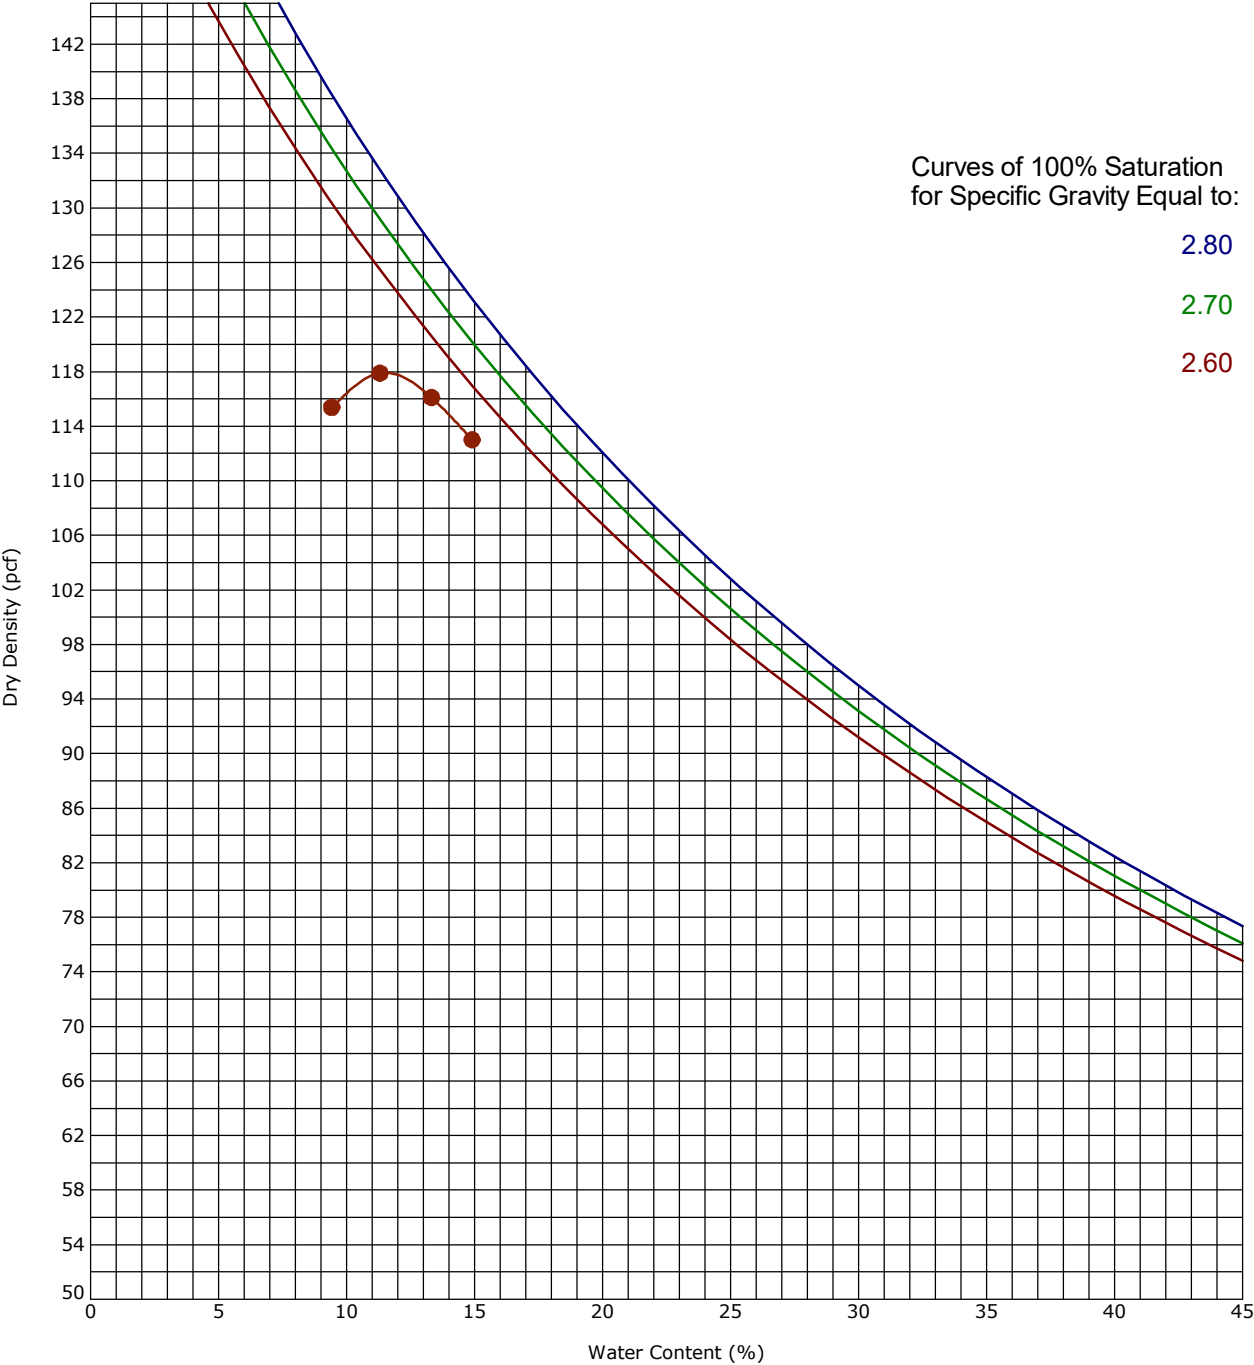
Moisture-Density Relationship

Boring ID		Depth (Ft)		Description of Materials			
S-23-41-1 Offset		0 - 5		SILTY SAND(SM)			
Fines (%)	Fraction > mm size	LL	PL	PI	Test Method	Maximum Dry Density (pcf)	Optimum Water Content (%)
26	0.0	NP	NP	NP	ASTM D698-Method B	117.9	11.5

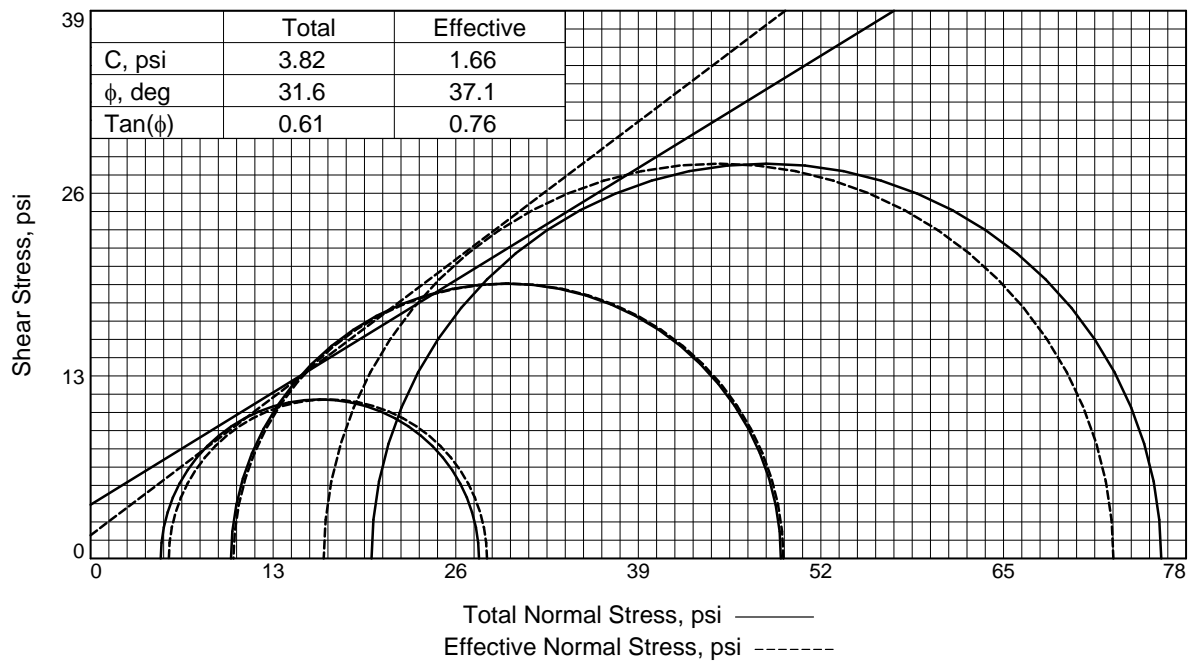
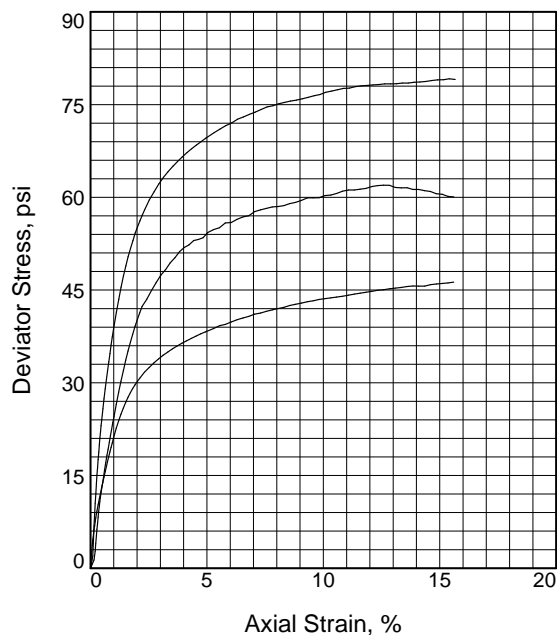
Sample No.		1	2	3
Initial	Water Content, %	11.3	11.4	11.4
	Dry Density, pcf	112.3	112.5	112.4
	Saturation, %	61.1	61.6	61.9
	Void Ratio	0.5013	0.4985	0.4990
	Diameter, in.	2.80	2.80	2.80
	Height, in.	5.62	5.62	5.62
At Test	Water Content, %	17.2	17.0	16.8
	Dry Density, pcf	115.1	115.6	116.0
	Saturation, %	100.0	100.0	100.0
	Void Ratio	0.4642	0.4583	0.4531
	Diameter, in.	2.77	2.77	2.77
	Height, in.	5.58	5.58	5.56
Strain rate, in./min.		0.001	0.001	0.001
Back Pressure, psi		50.0	50.0	50.0
Cell Pressure, psi		55.0	60.0	70.0
Fail. Stress, psi		22.7	39.2	56.2
Excess Pore Pr., psi		-0.6	-0.2	3.4
Ult. Stress, psi		46.1	60.5	79.0
Excess Pore Pr., psi		-10.5	-11.1	-7.6
$\bar{\sigma}_1$ Failure, psi		28.2	49.3	72.8
$\bar{\sigma}_3$ Failure, psi		5.6	10.2	16.6

Sample No.	Station	Offset (ft)	Sample Depth (ft)	USCS Soil Type	Compaction		Shear Strength ¹	
					Optimum Moisture (%)	Max Dry Density (pcf)	Total	Effective
S-23-41-1 Offset	17+06 and 17+12	11 R	0 – 5	SM	11.5	117.9	c=3.8 psi φ=32°	c'=1.7 psi φ'=37°

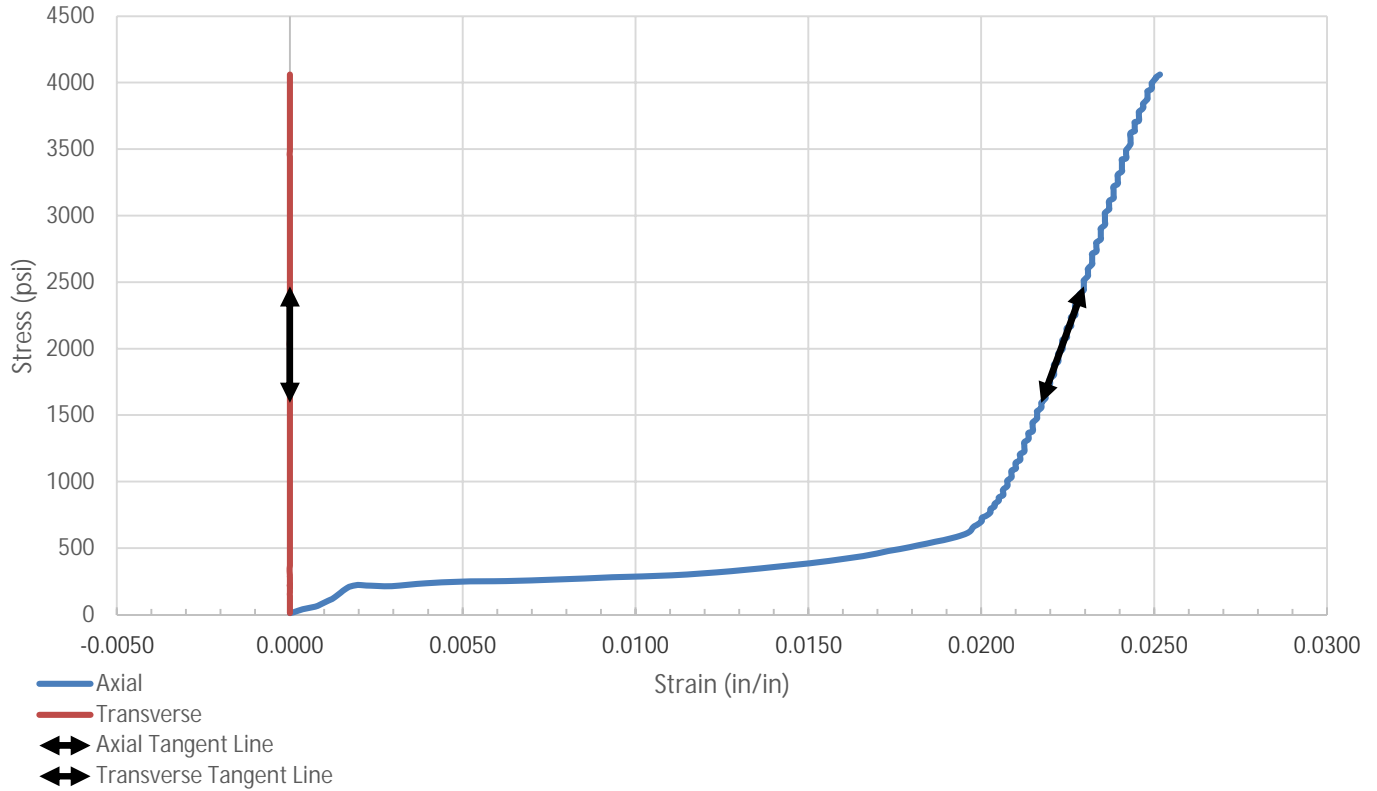
ASTM D7012 Stress/ Strain Curve

Failure Load (lbs):	12634
Failure Strain (%):	3.67
Unconfined Compressive Strength (psi):	4,062
Elastic Modulus, E, (ksi):	712
Poisson's Ratio, u:	0.0013
Time of Failure (min):	00:37
Rate of Loading (psi/sec):	109.788
Moisture Content Post-break:	0.01%

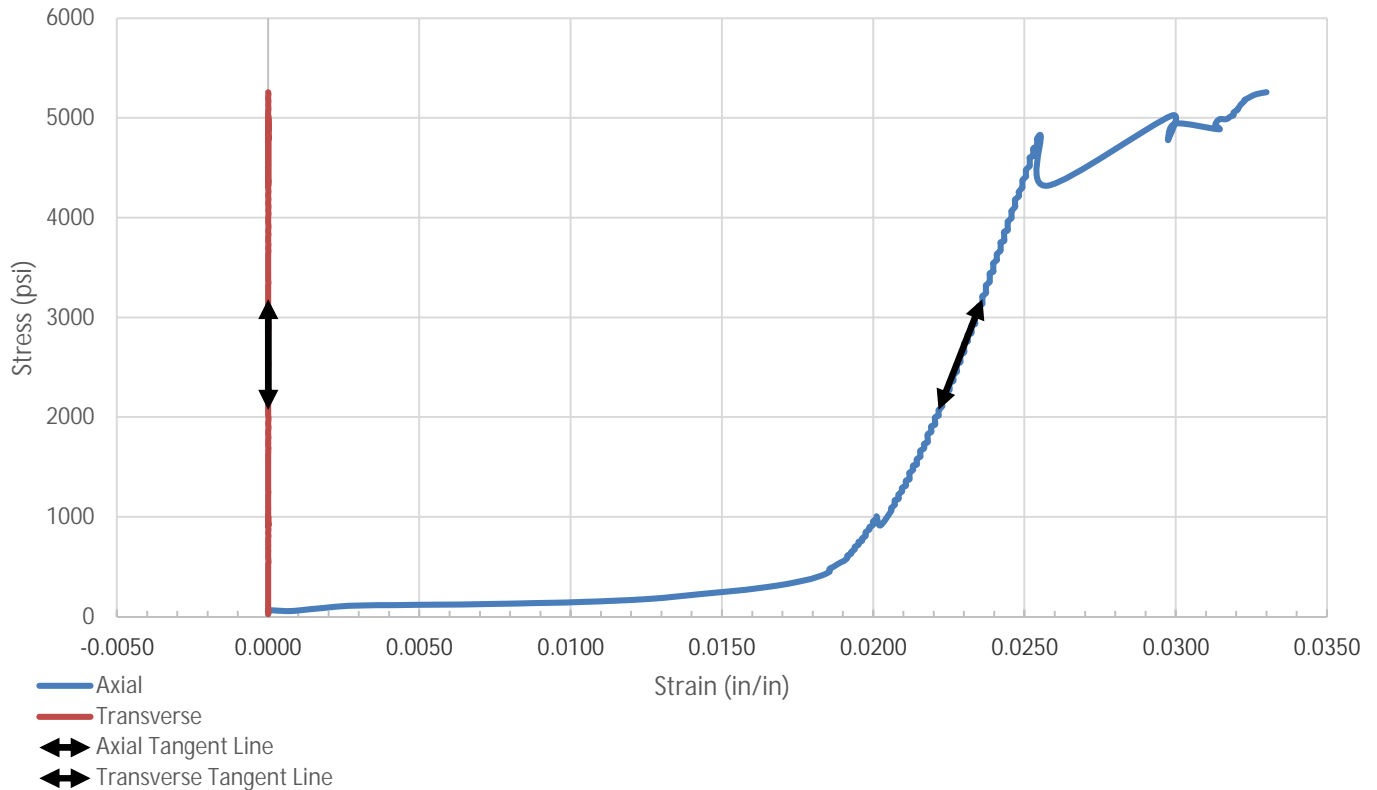
ASTM D7012 Stress/ Strain Curve

Failure Load (lbs):	16359
Failure Strain (%):	3.53
Unconfined Compressive Strength (psi):	5,260
Elastic Modulus, E, (ksi):	768
Poisson's Ratio, u:	0.000
Time of Failure (min):	00:48
Rate of Loading (psi/sec):	110.035
Moisture Content Post-break:	0.01%

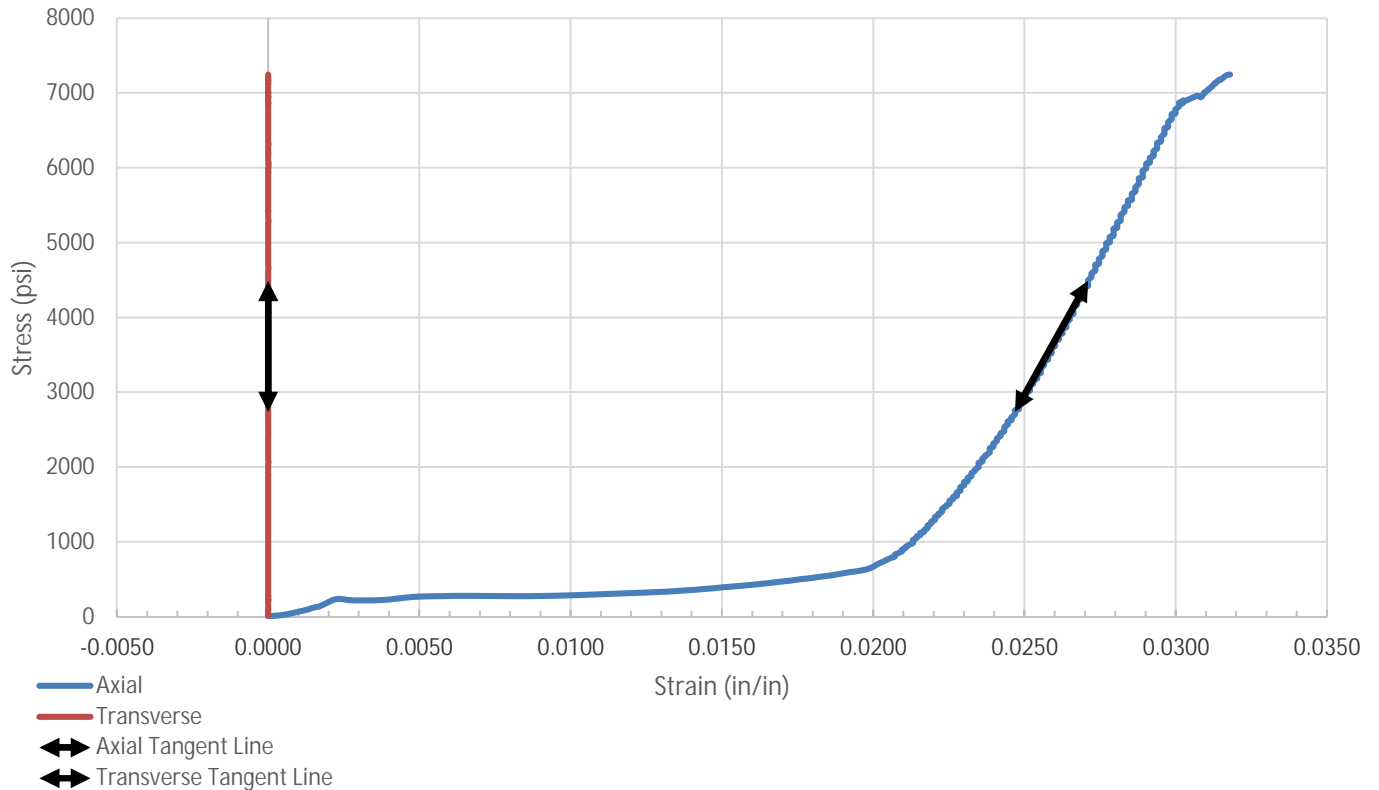
ASTM D7012 Stress/ Strain Curve

Failure Load (lbs):	22315
Failure Strain (%):	3.22
Unconfined Compressive Strength (psi):	7,247
Elastic Modulus, E, (ksi):	725
Poisson's Ratio, u:	0.001
Time of Failure (min):	01:06
Rate of Loading (psi/sec):	109.476
Moisture Content Post-break:	0.01%

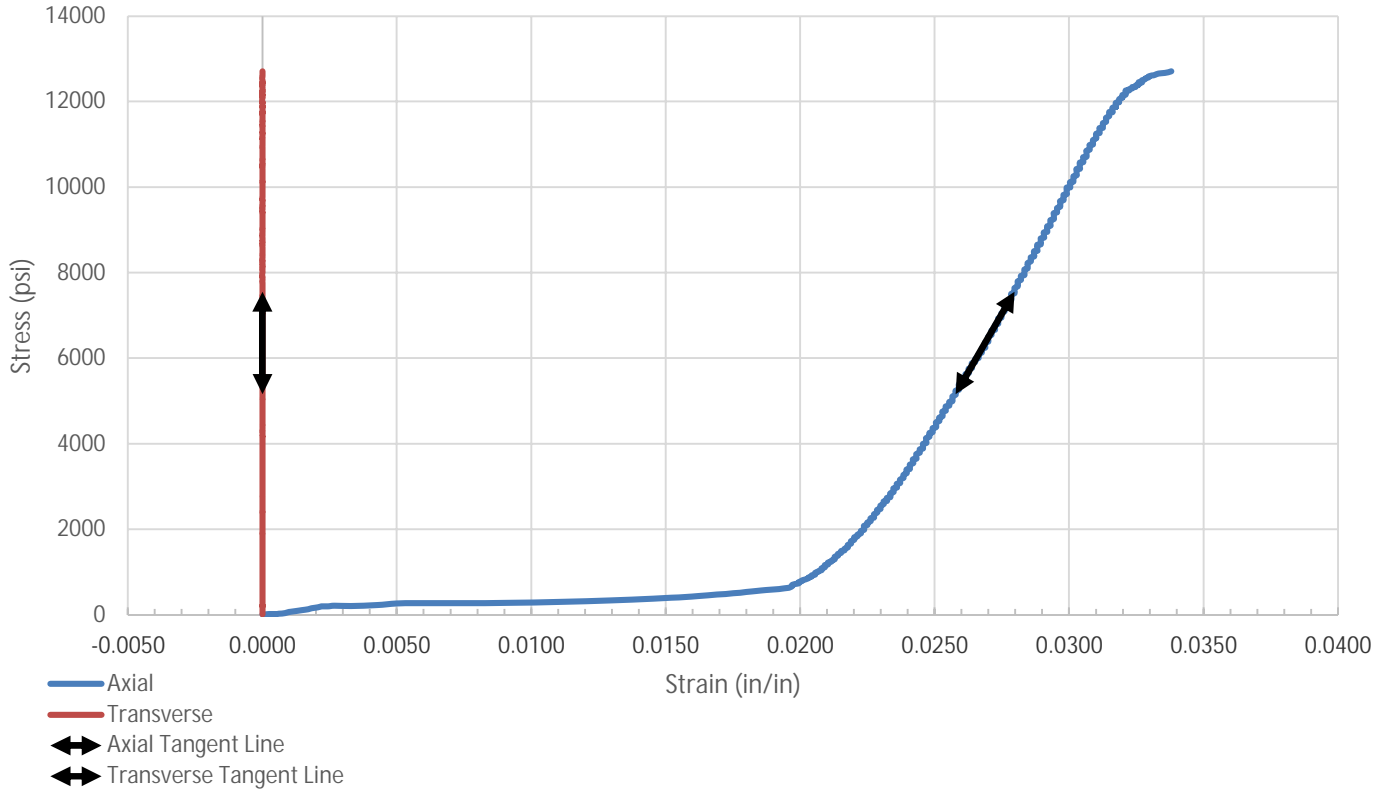
ASTM D7012 Stress/ Strain Curve

Failure Load (lbs):	39134
Failure Strain (%):	3.89
Unconfined Compressive Strength (psi):	12,710
Elastic Modulus, E, (ksi):	1095
Poisson's Ratio, u:	0.001
Time of Failure (min):	01:57
Rate of Loading (psi/sec):	108.816
Moisture Content Post-break:	0.012%

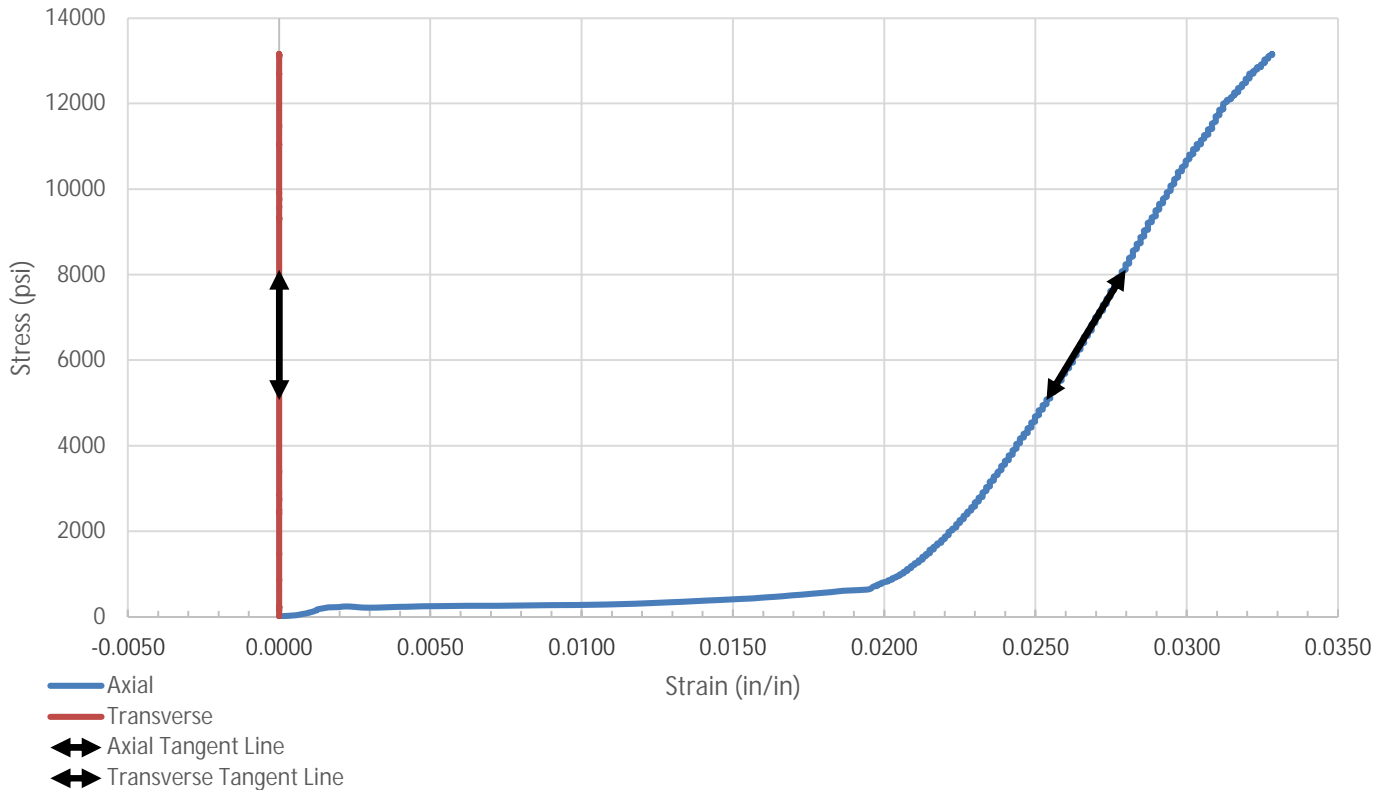
ASTM D7012 Stress/ Strain Curve

Failure Load (lbs):	40538
Failure Strain (%):	3.41
Unconfined Compressive Strength (psi):	13,166
Elastic Modulus, E, (ksi):	1168
Poisson's Ratio, u:	0.0002
Time of Failure (min):	02:00
Rate of Loading (psi/sec):	109.350
Moisture Content Post-break:	0.01%

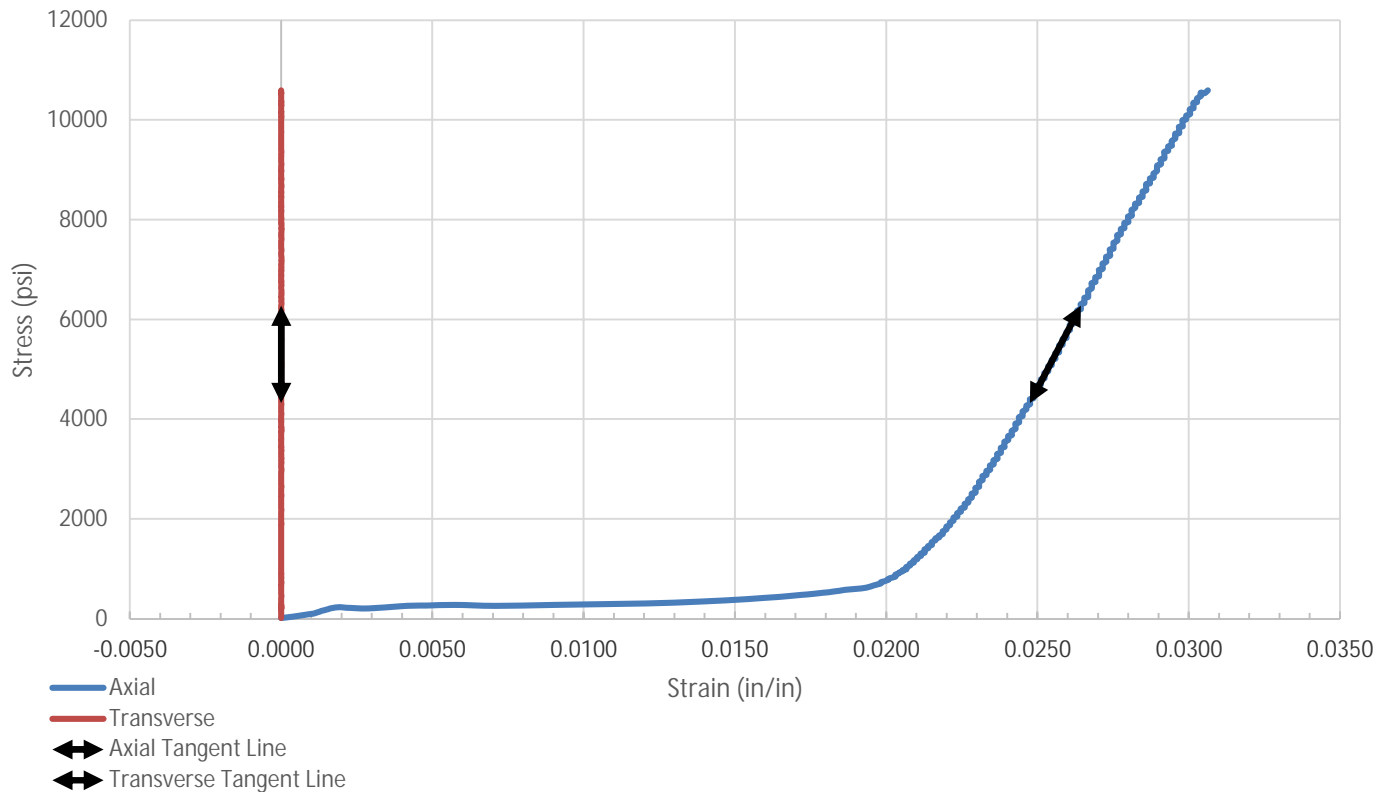
ASTM D7012 Stress/ Strain Curve

Failure Load (lbs):	32610
Failure Strain (%):	3.44
Unconfined Compressive Strength (psi):	10,591
Elastic Modulus, E, (ksi):	1158
Poisson's Ratio, u:	0.001
Time of Failure (min):	01:36
Rate of Loading (psi/sec):	109.863
Moisture Content Post-break:	0.01%

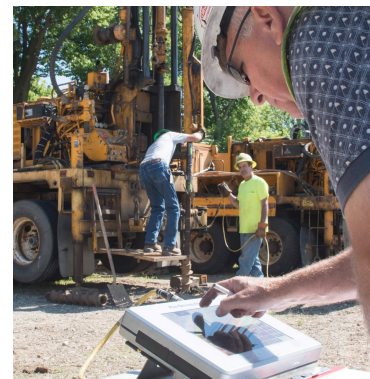
Exhibit B

- Calculates energy transferred by SPT hammers using force and velocity measurements
- Determines N Value to help improve reliability of soil strength estimates
- Offers simplified reporting and analysis option to speed testing results
- Operates in English, SI, or Metric units

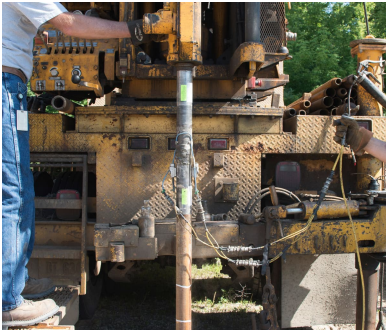
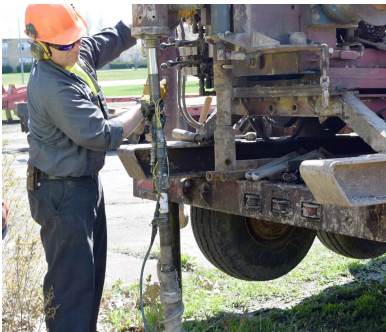
SPT Analyzer data is stored and transferred to a computer via USB memory stick. The software furnished with the SPT Analyzer has a Report Creation Option that makes it quick and easy to summarize results and create output graphs of Force, Velocity, Energy and Displacement versus Time, as well as numerical, statistical, and graphical results for each data set. The software is fully customizable.
