S-23-41 (Gap Creek Road) Bridge Replacement over Middle Saluda River

Geotechnical Baseline Report

October 30, 2024 | SCDOT Project ID: P041159
Terracon Project No.: 8623P180 Revision 1

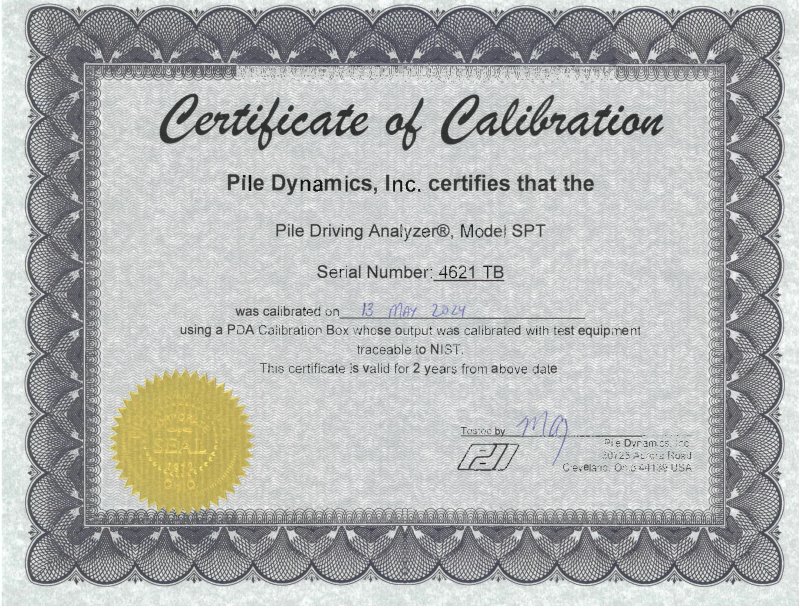
746AWJ		Cycle 1		
Sample	Force (lb)	Strain (µE)	Bridge 1 (V)	Bridge 2 (V)
1	0.00	0.00	0.00	0.00
2	1296.93	37.22	0.17	0.17
3	2135.32	62.74	0.28	0.28
4	3028.79	89.39	0.40	0.40
5	4377.09	128.61	0.58	0.57
6	5243.07	154.57	0.69	0.68
7	6143.17	181.90	0.81	0.81
8	7067.05	208.93	0.93	0.93
9	7958.18	235.42	1.04	1.05
10	9380.66	278.02	1.23	1.23
11	10161.74	300.76	1.34	1.33

Bridge 1		Bridge 2	
Force Calibration (lb/V)	7605.07	Force Calibration (lb/V)	7606.74
Offset	-0.16	Offset	12.66
Correlation	0.999997	Correlation	0.999999
Strain Calibration (µE/V)	225.99	Strain Calibration (µE/V)	226.04
Offset	-1.01	Offset	-0.83
Correlation	0.999989	Correlation	0.999992

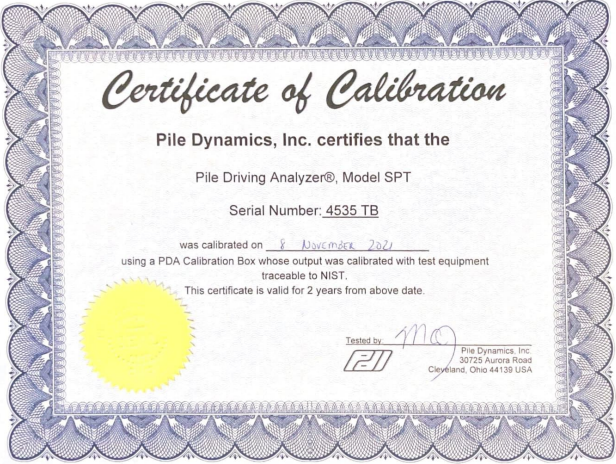
Exhibit B
PDA Equipment Calibration

648AWJ		Cycle 1		
Sample	Force (lb)	Strain (µE)	Bridge 1 (V)	Bridge 2 (V)
1	0.00	0.00	0.00	0.00
2	799.99	21.12	0.10	0.10
3	2111.63	58.22	0.26	0.26
4	2997.39	82.70	0.37	0.37
5	3848.07	106.26	0.47	0.47
6	5131.83	143.07	0.63	0.63
7	6017.79	167.81	0.74	0.75
8	6872.07	192.74	0.85	0.85
9	7783.57	218.15	0.96	0.96
10	9136.93	255.02	1.12	1.13
11	10026.70	280.73	1.24	1.24

Bridge 1		Bridge 2	
Force Calibration (lb/V)	8120.30	Force Calibration (lb/V)	8089.75
Offset	-4.24	Offset	-2.24
Correlation	0.999998	Correlation	0.999995
Strain Calibration (µE/V)	228.56	Strain Calibration (µE/V)	227.70
Offset	-1.57	Offset	-1.51
Correlation	0.999991	Correlation	0.999983
