S-23-310 (Crestwood Drive) over Langston Tributary

Greenville County, SC

Geotechnical Baseline Report

November 5, 2024 | SCDOT Project ID: P041162
Terracon Project No.: 8623P180 Revision 2

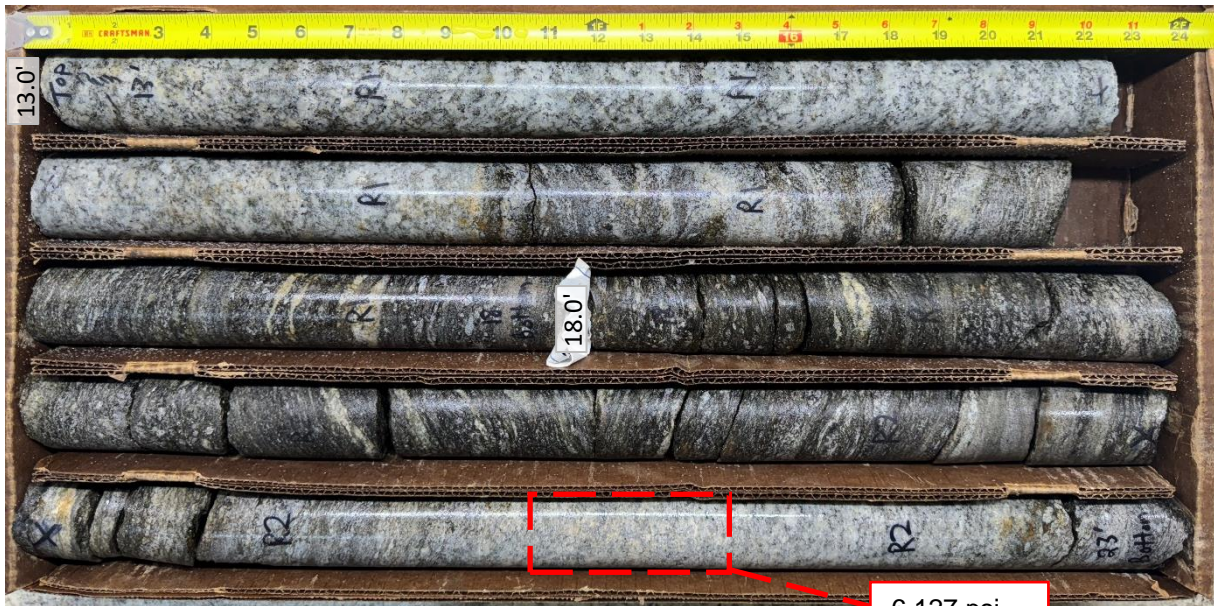
S-23-310-1, NQ-1 and NQ-2 (13 to 23 feet)

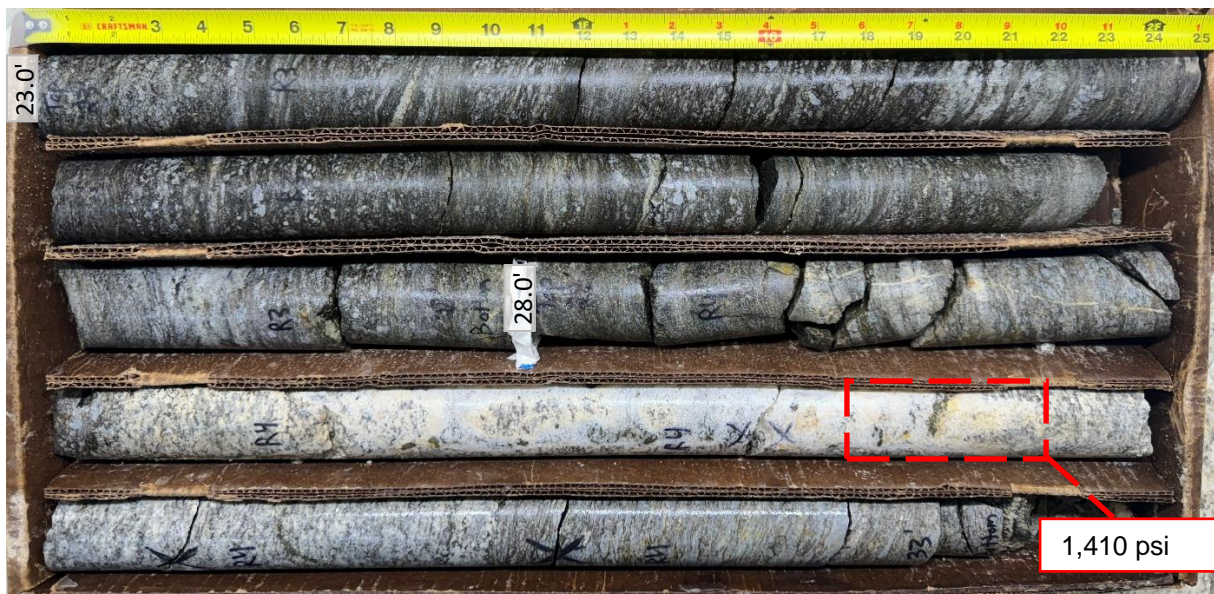
S-23-310-1, NQ-3 and NQ-4 (23 to 33 feet)

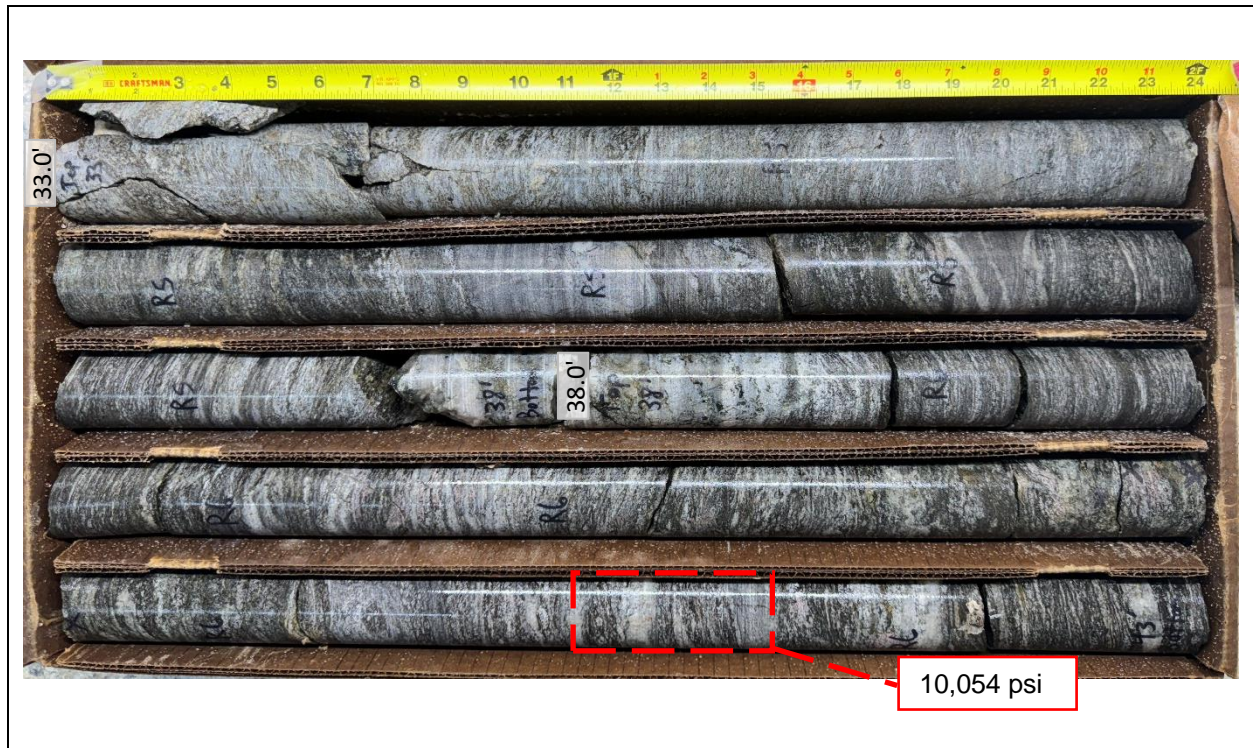
S-23-310-1, NQ-5 and NQ-6 (33 to 43 feet)

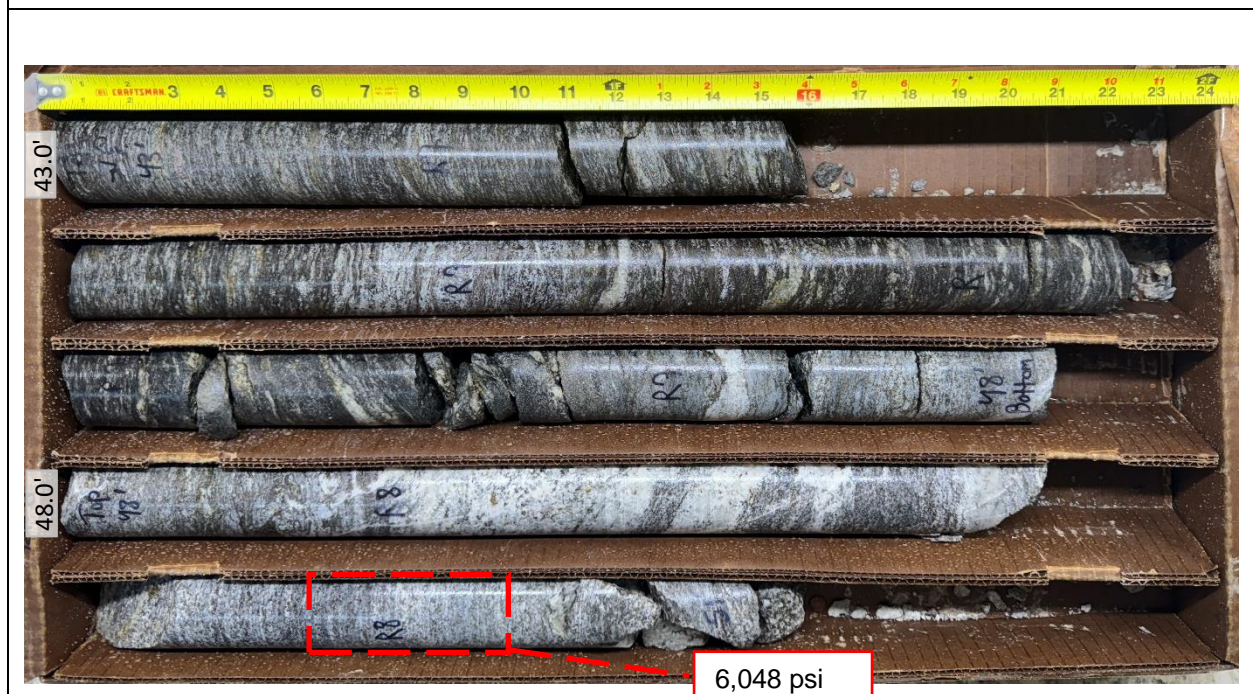
S-23-310-1, NQ-7 and NQ-8 (43 to 51 feet)

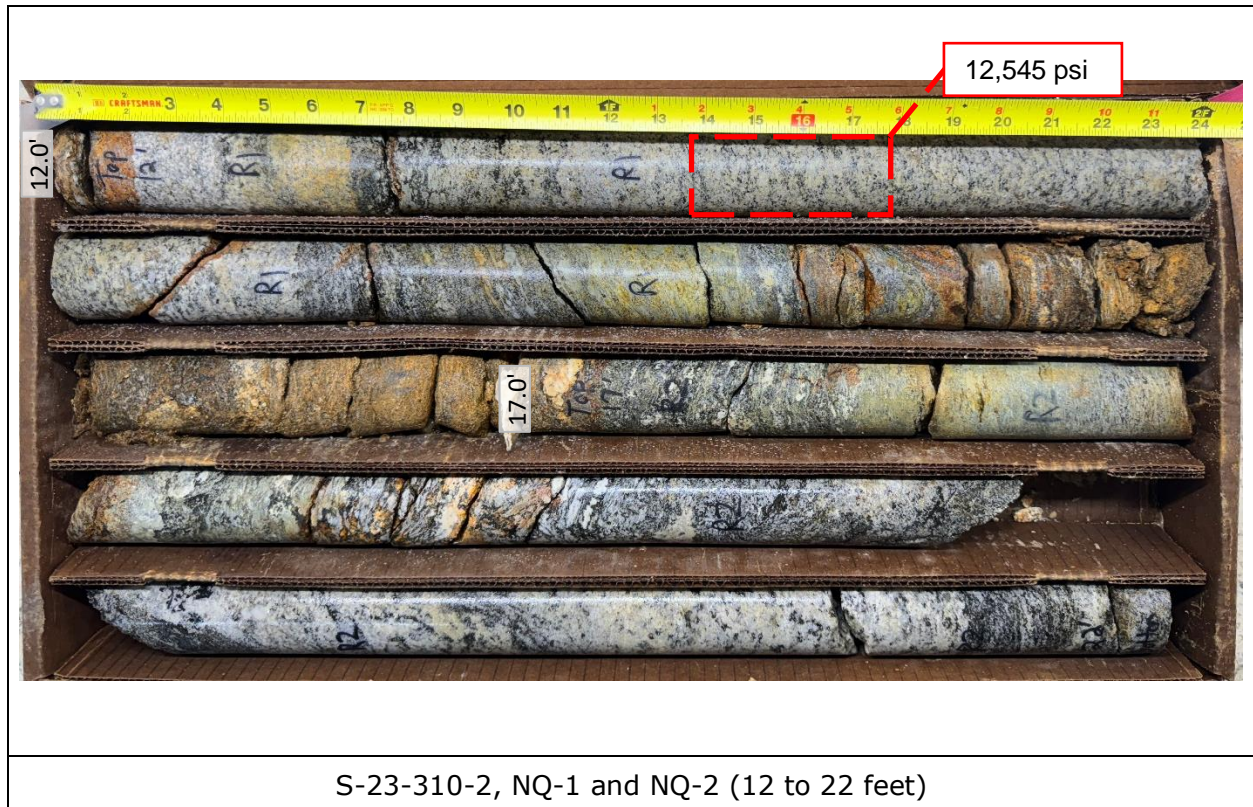
S-23-310-2, NQ-1 and NQ-2 (12 to 22 feet)

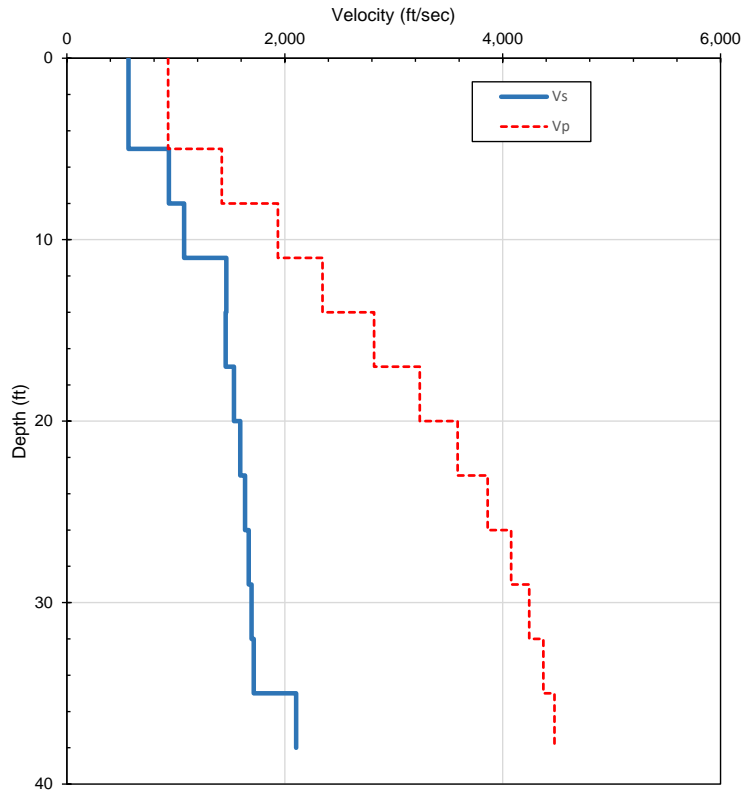
Downhole Seismic Velocity Fixed Interval Method

Shear Wave Velocity Test Results shows the downhole shear wave velocity and compressive wave velocity test results. The data was evaluated using the Fixed Interval method. S-wave arrival times using the Interval method were picked based on the onset of the signal (first break) as observed in the software package TomTime by GeoTom.

The shear wave and compression wave velocity results, as measured at Boring S-23-310-1 using downhole seismic tests, were provided to SCDOT. SCDOT used these velocity measurements to develop Acceleration Design Response Spectrum (ADRS) curves by determining the seismic hazard and evaluating the local site effects on the response spectra.

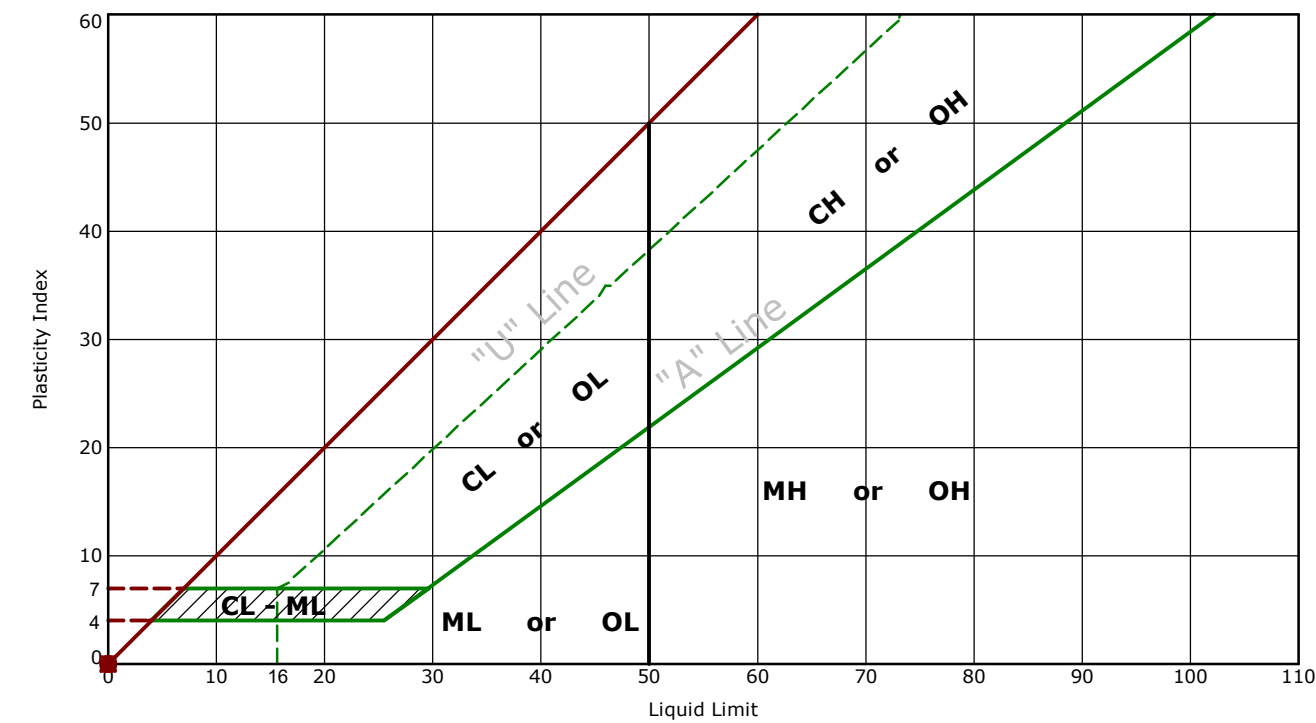
Atterberg Limit Results

ASTM D4318

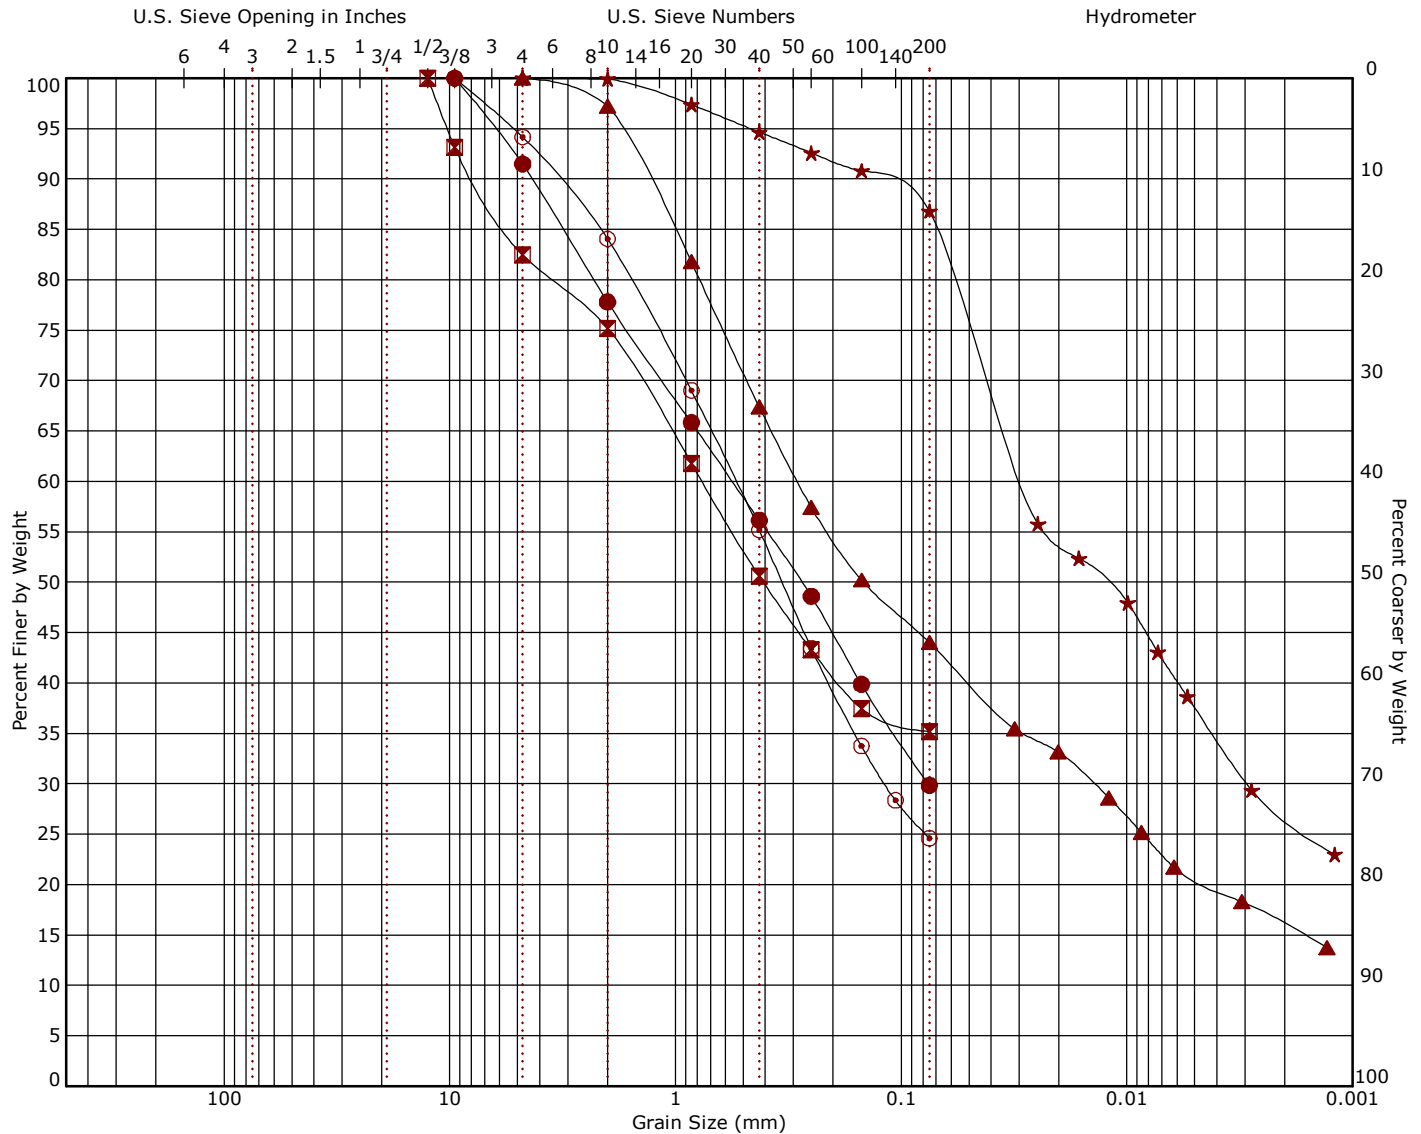
Grain Size Distribution

ASTM D422 / ASTM C136

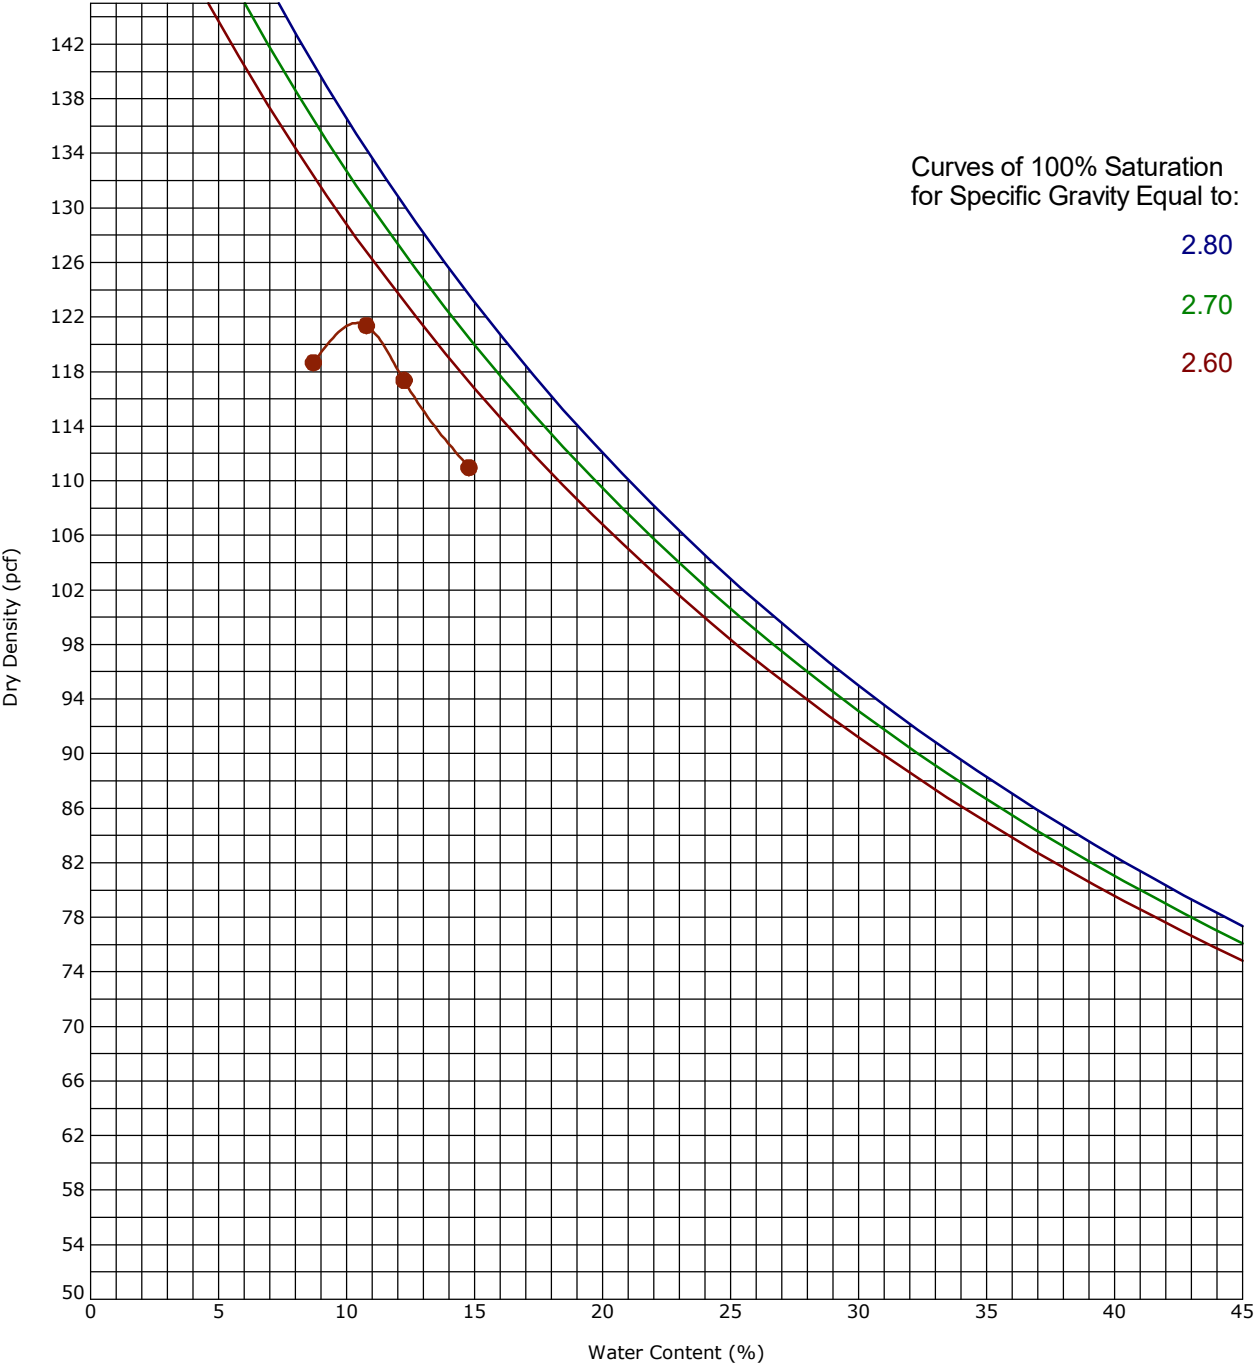
Moisture-Density Relationship

ASTM D698-Method B

| Boring ID | | Depth (Ft) | | Description of Materials | | | |
|---|---|---|---|---|---|---|---|
| 25 | 0.0 | NP | NP | NP | ASTM D698-Method B | 121.6 | 10.4 |

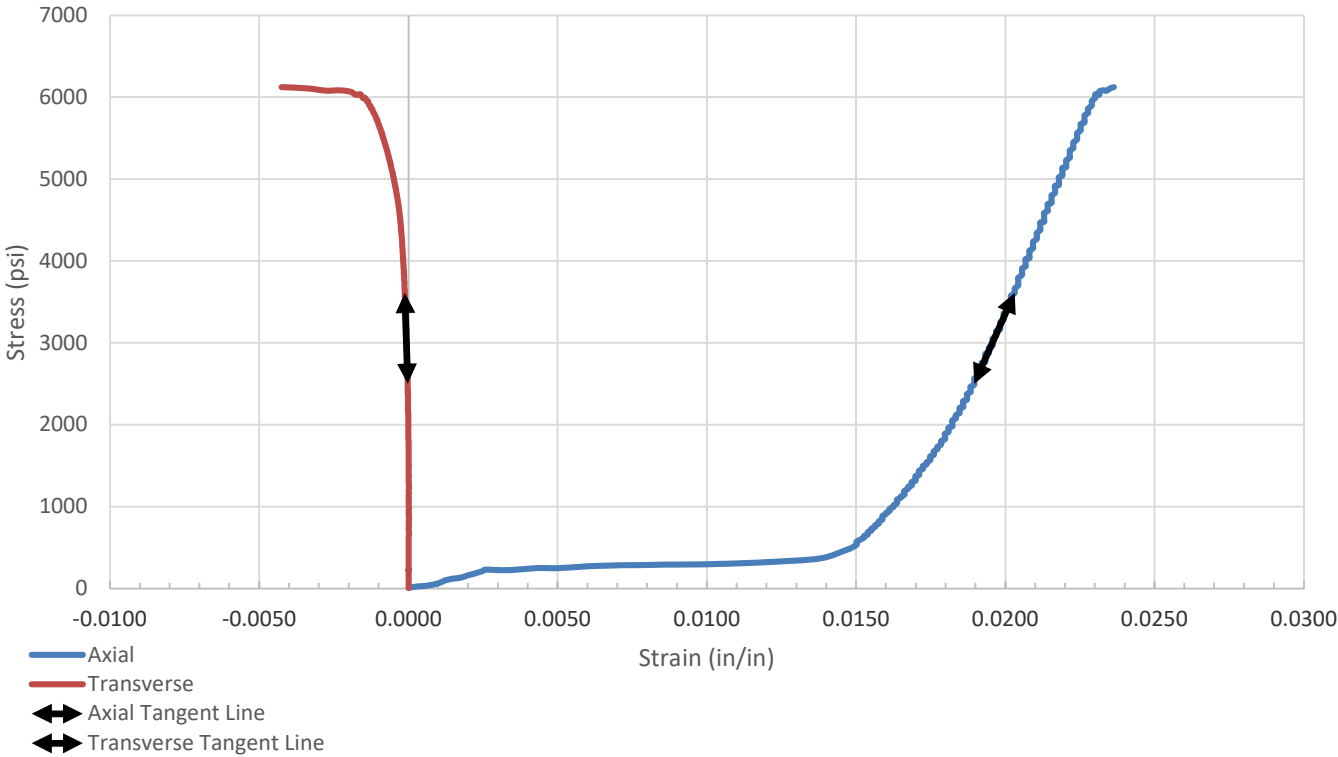
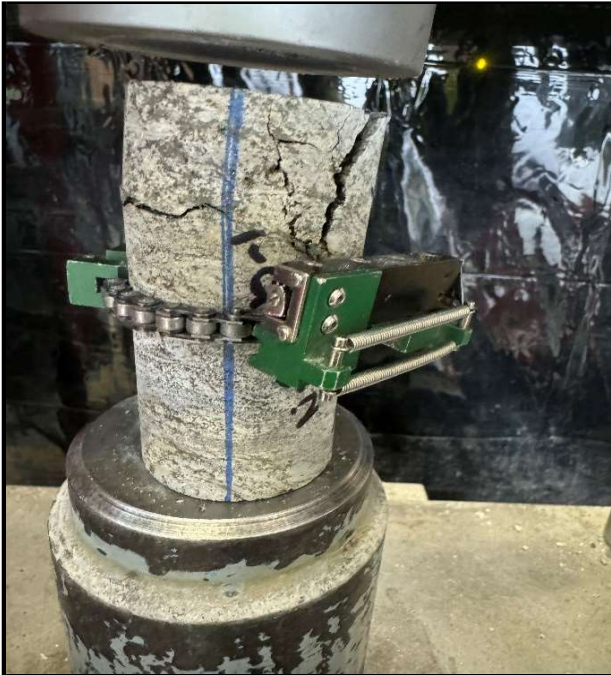
ASTM D7012 Stress/ Strain Curve

| Failure Load (lbs): | 18297 |
| Failure Strain (%): | 2.72 |

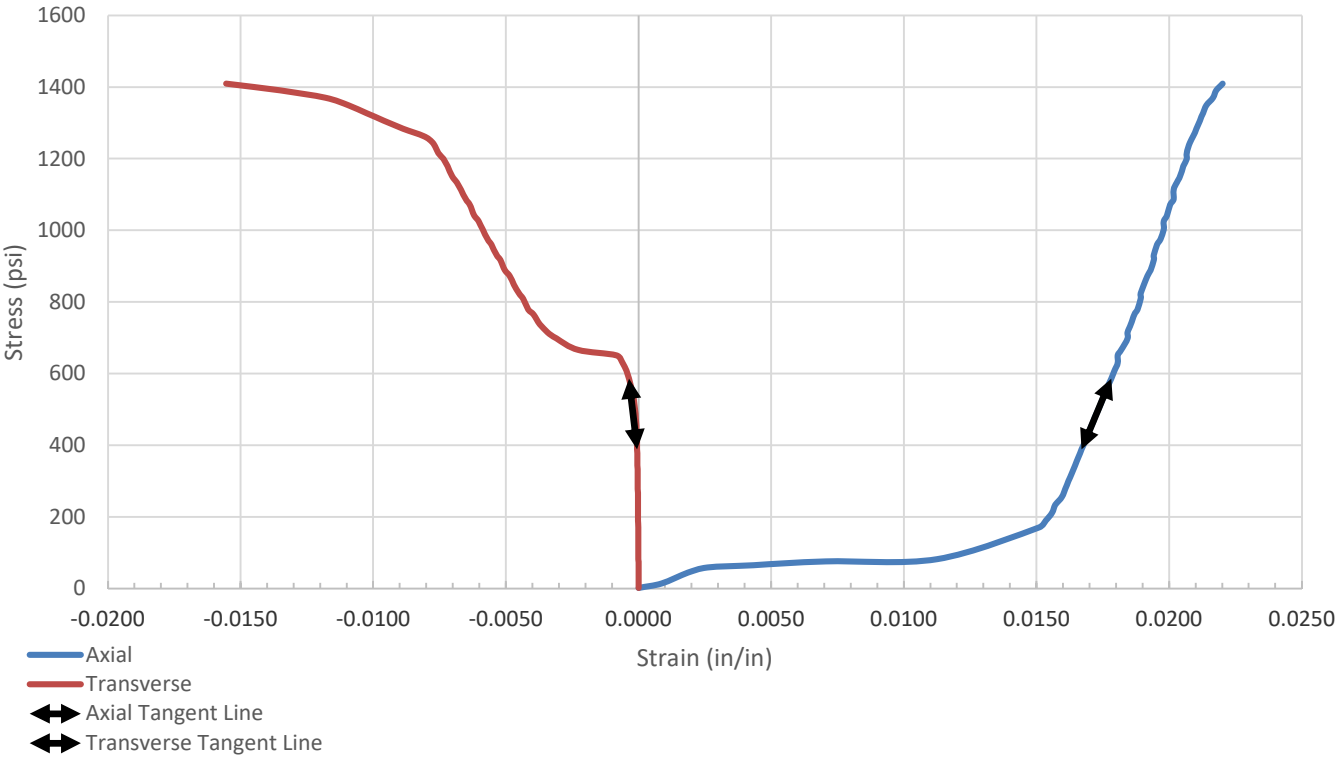
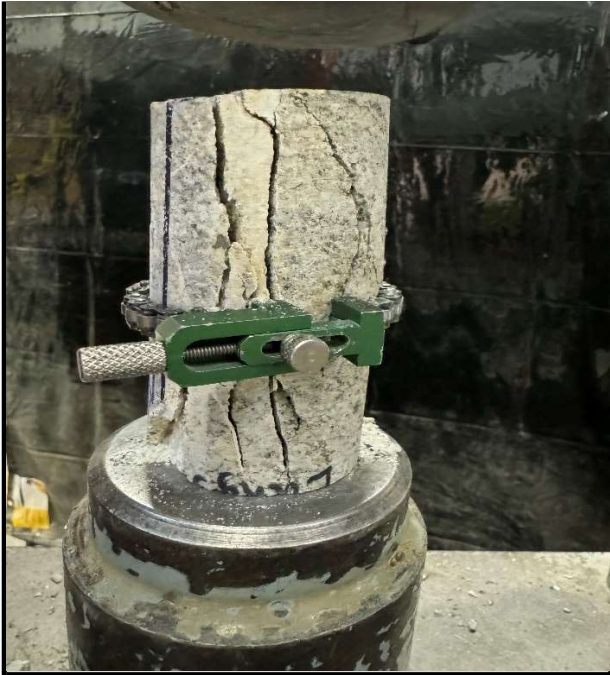
ASTM D7012 Stress/ Strain Curve

| Failure Load (lbs): | 15658 |
| Failure Strain (%): | 2.33 |

According to ASTM D7012 Section 8.2.1, this specimen, although not meeting all requirements of ASTM D4543 is acceptable for testing. However, the results reported may differ from results obtained from a test specimen that meets the requirements of D4543.

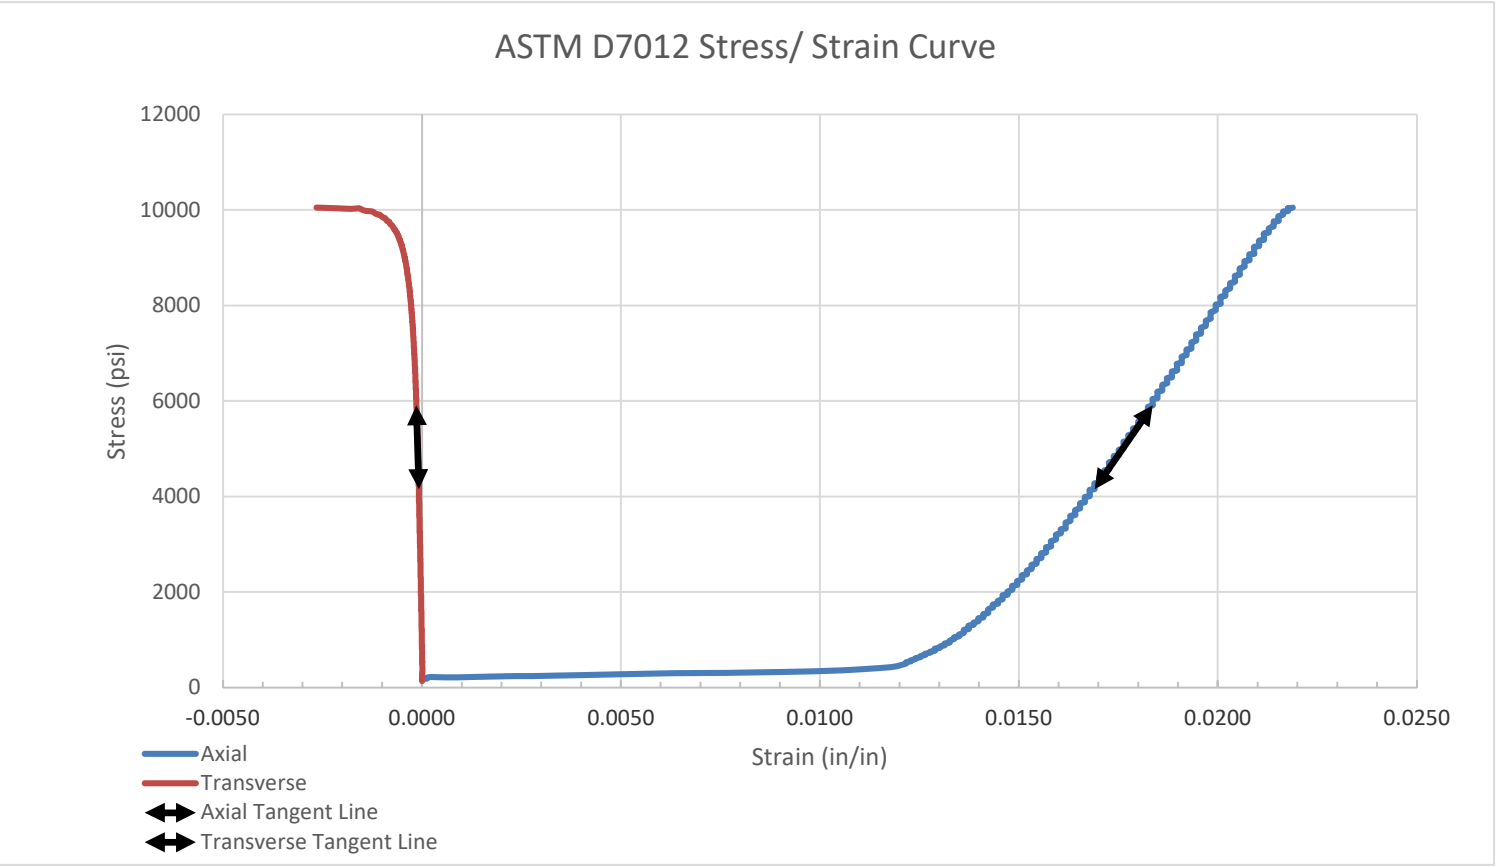
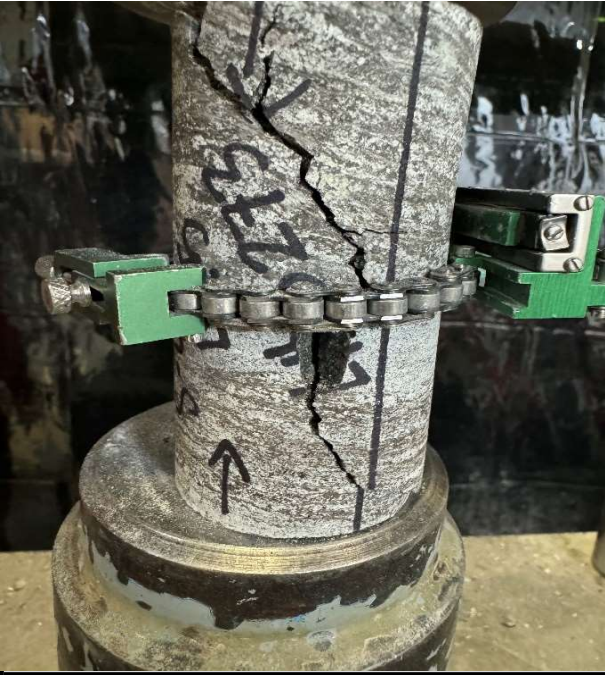
| SAMPLE LOCATION | | | |
|--|---|---|---|
| Failure Load (lbs): | | 30025 | |
| Failure Strain (%): | | 2.69 | |

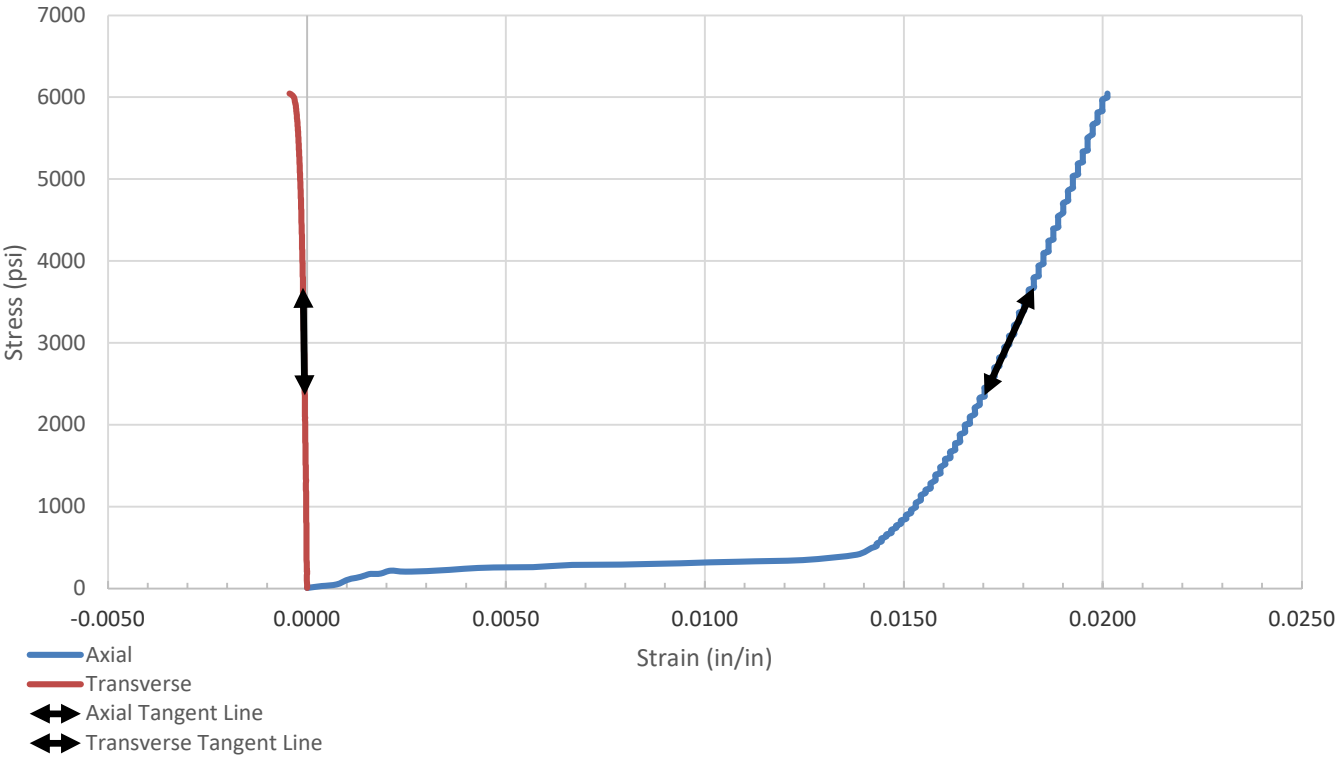
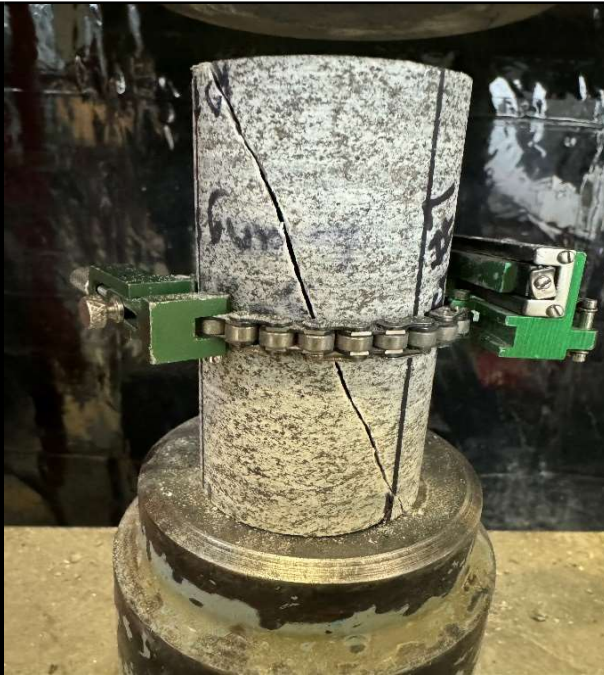
ASTM D7012 Stress/ Strain Curve

| SAMPLE LOCATION | | | |
|--|---|---|---|
| Failure Load (lbs): | | 18061 | |
| Failure Strain (%): | | 2.32 | |

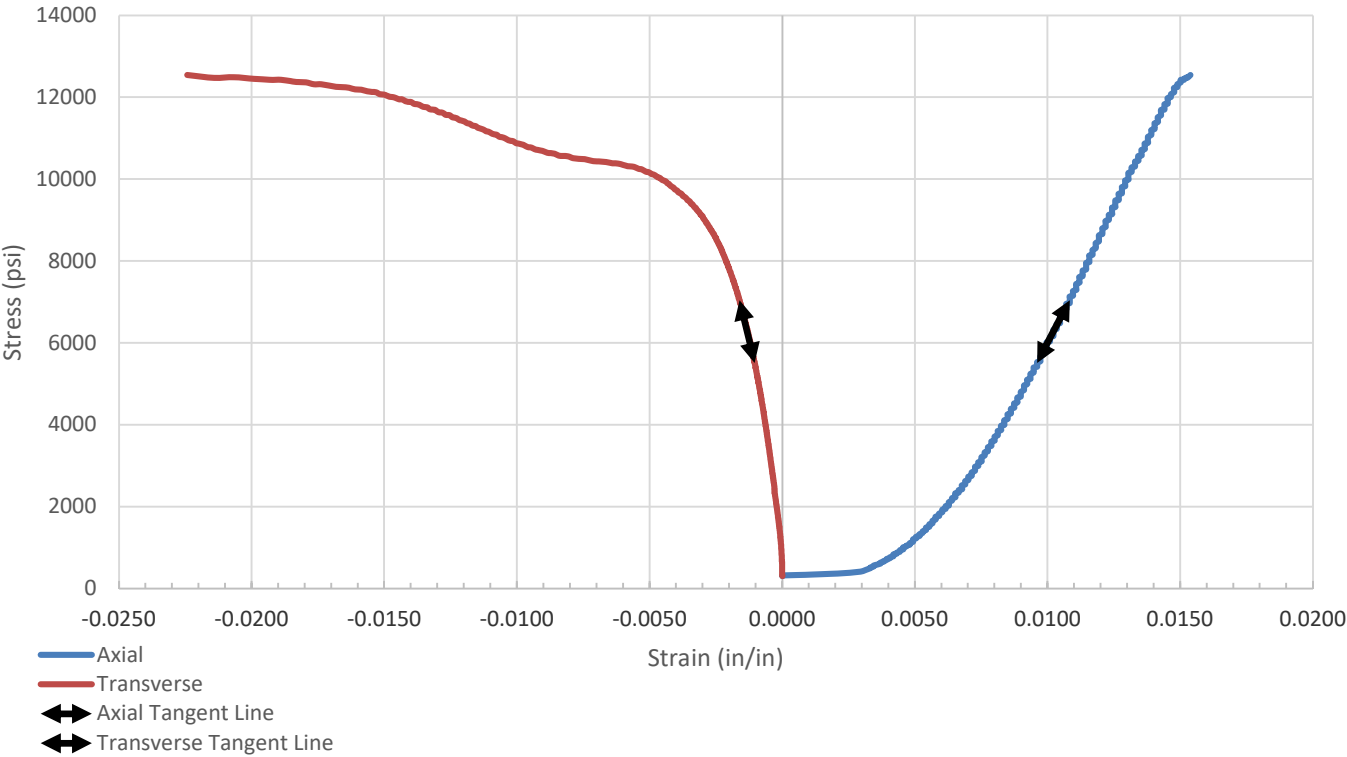
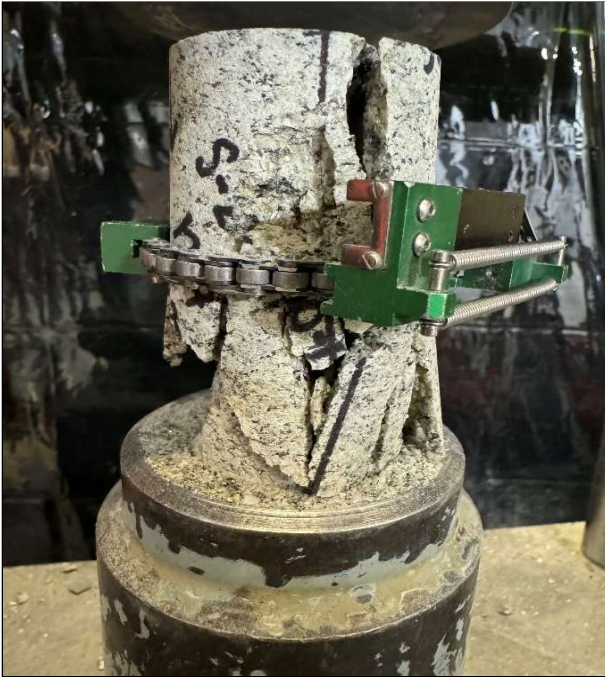
ASTM D7012 Stress/ Strain Curve

| Failure Load (lbs): | 37852 |
| Failure Strain (%): | 1.83 |

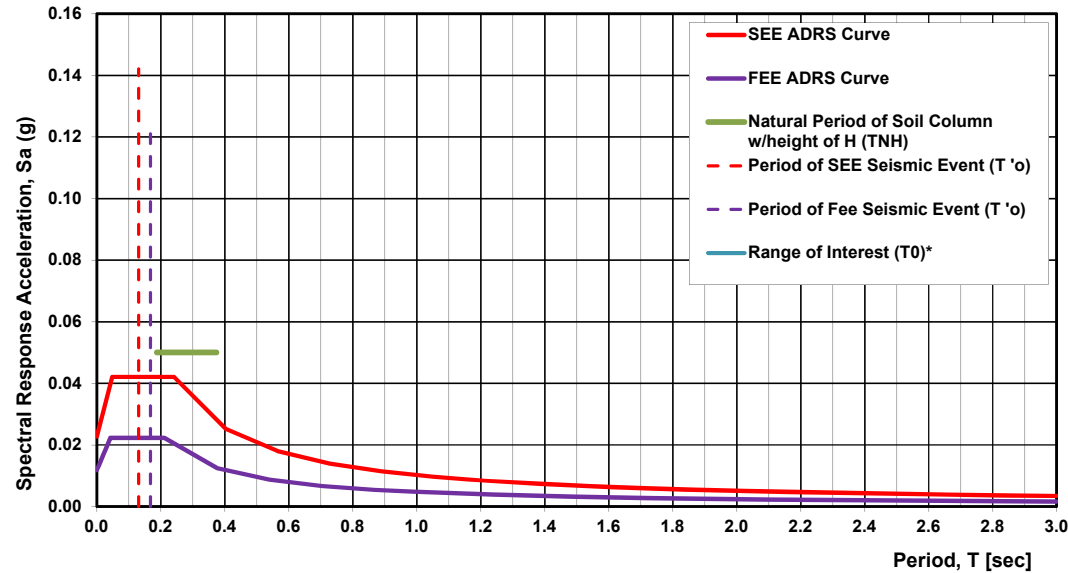
SC Seismic ADRS Curve

| Geologic Condition: | Geologically Realistic (Q = 100)* |

SCDOT provided "3-Point Acceleration Design Response Spectrum" curves along with a table that included pseudo-spectral accelerations (PSA) for 5% critical damping and at selected frequencies, consistent with a Geologically Realistic (B-C Boundary) condition (shear wave velocity, $V_s = 2,500$ feet per second). PSA values were provided for the:

The table below provides the maximum considered earthquake peak ground acceleration (PGA), the short period acceleration (S_{DS}), and one-second period acceleration (S_{D1}) for the FEE and SEE earthquakes at the ground surface. A copy of the "3-Point Acceleration Design Response Spectrum" provided by SCDOT is included in Appendix C.
