PROCESSING FORM FOR PROGRAMMATIC CATEGORICAL EXCLUSIONS  
NON MAJOR FEDERAL ACTIONS

Project ID P044048

Route S-147

**TITLE:** Cultural Resources Survey of the S-147 over Reedy River Emergency Bridge Replacement Project

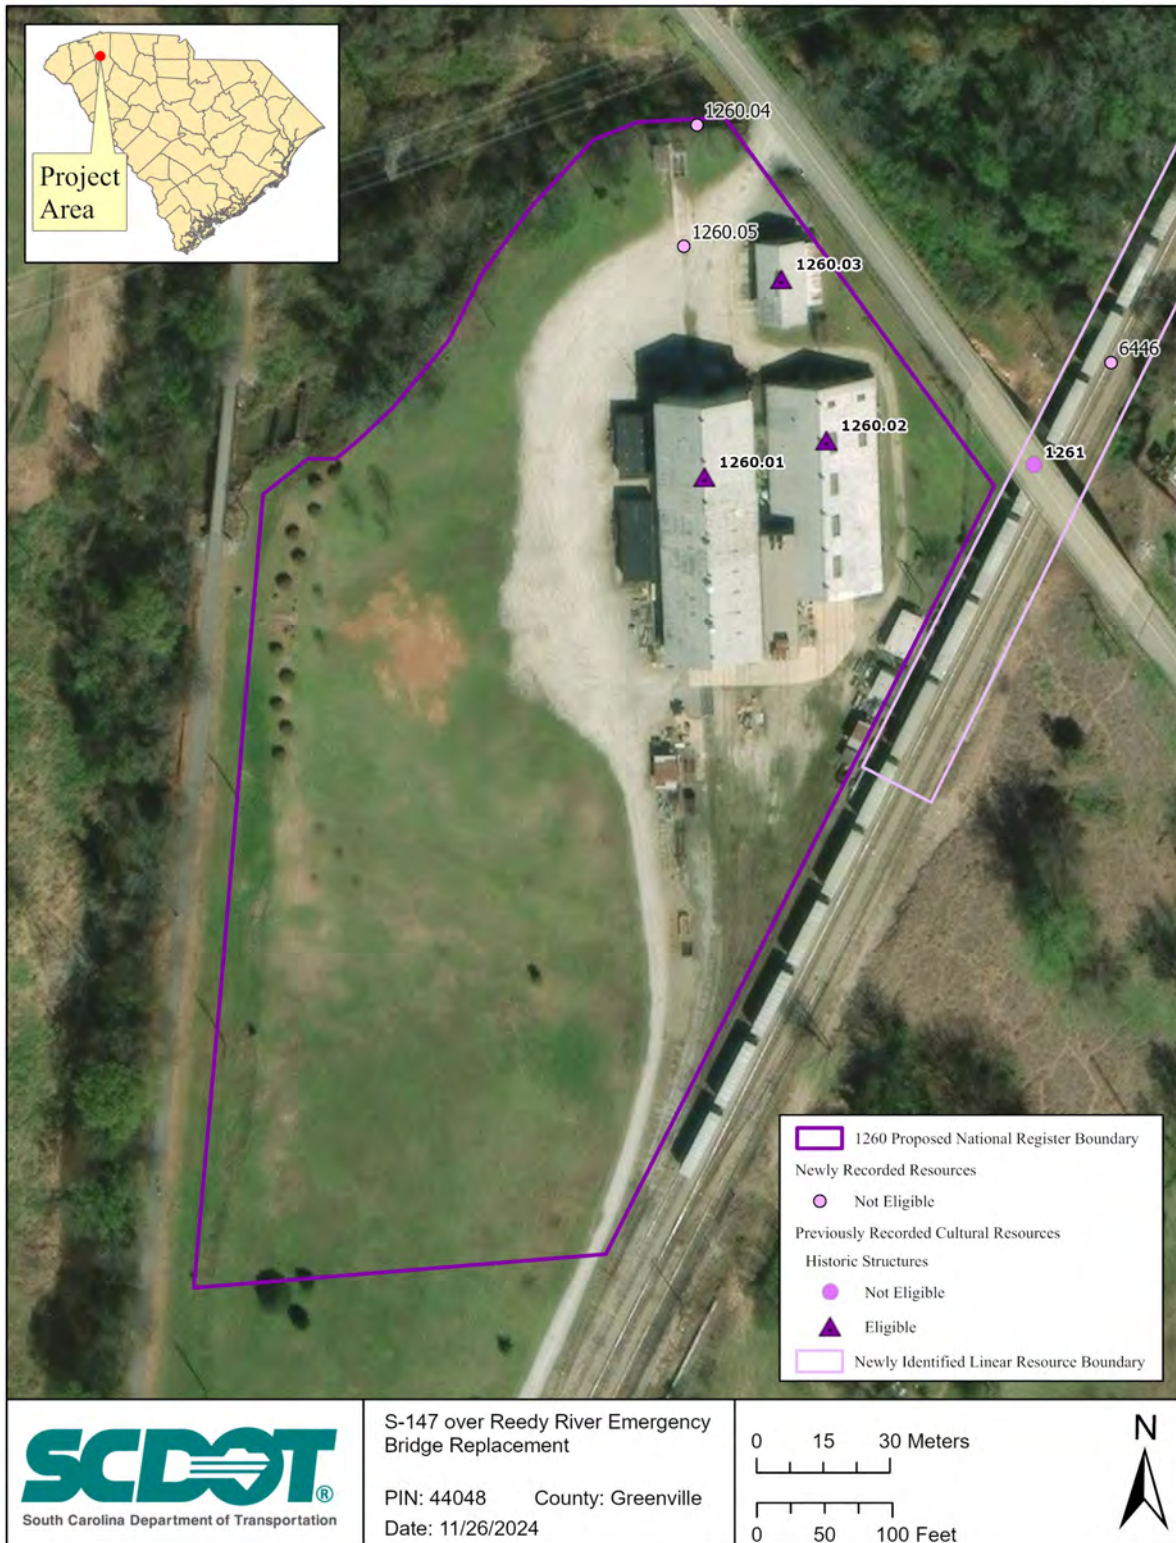
Figure 16. Proposed NRHP Boundary for SHPO Site No. 1260

SHPO Site Nos. 1260.01-1260.03 are the three remaining buildings associated with the River Junction Shops of the Piedmont and Northern Railroad, including the River Junction Machine Shop (SHPO Site No. 1260.01), the River Junction Car Barn (SHPO Site No. 1260.02), and the River Junction Substation (1260.03). These buildings, which were constructed from 1912-1913, served as the principal maintenance shops for the South Carolina Division of the Piedmont and Northern Railway, and later the entire line. These resources were originally recorded by SCDOT in 2002 and recommended eligible for listing on the National Register of Historic Places (NRHP) under Criteria A, B, and C (Roberts 2002). A detailed history and evaluation of these resources is presented in that report and summarized here. This survey revisited the three previously recorded resources and recorded an additional two components of the River Junction Shops as subresources, SHPO Site No. 1260.04, a concrete retaining wall/possible foundation ruin and SHPO Site No. 1260.05, the railroad segments utilized by the shops. A number of modern shed storage buildings and office trailers are also located on the property, which were not recorded. This survey also proposes a National Register boundary for the entire resource (**Figure 16**). **Figures 17-18** show views of the resource as a whole.

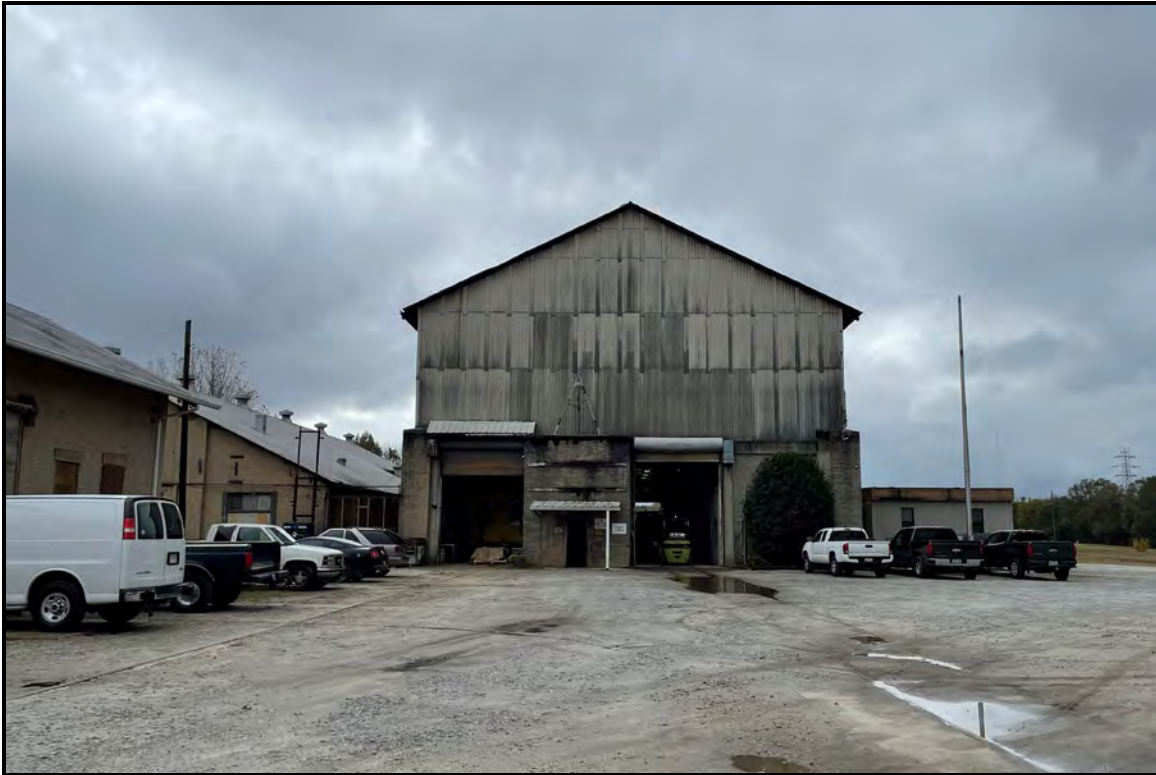
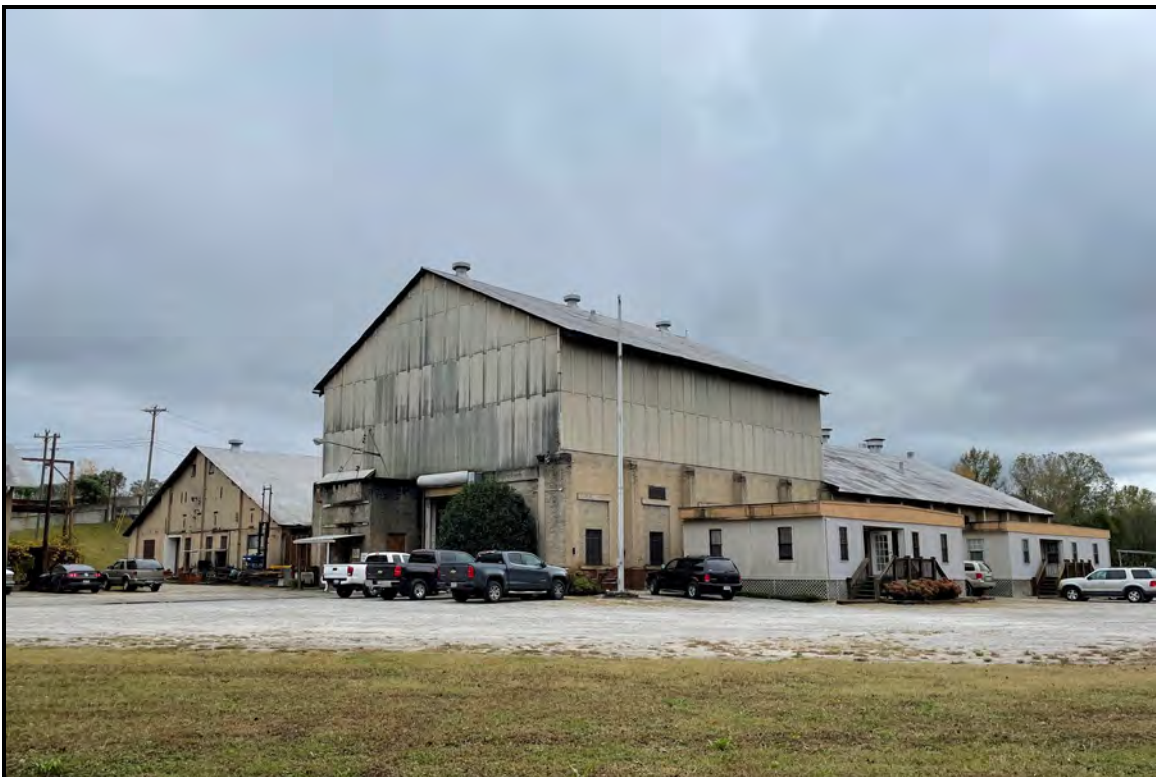
Figure 19. SHPO Site No. 1260.01, looking south

Figure 20. SHPO Site No. 1260.01, looking east

SHPO Site No. 1260.01, the River Junction Machine Shop, was originally built as a one-story, rectangular, brick industrial building with an end to front gabled raised seam metal roof. The building was used for the construction and repair of railroad cars and locomotives. According to Roberts (2002), the northern end of the building was raised two stories in height in the early 1950s. The original one story building is comprised of brick walls with buttressing along the eastern and western sides. The walls of the extended stories are made of sheet metal. The lower 15 courses of the brick walls are red while the rest of the walls are made of light, buff, or yellow colored bricks. This two-color brick style is typical of numerous Piedmont and Northern Railway buildings (Roberts 2002). Two garage bay doors are present on the northern façade and three bays are present on the southern façade. Three sets of train tracks lead into the garage bays on the south end and two lead out of the bays on the north end (see SHPO Site No. 1260.05). Few alterations have occurred to SHPO Site No. 1260.01 since its original documentation in 2002. A modern office trailer that was once situated on the northern façade of the building has been replaced by two office trailers along the western façade. Otherwise no other changes were evident. **Figures 19-20** show the resource at the time of survey.

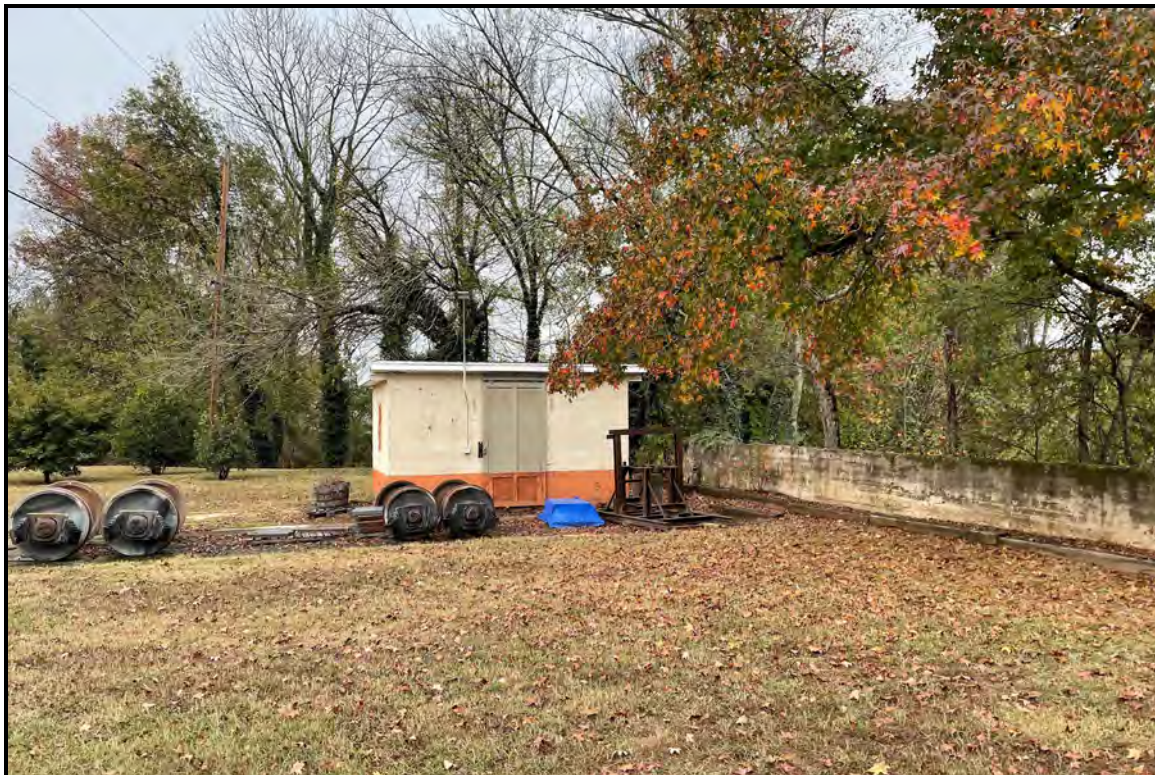
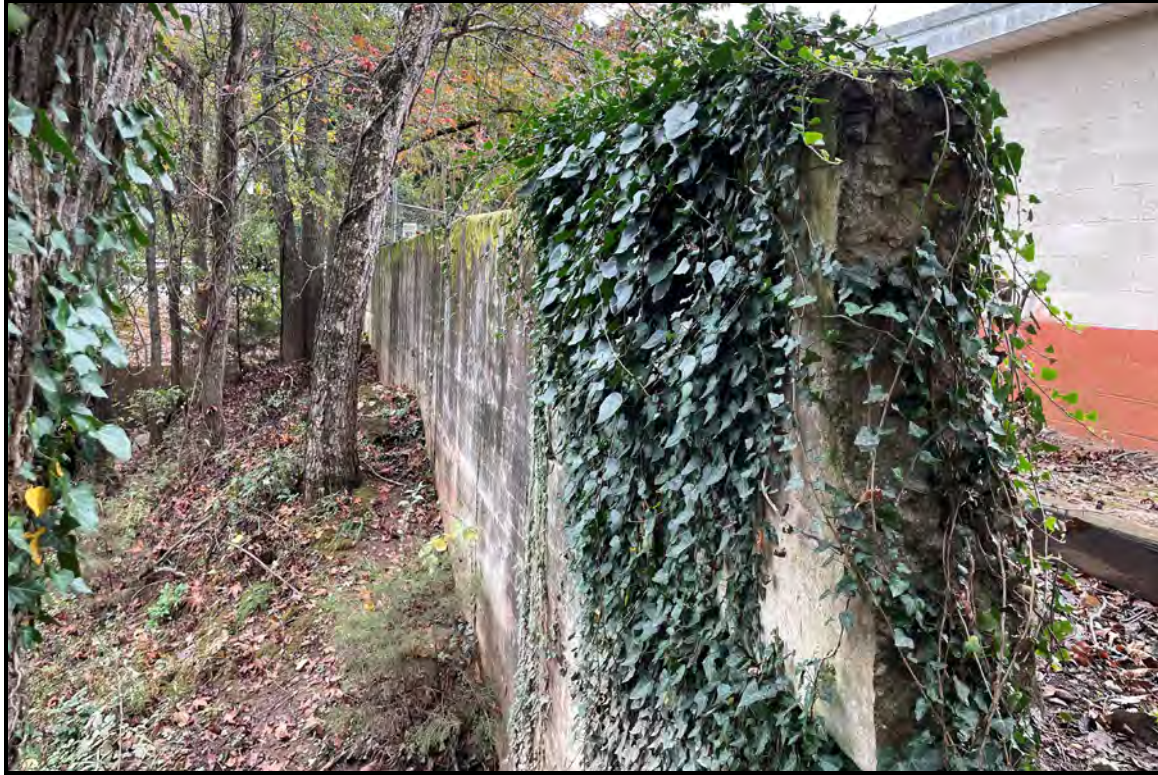
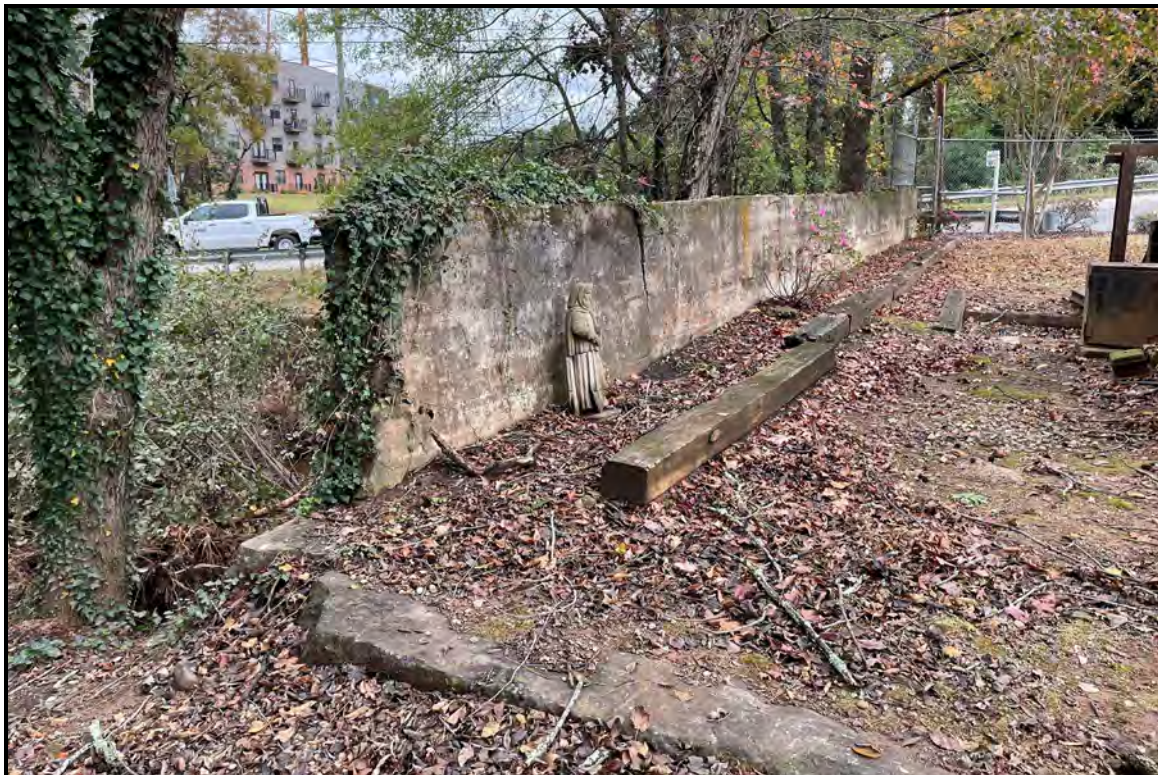
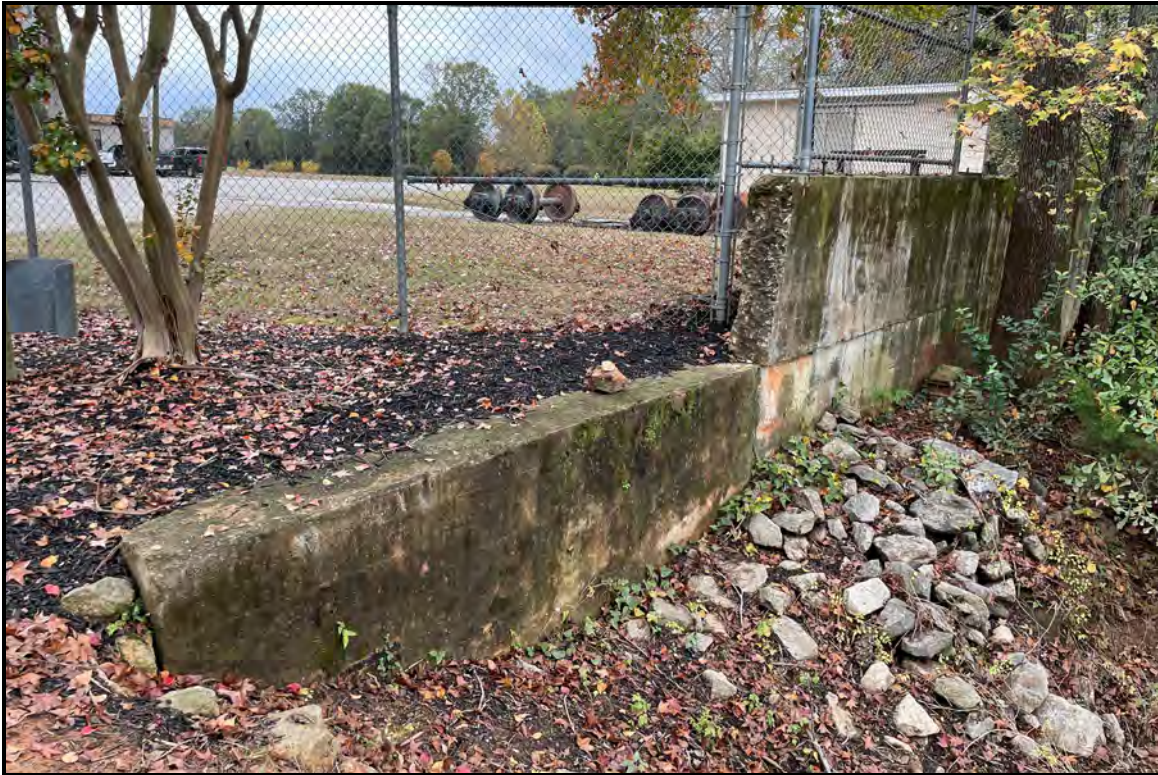
Figure 26. SHPO Site No. 1260.04, looking northwest

Figure 27. SHPO Site No. 1260.04, looking east

Figure 28. SHPO Site No. 1260.04, looking northeast

Figure 29. SHPO Site No. 1260.04, looking southwest

Situated on the northern end of the River Junction shop property adjacent to the bank of an unnamed tributary to the Reedy River is SHPO Site No. 1260.04, a remnant of a concrete retaining wall and possible foundation of an original River Junction Shop building. The wall stands approximately 4 feet tall from the ground surface on the River Junction shop side of the wall. The ground surface is lower on the river bank side of the wall, where the concrete wall is almost twice as tall. The wall extends approximately 70 feet (22 meters) westward along the bank of the tributary. A modern concrete block storage building is located approximately 10 feet south of the wall. The portion of the wall closest to S-147 has been damaged and does not extend to the full height in this location. The wall turns southward at its western extent, but is only present along the ground surface in this location. The wall is situated near the former location of the River Junction Carpentry and Paint Shop, as shown on a 1927 Sanborn Fire Insurance map (**Figure 25**). Historic imagery indicates the River Junction Carpentry and Paint shop was demolished sometime post-1983. The Sanborn indicates that this building was of frame construction with metal siding and does not indicate it had a concrete foundation. However, this Sanborn also shows that the other River Junction Shop buildings are constructed of concrete, when they are constructed of brick, so the accuracy of its information can be called into question. Given this, it is unclear if the wall is a retaining wall in its own right, or related to the former shop building. Additional research would be needed to determine its original function. **Figures 26-29** show the resource at the time of survey.

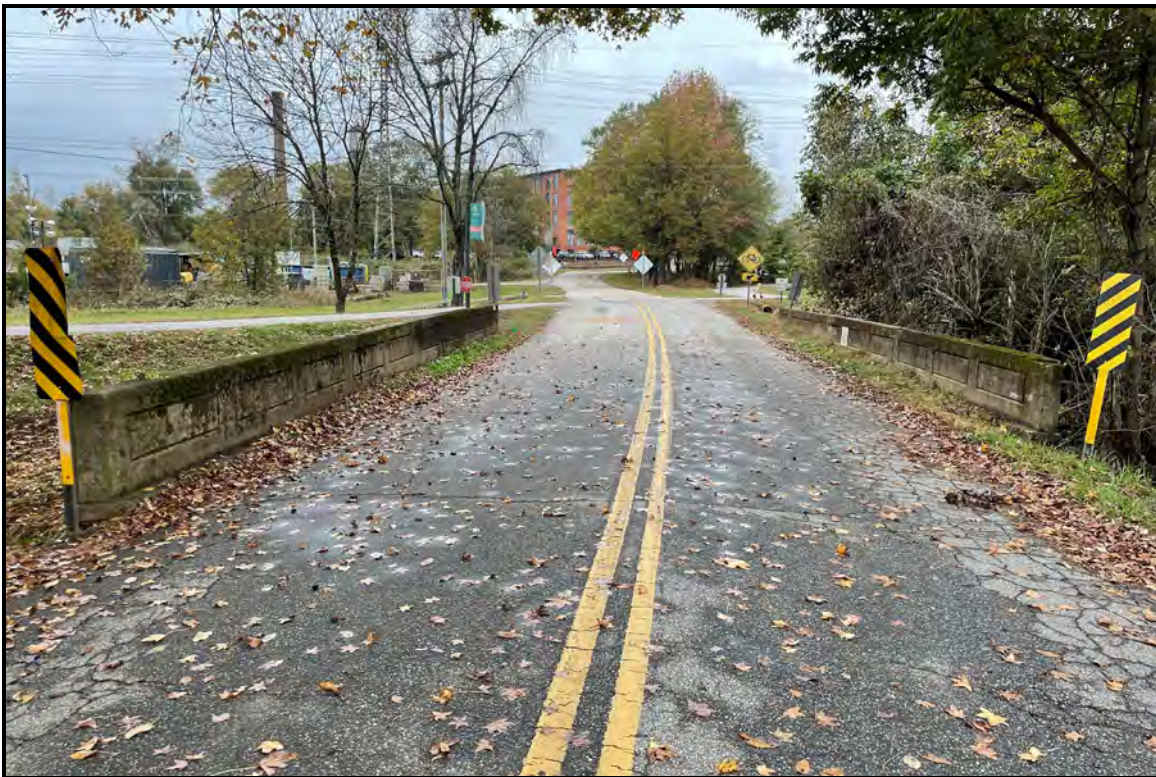
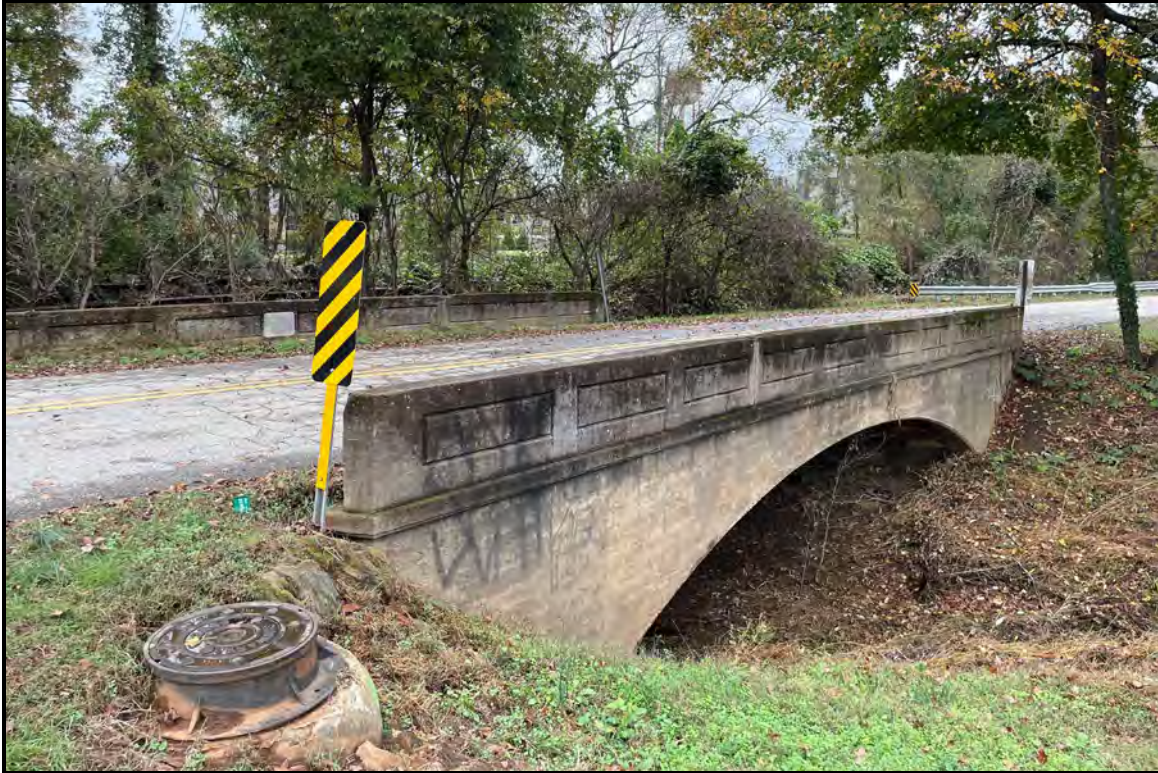
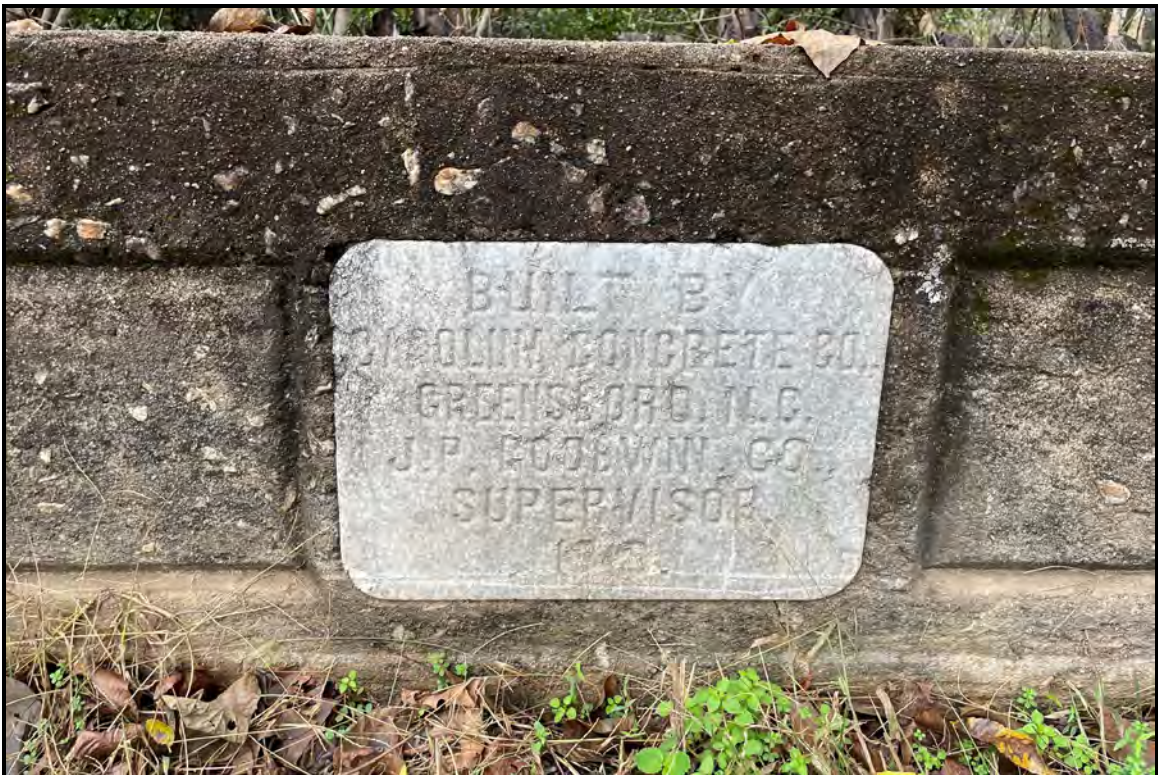
Figure 32. SHPO Site No. 6444, looking northwest

Figure 33. SHPO Site No. 6444, looking southeast

Figure 34. SHPO Site No. 6444, plaque detail

SHPO Site No. 6444 is an intact and notable early example of a bridge type once common in the 1910s and 1920s and the only extant example of an unaltered standard deck arch bridge in Greenville County. Therefore, SHPO Site No. 6444 is recommended eligible for the NRHP under Criterion C for significance in engineering design at the local level. The bridge was constructed by the Carolina Concrete Company under the supervision of Greenville County Supervisor J.P. Goodwin, however Goodwin or individuals associated with the Carolina Concrete Company are not known to be significant to the development of early twentieth century bridge design in South Carolina. Therefore, SHPO Site No. 6444 is recommended as not eligible under Criterion B. The S-147 over Brushy Creek crossing does not hold great significance to the overall transportation network or industrial development of Greenville County and SHPO Site No. 6444 is recommended not eligible for the NRHP under Criterion A.

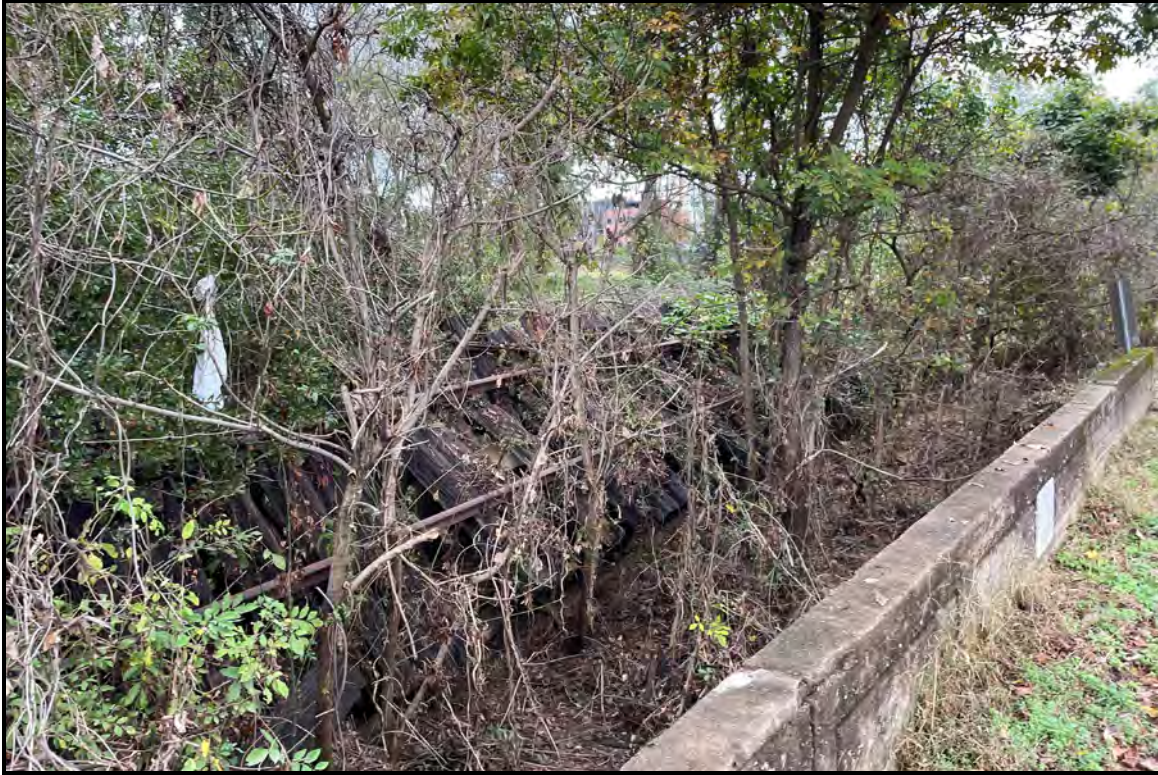
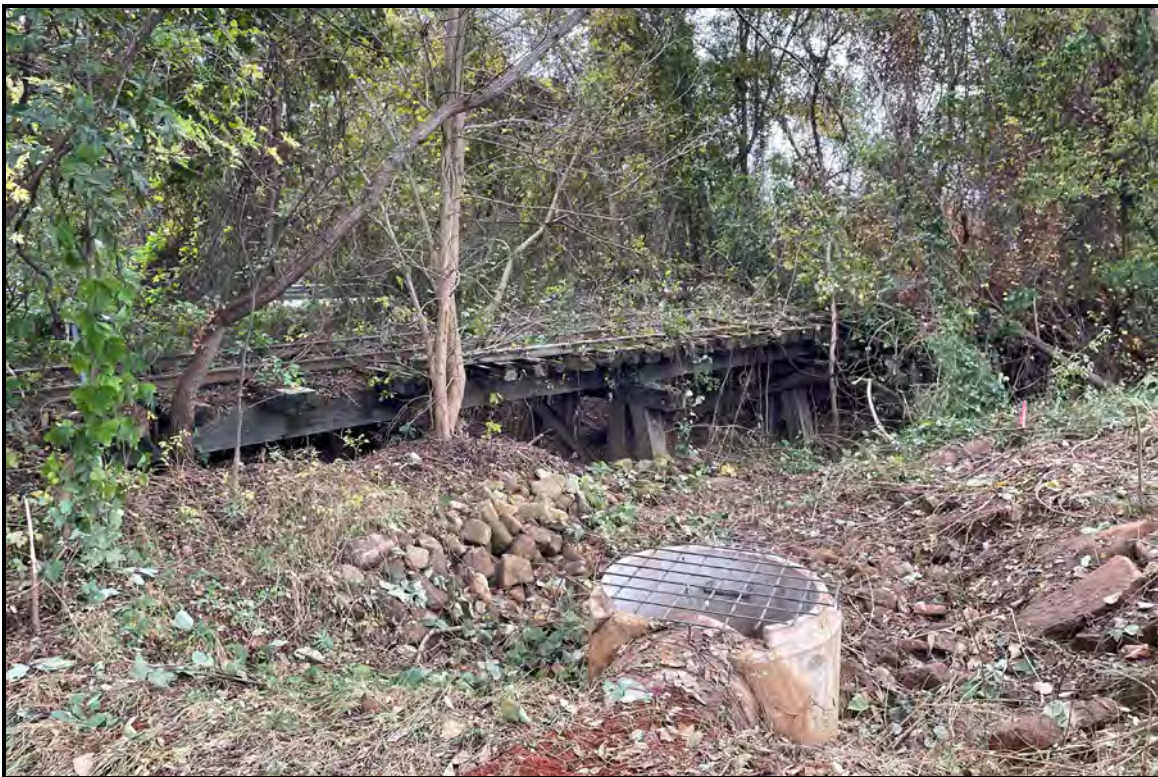
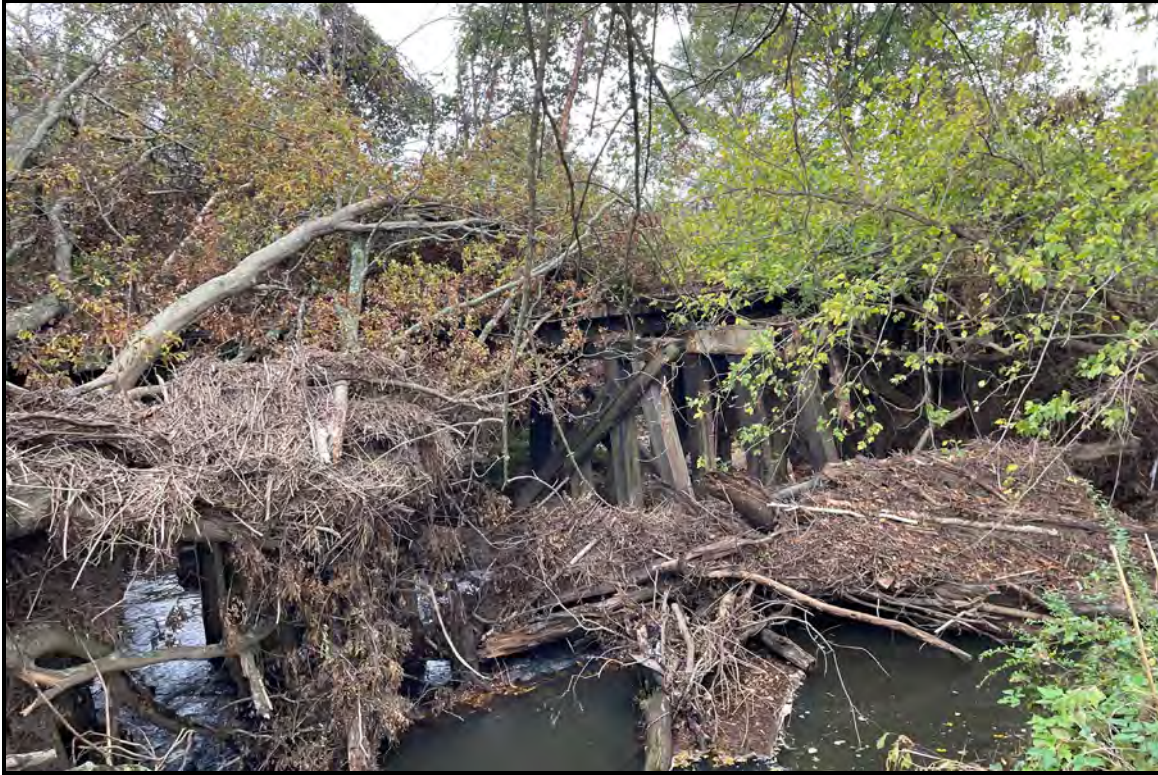
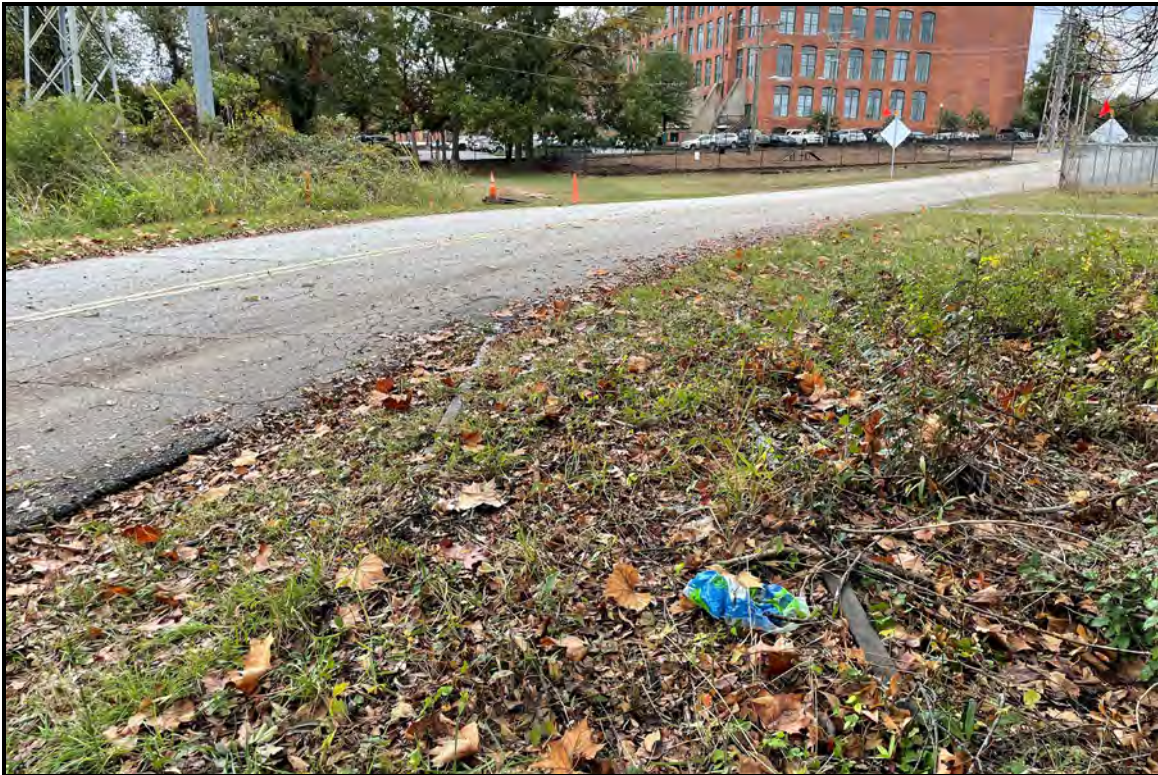
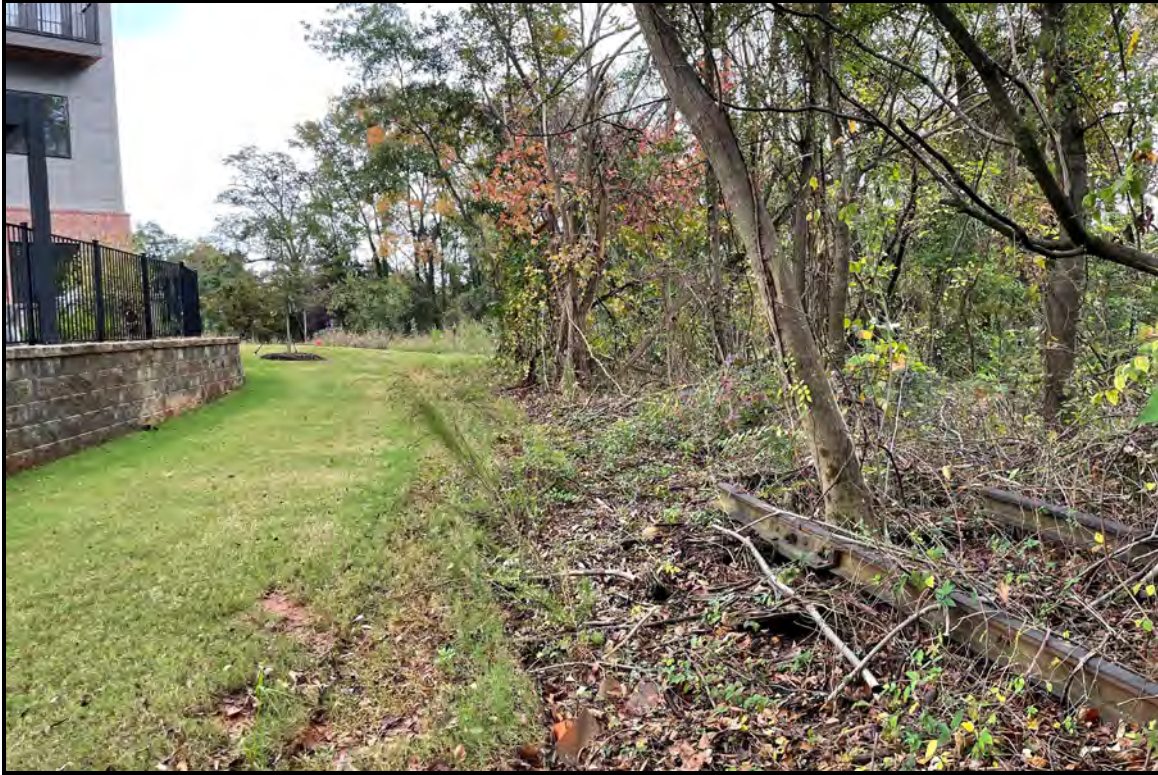
Figure 35. SHPO Site No. 6445, looking southeast from SHPO Site No. 6444

Figure 36. SHPO Site No. 6445, trestle bridge approach, looking northwest from Water Tower Apartments

**Figure 37. SHPO Site No. 6445, trestle bridge over Reedy River, looking northwest from Water Tower Apartments**

**Figure 38. SHPO Site No. 6445, rail remnants on either side of S-147, looking northwest from Swamp Rabbit Trail toward Monaghan Mill**

Figure 39. SHPO Site No. 6445, rail remnant, looking southeast toward Water Tower Apartments entrance road

Currently an extant portion of this segment runs westward from the entrance road of the Water Tower Apartment complex to the intersection of S-147 with the Swamp Rabbit Trail. The segment was cut off during construction of the Swamp Rabbit trail, but additional tracks associated with the railroad segment were observed on the northern side of S-147 in the small wooded area just east of the Swamp Rabbit Trail and on the southern side of S-147 adjacent to Monaghan Mill. The segment is a single track system of standard gauge. The track crosses the Reedy River with a wooden trestle bridge.

The integrity of the railroad segment has been significantly affected by neglect and decay. The eastern and western most portions of the segment now consist of only the metal tracks. The wooden crossties have begun to decay and in many locations trees grow between the tracks. The wooden trestle bridge is more intact and is still standing with intact track and crossties in most locations. However, sections of the bridge have been damaged by tree falls and the section closest to S-147, near SHPO Site No. 6444, has begun to collapse and tilt southward. **Figures 35-39** show the resource at the time of survey.

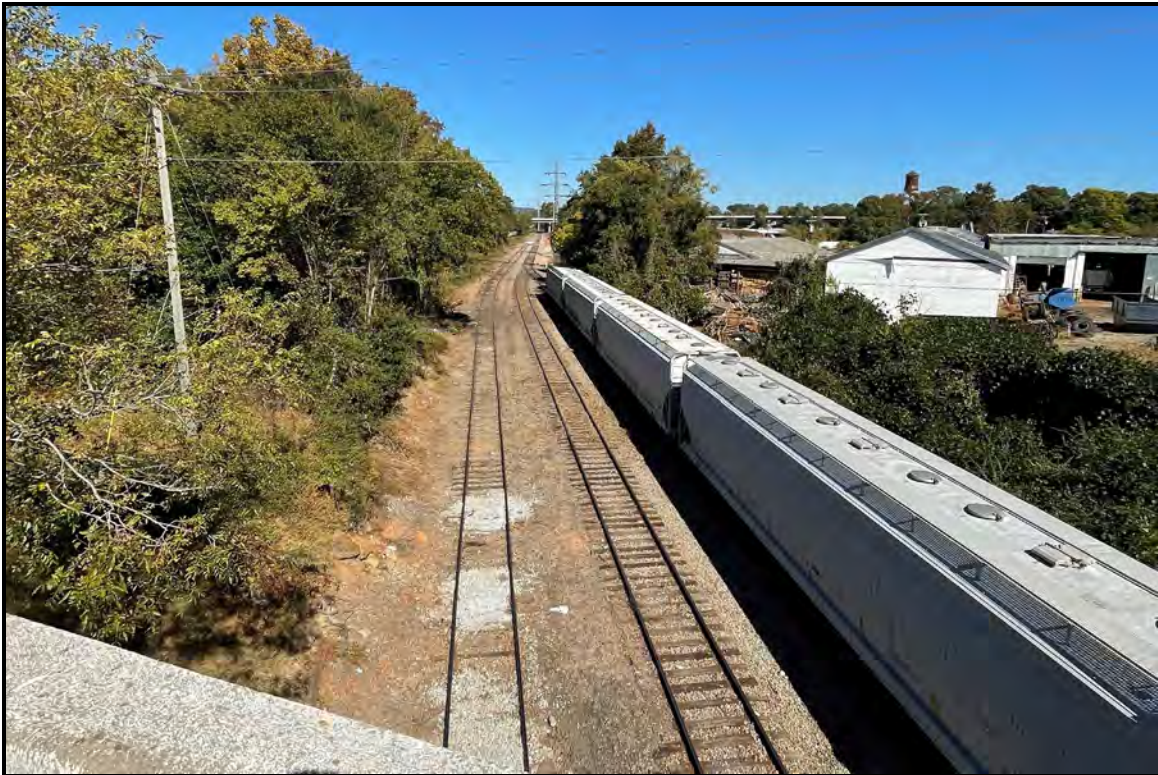
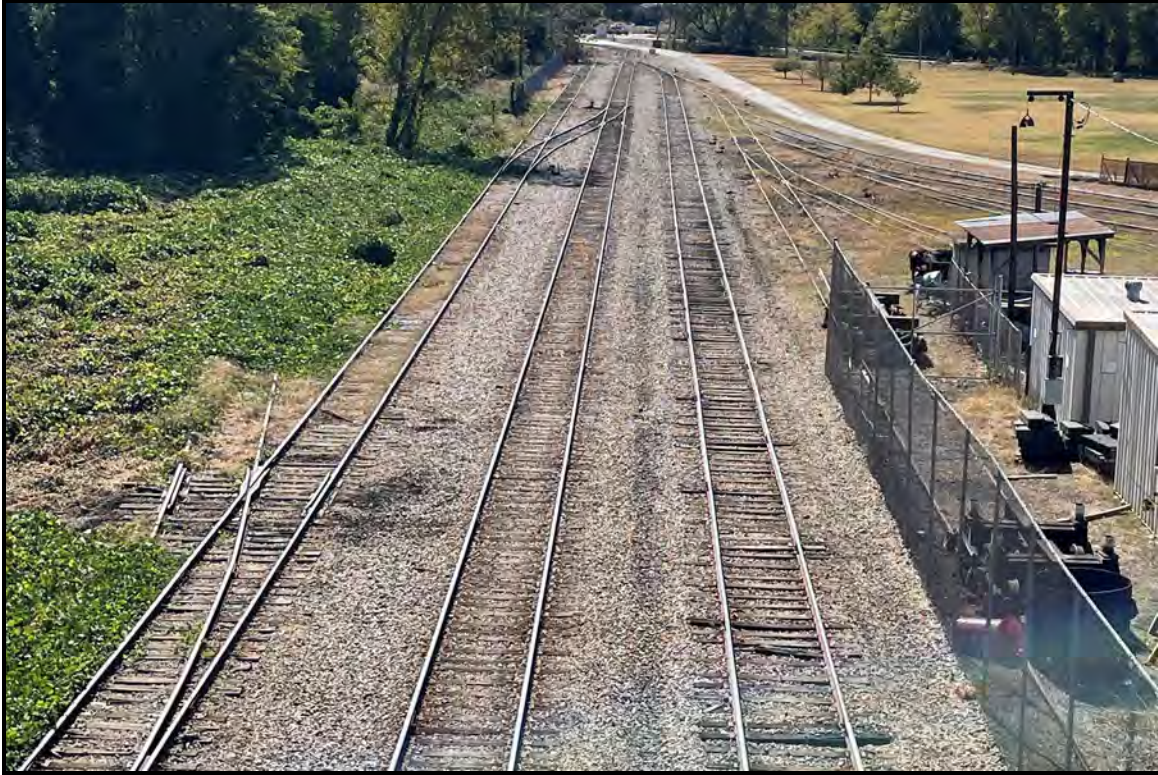
Figure 40. SHPO Site No. 6446, looking east from S-147 over CSX Railroad bridge

Figure 41. SHPO Site No. 6446, looking west from S-147 over CSX Railroad bridge

In this location SHPO Site No. 6446 is comprised of a three track system of standard gauge. The primary materials which comprise the resource, ballast, crossties, and tracks, have been replaced over time, however the general alignment of the rail bed remains unaltered. The railroad line traverses the APE in a northeasterly direction, passing beneath S-147. SHPO Site No. 1260.05, the railroad spur segment associated with the River Junction Shops, connects to this CSX line approximately 180 meters southwest of S-147. **Figures 40-41** show the resource at the time of survey.

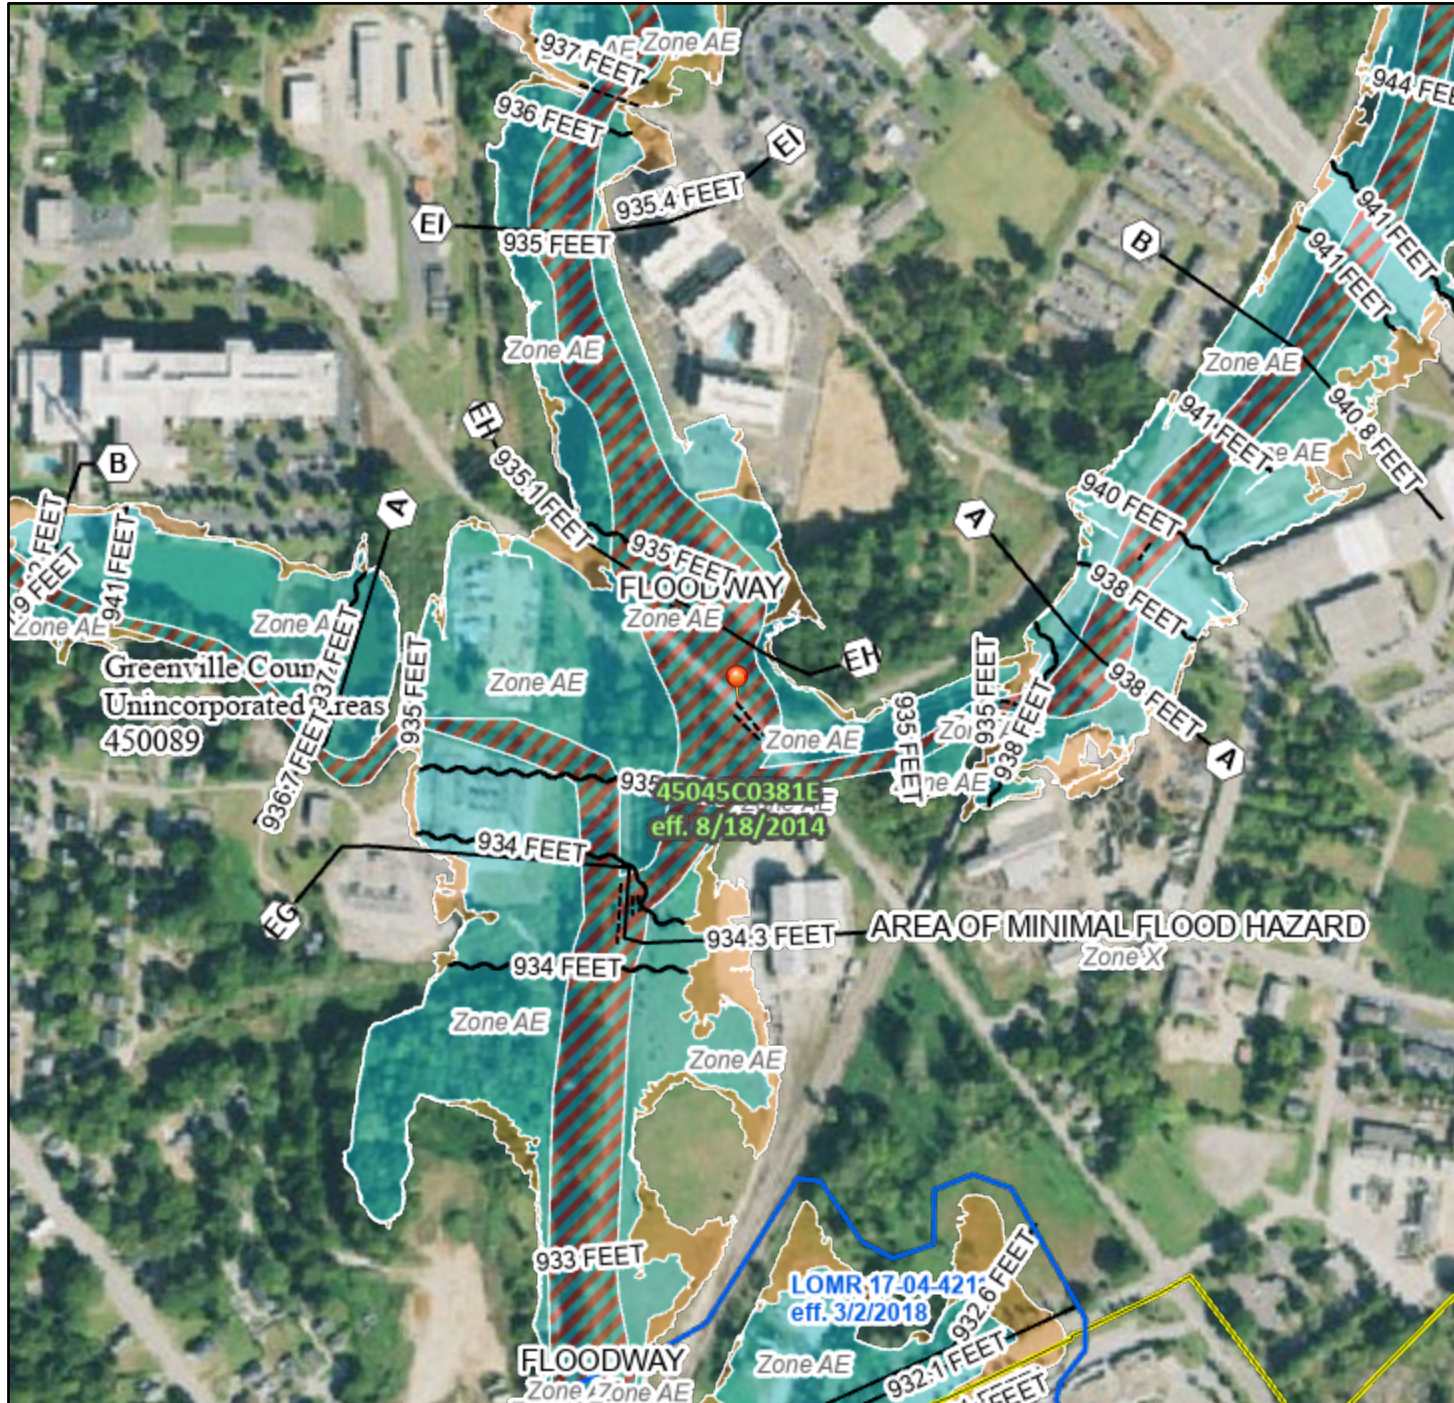
# National Flood Hazard Layer FIRMette

The flood hazard information is derived directly from the authoritative NFHL web services provided by FEMA. This map was exported on **10/29/2024 at 2:28 PM** and does not reflect changes or amendments subsequent to this date and time. The NFHL and effective information may change or become superseded by new data over time.
