S-13-531 (Henry Funderburk Road) Bridge Replacement over Mangum Branch

Chesterfield County, SC Geotechnical Baseline Report

August 21, 2023 (rev1) | SCDOT Project ID: P041959
Terracon Project No.: 7323P100

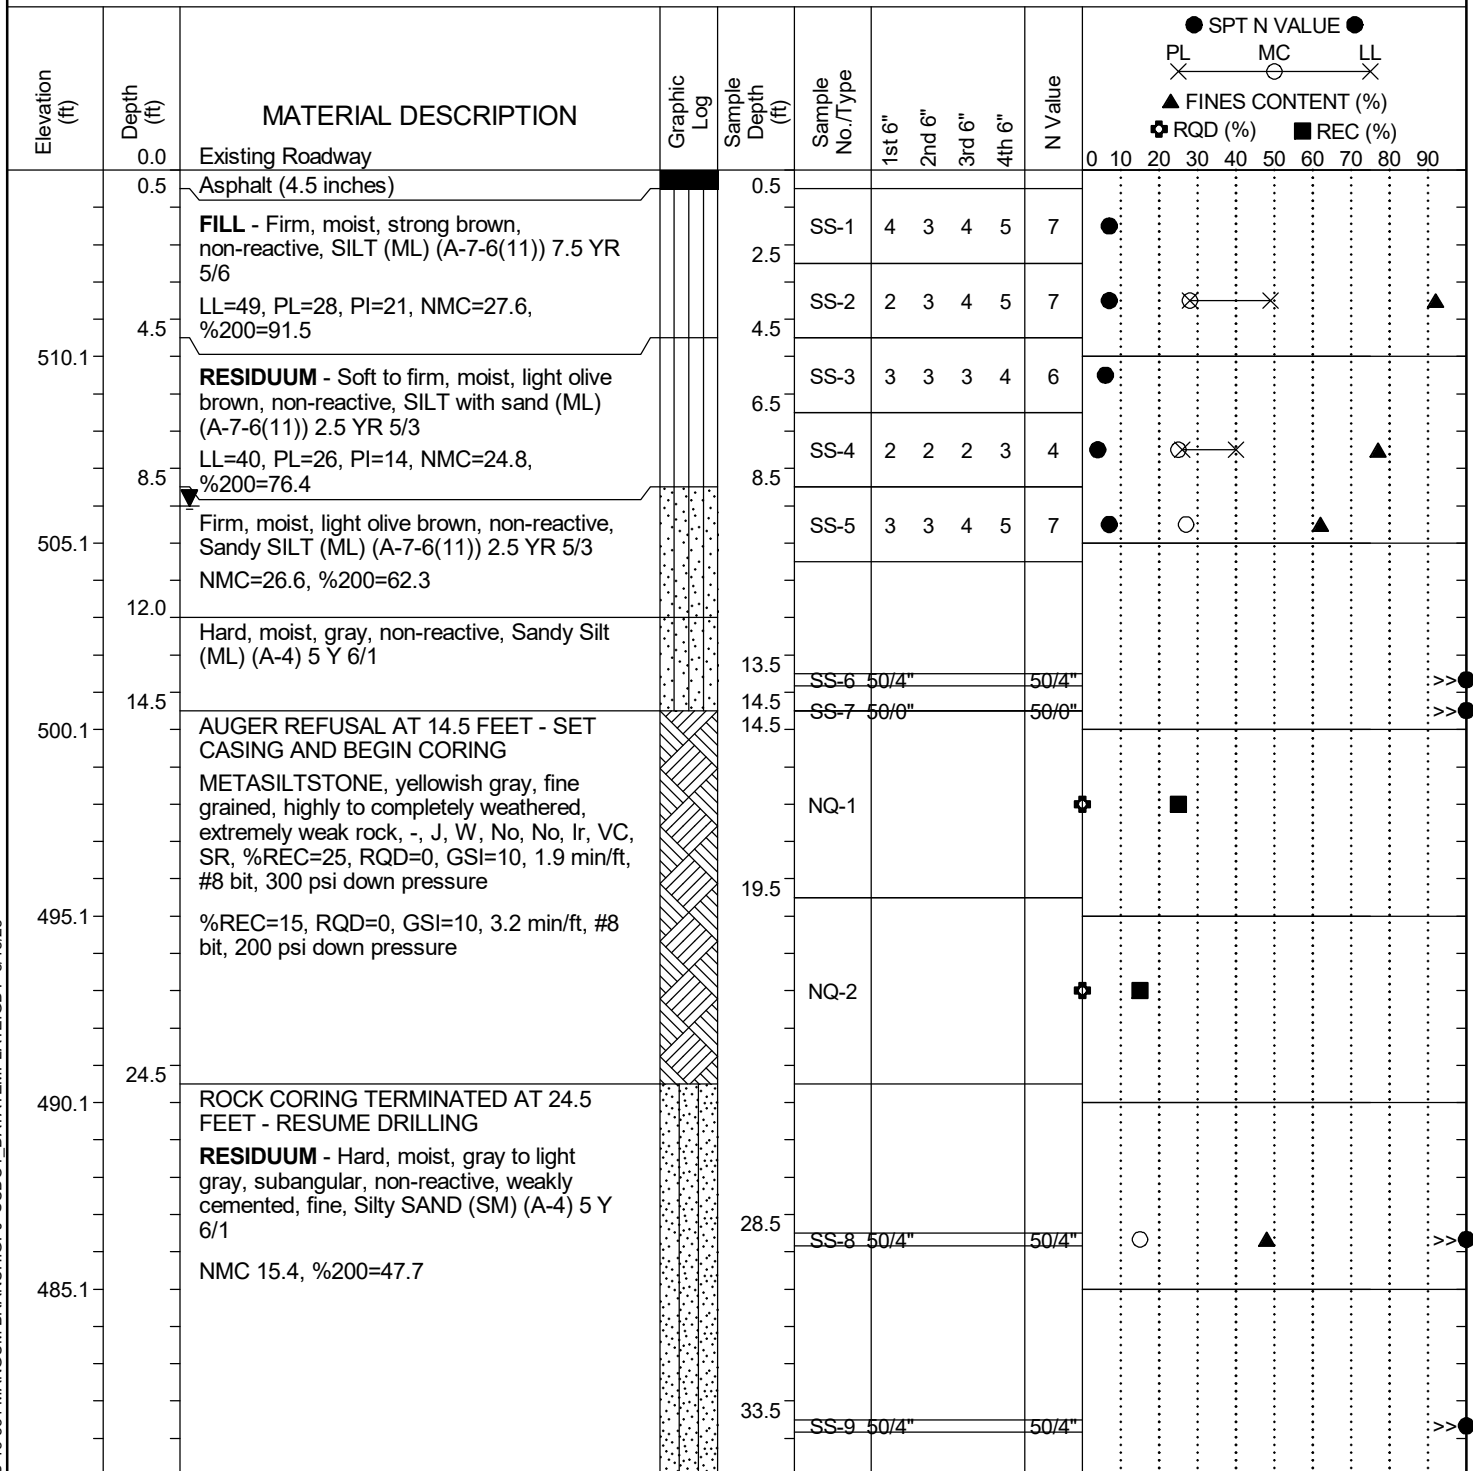
SCDOT Soil Test Log

Project ID: P041959				County: Chesterfield		Boring No.: S-13-531-1		
Site Description:		S-13-531 RBO Mangum Branch					Route: S-13-531	
Eng./Geo.: S.Pardy		Boring Location: 21+11.59		Offset: 2.14 L		Alignment: Existing		
Elev.: 515.1 ft		Latitude: 34.799302		Longitude: -80.457843		Date Started: 6/1/2023		
Total Depth: 65 ft		Soil Depth: 55 ft		Core Depth: 10 ft		Date Completed: 6/2/2023		
Bore Hole Diameter (in): 4		Sampler Configuration		Liner Required: Y (N)		Liner Used: Y (N)		
Drill Machine: DR 543		Drill Method: RW/RC		Hammer Type: Automatic		Energy Ratio: 93.5%		
Core Size: NQ2		Driller: C. Costner		Groundwater: TOB N.M.		24HR 9 ft

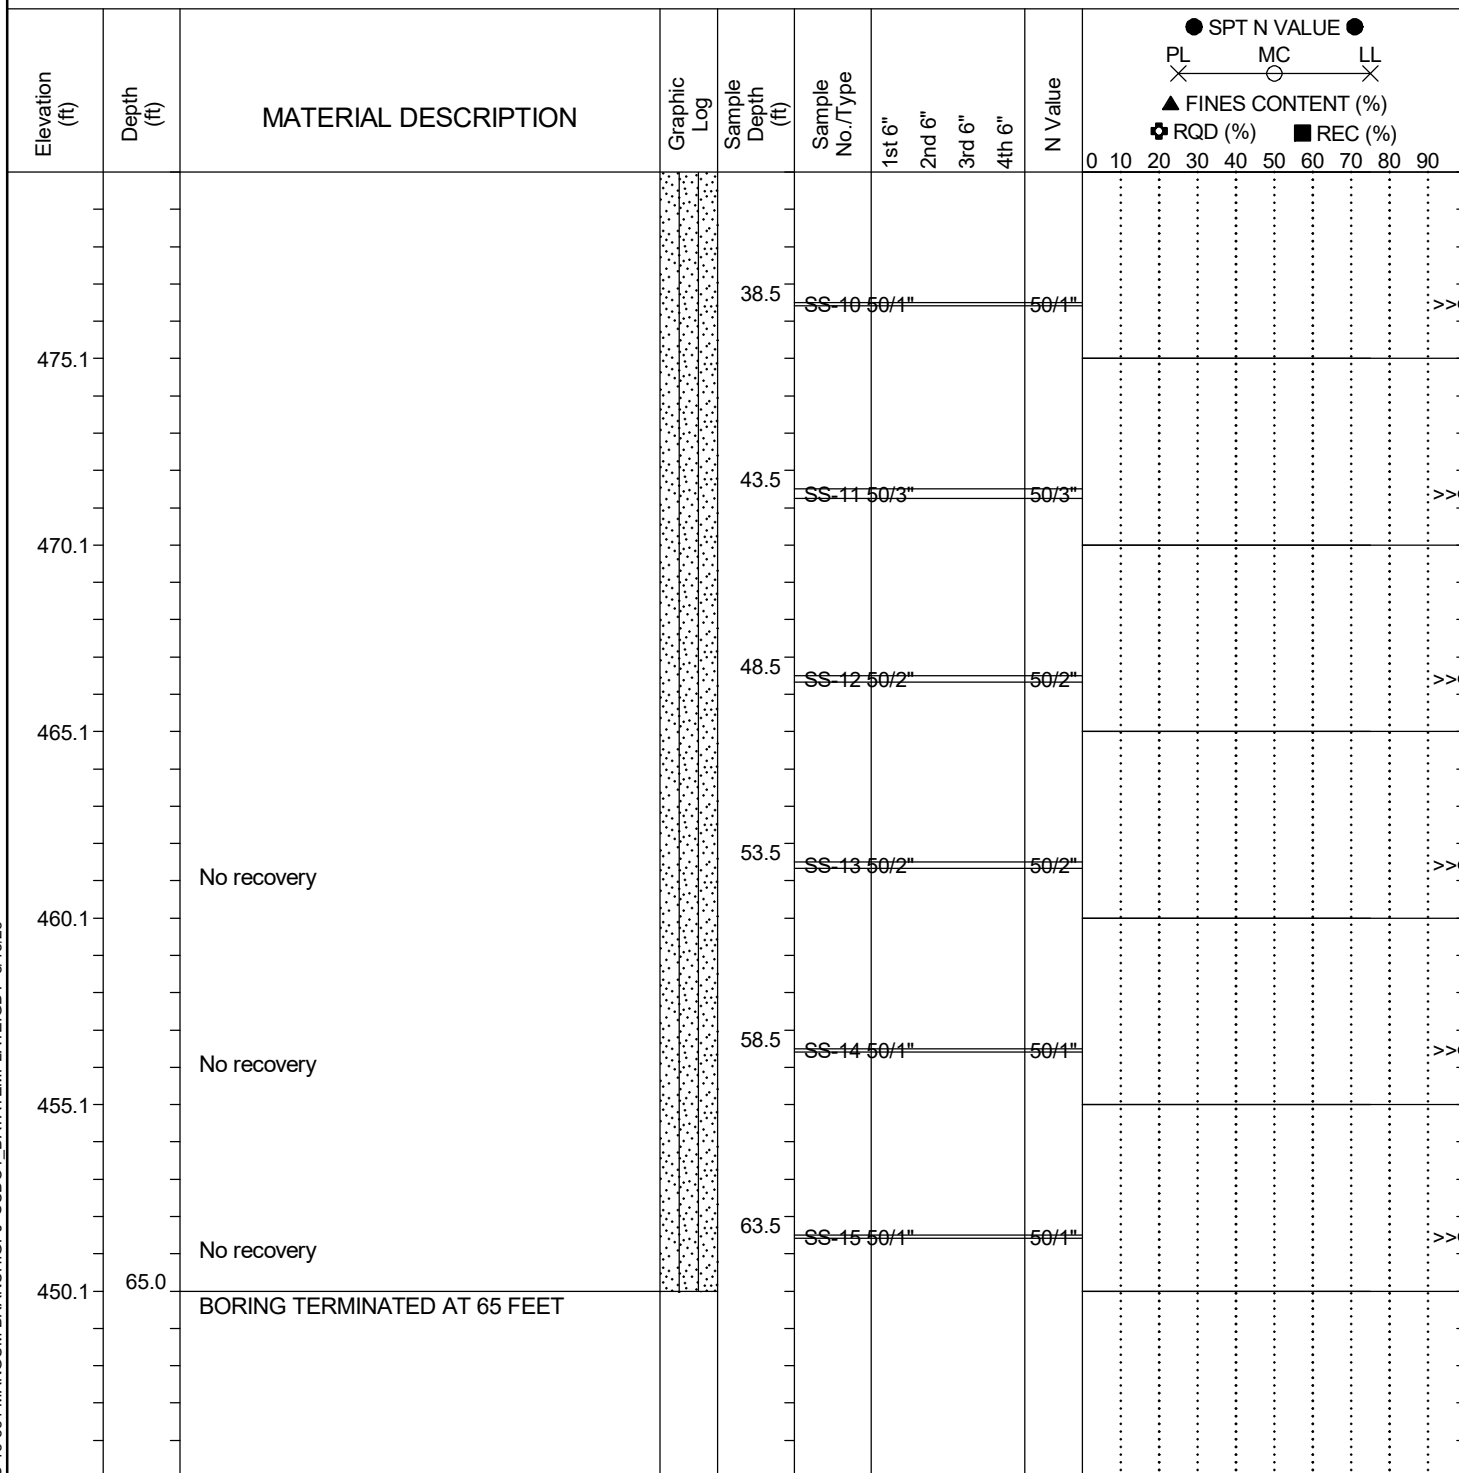
SCDOT Soil Test Log

Project ID:	P041959	County:	Chesterfield	Boring No.:	S-13-531-1
Site Description:	S-13-531 RBO Mangum Branch			Route:	S-13-531
Eng./Geo.:	S.Pardy	Boring Location:	21+11.59	Offset:	2.14 L
Elev.:	515.1 ft	Latitude:	34.799302	Longitude:	-80.457843
Date Started:	6/1/2023				
Total Depth:	65 ft	Soil Depth:	55 ft	Core Depth:	10 ft
Date Completed:	6/2/2023				
Bore Hole Diameter (in):	4	Sampler Configuration		Liner Required:	Y (N)
Liner Used:	Y (N)				
Drill Machine:	DR 543	Drill Method:	RW/RC	Hammer Type:	Automatic
Energy Ratio:	93.5%				
Core Size:	NQ2	Driller:	C. Costner	Groundwater:	TOB N.M.
24HR	9 ft

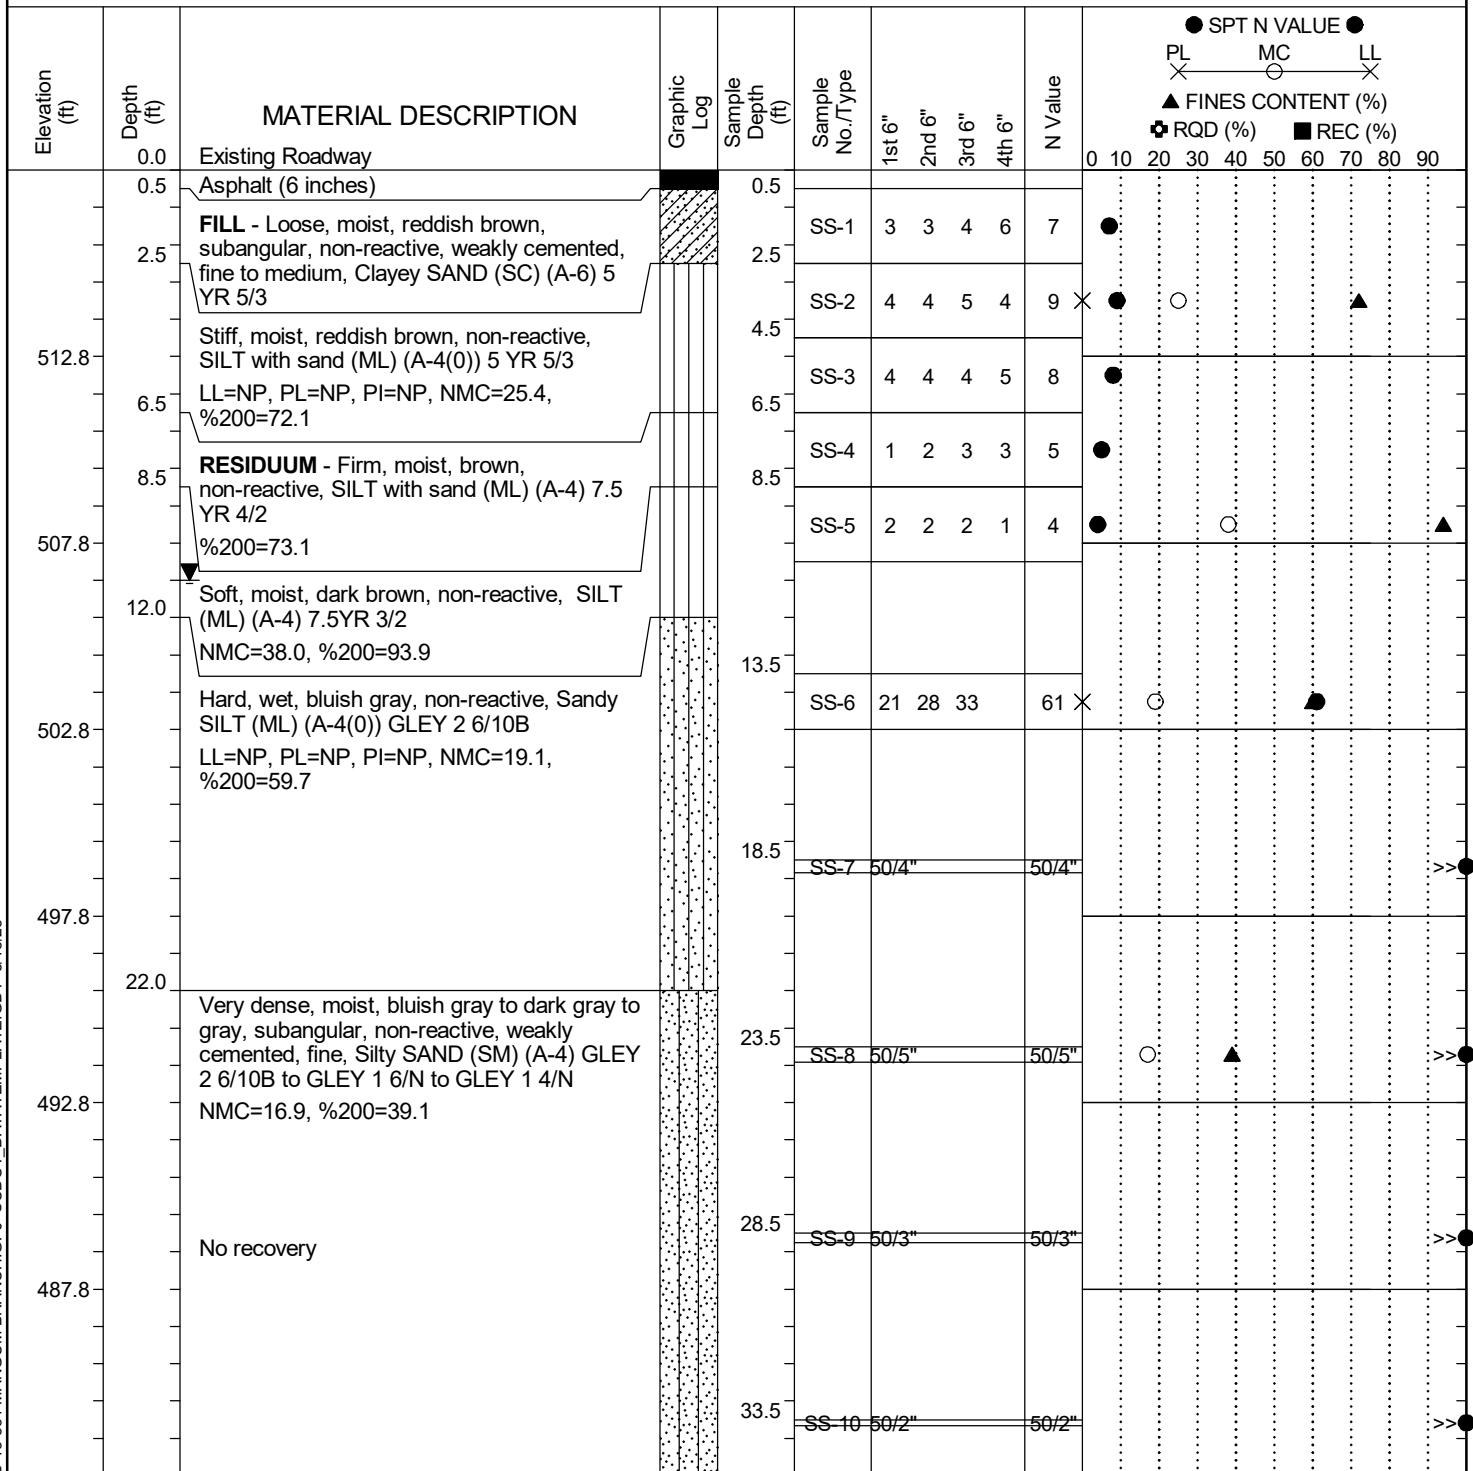
SCDOT Soil Test Log

Project ID:	P041959	County:	Chesterfield	Boring No.:	S-13-531-2
Site Description:	S-13-531 RBO Mangum Branch			Route:	S-13-531
Eng./Geo.:	W. Botts	Boring Location:	21+89.41	Offset:	2.13 L
Elev.:	517.8 ft	Latitude:	34.799306	Longitude:	-80.457584
Total Depth:	65 ft	Soil Depth:	65 ft	Core Depth:	0 ft
Date Started:	6/6/2023				
Date Completed:	6/7/2023				
Bore Hole Diameter (in):	3	Sampler Configuration	Liner Required: Y (N)		Liner Used: Y (N)
Drill Machine:	DR 543	Drill Method:	RW	Hammer Type:	Automatic
Energy Ratio:	93.5%				
Core Size:		Driller:	C. Costner	Groundwater:	TOB N.M.
24HR	11 ft

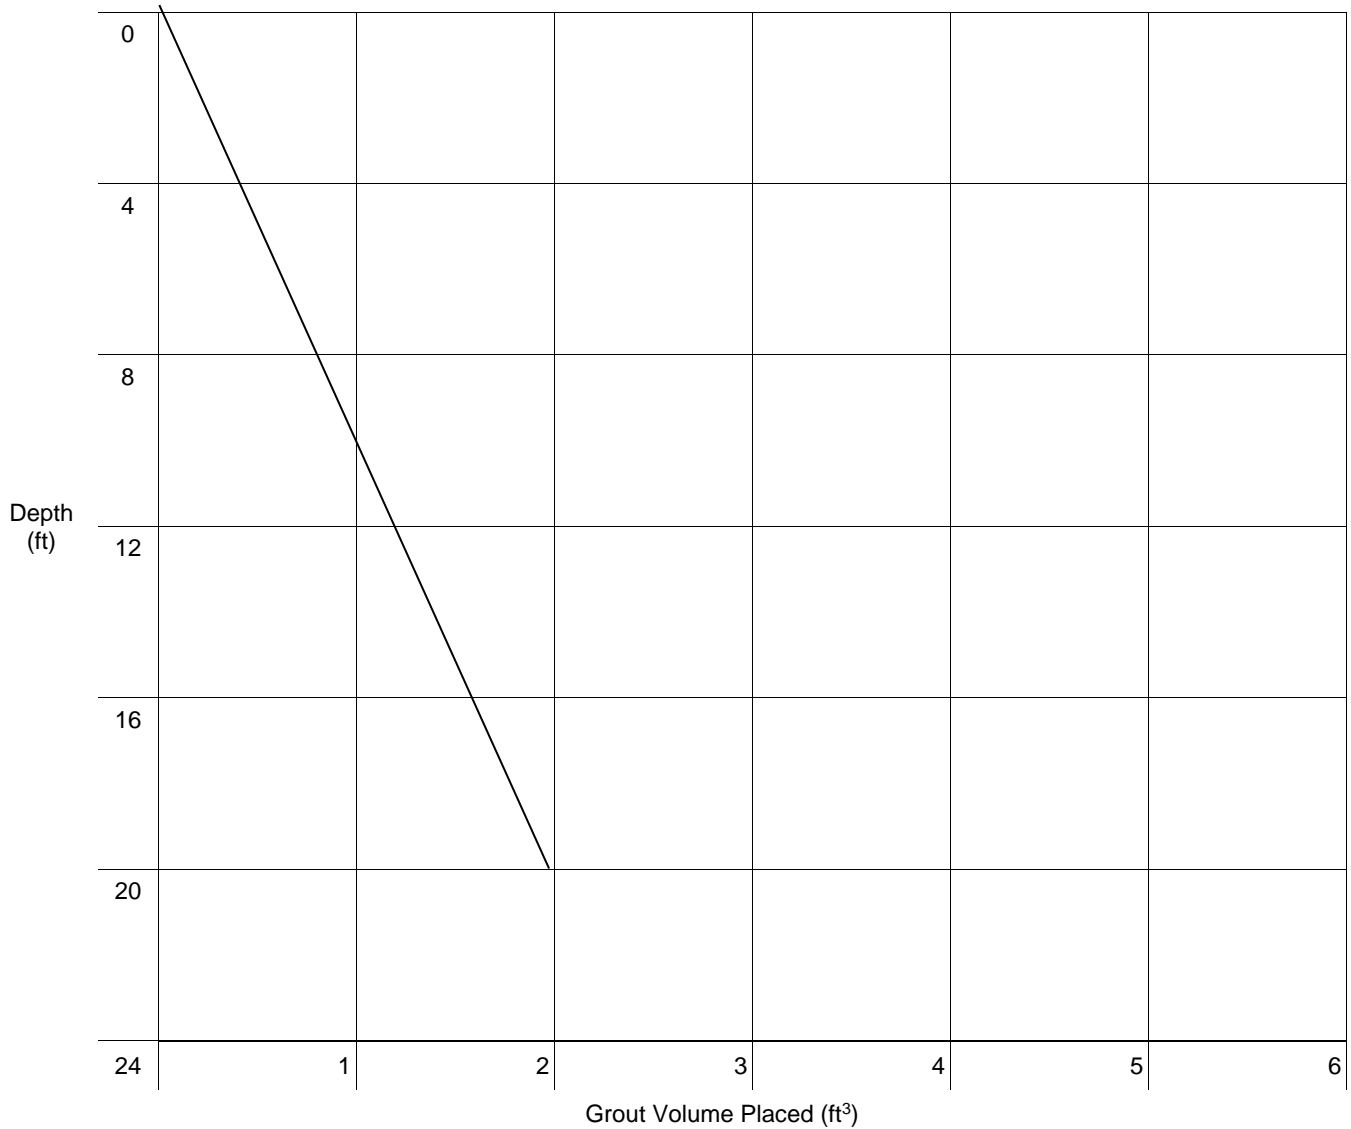
Grout Curve

Project Name:	S-13-531 RBO Mangum Branch		Test Hole No.:	S-13-531-1
Project ID:	P041959		Station:	21+11.59
Consultant Firm:	Terracon Consultants, Inc.		Offset:	2.14 L
Grouted By (Driller's Name):	Costner	Date	6/2/23	
Notes:	Mix design: 1 pound cement, 1 pound bentonite, 6 pounds water

Number of Bags On-Site	20	ea.
Depth of Test Hole Grouted	20	ft.
Diameter of Test Hole	0.33	ft.
Area of Test Hole	0.09	ft²
Volume of Test Hole	1.74	ft³
Volume of Casing (If applicable)	-	ft³
Theoretical Volume of Test Hole	1.74	ft³
Number of Bags Used	2.5	ea.
Volume Placed	2	ft³

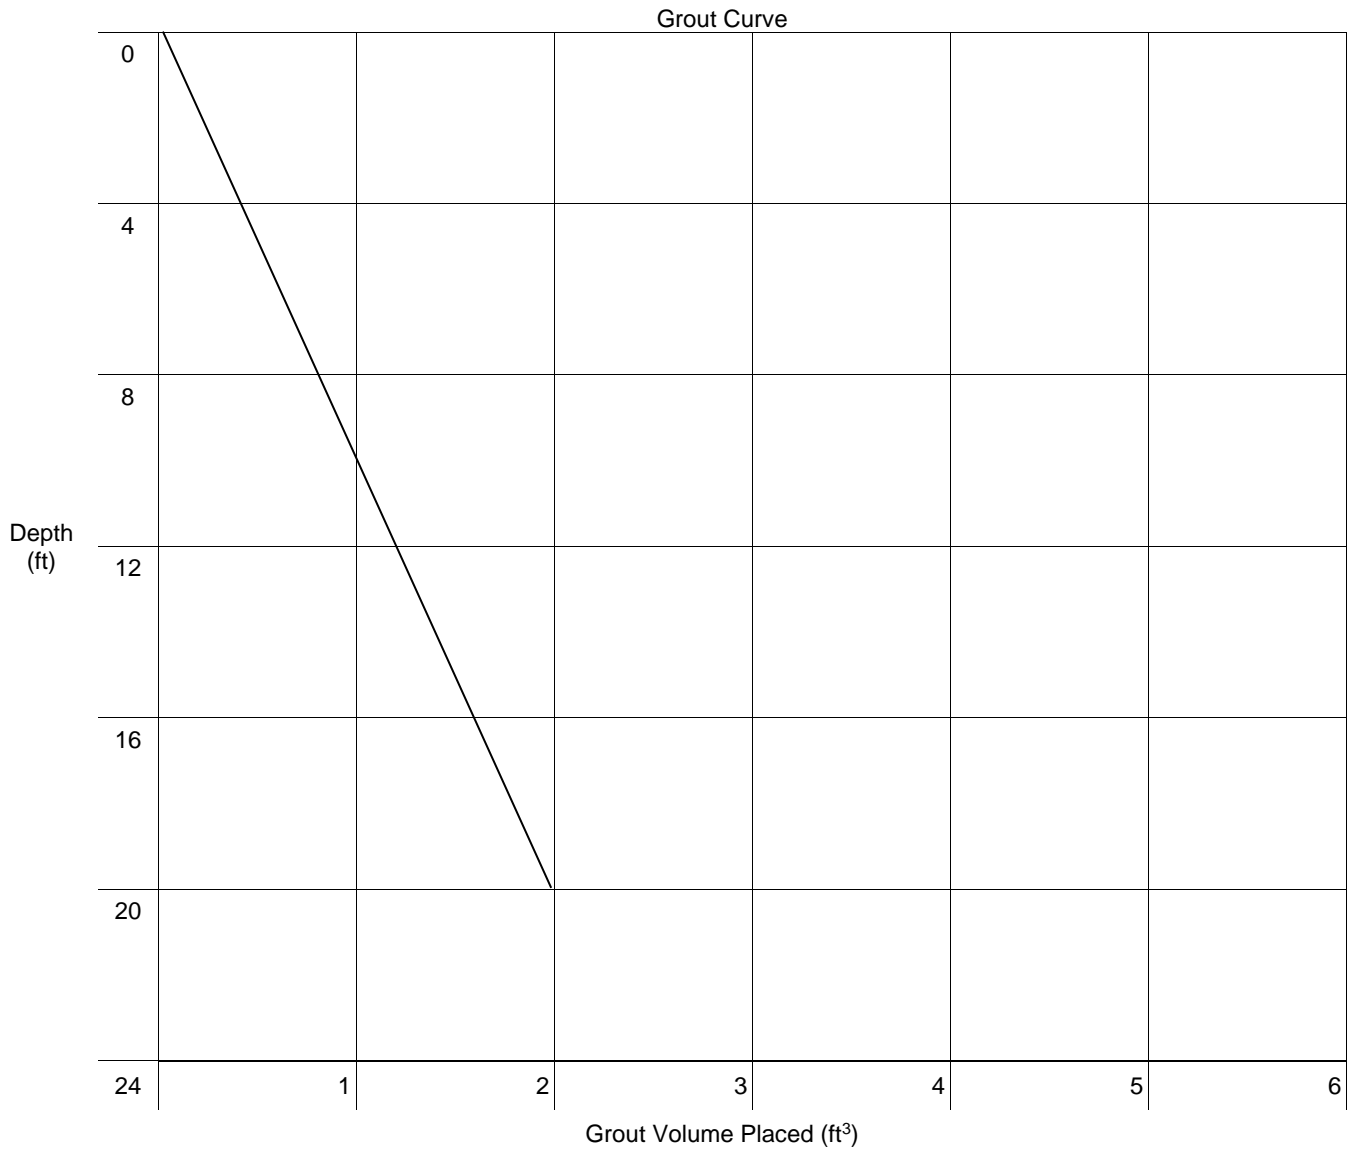
Project Name:	S-13-531 RBO Mangum Branch		Test Hole No.:	S-13-531-2
Project ID:	P041959		Station:	21+89.41
Consultant Firm:	Terracon Consultants, Inc.		Offset:	2.13 L
Grouted By (Driller's Name):	Costner	Date	6/7/23	
Notes:	Mix design: 1 pound cement, 1 pound bentonite, 6 pounds water

Number of Bags On-Site	20	ea.
Depth of Test Hole Grouted	20	ft.
Diameter of Test Hole	0.33	ft.
Area of Test Hole	0.09	ft²
Volume of Test Hole	1.74	ft³
Volume of Casing (If applicable)	-	ft³
Theoretical Volume of Test Hole	1.74	ft³
Number of Bags Used	2.5	ea.
Volume Placed	2	ft³

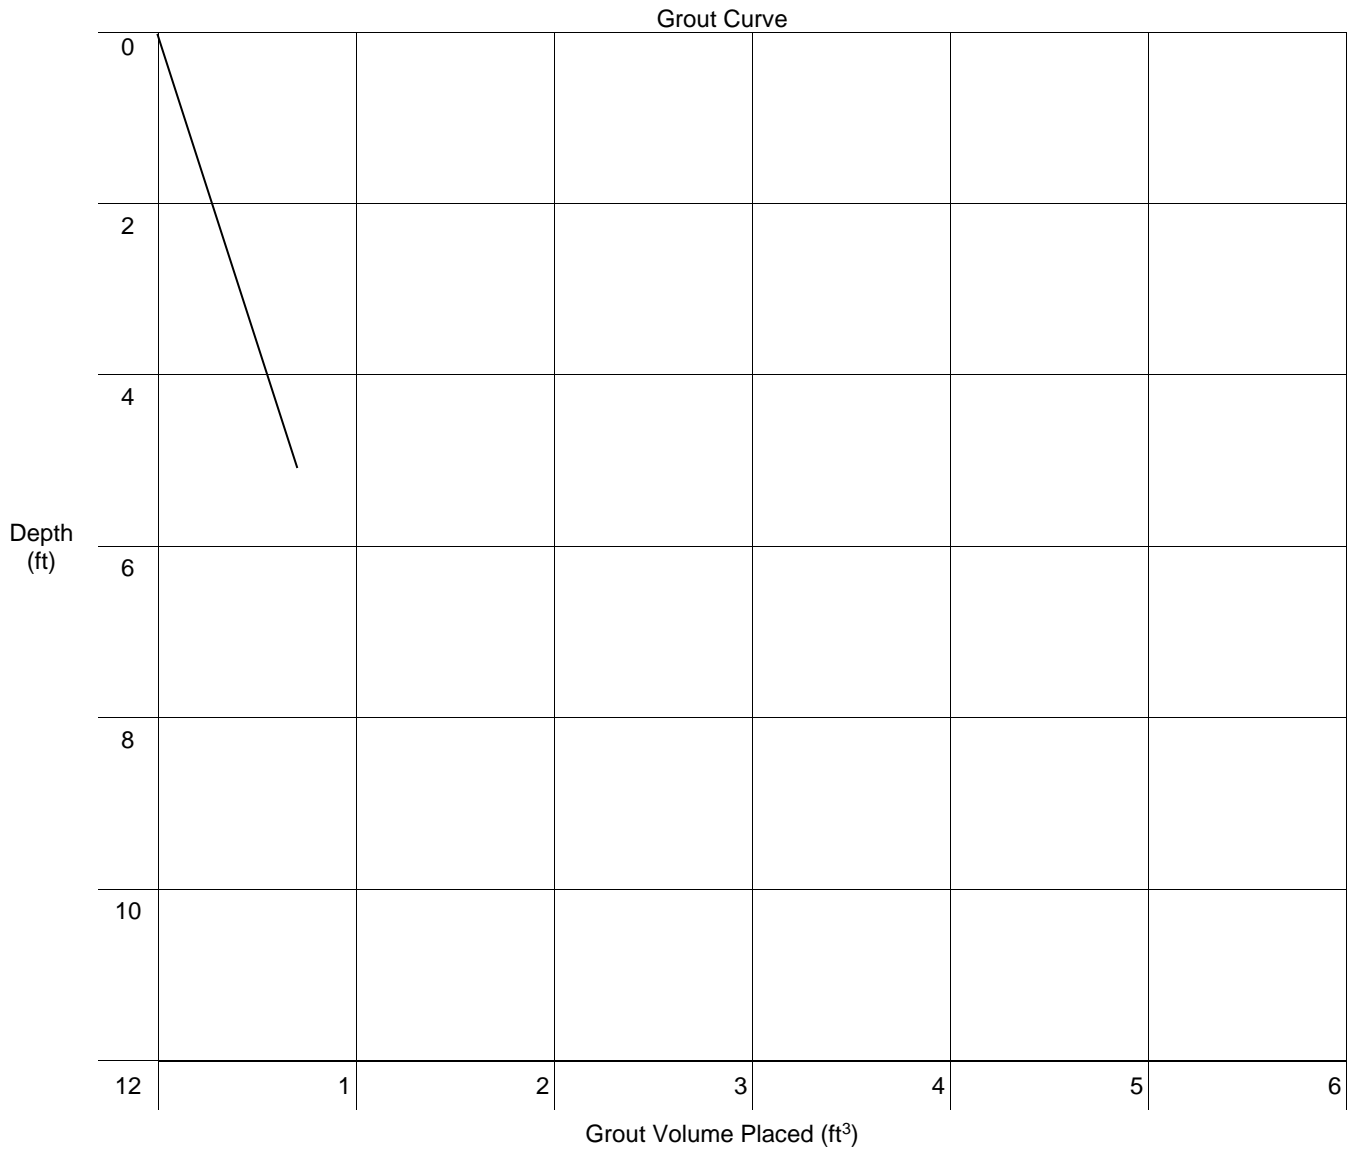
Project Name:	S-13-531 RBO Mangum Branch	Test Hole No.:	S-13-531-1
Project ID:	P041959	Station:	(BULK)
Consultant Firm:	Terracon Consultants, Inc.	Offset:	21+11.59
Grouted By (Driller's Name):	Truesdale	Date	6/7/23
Notes:	Mix design: 1 pound cement, 1 pound bentonite, 6 pounds water

Number of Bags On-Site	20	ea.
Depth of Test Hole Grouted	5	ft.
Diameter of Test Hole	0.5	ft.
Area of Test Hole	0.2	ft²
Volume of Test Hole	1.0	ft³
Volume of Casing (If applicable)	-	ft³
Theoretical Volume of Test Hole	1.0	ft³
Number of Bags Used	1.5	ea.
Volume Placed	0.7	ft³

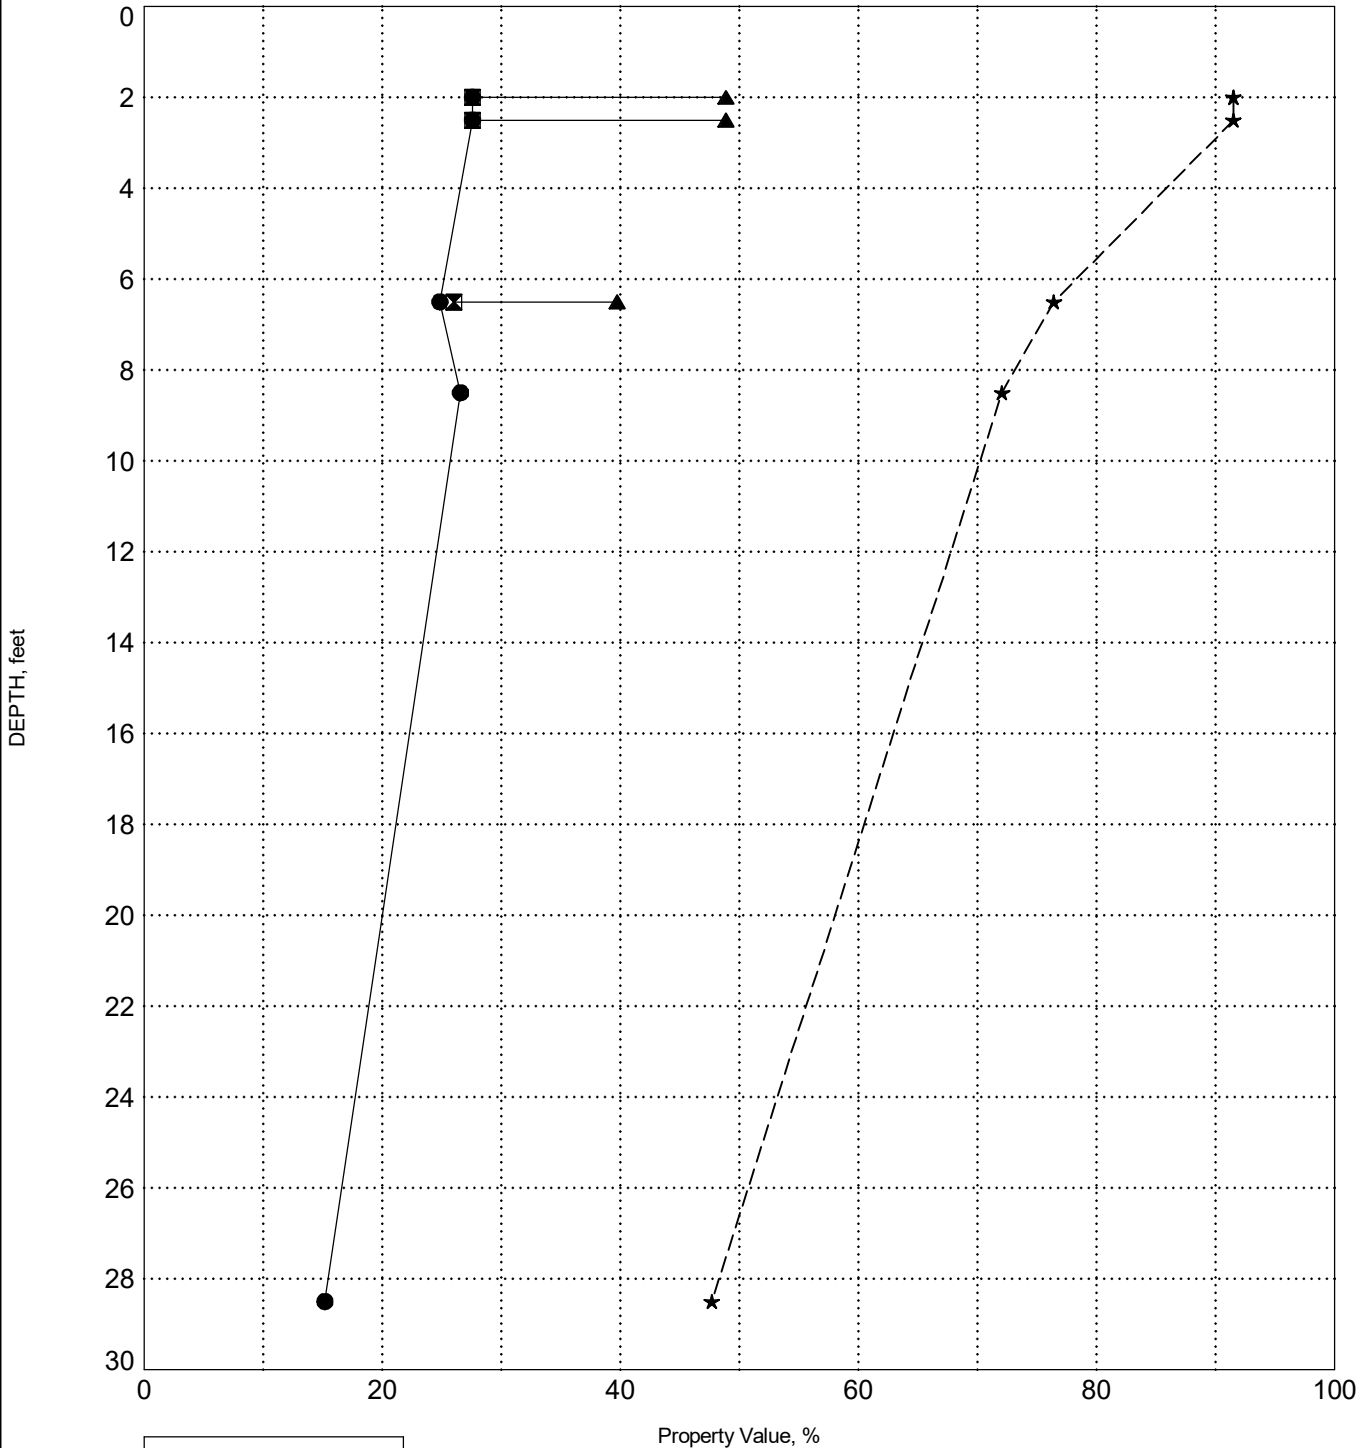
BORING S-13-531-1

SURFACE ELEVATION: 515.1

LEGEND	
●	Water Content
⊠	Plastic Limit
▲	Liquid Limit
★	Fines

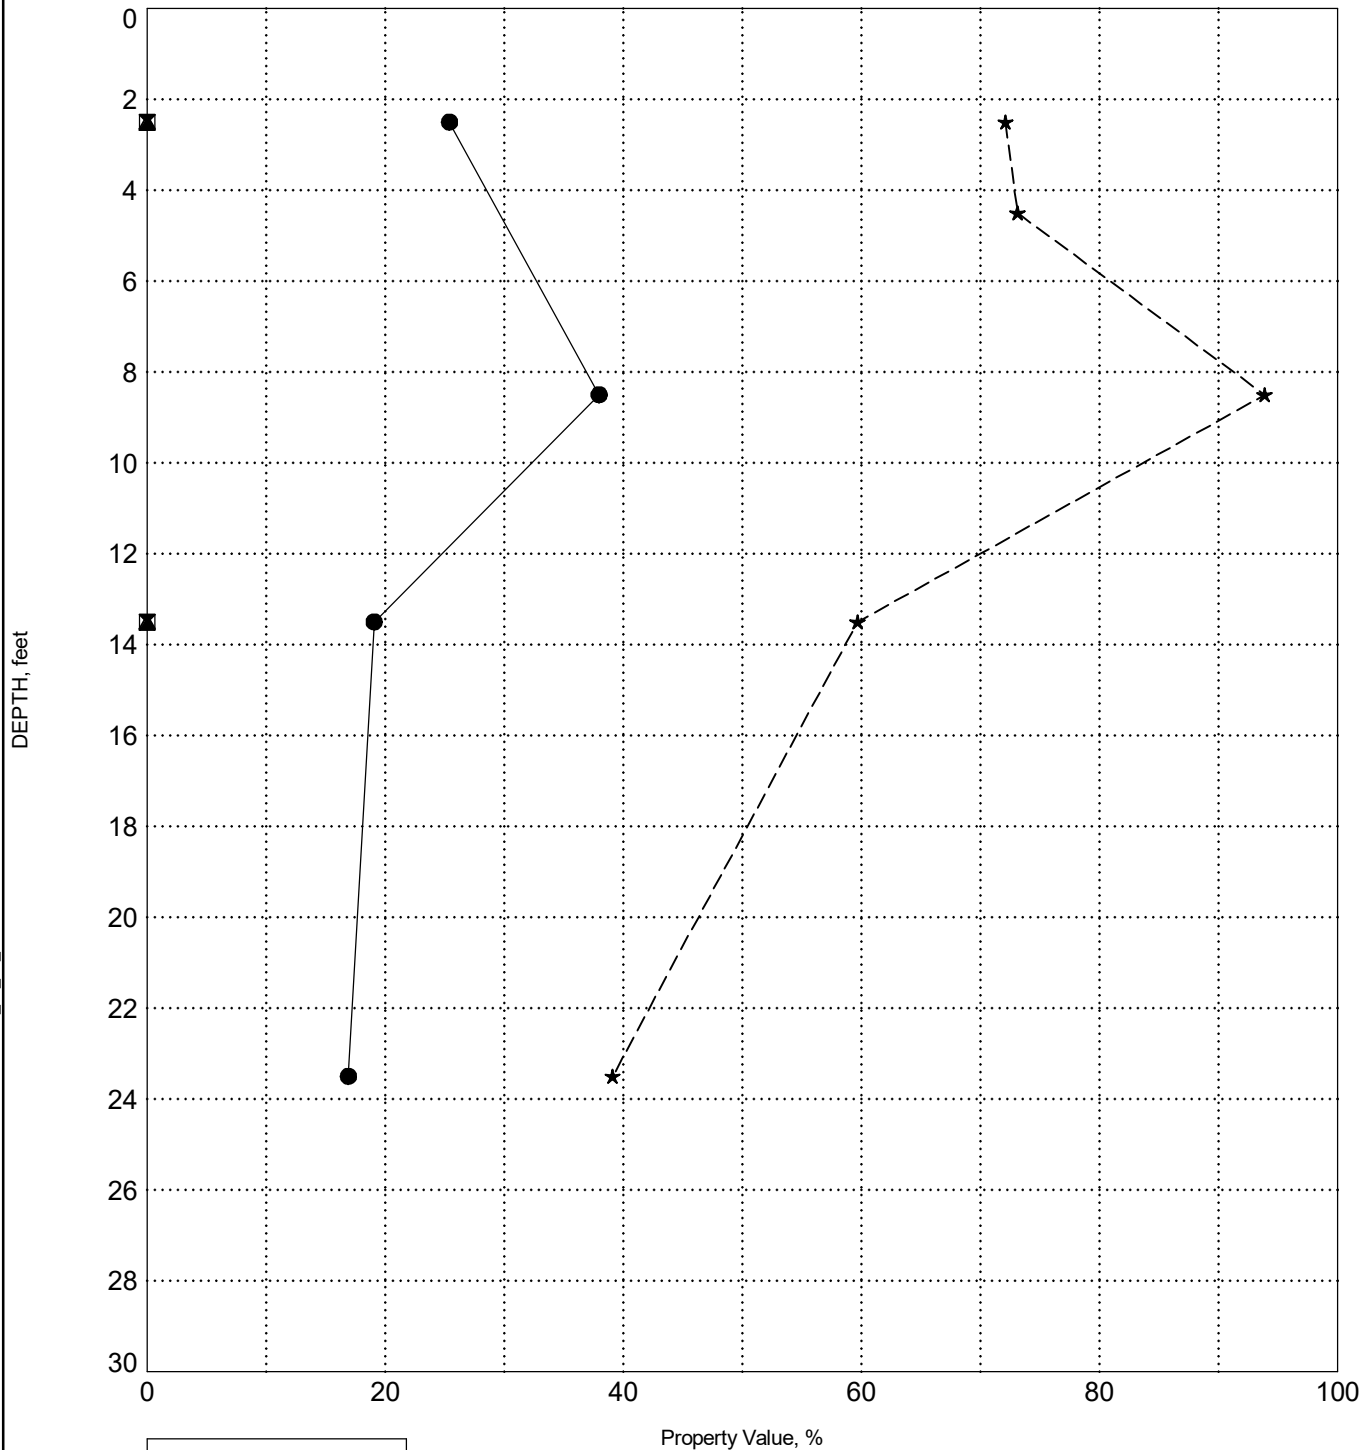
BORING S-13-531-2

INDEX PROPERTIES VERSUS DEPTH

SURFACE ELEVATION: 517.8

LEGEND	
●	Water Content
☒	Plastic Limit
▲	Liquid Limit
★	Fines

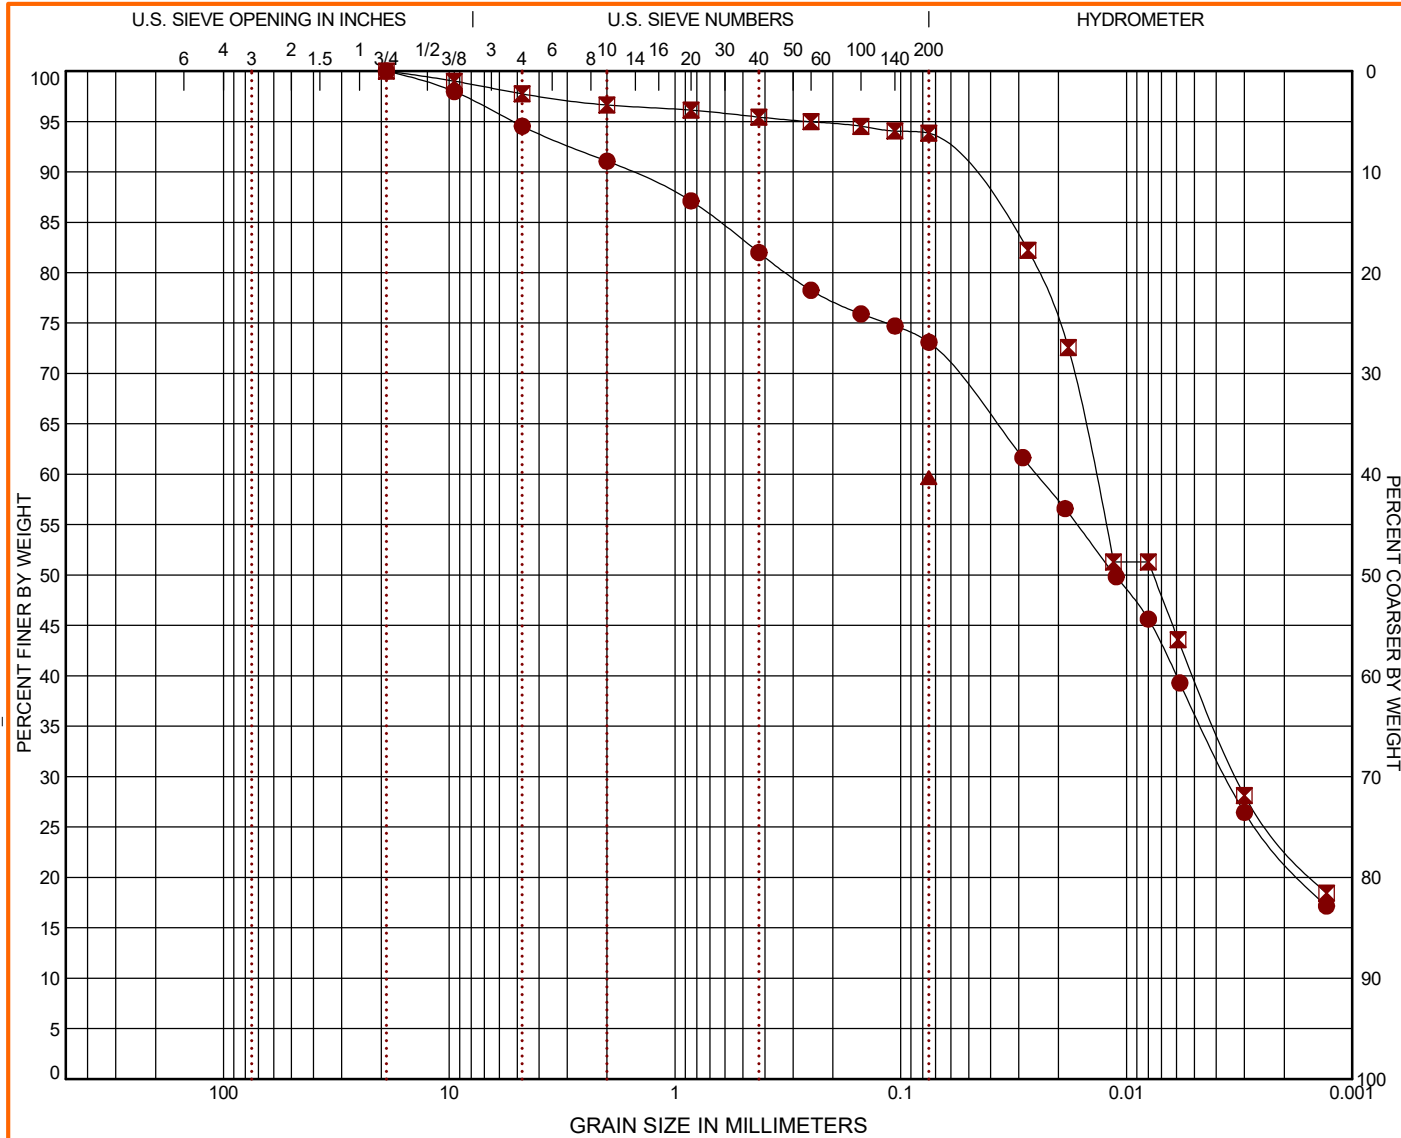
COBBLES	GRAVEL		SAND			SILT OR CLAY
	coarse	fine	coarse	medium	fine

BORING ID	DEPTH	% COBBLES	% GRAVEL	% SAND	% SILT	% FINES	% CLAY	USCS
●	S-13-531-2	4.5 - 6.5	0.0	5.5	21.4	36.7		36.4	
☒	S-13-531-2	8.5 - 10.5	0.0	2.3	3.9	54.1		39.8	
▲	S-13-531-2	13.5 - 15					59.7		ML

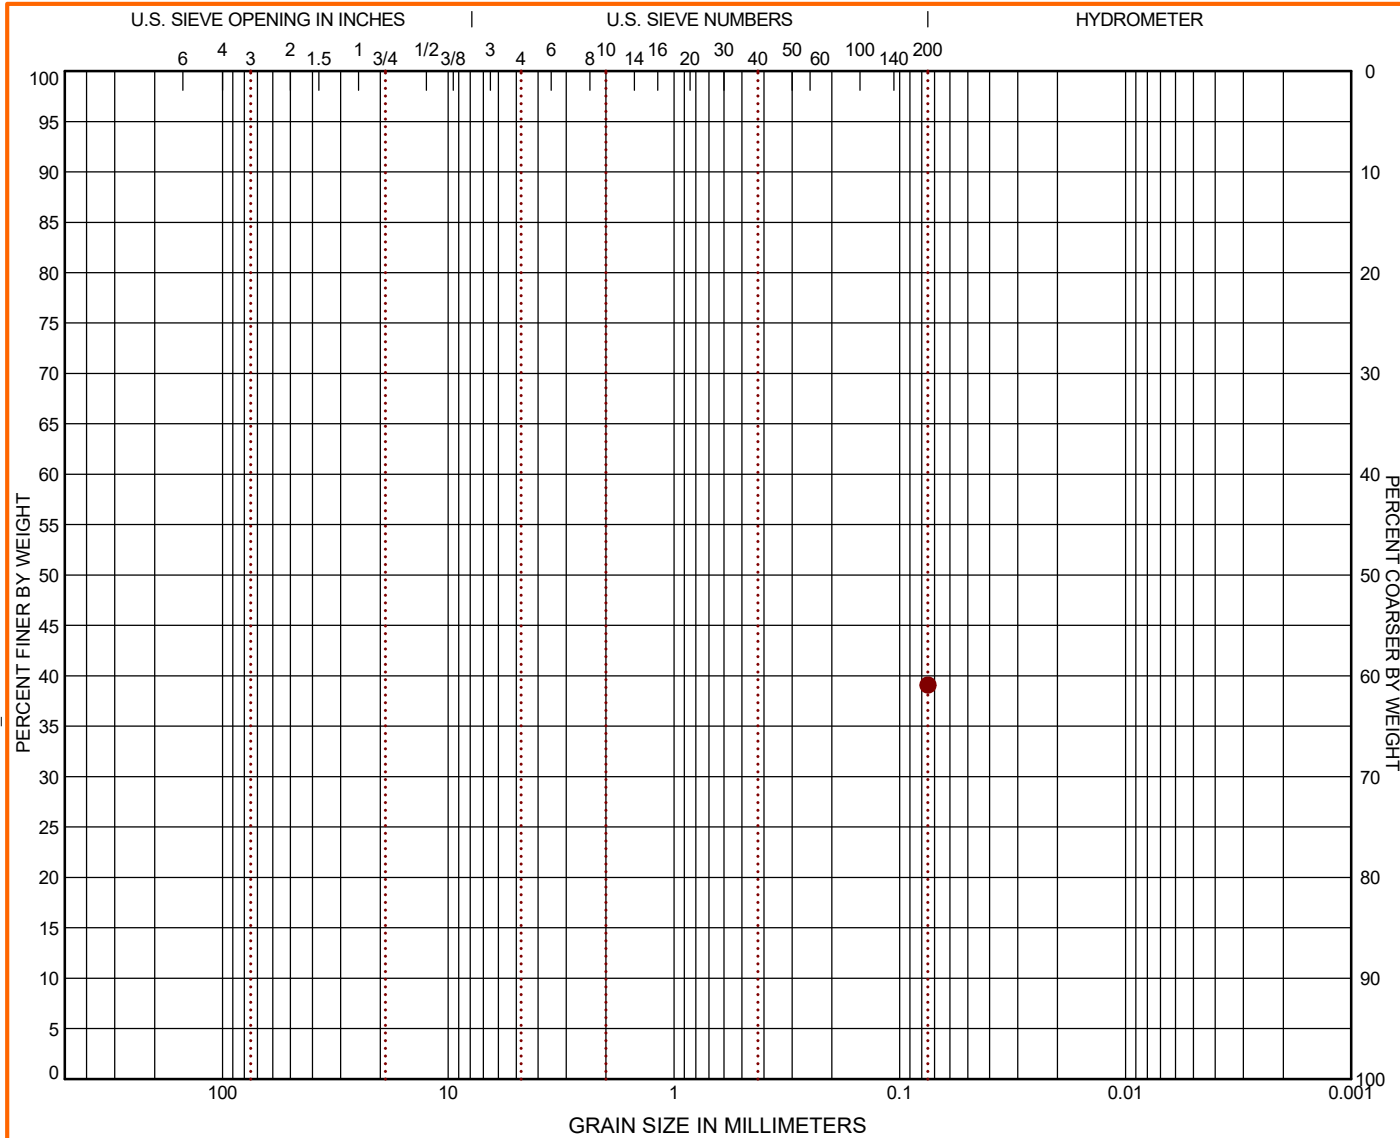
COBBLES	GRAVEL		SAND			SILT OR CLAY
	coarse	fine	coarse	medium	fine

BORING ID	DEPTH	% COBBLES	% GRAVEL	% SAND	% SILT	% FINES	% CLAY	USCS
● S-13-531-2	23.5 - 24					39.1

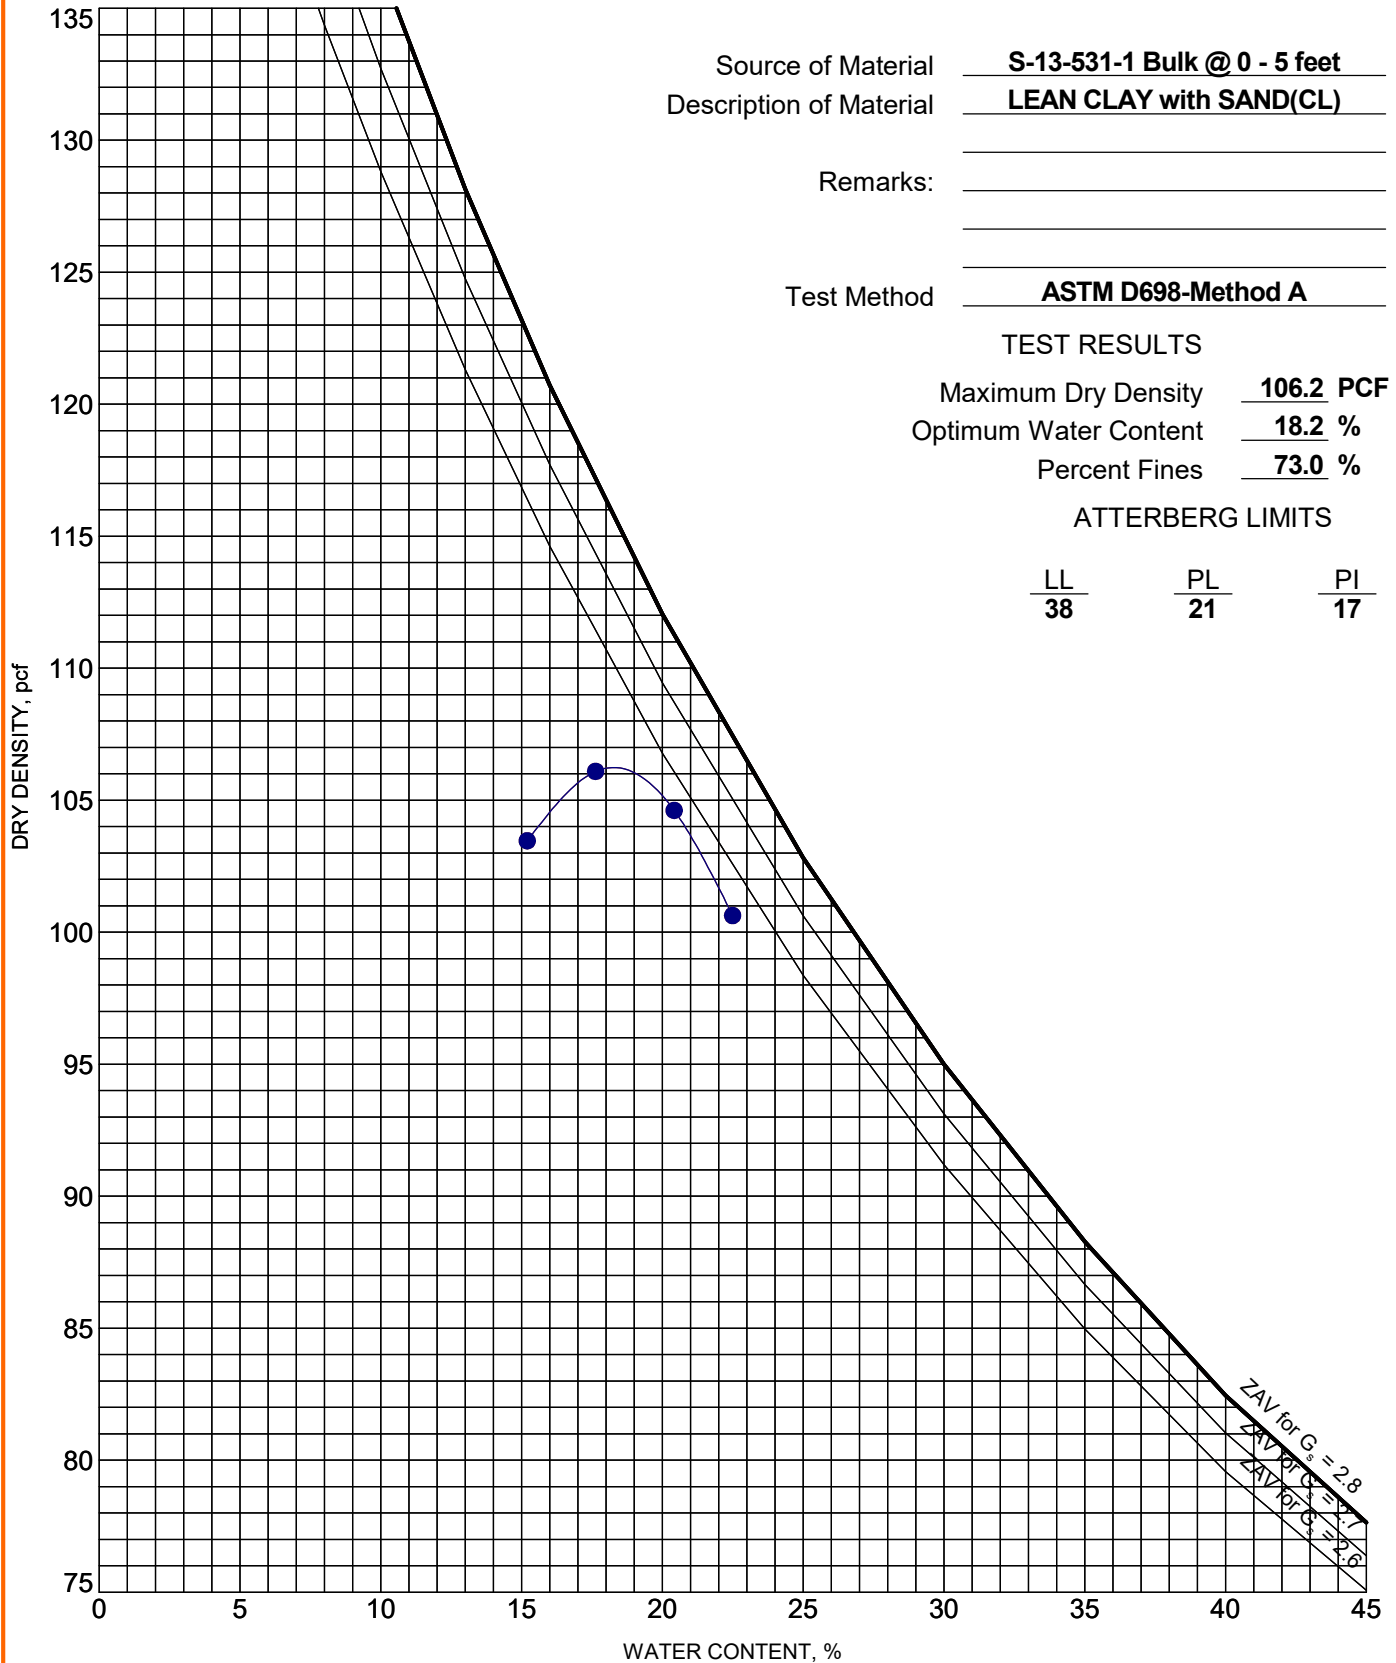
MOISTURE-DENSITY RELATIONSHIP

ASTM D698/D1557

PROJECT: S-13-531 BRO Mangum Branch

Sample No.	Station	Offset (ft)	Sample Depth (ft)	USCS Soil Type	Compaction		Shear Strength ¹	
					Optimum Moisture (%)	Max Dry Density (pcf)	c', c (psf)	φ', φ (°)
S-13-531-1	21+11.59	2.14 L	0 – 5	CL	18.2	106.2	72, 259	34, 21
