S-13-531 (Henry Funderburk Road) Bridge Replacement over Mangum Branch

Chesterfield County, SC Geotechnical Baseline Report

August 21, 2023 (rev1) | SCDOT Project ID: P041959
Terracon Project No.: 7323P100

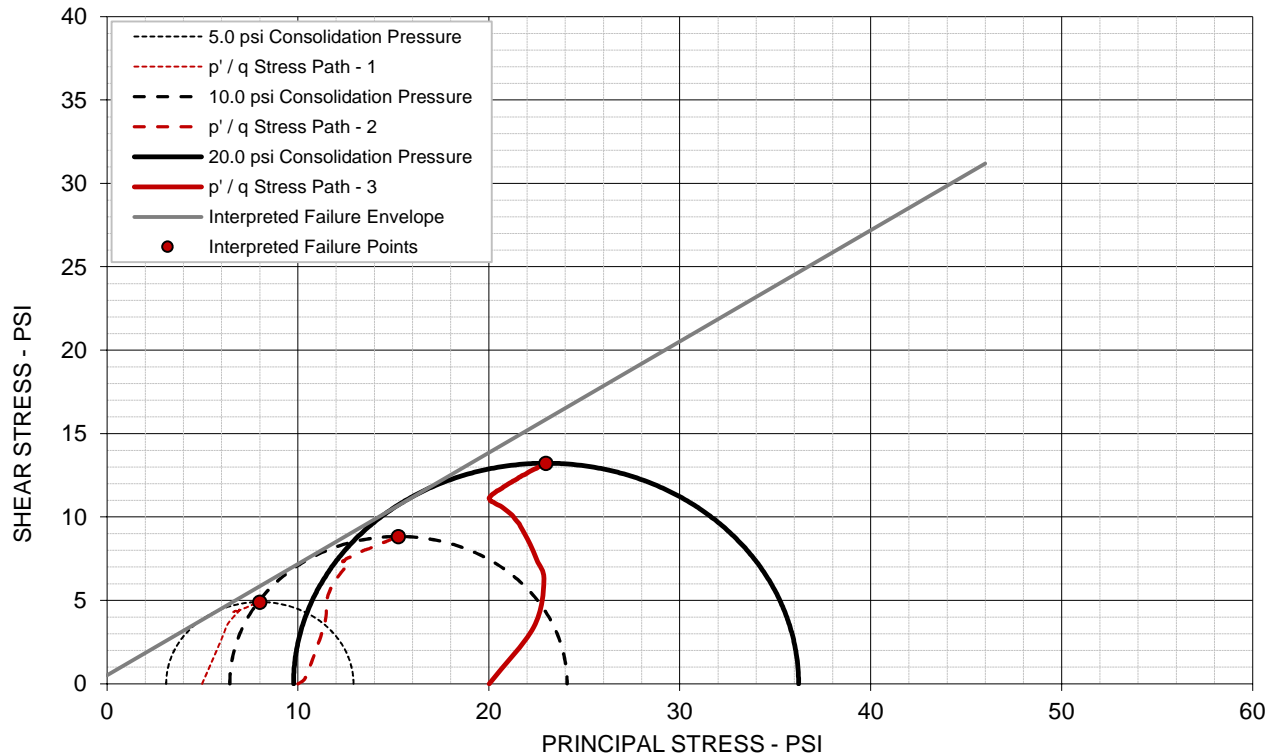
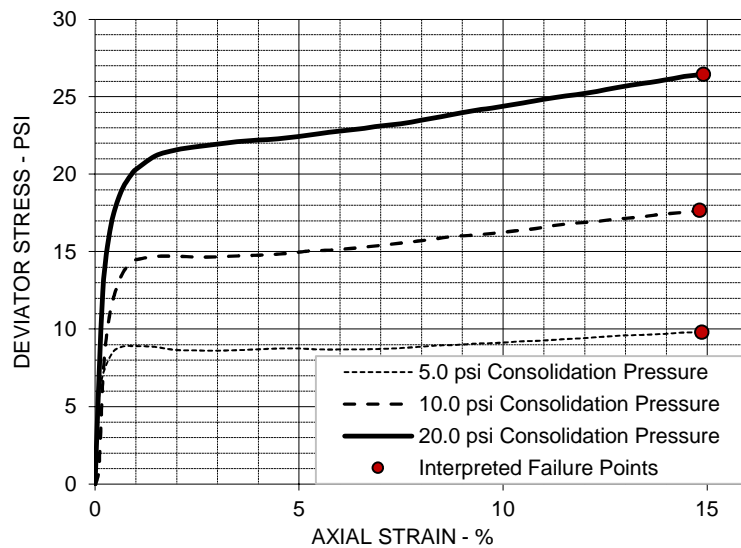
Failure Criteria: Max Deviator Stress

EFFECTIVE STRESS PARAMETERS

$\phi' = 33.7$ deg $c' = 0.5$ psi

SPECIMEN NO.	1	2	3
INITIAL			
Moisture Content - %	17.8	17.8	18.3
Dry Density - pcf	100.2	100.6	100.8
Diameter - inches	2.86	2.86	2.86
Height - inches	6.05	6.03	6.00
AT TEST			
Final Moisture - %	24.8	23.4	23.1
Dry Density - pcf	100.3	101.2	103.4
Calculated Diameter (in.)	2.85	2.84	2.83
Height - inches	6.04	5.99	5.93
Effect. Consol. Stress - psi	5.0	10.0	20.0
Failure Stress - psi	9.81	17.67	26.45
Total Pore Pressure - psi	81.9	83.6	90.3
Strain Rate - %/min.	0.0330	0.0335	0.0331
Failure Strain - %	14.9	14.8	14.9
σ_1' Failure - psi	12.91	24.09	36.22
σ_3' Failure - psi	3.09	6.43	9.77

Sample No.	Station	Offset (ft)	Sample Depth (ft)	USCS Soil Type	Compaction		Shear Strength ¹	
					Optimum Moisture (%)	Max Dry Density (pcf)	c', c (psf)	φ', φ (°)
S-13-531-1	21+11.59	2.14 L	0 – 5	CL	18.2	106.2	72, 259	34, 21

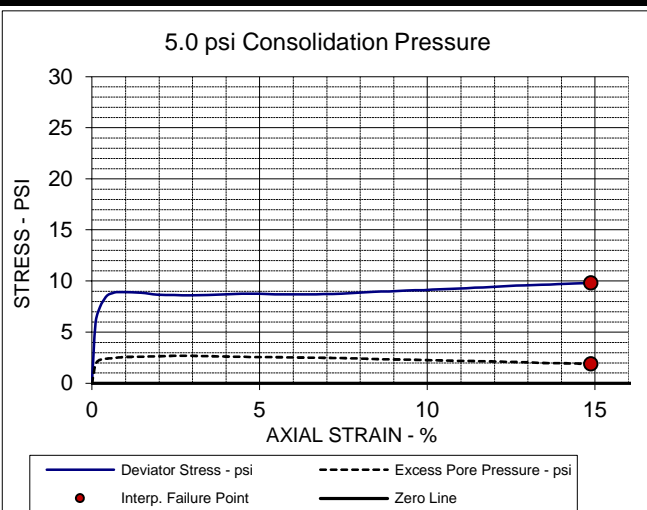
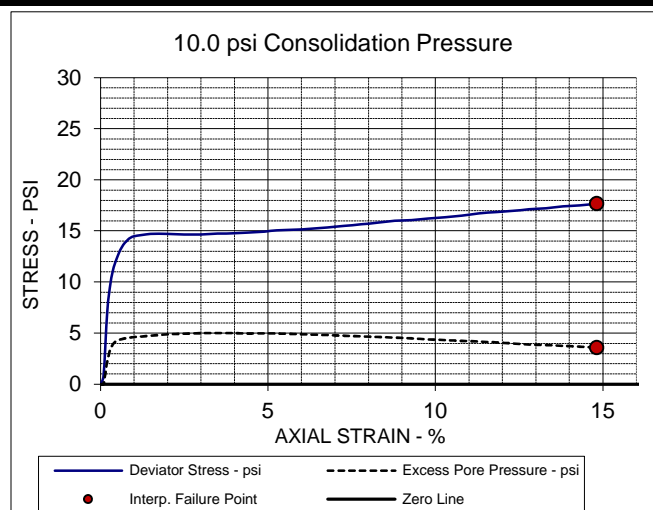
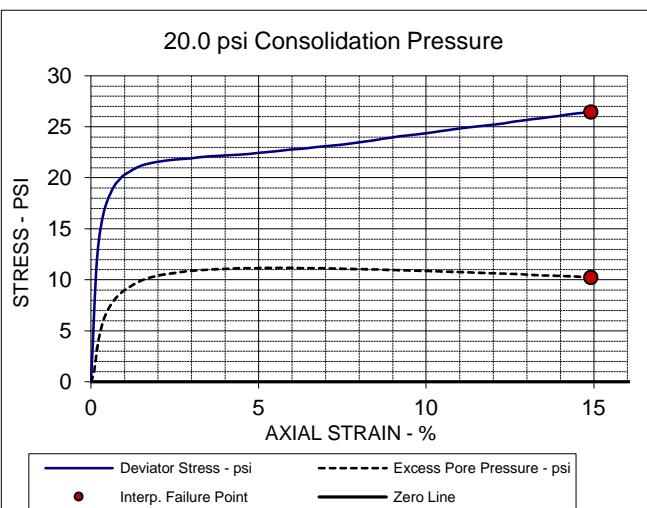
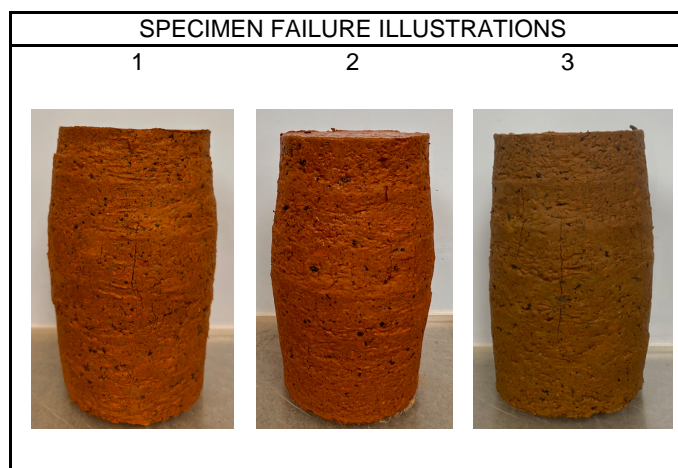
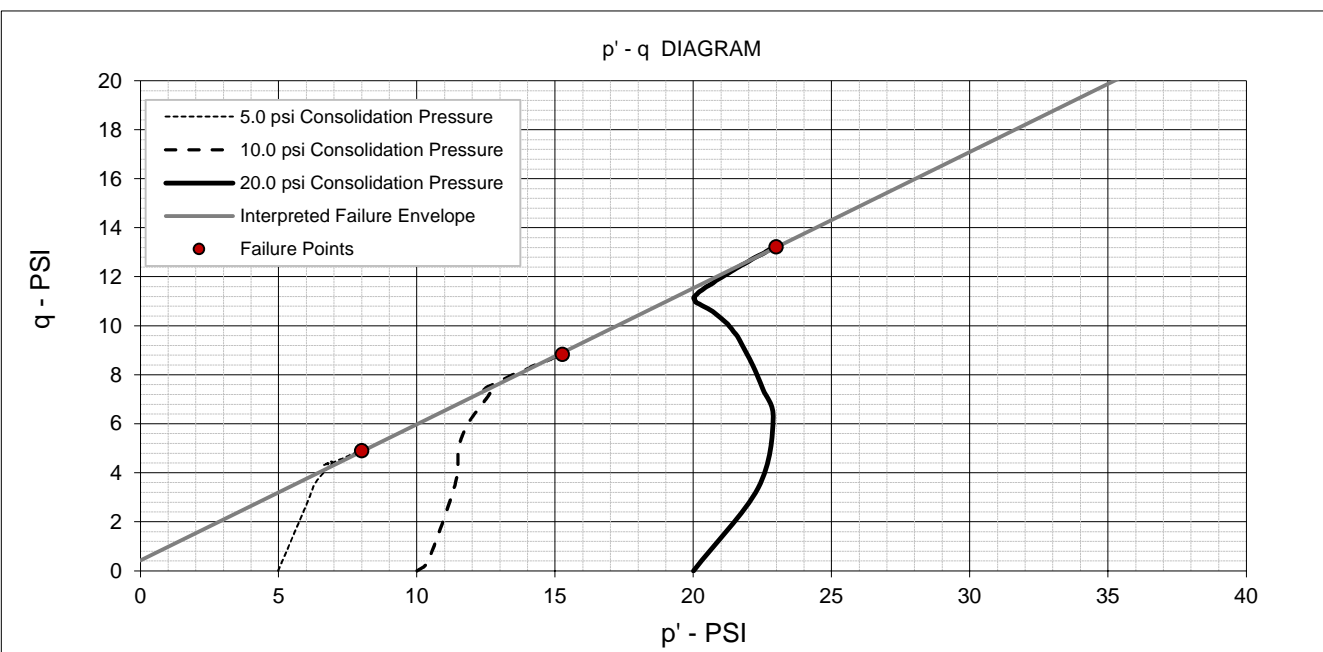
EFFECTIVE STRESS PARAMETERS		R ² = 1.00	α = 29.1 deg	a = 0.4 psi
PROJECT: S-13-531 Mangum Branch			ISOTROPICALLY CONSOLIDATED, UNDRAINED TRIAXIAL COMPRESSION TEST	
LOCATION: Chesterfield County, SC			CLIENT: HNTB	
SAMPLE ID: S-13-531-1 Bulk 0-5'			<div>521 Clemson Road Columbia, SC</div> <div>

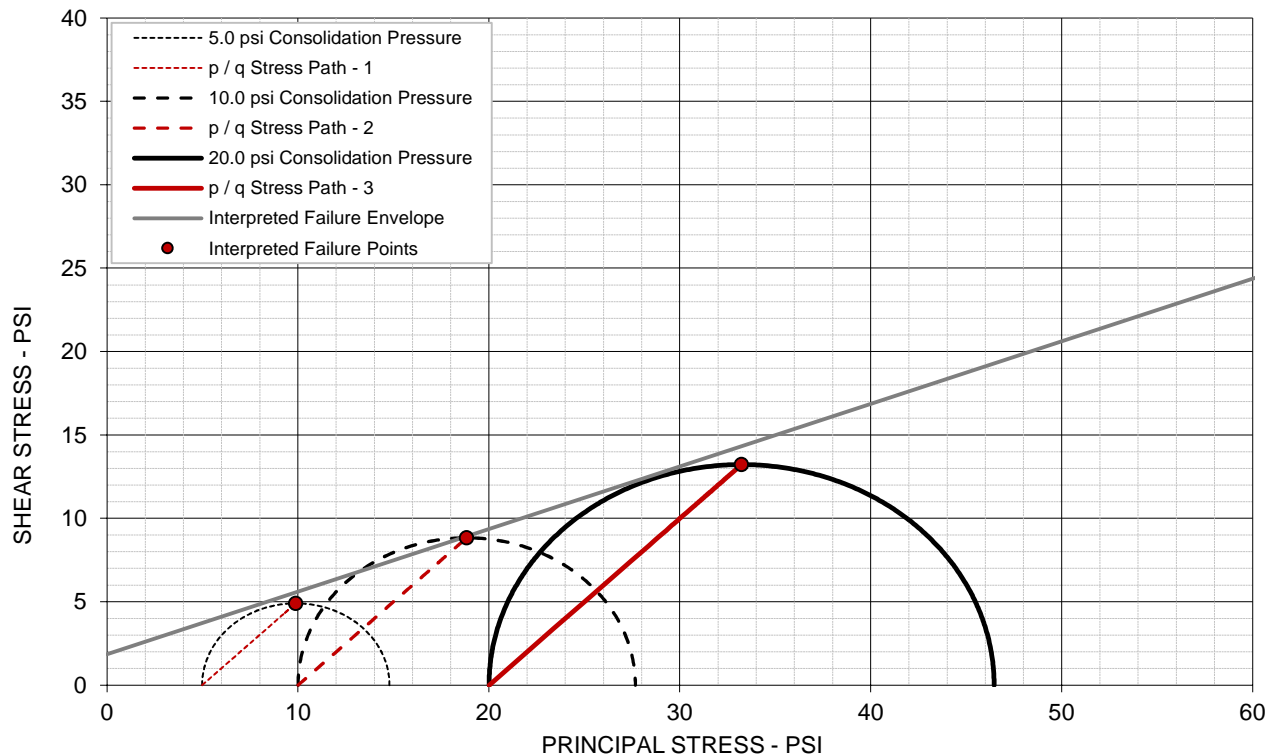
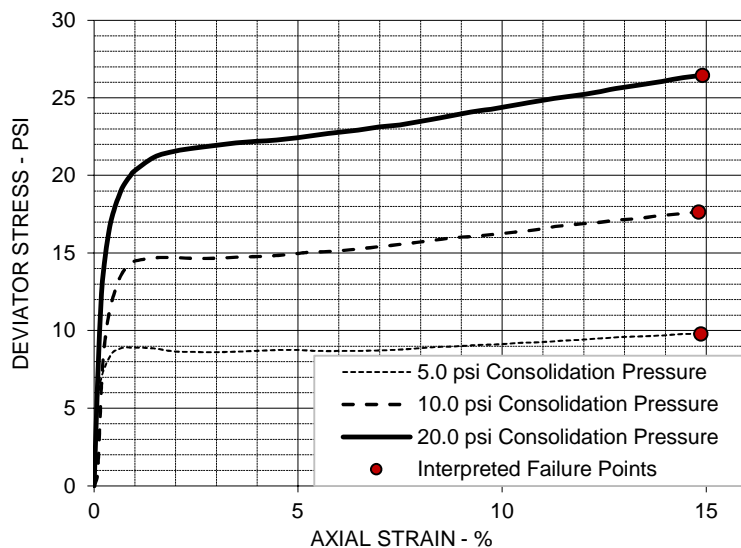
Failure Criteria: Max Deviator Stress

TOTAL STRESS PARAMETERS

$\phi = 20.6$ deg $c = 1.8$ psi

Final Moisture - %	24.8	23.4	23.1
Dry Density - pcf	100.3	101.2	103.4
Calculated Diameter (in.)	2.85	2.84	2.83
Height - inches	6.04	5.99	5.93
Effect. Consol. Stress - psi	5.0	10.0	20.0
Failure Stress - psi	9.81	17.67	26.45
Total Pore Pressure - psi	81.9	83.6	90.3
Strain Rate - %/min.	0.0330	0.0335	0.0331
Failure Strain - %	14.9	14.8	14.9
σ_1 Failure - psi	14.79	27.67	46.46
σ_3 Failure - psi	4.98	10.00	20.01

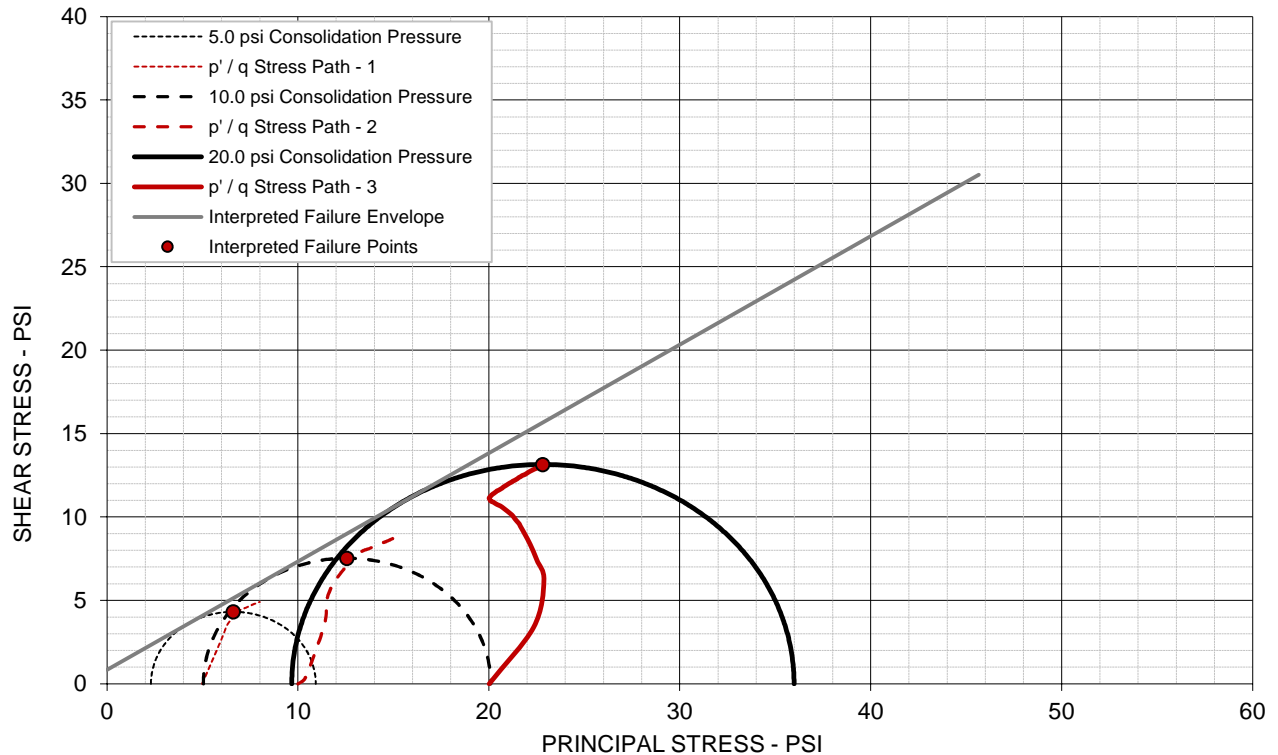
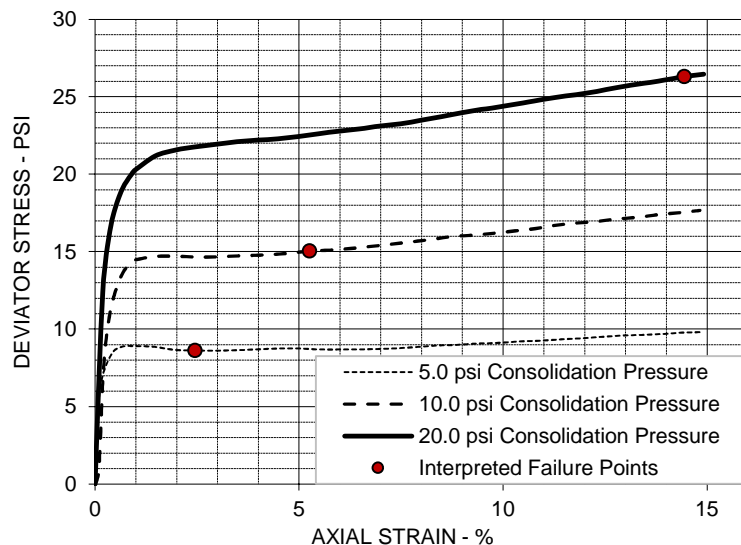
Failure Criteria: Max Obliquity (s1': s3')

EFFECTIVE STRESS PARAMETERS

$\phi' = 33.1$ deg $c' = 0.8$ psi

Final Moisture - %	24.8	23.4	23.1
Dry Density - pcf	100.3	101.2	103.4
Calculated Diameter (in.)	2.85	2.84	2.83
Height - inches	6.04	5.99	5.93
Effect. Consol. Stress - psi	5.0	10.0	20.0
Failure Stress - psi	8.63	15.05	26.30
Total Pore Pressure - psi	82.7	85.0	90.3
Strain Rate - %/min.	0.0330	0.0335	0.0331
Failure Strain - %	2.4	5.3	14.4
σ_1' Failure - psi	10.93	20.10	35.98
σ_3' Failure - psi	2.30	5.04	9.68

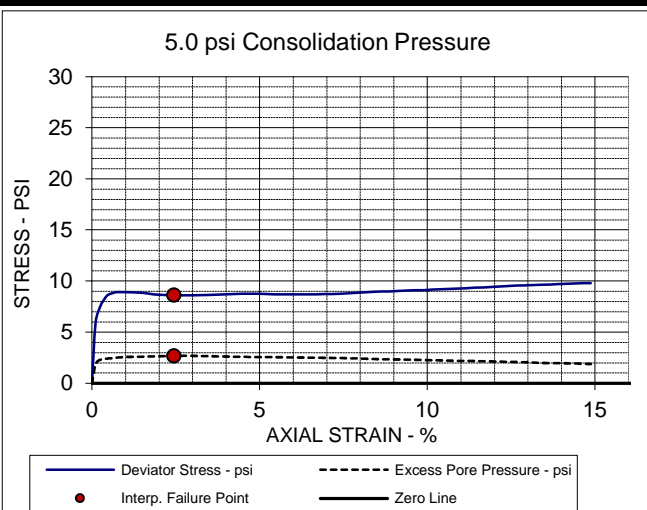
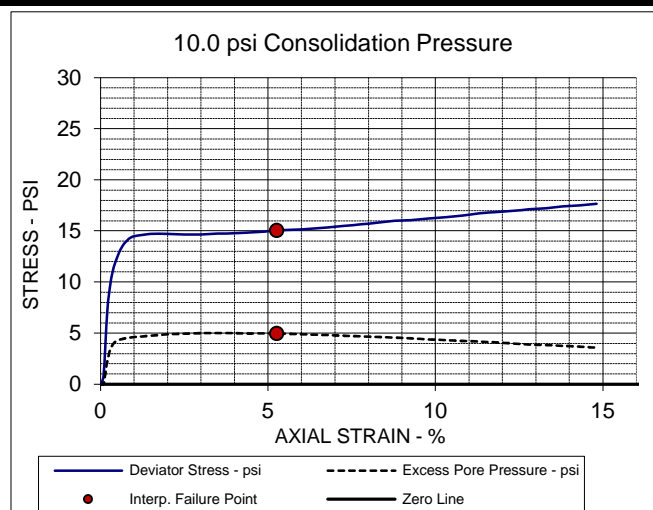
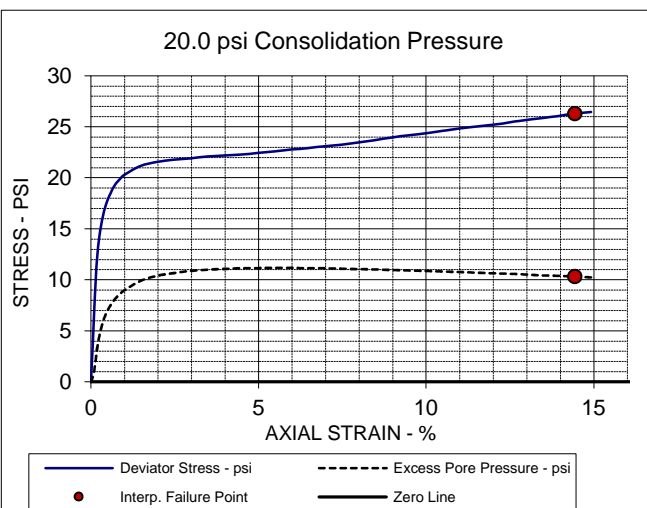
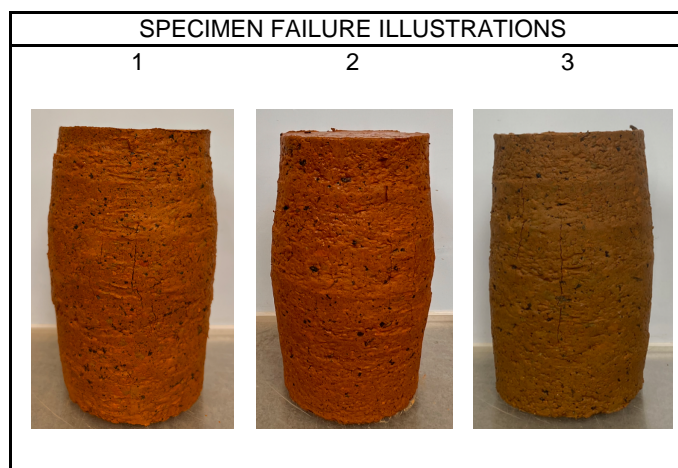
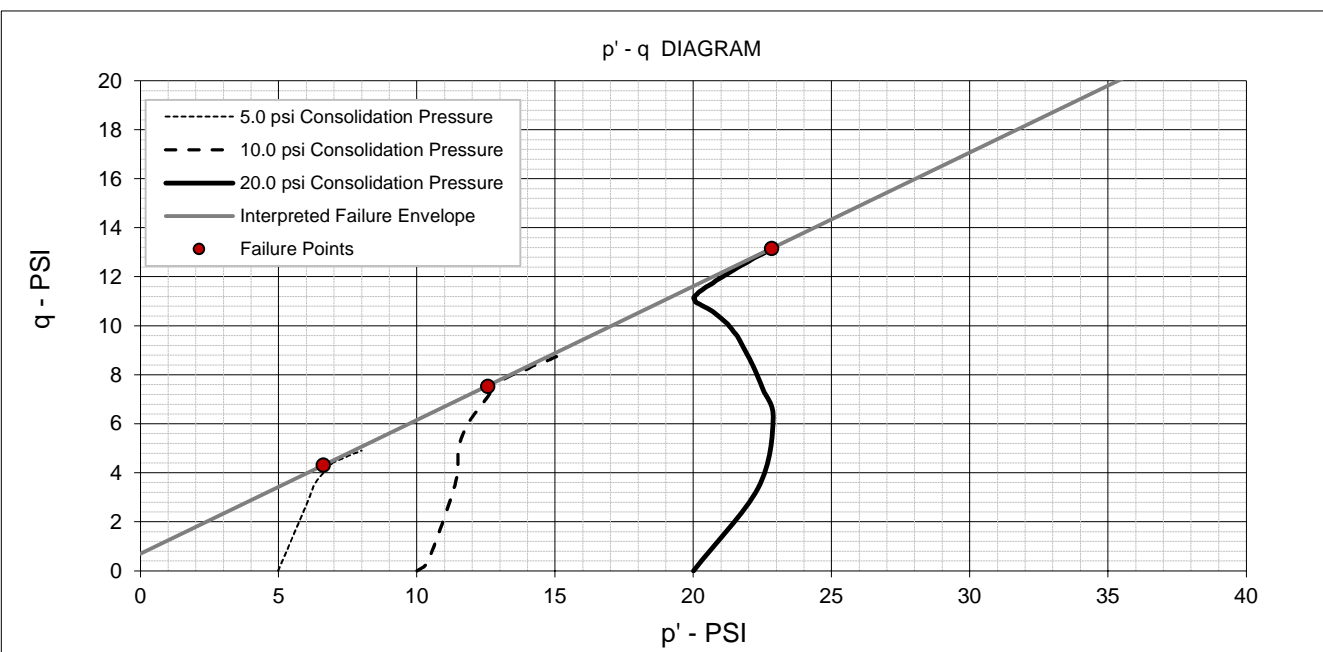
EFFECTIVE STRESS PARAMETERS		R ² = 1.00	α = 28.6 deg	a = 0.7 psi
PROJECT: S-13-531 Mangum Branch			ISOTROPICALLY CONSOLIDATED, UNDRAINED TRIAXIAL COMPRESSION TEST	
LOCATION: Chesterfield County, SC			CLIENT: HNTB	
SAMPLE ID: S-13-531-1 Bulk 0-5'			<div>521 Clemson Road Columbia, SC</div> <div>

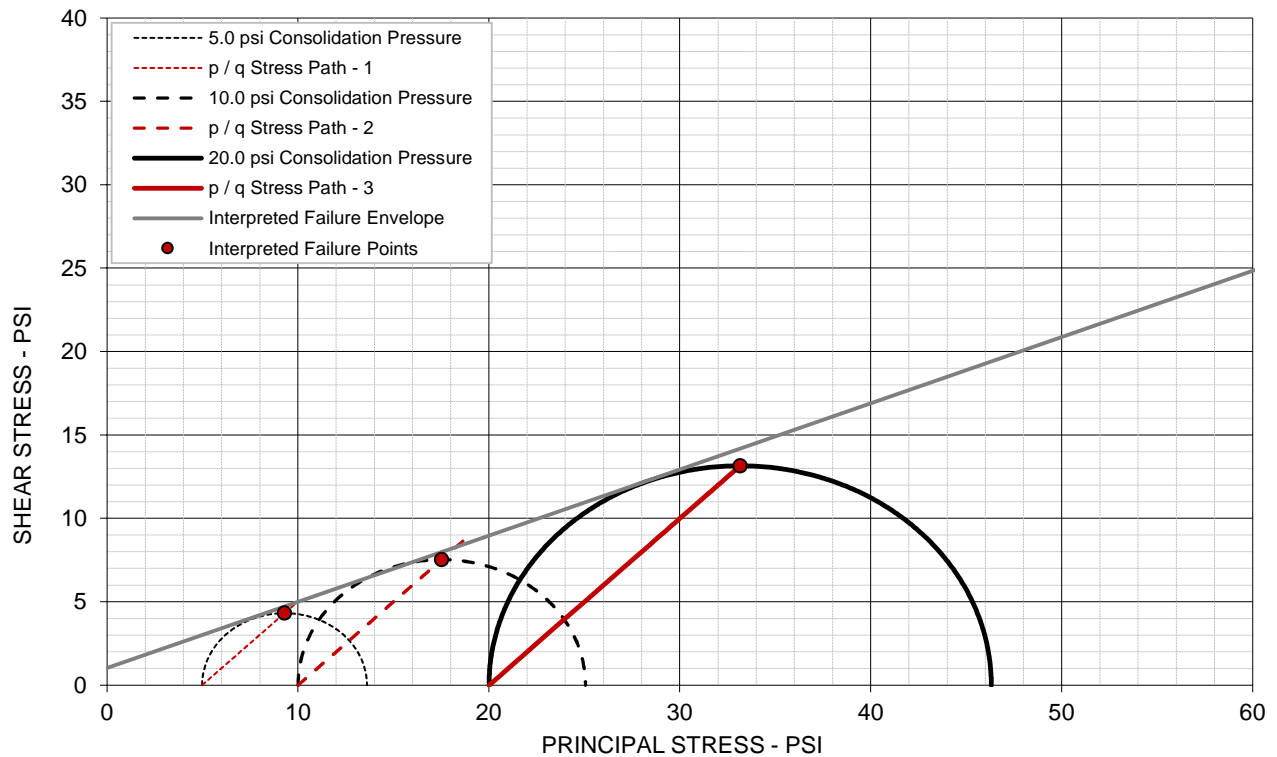
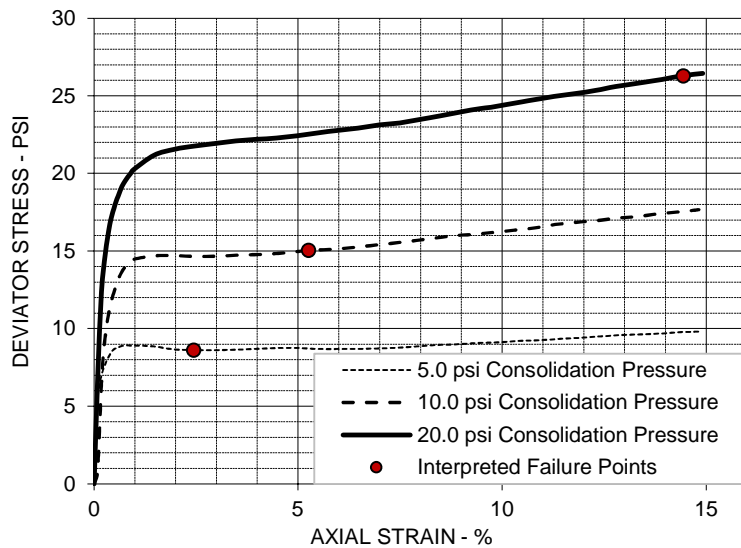
Failure Criteria: Max Obliquity (s1': s3')

TOTAL STRESS PARAMETERS

$\phi = 21.7$ deg

$c = 1.0$ psi

Final Moisture - %	24.8	23.4	23.1
Dry Density - pcf	100.3	101.2	103.4
Calculated Diameter (in.)	2.85	2.84	2.83
Height - inches	6.04	5.99	5.93
Effect. Consol. Stress - psi	5.0	10.0	20.0
Failure Stress - psi	8.63	15.05	26.30
Total Pore Pressure - psi	82.7	85.0	90.3
Strain Rate - %/min.	0.0330	0.0335	0.0331
Failure Strain - %	2.4	5.3	14.4
σ_1 Failure - psi	13.61	25.06	46.31
σ_3 Failure - psi	4.98	10.00	20.01

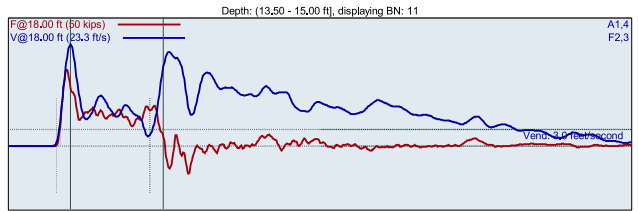
DU-543-406484
Jim Smith
AR: 1.20 in²
LE: 18.00 ft
WS: 16807.9 fts

13.5-15.1
Test date: 7/28/2022
SP: 0.492 k/ft³
EM: 30000 ksi

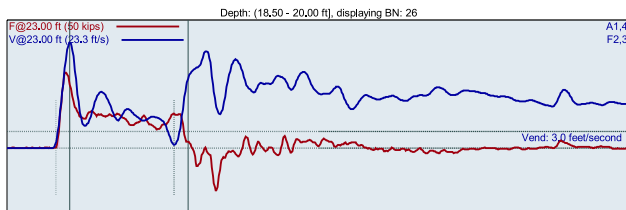
DU-543-406484
Jim Smith
AR: 1.20 in²
LE: 23.00 ft
WS: 16807.9 fts

13.5-15.1
Test date: 7/28/2022
SP: 0.492 k/ft³
EM: 30000 ksi

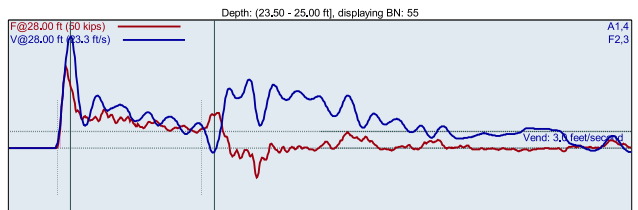
DU-543-406484
Jim Smith
AR: 1.20 in²
LE: 28.00 ft
WS: 16807.9 fts

13.5-15.1
Test date: 7/28/2022
SP: 0.492 k/ft³
EM: 30000 ksi

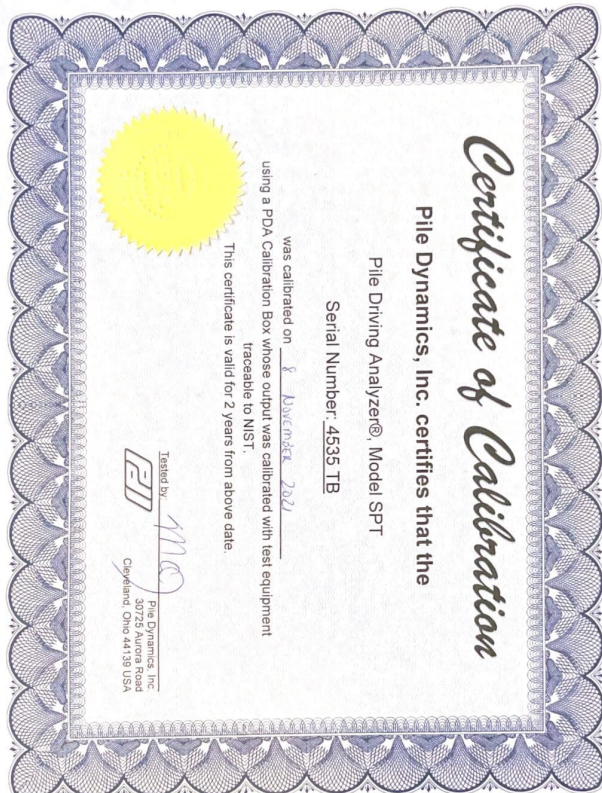
Project: DU-543-406484, Test Date: 7/28/2022

FMX: Maximum Force					EFV: Maximum Energy				
VMX: Maximum Velocity					ETR: Energy Transfer Ratio - Rated				
BPM: Blows/Minute									
Blow Length ft	Blows Applied /ft	N Value	N50 Value	Average FMX kips	Average VMX ft/s	Average BPM bpm	Average EFV ft-lb	Average ETR %	
18.00	2-2-0	11	17	30	18.6	51.3	312	89.2	
23.00	3-5-0	10	15	29	19.0	55.3	317	90.4	
28.00	12-0-0	17	26	31	19.9	55.4	344	96.1	
Overall Average Values:				30	19.3	54.2	327	93.3	
Standard Deviation:				1	0.7	1.9	16	4.5	
Overall Maximum Value:				32	20.3	55.9	352	100.7	
Overall Minimum Value:				29	18.0	51.0	301	86.0

This report provides the Energy Transfer Ratio (ETR) for the SPT automatic hammer found on drill rig model CME 45C; Terracon Drill Rig Asset Number DR#543 (Serial Number: 406484).

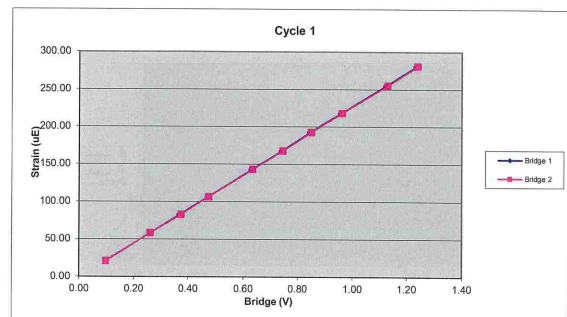
648AWJ				
Cycle 1				
Sample	Force (lb)	Strain (µE)	Bridge 1 (V)	Bridge 2 (V)
1	0.00	0.00	0.00	0.00
2	799.99	21.12	0.10	0.10
3	2111.63	58.22	0.26	0.26
4	2997.39	82.70	0.37	0.37
5	3848.07	106.26	0.47	0.47
6	5131.83	143.07	0.63	0.63
7	6017.79	167.81	0.74	0.75
8	6872.07	192.74	0.85	0.85
9	7783.57	218.15	0.96	0.96
10	9136.93	255.02	1.12	1.13
11	10026.70	280.73	1.24	1.24

Bridge 1		Bridge 2	
Force Calibration (lb/V)	8120.30	Force Calibration (lb/V)	8089.75
Offset	-4.24	Offset	-2.24
Correlation	0.999998	Correlation	0.999995
Strain Calibration (µE/V)	228.56	Strain Calibration (µE/V)	227.70
Offset	-1.57	Offset	-1.51
Correlation	0.999991	Correlation	0.999983

Force Strain Calibration	
EA (Kips)	35527.98
Offset	51.69
Correlation	0.999986

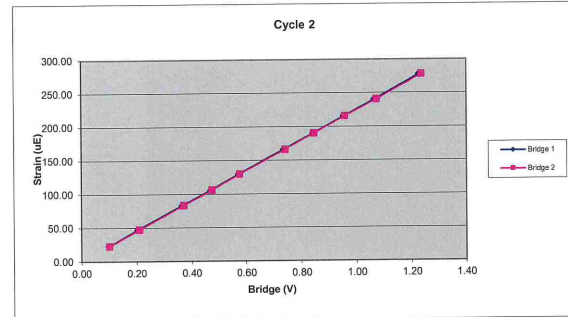
648AWJ	Sample	Force (lb)	Cycle 2 Strain (µE)	Bridge 1 (V)	Bridge 2 (V)
	1	0.00	0.00	0.00	0.00
	2	805.54	22.23	0.10	0.10
	3	1679.81	47.04	0.20	0.21
	4	2989.11	83.03	0.37	0.37
	5	3830.62	105.81	0.47	0.47
	6	4658.00	129.50	0.57	0.58
	7	5984.74	165.81	0.74	0.74
	8	6848.87	189.76	0.84	0.84
	9	7747.90	215.15	0.95	0.96
	10	8674.21	240.08	1.07	1.07
	11	9994.82	277.48	1.23	1.24

Bridge 1	Bridge 2
Force Calibration (lb/V)	8127.14
Offset	10.37
Correlation	0.999997
Strain Calibration (µE/V)	225.29
Offset	0.36
Correlation	0.999990

Force Strain Calibration	
EA (Kips)	36073.41
Offset	-2.66
Correlation	0.999993

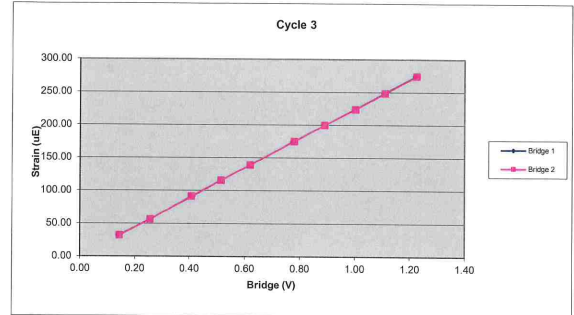
648AWJ	Sample	Force (lb)	Cycle 3 Strain (µE)	Bridge 1 (V)	Bridge 2 (V)
	1	0.00	0.00	0.00	0.00
	2	1153.24	31.90	0.14	0.14
	3	2056.55	56.28	0.26	0.26
	4	3310.19	91.18	0.41	0.41
	5	4155.51	115.51	0.51	0.51
	6	5035.81	139.16	0.62	0.62
	7	6303.78	175.10	0.78	0.78
	8	7221.91	199.87	0.89	0.89
	9	8120.94	223.92	1.00	1.00
	10	9001.15	248.68	1.11	1.11
	11	9931.66	274.33	1.22	1.23

Bridge 1	Bridge 2
Force Calibration (lb/V)	8132.32
Offset	-20.37
Correlation	0.999998
Strain Calibration (µE/V)	224.79
Offset	-0.57
Correlation	0.999984

Force Strain Calibration	
EA (Kips)	36175.62
Offset	0.42
Correlation	0.999984

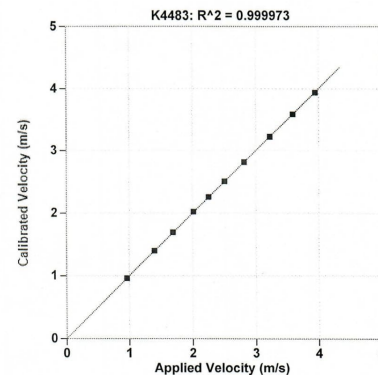
Reference Velocity m/s	S/N K4483 Velocity m/s
0.964	0.962
1.399	1.401
1.691	1.700
2.014	2.022
2.254	2.257
2.507	2.508
2.815	2.814
3.226	3.220
3.590	3.591
3.947	3.941

Maximum Acceleration: 874 g's

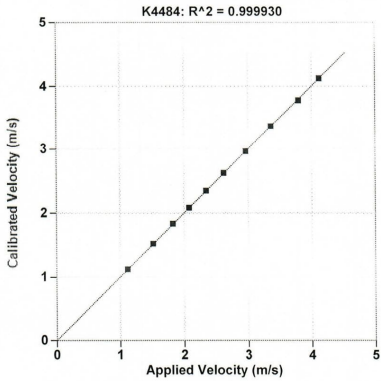
Reference Velocity	S/N K4484 Velocity
m/s	m/s
1.117	1.124
1.518	1.523
1.823	1.835
2.078	2.080
2.344	2.349
2.616	2.624
2.963	2.962
3.360	3.357
3.794	3.778
4.121	4.122

Maximum Acceleration: 916 g's
