# **ASBESTOS CONTAINING MATERIALS INVESTIGATION REPORT**

**S-32-49 BRIDGE OVER I-26  
SCDOT #3270049000200  
LEXINGTON COUNTY, SOUTH CAROLINA**

Re.: Asbestos Containing Materials Investigation Report  
S-32-49 Bridge over I-26  
SCDOT #3270049000200  
Lexington County, South Carolina  
F&ME Project No.: E5350.02

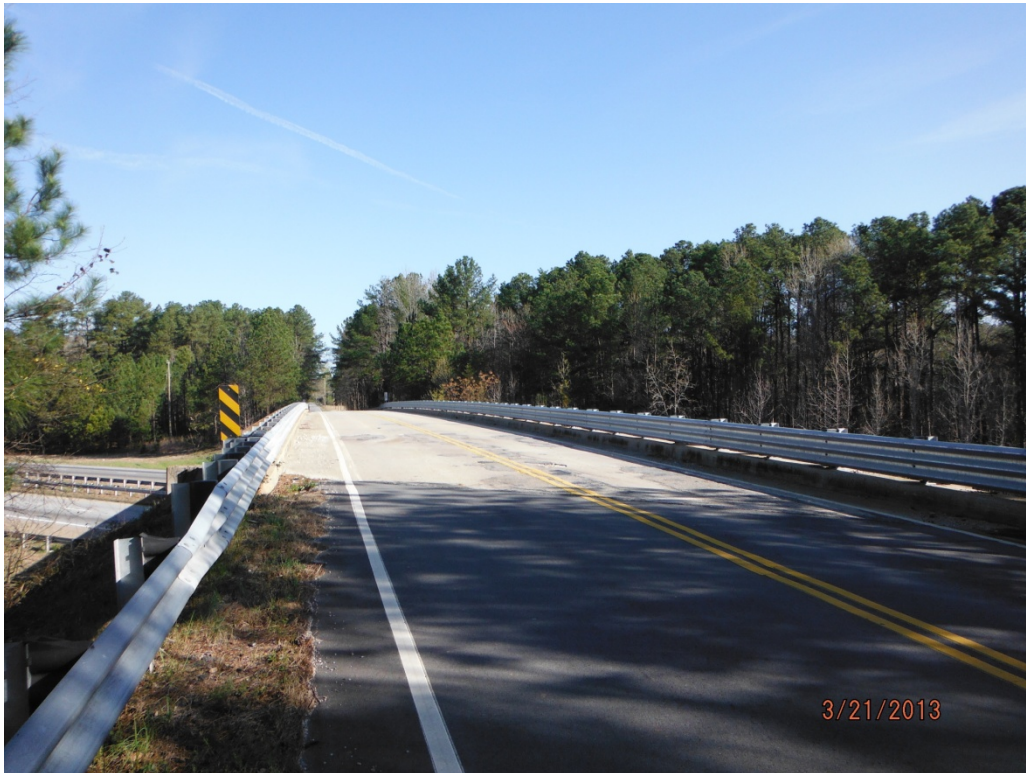
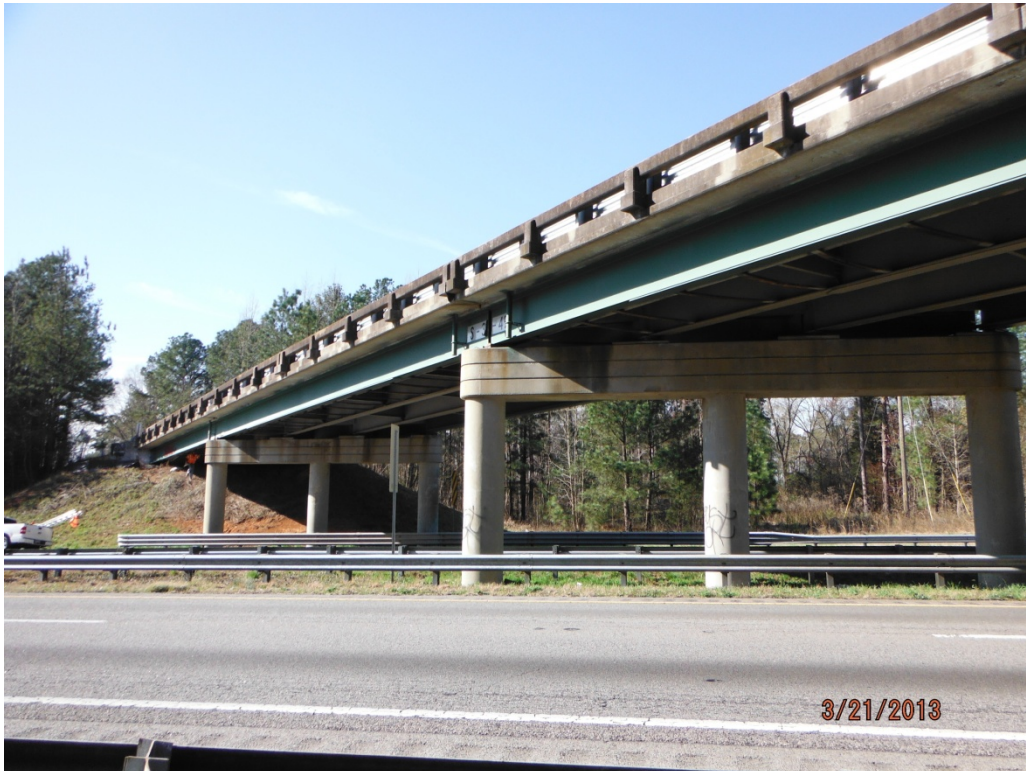
**S-32-49 Bridge over I-26**

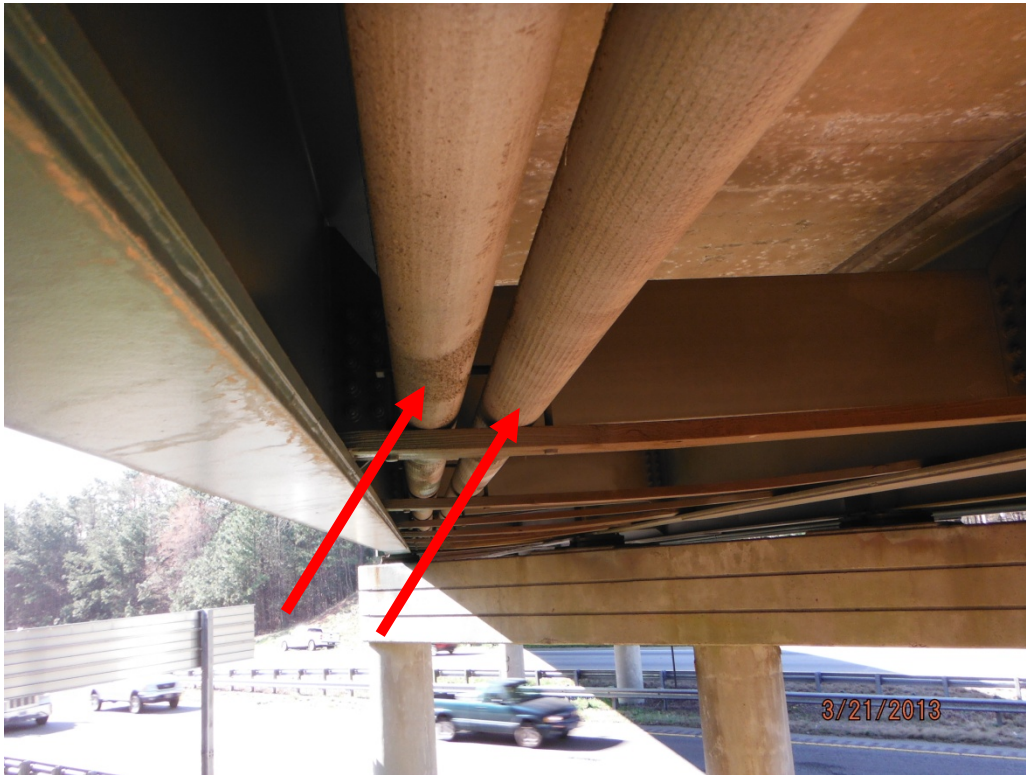
The asbestos-containing transite pipes are suspended from the underside of the bridge. The pipes extend the length of the bridge and serve as utility conduits. This material is intact with localized damage noted on the ends of each pipe. Since demolition and/or renovation activities will impact the pipes, they must be removed and disposed of as ACM by a licensed abatement contractor. This work will also require coordination with the owner of the utility lines encased in these pipes.

**Asbestos-Containing Transite Utility Conduits**

All ACM associated with the bridge structure must be removed, handled and disposed of per SCDHEC regulations pertaining to asbestos waste. Removal of the Transite pipes must be performed by a licensed and certified asbestos contractor prior to bridge demolition and/or renovation activities. Based on the quantities of ACM identified, no abatement project design will be required.

It is our understanding that the results of this investigation are intended to aide in planning for the demolition and/or renovation of the subject bridge structure. As a function of demolition and/or renovation activities, the identified ACM associated with the bridge structure must be removed, handled and disposed of per SCDHEC regulations pertaining to asbestos waste. Removal of the Transite utility conduits must be performed by a licensed and certified asbestos contractor prior to bridge demolition and/or renovation. Based on the quantities of ACM identified, no abatement project design will be required.
