# **ASBESTOS CONTAINING MATERIALS INVESTIGATION REPORT**

**S-40-405 BRIDGE OVER I-26  
SCDOT #407040500100  
RICHLAND COUNTY, SOUTH CAROLINA**

**March 28, 2013**

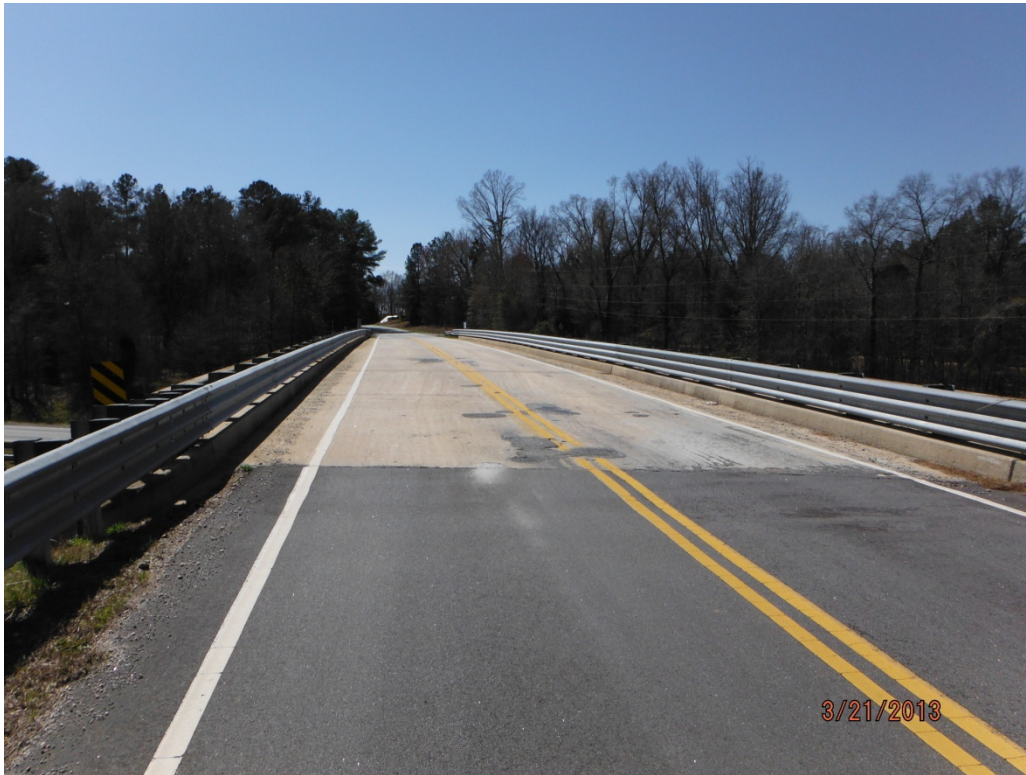
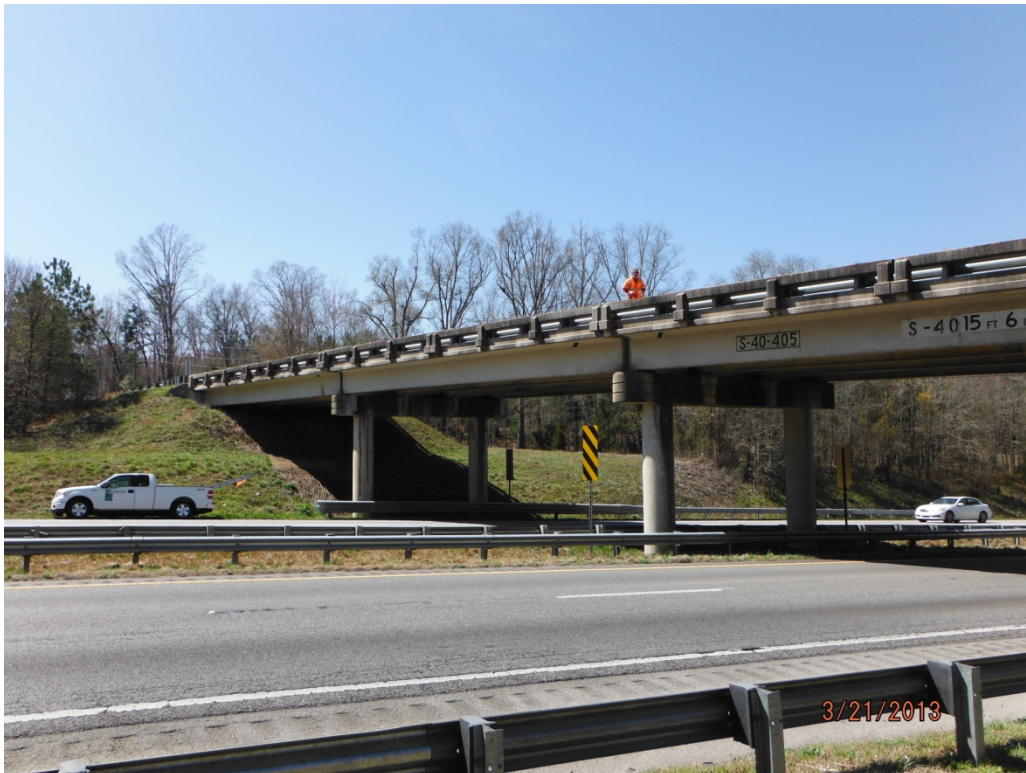
**S-40-405 Bridge over I-26**

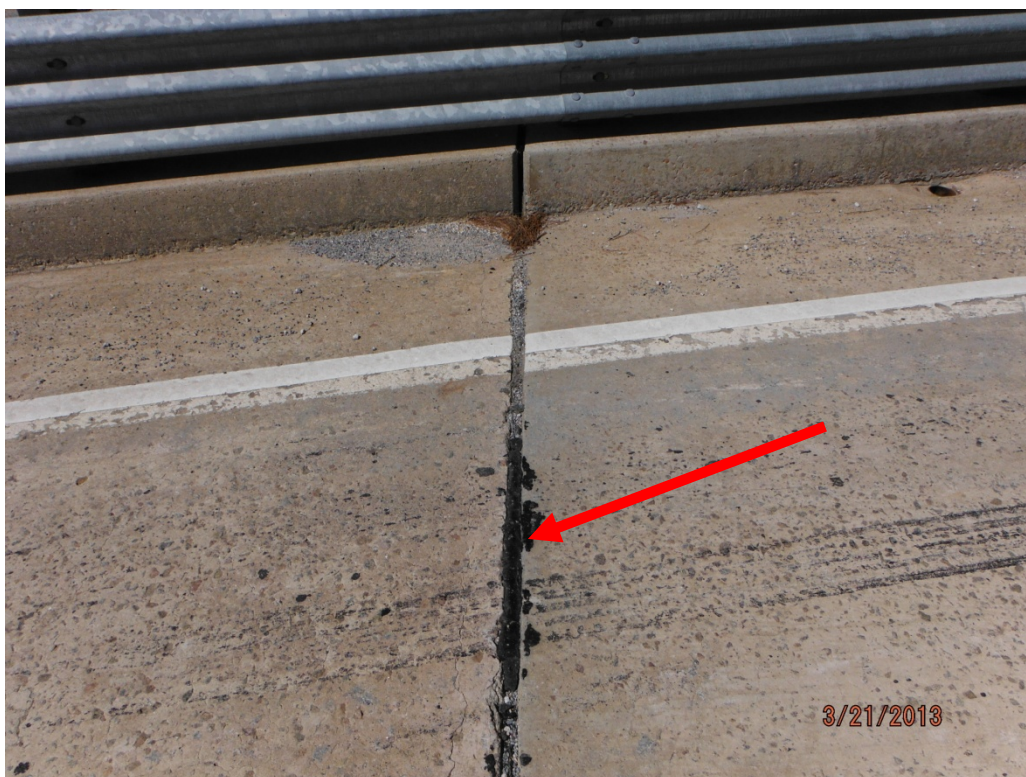
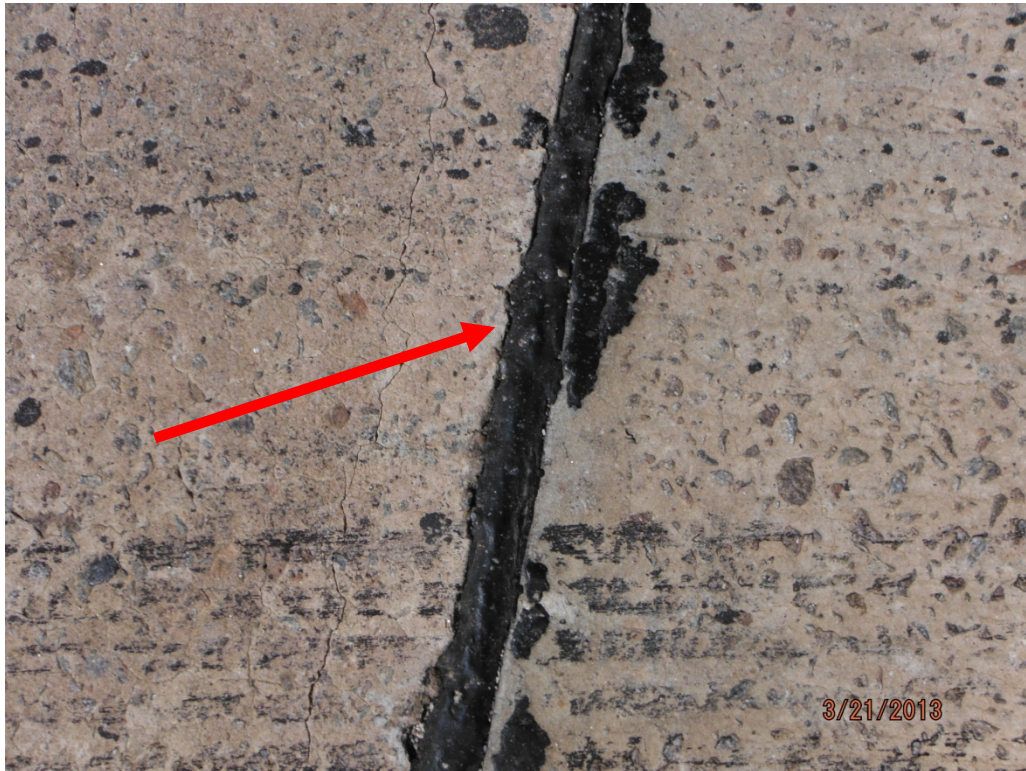
Asbestos-containing expansion joint material is located in each of the five (5) bridge deck expansion joints. This material fills the top one-fifth of each expansion joint of the bridge deck. Due to this material being encapsulated between adjacent concrete spans, assessment of its complete condition is not possible. The exposed portions where this material was sampled appeared to be in good condition. Since demolition and/or renovation activities will impact this material, it must be removed and disposed of as ACM by a licensed abatement contractor.

**Asbestos-Containing Top of Decking Expansion Joint Material**

It is our understanding that the results of this investigation are intended to aide in the demolition and/or renovation planning of the subject bridge structure. Prior these activities, the identified ACM associated with the bridge structure must be removed, handled and disposed of per SCDHEC regulations pertaining to asbestos waste. Since removal of these types of bridge components (i.e. bent cap felt pads and expansion joint compound) prior to demolition and/or renovation activities is not practical, these activities will require coordination with a licensed abatement contractor. Based on the quantities of ACM identified, no abatement project design will be required.

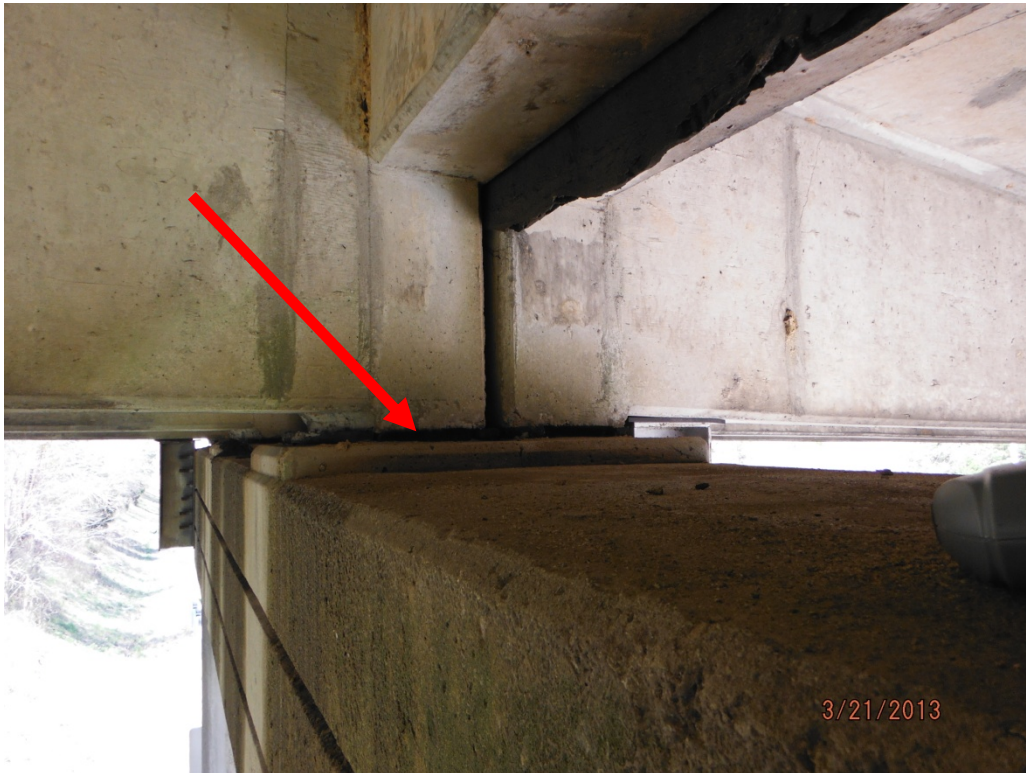
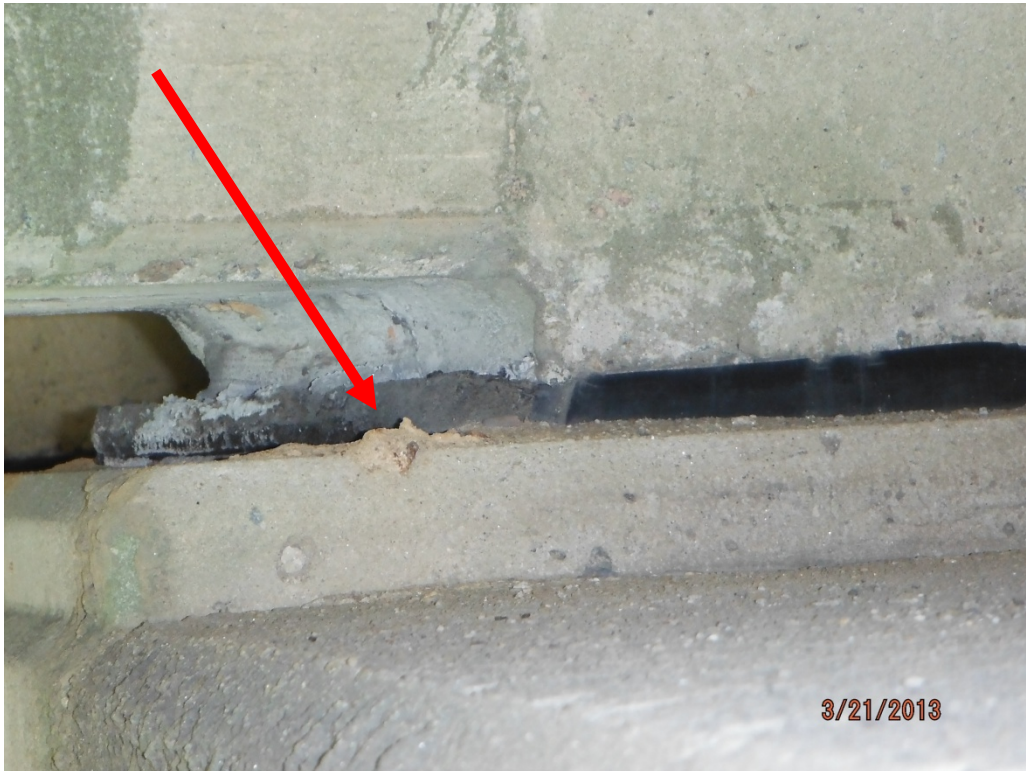
The asbestos-containing bent cap felt pads are located on top of each of the three (3) interior bent caps where the bent caps meet the bridge deck. There are four (4) pads per interior bent, resulting in a total of twelve (12) felt pads. Due to the majority of this material being encapsulated between the bent caps and the bridge deck, assessment of the condition of the entire pads is not possible. Based on the portions accessed for sample collection, the pads are more than likely intact. Since demolition and/or renovation activities will impact this material, it must be removed and disposed of as ACM by a licensed abatement contractor.

**Asbestos-Containing Interior Bent Cap Pads**
