# **ASBESTOS CONTAINING MATERIALS INVESTIGATION REPORT**

**S-40-80 BRIDGE OVER I-26  
SCDOT #4070008000100  
RICHLAND COUNTY, SOUTH CAROLINA**

**March 1, 2013**

**E5350.02**

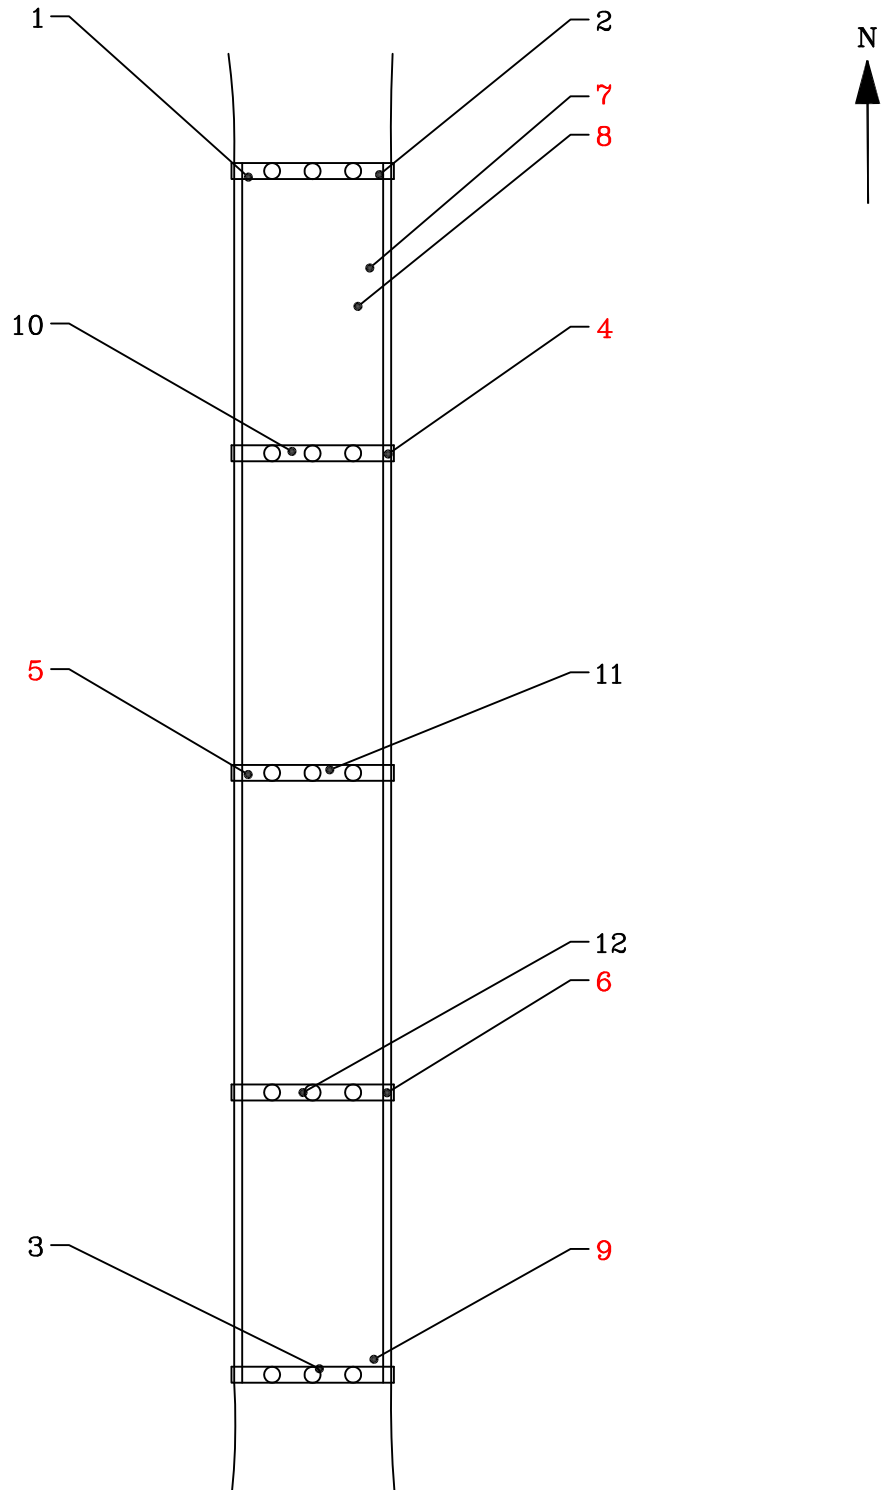
SCALE: N.T.S  
PROJECT: E5350.02  
FIGURE NO.: 2

SAMPLE LOCATION PLAN  
S-40-80 BRIDGE OVER I-26  
RICHLAND COUNTY, SOUTH CAROLINA

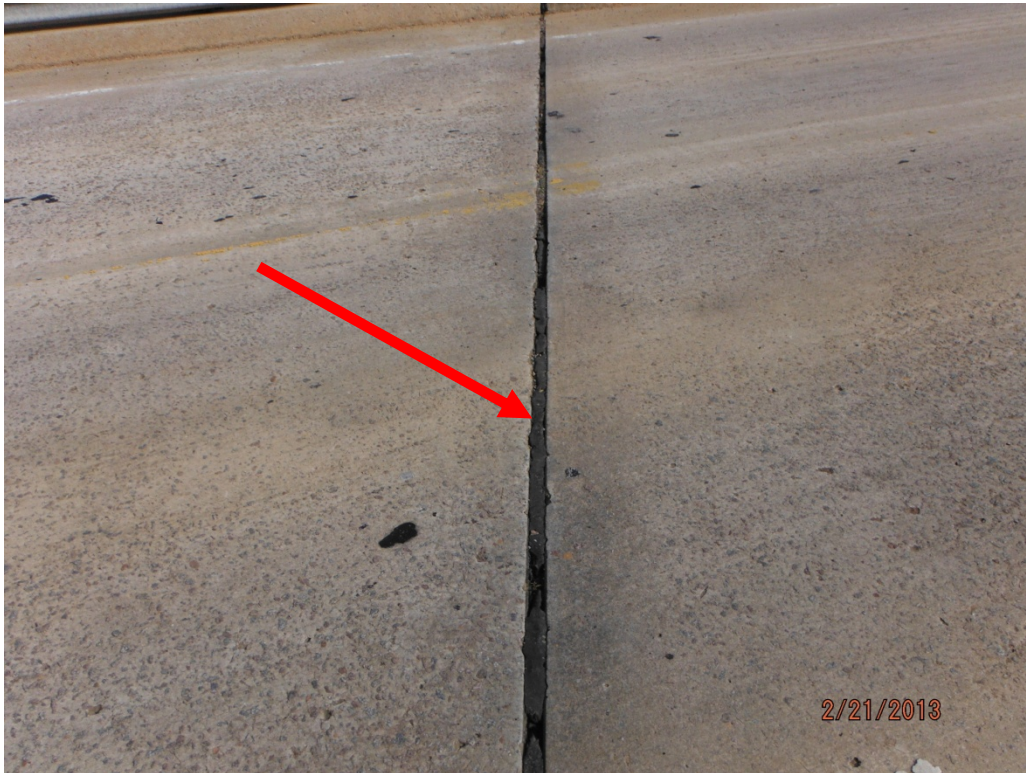
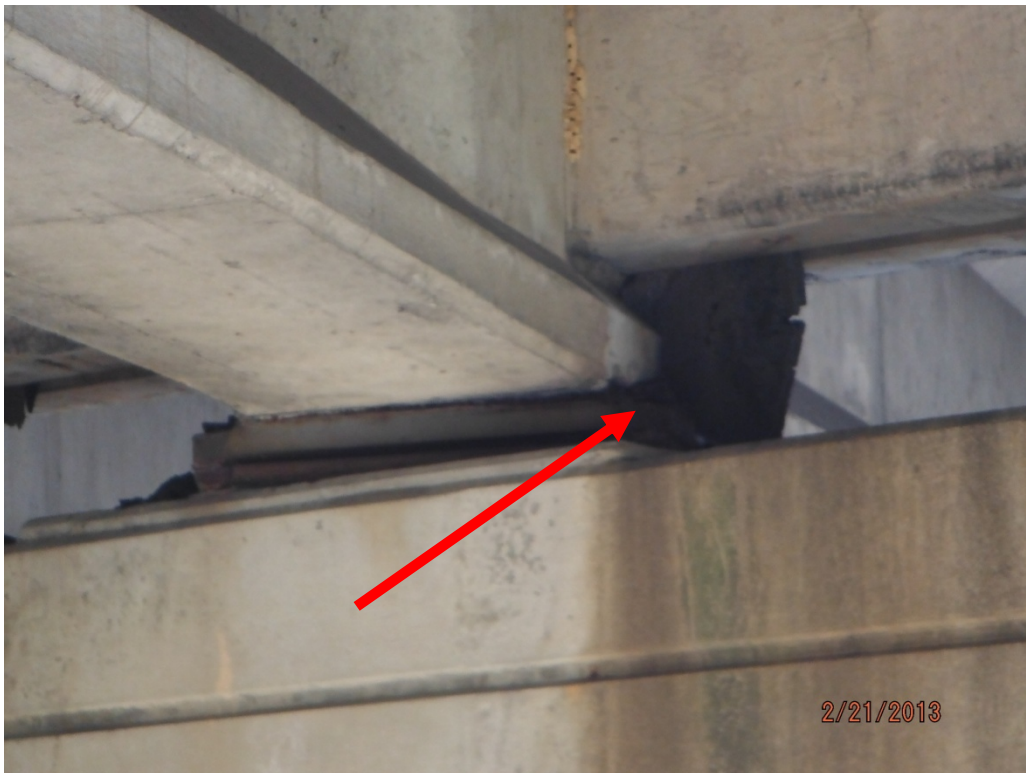
Asbestos-containing expansion joint material is located in each of the five (5) bridge deck expansion joints. This material fills each expansion joint from the top of the bridge deck to the underside of the bridge deck. This type of material is typically encapsulated between adjacent concrete spans, and assessment of its overall condition is not possible. However, this material was found exposed, hanging from the underside of the bridge and debris from this material was observed lying on top of some of the interior bent caps. Based on these observations, this material is considered to be in a significantly damaged condition. Since demolition and/or renovation activities will impact this material, it must be removed and disposed of as ACM by a licensed abatement contractor.

Asbestos-containing expansion joint material is located in each of the five (5) bridge deck expansion joints. This material fills each expansion joint from the top of the bridge deck to the underside of the bridge deck. This type of material is typically encapsulated between adjacent concrete spans, and assessment of its overall condition is not possible. However, this material was found exposed, hanging from the underside of the bridge and debris from this material was observed lying on top of some of the interior bent caps. Based on these observations, this material is considered to be in a significantly damaged condition.

**Expansion Joint Material**

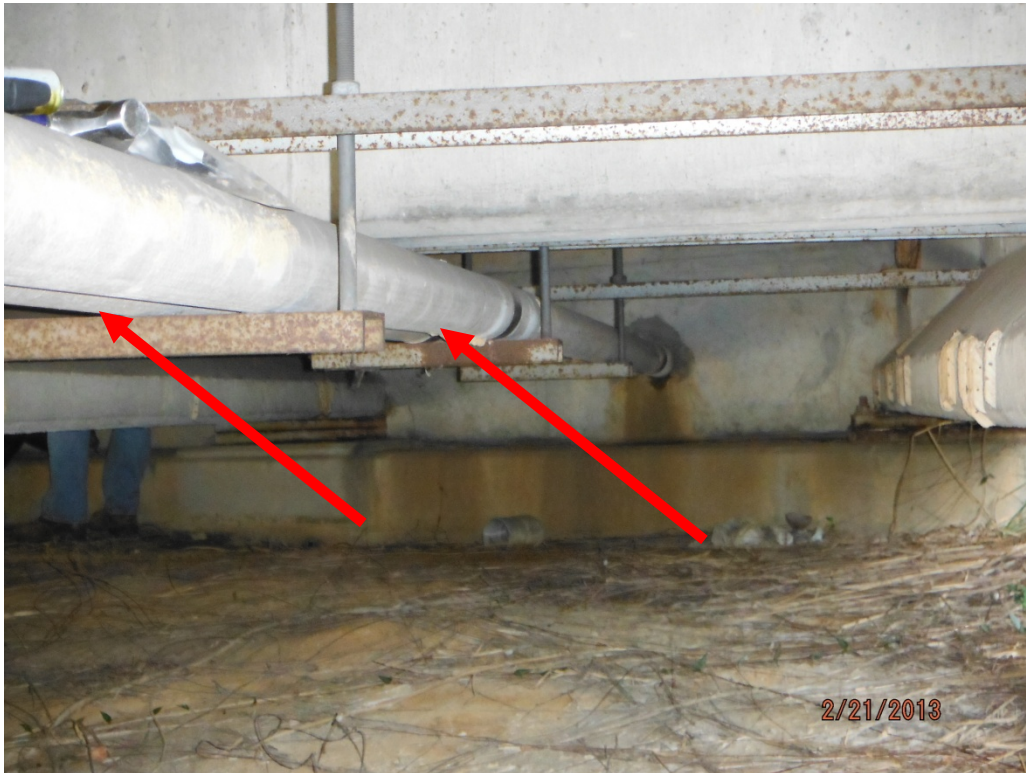
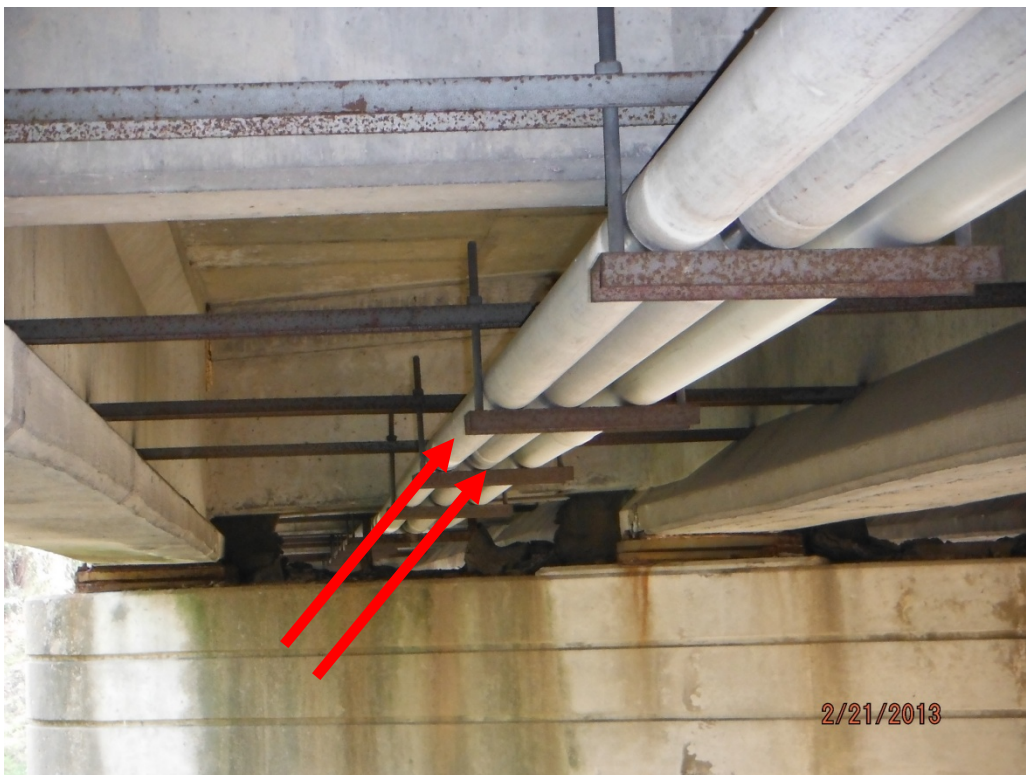
The asbestos-containing Transite pipes are suspended from the underside of the bridge. The pipes extend the length of the bridge and serve as utility conduits. This material is intact with localized damage noted where it appears that the pipes were partially cut. Since demolition and/or renovation activities will impact the pipes, they must be removed and disposed of as ACM by a licensed abatement contractor. This work will also require coordination with the owner of the utility lines encased in these pipes.

The asbestos-containing transite pipes are suspended from the underside of the bridge. The pipes extend the length of the bridge and serve as utility conduits. This material is intact with localized damage noted where it appears that the pipes were partially cut.

**Transite Utility Pipes**
