## ASBESTOS CONTAINING MATERIAL INVESTIGATION REPORT

US-1 BRIDGE OVER I-20  
LEXINGTON COUNTY, SOUTH CAROLINA

**March 25, 2019**

F&ME Project No.: G6018.000

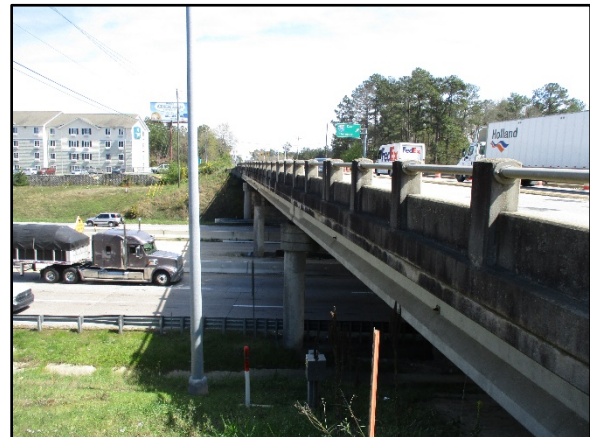
The existing bridge structure (~270.0'L x 60'W, inside curb to inside curb), is located on US-1 and crosses over I-20 in Lexington County, South Carolina. The actual date of construction for the original bridge structure is unknown. The structure is a four-lane bridge constructed with a poured-in-place concrete bridge deck, with concrete curb and gutters, sidewalks and consists of four (4) bridge deck spans. The bridge deck spans are supported by ten (10) precast horizontal concrete beams, concrete diaphragms and each bent is supported by four (4) concrete columns with poured in place concrete bent caps. End bents are constructed with vertical concrete walls and have soil and concrete covering the piles with only the top of the concrete bent cap exposed. Galvanized guardrails and posts are attached to both ends of the bridge. The bridge approach on each end of the bridge consist of a four-lane asphalt paved roadway.

*Photo 1 – US 1 Bridge over I-20 in Lexington, SC.*

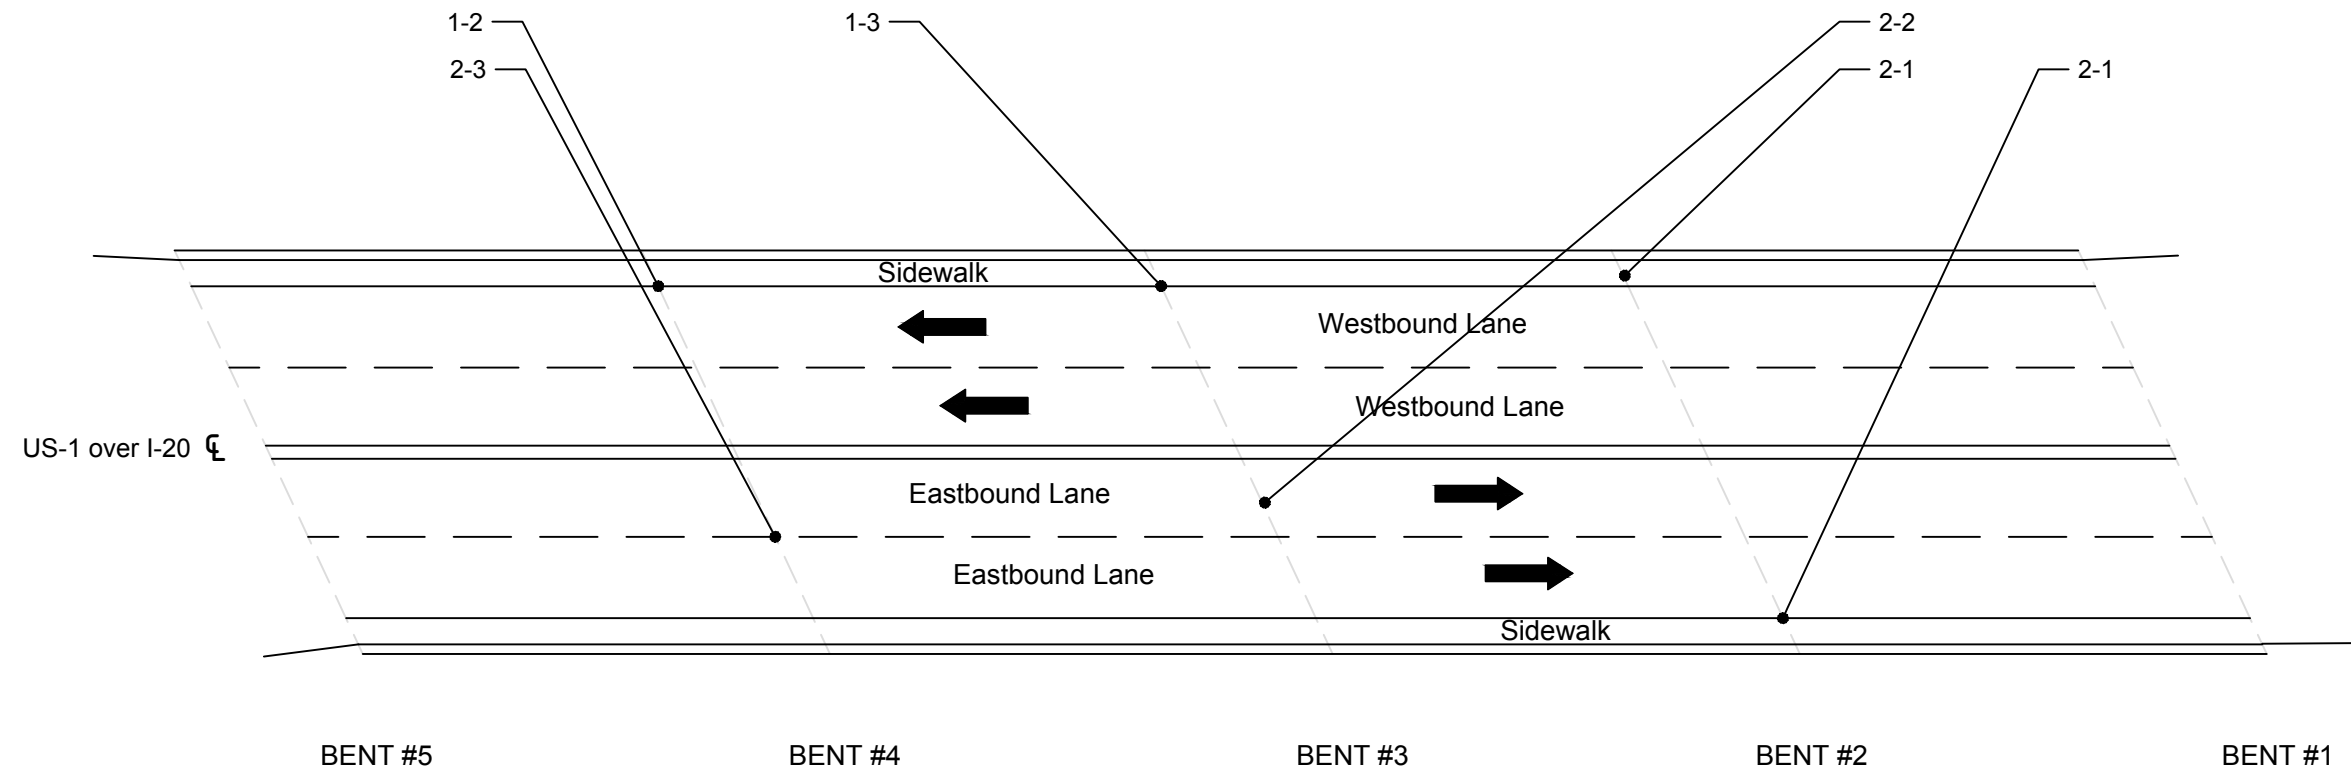
FIGURE NUMBER:  
**2**

the sides of the bridge. A black expansion joint board and a black expansion joint material were noted during the investigation and were the only suspect materials identified. See Appendix B – Sample Location Plan, for detailed sample locations. Also, see Appendix G – Site Photographs, for more details.

**ASBESTOS CONTAINING MATERIALS INVESTIGATION**  
 US-1 over I-20  
 Lexington County, SC  
**Sample Location Map**  
 Prepared for: STV, Inc.  
 454 South Anderson Road, Suite 3  
 Rock Hill, SC 29730

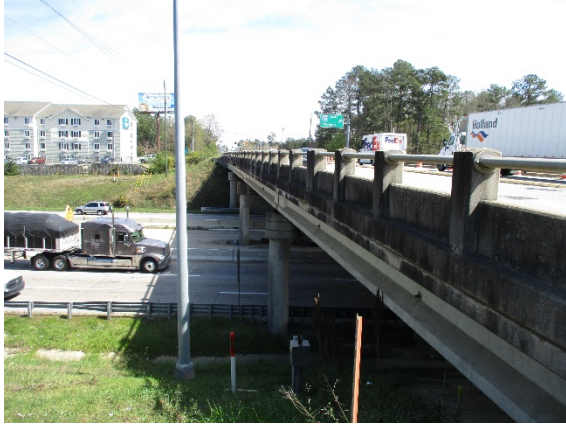
**Photo 1.** North Side View of Bridge

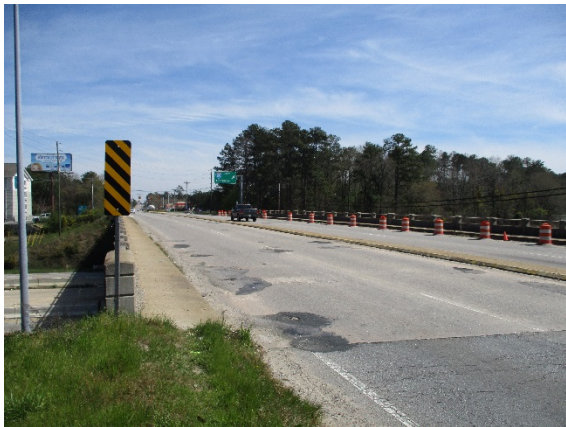
**Photo 3.** View of Topside of Bridge

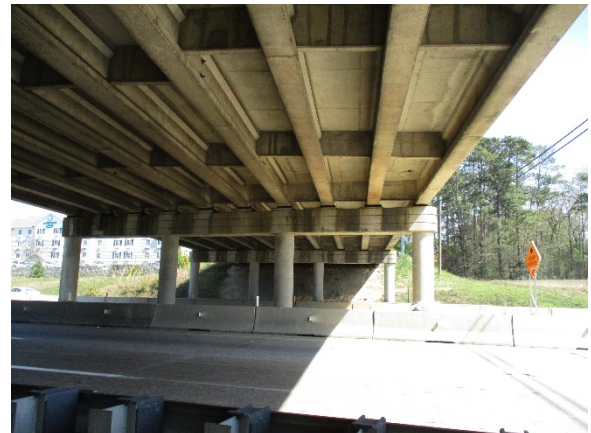
During the inspection, all bridge components (i.e. concrete bent caps, piles, and expansion joints) were visually inspected for suspect ACM. Examples of possible suspect materials include bent and pile cap felt, bond-break pads, expansion joint material, and drainage scuppers. The bridge deck rested directly on the bent caps, with steel plates observed/visible between them. Non-suspect PVC scuppers were observed on

**Photo 4.** View of Underside of Bridge

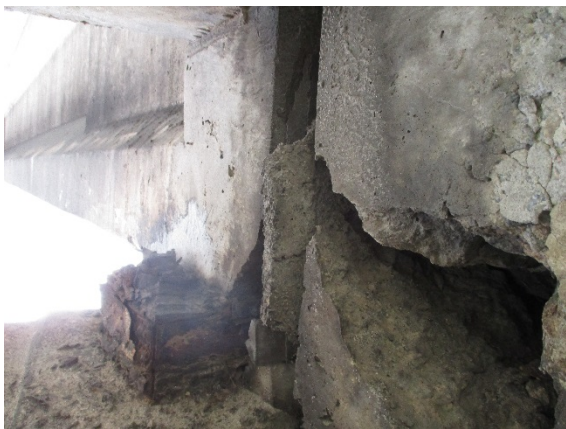
During the investigation, an expansion joint board and black expansion joint material were the only suspect materials observed on the subject bridge. Three (3) random samples of each suspect material were collected for laboratory analysis, and their physical characteristics were recorded. The remaining bridge materials (i.e. concrete, steel, etc.) were not considered suspect and were not sampled.

**Photo 5.** Non-ACM Expansion Joint Board

It is our understanding that the existing bridge structure is scheduled for demolition. All accessible suspect materials have been sampled and analyzed by an accredited laboratory and found to be negative for ACM. Therefore, there are no foreseen special handling or disposal requirements, regarding asbestos, that will be required for the demolition of this bridge.

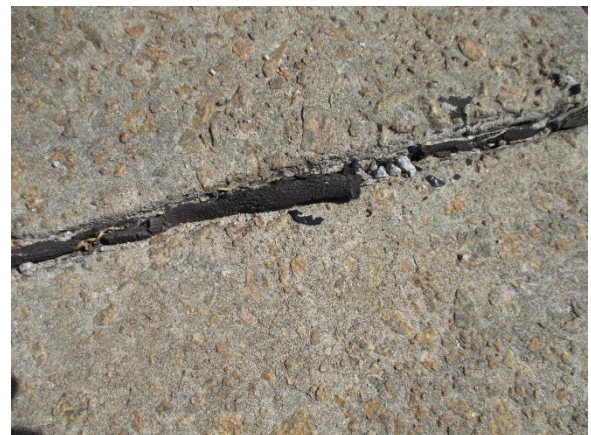
**Photo 6.** Non-ACM Expansion Joint Material
