Crash Analysis

*Carolina Crossroads
I-20/26/126 Corridor Project
Lexington and Richland Counties, South Carolina*

Draft 01 February 2016

Prepared for South Carolina Department of Transportation
and the Federal Highway Administration

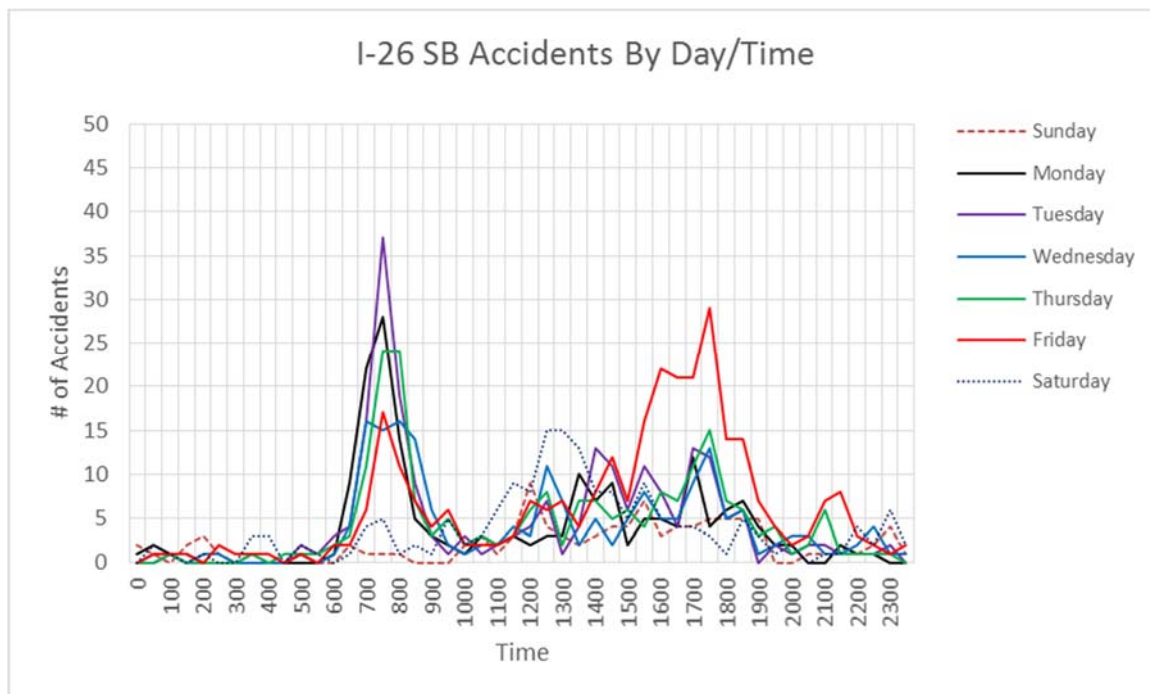
Figure 2.1: I-26 Southbound Crash Summary - Day of the Week and Time of Day

As can be seen from **Figure 2.1**, the total number of crashes was highest on Tuesday during the morning peak period. A large number of crashes occurred during the morning peak period on the other weekdays. During the afternoon peak period, the highest number of accidents occurred on Friday. The highest occurrence of accidents on the weekends occurred during midday on Saturday.

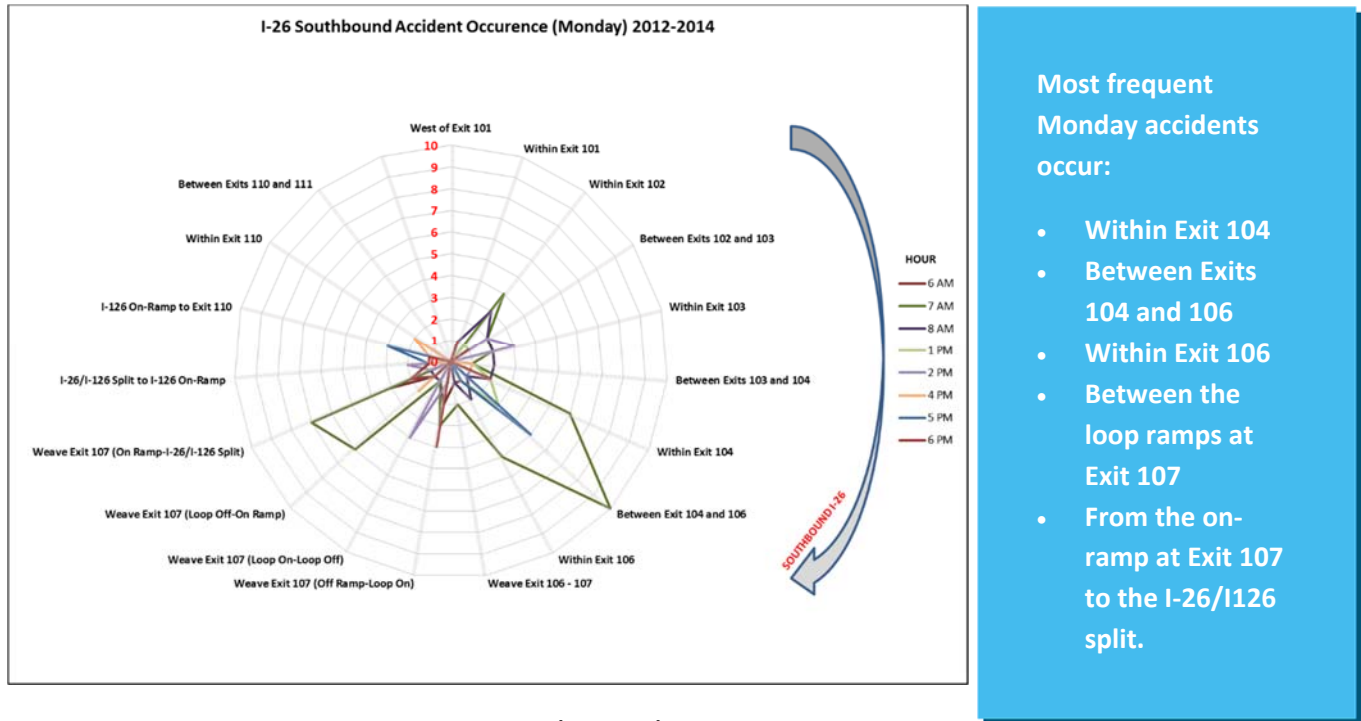
Figure 2.2: Southbound I-26 Accident Occurrence (Monday)

The accidents occurring during the morning and afternoon peak periods for each day of the week and on typical weekdays (Tuesday through Thursday) were plotted on graphs. The resulting graphs are shown in **Figures 2.2 through 2.9**. From the graphs, the general locations of the most frequently occurring crashes can be identified. For example, in **Figure 2.2**, the southbound segments with the most crashes occurred between 7:00 and 8:00 AM within Exit 104, between Exit 104 and Exit 106, within Exit 106, and at Exit 107 between the loop off-ramp to eastbound I-20 and the I-26/I-126 split.

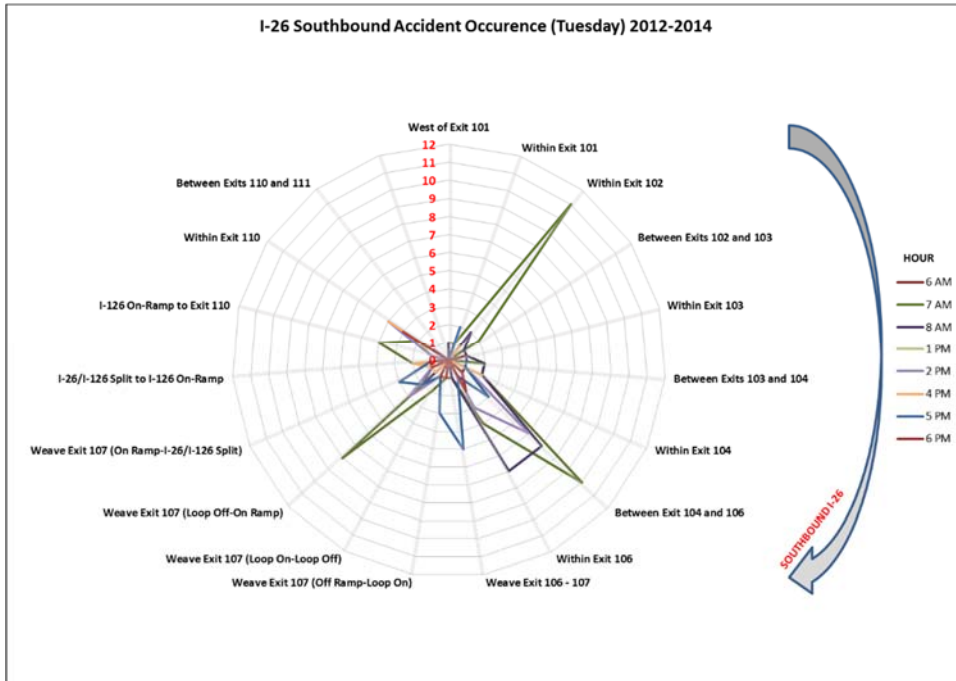
Figure 2.3: Southbound I-26 Accident Occurrence (Tuesday)

Most frequent Tuesday accidents occur:

- Within Exit 102
- Between Exits 104 and 106
- Within Exit 106
- In the weaving area between Exits 106 and 107
- In the weaving area between the loop ramps at Exit 107

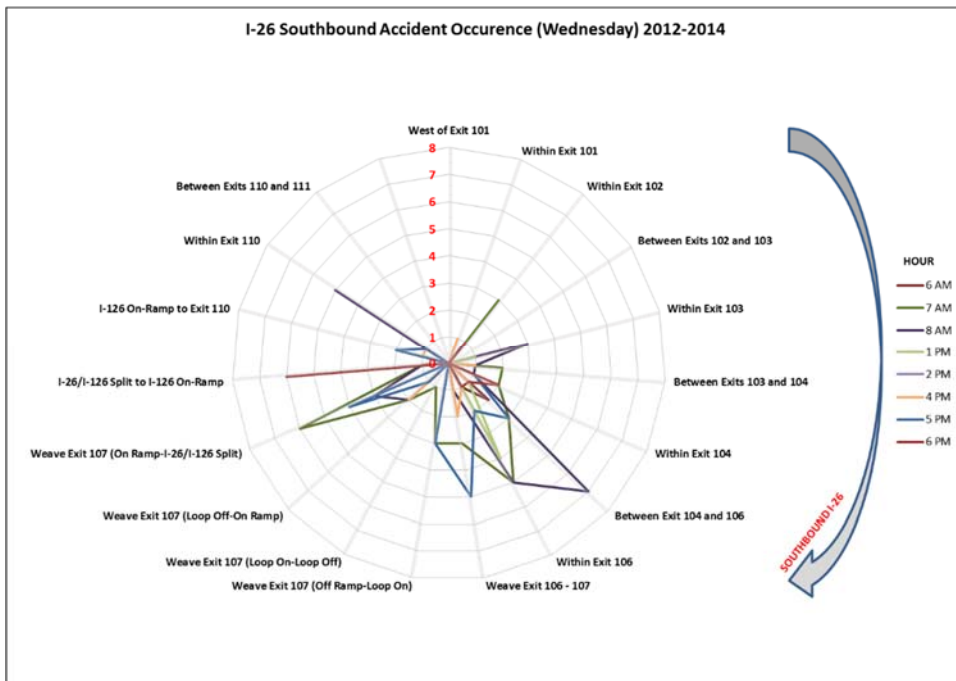
Most frequent Wednesday accidents occur:

- Between Exits 104 and 106
- Within Exit 106
- In the weaving area between Exits 106 and 107
- From the on-ramp at Exit 107 to the I-26/I126 split.

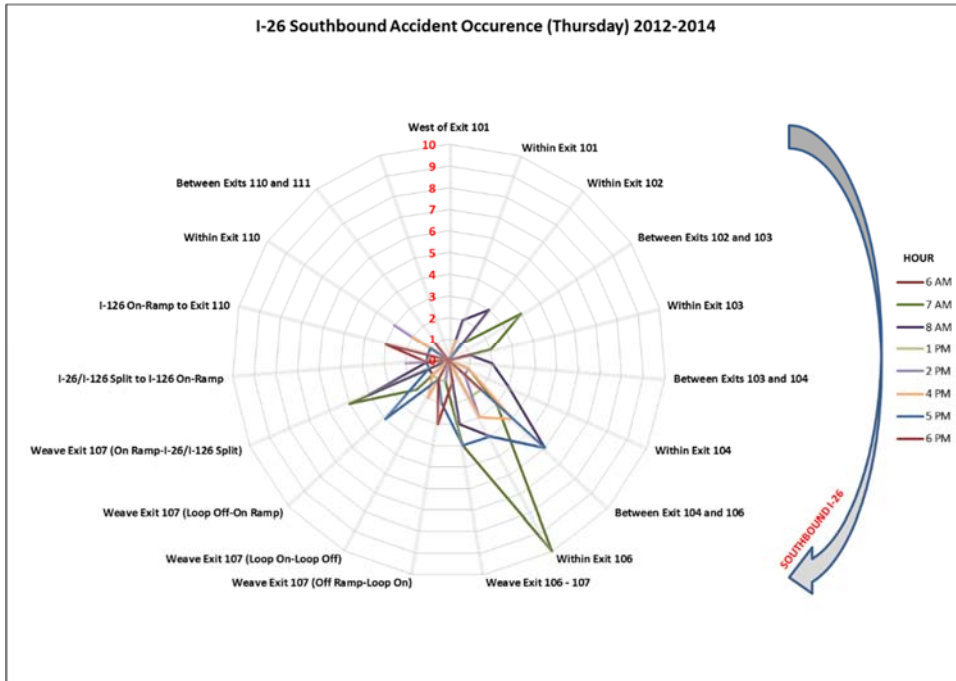
Figure 2.5: Southbound I-26 Accident Occurrence (Thursday)

Most frequent Thursday accidents occur:

- Between Exits 104 and 106
- Within Exit 106
- In the weaving area between Exits 106 and 107

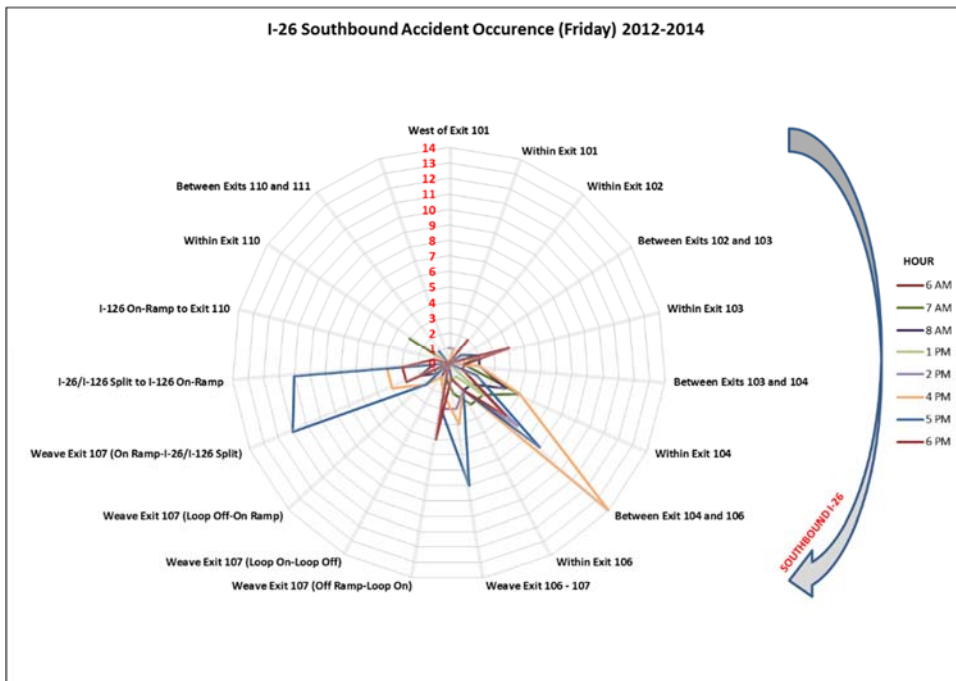
Most frequent Friday accidents occur:

- Between Exits 104 and 106
- Weaving section between Exits 106 and 107
- From the on-ramp at Exit 107 to the I-26/I-126 split.
- From the I-26/I-126 split to the I-126 on-ramp

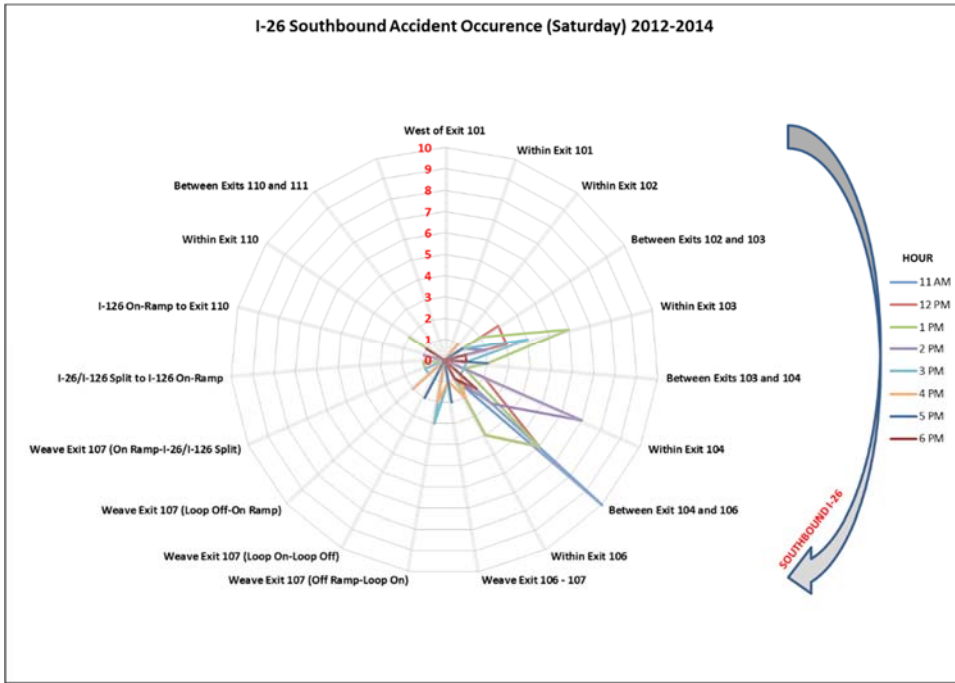
Figure 2.7: Southbound I-26 Accident Occurrence (Saturday)

Most frequent Saturday accidents occur:

- Within Exit 103
- Within Exit 104
- Between Exits 104 and 106

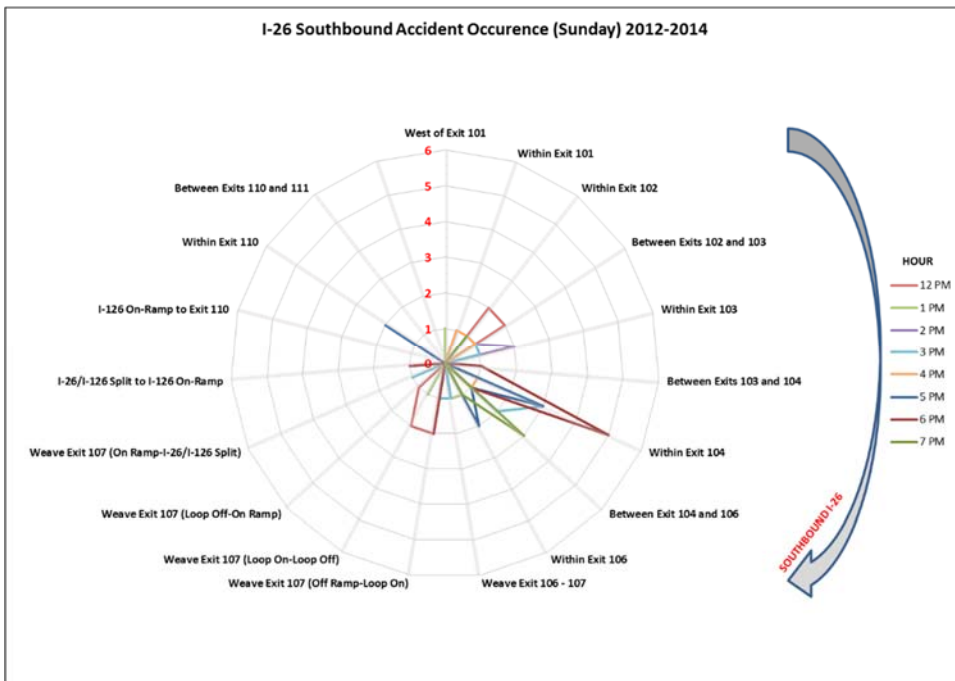
Most frequent Sunday accidents occur:

- Within Exit 104
- Between Exits 104 and 106

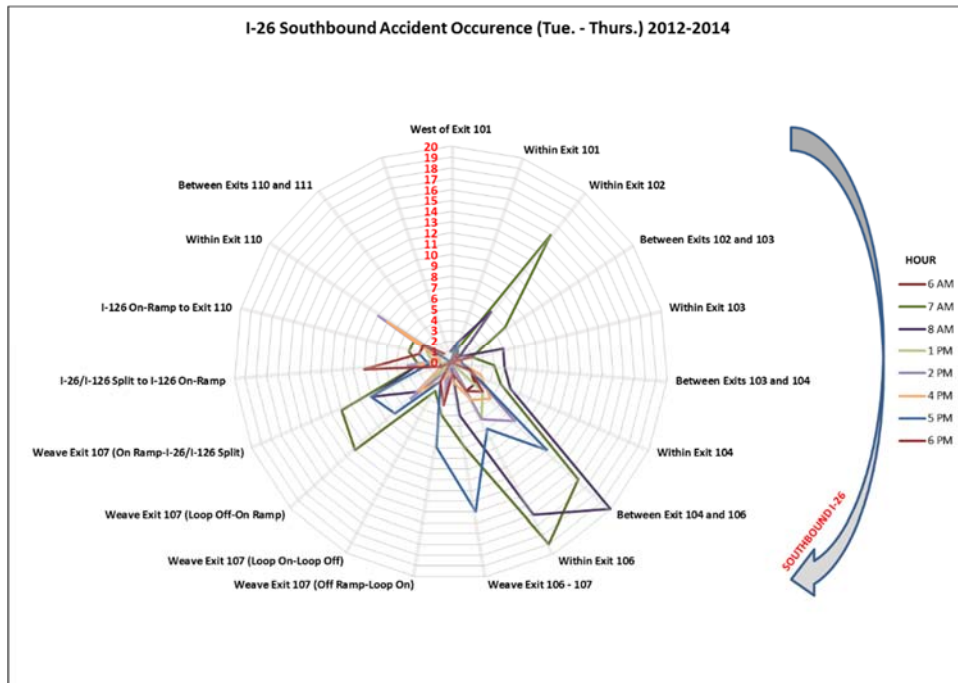
Most frequent Weekday accidents occur at:

- Within Exit 102
- Between Exits 104 and 106
- Within Exit 106
- Between Exits 106 and 107
- Between the loop ramps at Exit 107
- From the on-ramp at Exit 107 to the I-26/I126 split.

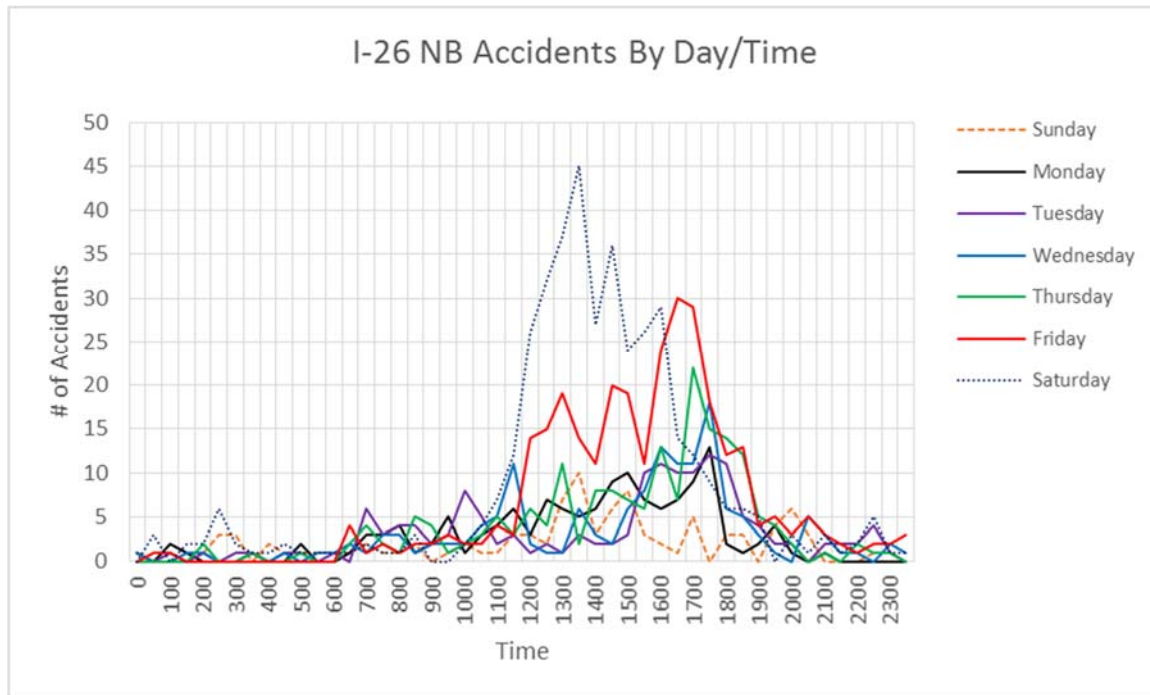
Figure 2.10: I-26 Northbound Summary by Day of Week and Time of Day

Crash data along northbound I-26 were also summarized based on day of the week and time of day. A graph depicting the time and day of the week is shown in **Figure 2.10**.

As can be seen from Figure 10, the highest number of accidents on westbound I-26 occur on Saturday during the midday. Friday also has a high number of accidents occurring throughout the midday and into the afternoon peak period. Most of the other periods with a high number of accidents occur during the other weekdays (Monday through Thursday) during the afternoon peak period.

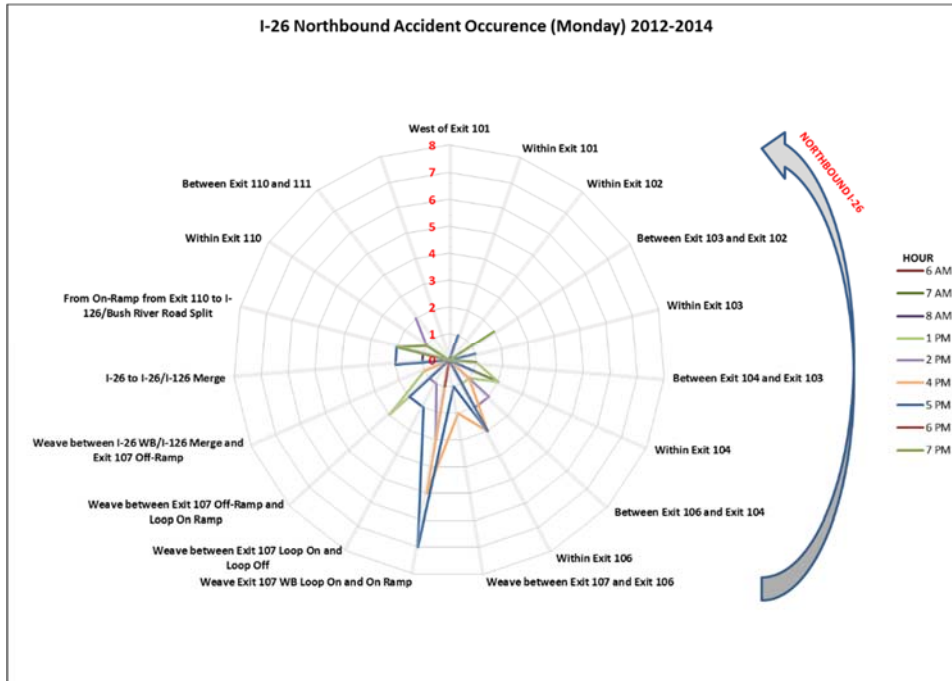
Figure 2.11: I-26 Northbound Accident Occurrence (Monday)

Most frequent Monday accidents occur:

- Between the loop ramps at Exit 107

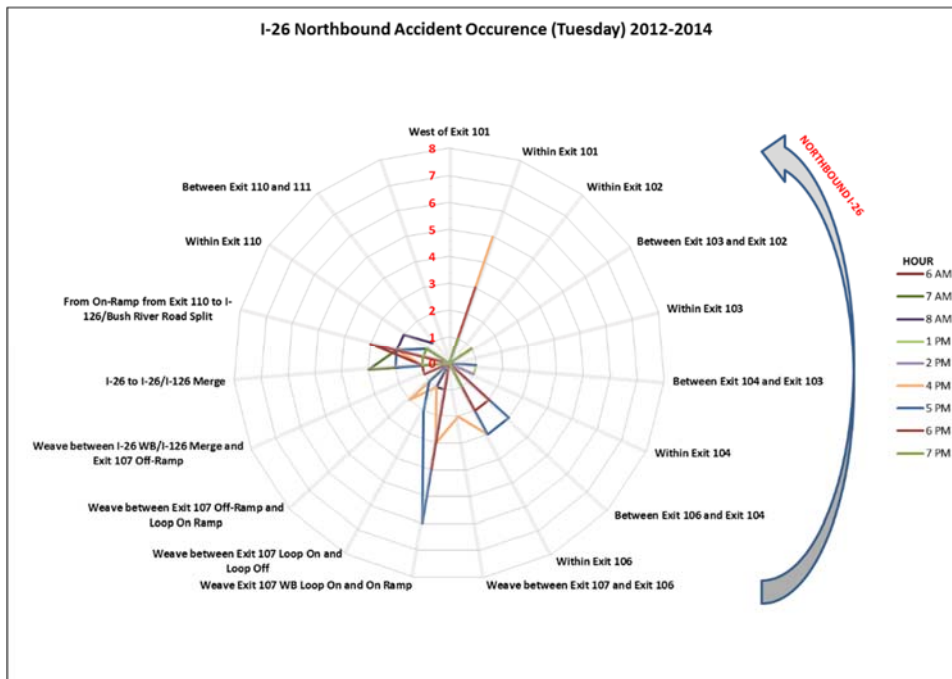
Most frequent Tuesday accidents occur:

- Between the loop ramps at Exit 107

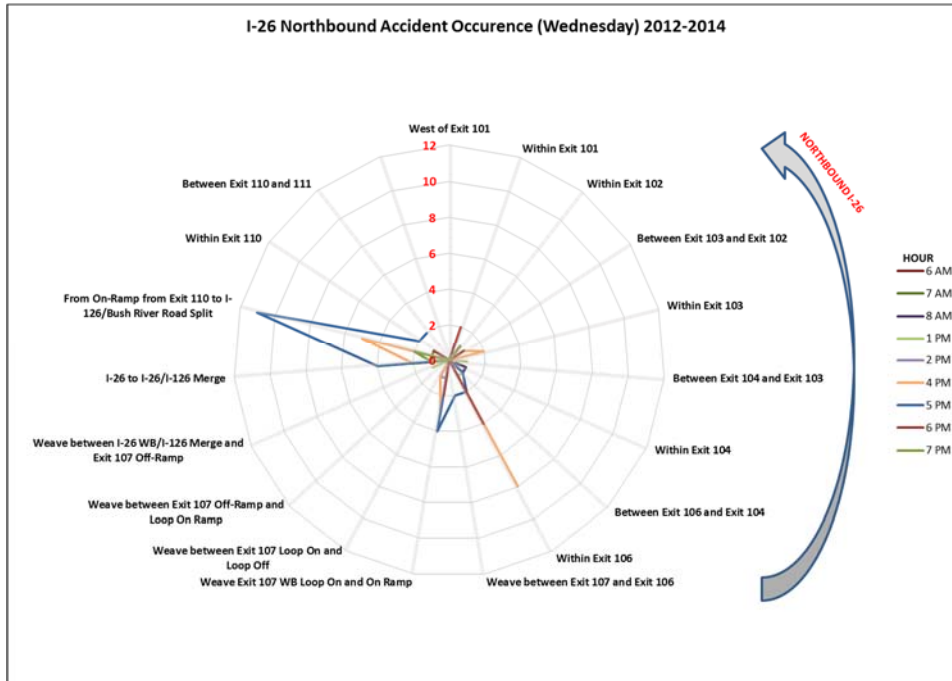
Figure 2.13: I-26 Northbound Accident Occurrence (Wednesday)

Most frequent Wednesday accidents occur:

- Between Exit 110 and the I-126/Bush River Road Split
- Between the I-126 Split and the I-126 Merge
- Within Exit 106

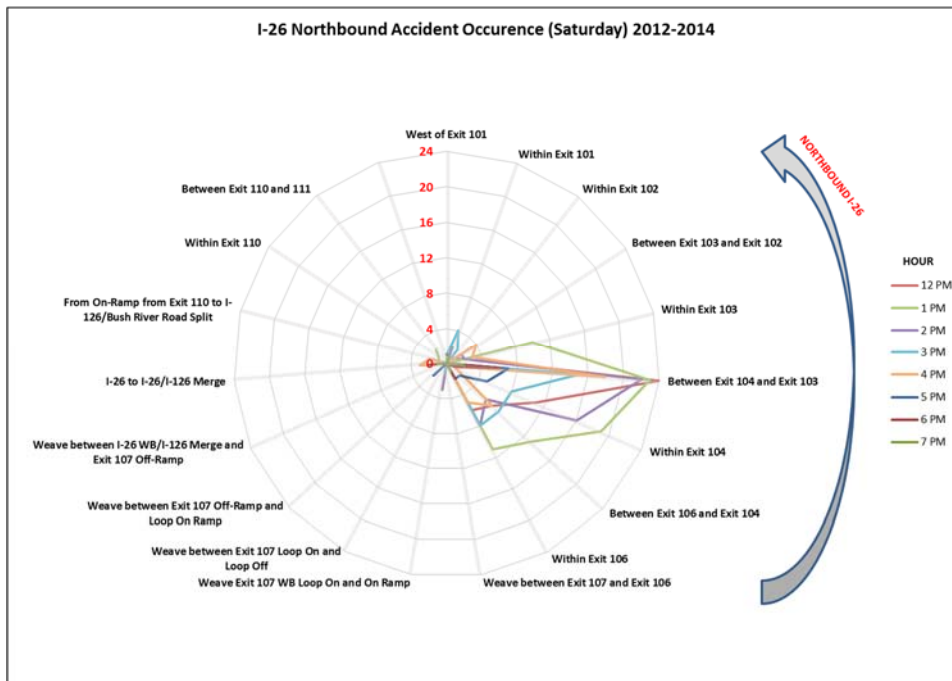
Most frequent Saturday accidents occur:

- Within Exit 106
- Between Exits 106 and 104
- Within Exit 104
- Between Exits 104 and 103
- Within Exit 103

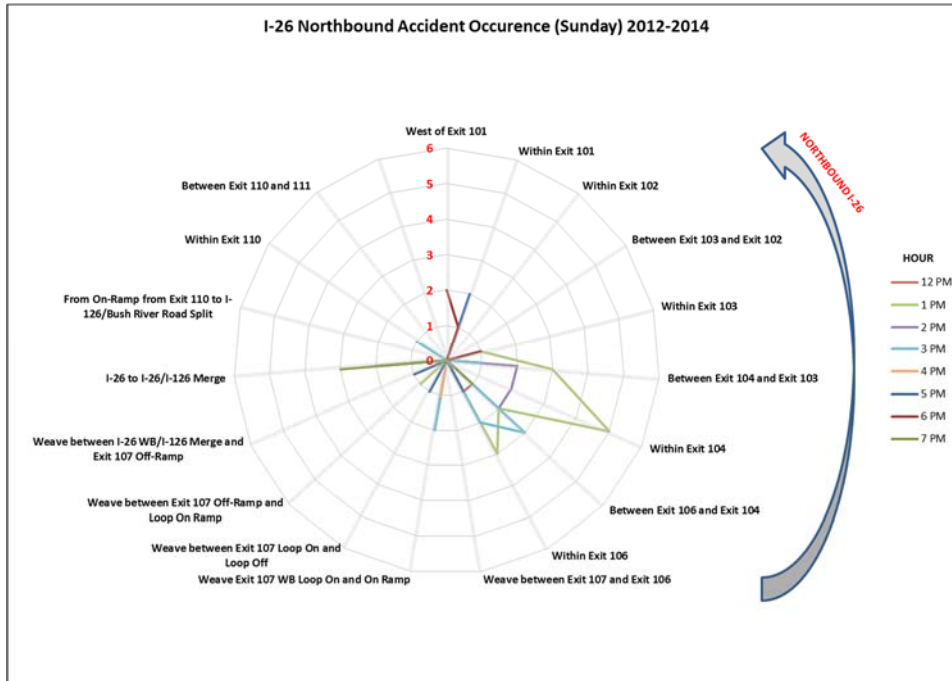
Figure 2.17: I-26 Northbound Accident Occurrence (Sunday)

Most frequent Sunday accidents occur:

- Within Exit 106
- Between Exits 106 and 104
- Within Exit 104
- Between Exits 104 and 103

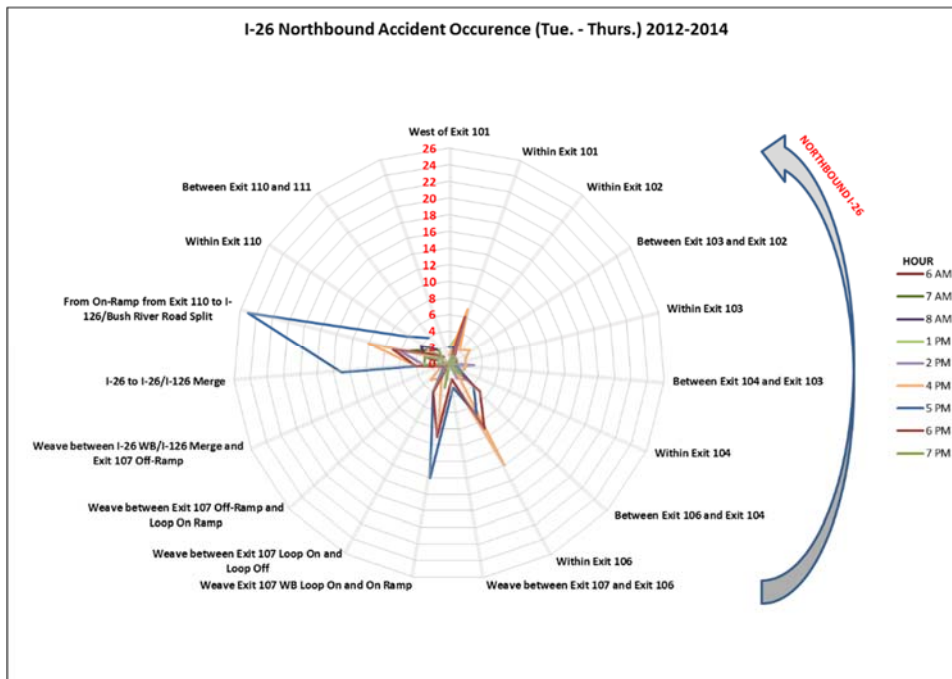
Most frequent Weekday accidents occur:

- Between Exit 110 and the I-126/Bush River Road Split
- Between the I-126 Split and the I-126 Merge
- Between the loop ramps at Exit 107
- Within Exit 106

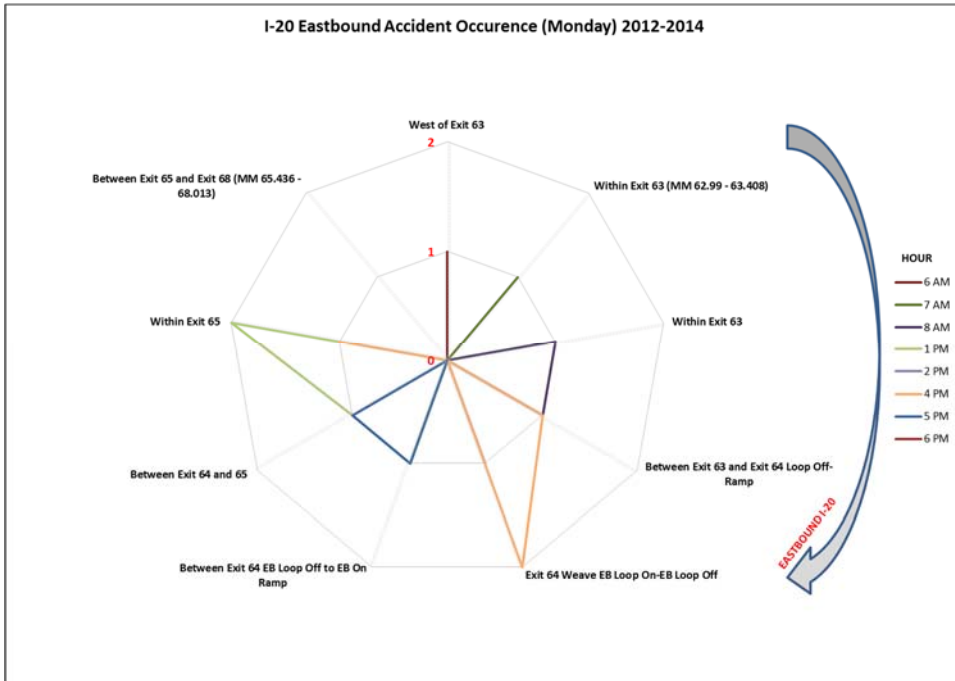
Figure 2.20: Eastbound I-20 Accident Occurrence (Monday)

Most frequent Monday accidents occur:

- At the weaving movement between the Exit 64 loop ramps
- Within Exit 65

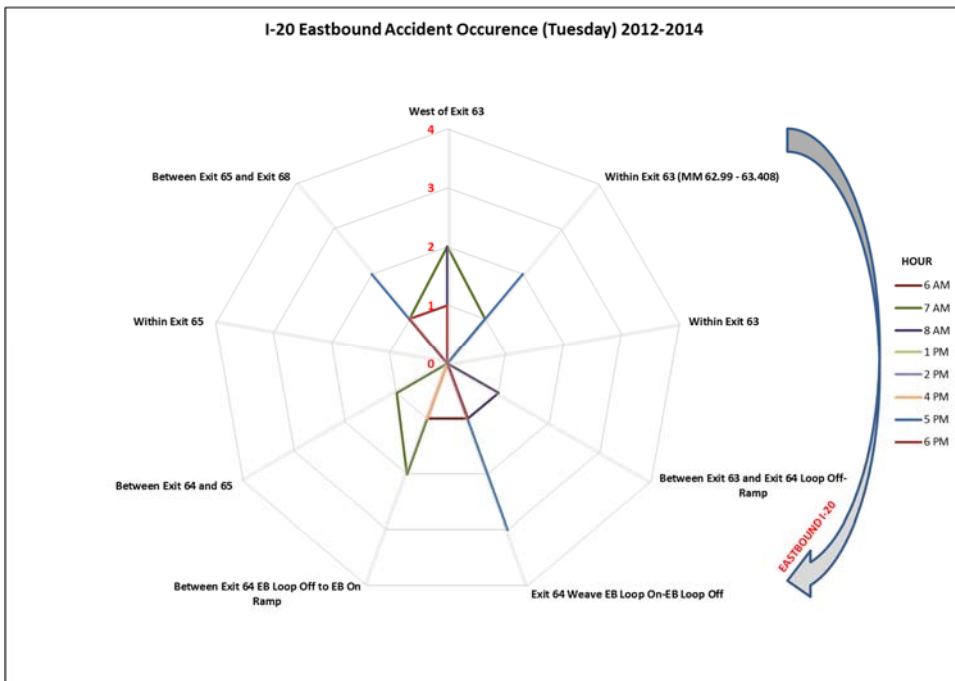
Most frequent Tuesday accidents occur:

- At the weaving movement between the Exit 64 loop ramps
- Between the loop off-ramp and the on-ramp at Exit 64

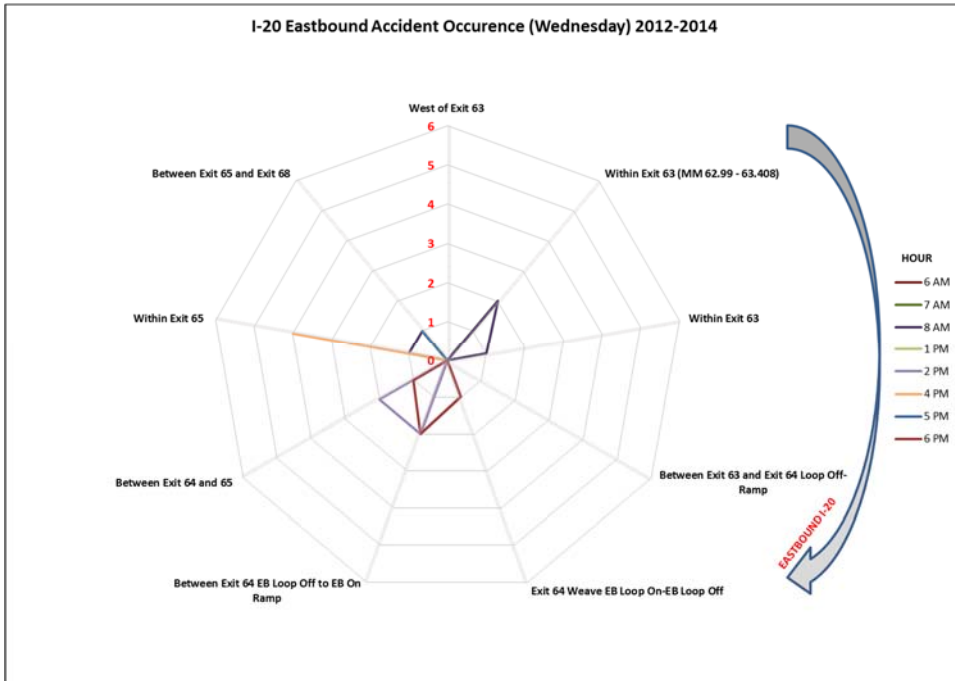
Figure 2.22: Eastbound I-20 Accident Occurrence (Wednesday)

Most frequent Wednesday accidents occur:

- Within Exit 65

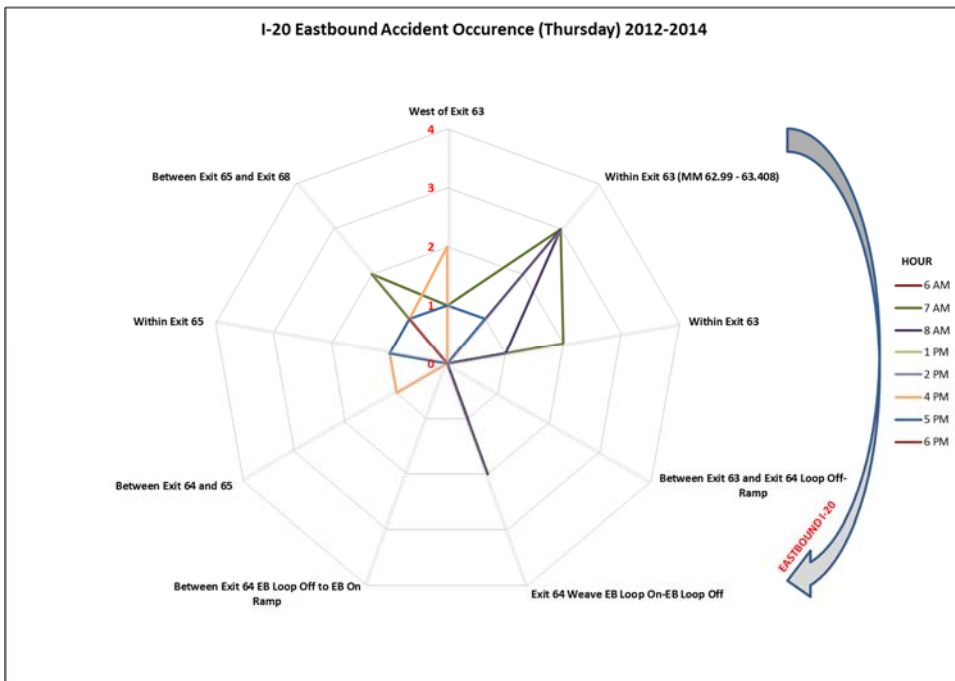
Most frequent Thursday accidents occur:

- Within Exit 63
- At the weaving movement between the Exit 64 loop ramps

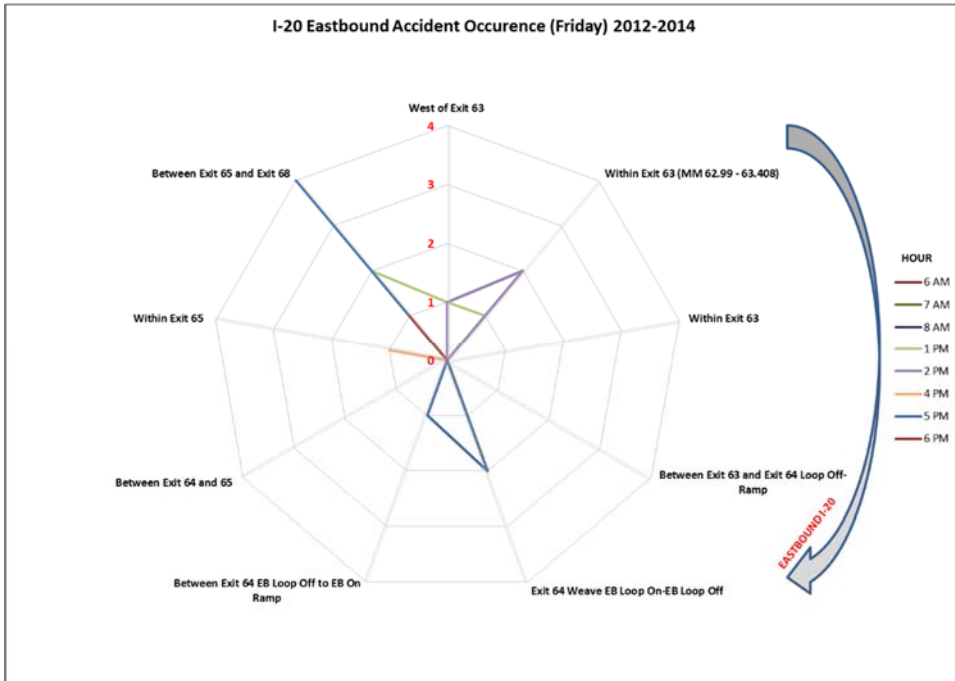
Figure 2.24: Eastbound I-20 Accident Occurrence (Friday)

Most frequent Friday accidents occur:

- East of Exit 65
- At the weaving movement between the Exit 64 loop ramps

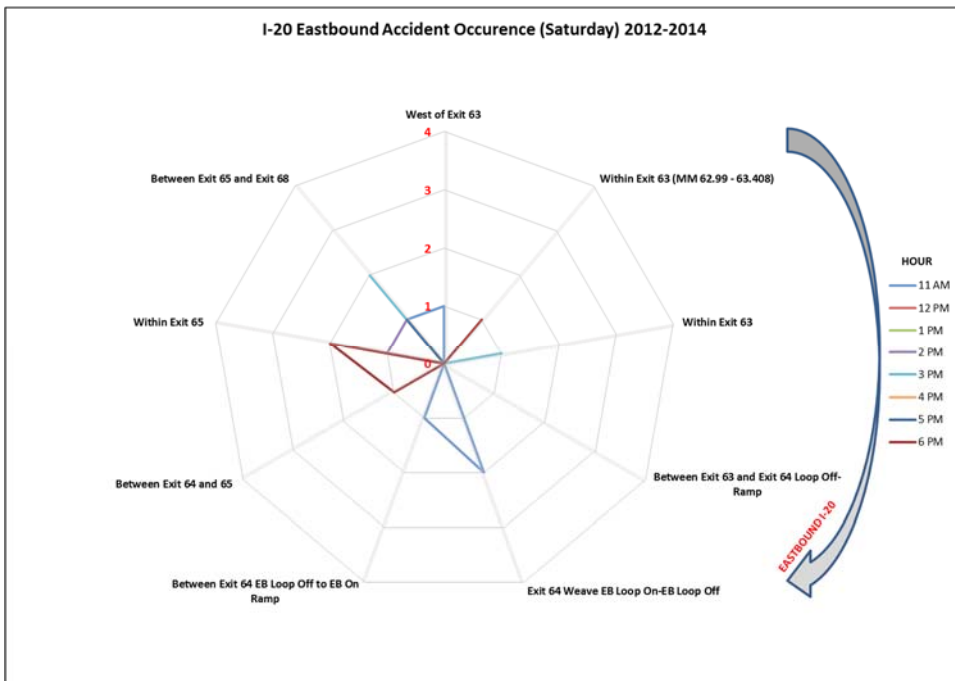
Most frequent Saturday accidents occur:

- At the weaving movement between the Exit 64 loop ramps
- Within Exit 65

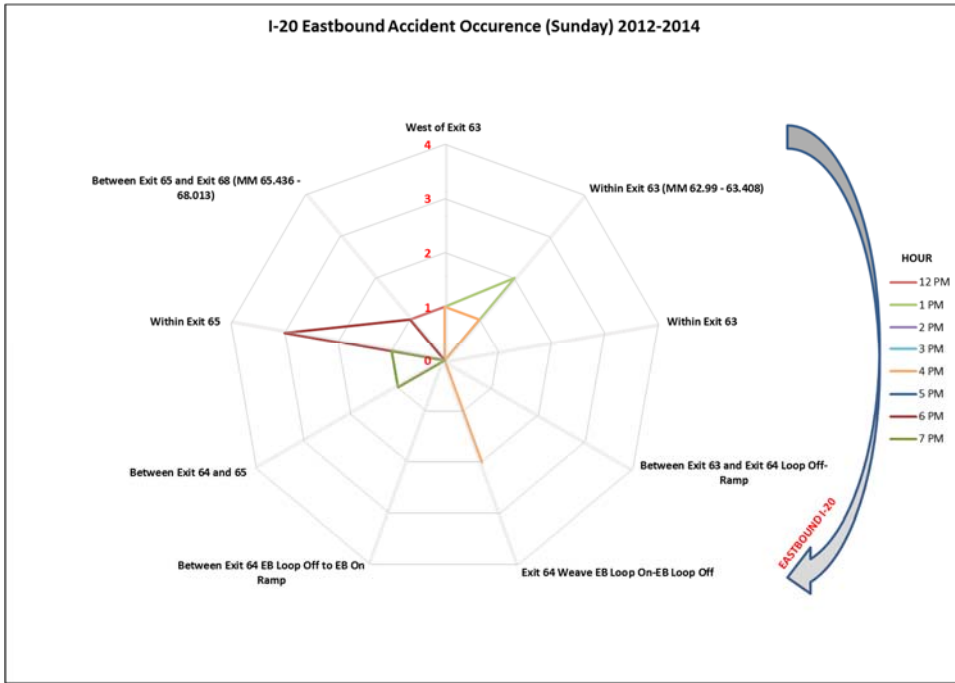
Figure 2.26: Eastbound I-20 Accident Occurrence (Sunday)

Most frequent Sunday accidents occur:

- Within Exit 63
- At the weaving movement between the Exit 64 loop ramps
- Within Exit 65

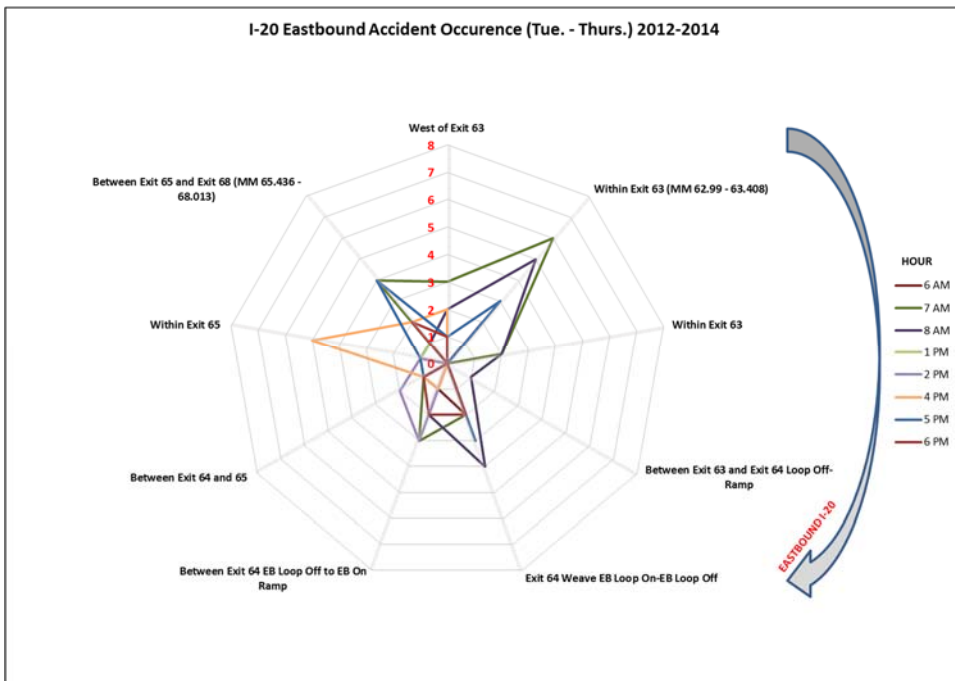
Most frequent Weekday accidents occur:

- Within Exit 63
- At the weaving movement between the Exit 64 loop ramps
- Within Exit 65
- East of Exit 65

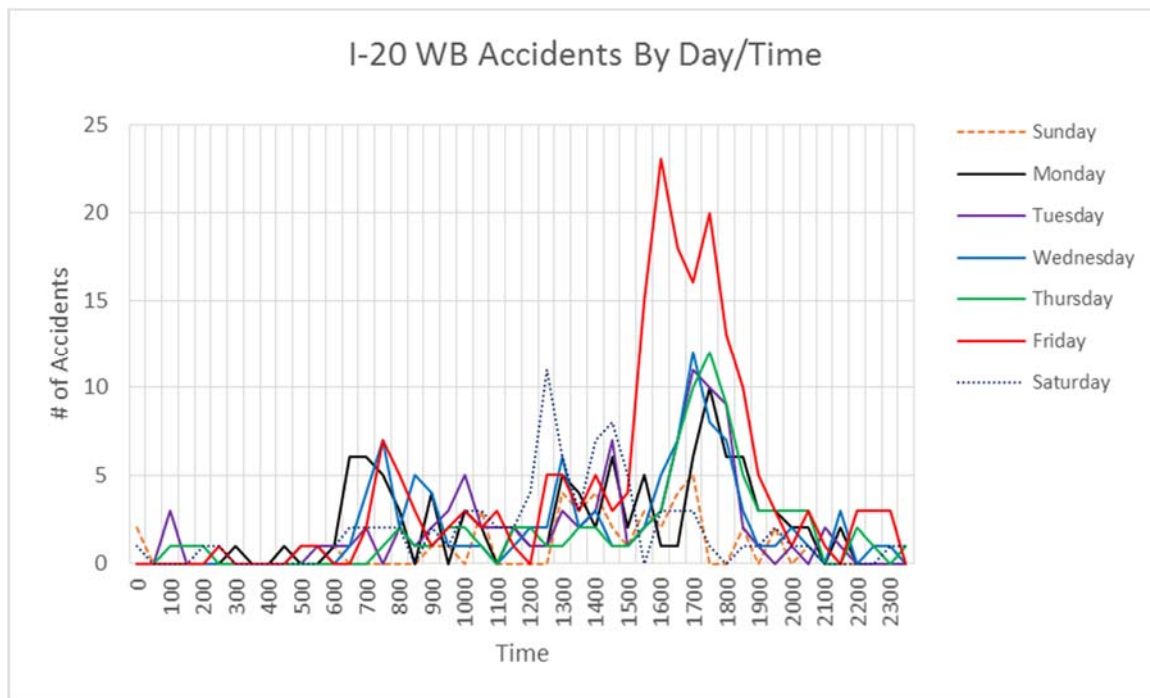
Figure 2.28: I-20 Westbound Crash Summary - Day of the Week and Time of Day

The crash data along westbound I-20 is depicted graphically by the time-of-day and day of the week in **Figure 2.28**.

As can be seen from **Figure 2.28**, a significant number of the accidents along westbound I-20 occurs between 7:00 AM and 7:00 PM. A high number of accidents between 6:30 and 8:30 AM occurred on Monday, Wednesday and Friday. There were similarly frequent accidents between noon and 3:00 PM. Westbound

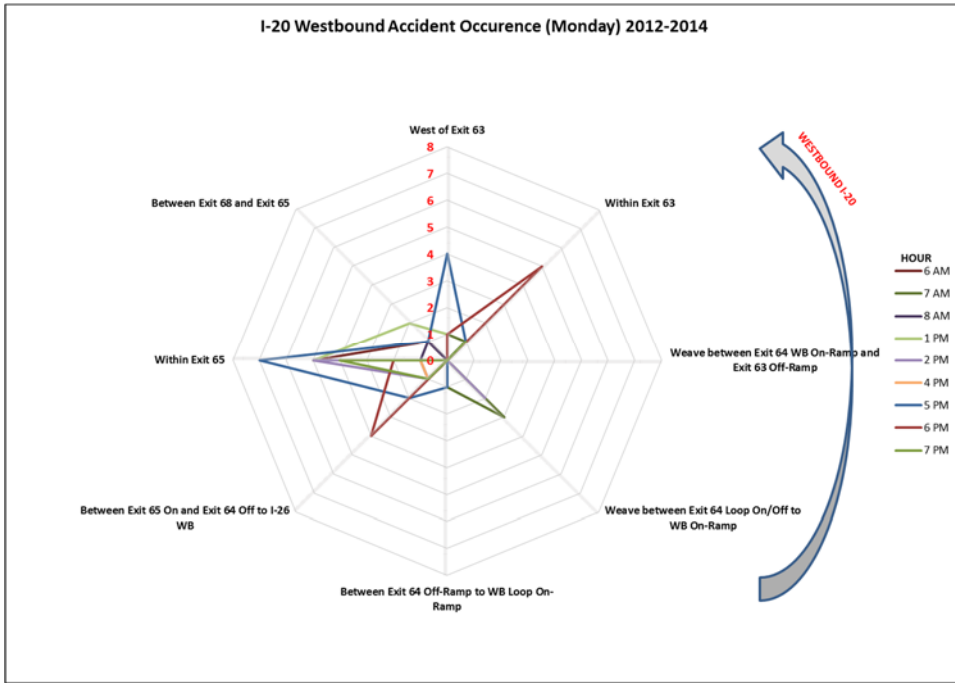
Figure 2.29: Westbound I-20 Accident Occurrence (Monday)

Most frequent Monday accidents occur:

- Within Exit 65
- Within Exit 63
- West of Exit 63

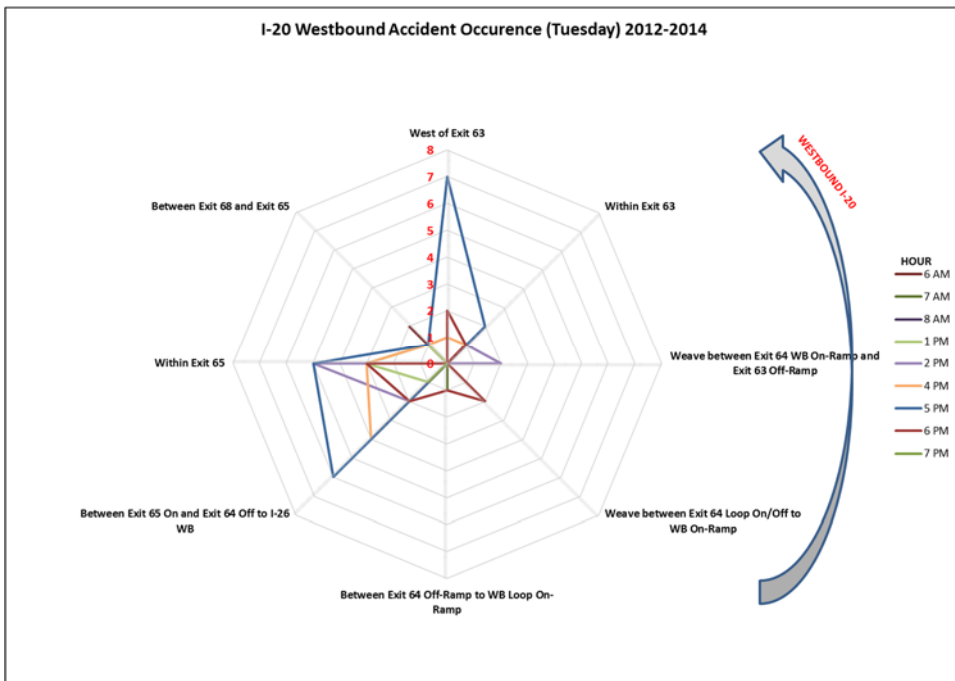
Most frequent Tuesday accidents occur:

- Within Exit 65
- Between Exit 65 and Exit 64 off-ramp to I-26 northbound
- West of Exit 63

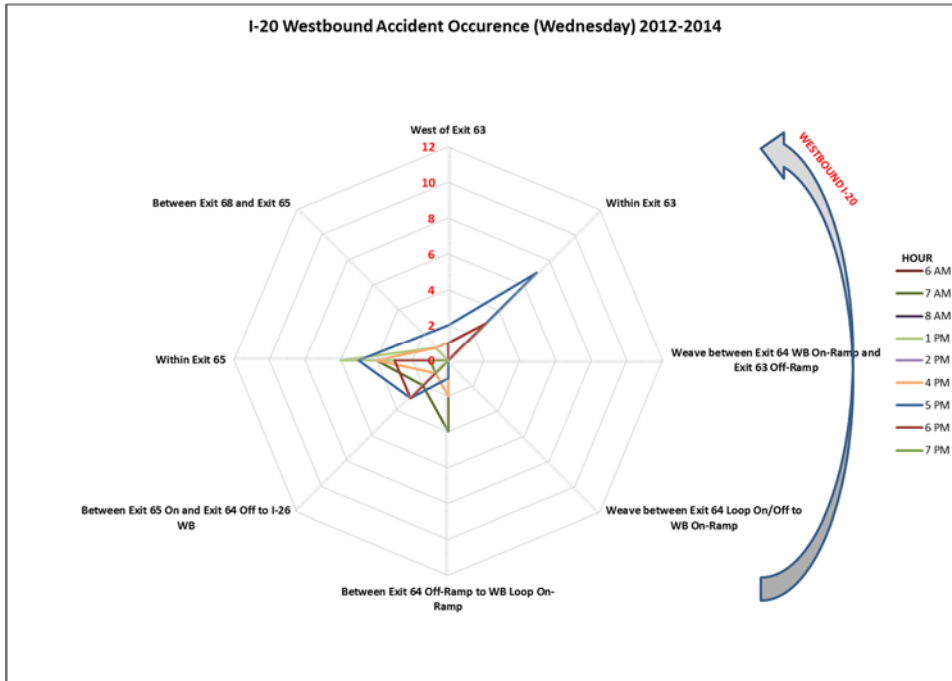
Figure 2.31: Westbound I-20 Accident Occurrence (Wednesday)

Most frequent Wednesday accidents occur:

- Within Exit 65
- Within Exit 63

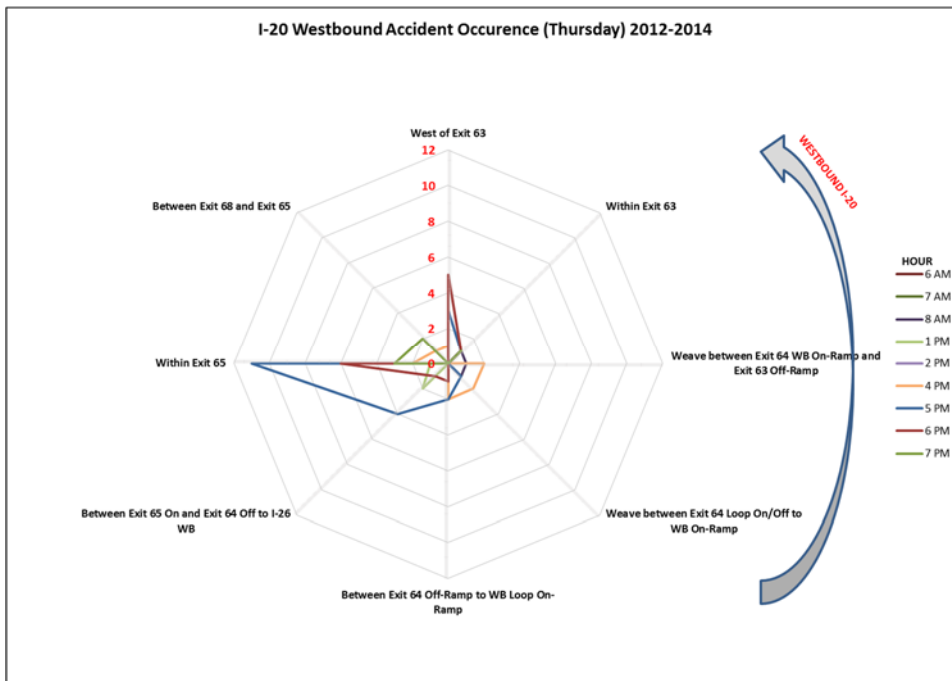
Most frequent Thursday accidents occur:

- Within Exit 65
- Between Exit 65 and Exit 64 off-ramp to I-26 northbound
- West of Exit 63

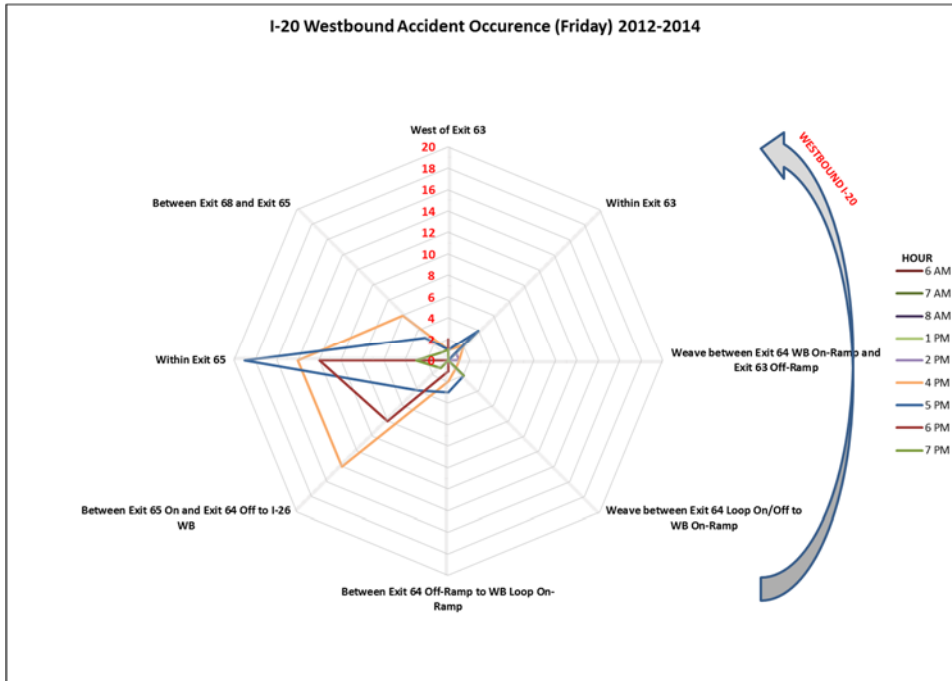
Figure 2.33: Westbound I-20 Accident Occurrence (Friday)

Most frequent Friday accidents occur:

- Within Exit 65
- Between Exit 65 and Exit 64 off-ramp to I-26 northbound

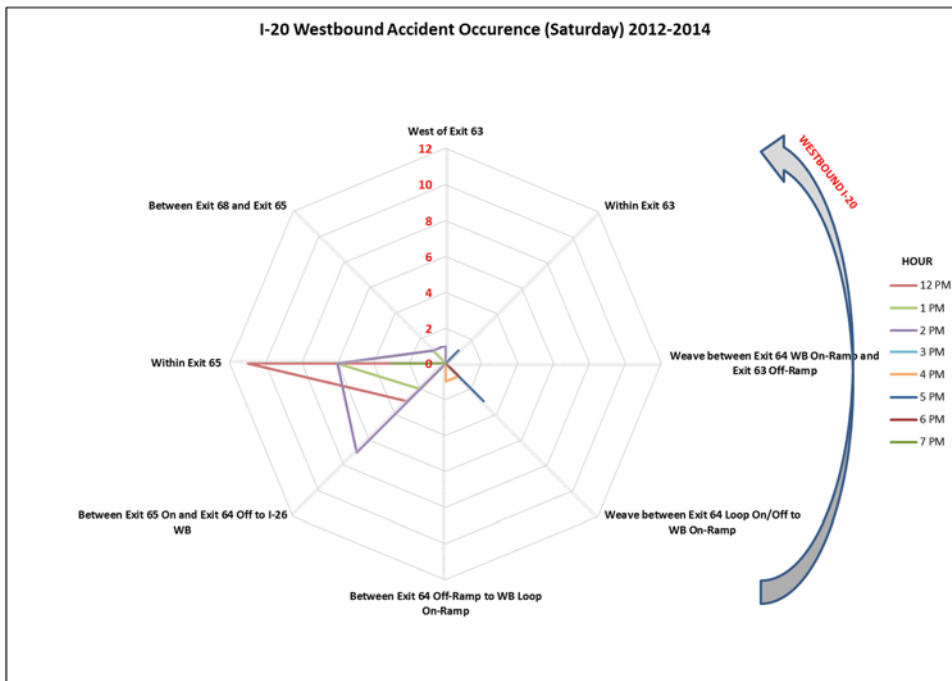
Most frequent Saturday accidents occur:

- Within Exit 65
- Between Exit 65 and Exit 64 off-ramp to I-26 northbound
- West of Exit 63
