Crash Analysis

*Carolina Crossroads
I-20/26/126 Corridor Project
Lexington and Richland Counties, South Carolina*

Draft 01 February 2016

Prepared for South Carolina Department of Transportation
and the Federal Highway Administration

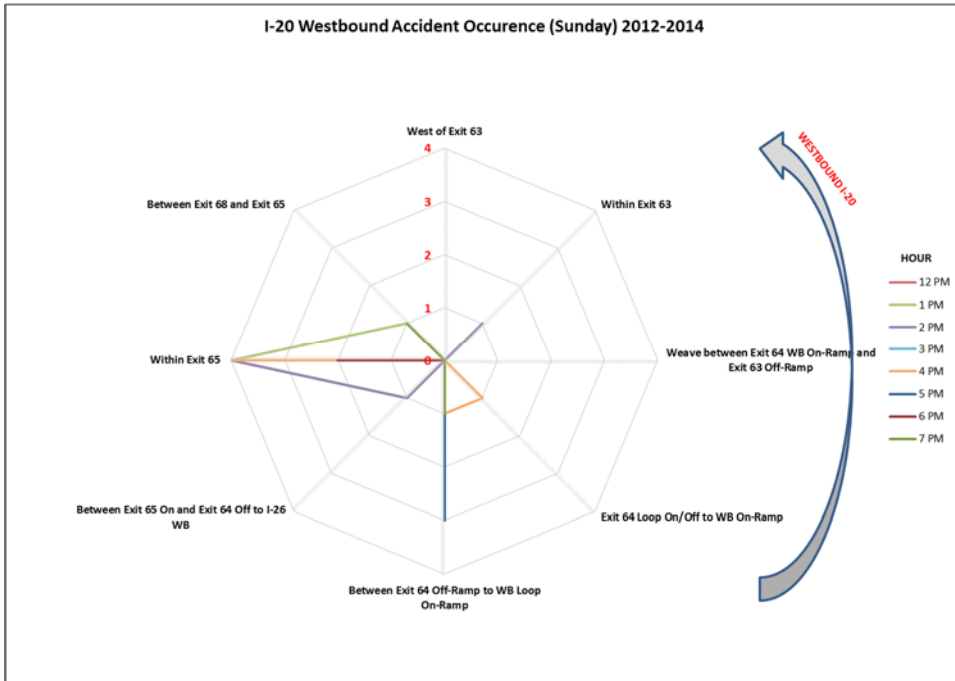
Figure 2.35: Westbound I-20 Accident Occurrence (Sunday)

Most frequent Sunday accidents occur:

- Within Exit 65
- Between the Exit 64 off-ramp and the loop on-ramp

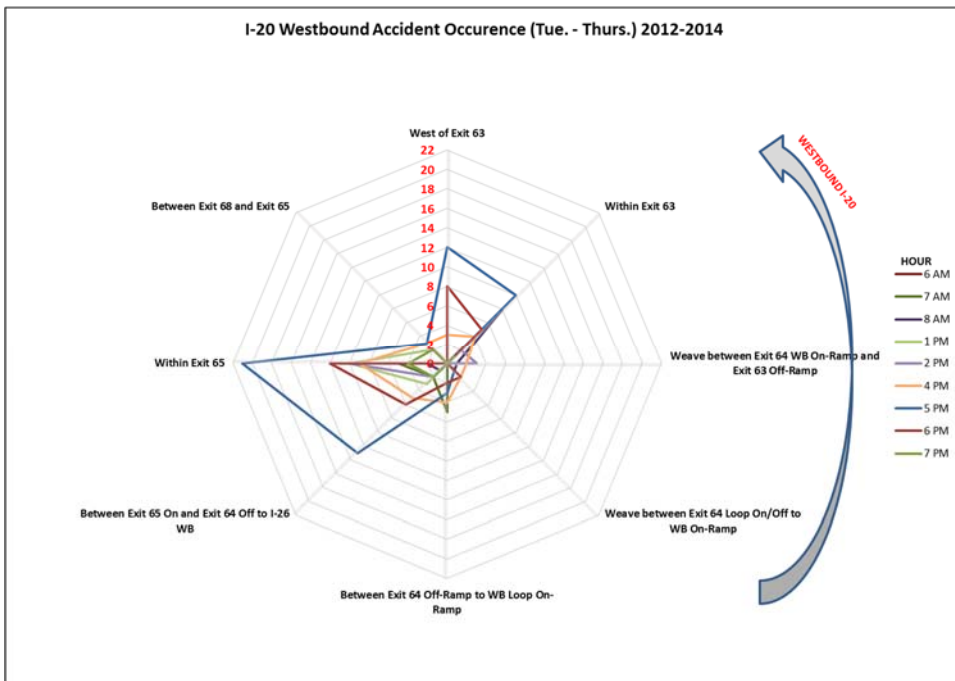
Most frequent Weekday accidents occur:

- Within Exit 65
- Between Exit 65 and Exit 64 off-ramp to I-26 northbound
- Within Exit 63
- West of Exit 63

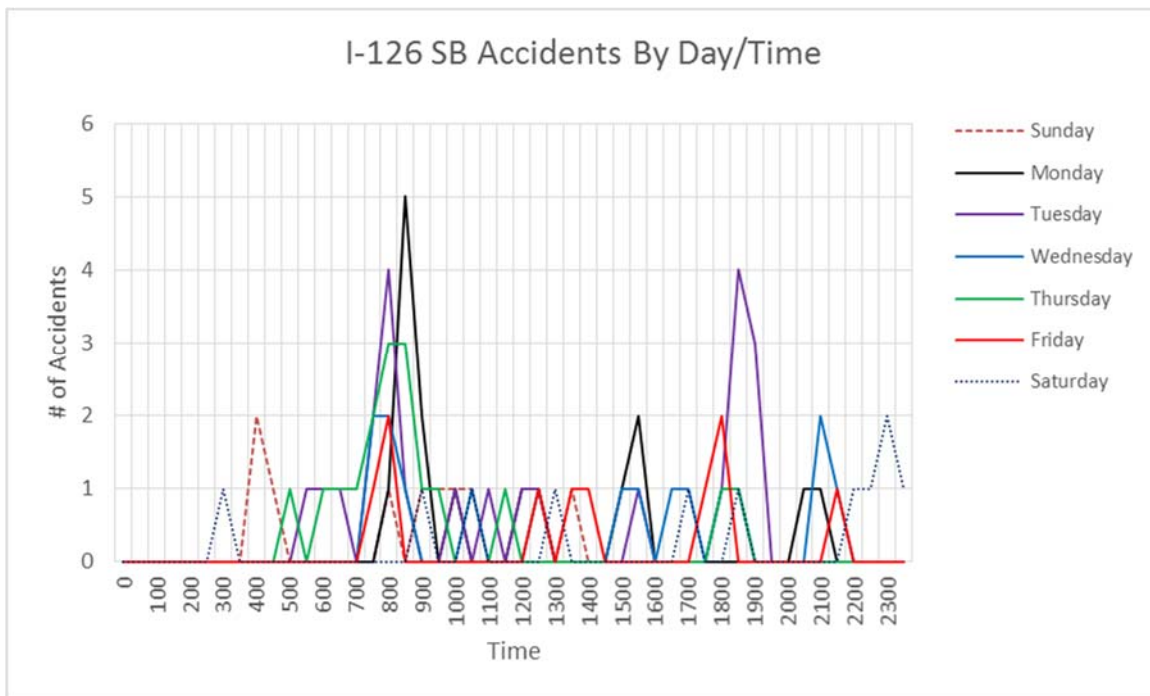
Figure 2.37: I-126 Southbound Crash Summary - Day of the Week and Time of Day

Crash data along southbound I-126 were also summarized based on day of the week and time of day. A graph depicting the time and day of the week is shown in **Figure 2.37**.

As can be seen from **Figure 2.37**, the morning peak period (between 7:00 AM and 9:00 AM) along southbound I-126 has the highest occurrence of crashes. Most of the crashes during the morning peak period occur on Monday, Tuesday and Thursday. There is also a noticeable peak in accidents between 6:00 and 7:00 PM on Tuesday. Saturday crashes are most frequent at 10:00 and 11:30 PM, while Sunday crashes are most frequent at 4:00 AM.

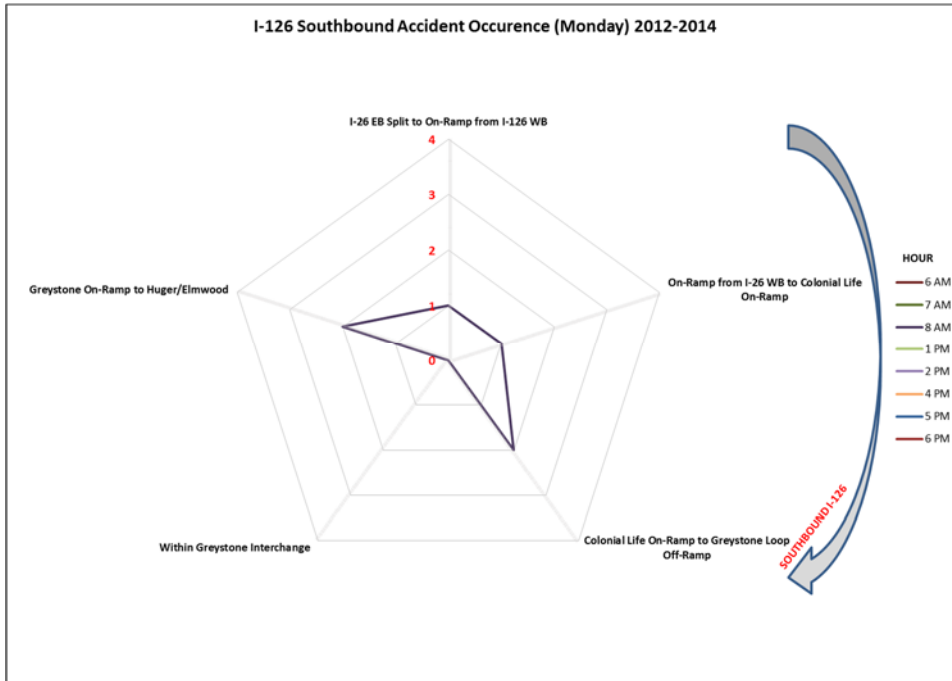
Figure 2.38: Southbound I-126 Accident Occurrence (Monday)

Most frequent Monday accidents occur:

- Between the Greystone Blvd. on-ramp to Huger St. /Elmwood Ave.
- Between the Colonial Life On-Ramp to the Greystone Blvd. Loop off-ramp

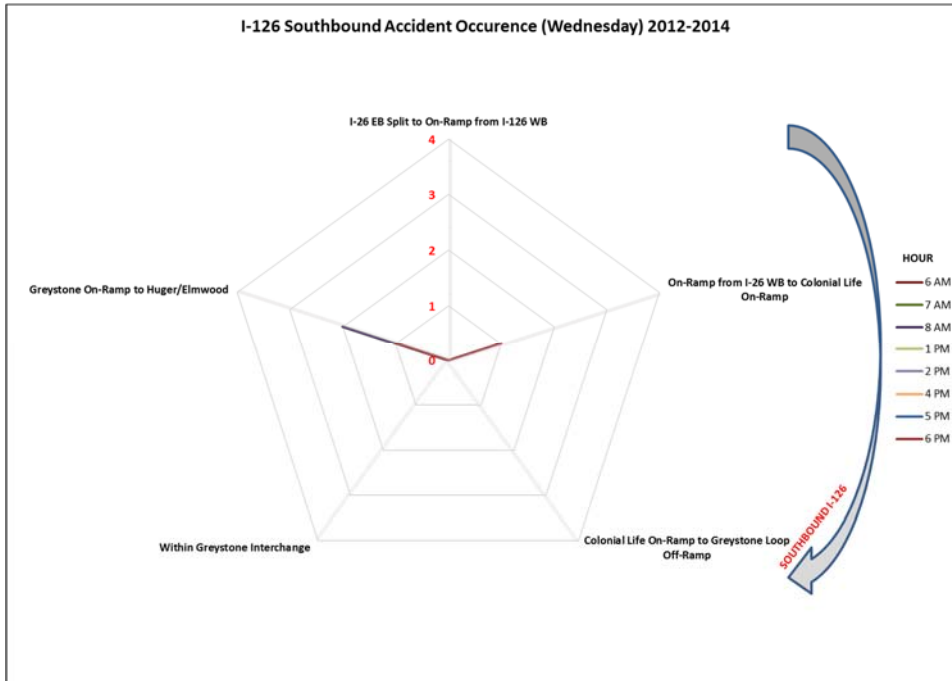
Figure 2.40: Southbound I-126 Accident Occurrence (Wednesday)

Most frequent Wednesday accidents occur:

- Between the Greystone Blvd. on-ramp to Huger St. /Elmwood Ave.

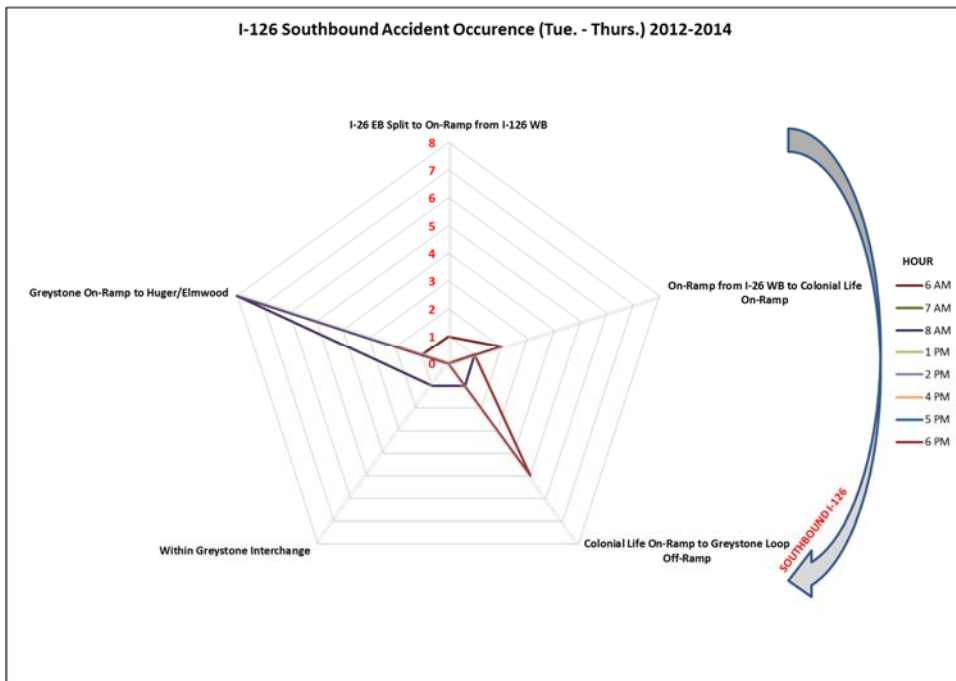
Most frequent Weekday accidents occur:

- Between the Greystone Blvd. on-ramp to Huger St. /Elmwood Ave.
- Between the Colonial Life On-Ramp to the Greystone Blvd. Loop off-ramp

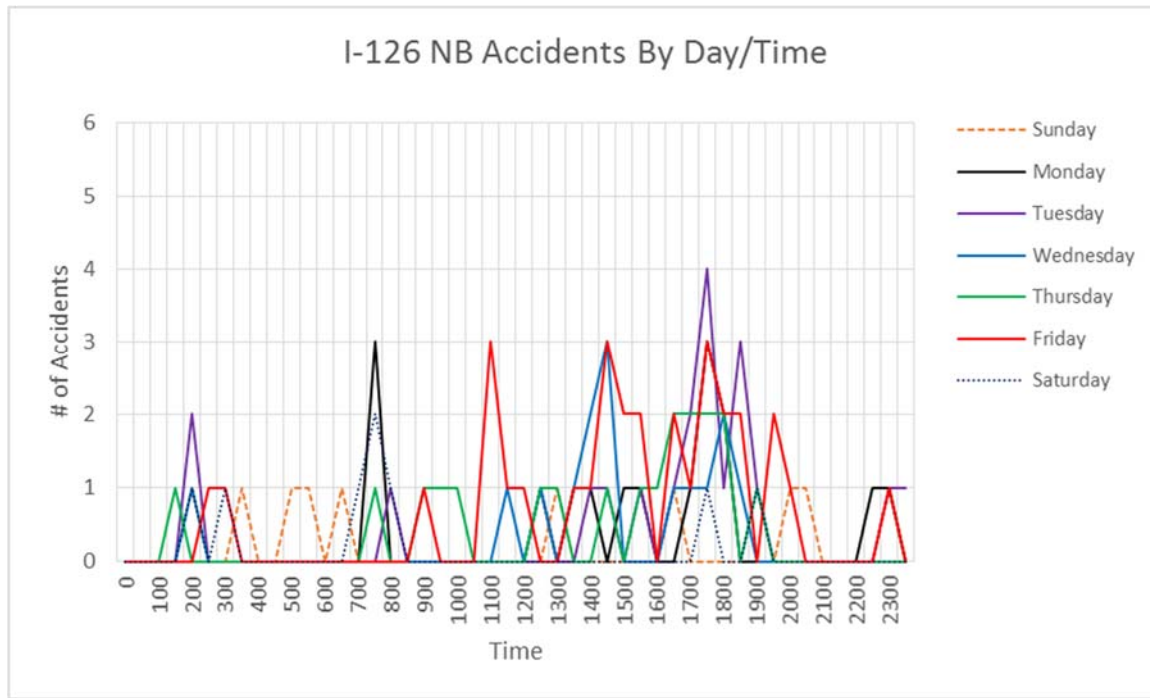
Figure 2.46: I-126 Northbound Crash Summary - Day of the Week and Time of Day

Crash data along northbound I-126 were also summarized based on day of the week and time of day. A graph depicting the time and day of the week is shown in **Figure 2.46**

As can be seen from **Figure 2.46**, there are multiple accident peaks throughout the day, including 7:30 and 11:00 AM on Monday and Friday respectively, and at 2:30 PM (Wednesday and Friday), 5:30 PM (Monday, Tuesday and Friday), and at 6:30 PM (Tuesday). There is also a noticeable peak in accidents between 1:30 and 3:30 AM occurring on multiple days.

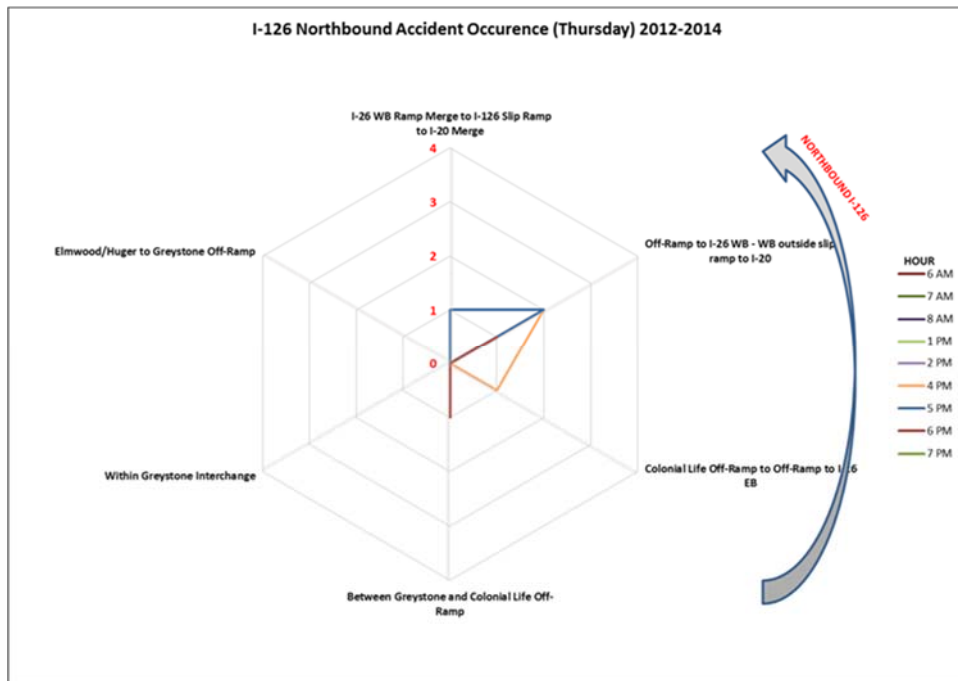
Most frequent Thursday accidents occur:

- Between the off-ramp to I-26 southbound to the diverge area for the outside slip ramp to I-20
