Asbestos Inspection Report
I-20 Road Widening & Bridge Replacement Project
I-20 Bridges over Norfolk Southern Railroad
& Meat Plant Road
Lexington County, South Carolina

Prepared For:
ICA Engineering
Columbia, South Carolina

May 26, 2015

RE: Asbestos Inspection Report
I-20 EB over NSRR - Structure No. 3210002020300
I-20 WB over NSRR - Structure No. 3210002040300
Lexington County, South Carolina

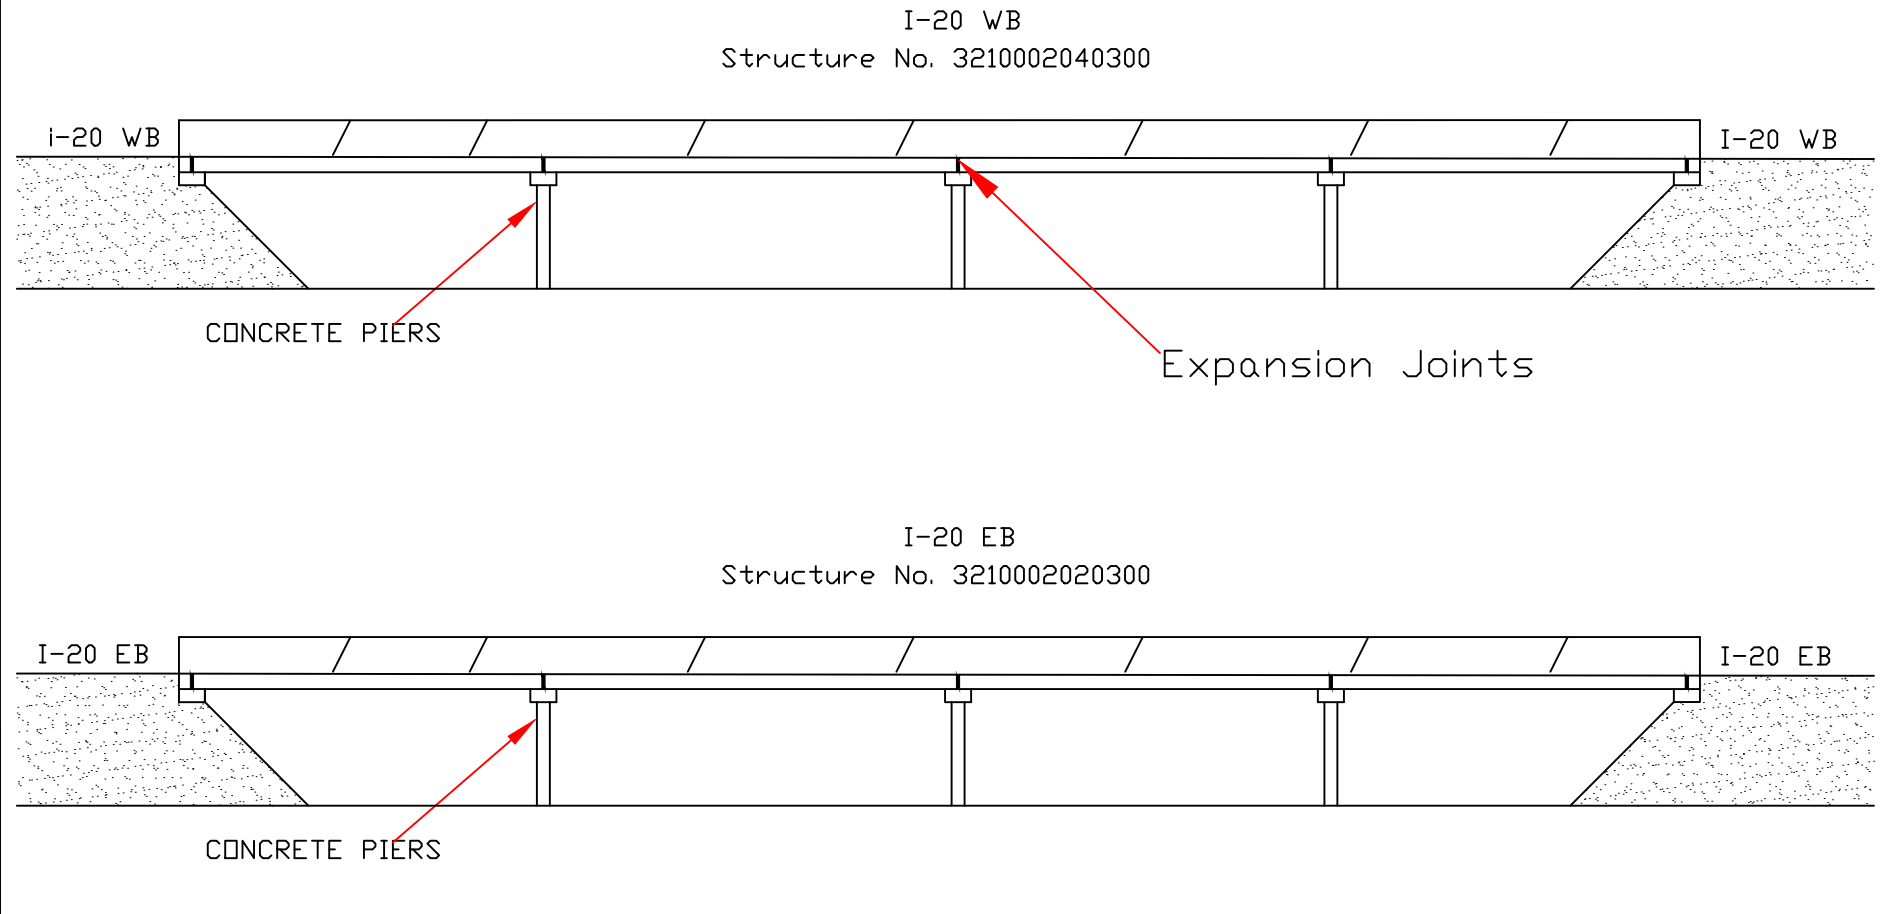
Figure 1

Note: See *Figure 1* for locations

Structure No. 3210002020300 - EB

Structure No. 3210002040300 - WB

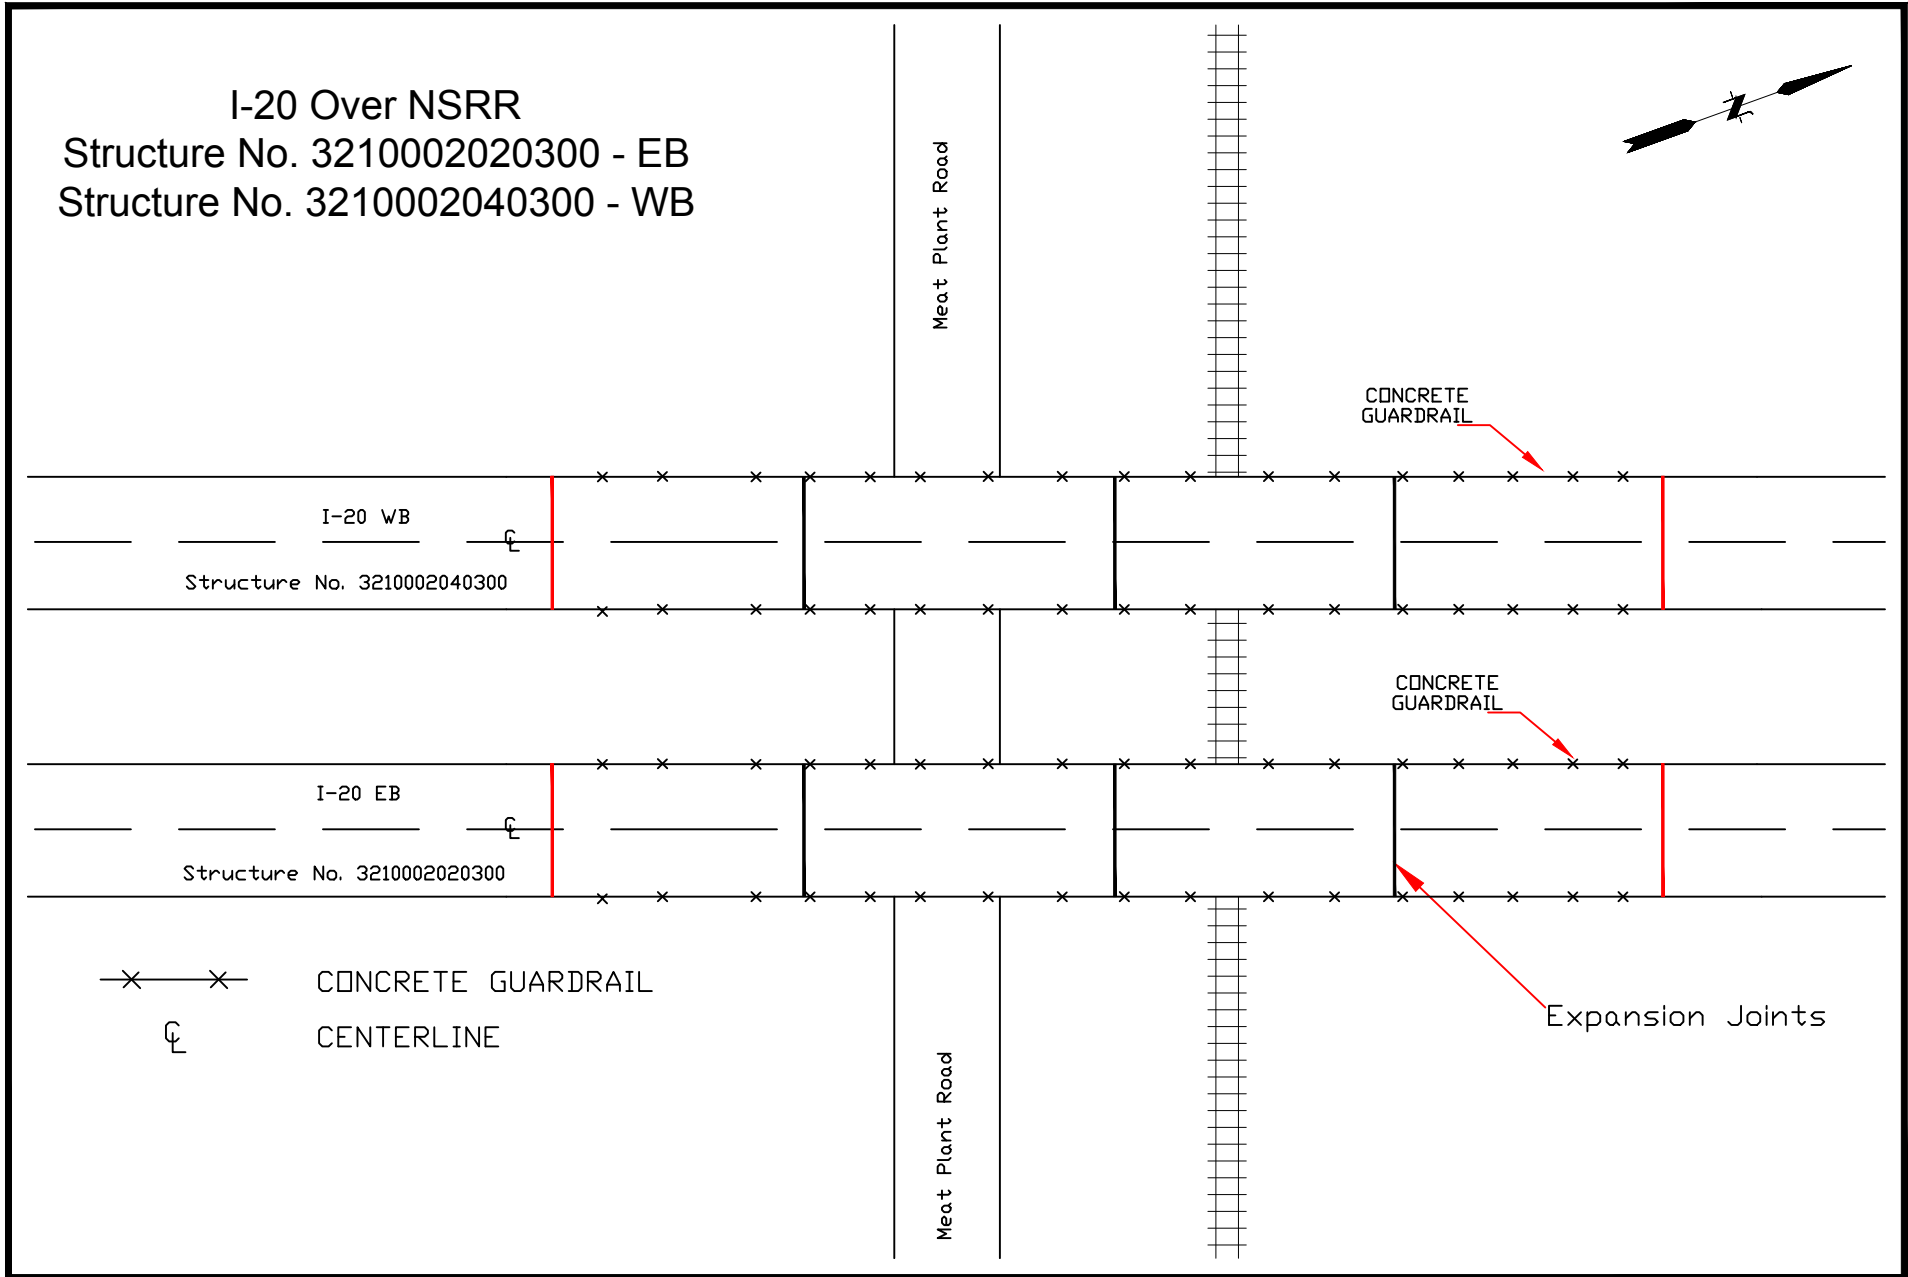
Figure 1

Figures 1 and 2 depicting an aerial and profile view of the bridge structures are included along with this letter for your use. As always, please call if you have any questions or require additional information.
