Substructure Foundation Investigation Report

SCDOT Structure Number: 2670015400100

Road Designation: S-26-154

Feature Crossing Name: Swash

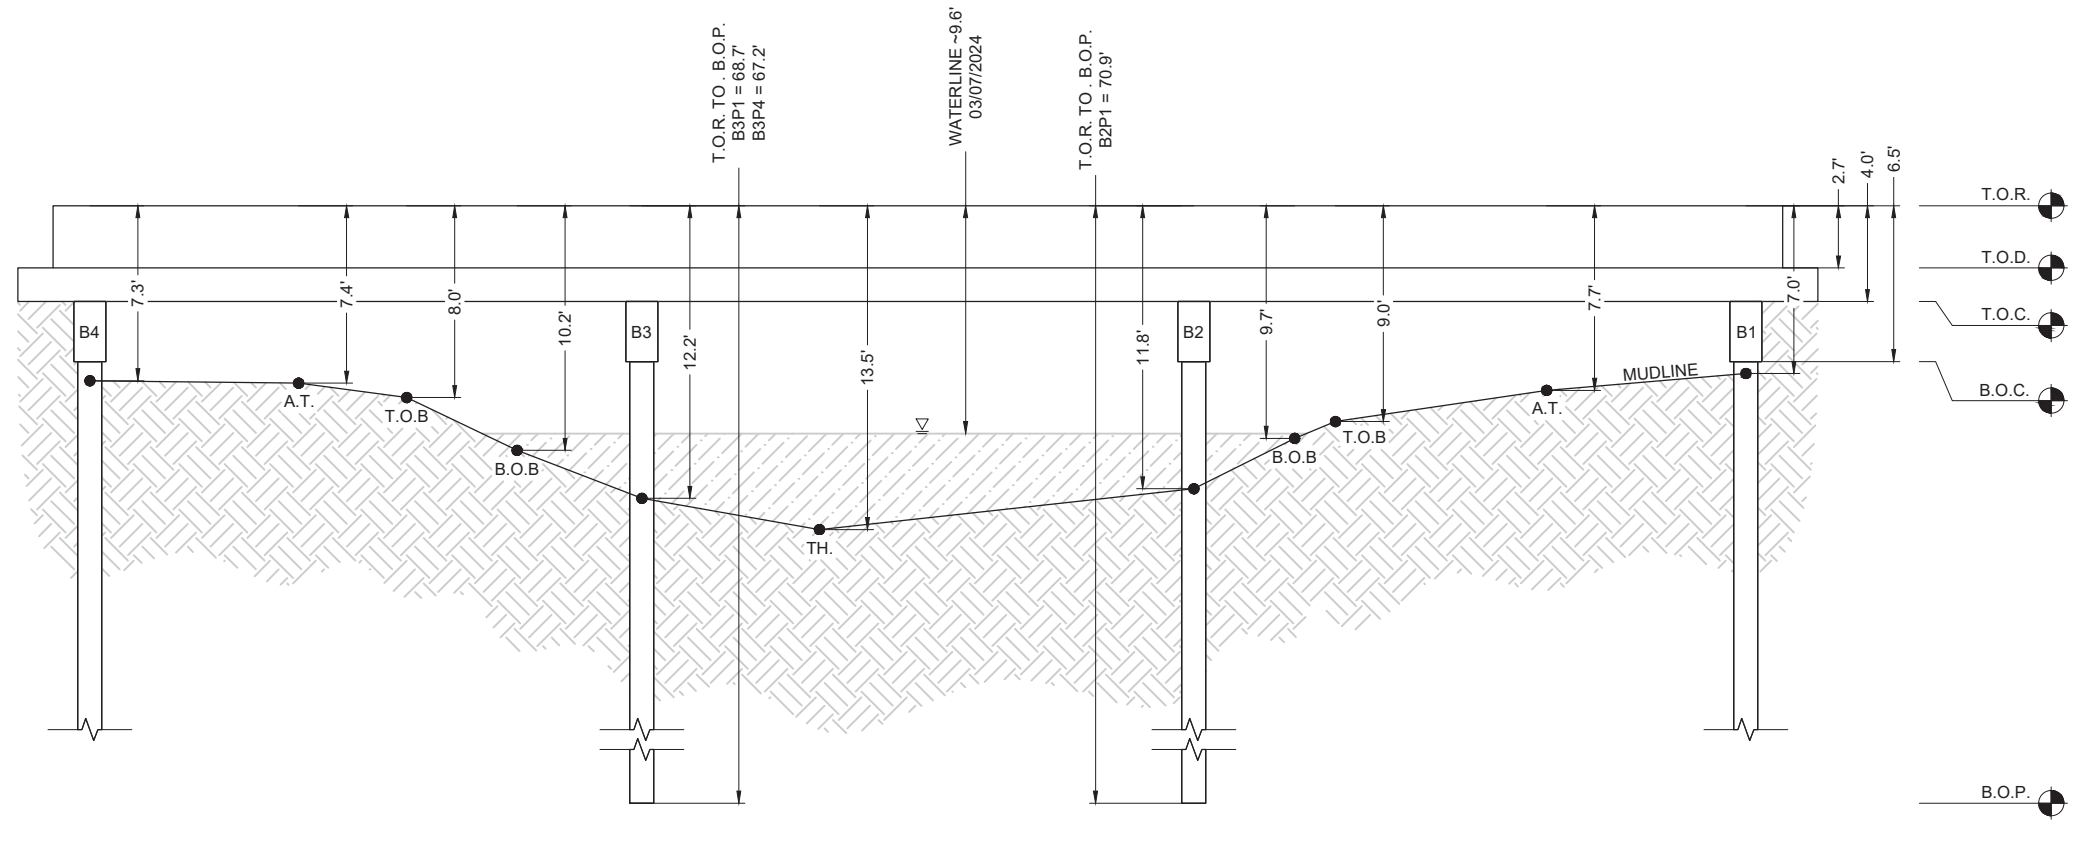
FIGURE 4: DOWNSTREAM PROFILE
 NTS

1. Values are approximated.
2. Measured Thalweg from Top of Rail: 13.5 ft. Downstream
3. Top of Rail to Top of Pile: 6.5 ft.
4. The Computed Overall Length shown for this pile is calculated from the measured distance from top of rail to top of pile, plus the distance from the pile top, where the pile touches or enters the pile cap, to the pile tip; or it may be from the pile top to the location of a material anomaly such as a break, fracture, split, splice, area of deterioration or corrosion, etc. There is no definitive way to mathematically determine which case exists. If pile damage or other material anomalies are present, they create areas that can reflect wave energy and result in computed lengths that represent the distance from the pile top to the location of such. The Top of Pile to Pile Tip, Computed Embedment, and Embedment Below Thalweg measurements are calculated using the more conservative Computed Overall Length measurement.

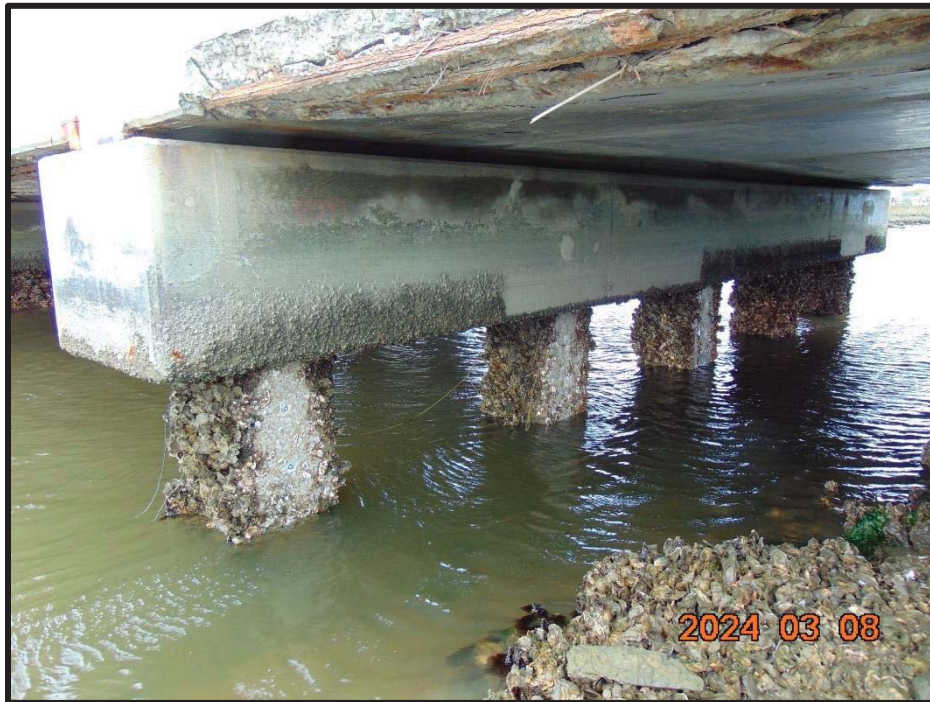
Photo 15: Bent 2 (Looking Upstream)

Number of Foundations tested: 3 (1 pile on Bent 2 and 2 piles on Bent 3)
