# Underwater Inspection Report

## I-126 RAMP

## Saluda River

Bridge ID No. 4010012620071

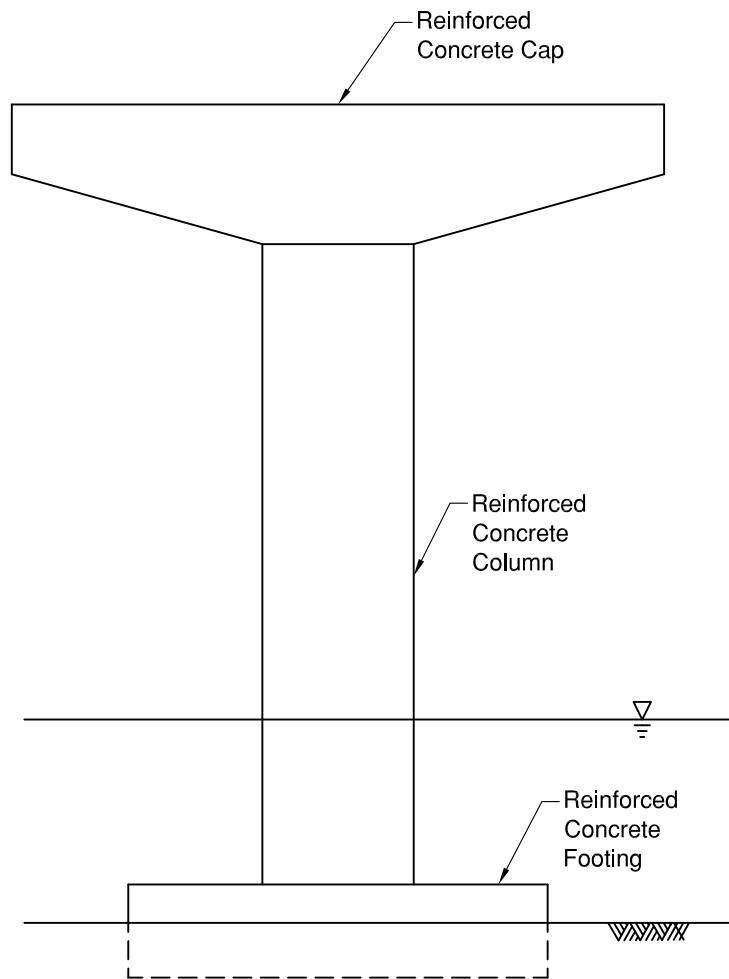
<p><b>SOUTH CAROLINA DEPARTMENT OF TRANSPORTATION</b></p> <p>Bridge ID: 4010012620071</p>	<p>I-126 Ramp over Saluda River</p> <p>Typical Pier Elevation</p>	<p>FIG NO.</p> <p>2</p>
Not to Scale	<p>DATE</p> <p>September 2012</p>

Typical Elevation (Piers A through C)

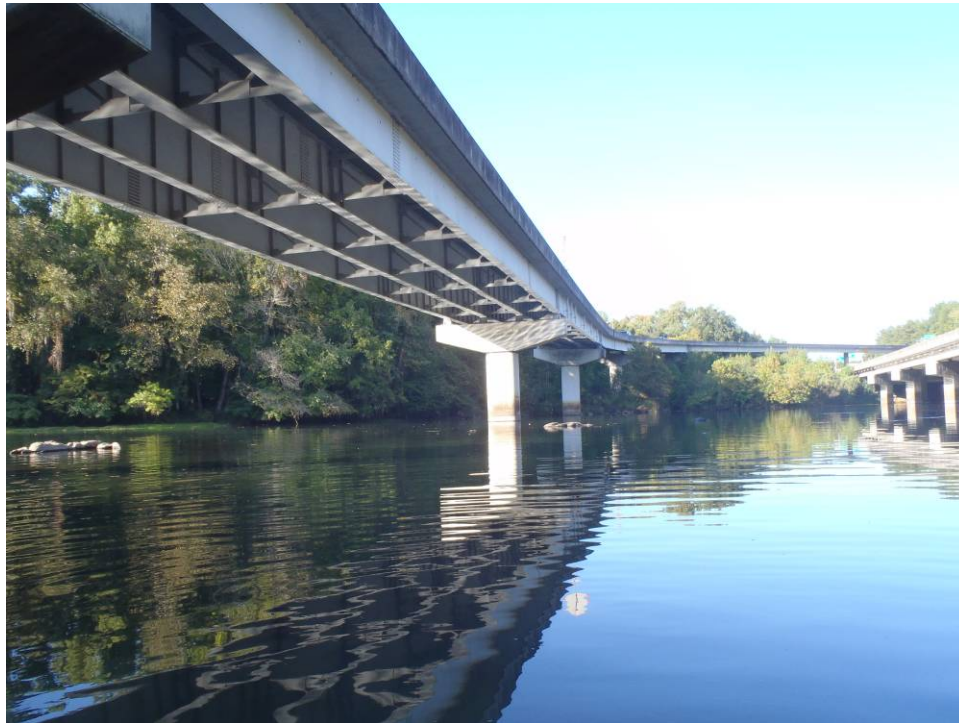
The report cover photograph shows an overall view of the bridge's upstream fascia, and Photograph 1 in Appendix B shows a downstream fascia view.

Photograph 1. Downstream Fascia.

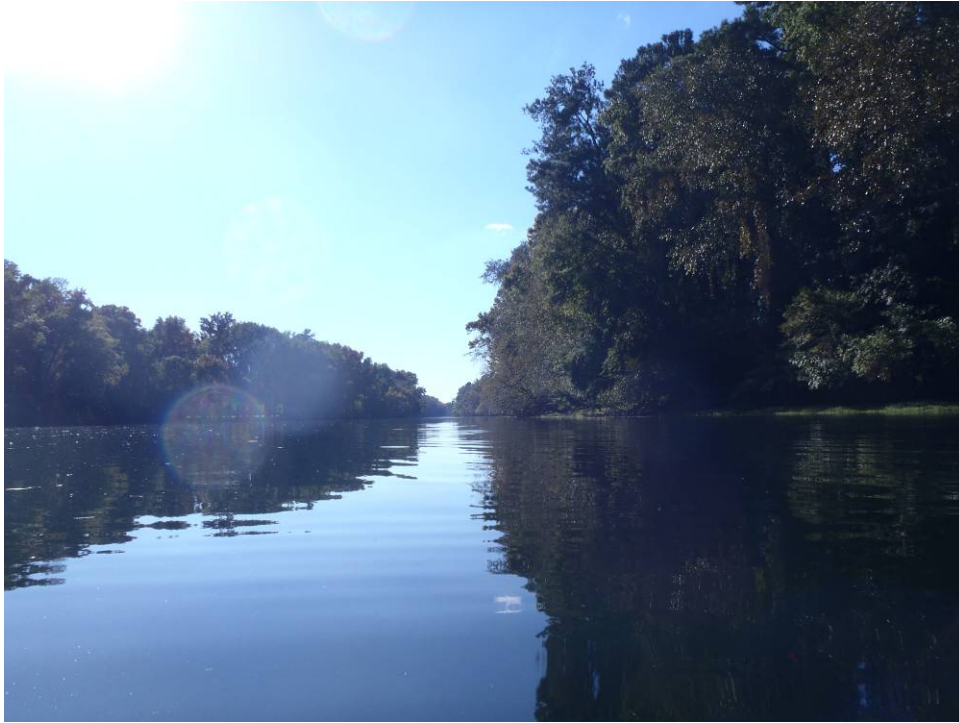
**Photograph 5. View Upstream from Under Bridge.**

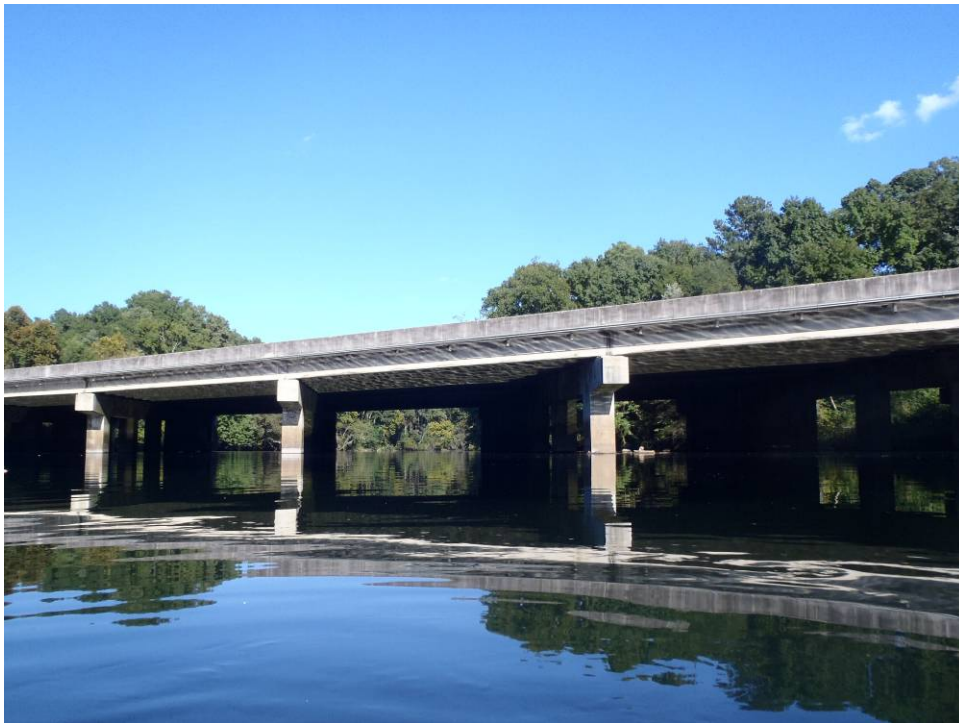
**Photograph 6. View Downstream from Under Bridge.**
